## **NATIONAL TRANSPORTATION SAFETY BOARD**

# **AIRFRAME AND ENGINE EXAMINATION**

**WPR17LA020**

Location: Taylor, AZ  
Date: November 12, 2016  
Aircraft: Piper PA 28-235, Registration Number: N9398W, Serial #: 28-11095  
NTSB IIC: Elliott Simpson

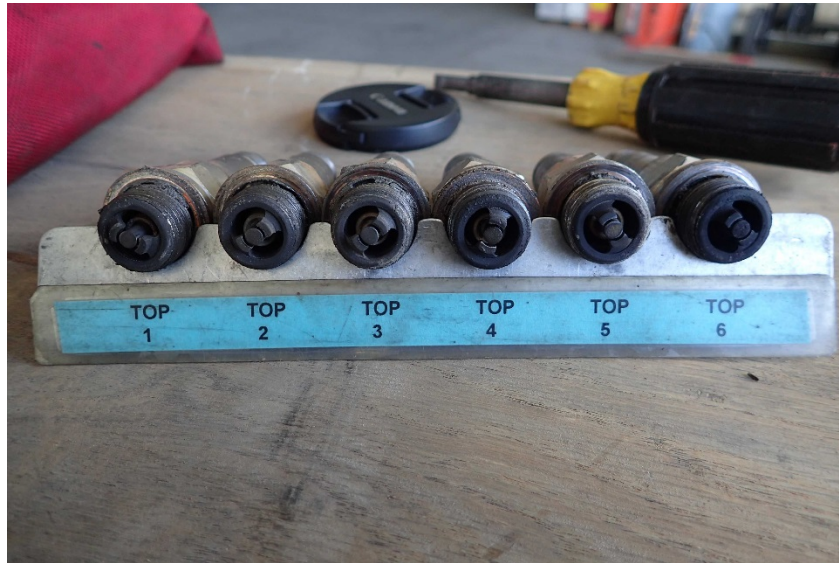
Photo 1 – Top Spark Plugs

The top spark plugs were removed, and examined. They were Tempest massive-electrode types, and their electrodes remained mechanically undamaged, coated in black soot, and displayed normal wear signatures when compared with the Champion Spark Plugs AV-27 Check-A-Plug chart (Photo 1). The crankshaft turned freely when rotated by hand utilizing the propeller, and cylinder “thumb” compression was present on all cylinders.

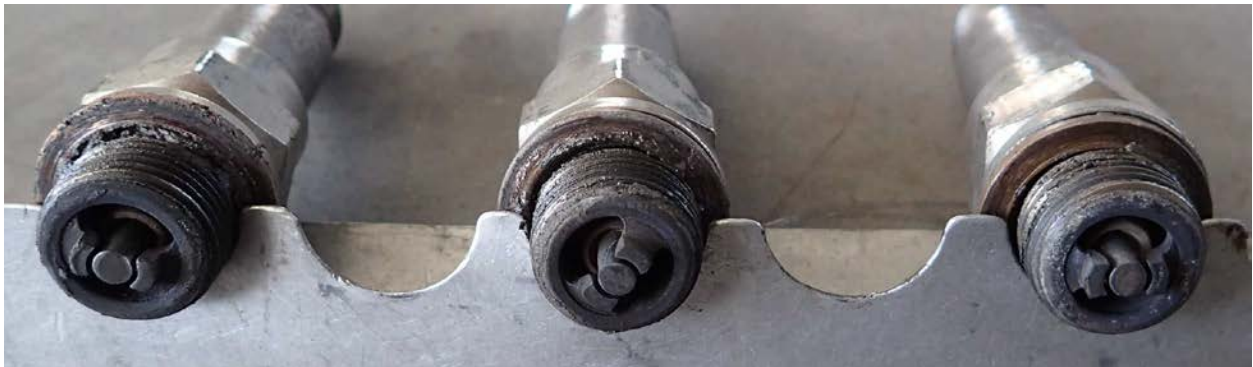
Photo 2 – Top Spark Plugs after Engine Run

The engine was then operated throughout its speed range for an additional 10 minutes, with multiple throttle “chops” and rapid accelerations initiated in an attempt to simulate the accident scenario. The engine responded appropriately at all times, with no hesitation or speed fluctuations. The JPI engine monitor revealed that the exhaust gas temperatures for cylinder number 3 were slightly higher than the other cylinders. The engine was shut down and examined further. The top spark plugs for cylinder 1, 3, and 5 were removed and now exhibited a grey coloration (Photo 2). The inner surface of the exhaust pipe was coated in light grey deposits, and were free of oil residue.

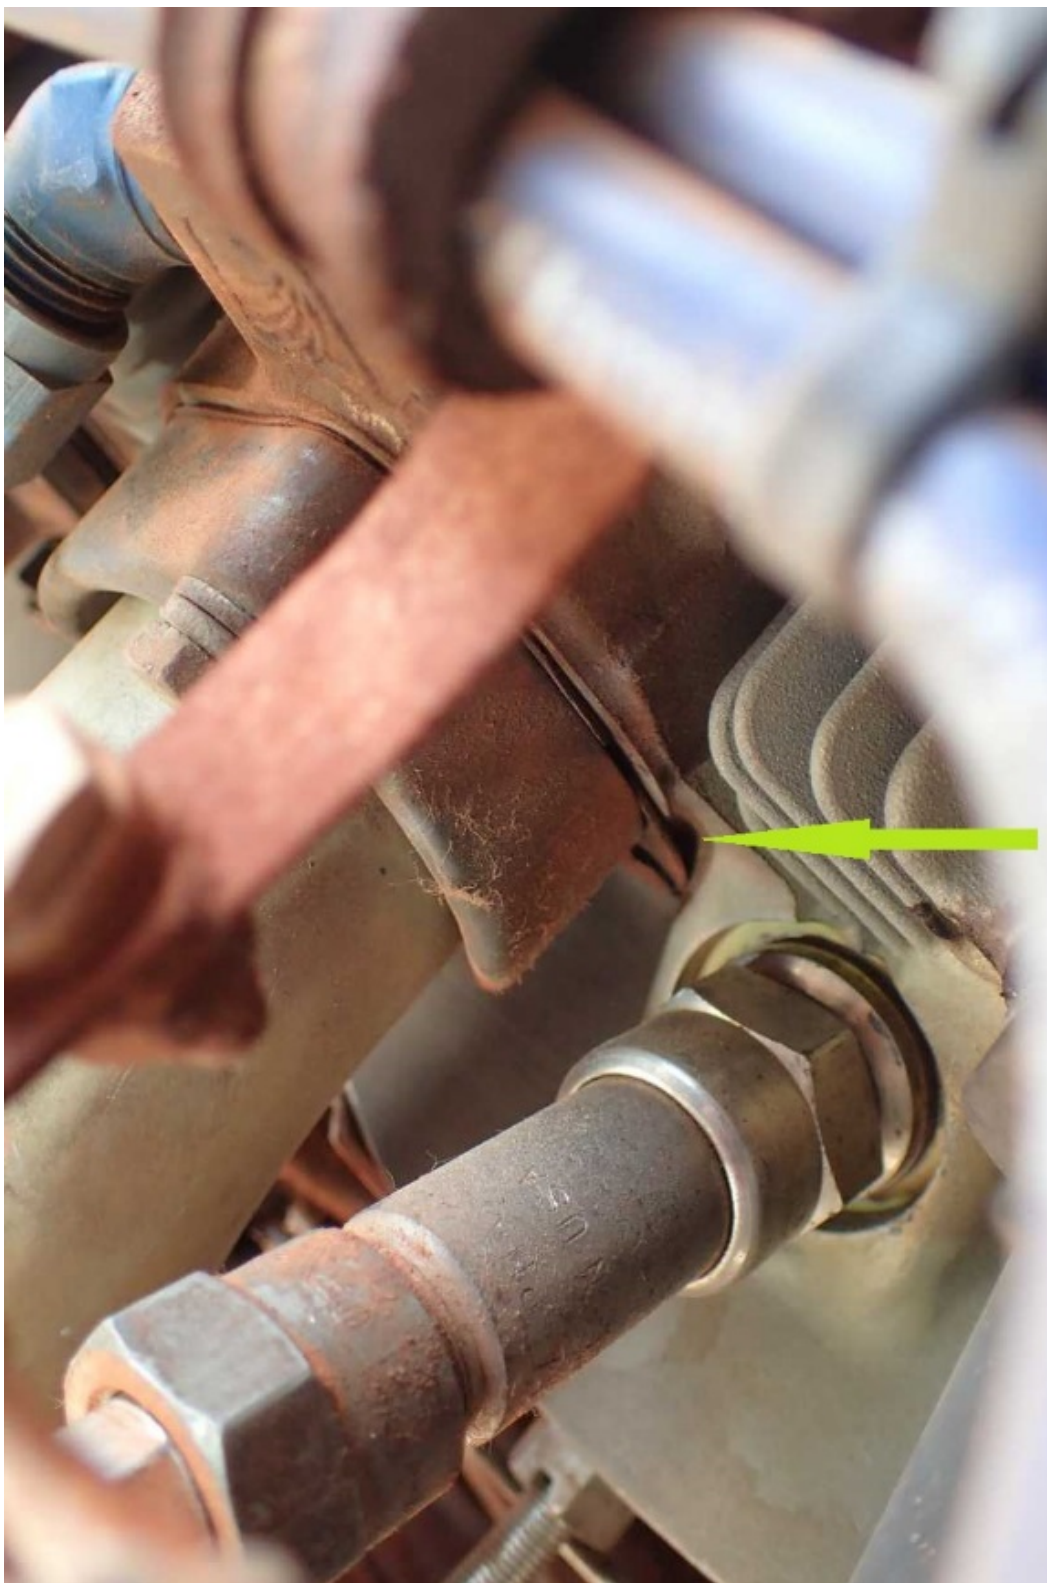
Photo 3 – Number 3 Cylinder Intake Manifold Gasket

The gasket sealing the number 3-cylinder intake manifold to the cylinder head appeared to have become displaced on one of its sides (Photo 3). The manifold was removed, and the gasket appeared broken into two distinct pieces (Photo 4). Dark-soot discoloration was present on about 3/8 of the mating surfaces of the manifold and adjoining cylinder head flange where the gasket had broken free (Photo 5,6).

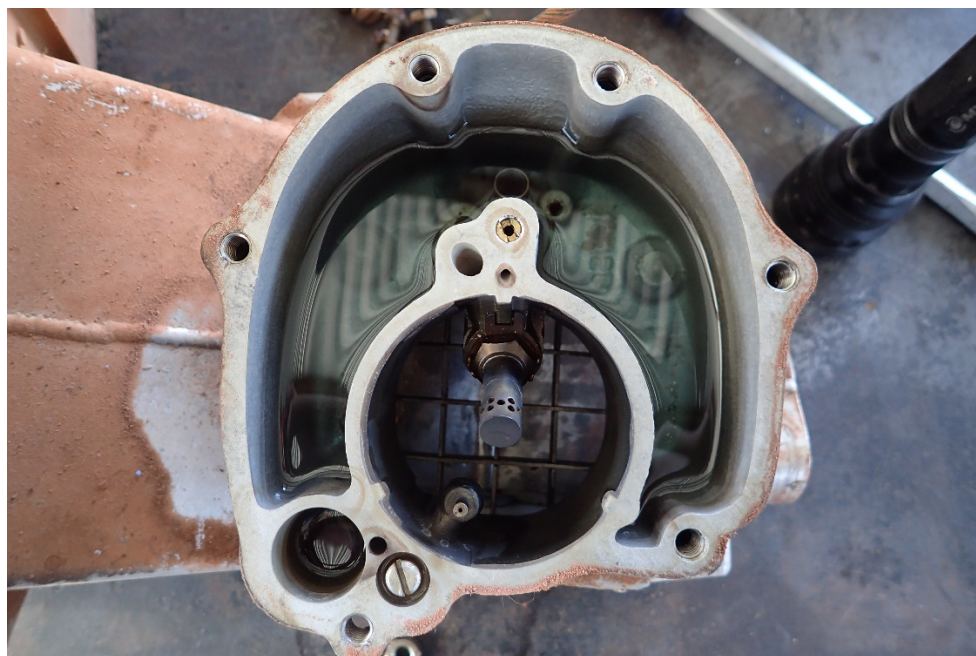
Photo 7 – Carburetor Bowl

The carburetor (PN: 10-44-4, SN: R4297) was removed, disassembled, and examined. The accelerator pump port ejected fuel when the throttle lever was activated. The carburetor bowl was full of fuel, and contained no foreign objects (Photo 7). The floats were of the hollow white plastic type, and did not appear to be leaking (Photo 8). The floats moved freely on their respective pivot assembly. The main jet was clear, and the mixture metering valve assembly was undamaged and free of obstruction.

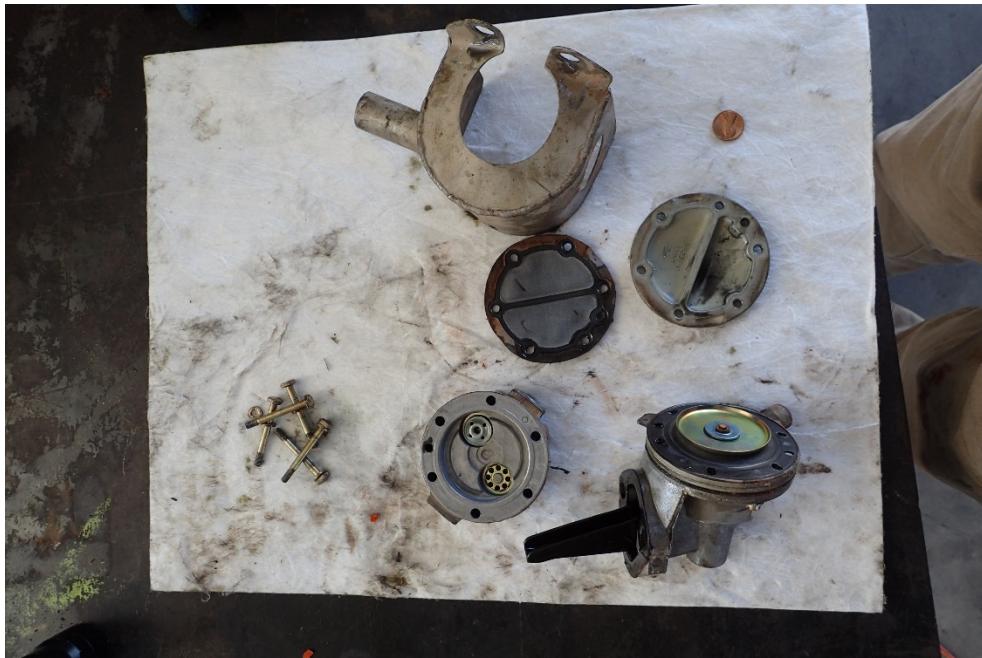
Photo 9 – Engine Driven Fuel Pump

The engine driven fuel pump was removed, disassembled, and examined. All internal diaphragms and valves were intact, and the unit contained fuel (Photo 9).
