## **NATIONAL TRANSPORTATION SAFETY BOARD**

# **STRUCTURES**

**Group Chairman's Factual Report**

**WPR17LA031**

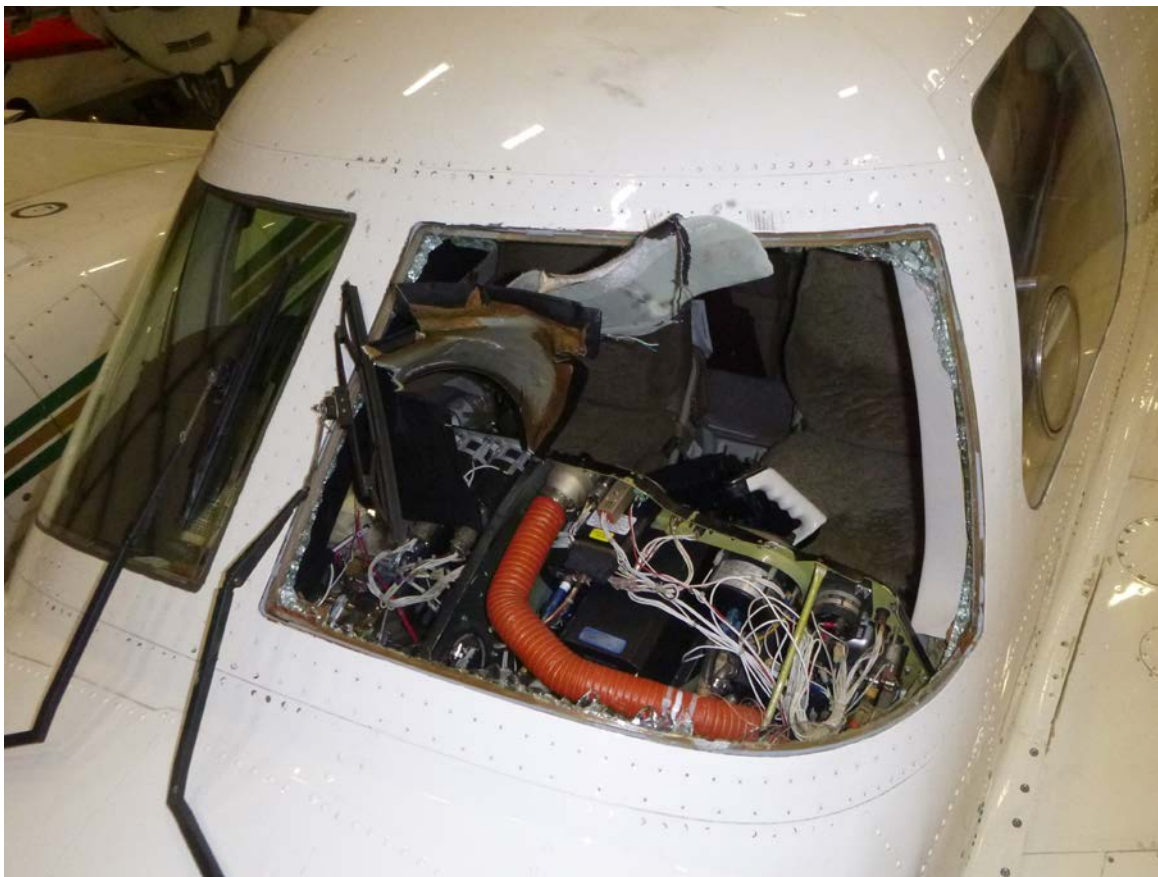
**Figure 2 – Fractured left windshield, N909PW**

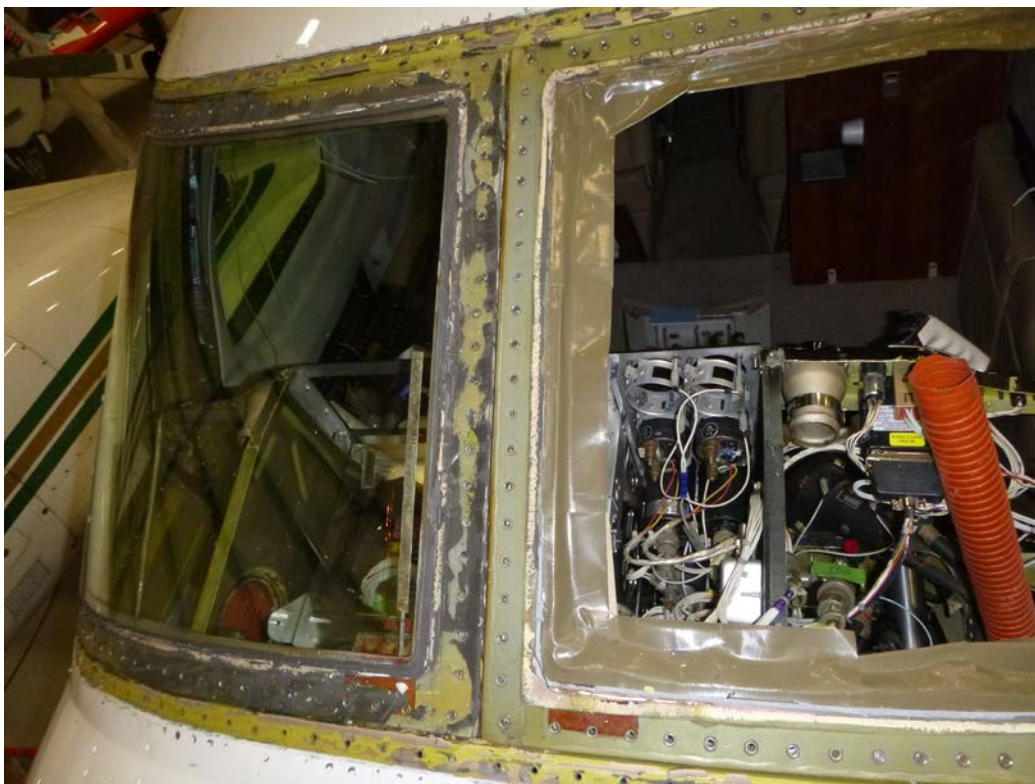
**Figure 3 – Left and right windshields after frame removal, N909PW**

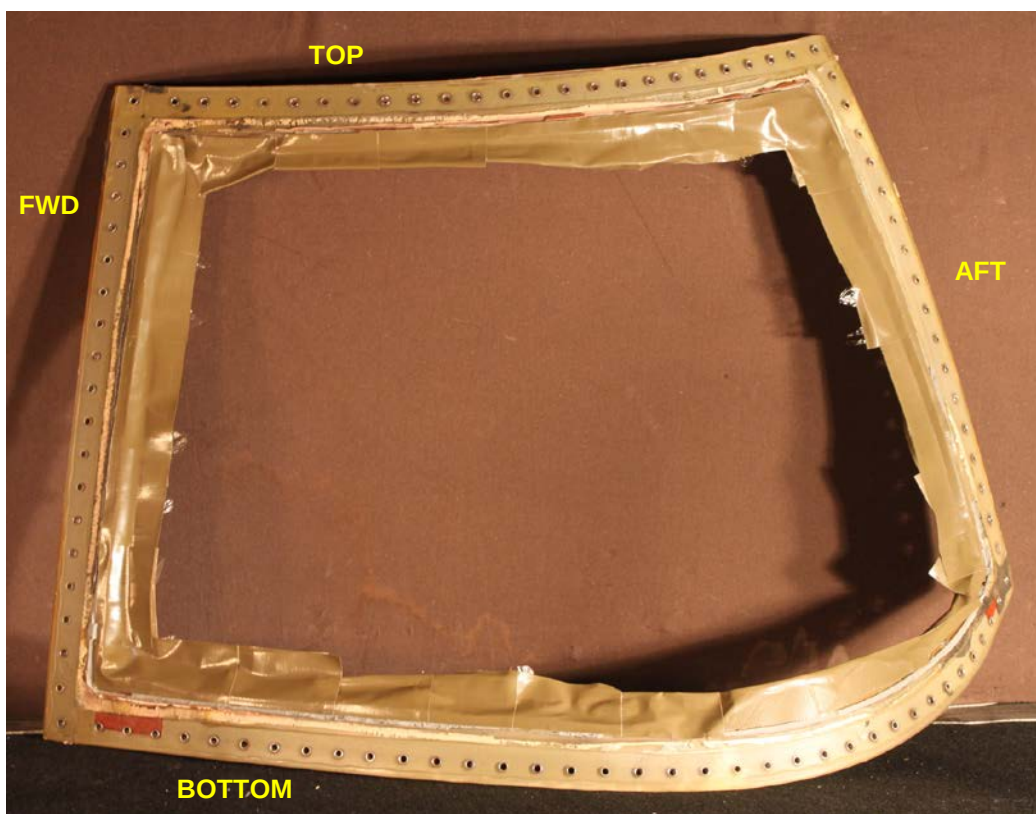
**Figure 4 – Fractured left windshield, N909PW**

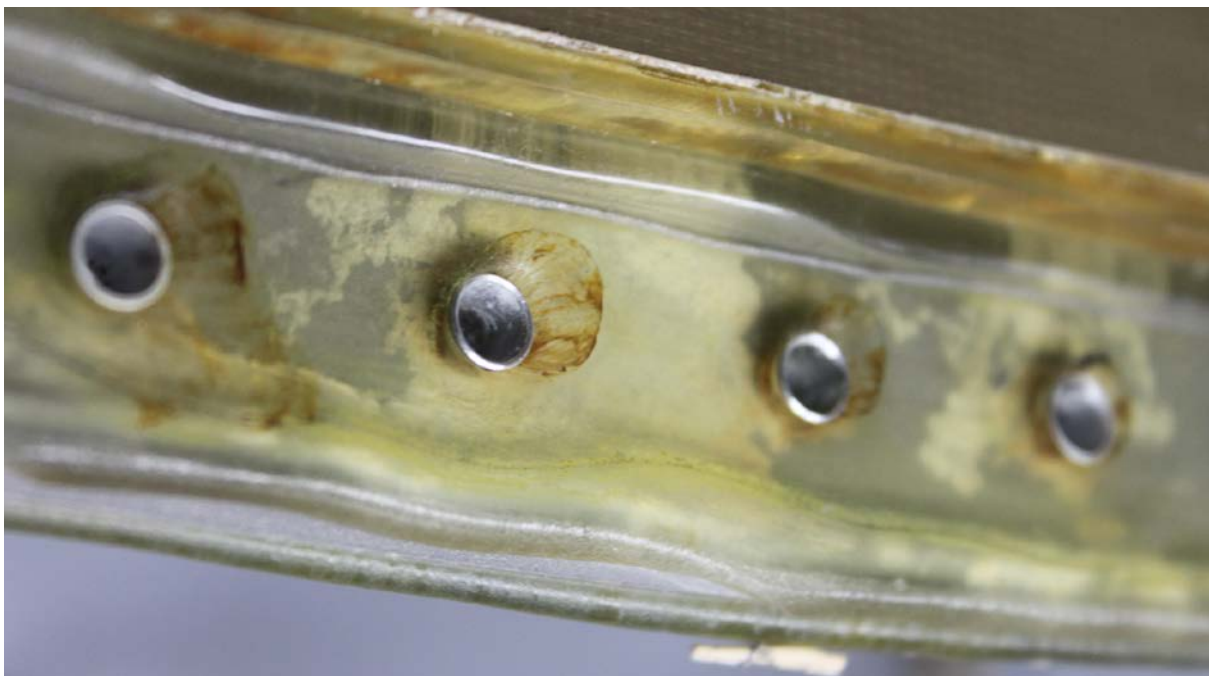
**Figure 5 – Example of warped vinyl and discoloration of retainer on left windshield**

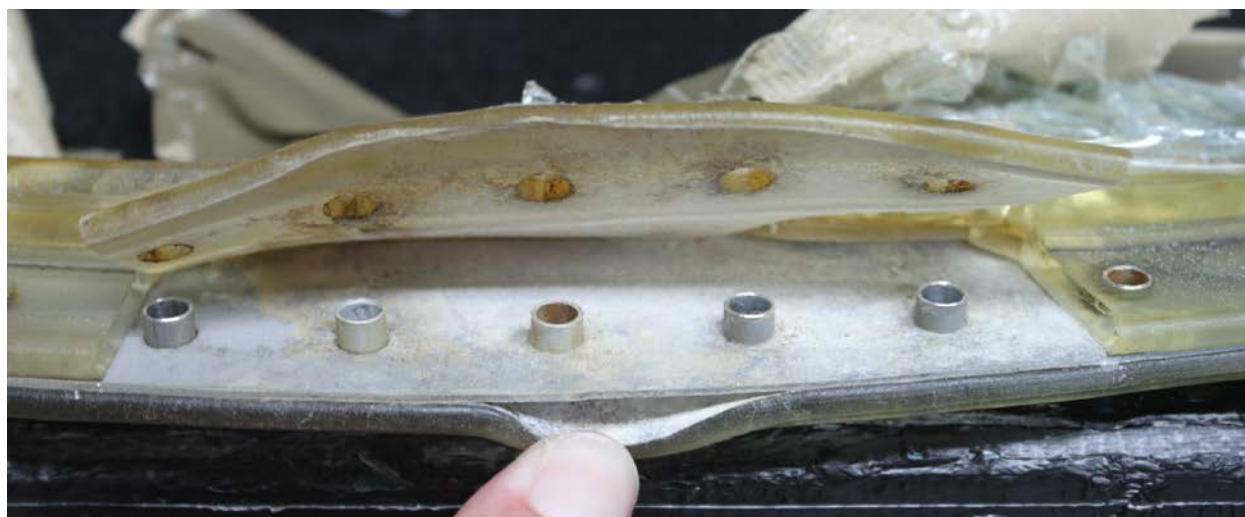
**Figure 6 – Disassembled area of lower flange on left windshield**

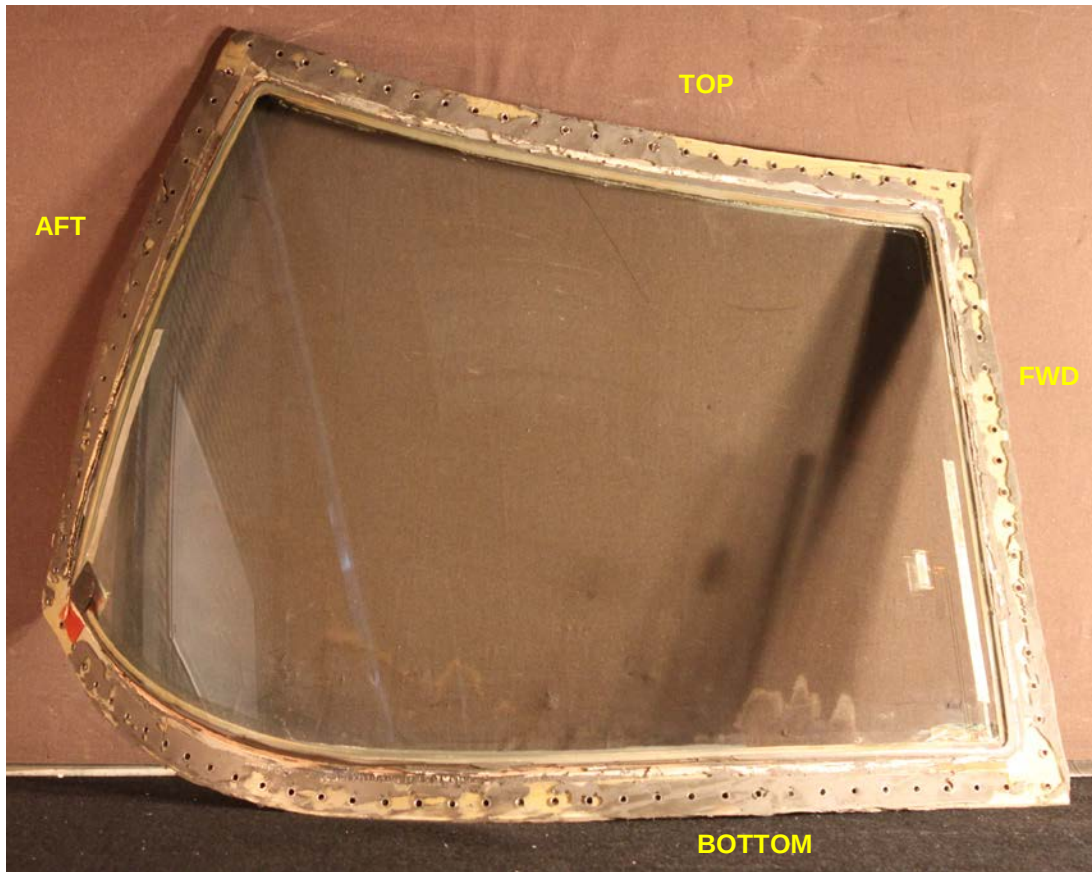
**Figure 7 – Intact right windshield, N909PW**

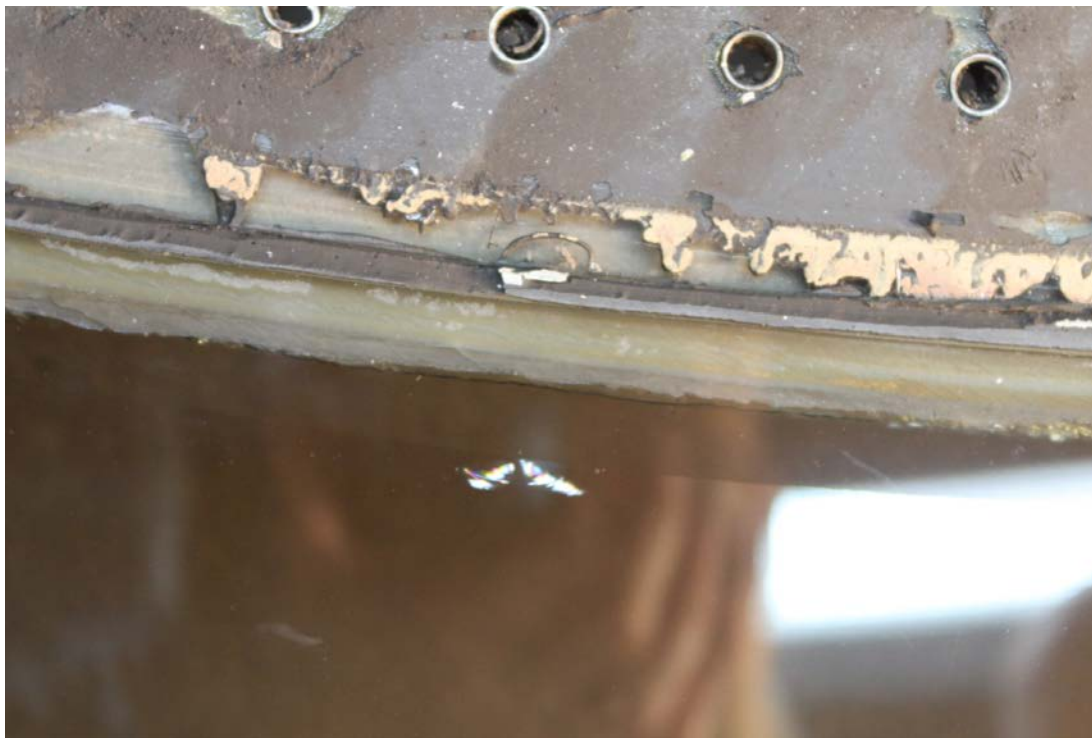
**Figure 8 – Peel chip fracture on right windshield**
