## **NATIONAL TRANSPORTATION SAFETY BOARD**

## **Group Chairman's Factual Report**

**WPR17LA031**

**RE: Evaluation of a Left Hand Main Windshield for Piper; PPG Part Number 45213; S/N 7-H-1-2-147**

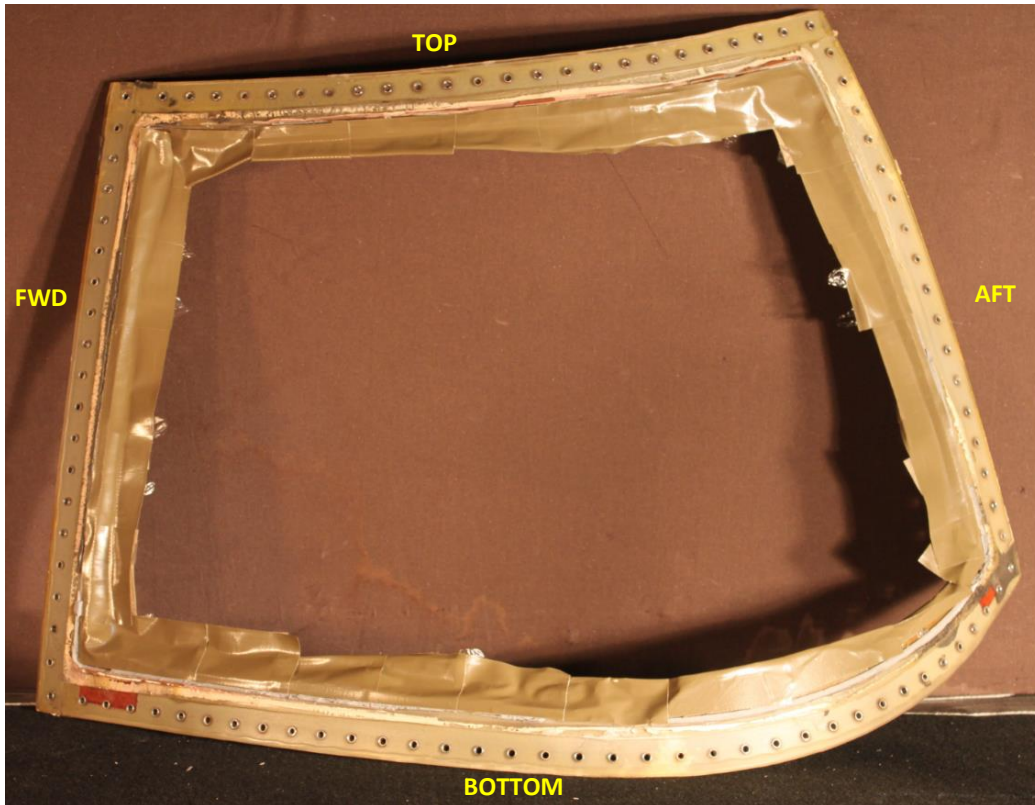
**Figure A:** Overall View - LH

**Figure A:** Outboard overall view of the LH windshield as received.

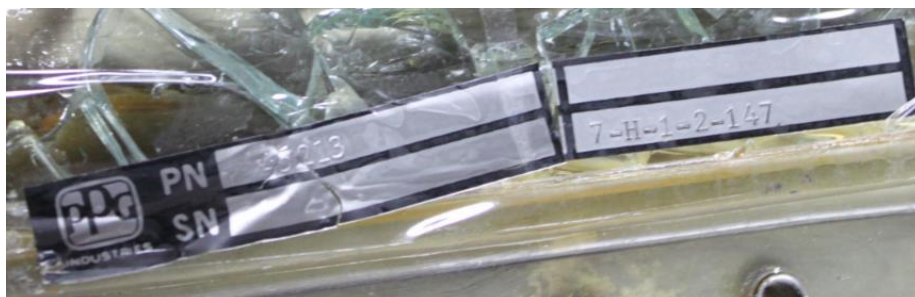
**Figure B:** Trademark Label - LH

**Figure B:** Trademark label including the part number and serial number.

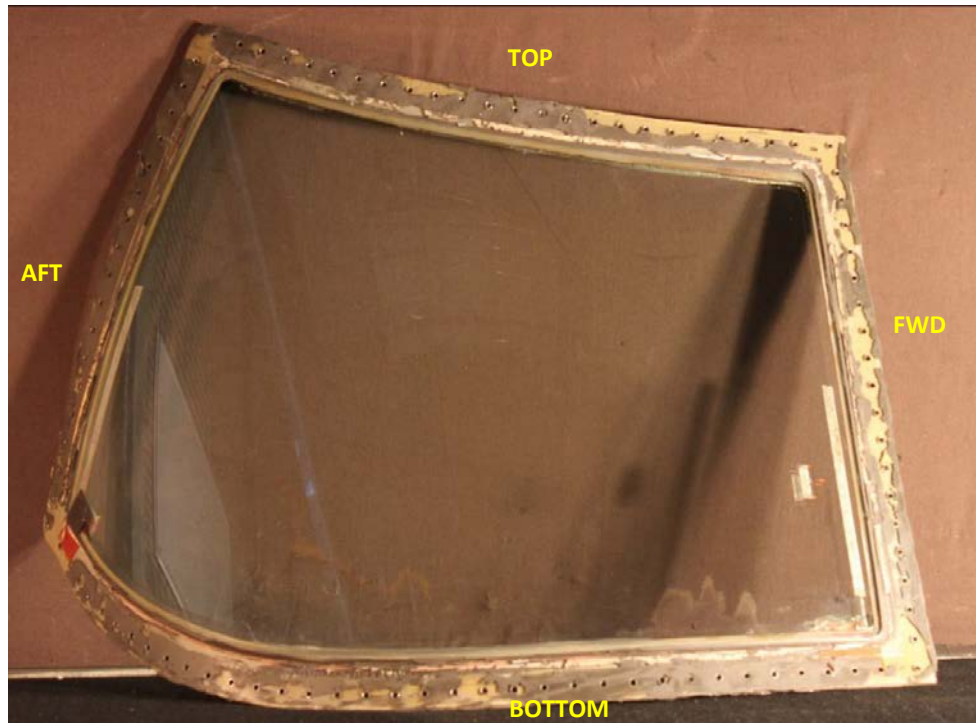
**Figure C:** Overall View - RH

- RH windshield (1-H-8-16-310 – Manufactured August 16, 1981) received intact.
  - Both had visible warped inner retainers – likely caused by application of heat via heat gun during removal.

**Figure C:** Outboard overall view of the RH windshield as received.

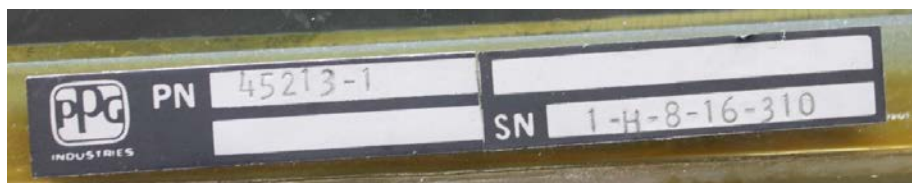
**Figure D:** Trademark Label - RH

**Figure D:** Trademark label including the part number and serial number.

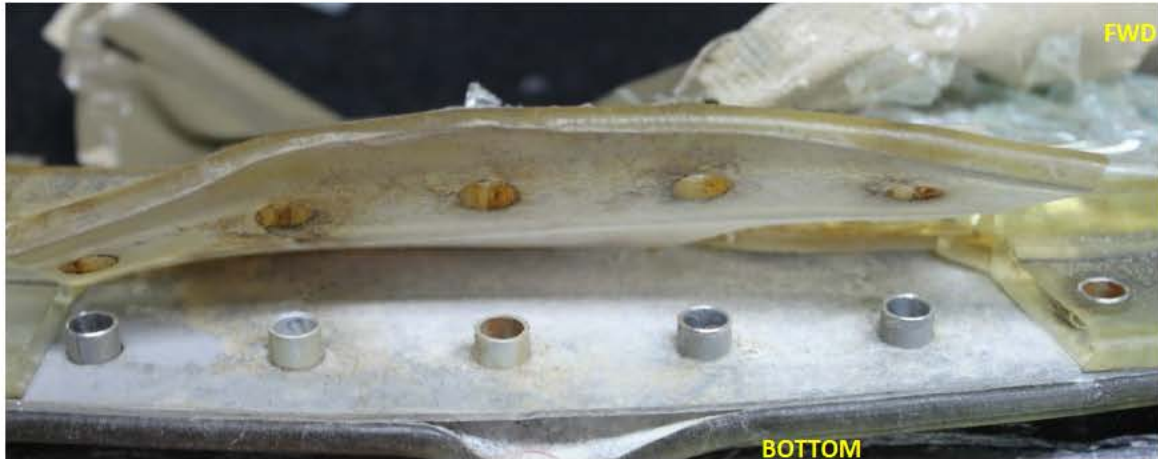
Figure E: LH Windshield Corroded Insert

- Per glass remnants left along periphery, center-aft area of LH window is suspect for failure origin location.
- Corrosion of metal insert visible on both LH and RH windows around entire periphery. Heavy areas evident where vinyl retainer was no longer bonded on both inboard and outboard sides (see Figure E).

Figure E: Corroded metal insert of LH windshield.

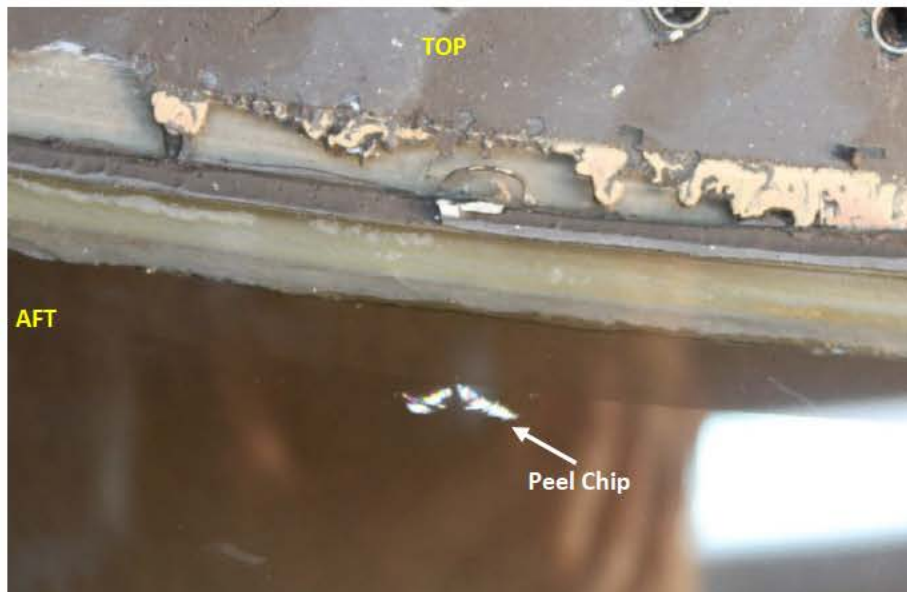
Figure F: RH Windshield Peel Chip

- Inspection of RH windshield revealed peel chip visible along top edge of window – 14.5” from center post, 5/8” from window edge (see Figure F). Peel chips are created by local excessive adhesion at the glass surface from contraction of vinyl during operation.

Figure F: Outboard view of peel chip in RH windshield.
