# Continental Motors

## ENGINE FIELD INSPECTION REPORT

| ENGINE MODEL | TSIO-520-R |
| FILE NUMBER | 16-317 |

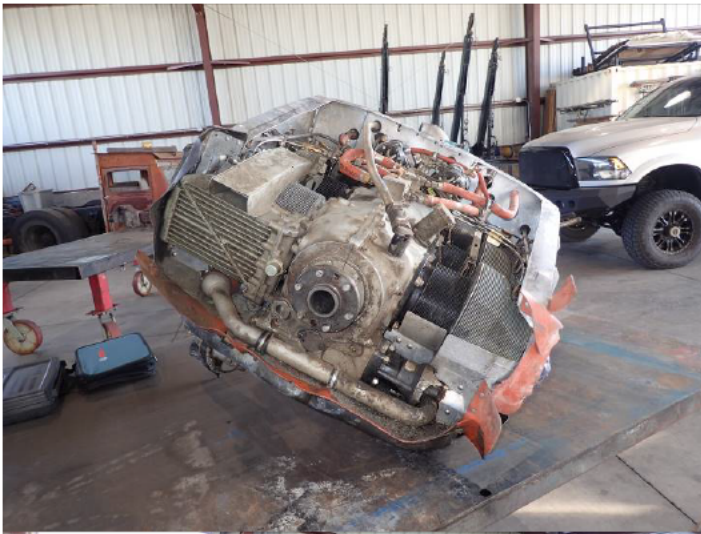
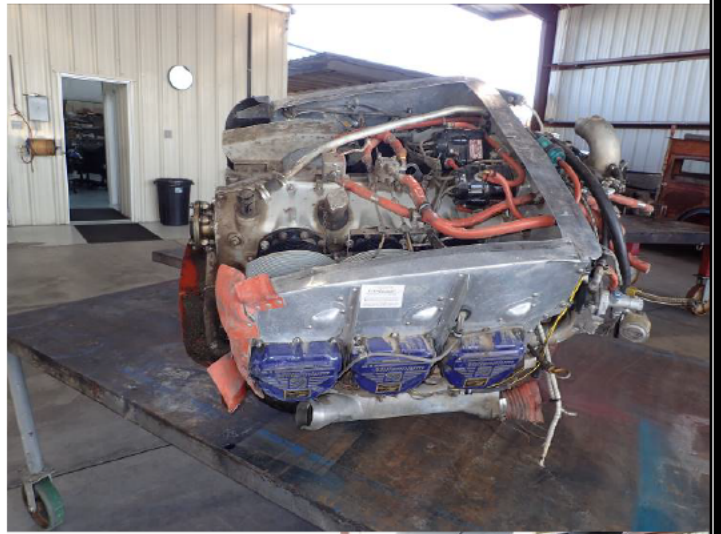
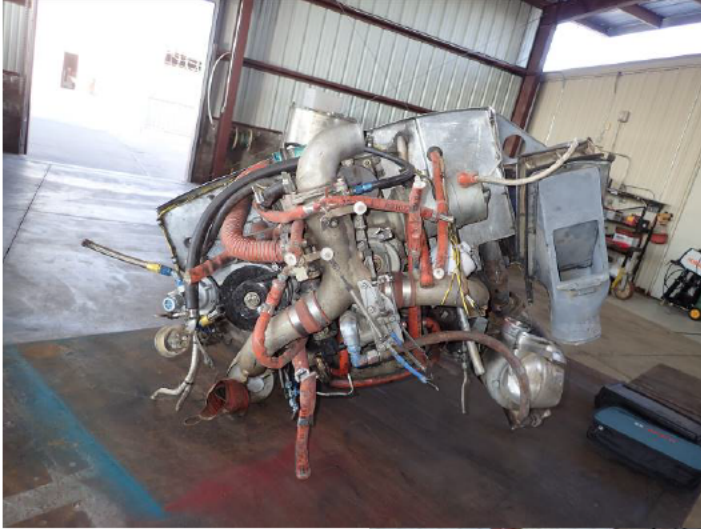
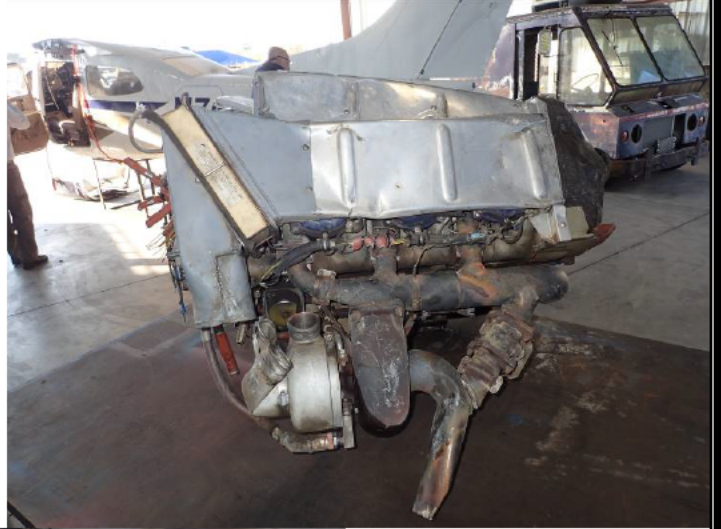
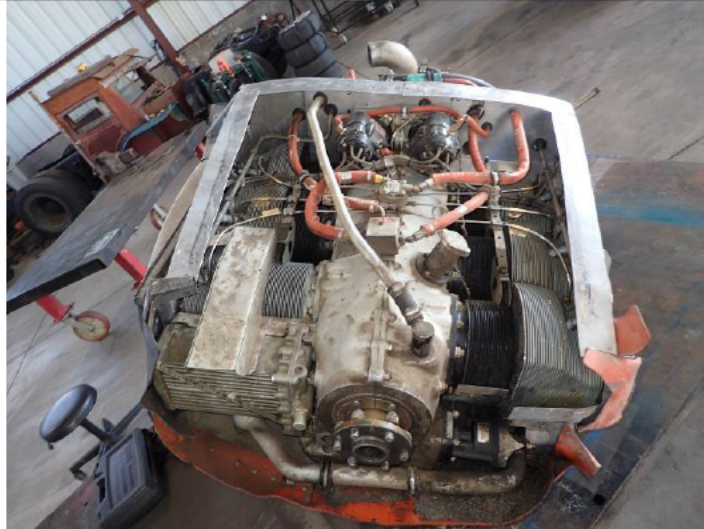
The engine had been removed from the airframe prior to the investigators' arrival. The engine displayed impact damage signatures. All six cylinders remained attached to their cylinder bays and were undamaged. The crankcase remained intact and displayed minor impact damage signatures. The three blade, variable pitch propeller had broken free from the propeller flange; the propeller studs remained attached to the crankshaft propeller flange. All three propeller blades remained within the propeller hub and displayed impact damage signatures.

The turbocharger remained attached to the exhaust and to the installation bracket; however, the induction outlet had broken free from the turbocharger which was consistent with impact damage. The wastegate remained attached to its installation point and was undamaged. The turbocharger controller had broken free from its installation point and remained attached to the engine through hoses; the controller displayed minor impact damage signatures. The overboost valve remained attached to its installation point and displayed minor impact damage signatures.

The exhaust system displayed impact damage signatures in the form of bending with the exhaust tailpipe displaying the most impact damage. The induction system displayed impact damage signatures with the most damage occurring to the induction components attached to the turbocharger.

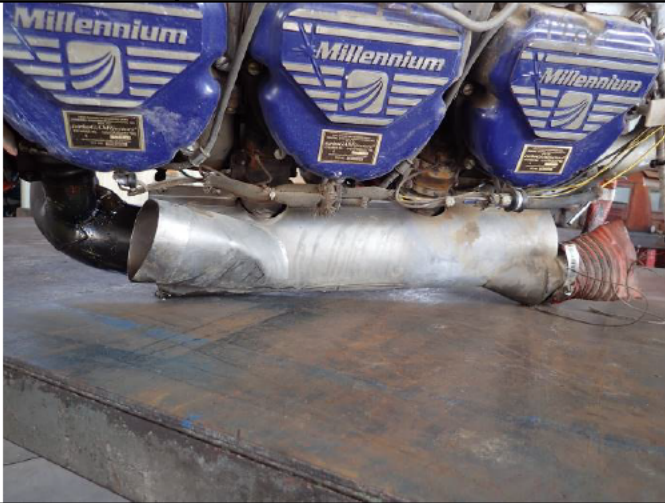
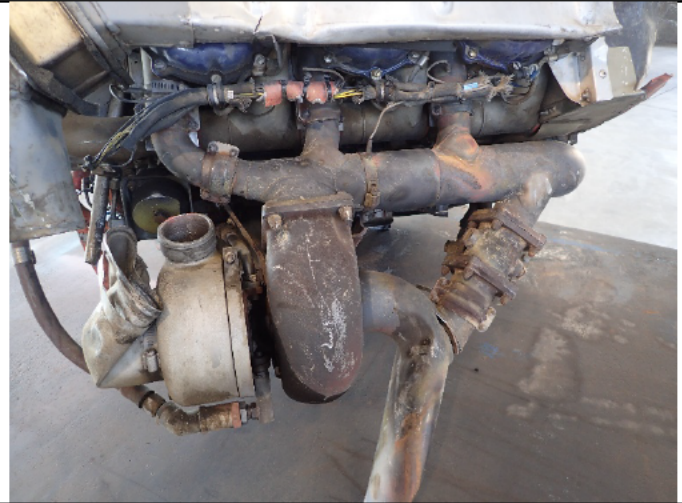
The exhaust system remained attached to the engine and displayed impact damage signatures with the most impact damage displayed at the exhaust tailpipe. The damage to the tailpipe included bending, crushing and tearing. There were no anomalies noted with the exhaust system.

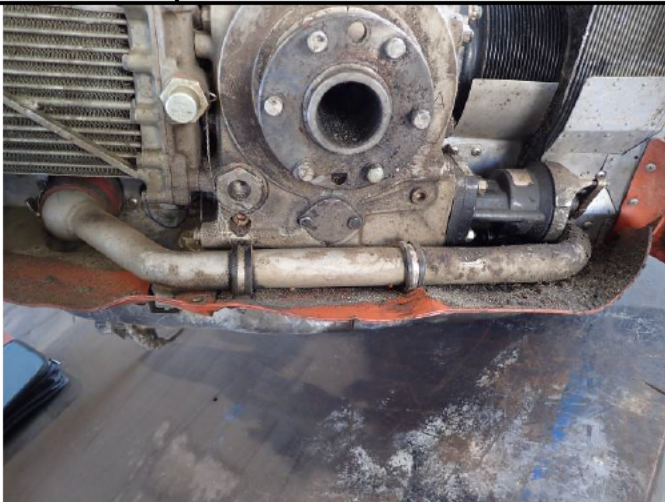
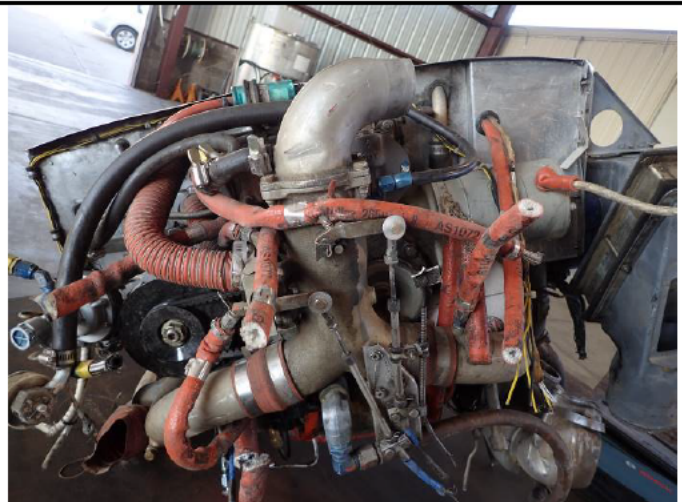
The induction system displayed impact damage signatures with the most impact damage occurring to the components attached to the turbocharger. There were no signs of induction leaks and the induction system displayed normal operating signatures. There were no anomalies noted.

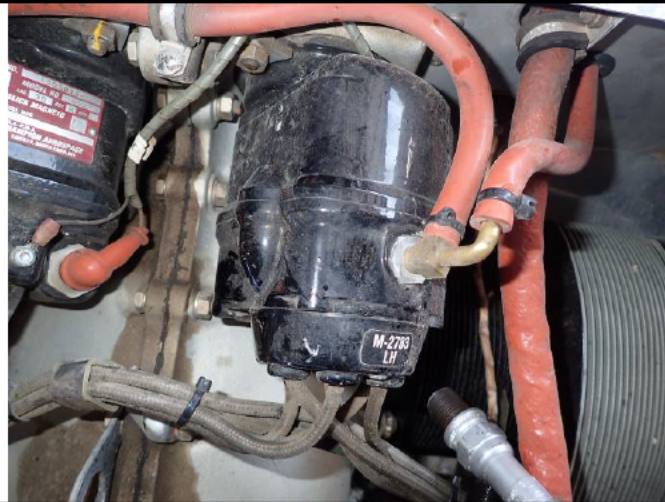
The magneto remained attached to its installation point and was undamaged. It was noted that during crankshaft rotation the impulse coupling would operate normally. The spark plugs were removed from their cylinders and reinstalled on their ignition leads. It was noted that during impulse coupling operation the magneto was capable of producing a spark that reached each individual spark plug and it would produce a spark in sync with the right magneto. There were no anomalies noted with the magneto.

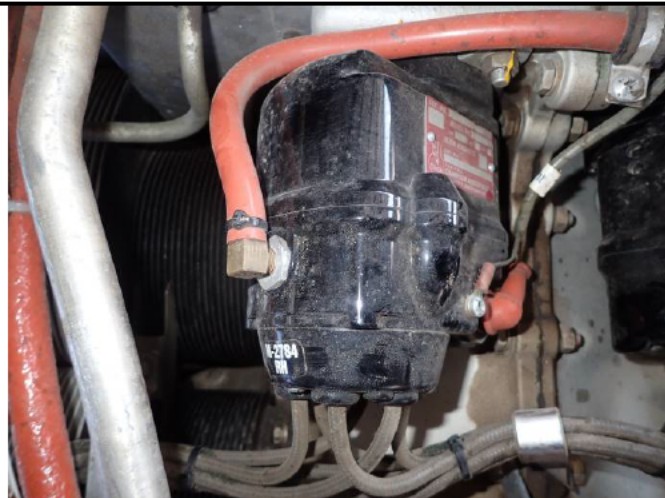
The magneto remained attached to its installation point and was undamaged. It was noted that during crankshaft rotation the impulse coupling would operate normally. The spark plugs were removed from their cylinders and reinstalled on their ignition leads. It was noted that during impulse coupling operation the magneto was capable of producing a spark that reached each individual spark plug and it would produce a spark in sync with the left magneto. There were no anomalies noted with the magneto.

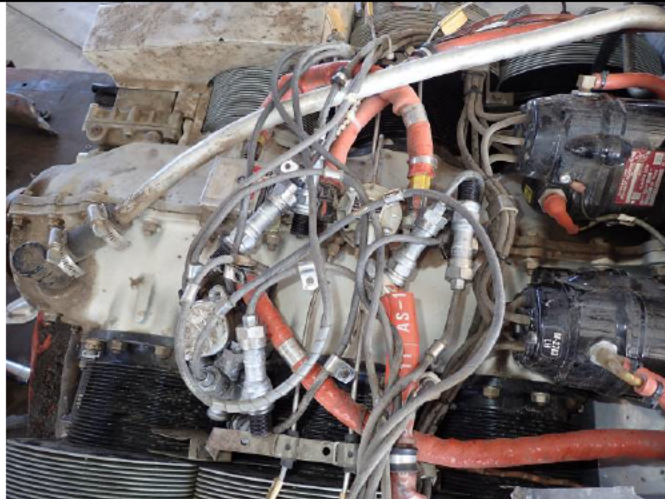
The ignition harness remained attached to both magnetos and to each of the spark plugs. It was noted that the ignition harness was capable of conducting a spark from the magneto to each of the spark plugs. There were no anomalies noted with the ignition harness.

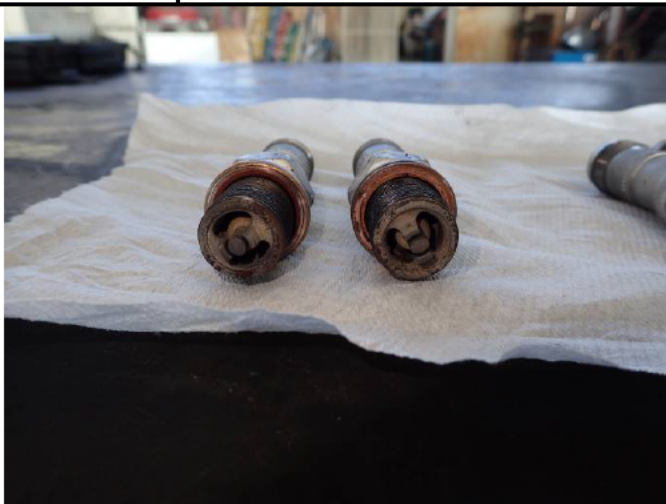
#1 top and bottom spark plugs

All of the spark plugs remained installed in their cylinders and were undamaged. The spark plugs were removed and it was noted that all of the spark plugs displayed normal wear signatures when compared to Champion Aviation Service Manual AV6-R. The bottom even number spark plugs were oil soaked which was consistent with post-accident accumulation. All of the spark plugs displayed normal operating signatures. There were no anomalies noted.

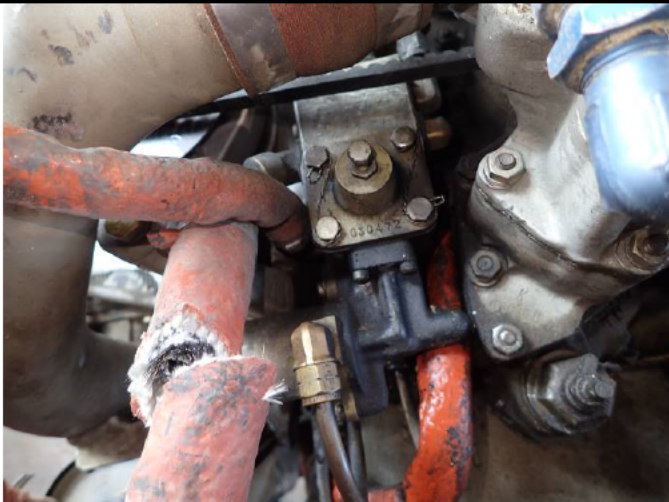
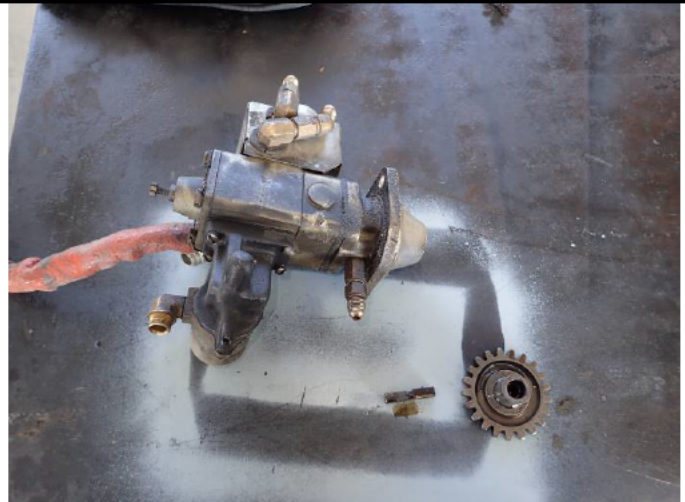
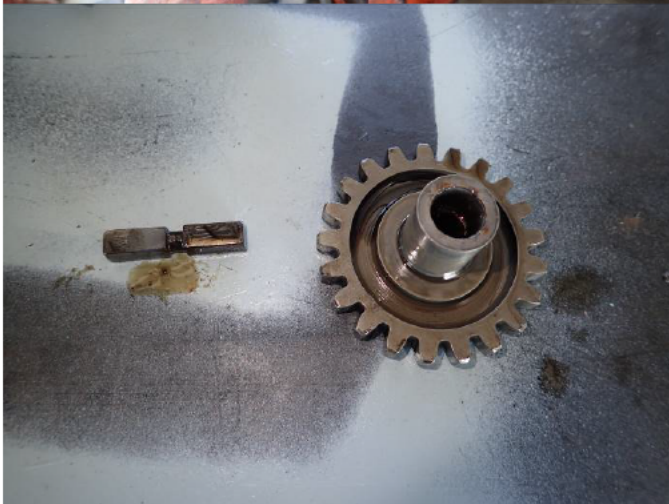
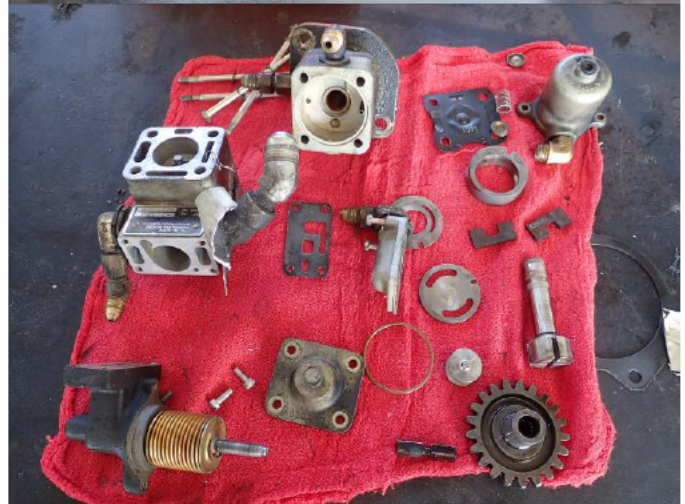
The fuel pump remained attached to its installation point and was undamaged. All of the fuel AN fittings were secured to the fuel pump; however, the fuel inlet fuel line was cut by the recovery crew. The fuel pump was removed and it was noted that the drive coupling remained intact. The fuel pump was rotated by hand and it was noted to rotated normally. The fuel pump was disassembled and the internal components were visually inspected; the internal components displayed normal operating signatures. There were no anomalies noted with the fuel pump.

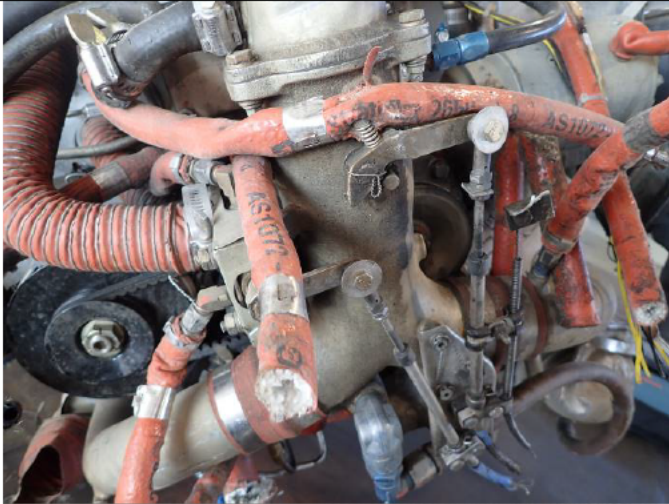
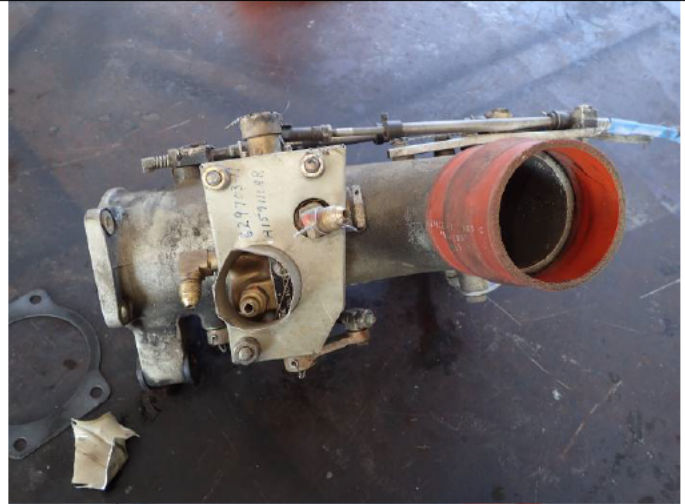
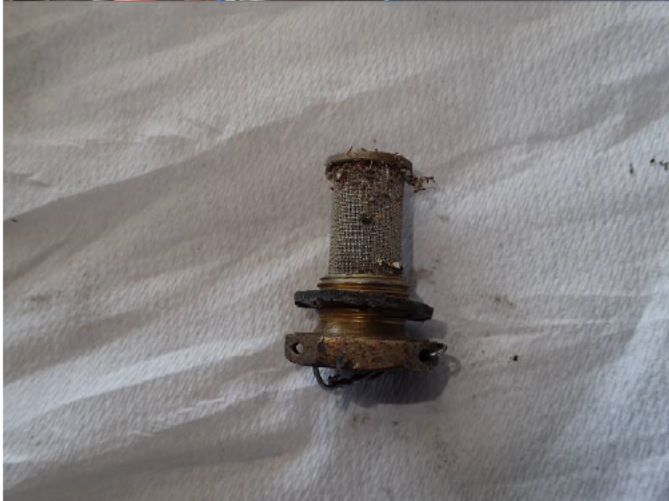
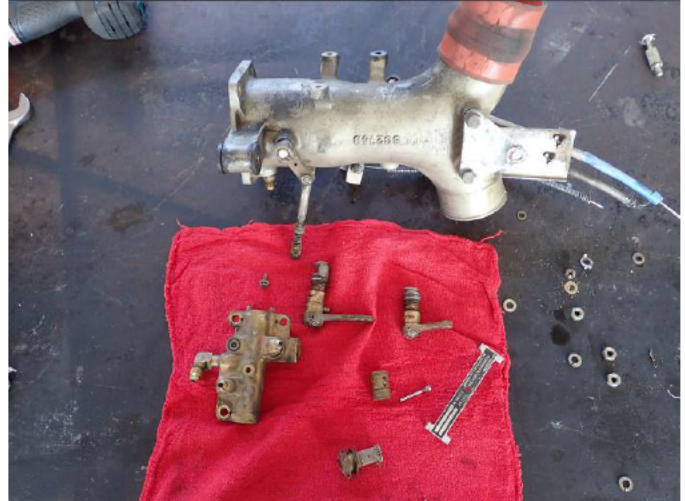
The throttle and metering unit remained attached to its installation point and to the induction system. The assembly was undamaged and all of the fuel lines remained secured to the metering unit. The throttle and mixture control arms remained secured to their control shafts. The throttle and metering unit was disassembled and the internal components were visually inspected. All of the internal components displayed normal operating signatures. The fuel inlet screen was removed and it was noted there was a significant amount of debris on the fuel screen; however, the screen was not blocked.

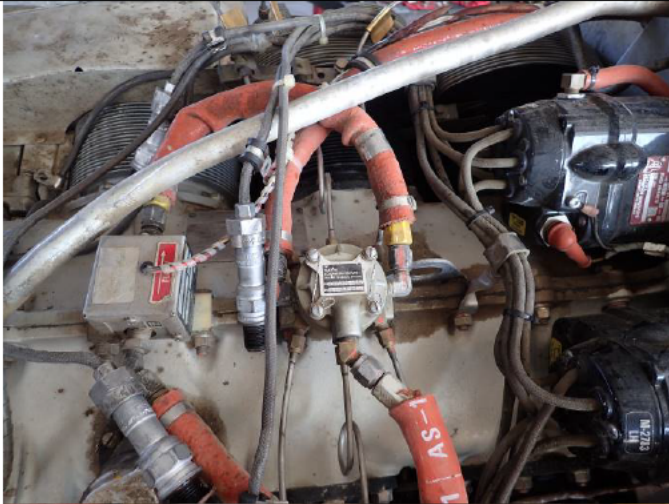
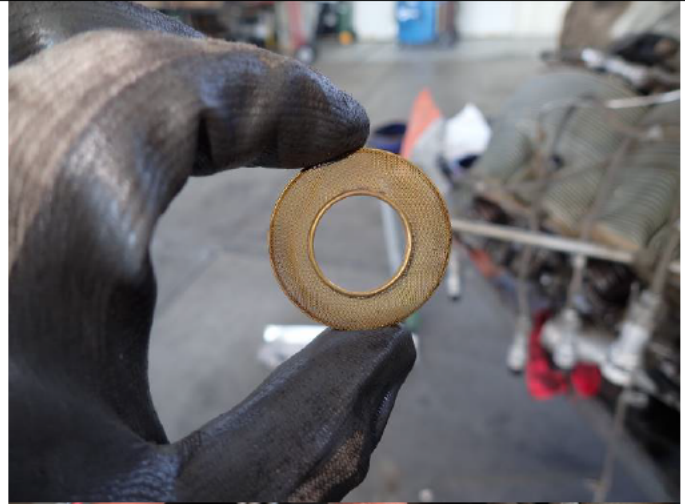
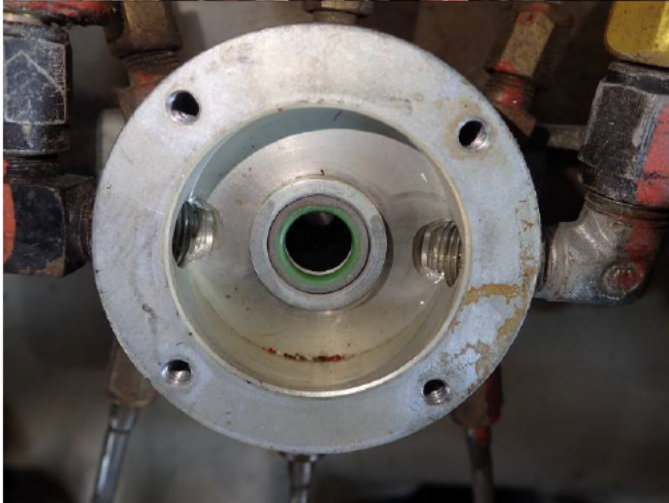
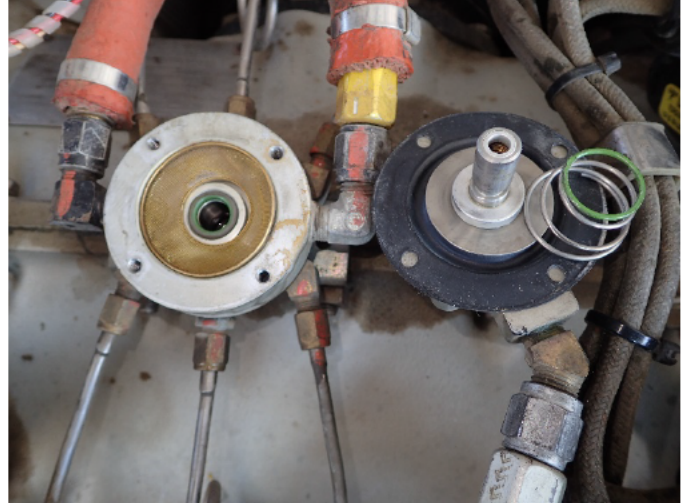
The fuel manifold valve remained attached to its installation point and was undamaged. All of the fuel lines remained secured to the manifold valve and there were no signs of fuel leaks. The manifold valve was disassembled and the internal components were visually inspected. The internal components displayed normal operating signatures and the manifold valve screen contained only a miniscule amount of lint like material. There was a small amount of fuel contained within the manifold valve. There were no anomalies noted with the manifold valve.

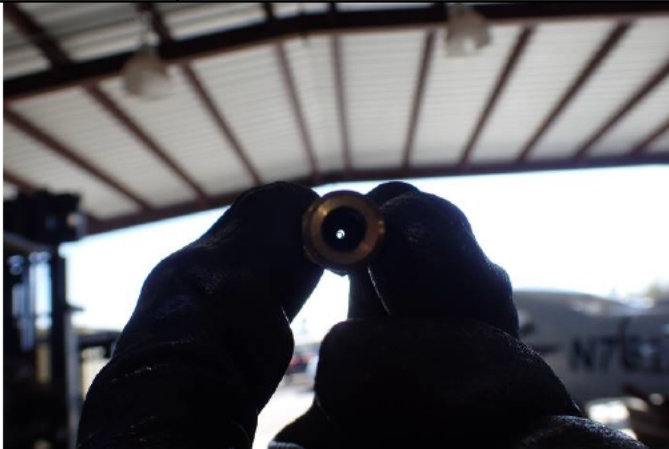
#1 Fuel Nozzle

| Position | #1 | #3 | #5 | #2 | #4 | #6 |
|---|---|---|---|---|---|---|
| Condition: | All of the fuel nozzles remained installed in their cylinders and were undamaged. The fuel nozzles were removed and it was noted that all of the nozzles were clear of obstructions. There were no anomalies noted with the fuel nozzles. | | | | | |

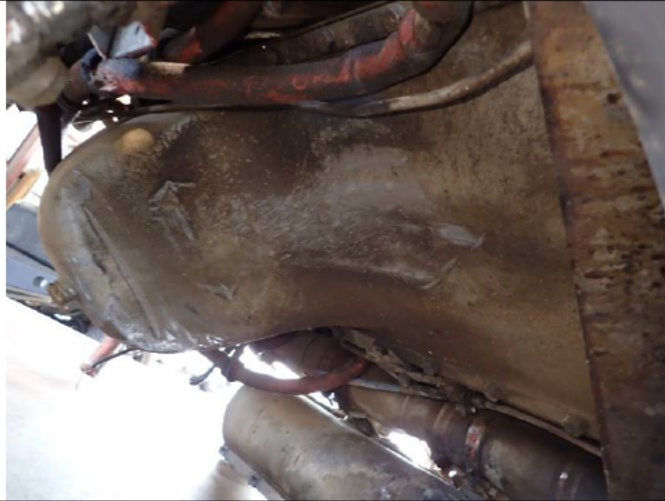
The oil sump remained attached to the crankcase and displayed impact damage signatures; however, the oil sump was not breached. There were no anomalies noted with the oil sump.

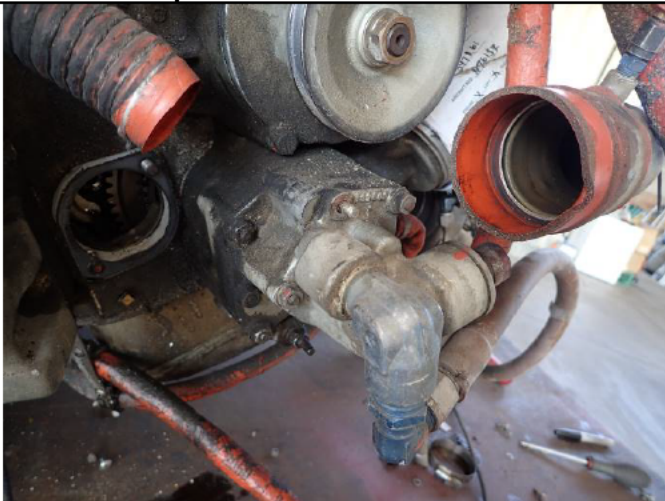
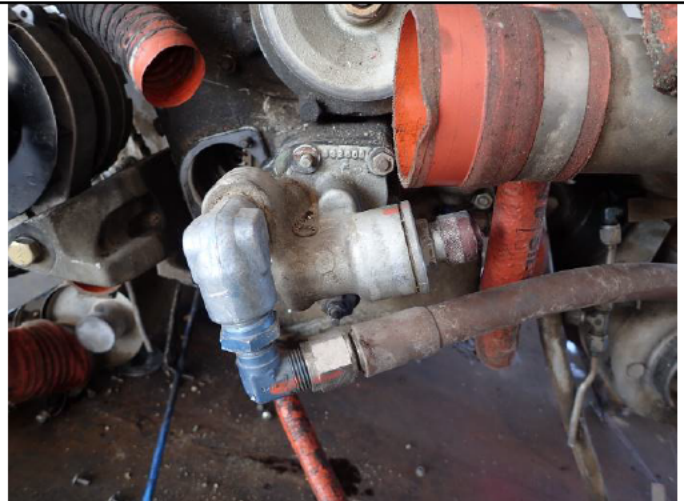
The oil pump housing remained intact and undamaged. There were no anomalies noted with the oil pump.

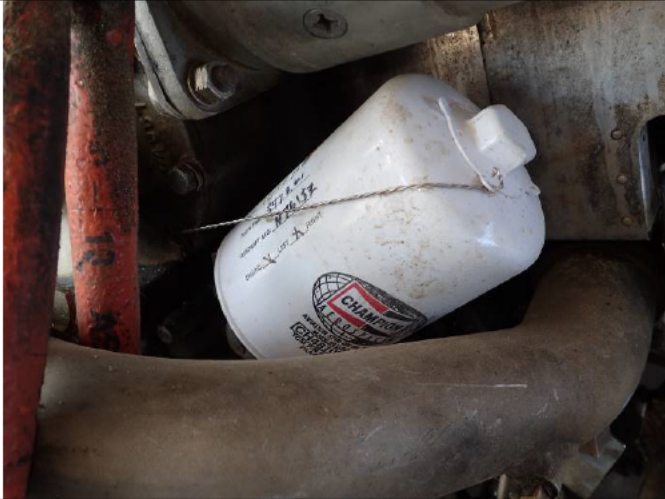
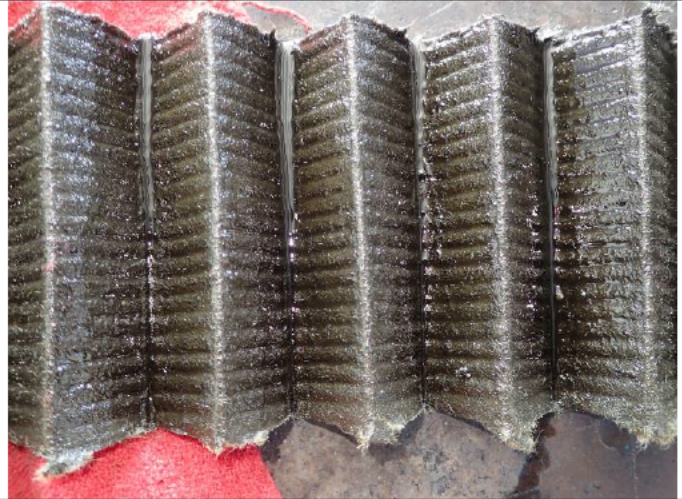
The oil filter remained attached to the oil filter adapter and was undamaged. The oil filter was removed and the housing was cut open. The filter pleats were inspected and there were no anomalies noted with the oil filter inspection.

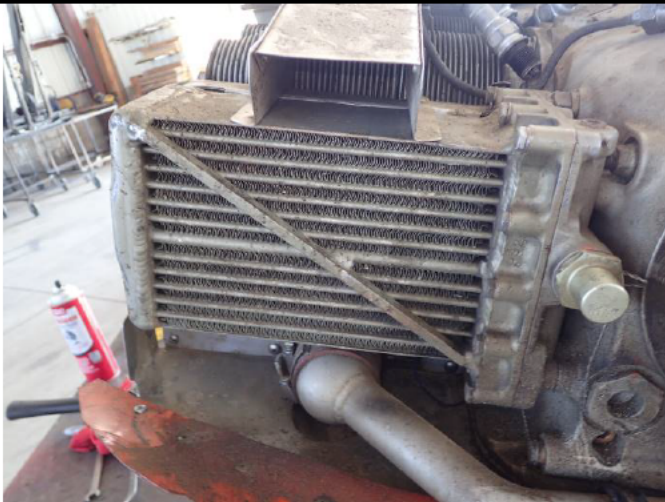
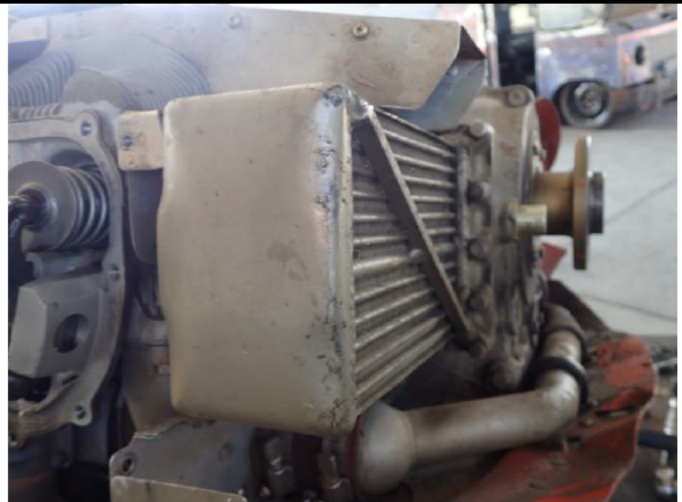
The oil cooler remained attached to the oil cooler adapter and displayed minor impact damage signatures. There were no anomalies noted with the oil cooler.

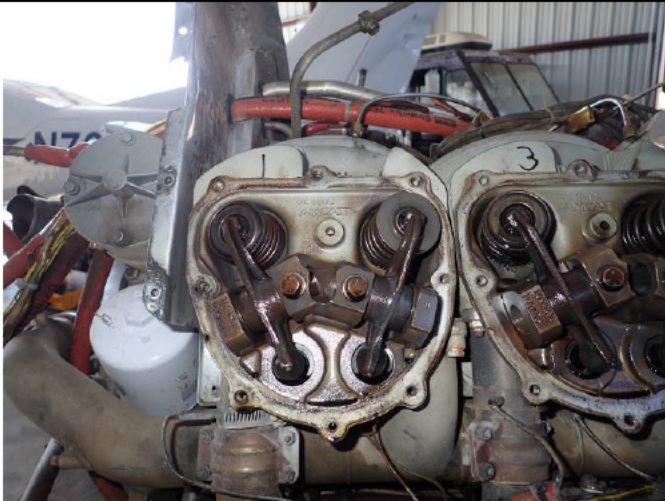
#1 Cylinder

All of the cylinders remained attached to their cylinder bays and were undamaged. The internal portions of the cylinders were inspected using a lighted borescope. The cylinder bore, piston faces, and valve heads displayed normal operating and combustion signatures as well as some oxidation consistent with post-accident accumulation. The overhead components (rocker arms, valve springs, valves, and push rods) displayed normal operating and lubrication signatures. During crankshaft rotation all six cylinders displayed good thumb compression and suction. During crankshaft rotation all of the overhead components operated normally. There were no anomalies noted with the cylinders.

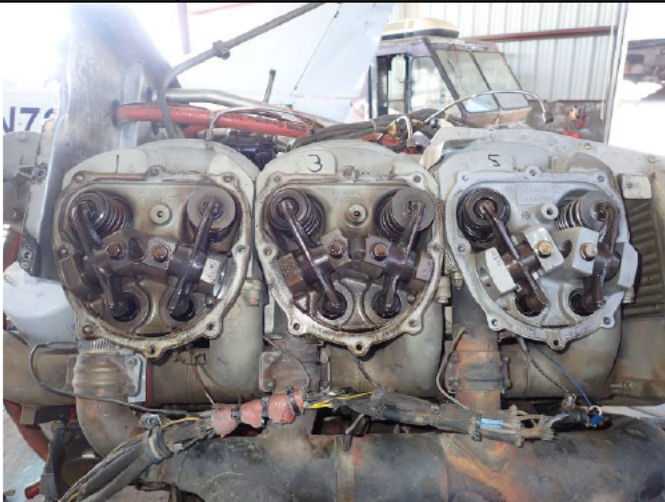
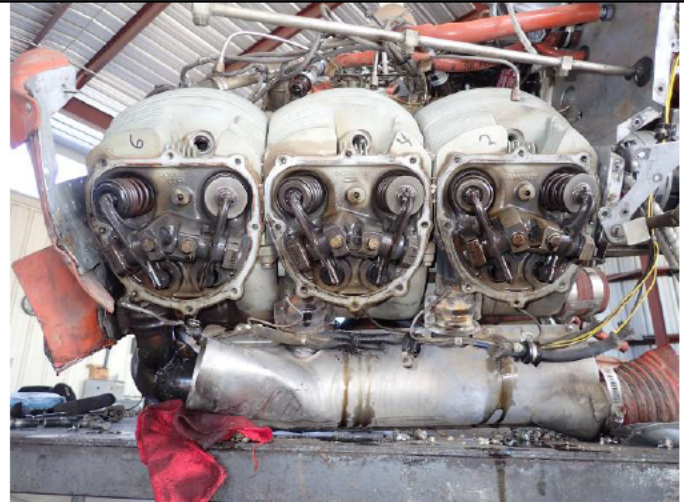
All of the rocker arms were intact and undamaged. The rocker arms displayed normal operating and lubrication signatures; during crankshaft rotation all of the rocker arms operated normally.

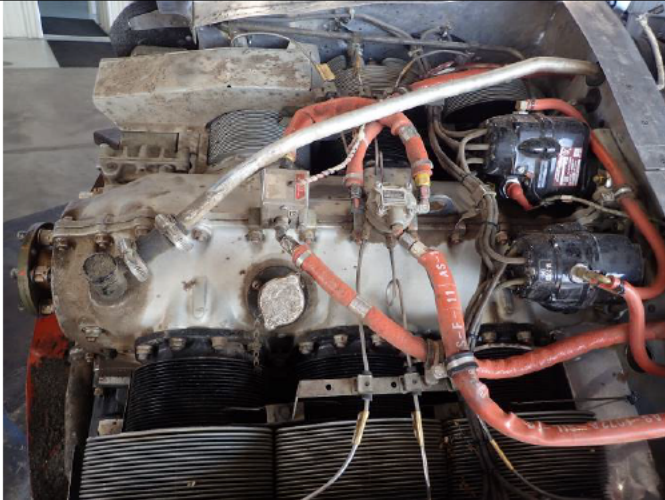
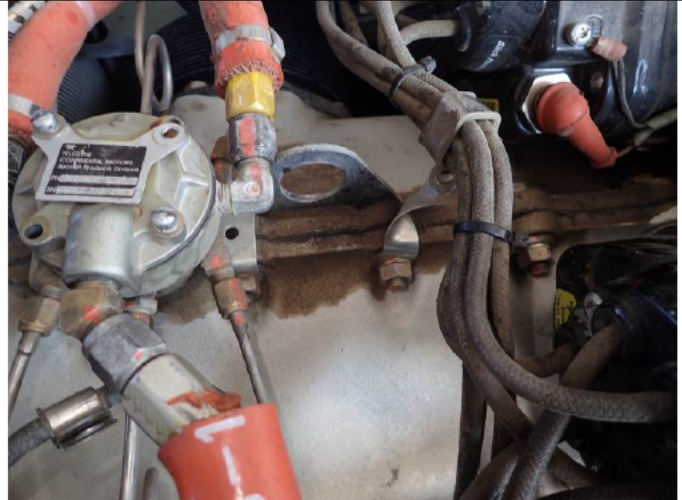
| CRANKCASE | Casting Number: | 1-3-5: 649043 | 2-4-6: 649042 | S/N: Not observed |
|---|---|---|---|---|
| Condition: | The crankcase remained intact and displayed minor impact damage signatures. It was noted that there were signs of an oil seep along a portion of the crankcase backbone. There were no further anomalies noted with the crankcase. | | | |

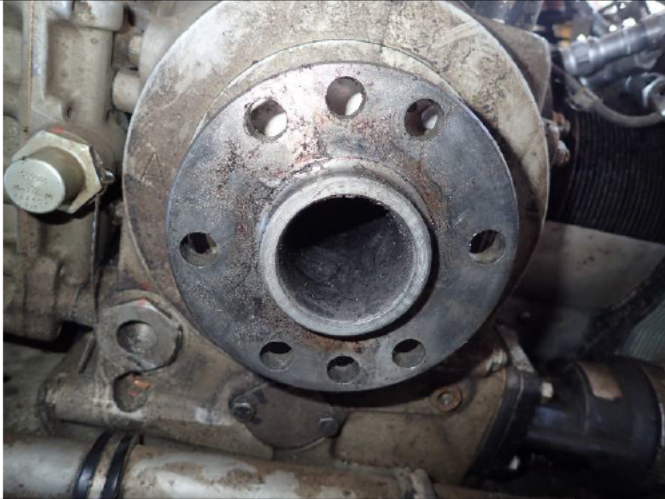
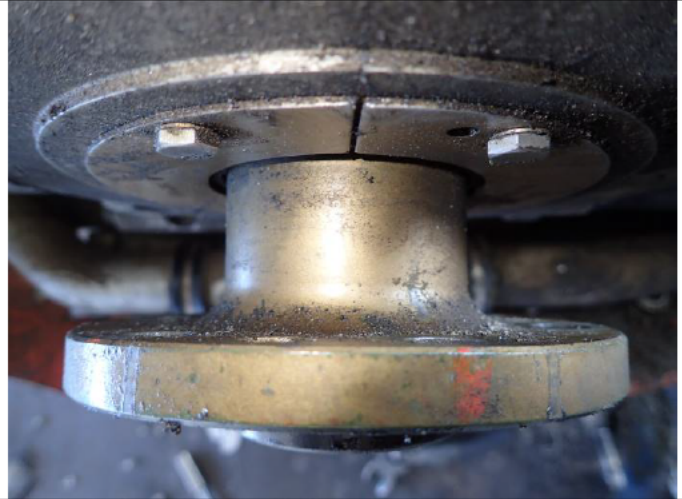
The propeller flange remained attached to the crankshaft; the crankshaft displayed impact damage signatures in the form of small cracks aft of the propeller flange. The crankshaft was rotated through the use of a hand tool and continuity was established between the crankshaft, camshaft, connecting rods and associated components. There were no anomalies noted with the crankshaft.

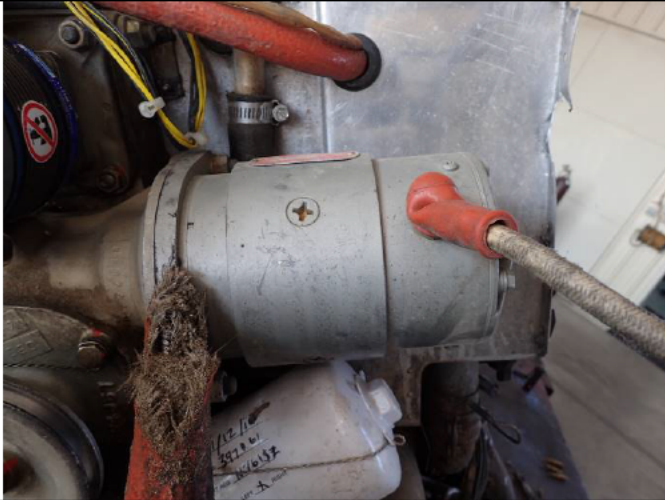
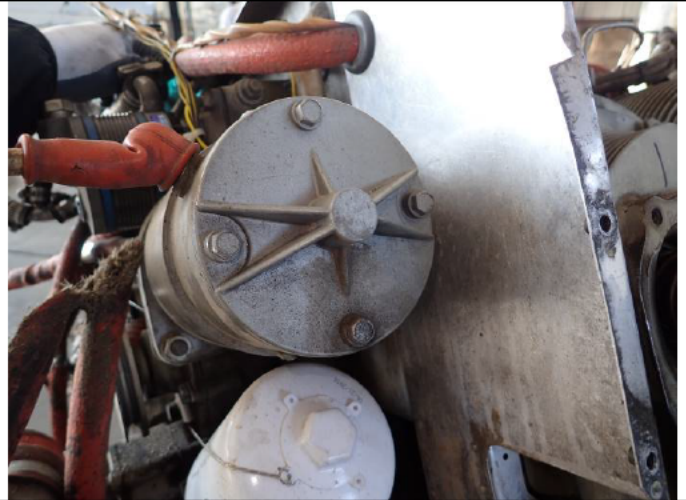
The starter remained attached to the starter adapter and was undamaged. There were no anomalies noted with the starter.

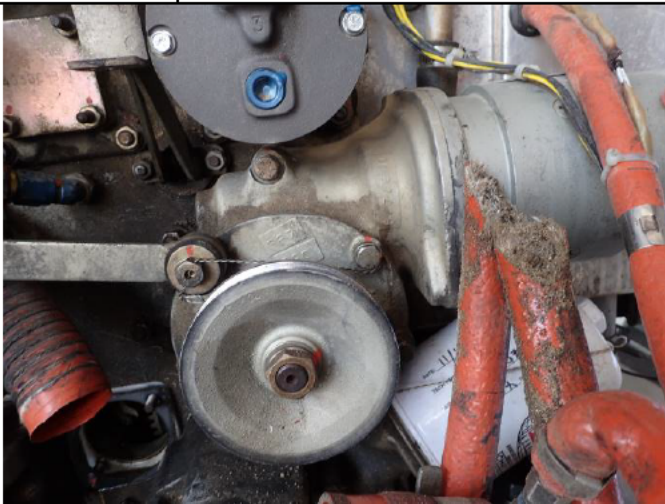
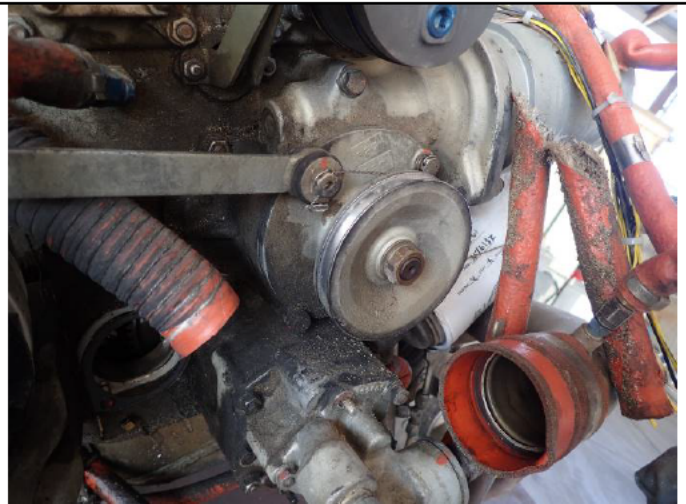
The starter adapter remained attached to its installation point and was undamaged. There were no anomalies noted with the starter adapter.

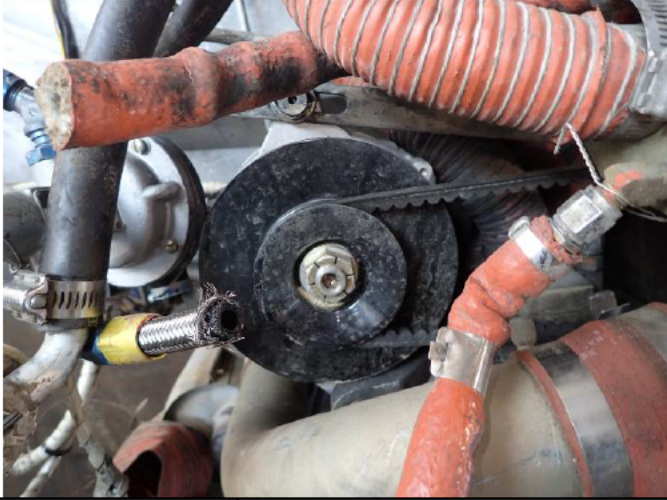
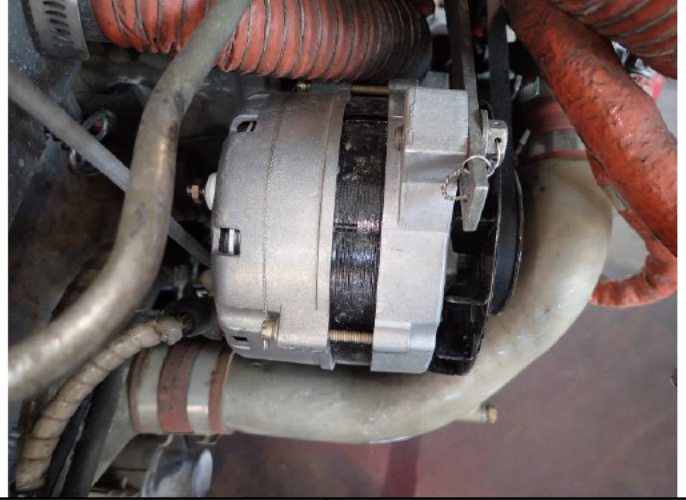
The alternator remained attached to its installation point and was undamaged. The alternator drive was capable of normal rotation. There were no anomalies noted with the alternator.

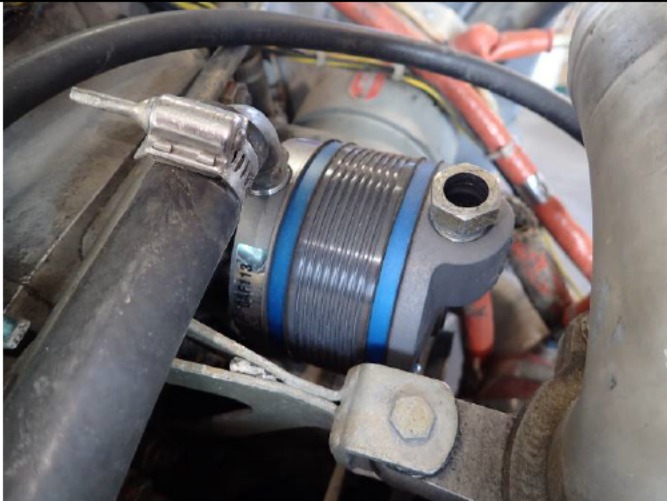
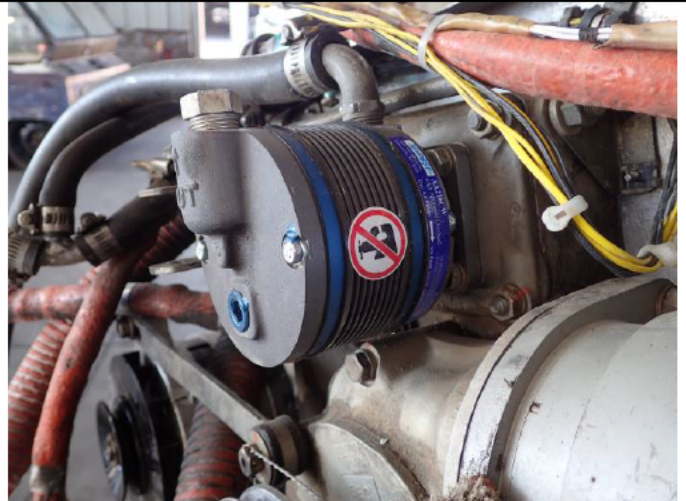
The vacuum pump remained attached to its installation point and displayed minor impact damage; the vacuum pump outlet pipe had broken free from the vacuum pump. There were no anomalies noted with the vacuum pump.

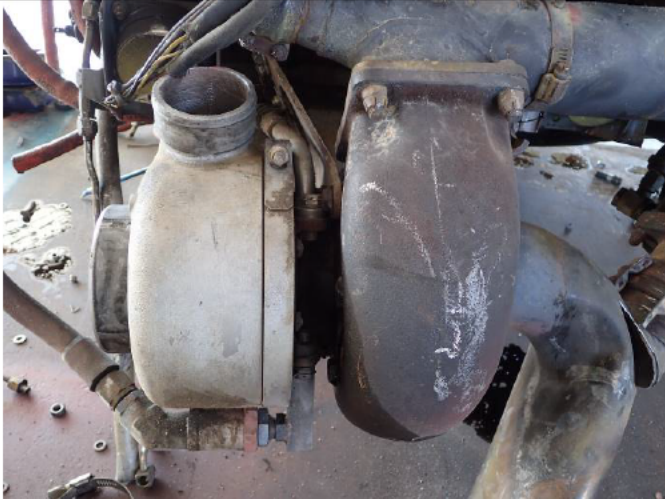
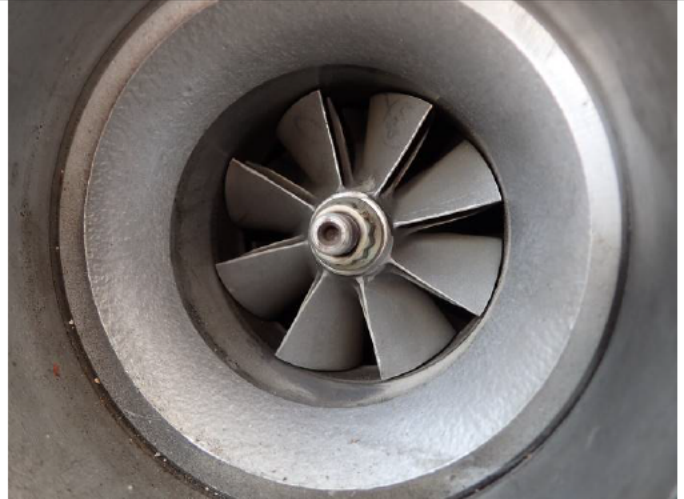
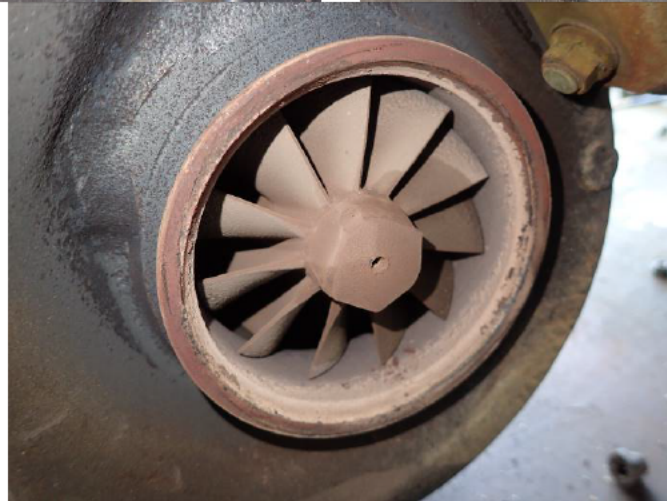
The turbocharger remained attached to the exhaust system and to its attach bracket; the majority of the induction system had broken free from the compressor section of the turbocharger. The compressor blades were visually inspected and were noted to be undamaged and capable of normal rotation. The tailpipe was removed and the turbine blades were noted to be undamaged and capable of normal rotation; continuity was established between the turbine and compressor blades. There were no anomalies noted with the turbocharger.

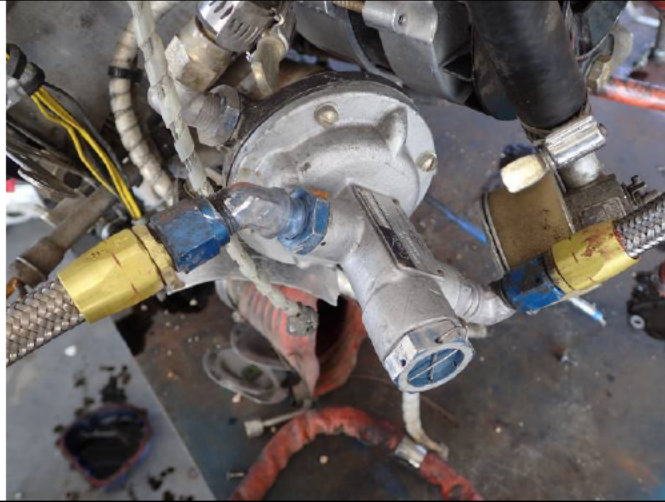
The turbocharger controller had broken free from its attachment and displayed minor impact damage signatures; the controller lines remained secure to the controller. There were no anomalies noted with the controller.

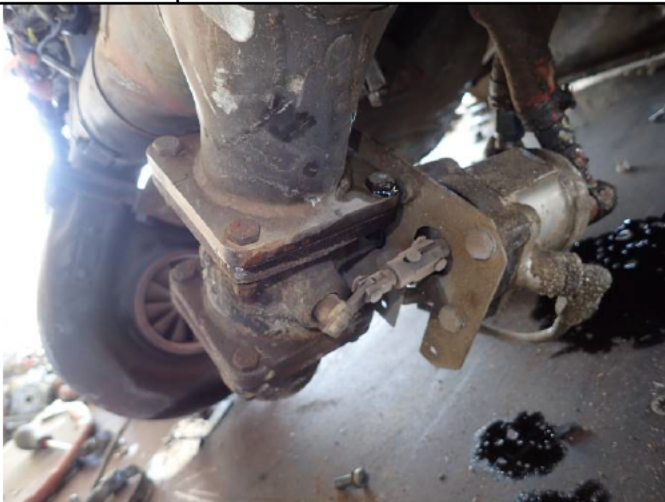
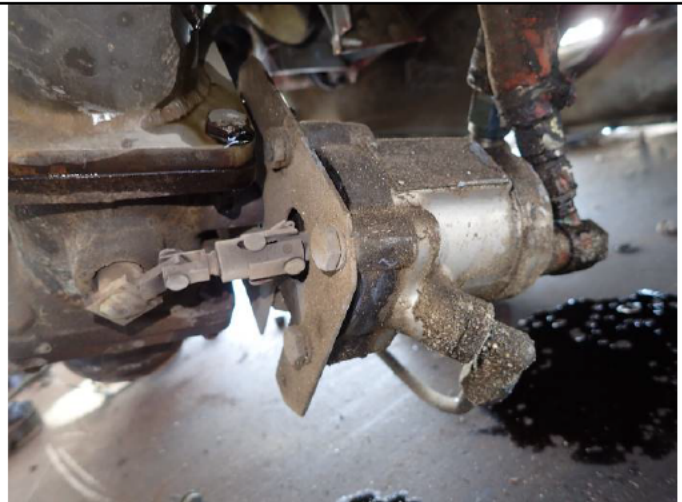
The wastegate remained attached to its installation point and was undamaged. There were no anomalies noted with the wastegate.

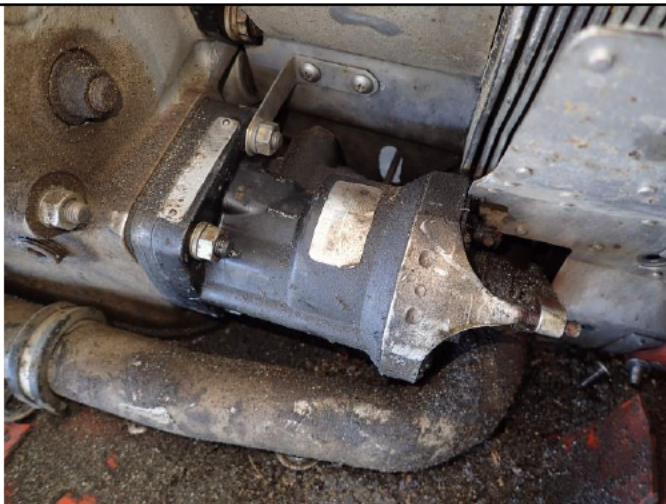
| Condition: | The propeller governor remained attached to its installation point and displayed minor impact damage signatures. The propeller control rod end remained attached to the governor control arm. There were no anomalies noted with the governor. | | |

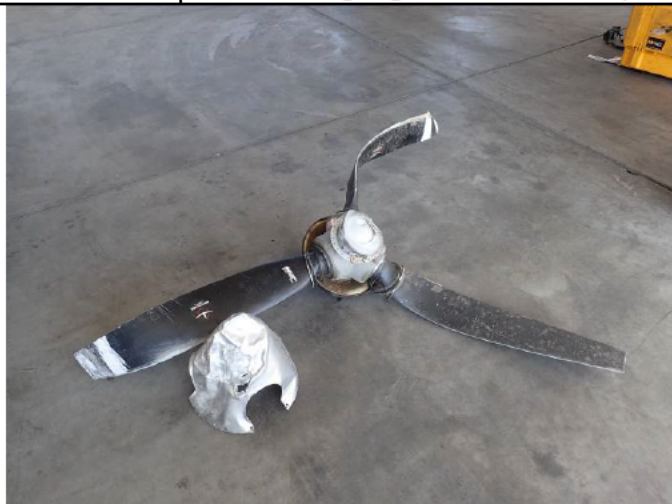
| Condition: | The three blade, variable pitch propeller had pulled free from the propeller flange; the propeller studs remained attached to the crankshaft propeller flange. All three propeller blades remained within the propeller hub and displayed impact damage signatures. Blade #1 displayed forward bending deformation, leading edge gouging, and minor tip curling. Blade #2 displayed aft bending deformation, leading edge gouging and polishing. Propeller blade #3 displayed aft bending deformation, leading edge gouging at the blade tip, and chordwise gouges at the blade tip. There were no anomalies noted with the propeller. | | |
