## **NATIONAL TRANSPORTATION SAFETY BOARD**

### **AIRFRAME AND ENGINE EXAM REPORT**

WPR17LA036

Aircraft: Textron Aviation T210M, Registration Number: N761SZ, Serial #: 21062493

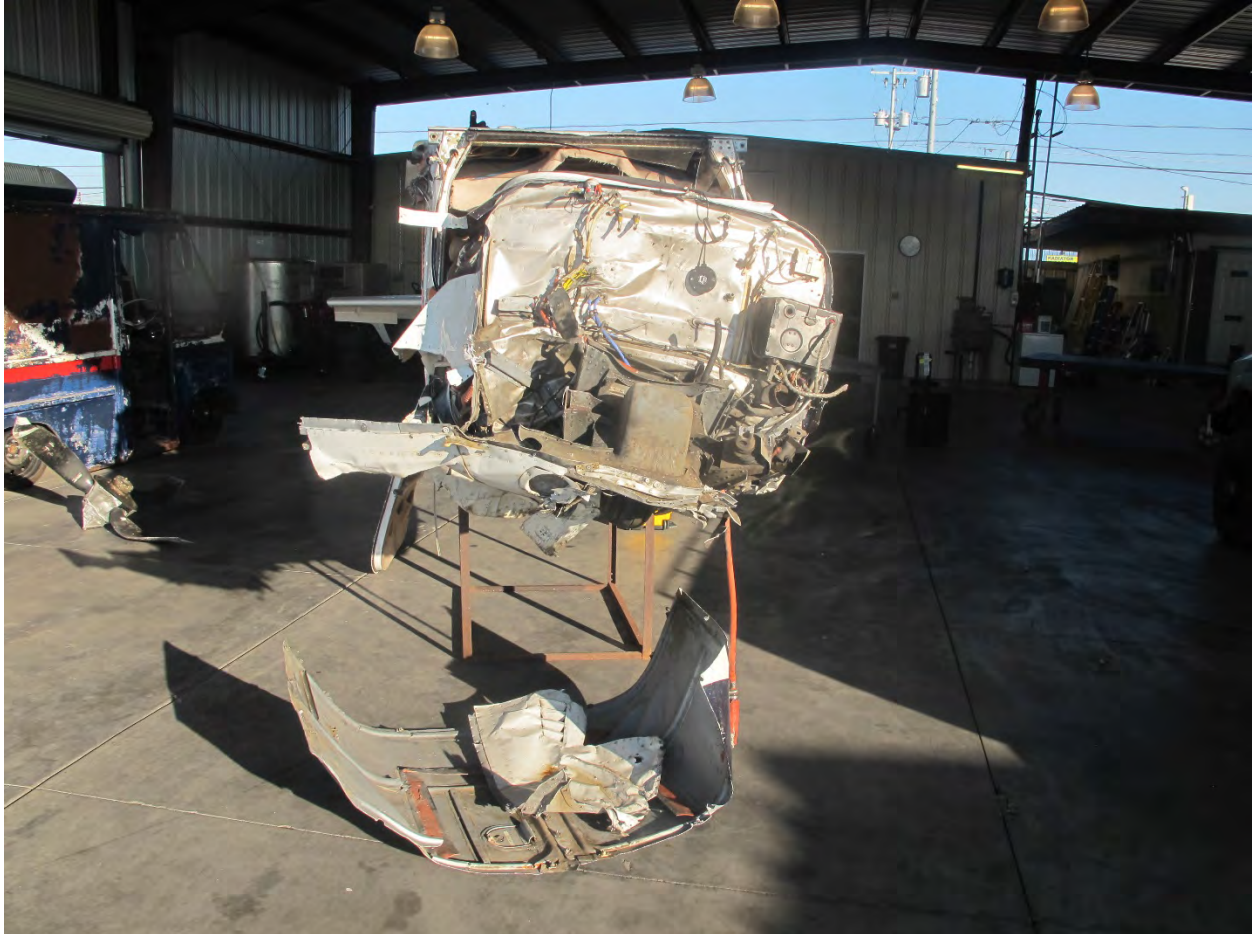
*Photo 1 Front of Airplane with Engine Removed*

The air filter had dirt on the front of the filter element. The nose of the airplane exhibited up and aft crush damage.

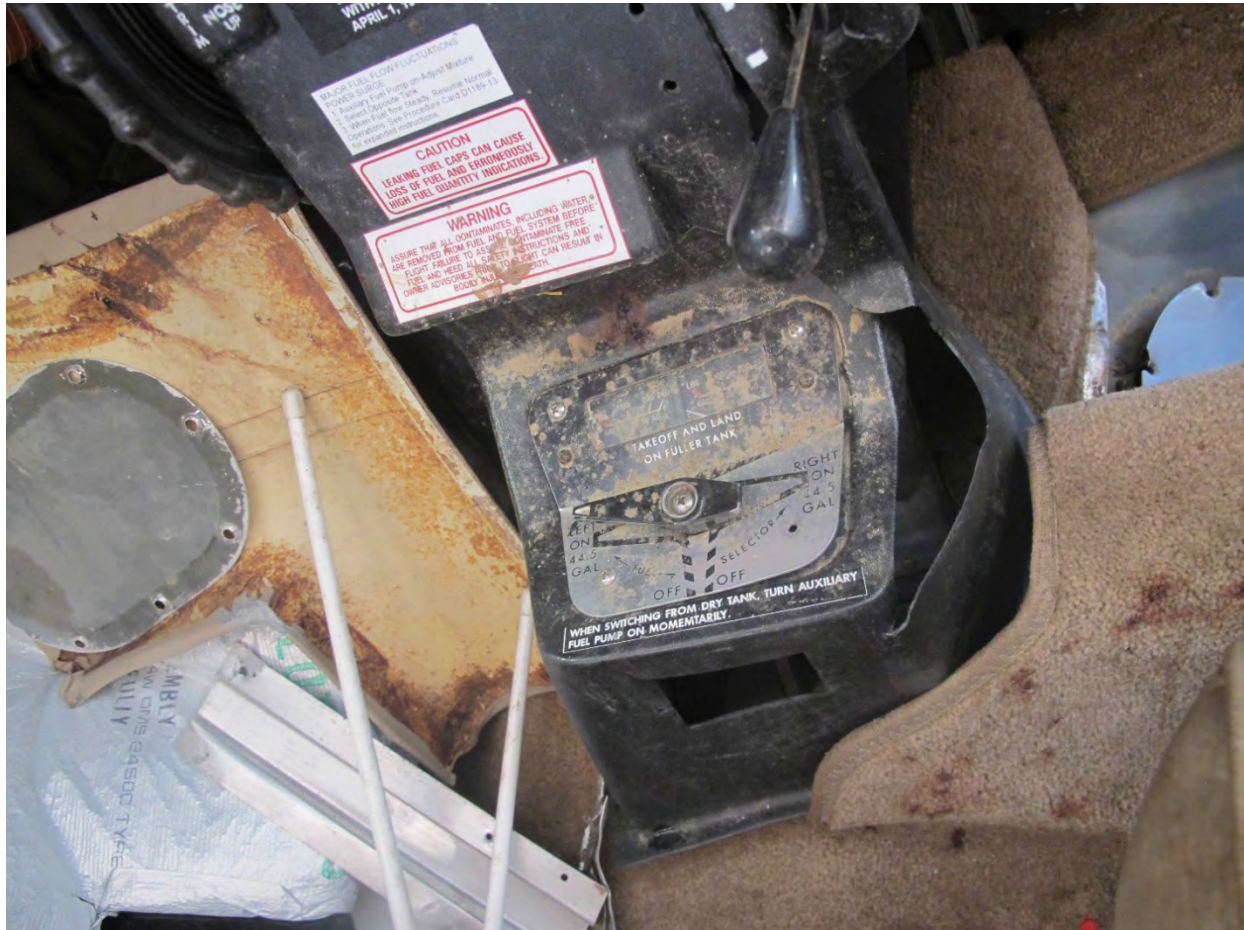
The fuel selector valve and handle were both in the left main position.

*Photo 2 Fuel Selector Valve Handle*

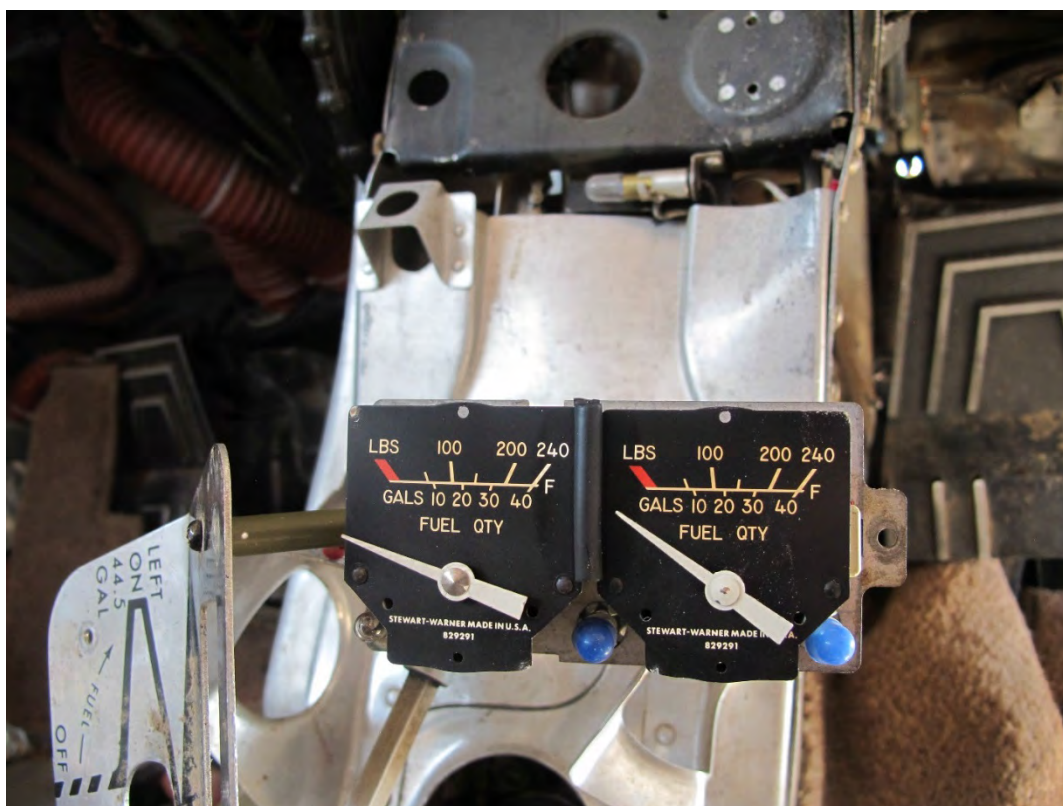
The left fuel quantity indicator moved from a no power position to an empty position when power was applied to the aircraft. The right fuel quantity indicator was damaged. The right needle was observed to “jump” when power was applied to the aircraft. An ohm meter was attached to each fuel quantity float. A change in resistance was observed when each float was moved.

*Photo 3 Fuel Quantity Indicators*

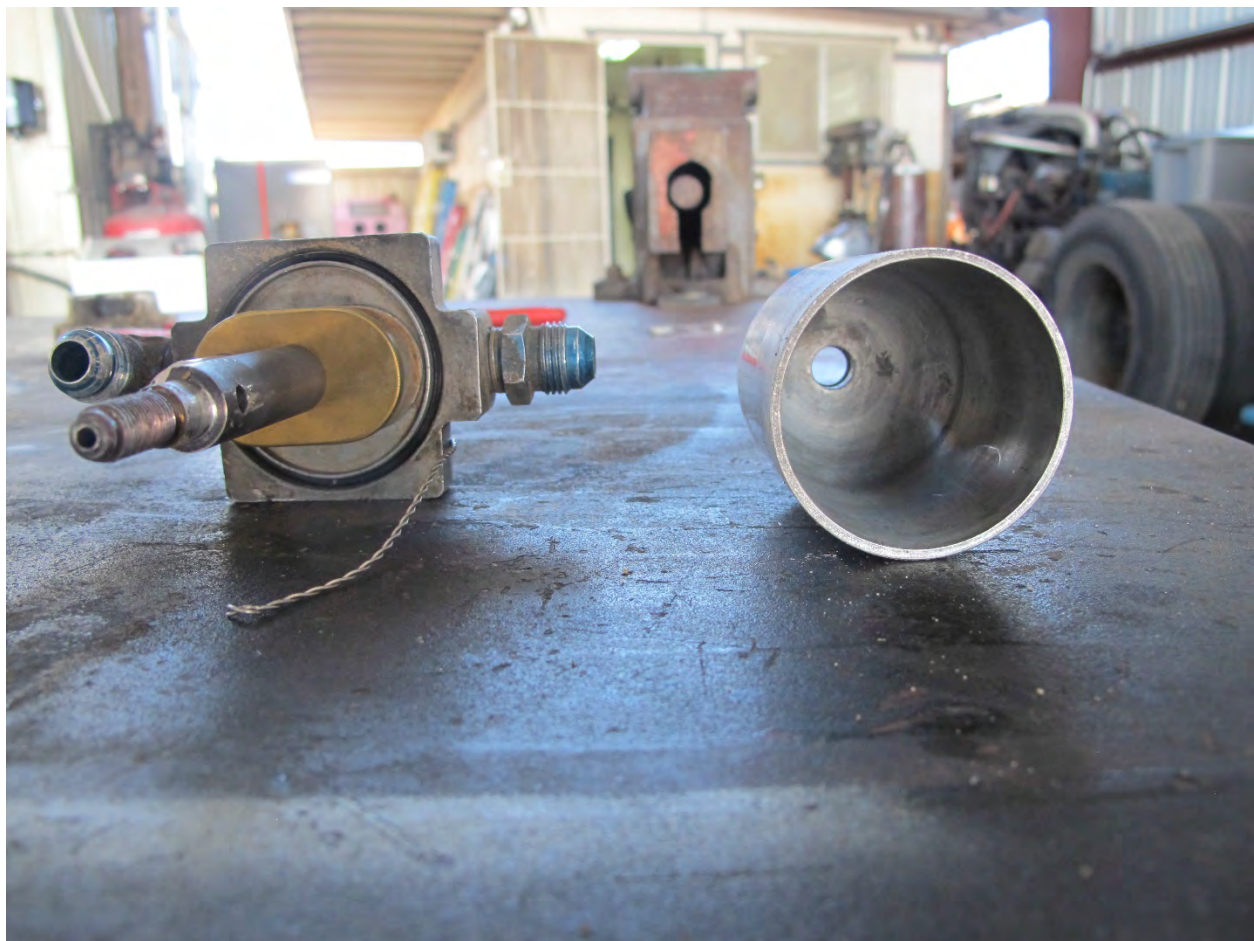
The gascolator contained no fluid; the screen contained a few small pieces of lint.

*Photo 4 Gascolator*

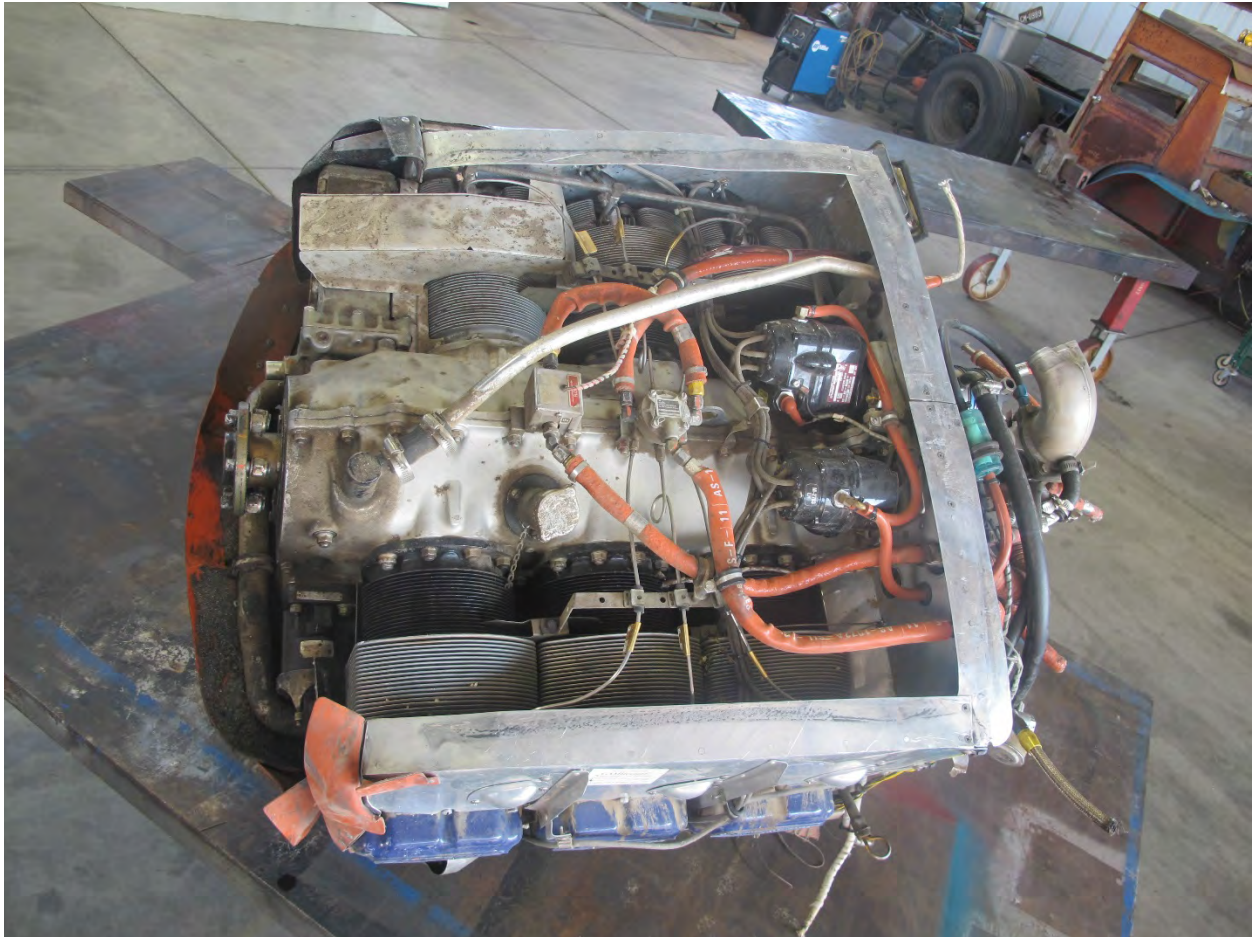
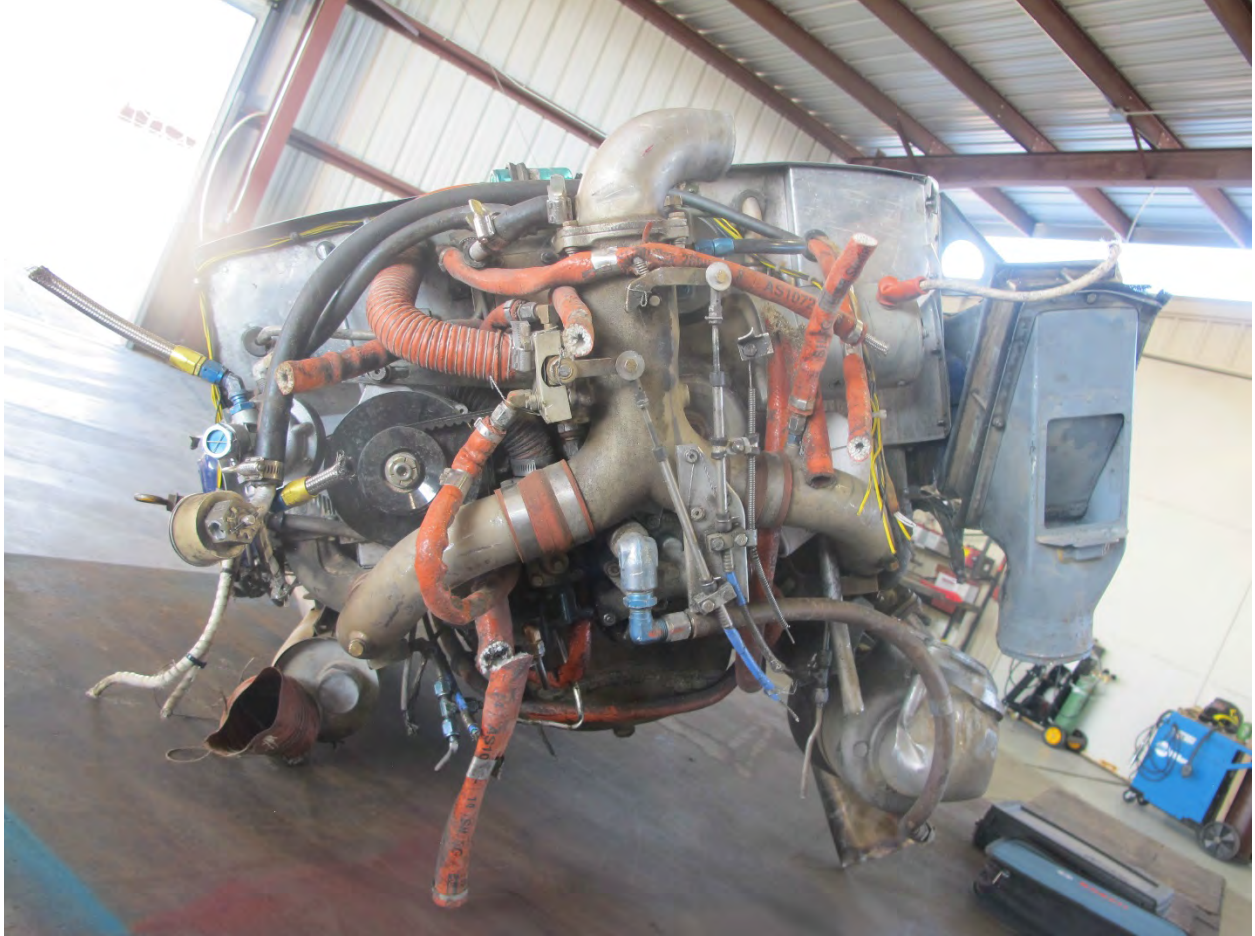
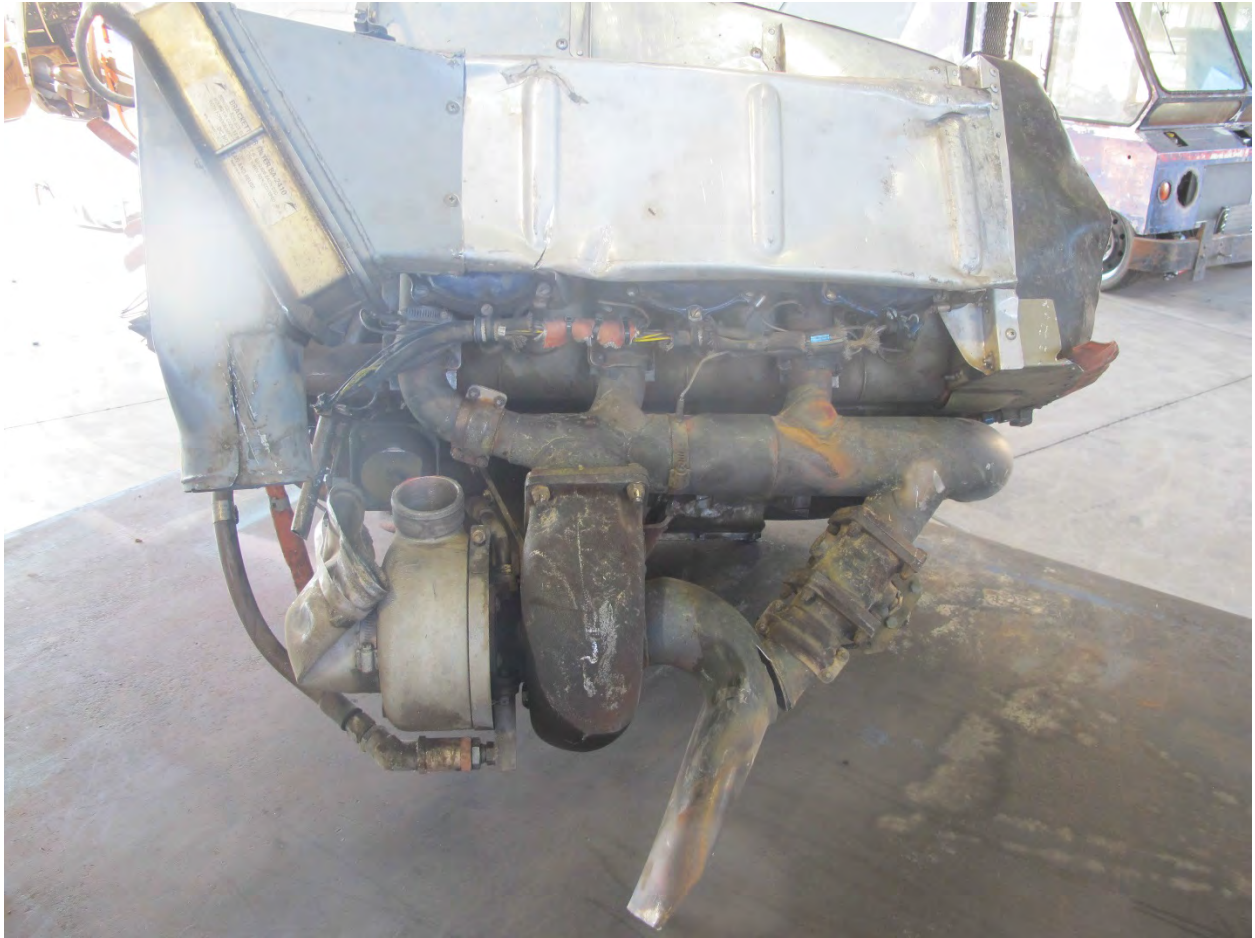
*Photo 5 Top of the Engine*

*Photo 6 Back of Engine*

*Photo 7 Right Side of Engine*

There were no holes in the crankcase or cylinders that indicated a catastrophic failure of the engine.

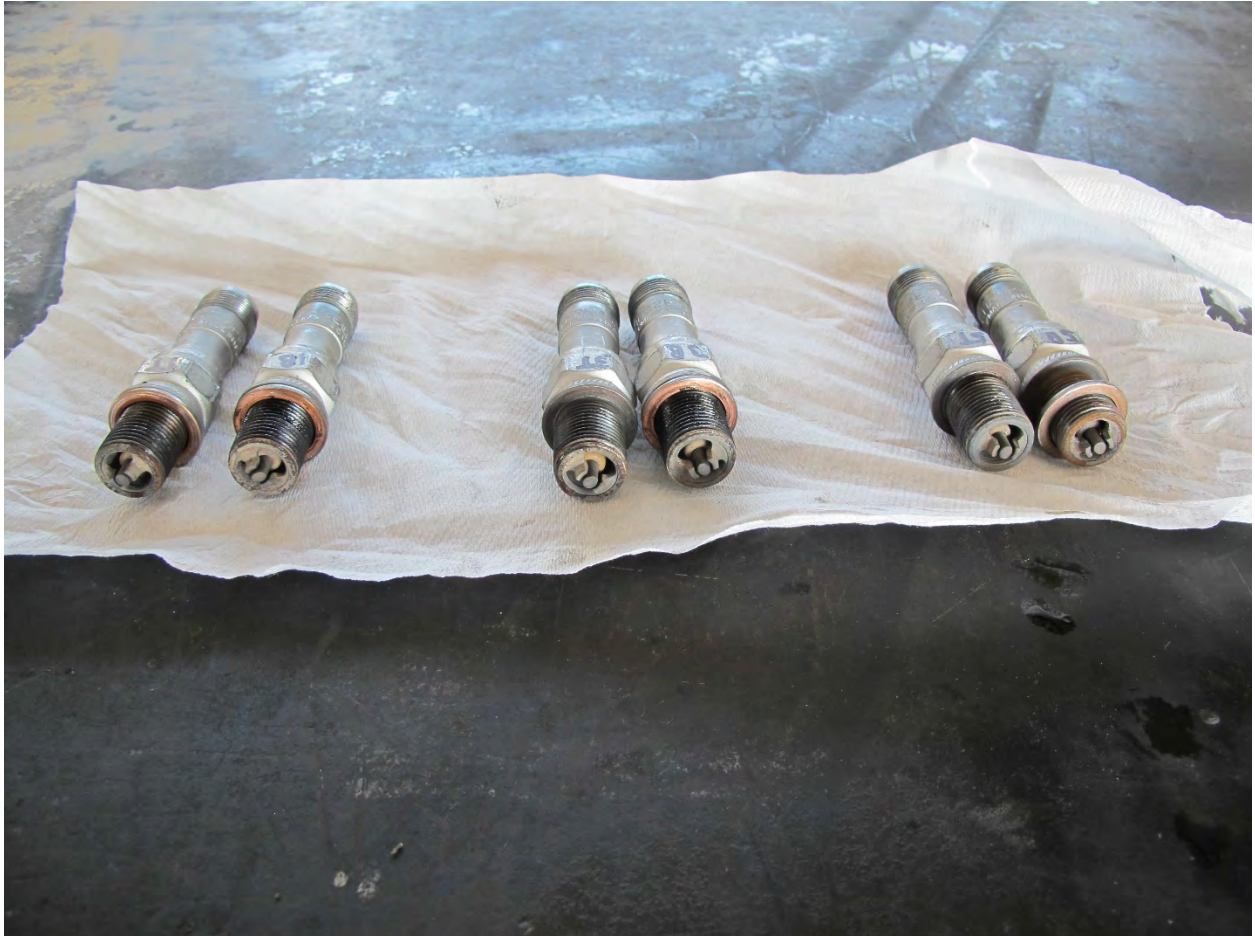
Investigators removed the spark plugs; all center electrodes were elliptical with no mechanical deformation. All plugs were clean except the bottom left side plugs for cylinders two, four, and six, which were oily; the engine lay canted on its left side during storage. The spark plug electrodes were gray, which corresponded to normal operation according to the Champion Aviation Check-A-Plug AV-27 Chart.

*Photo 8 Spark Plugs for Cylinders One, Three, and Five*

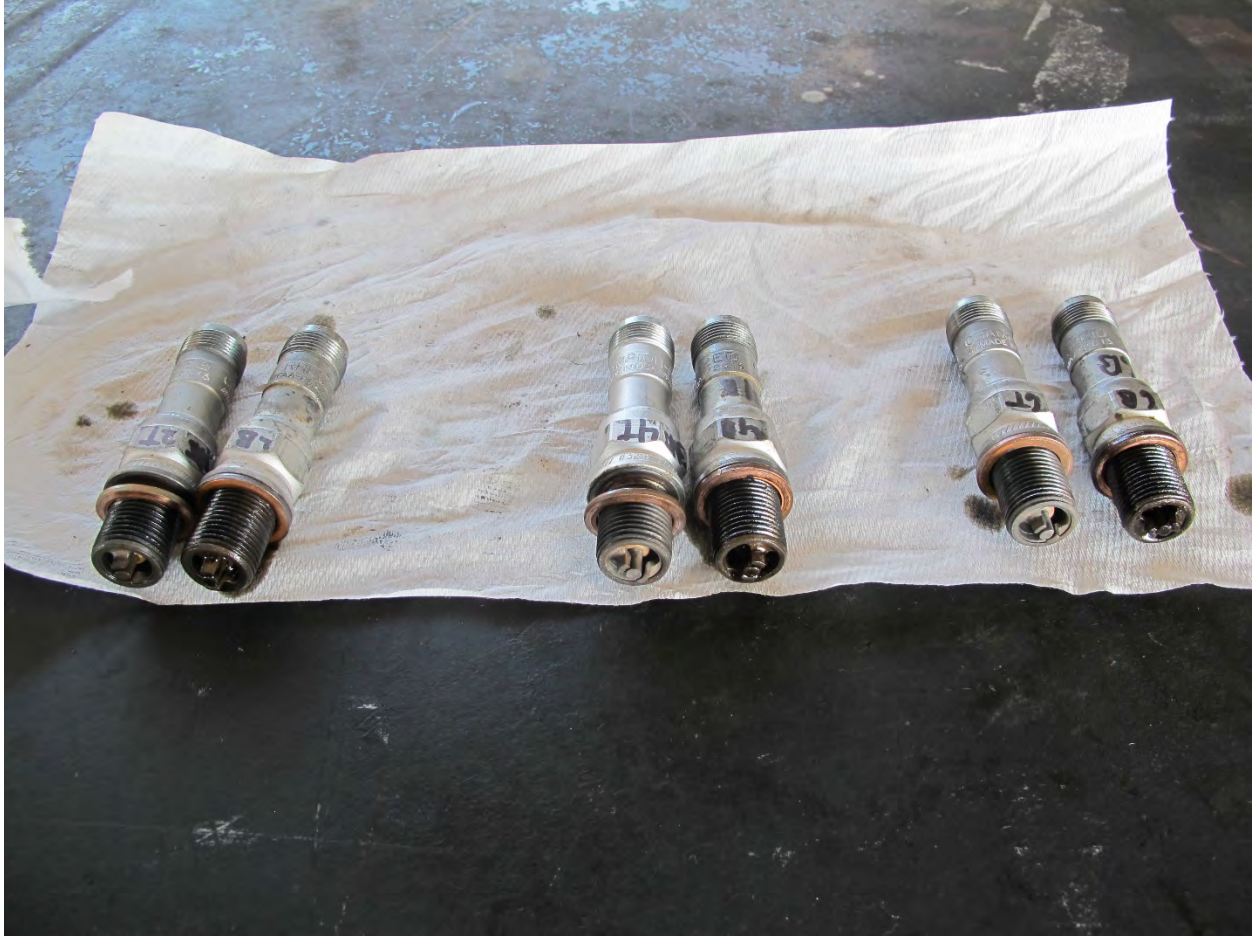
*Photo 9 Spark Plugs for Cylinders Two, Four, and Six*

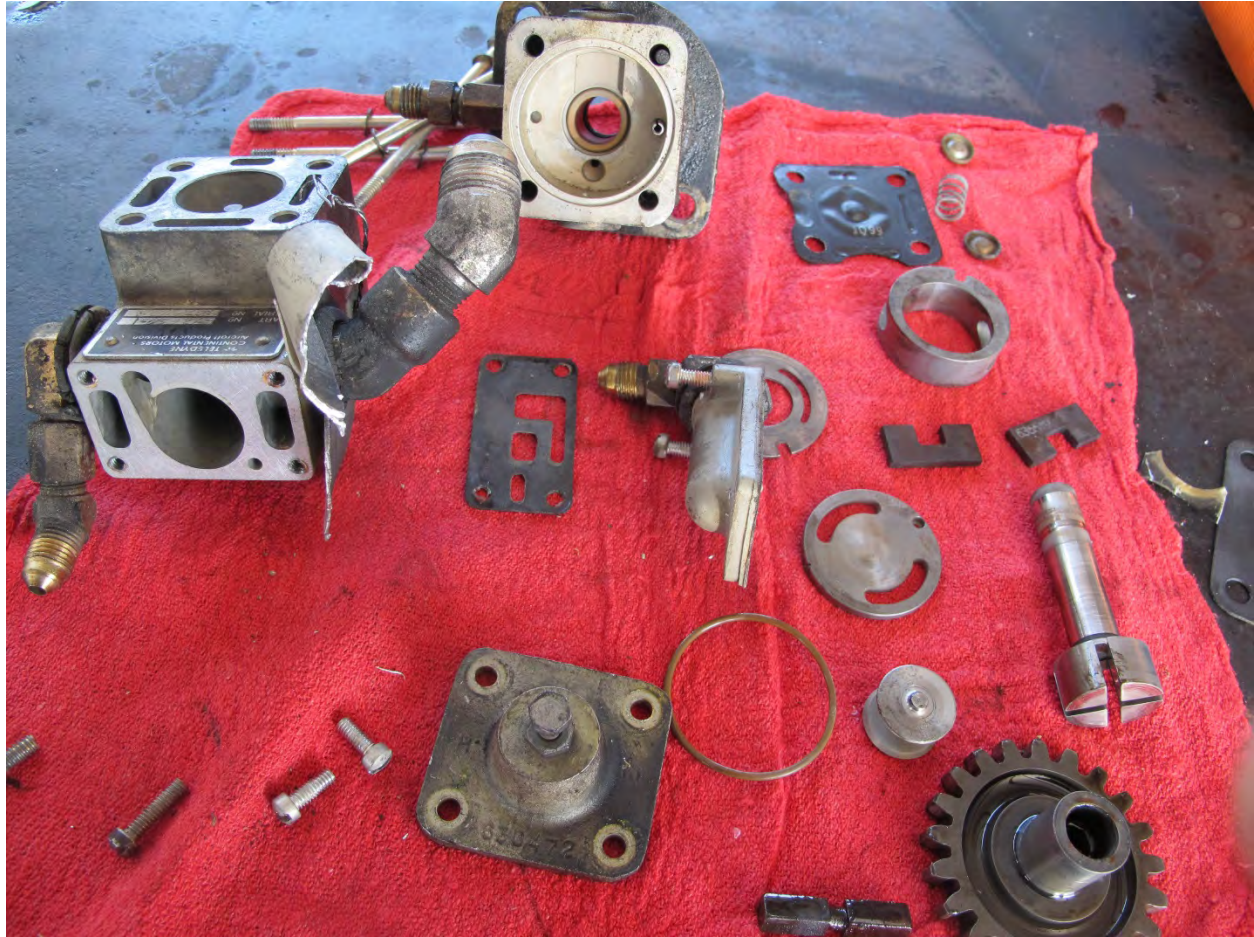
About 1/2 ounce of a clear light blue fluid remained in the fuel pump. The fuel pump's rubber diaphragm was unbroken. The engine driven fuel pump drive gear was undamaged, and the pump rotated freely.

*Photo 10 Fuel Pump*

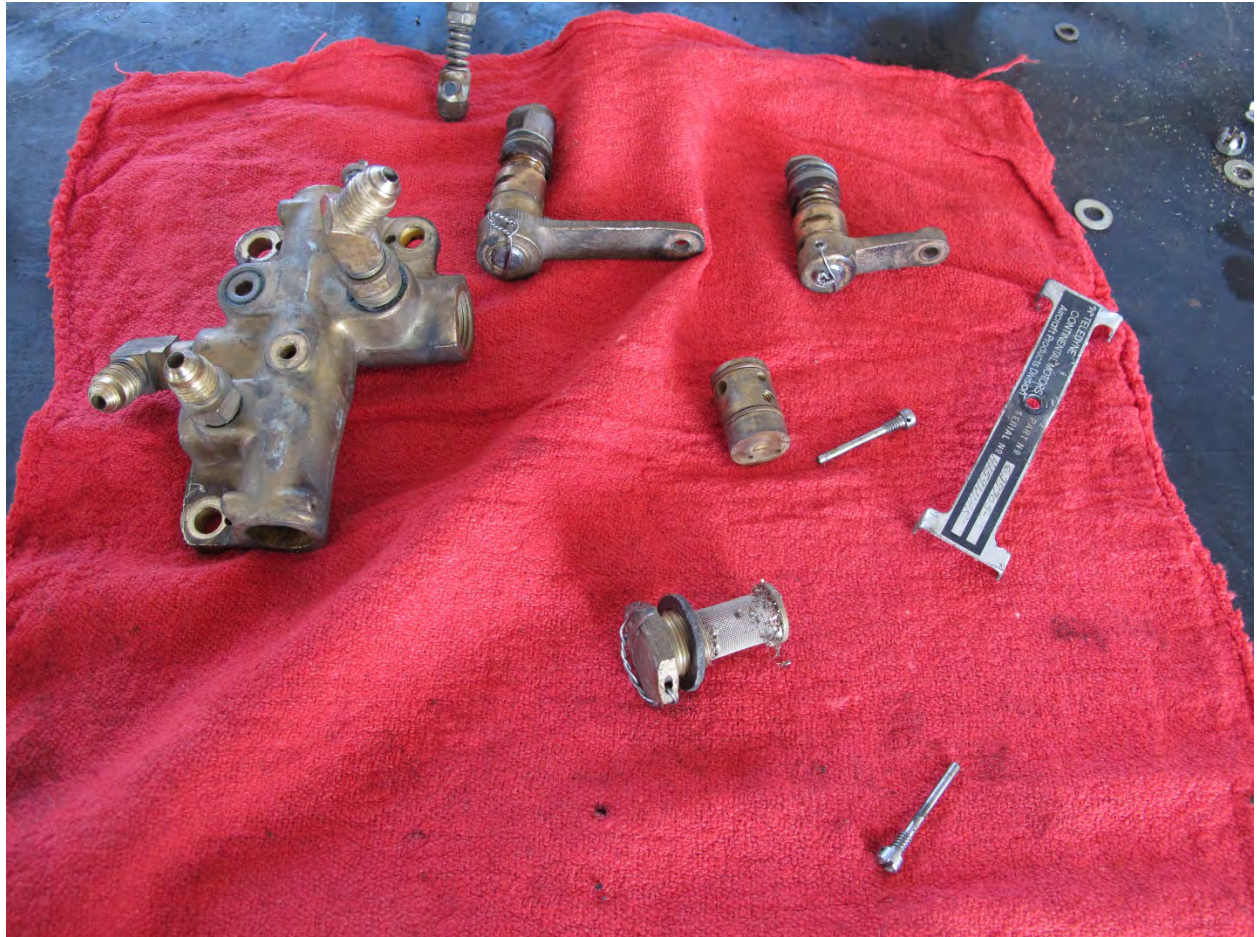
The throttle and metering assembly screen contained lint on an estimated 5 % of the screen.

*Photo 11 Fuel Metering Unit*

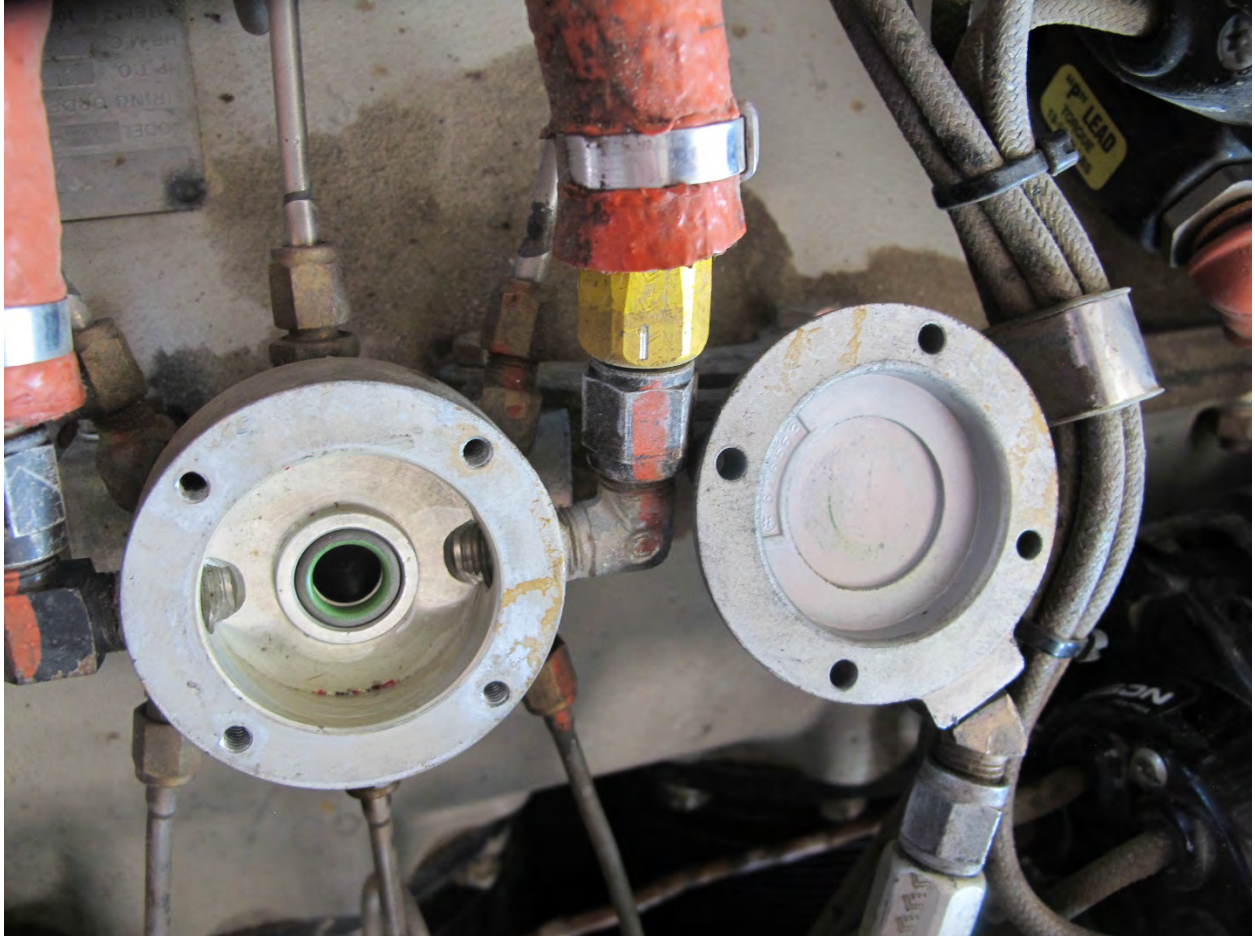
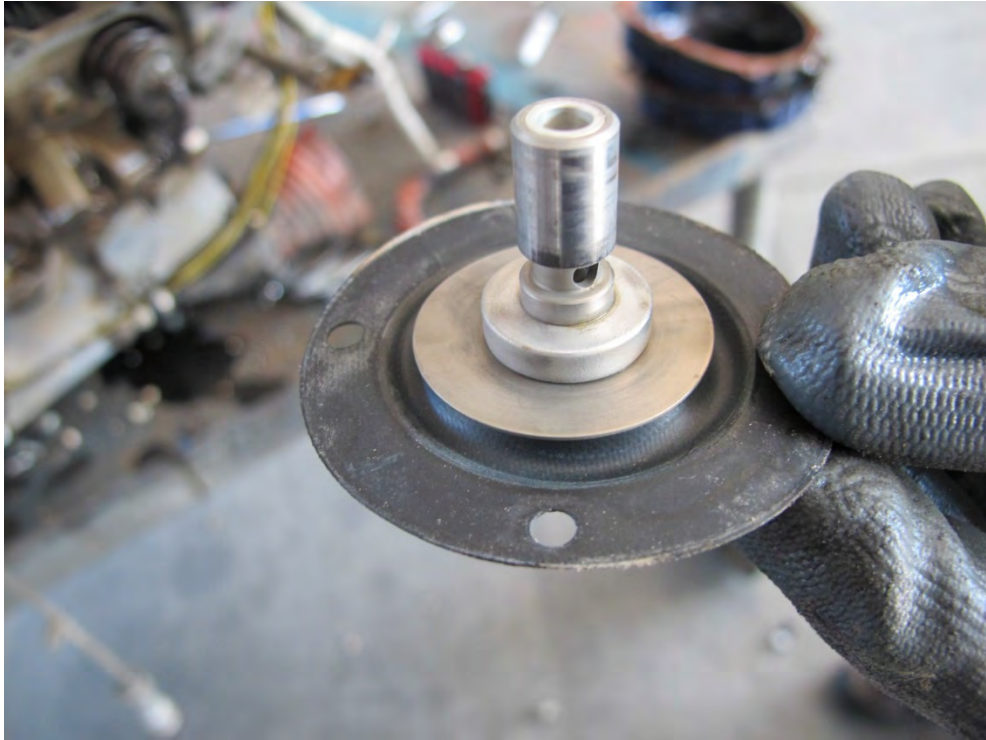
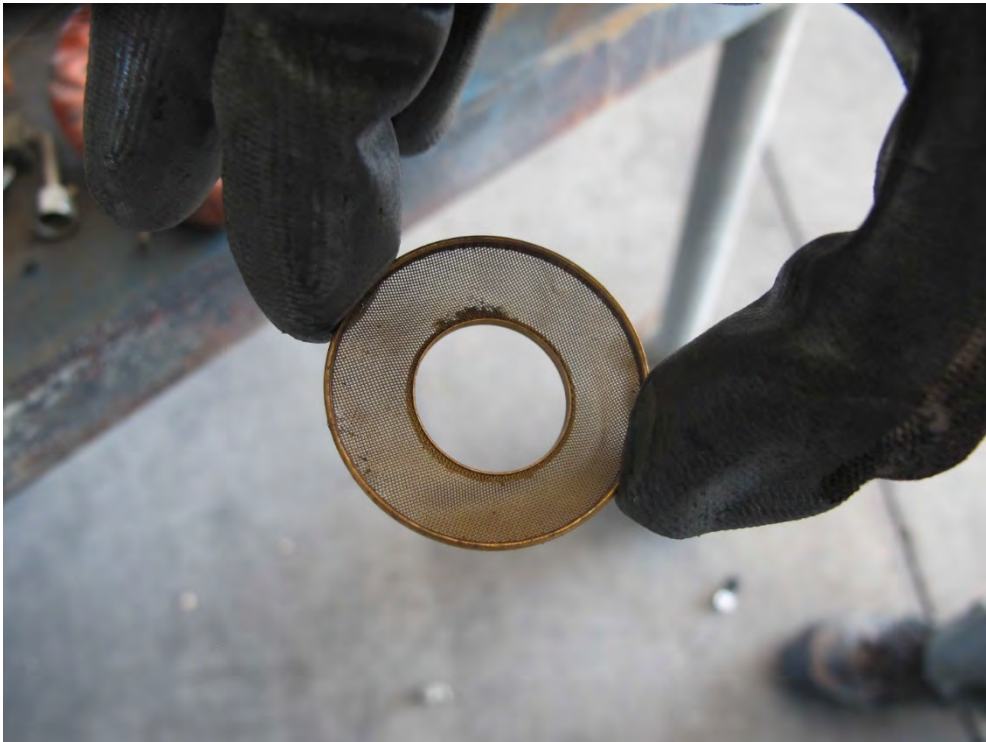
The fuel manifold valve contained less than 1/2 ounce of a light blue fluid. The rubber diaphragm was intact and pliable. The screen had some debris along a small section, and investigators observed a few drops of blue fluid with some black contamination in the valve.

*Photo 12 Fuel Manifold Valve*

*Photo 13 Fuel Manifold Diaphragm*

*Photo 14 Fuel Manifold Valve Screen*

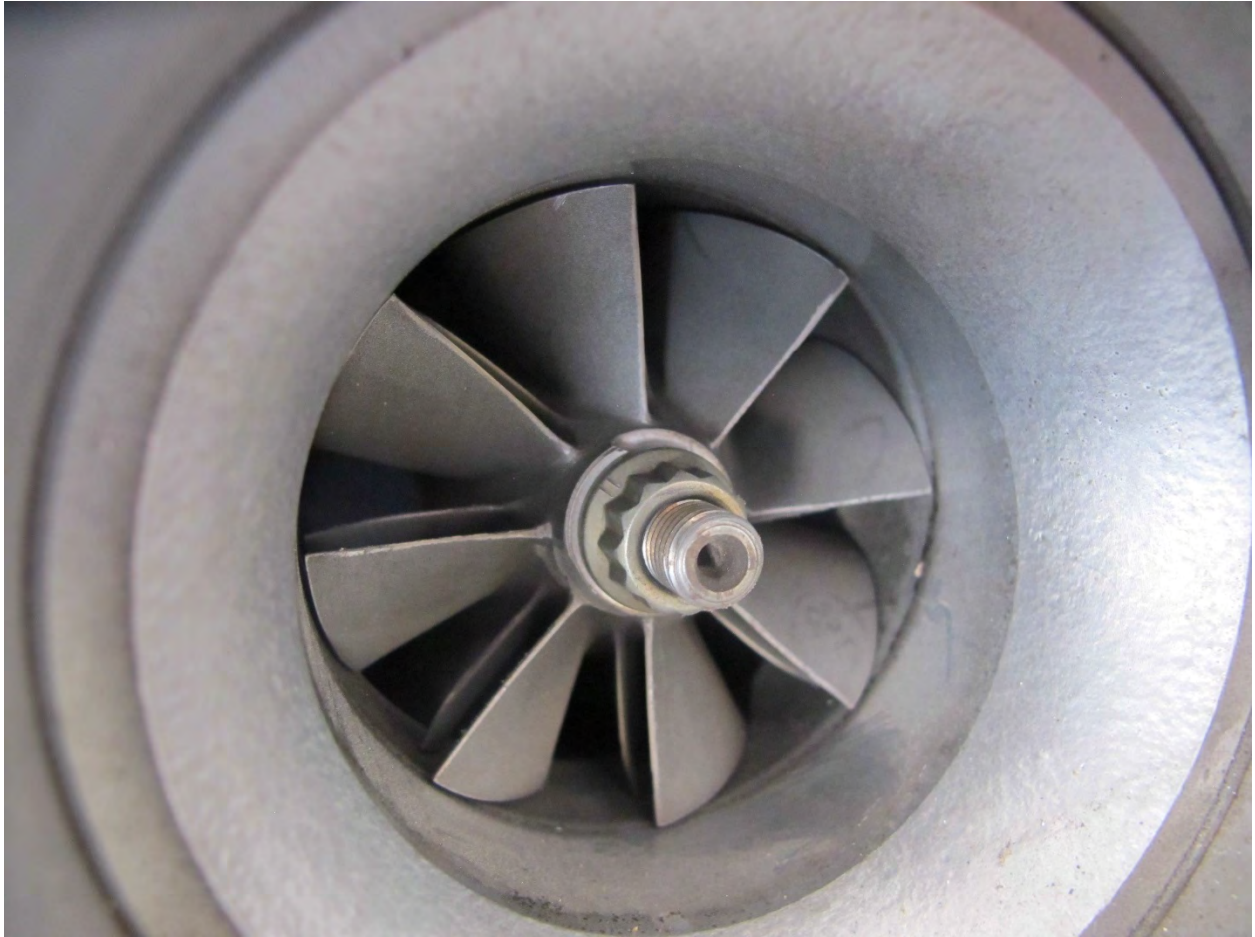
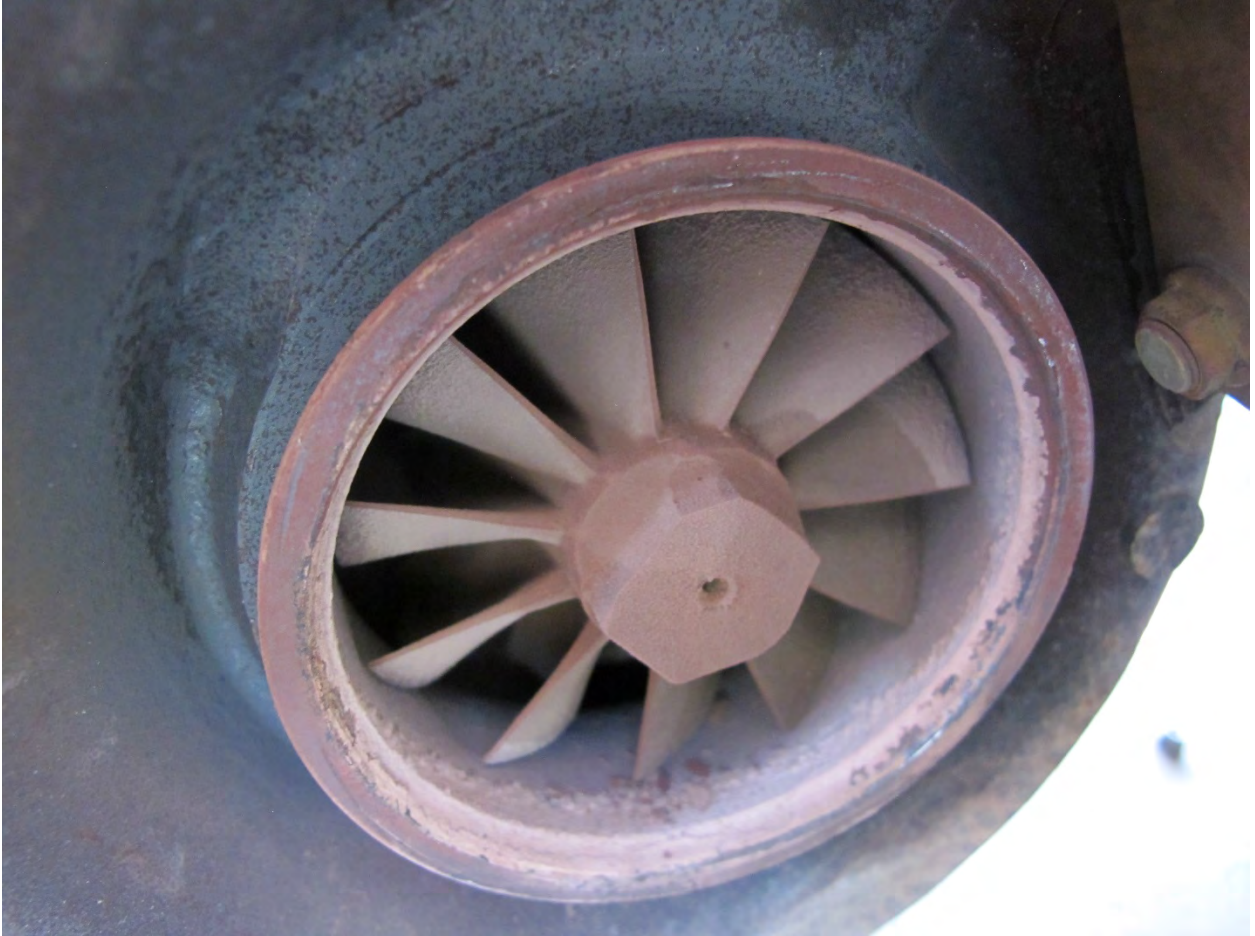
The blades of the compressor and turbine in the turbocharger turned freely, and appeared undamaged.

*Photo 15 Turbocharger Compressor Blades*

*Photo 16 Turbocharger Turbine Blades*

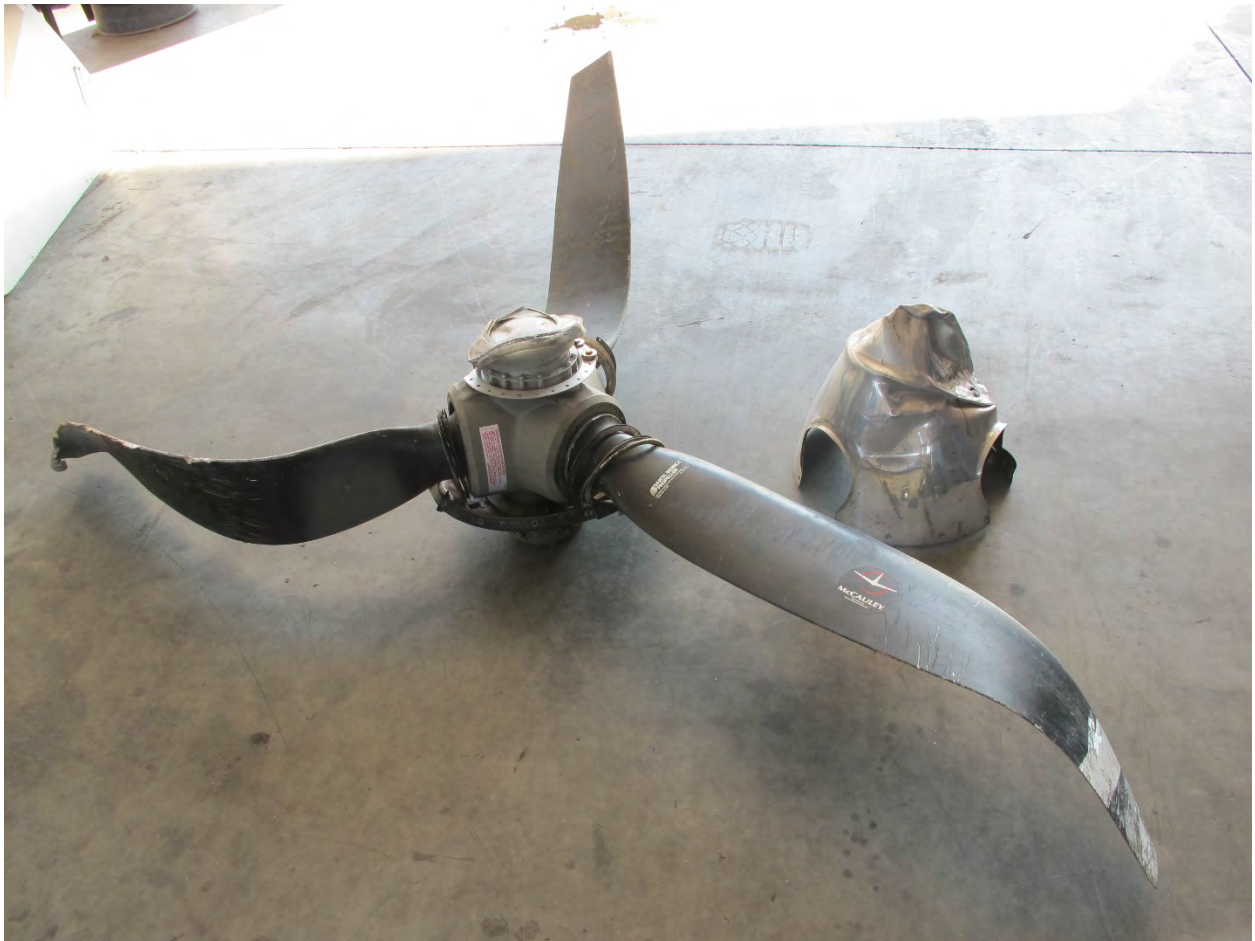
*Photo 17 Propeller*

The propeller separated from the engine crankshaft at the propeller flange; all the studs were pulled out of the propeller hub. All blades rotated in the hub. The spinner was crushed.

One blade was more damaged than the others; it was bent, twisted, and curled at the tip with severe leading edge gouges.

The outboard fifth of one blade bent aft about 45 degrees, and exhibited leading edge gouges.

The third blade was the least damaged. It had a sweeping aft bend with twist toward low pitch.
