# NATIONAL TRANSPORTATION SAFETY BOARD

## MATERIALS LABORATORY FACTUAL REPORT

Report No. 17-088

Place : Safford, Arizona  
Date : November 24, 2016  
Vehicle : Cessna 182A, N6077B  
NTSB No. : WPR17LA038  
Investigator : Joshua Cawthra, AS-WPR

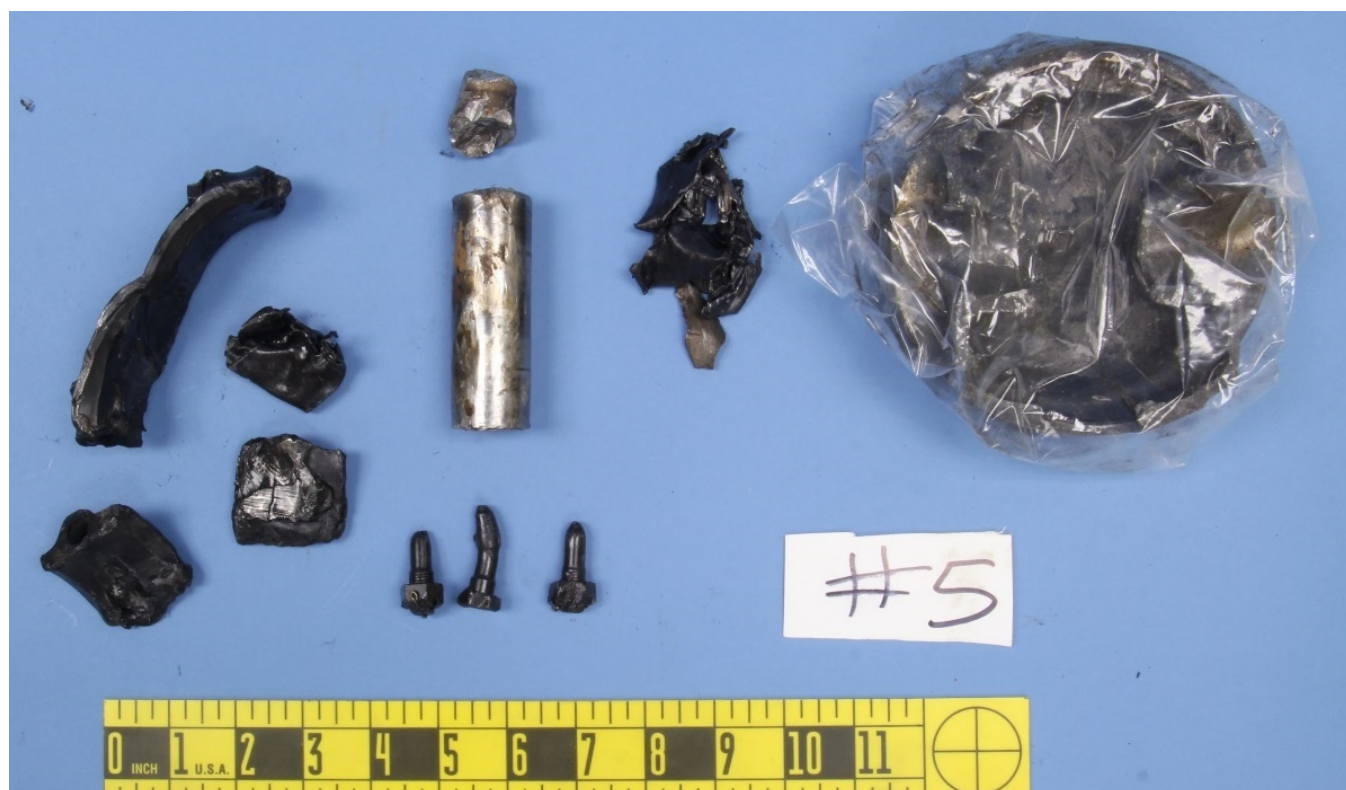
The components from the #5 engine position are shown in Figure 1, as received (except for a small bag of miscellaneous piston parts, shown later). All of the submitted pieces exhibited damage significant enough to deform the outer surfaces. Some of the pieces had been so damaged, they could not be readily identified. All of this damage was consistent with post-fracture damage while the engine was still running.

Figure 1 – The components of the #5 engine position (less the connecting rod shaft), as received.

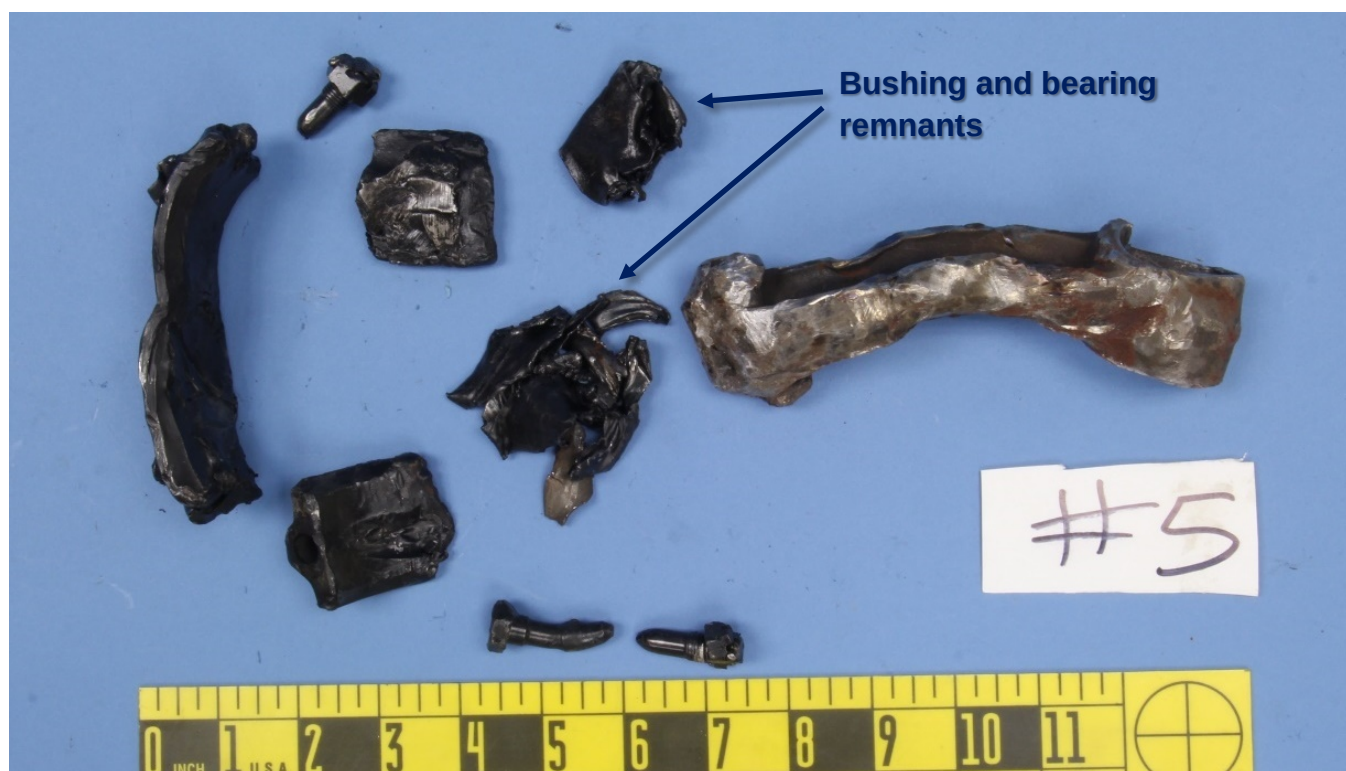
Figure 2 shows all the components submitted from the #5 connecting rod assembly. As shown in the figure, all of the pieces exhibited severe batter and deformation. The center of Figure 2 shows the remainder of the bushing and bearing pieces. These pieces had been so battered that they had folded in on themselves. No discernible features prior to this folding deformation could be observed.

Figure 2 – The received pieces of the #5 connecting rod, cap, and bolts.

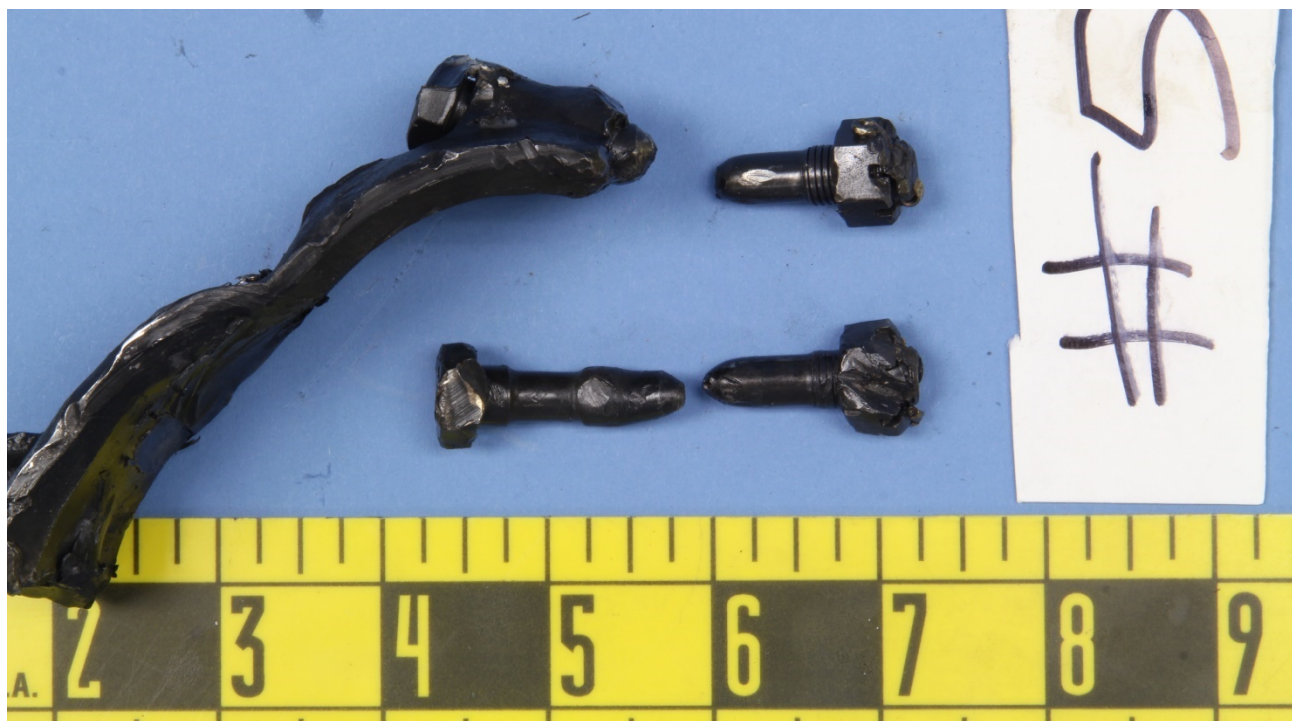
Figure 3 illustrates the condition of the connecting rod bolts. Both bolts had fractured at midlength, consistent with where the faces of the cap and connecting rod mate. Both bolts exhibited necking adjacent to their fracture surfaces. The fracture surfaces were generally oriented 90° toward the bolt length and exhibited a rough texture and dull luster. These features were consistent with the bolts having fractured from tensile overstress.

Figure 3 – Closer view of the bolts from the #5 connecting rod, as received.

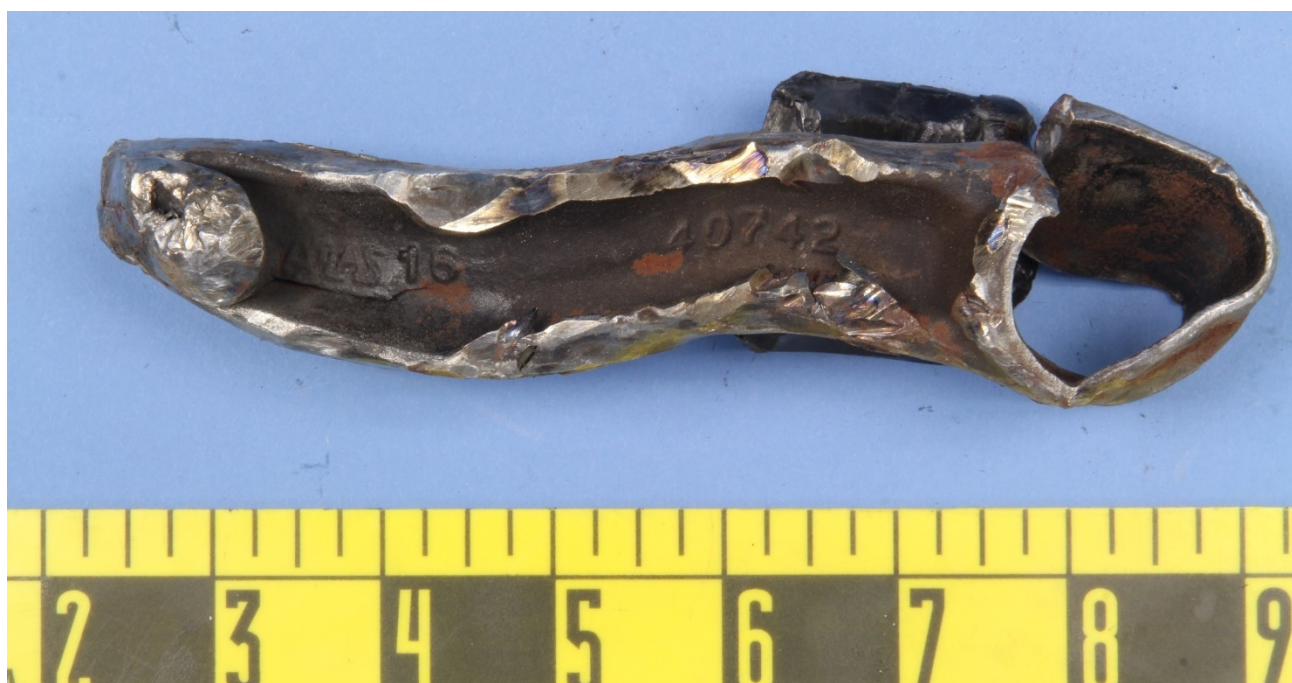
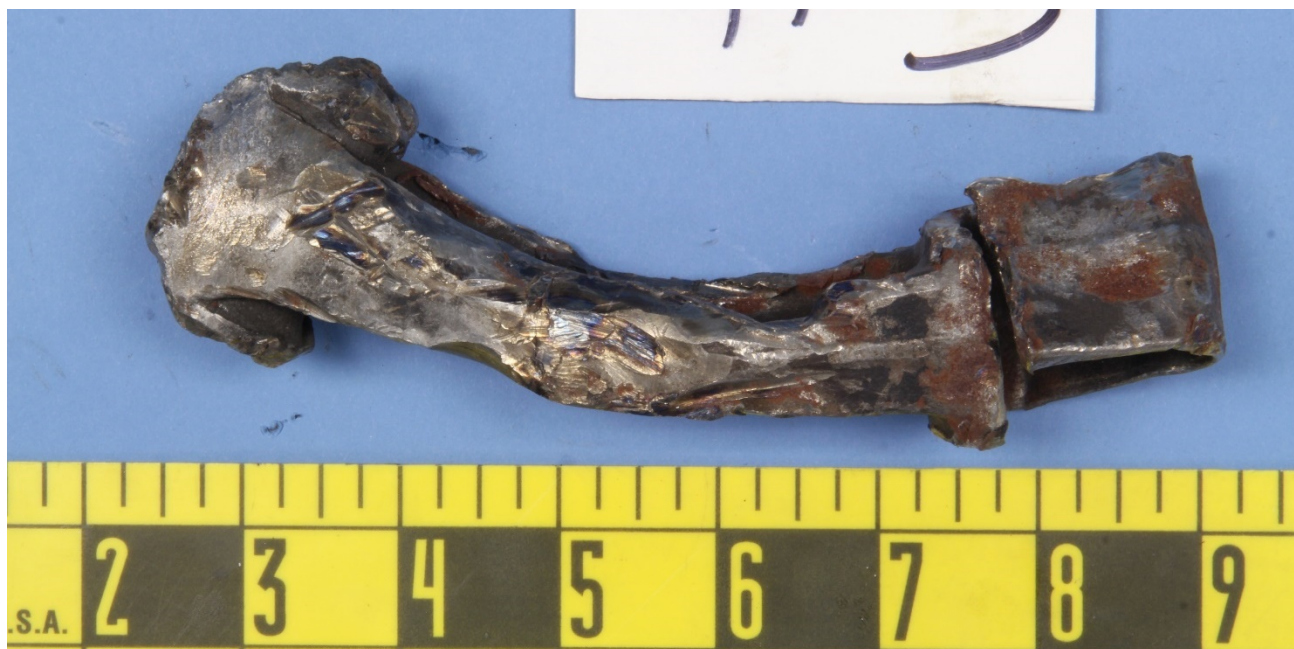
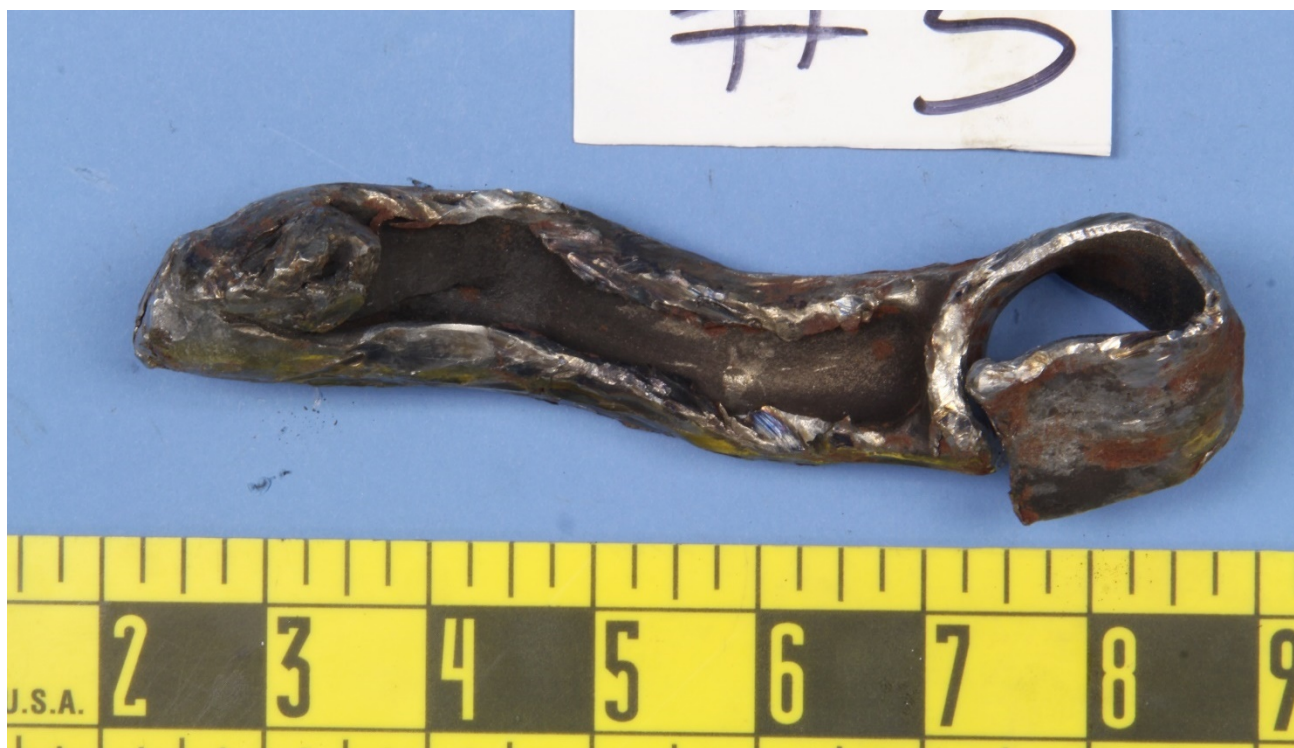
Figures 4 through 6 illustrate the connecting rod body, as received. The markings on the connecting rod (Figure 4) stated "ATLAS 16 40742". As shown in the figures, the connecting rod was severely battered. The end facing the crankshaft had been battered into a "mushroom head" shape and the web of the rod had been deformed approximately 30° out of plane.

The most notable feature on pin side bore was the fracture at the neck yoke of the rod web, shown in Figures 5 and 6. A portion of the pin bore wall was sectioned away to observe the fracture surfaces. Figure 7 shows the connecting rod pin bore after this sectioning. As shown in the figure, the rod bore exhibited deformation consistent with having been twisted about the piston pin. The inner bore surfaces exhibited circumferential scoring marks. This surface also exhibited discernible rust, consistent with later exposure to water or humidity after the engine ceased functioning properly.

Figure 4 – The web and camshaft bearing of the #5 connecting rod, as received.

Figure 5 – The #5 connecting rod, rotated 90° from Figure 4.

Figure 6 – The #5 connecting rod, side opposite of the one in Figure 4.

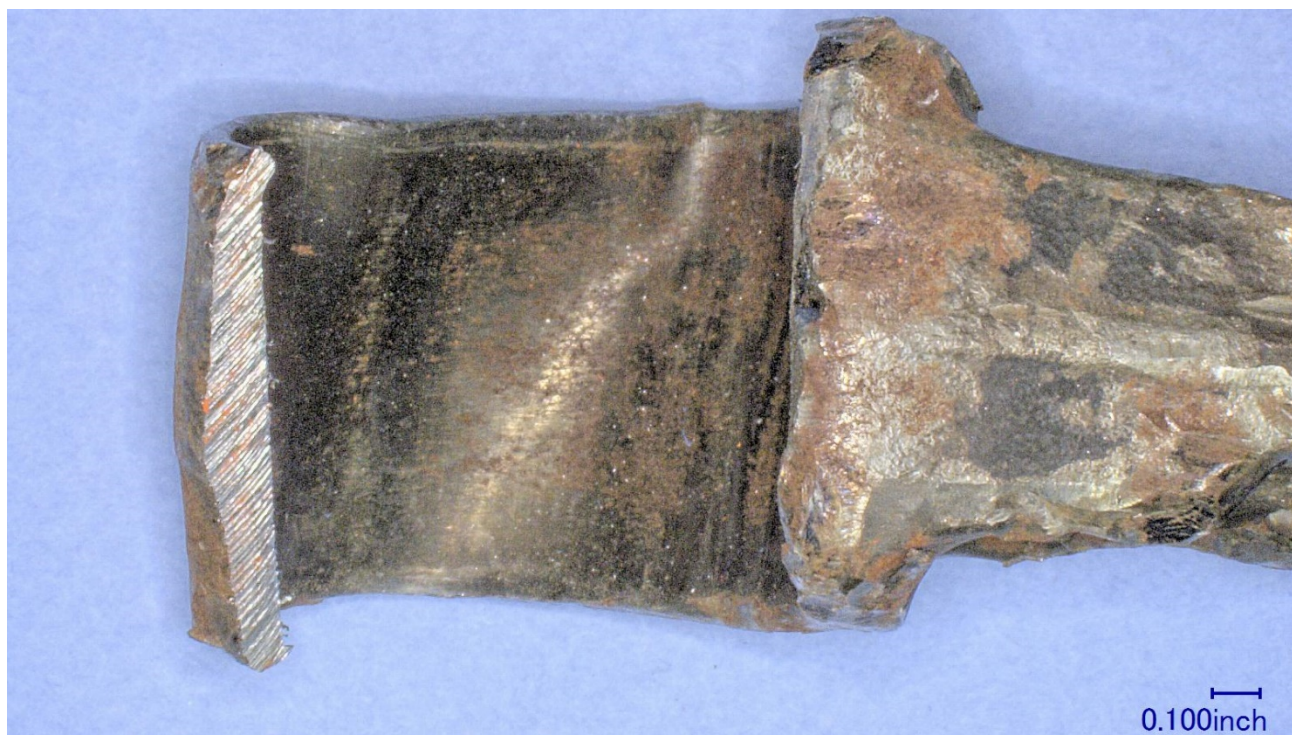
Figure 7 – The pin side of #5 connecting rod, after sectioning the fractured bore half away.

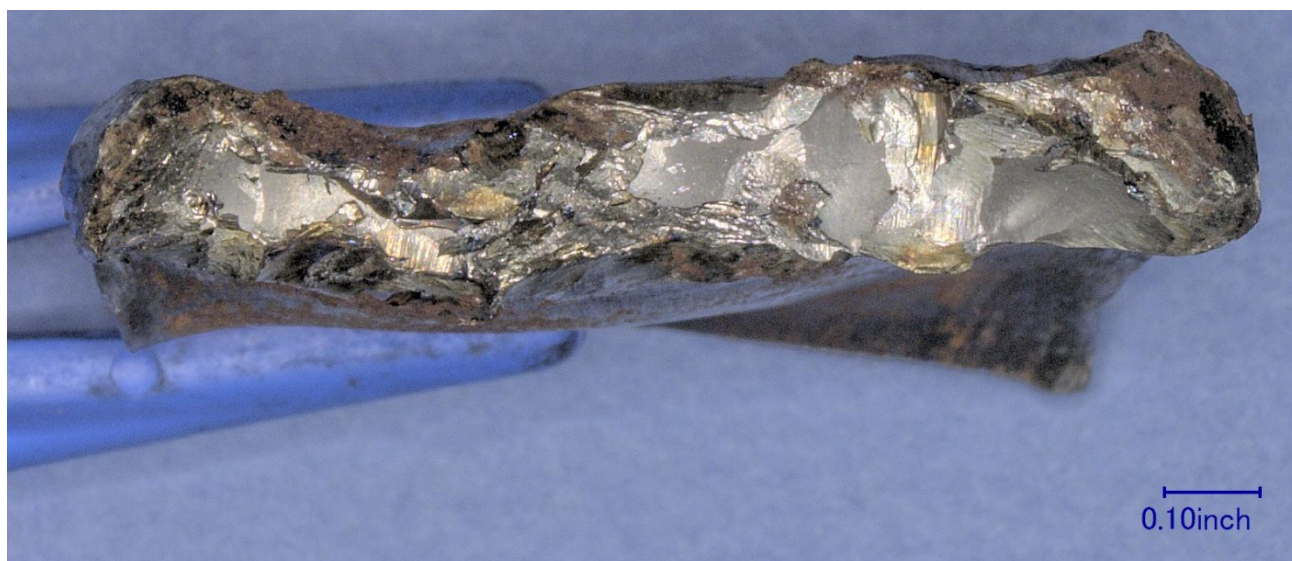
The fracture surface of the sectioned pin bore wall is shown in Figure 8. This fracture surface had been damaged by post-fracture batter and deformation. The areas adjacent to the fracture surface exhibited local thinning, or necking. The undamaged portion of the fracture surface exhibited a dull gray luster with rough surface texture. Examining this fracture surface using a scanning electron microscope (SEM) revealed dimple rupture. All of these features were consistent with fracture from overstress. In addition, examination of the mating fracture surface revealed similar features, with no indication of other fracture features.

Figure 8 – The fracture surface of the sectioned bore half from the #5 connecting rod pin side bore.

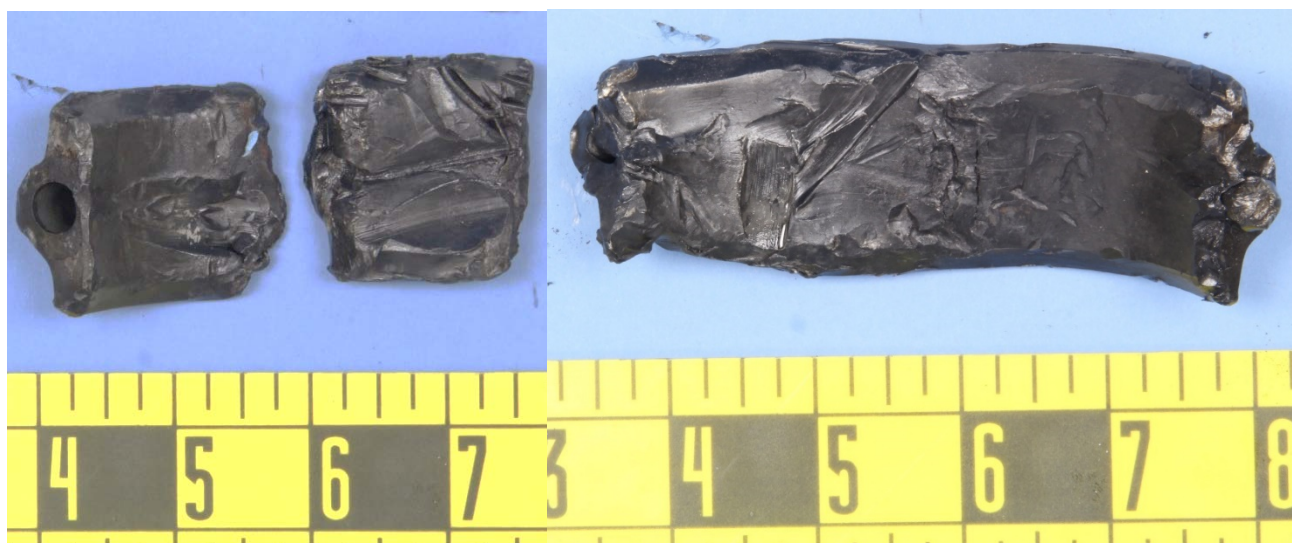
The three portions of the connecting rod cap are shown in Figure 9. The cap had fractured in two places, and the previously curved cap had been deformed outward in an almost flat orientation. The fracture surfaces, along with the other surfaces of the cap, exhibited severe post-fracture damage in the form of batter, gouging, and scraping. The gouging marks on the inside bearing surface were consistent with either the cap being bounced around after fracture/separation or having an adjacent object impressed into the cap.

Figure 9 – The inside bearing surfaces of the #5 connecting rod cap.

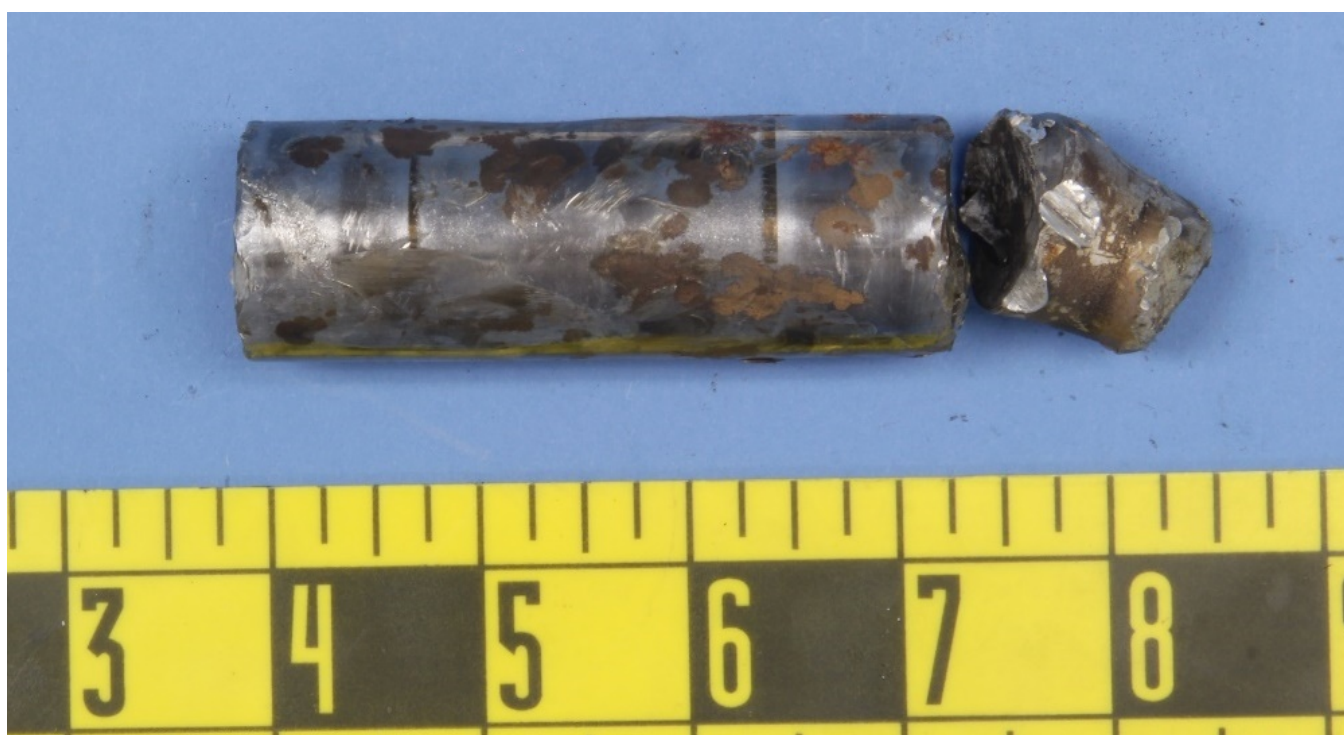
Figure 10 illustrates the pieces of the piston pin, as received. Both endcaps of the pin had fractured away, but only one of the cap remnants was received. The outer surface

of the pin exhibited batter and gouge marks, as well of surface rust consistent with post-fracture exposure to water or humidity. The mating fracture surfaces of the pin and pin endcap fragment are shown in Figure 11. Both fracture surfaces had been extensively damaged, consistent with post-fracture impact. No discernible information could be obtained from examination of the fracture surfaces.

Figure 10 – The pieces of the piston pin from the #5 piston.

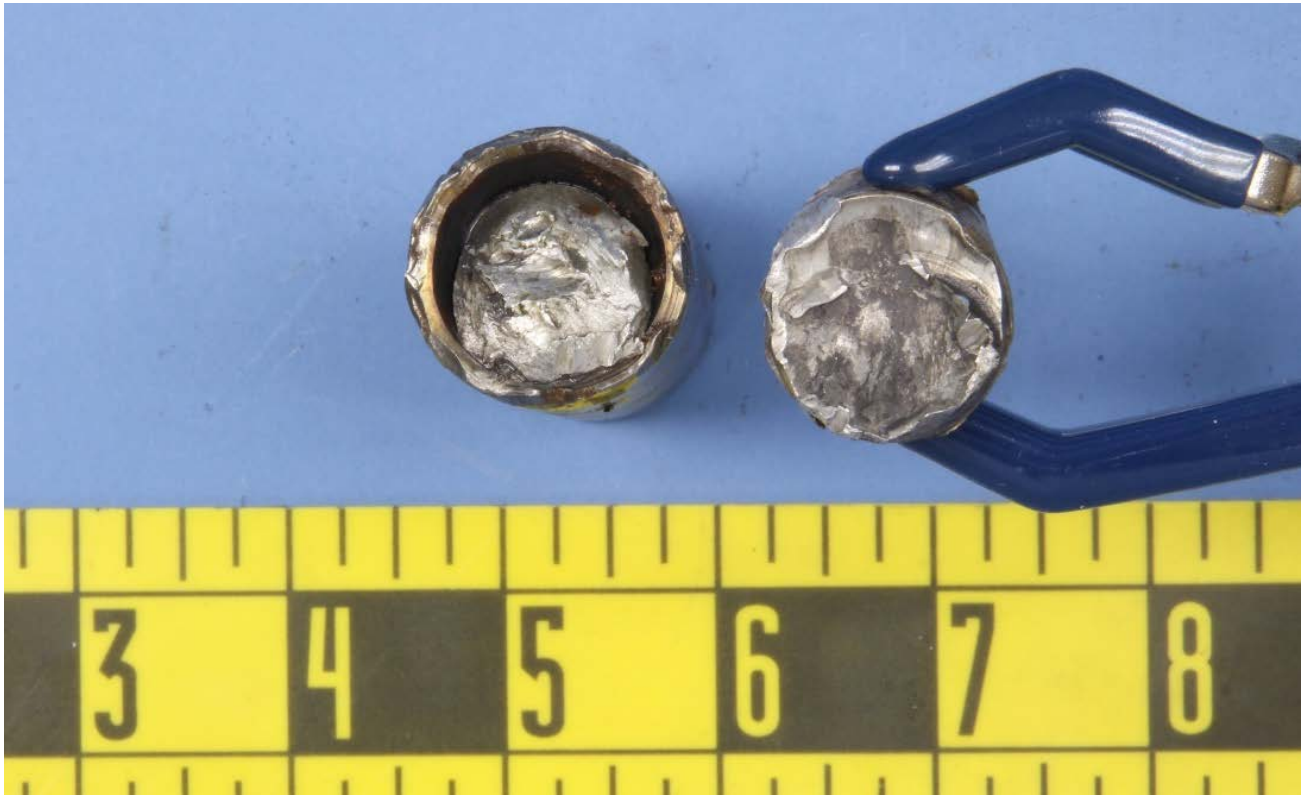
Figure 11 – The battered fracture surfaces of the #5 piston pin pieces.

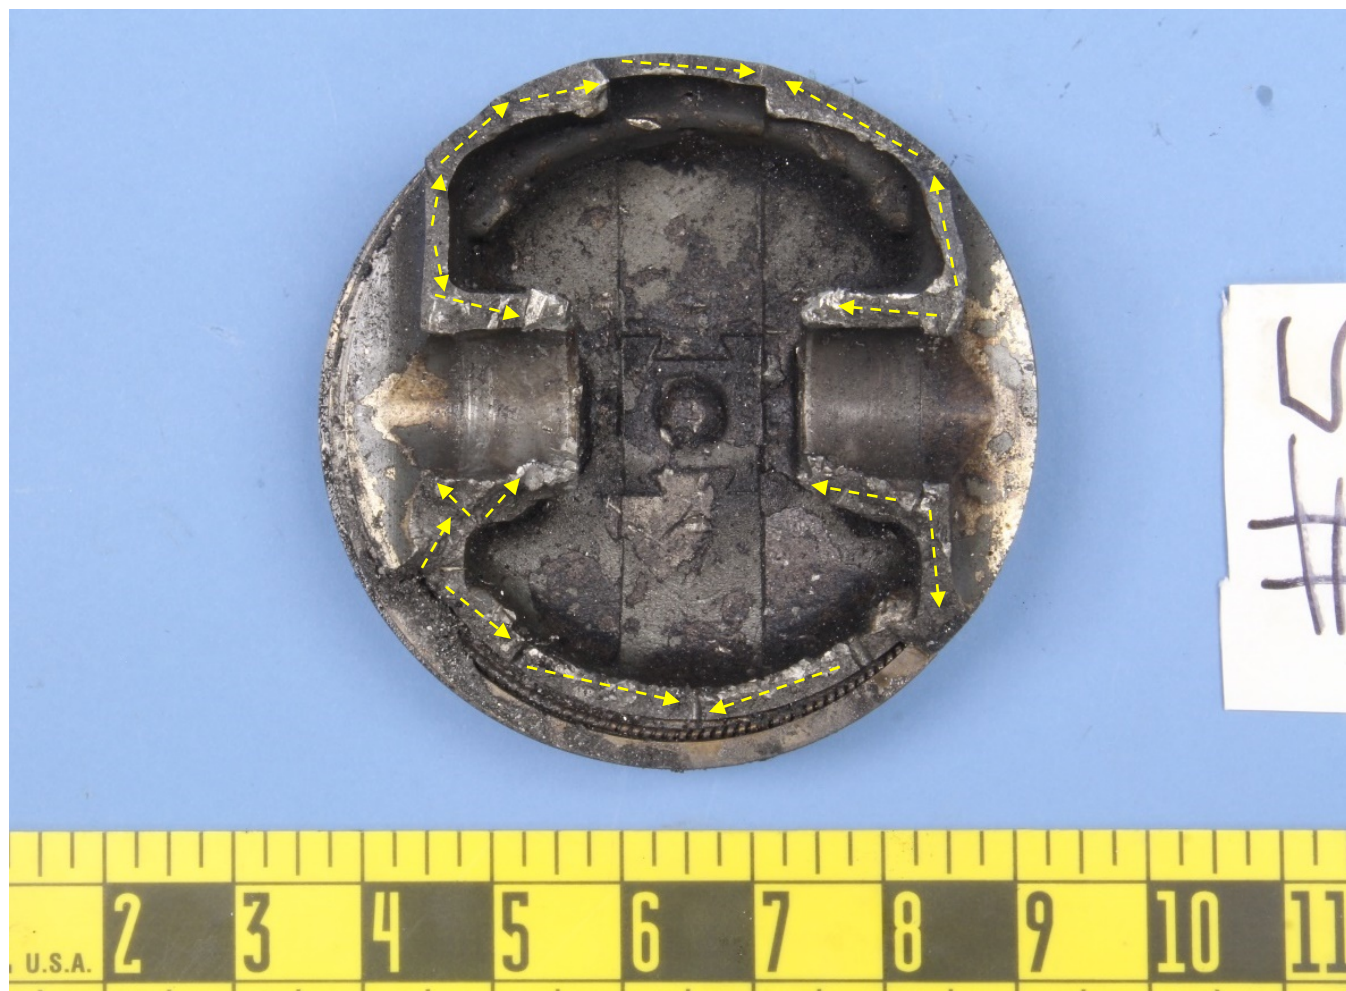
The piston is shown in Figures 12 through 14. The majority of damage to the piston was present on the underside of the part to the skirt flanges, shown in Figures 12 and 14. The crown or head of the piston facing the cylinder interior exhibited some combustion deposits, but there were no features consistent with severe wear, impact, or thermal damage. The underside of the piston exhibited small gouge and batter marks, consistent with impact with multiple metallic pieces.

Examination of the chevron marks and river patterns on the piston fracture surfaces found that they were consistent with fracture beginning from the inside of the piston. These general directions are annotated on Figure 12. Many of the fracture features were consistent with having emanated from the piston pin boss.

Figure 12 – The underside of the #5 piston crown, showing fracture surfaces of the skirt. The yellow dashed arrows indicate the direction of overstress fracture, based on the radial and chevron marks on the fracture surfaces.

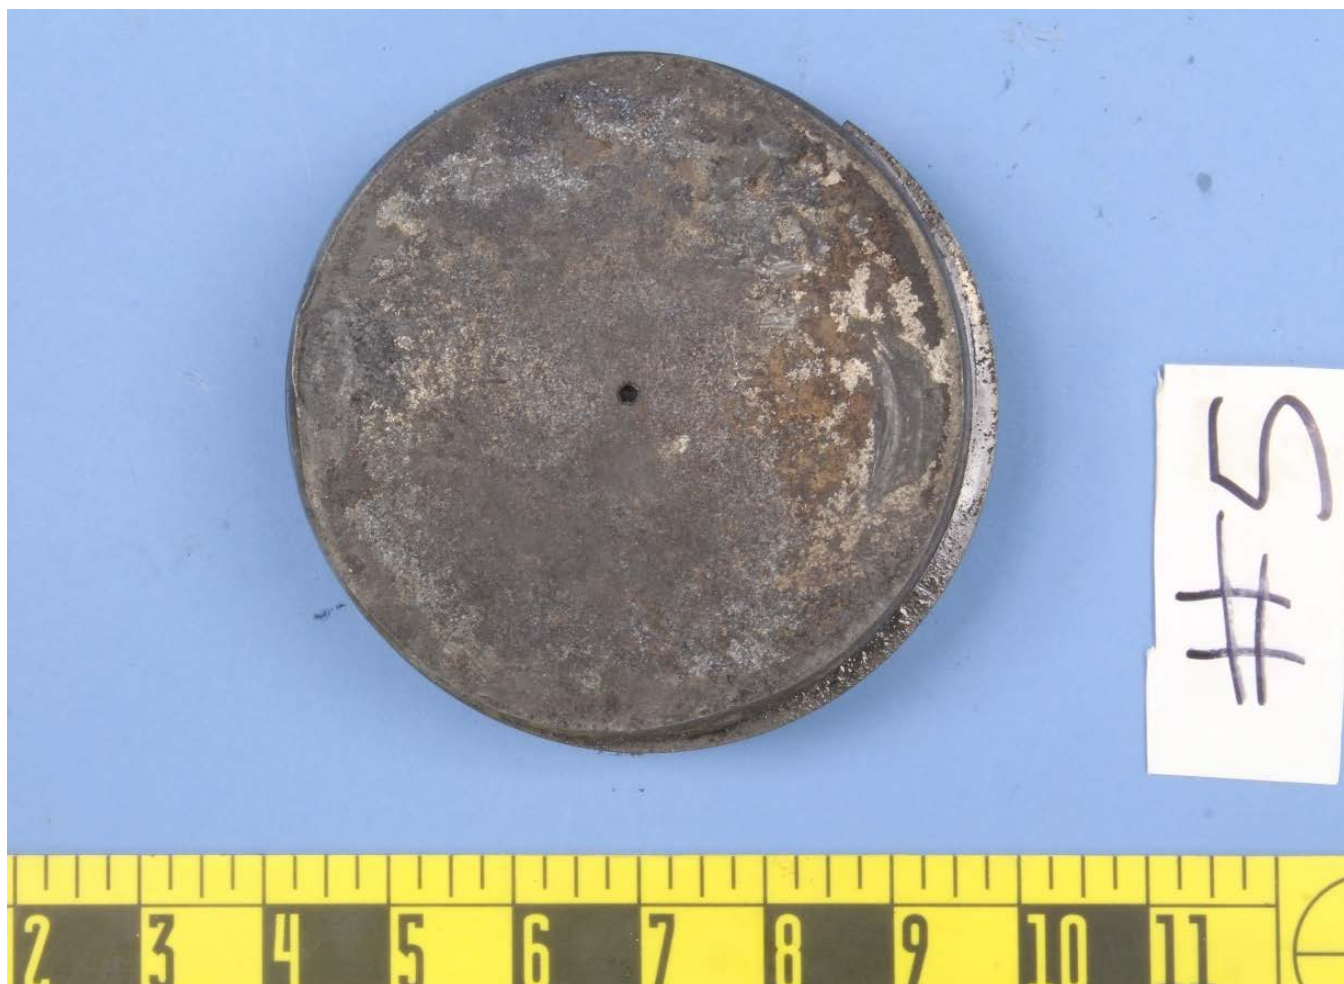
Figure 13 – The top of the #5 piston, which had faced the interior of the #5 cylinder.

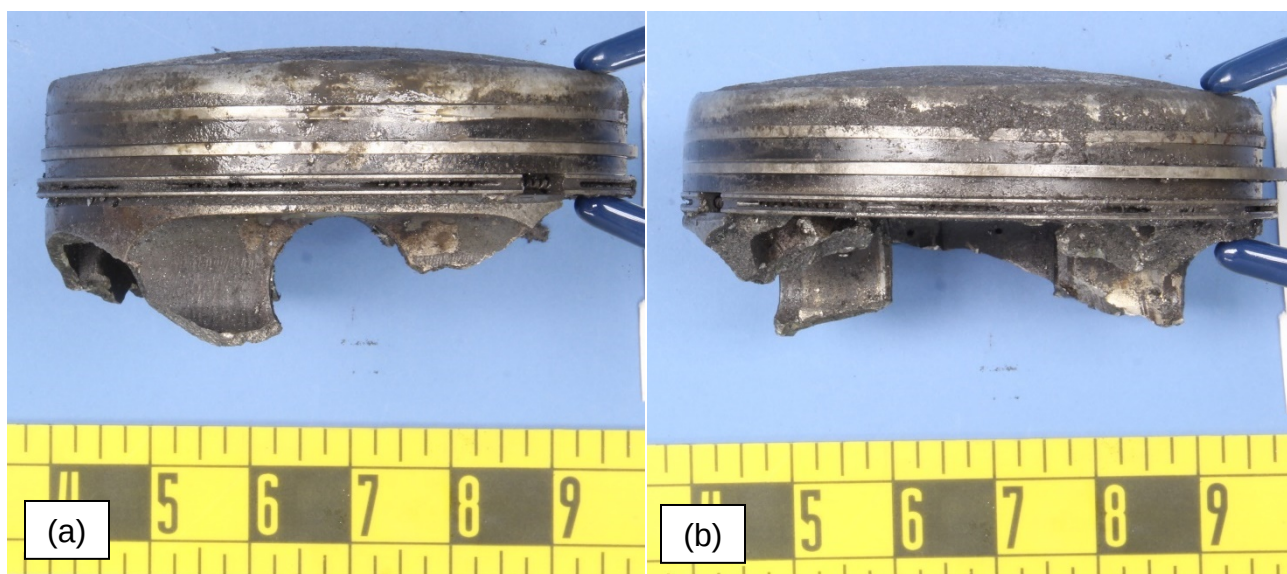
Figure 14 – The sides of the #5 piston, showing the damage about the pin boss from (a) the pin boss side and (b) rotated 90° from Figure 14a.

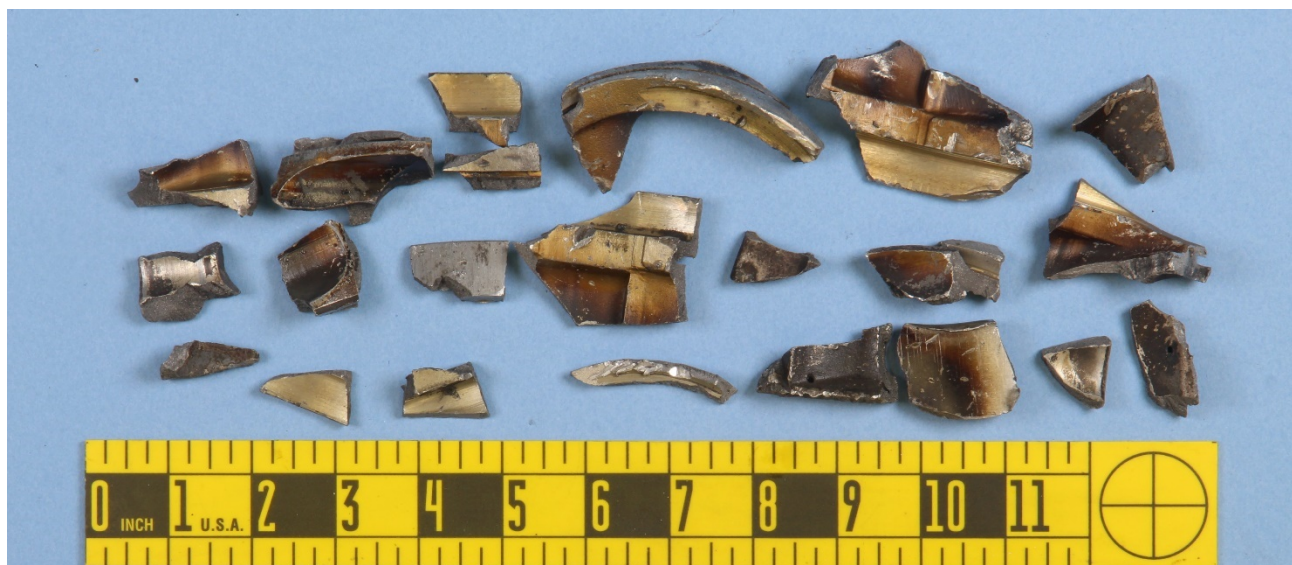
The lower portions of the piston, including those surrounding the piston pin boss, had fractured into many multiple pieces, collected and illustrated in Figure 15. All of the fracture surfaces examined exhibited features consistent with overstress failure of aluminum castings—rough and tortuous surfaces, dull luster, and no indications of pre-existing cracks or discontinuities. The oil and guide rings were found relatively undamaged.

Figure 15 – The miscellaneous piston pieces from the #5 piston.

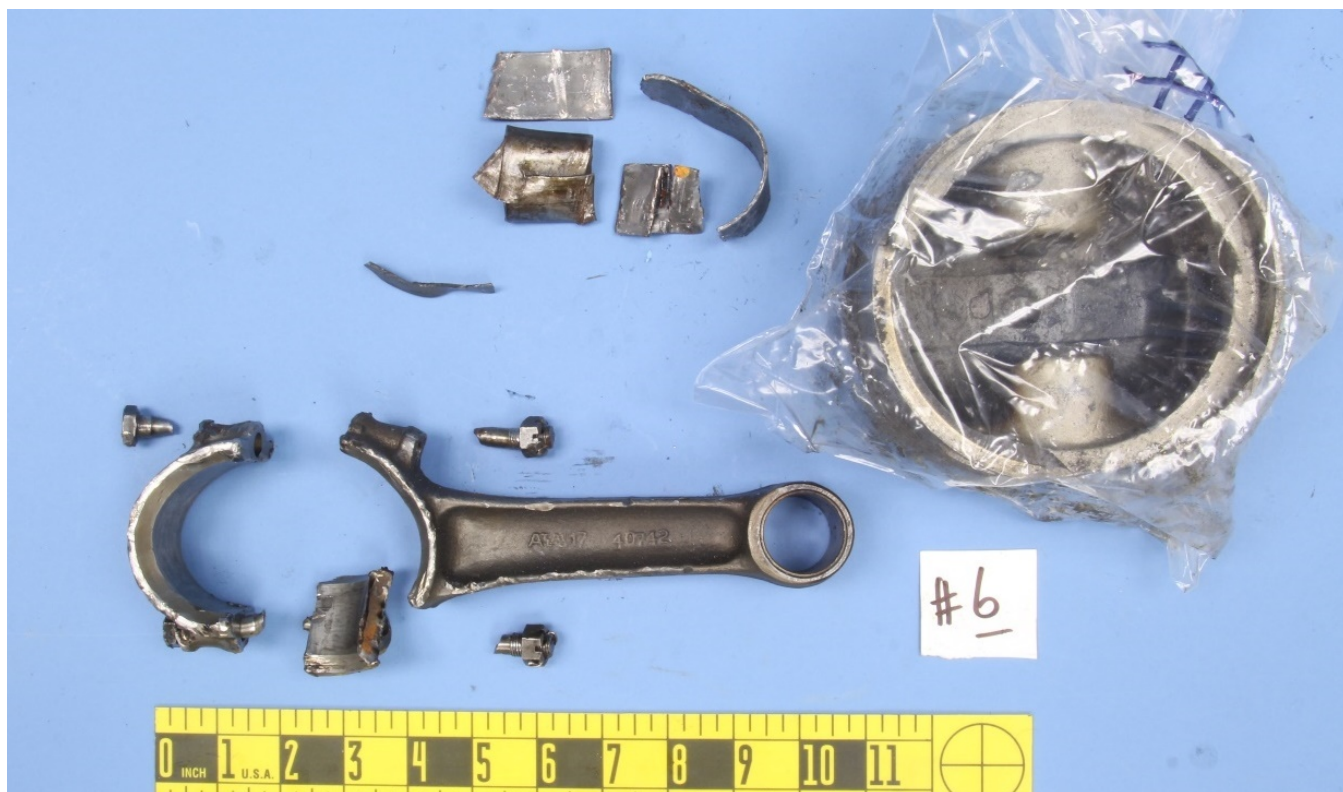
The components from the #6 engine position are shown in Figure 16, as received. While all the submitted pieces exhibited damage significant enough to deform the outer surfaces, this damage was less than those observed on the components received from #5 engine position. This damage was consistent with post-fracture damage while the engine was still running.

Figure 16 – The components of the #6 engine position, as received.

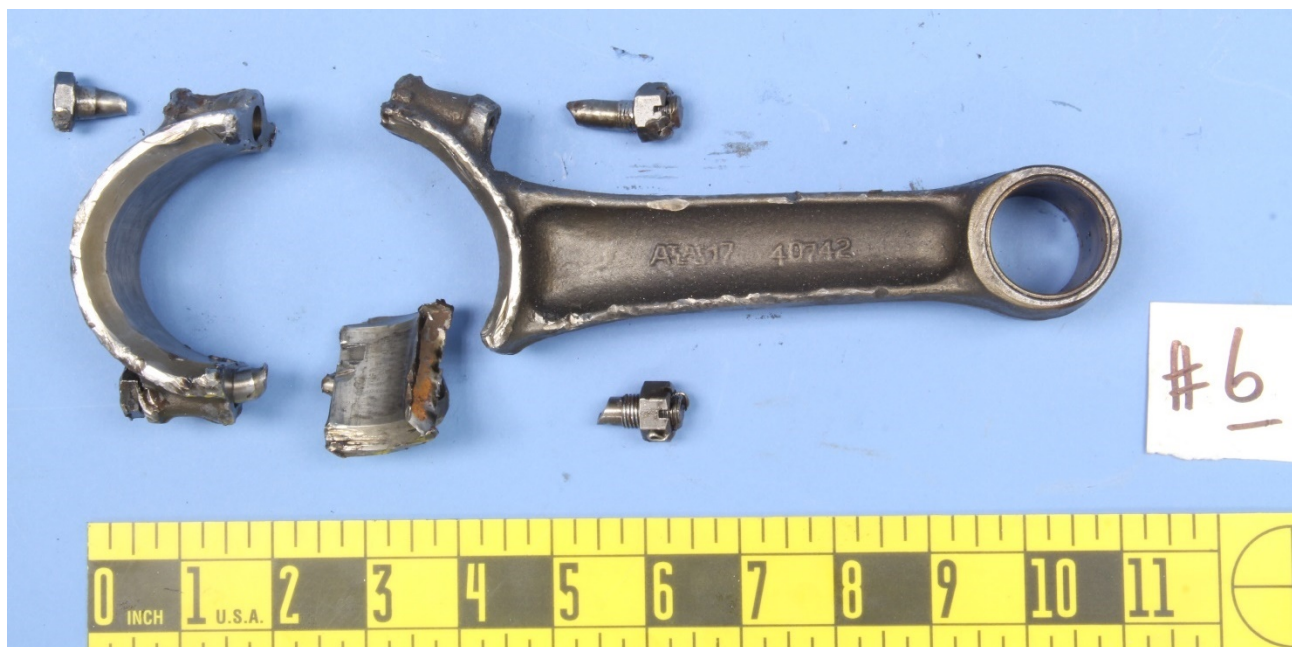
Figure 17 shows the connecting rod components, as received. The markings on the web of the connecting rod stated, "ATLAS 17 40742". The connecting rod components had been damaged with batter and other post-fracture damage, but the degree of damage was less than that of the components of the #5 connecting rod.

Figure 17 – The received pieces of the #6 connecting rod, cap, and bolts.

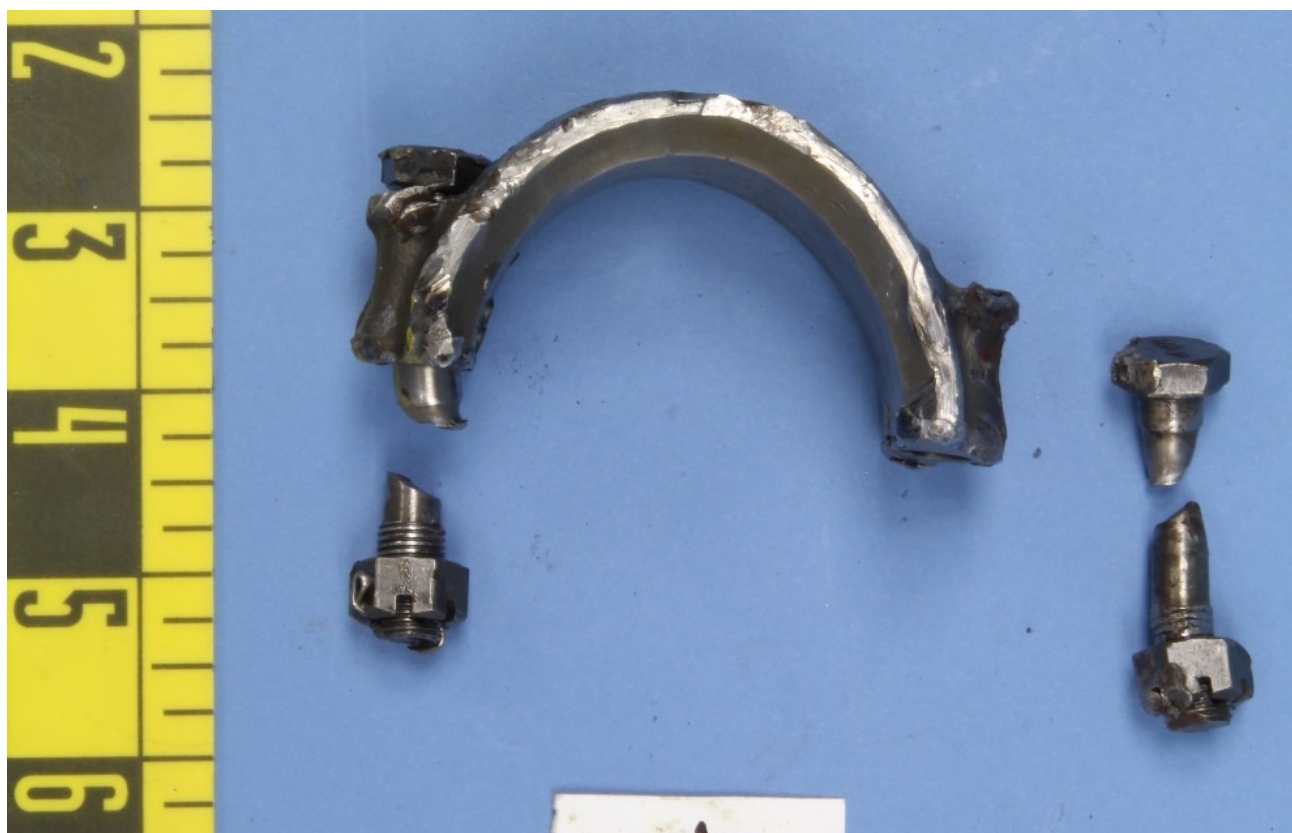
The bolts from the connecting rod are shown in Figure 18. Both bolts had fractured at midlength, consistent with where the rod and cap mate. The areas on the bolts adjacent to their fracture surfaces thinned down, or necked. The fracture surfaces themselves exhibited a 45° slant. These features were consistent with fracture from tensile overstress.

Figures 18 through 20 show the condition of the connecting rod cap. From Figure 18, the cap had been deformed, consistent with having been bent inward about the uppermost point in Figure 18. Figure 19 shows the inside bearing surface of the rod cap—this surface was relatively undamaged, exhibiting no indications of significant wear or

Figure 18 – Closer view of the bolts and cap from the #6 connecting rod, as received.

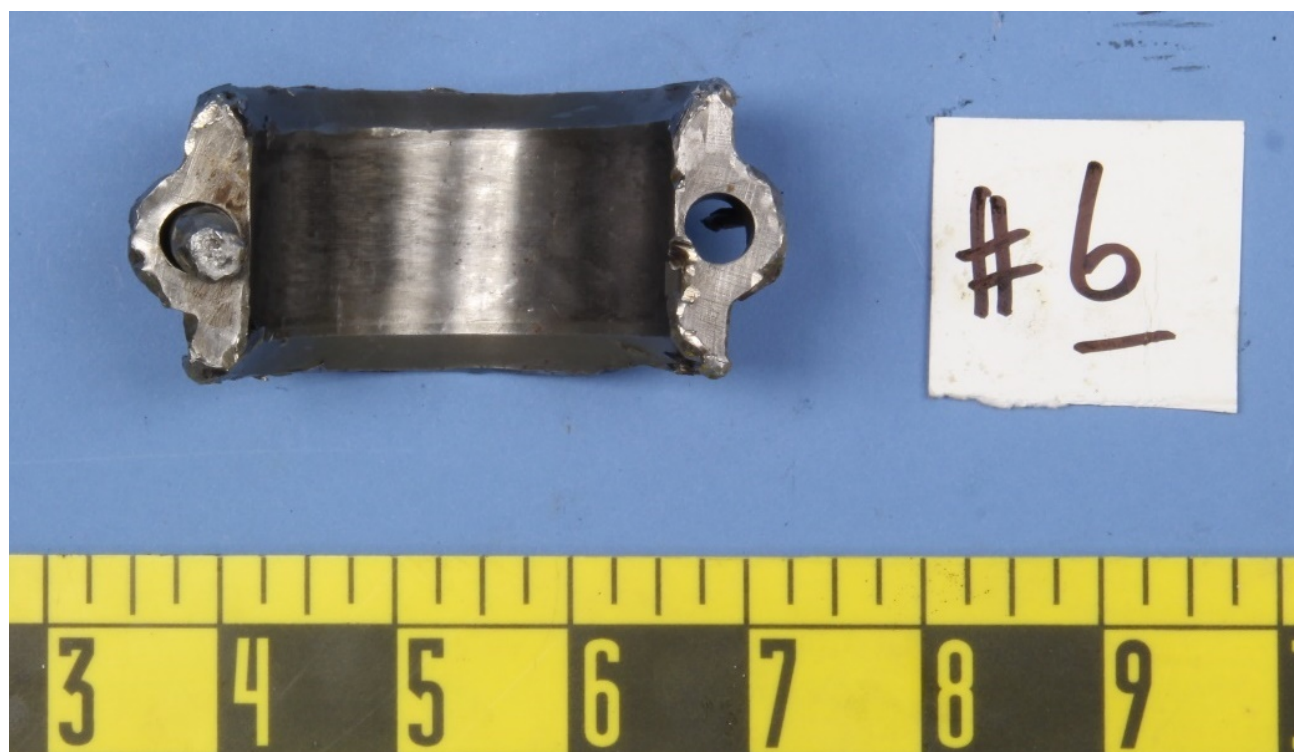
Figure 19 – The inside bearing surface of the #6 connecting rod cap.

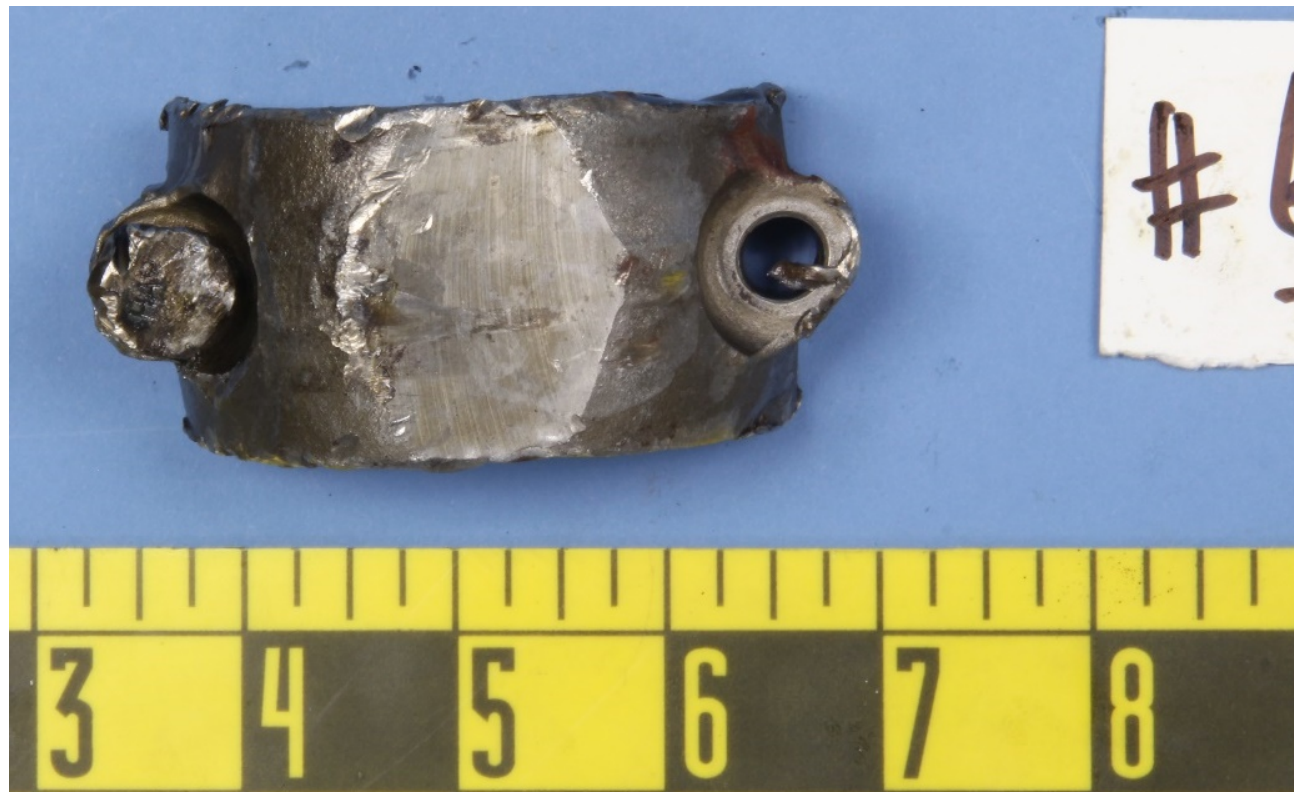
damage. The top or exterior of the cap is shown in Figure 20. One of the bolt fragments was still present and lodged into one of the bolt holes. All the surfaces in this view exhibited deformation and batter. Most notably, a large 1 inch smear was present on the apex of the rod cap, consistent with contact with an adjacent component.

Figure 20 – The outside of the #6 connecting rod cap, showing batter.

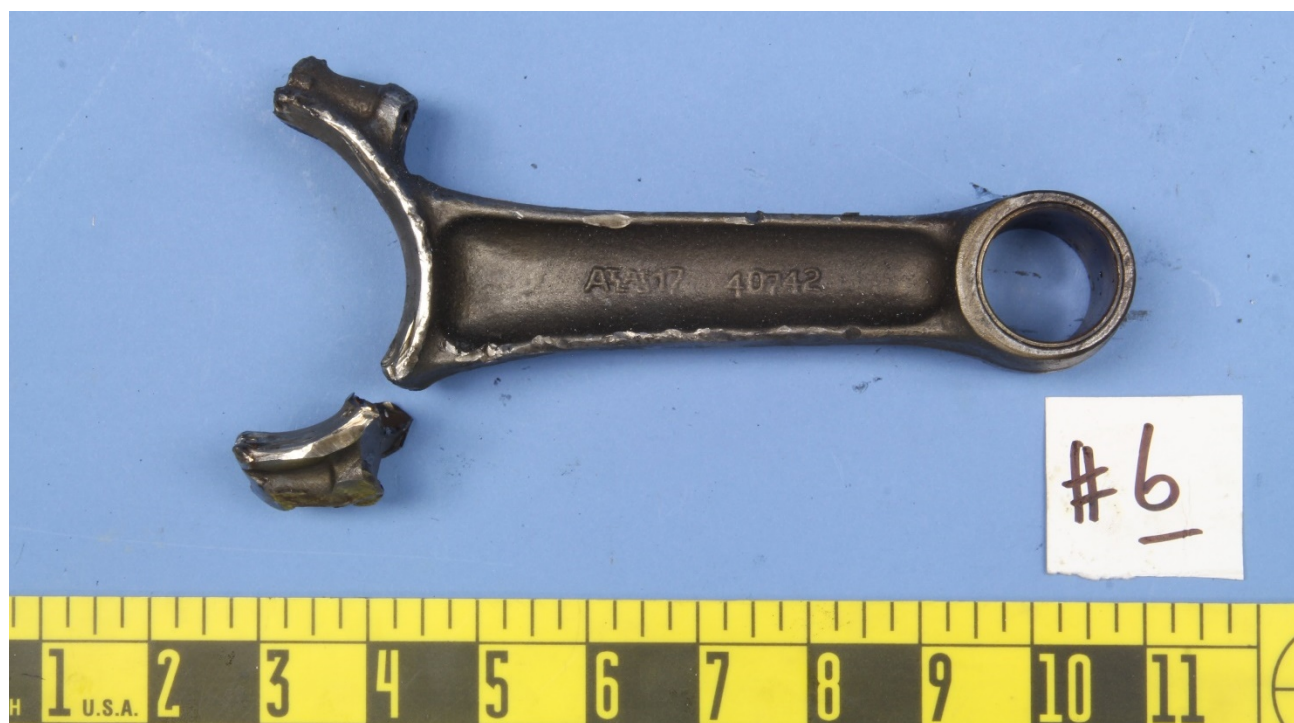
Figure 21 shows the connecting rod, as received. The crankshaft side of the connecting rod had fractured near the yoke neck. The pin side of the rod arm was relatively undamaged. The bushing was still present inside the pin bore of the rod.

Figure 21 – The pieces of the #6 connecting rod.
