# NATIONAL TRANSPORTATION SAFETY BOARD

## MATERIALS LABORATORY FACTUAL REPORT

Report No. 17-088

Place : Safford, Arizona  
Date : November 24, 2016  
Vehicle : Cessna 182A, N6077B  
NTSB No. : WPR17LA038  
Investigator : Joshua Cawthra, AS-WPR

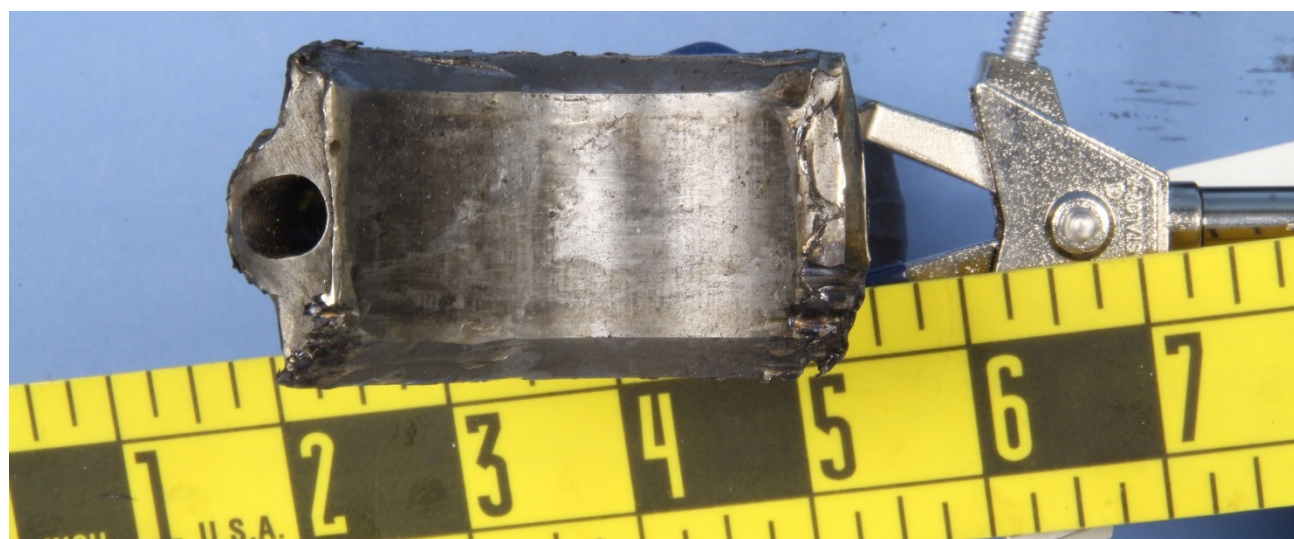
Figure 22 shows the inner bearing surface of the connecting rod that had faced a crankshaft journal surface. This surface exhibited some wear marks, consistent with sliding in a lateral direction. In addition, some material smearing outward of the bearing surface was present on the left side of Figure 22.

Figure 22 – The inner bearing surface of the #6 connecting rod, facing left in Figure 21.

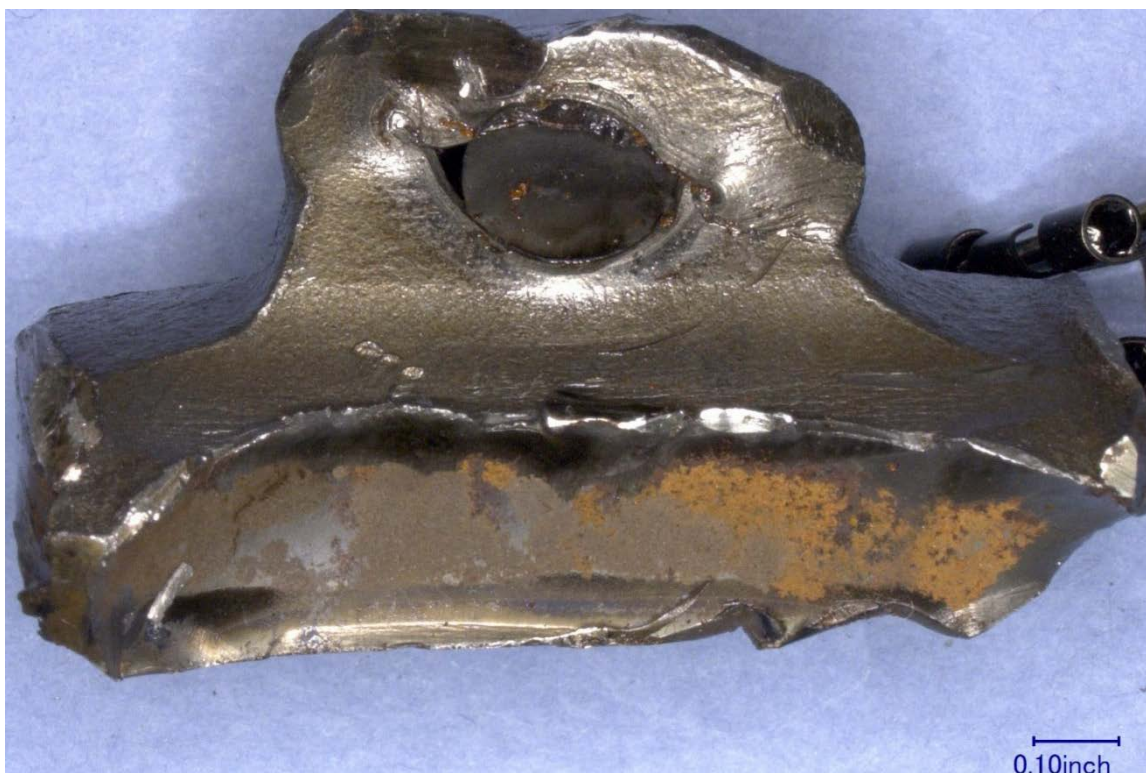
The fracture surface of the rod arm remnant is shown in Figure 23. The fracture surface was generally dull in luster, with post-fracture iron oxide (rust) corrosion and smearing damage on the outer regions of the fracture surface. Examination of the undamaged portions of the fracture surface using an SEM revealed dimple rupture, consistent with overstress.

Figure 23 – The fracture surface of the #5 connecting rod pin bore near the yoke neck, which mated with the fracture surface in Figure 22.

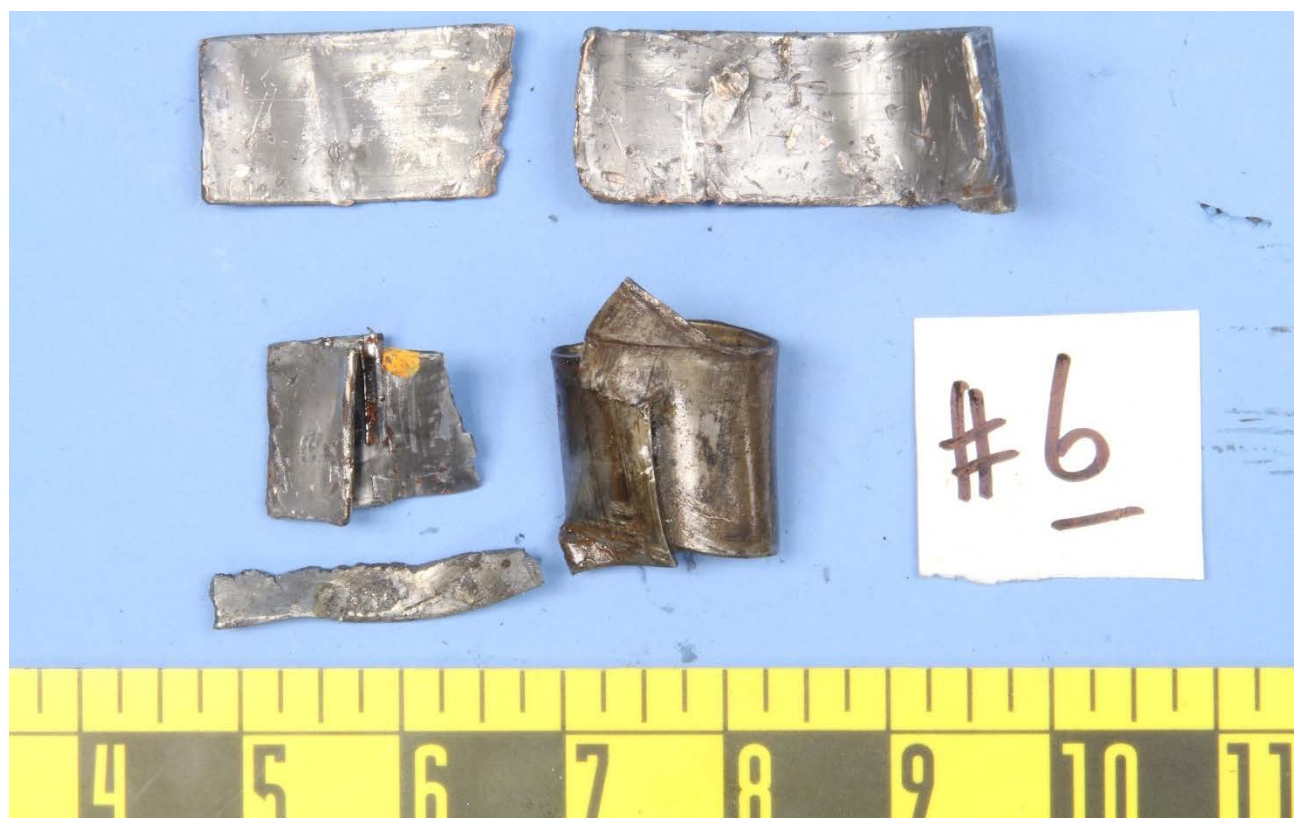
Figure 24 shows the remnants of the crankshaft side bearing materials from the connecting rod. These pieces had been severely deformed and fractured in several places. However, there were no indications of material thinning or exposure of the underlying babbitt material on the bearing. These features were consistent with the bearing having deformed and fractured after engine failure began.

Figure 24 – The pieces for the bearing from the #6 connecting rod.

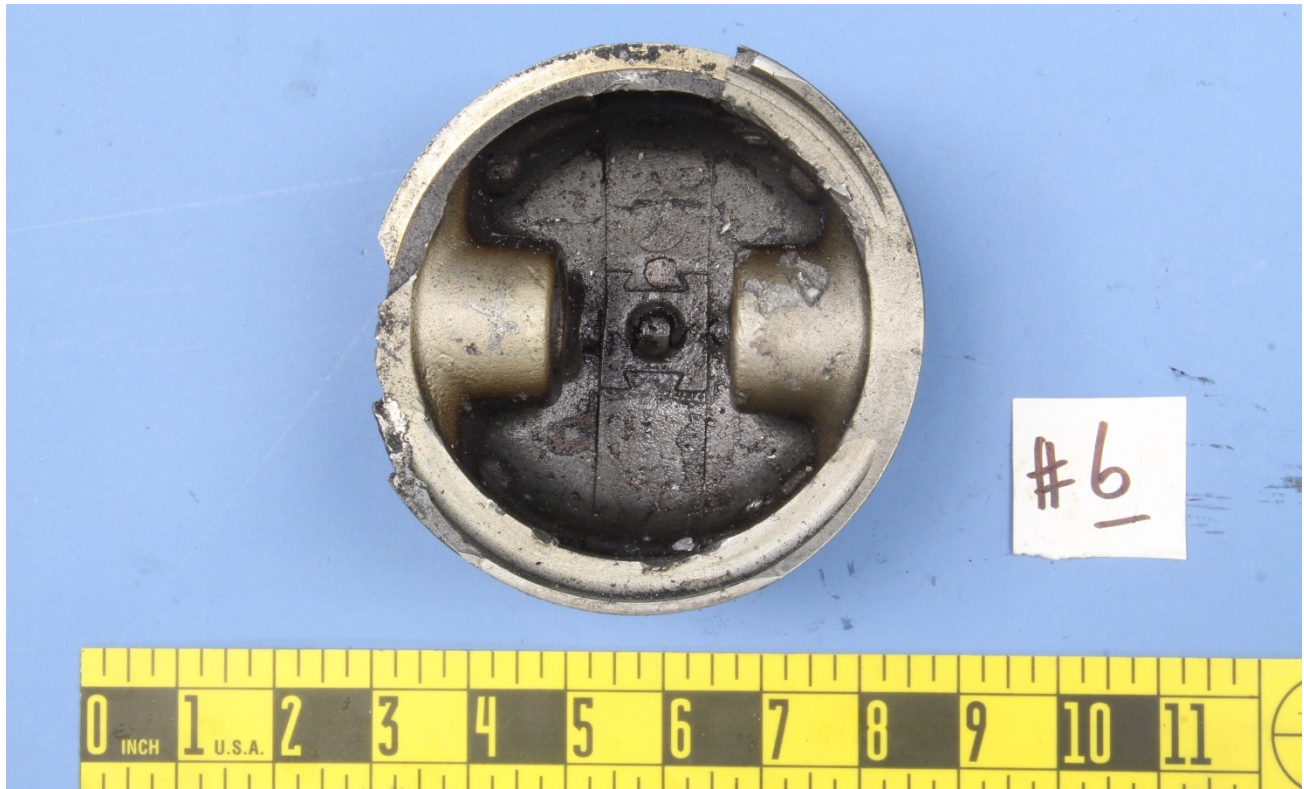
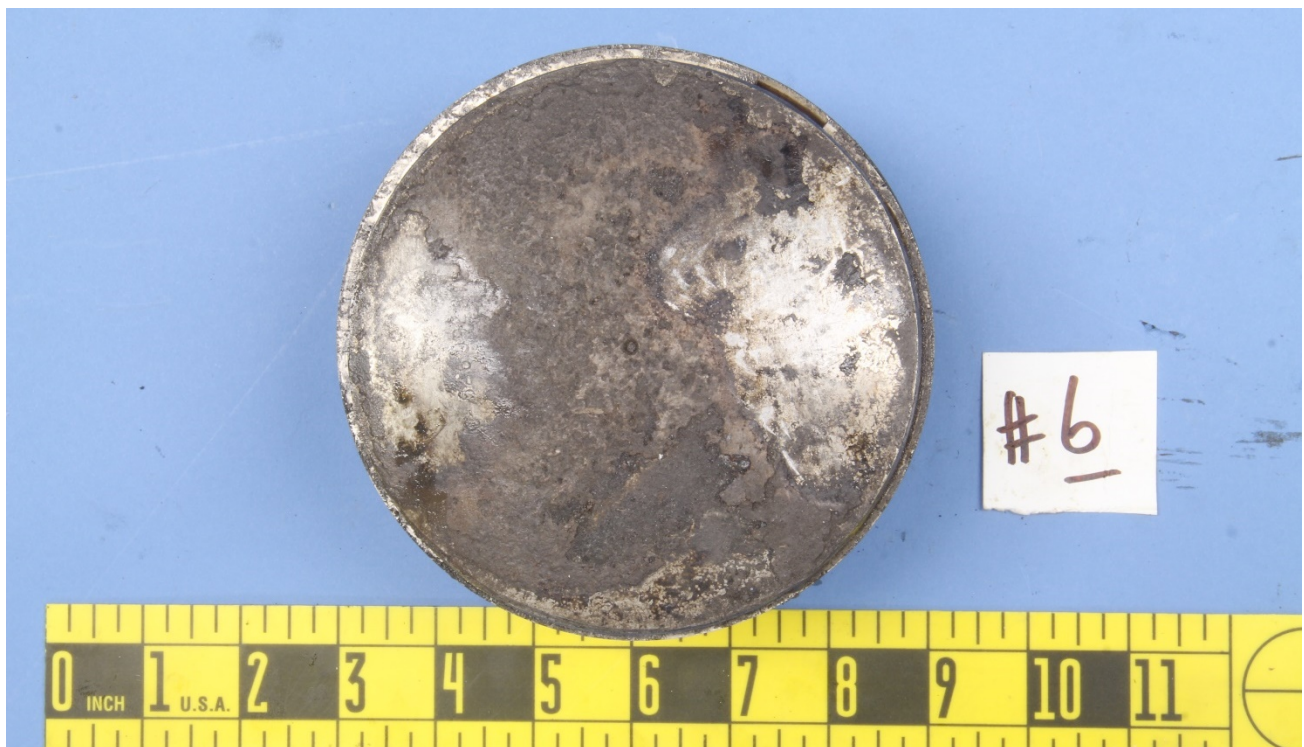
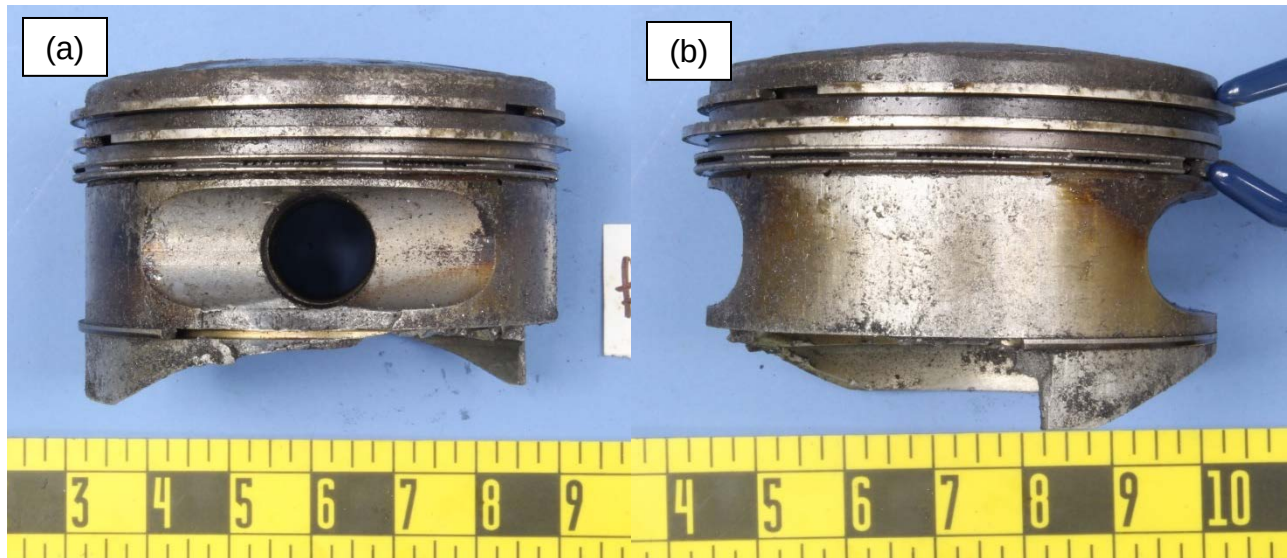
Figures 25 through 27 show the #6 piston, as received. This piston was less damaged than the #5 piston. The underside had exhibited one primary fracture along a skirt flange, as seen in the top of Figure 25. The top of the piston, shown in Figure 26, exhibited two regions with smeared material, consistent with impact or rubbing of an adjacent component, or post disassembly handling. Examination of the side of the piston found little additional damage, excepting the aforementioned piston skirt fracture (Figure 27). The compression and oil control rings were in place and undamaged.

Figure 25 – The underside of the #6 piston.

Figure 26 – The top of the #6 piston crown.

Figure 27 – The #6 piston viewed from (a) the pin boss side and (b) rotated 90° from Figure 27a.
