# Continental Motors

## ENGINE INSPECTION REPORT

| AIRCRAFT MAKE & MODEL | Cessna-182A |

## ENGINE FIELD INSPECTION REPORT

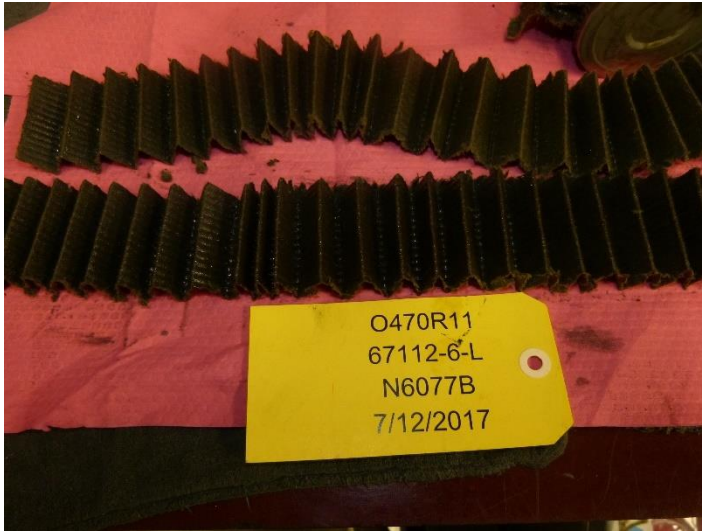
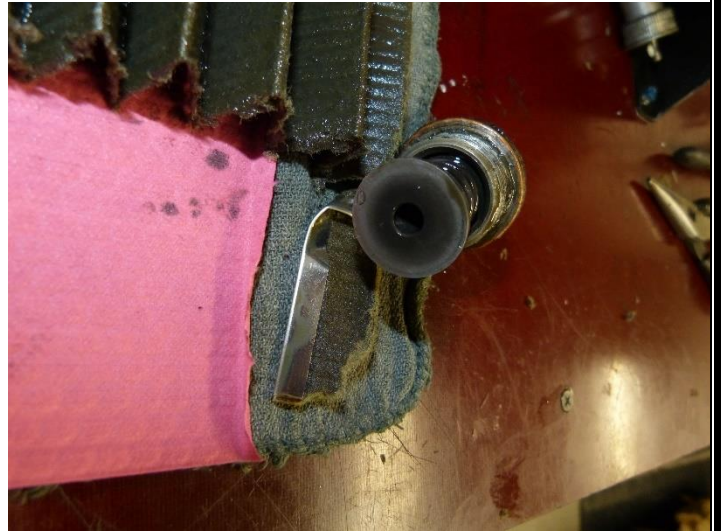
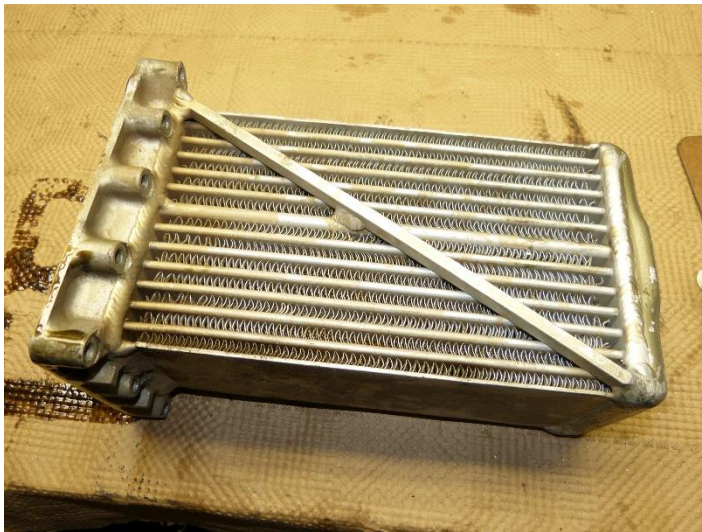
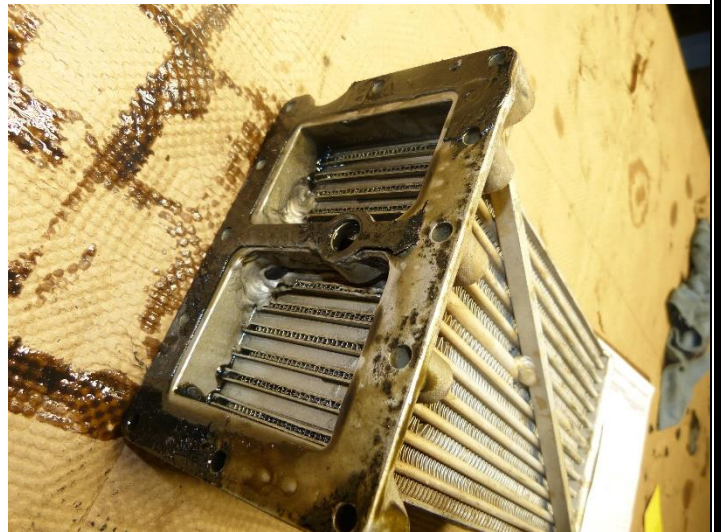
Oil Cooler: No Tag.

The oil cooler was in place and not damaged.

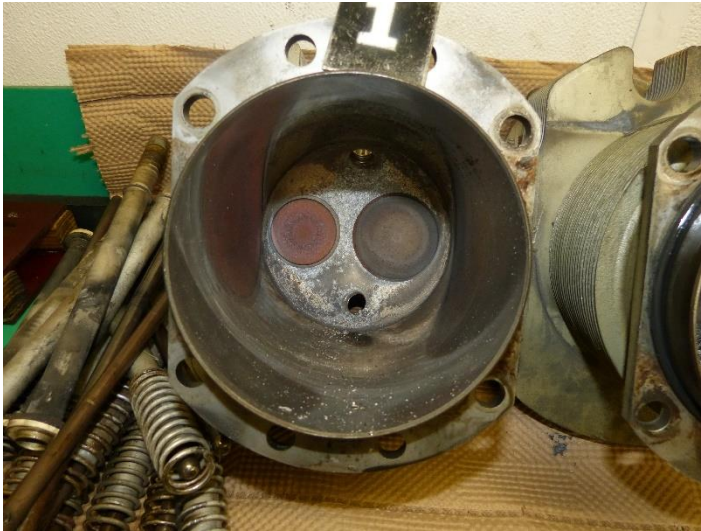
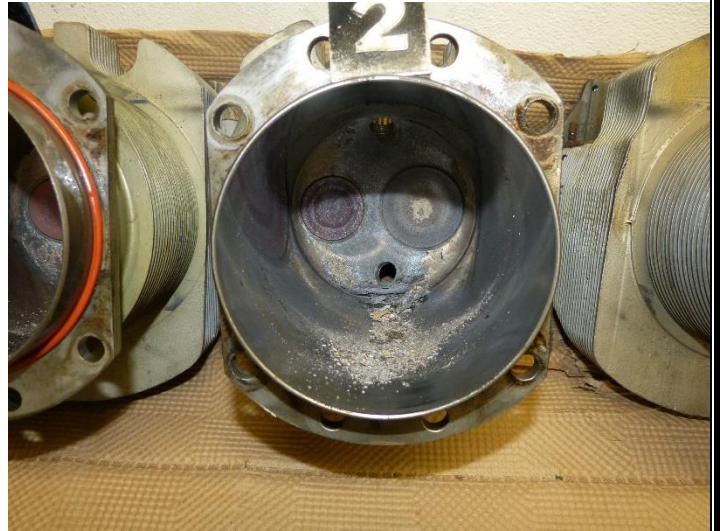
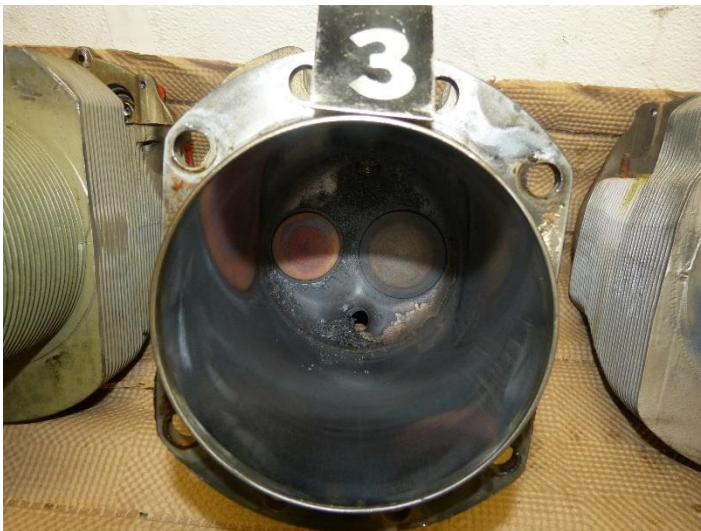
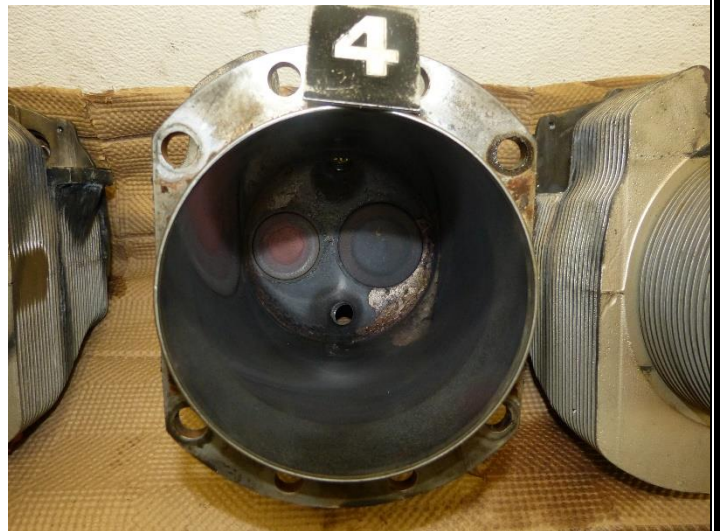
Cylinders: ECC68.05N3

Cylinders one, two, three, and four were in place and not damaged. Cylinders five and six were in place and had internal impact damage. All of the valves were in place and were not damaged. Pistons five and six were stuck in the cylinders because of impact damage to the cylinder skirts, and had to be removed by cutting away parts of the cylinder skirts.

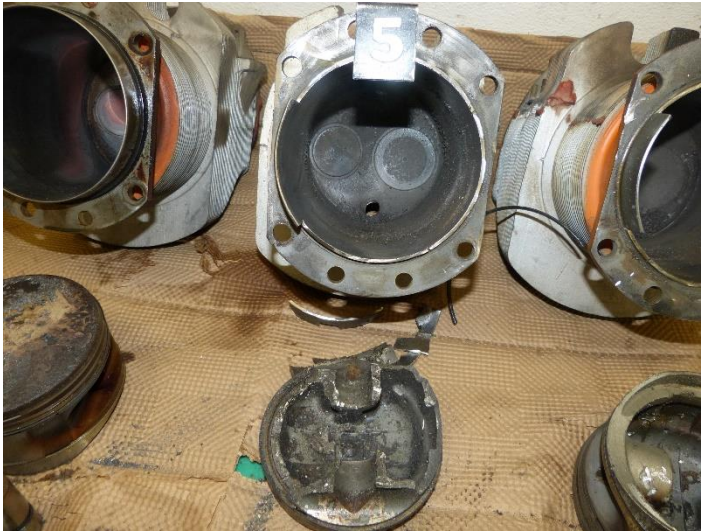
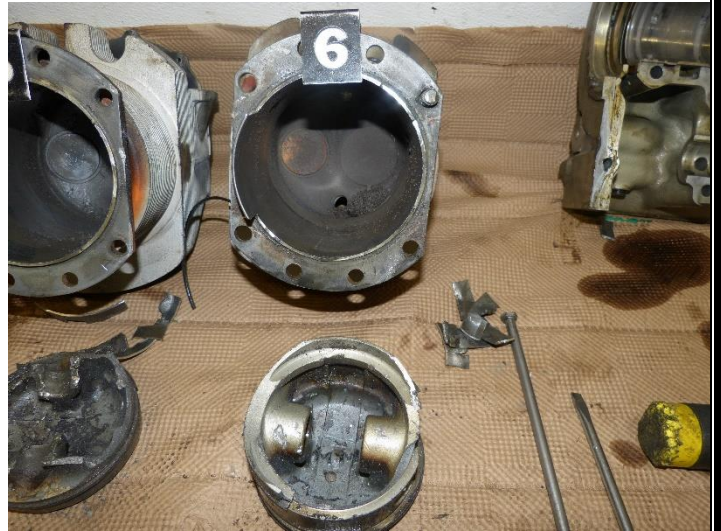
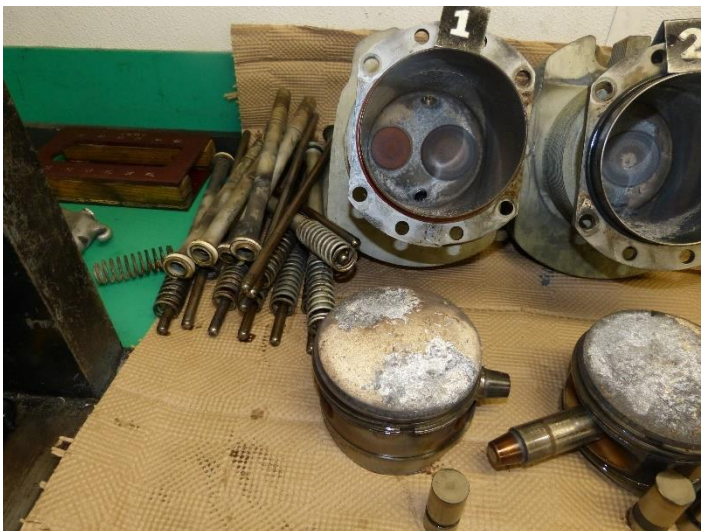
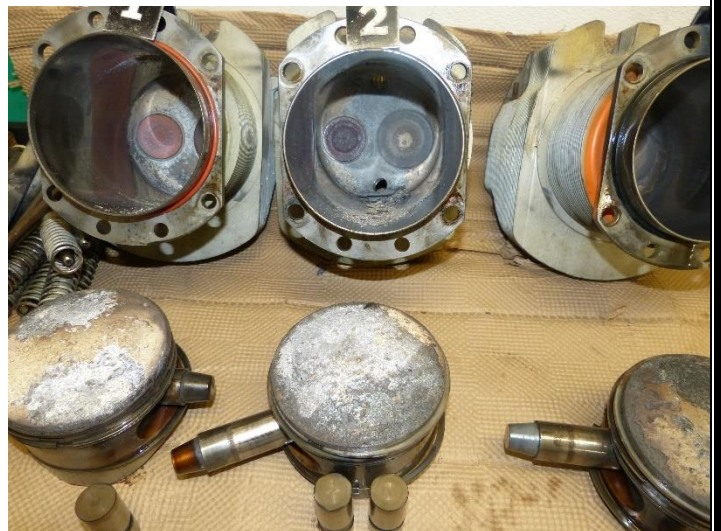
Pistons one, two, three, and four were intact and not damaged. They had normal combustion deposits and the rings were in place and free to move. Pistons five and six had heavy impact damage on the skirts and parts of the pistons were found in the oil sump.

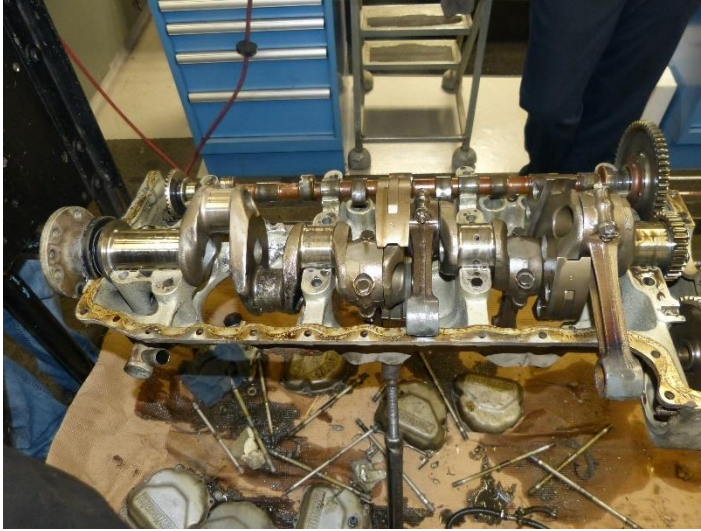
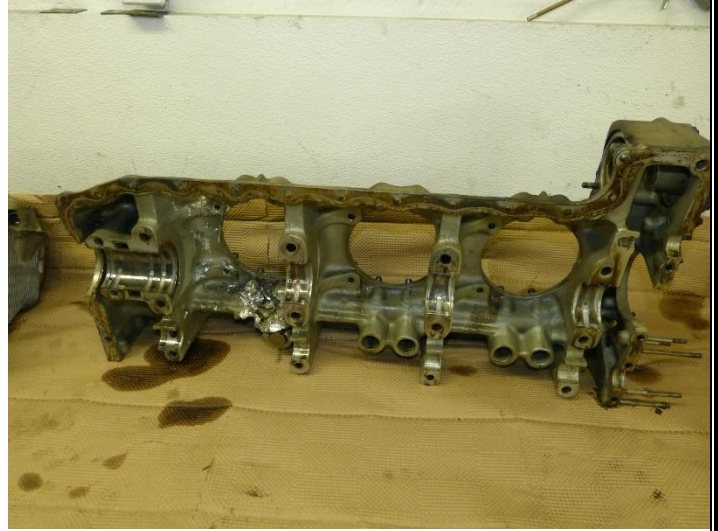
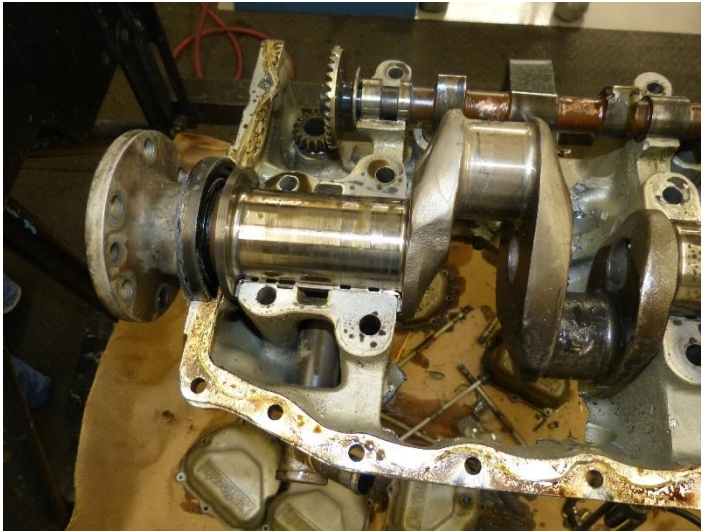
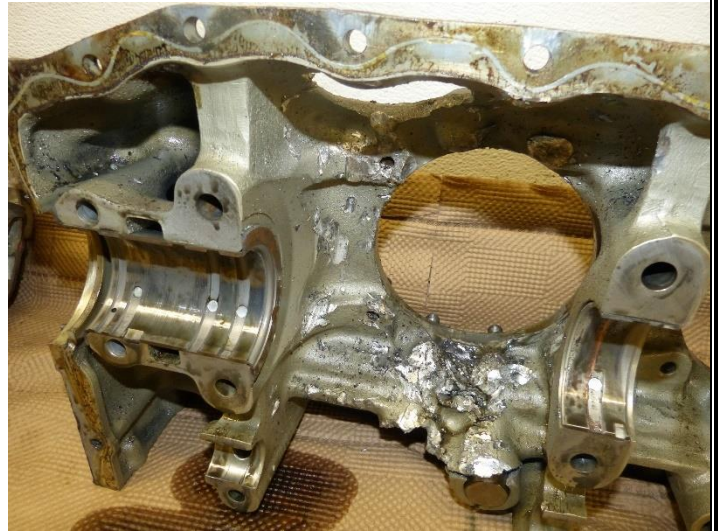
Crankshaft: Serial Number-632, Heat Code-HCE43

The crankshaft was intact and not damaged except for the number five connecting rod journal which had heat damage and heavy gouging. The number six connecting rod journal had rotational damage and was slightly discolored. All of the main journals were not damaged and were coated with oil.

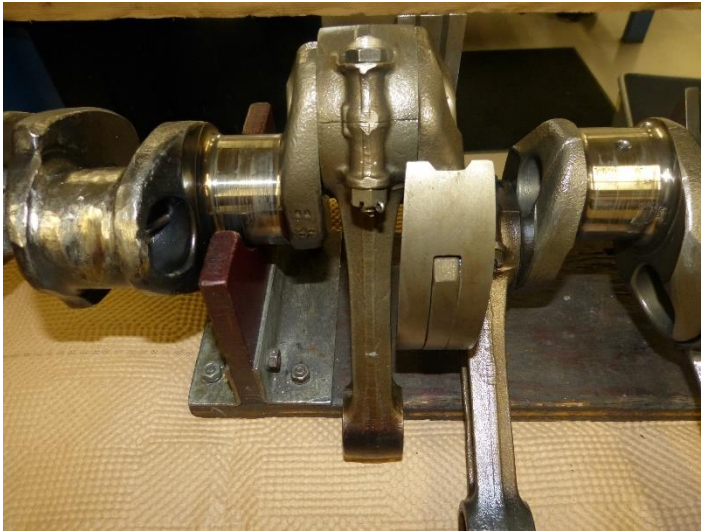
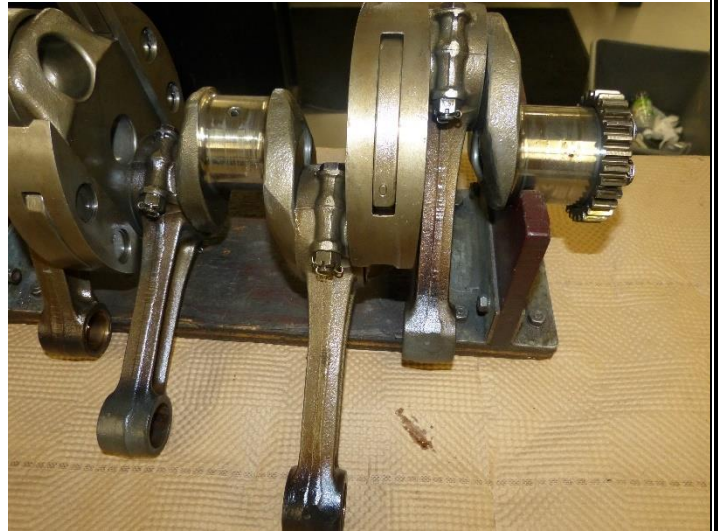
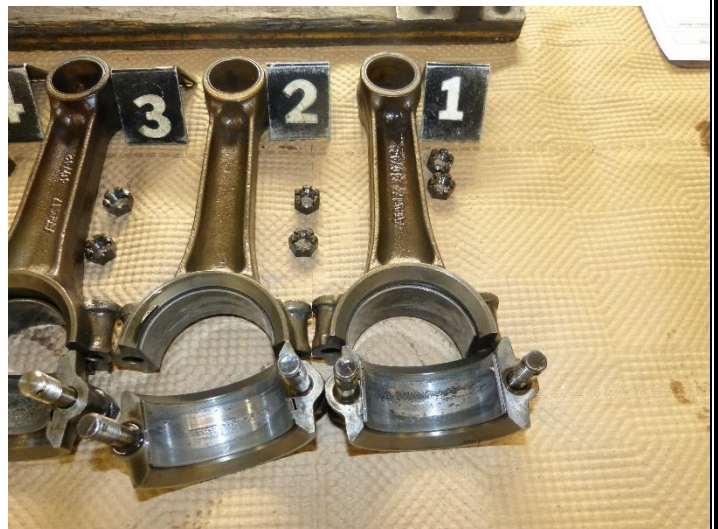
Connecting Rods: Atlas 40742, Rod Cap Bearings-SA530383-010, 8/5

Connecting rod number five was missing except for the rod cap which was found in the oil sump. Rod cap six was also found in the oil sump with the number five piston pin. The rod cap bearings from connecting rods five and six were also found in the oil sump and they had heavy impact damage. Connecting rods one, two, three and four were not damaged, and the rod bearings were in place and not damaged.

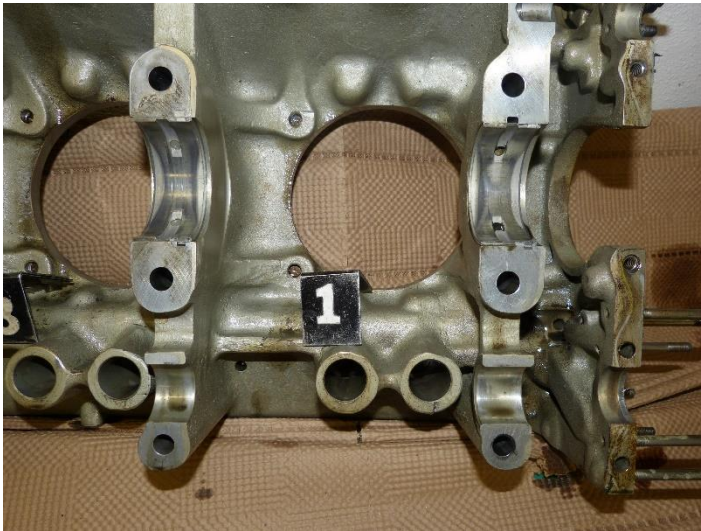
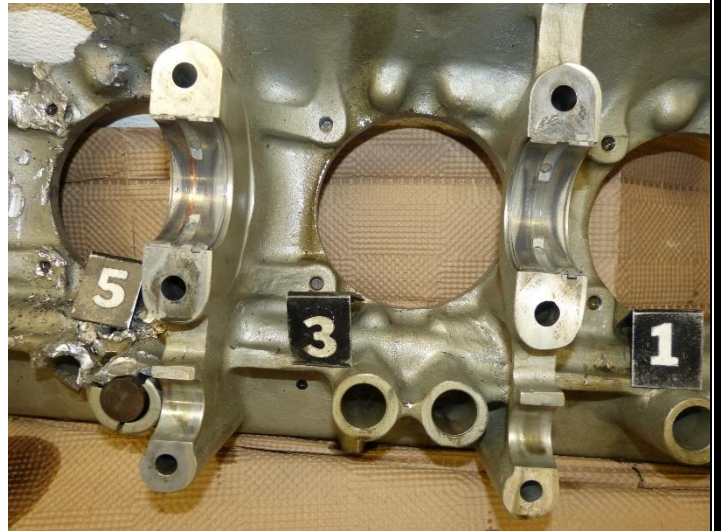
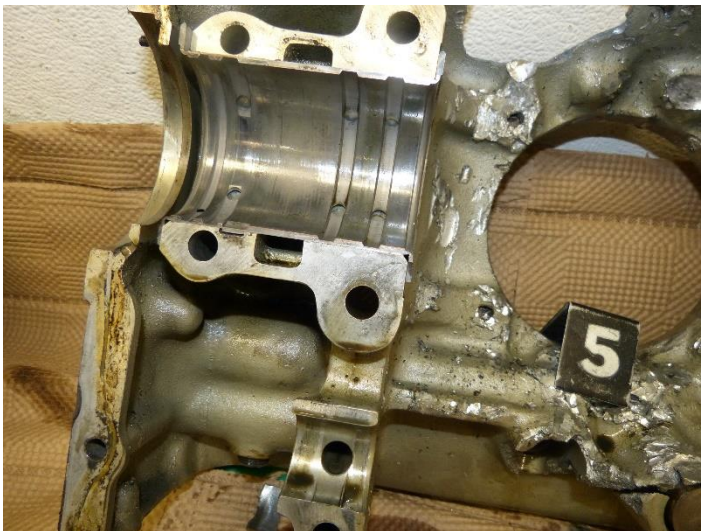
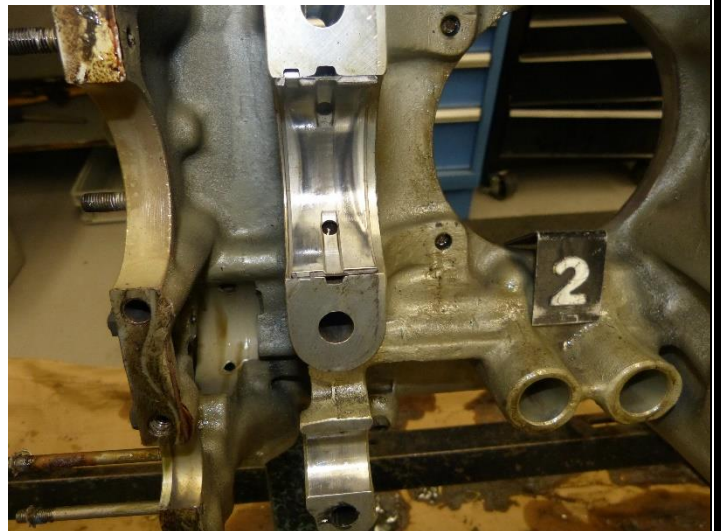
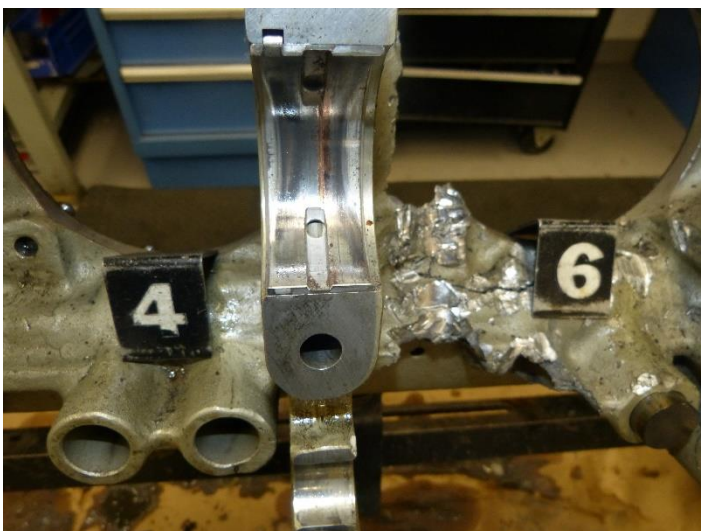
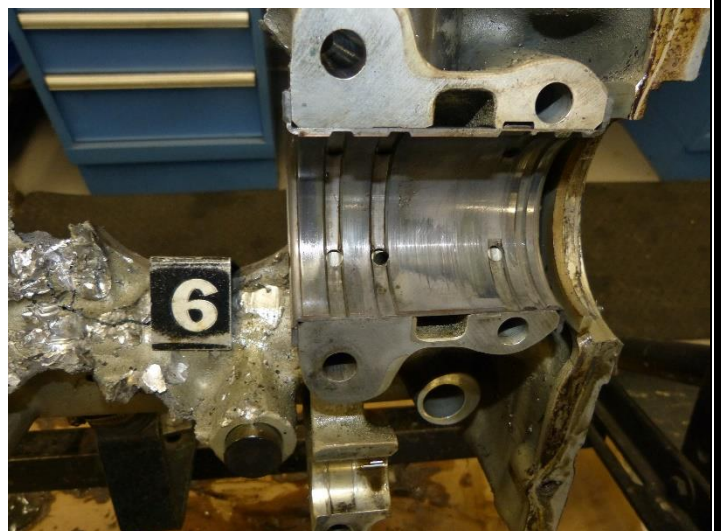
Main Bearings: Front Main: SA537401-010, 11/5, Rear mains SA630464-010

The main bearings were in place and were not damaged. They were coated with oil.

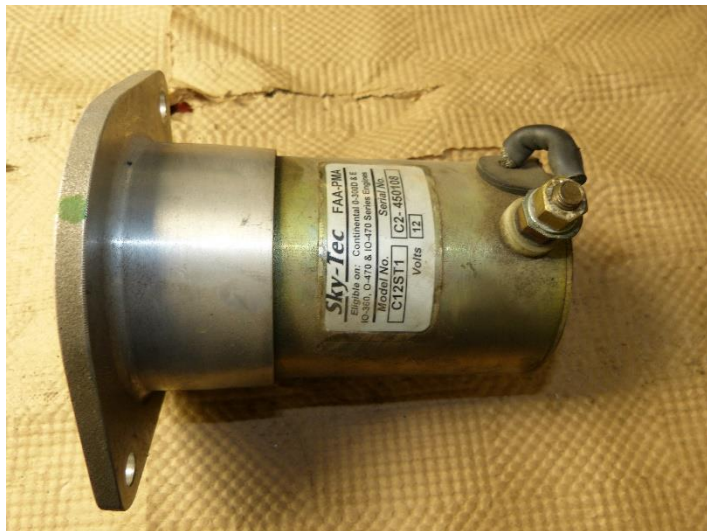
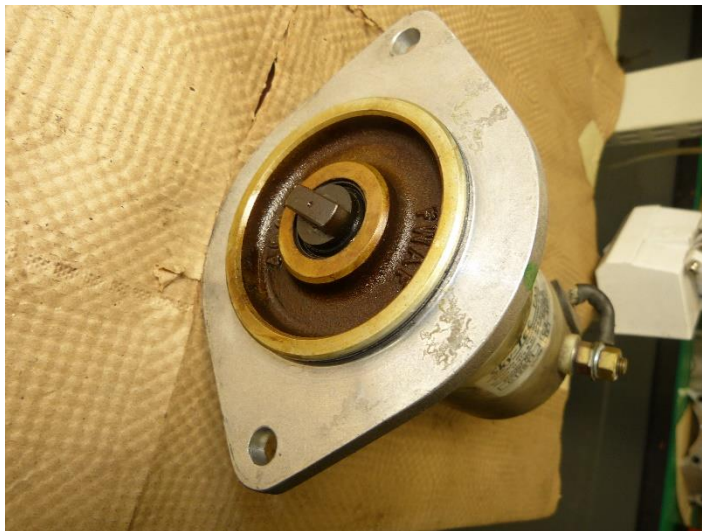
Starter: SkyTec C12ST1, C2-450108

The starter was in place and not damaged. The drive shaft was free to rotate.

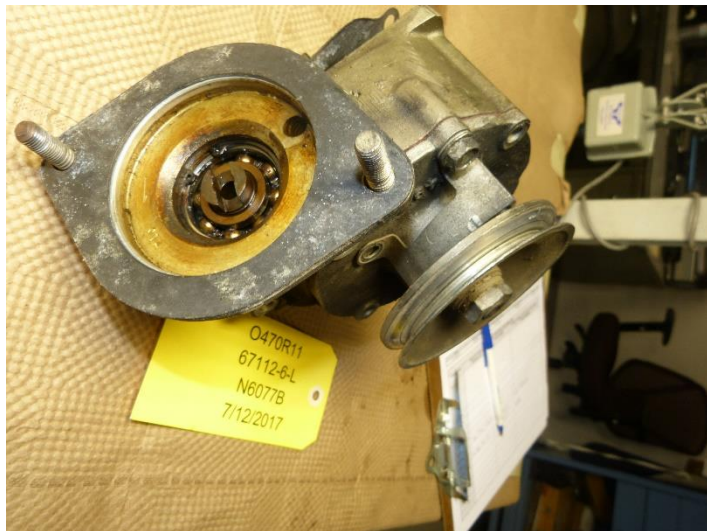
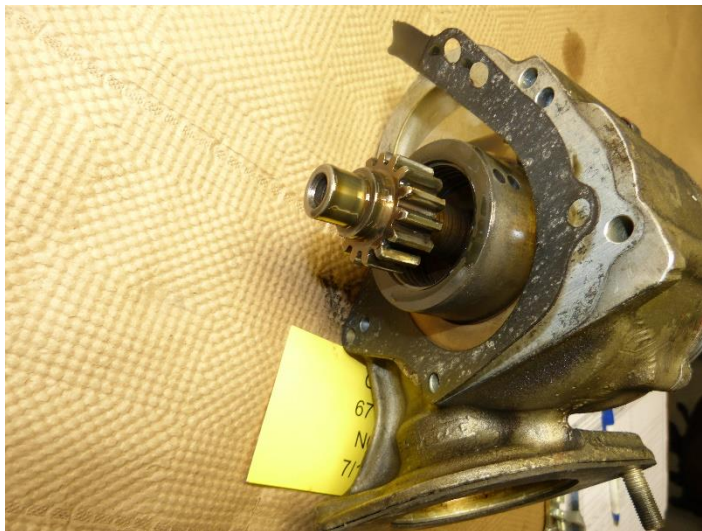
Starter Adapter: 660468J

The starter adapter was not damaged. The drive shaft rotated freely.

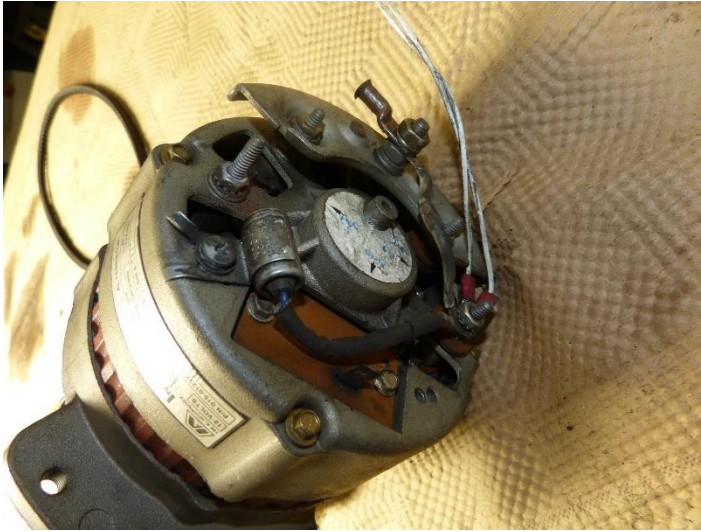
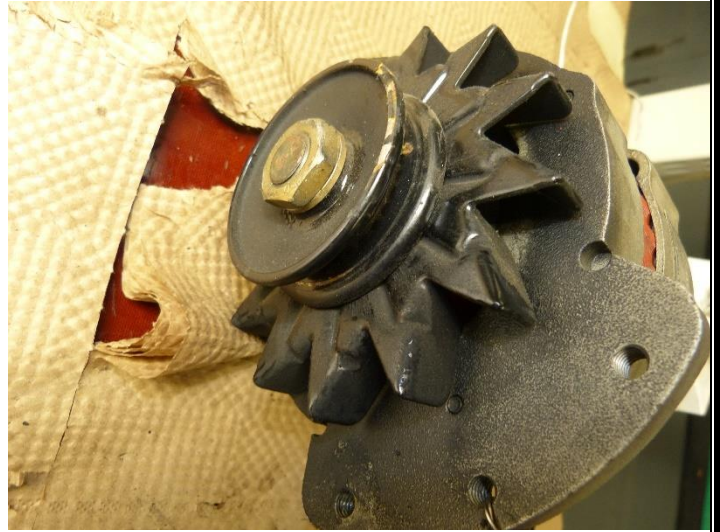
Alternator: Inter AV Inc. PN-015-01237, SN-6880

The alternator was not damaged. The drive shaft was free to rotate.

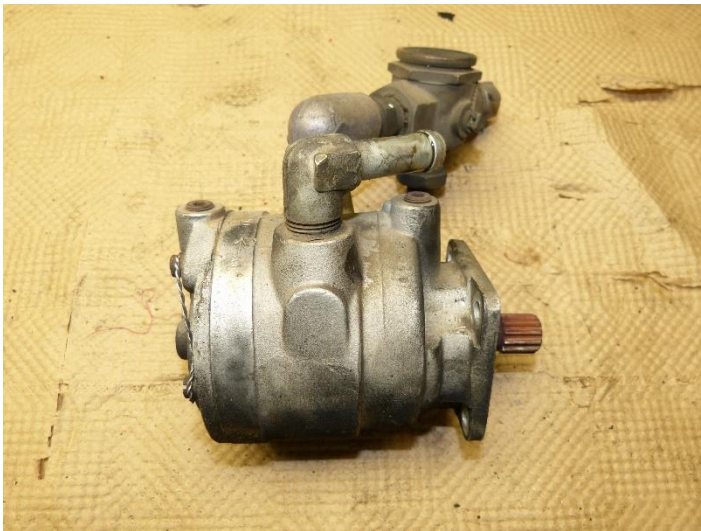
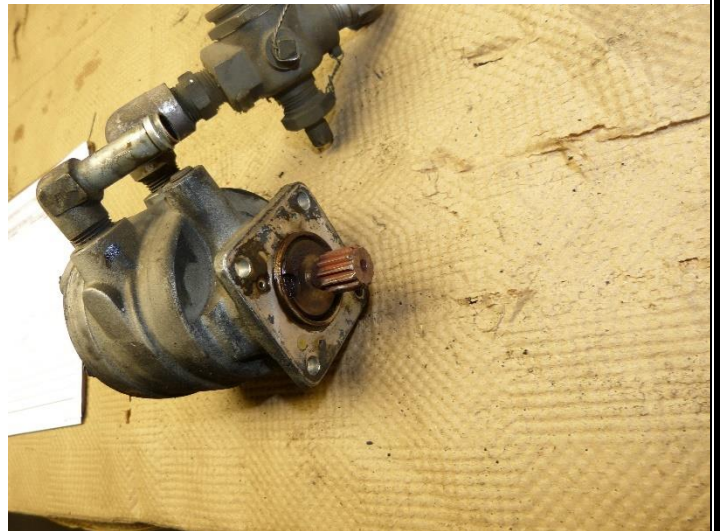
Vacuum Pump: Garwin G-450,

The vacuum pump was not damaged. The drive shaft was free to rotate.

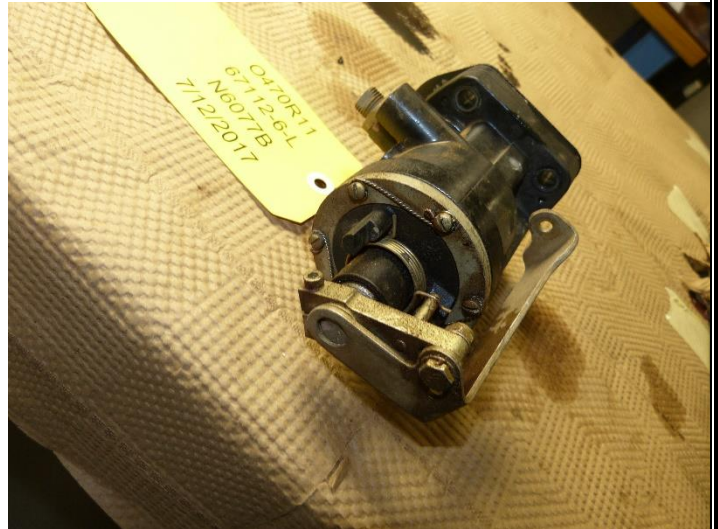
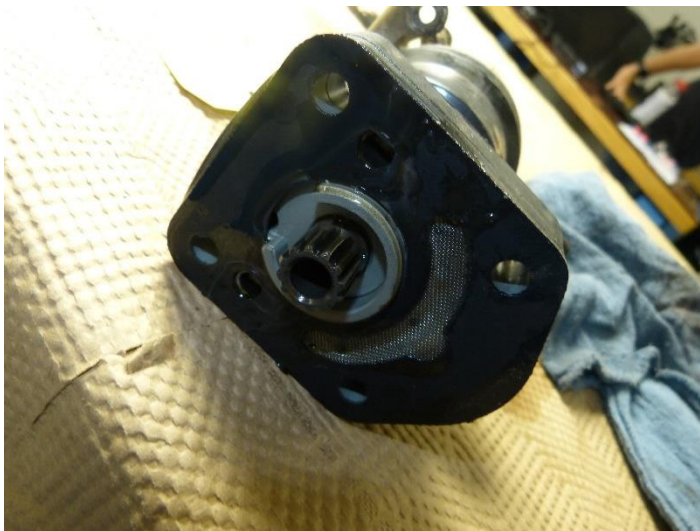
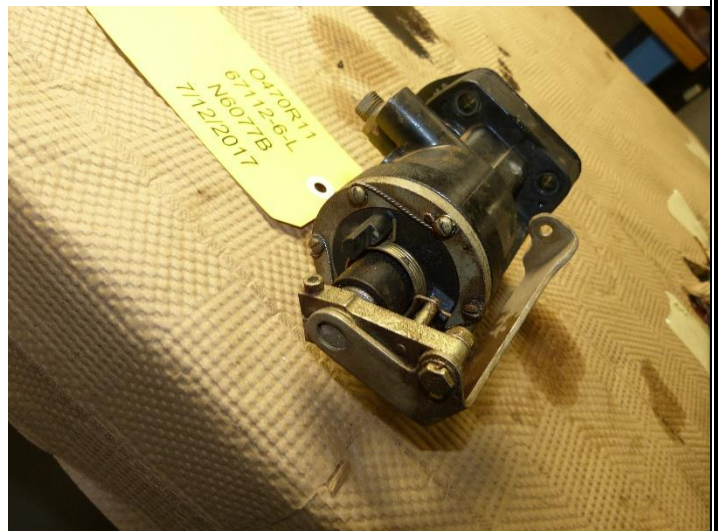
Propeller Governor: McCauley, C290D3K1T1, SN-735551

The propeller governor was not damaged. The drive shaft was free to rotate, and a very small amount of metal was noted on the oil screen.
