## MEMORANDUM FOR RECORD

**Stephen Stein**  
**Air Safety Investigator**  
**National Transportation Safety Board**  
**Office of Aviation Safety – Western Pacific Region**

**NTSB Accident Number: WPR17LA042**  
**Aircraft Registration & Make/Model: N602L; Air Tractor AT-602**  
**Accident Location: Willows, California**  
**Accident Date: December 27, 2016**

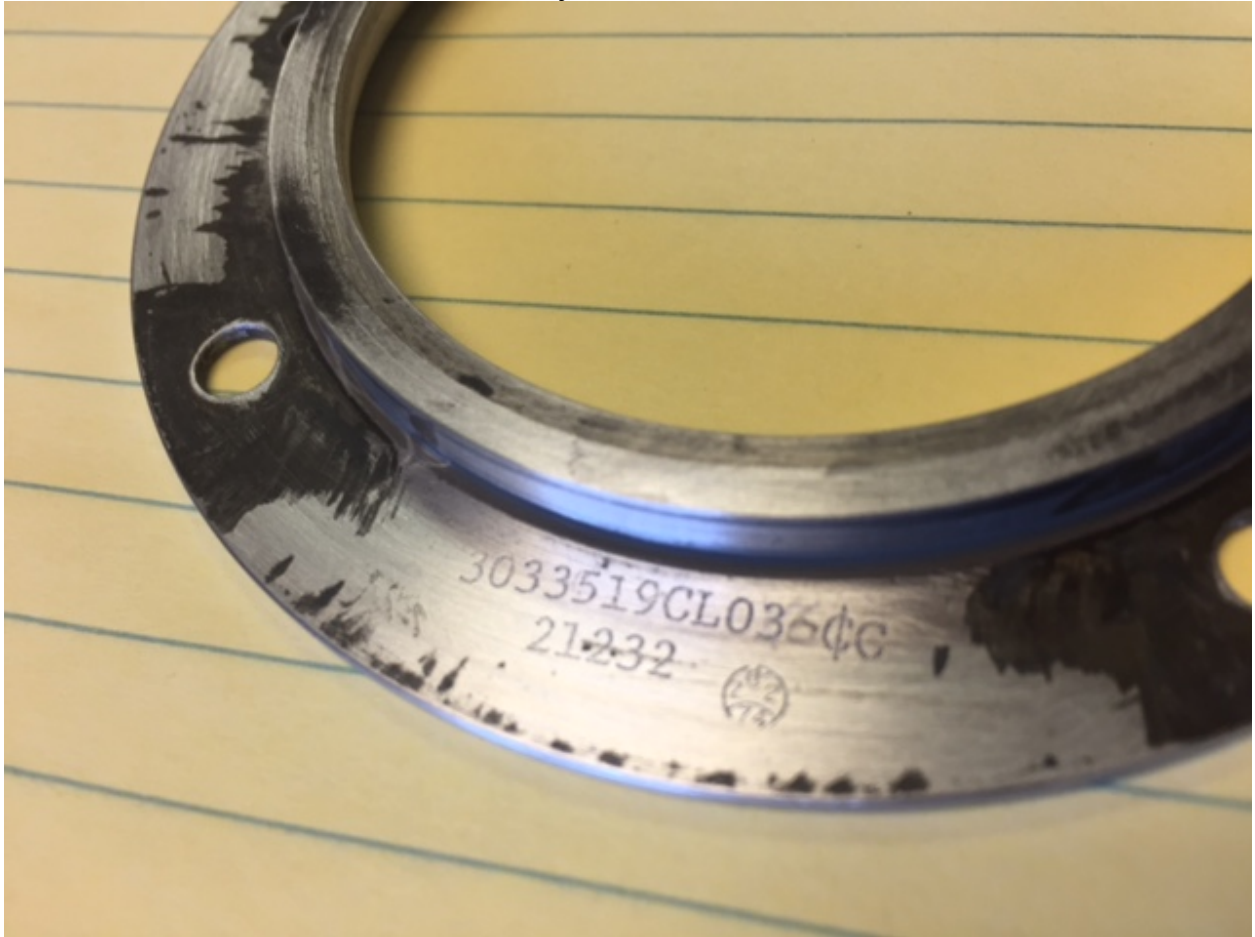
According to the representative, Prime Turbines will send a customer an overhauled bleed valve when service is requested and the customer will send them the core unit that was removed. In this case, the maintenance facility submitted the core bleed valve with the valve seat, which was at their facility at the time this conversation took place.

Mr. Carl stated his records indicate the core unit was sent to them on December 12, 2016. The photograph below was taken by Mr. Carl on January 13, 2017 and shows the valve seat that was found on the core unit that was submitted by Grower's Air Service.
