# **ENGINE EXAMINATION REPORT**

**NATIONAL TRANSPORTATION SAFETY BOARD**

**January 11, 2018**

**WPR17LA042**  
**Willows, California**  
**December 27, 2016**  
**1553 PST**  
**Air Tractor AT-602; N602L**

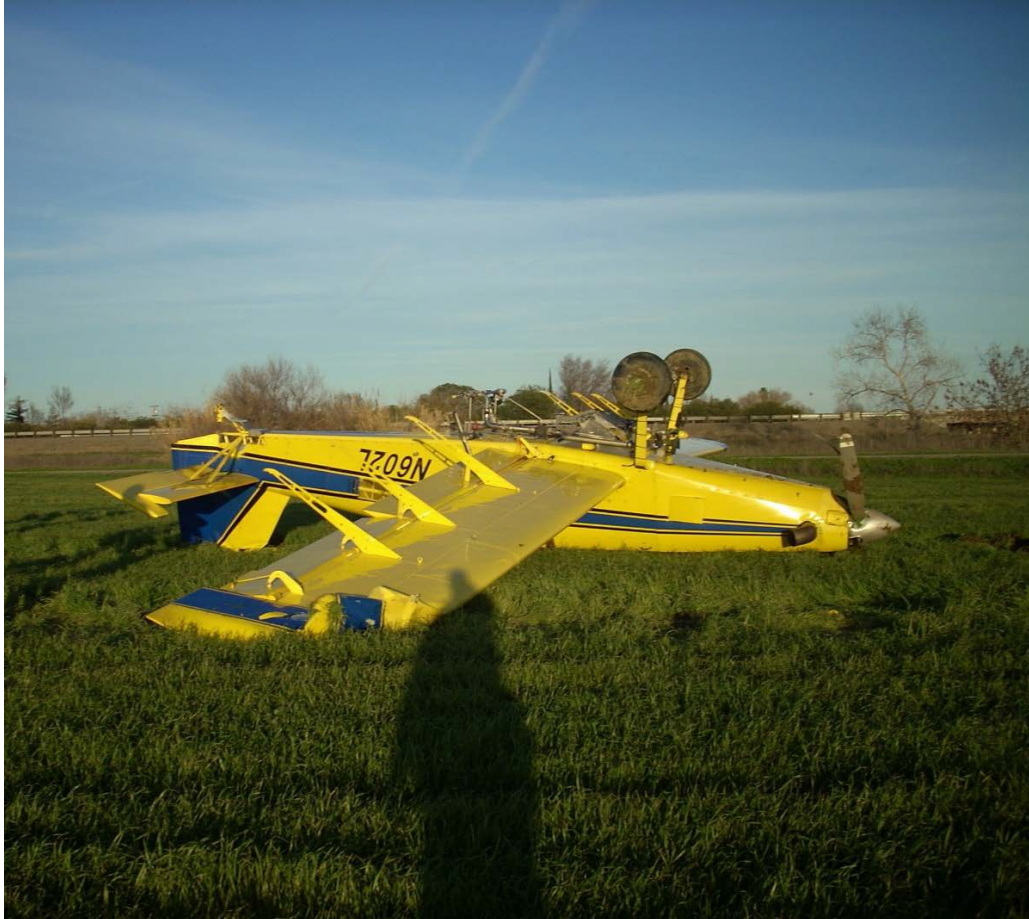
Postaccident examination by a Federal Aviation Administration inspector revealed substantial damage to the rudder and left wing spar.

Photo 1: Airplane at Rest

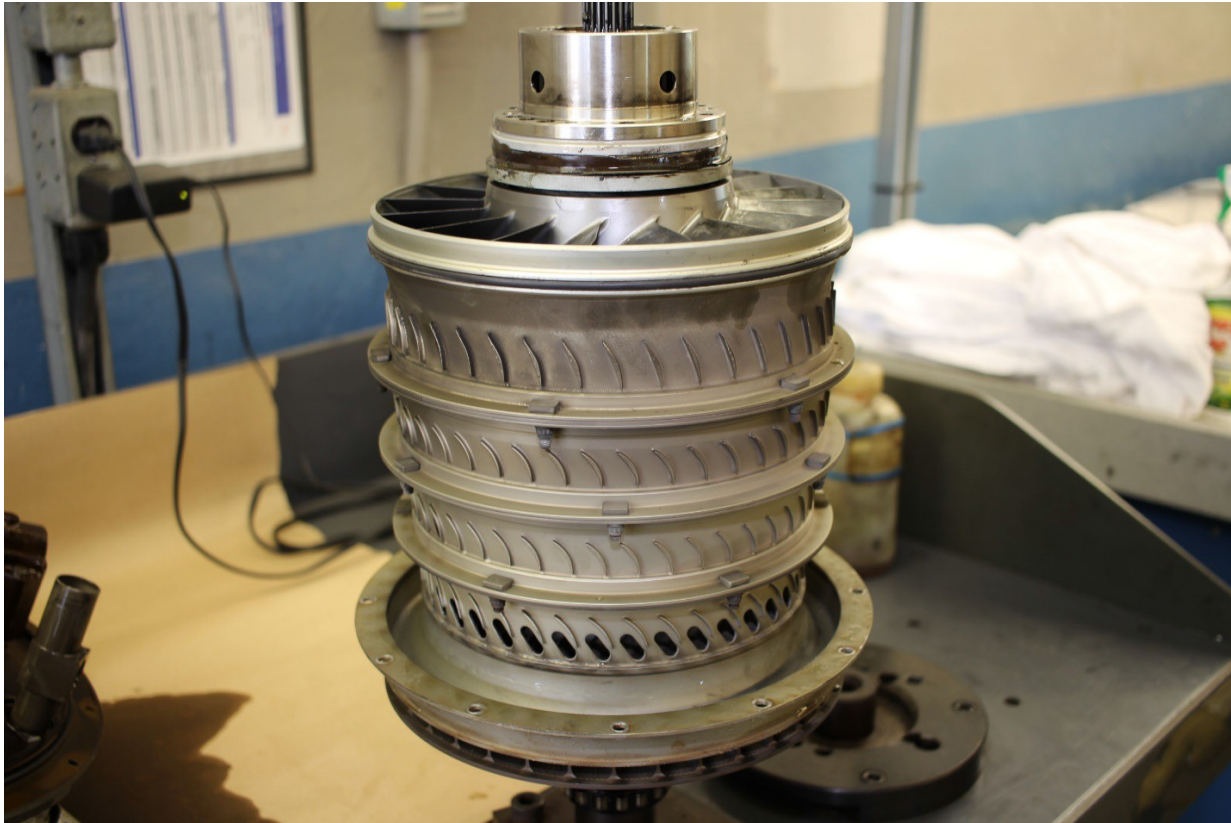
The compressor was not displaced and displayed no evidence of impact damage. The impeller rotated freely through the N1 tach generator. During the subsequent examination, a small corner piece to one of the 2nd stage compressor blades was missing and several stage 3 and 4 compressor blades exhibited trailing edge damage.

Photo 2: Compressor Section

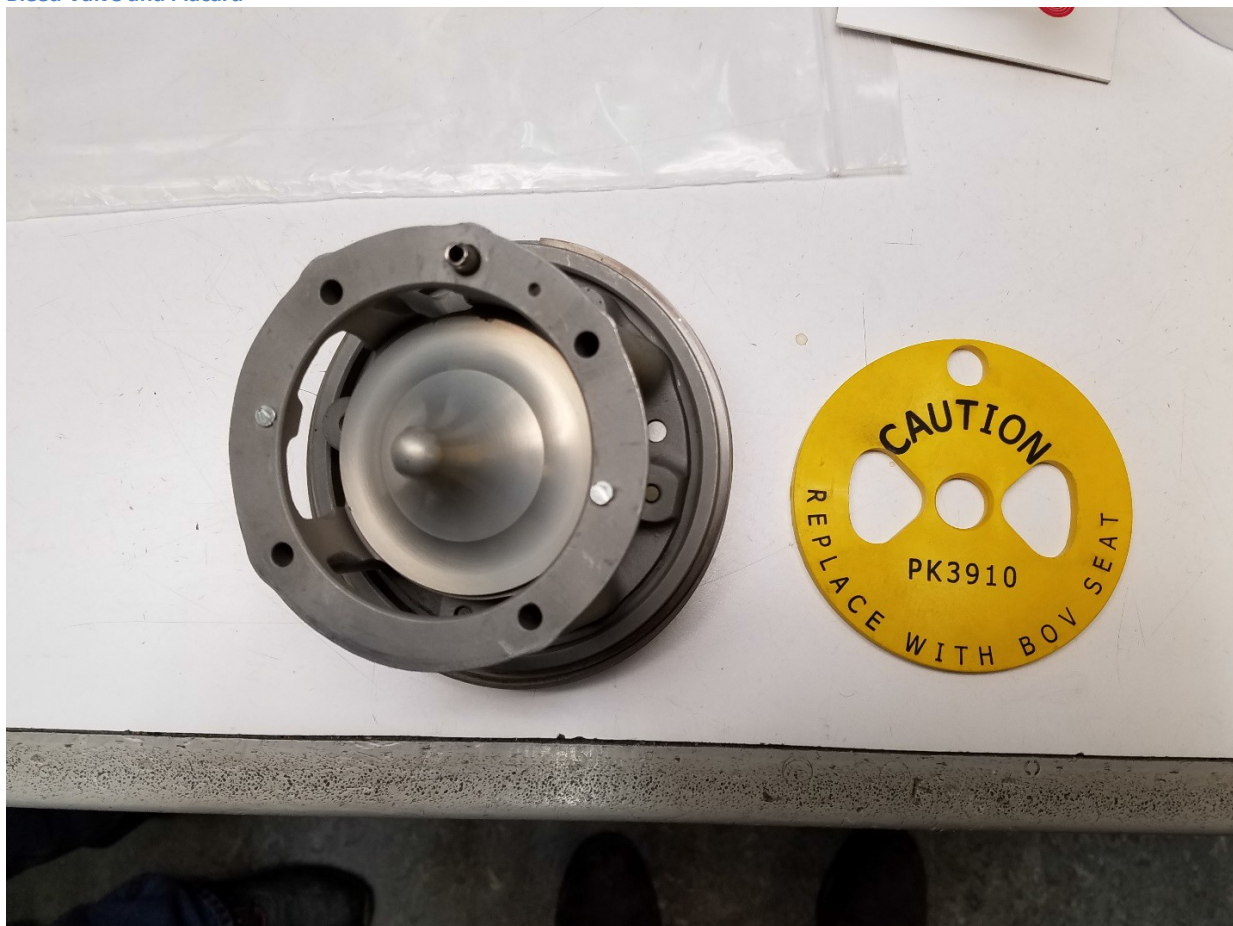
A slave seat was installed on the bleed valve and the unit was tested on a stand. About 55PSIA of pressurized air was pumped into the P3 inlet port of the bleed air valve and the unit's standing air pressure was measured. During the first test the standing air was measured at 54.5 PSIA using the accident O ring for the P3 inlet and 54.6 using a new O ring for the P3 inlet. Leaktec was distributed along the valve to locate the source of the leak. When the piston was moved, the leak was observed near the main body of the piston, but was negligible.

A representative of PWC showed the investigation team that overhauled or repaired unit is returned to the customer with a placard in lieu of the seat that states "Replace with BOV Seat." BOV is the abbreviation for Bleed Off Valve.

Once the piston moved beyond the carbon spacer, the piston exposed a P3 air leak, at which point P2.5 air would have prevailed and prevented the piston from moving any further.

The actual tested production ITT was 725C and the engine's max ITT is 810C. The bleed valve gap between the piston and the valve case was about one hundred and then thousandths. This particular valve was class six, (1 valve class will increase ITT from 8-14 degrees C), but without the valve seat would have placed the valve 15 classes above its production position and increased the ITT.

Photo 3: Bleed Valve and Placard

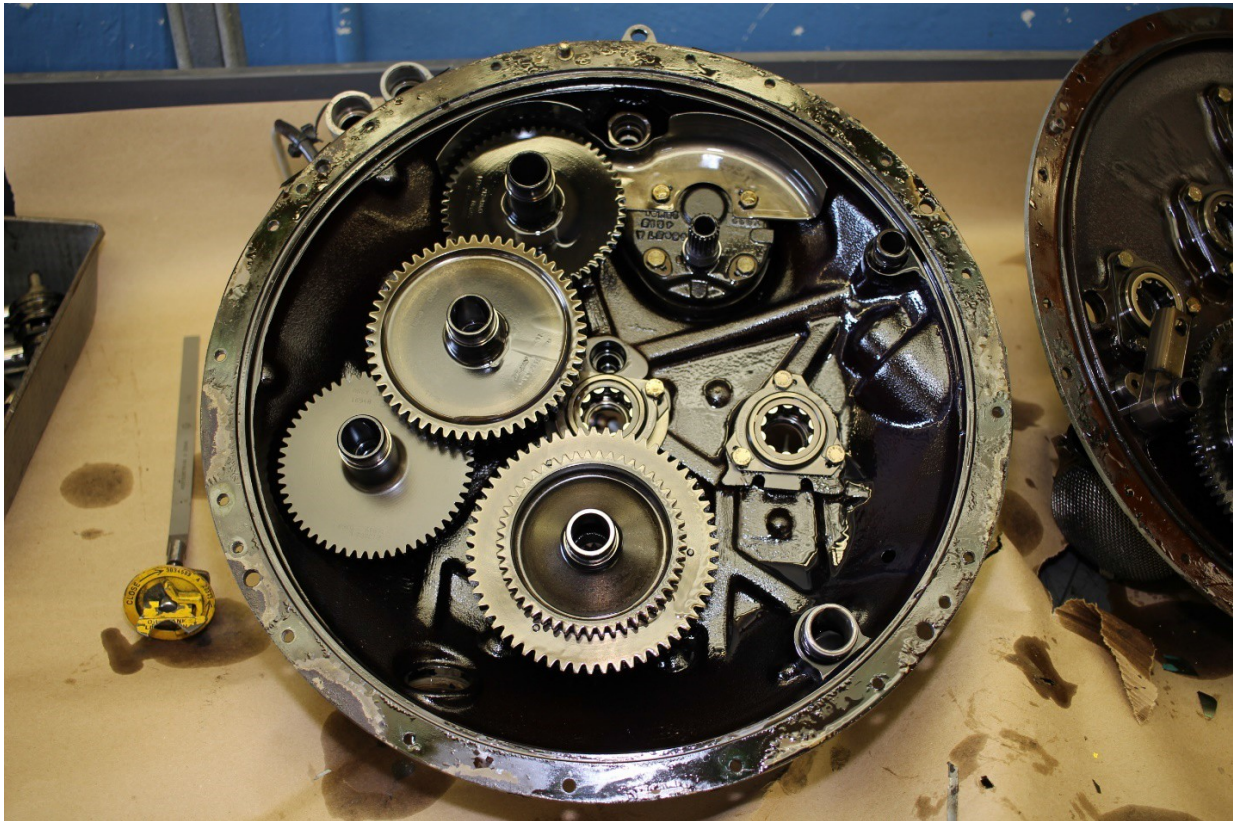
The accessory gearbox section gears and shafts rotated freely when actuated by hand.

Photo 7: Accessory Gearbox Section

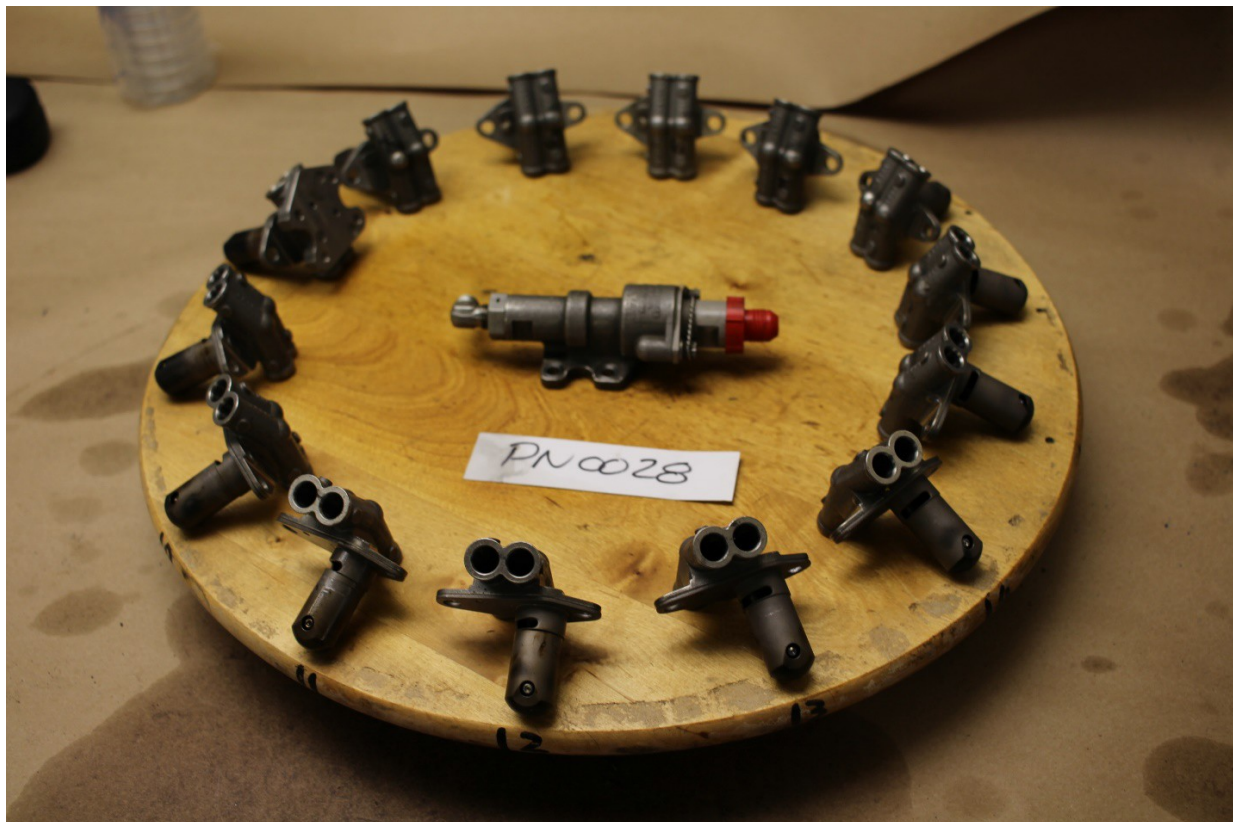
The fuel nozzles tested within normal limits with the exception of nozzle positions nos. 5, 9, 10, and 12. The spray angles produced by fuel nozzle nos. 5 was uneven. Further examination of the nozzles tips underneath a microscope revealed the presence of varnish along the circumference of each tip. Nozzle position no. 12 produced a flow rate of 19.3 pph, 0.1 pph below the minimum requirement and nozzle position no. 9 displayed a leak during the pressure test. Nozzle position nos. 2, 3 and 10 were comprised of tab washer tangs were wider than the manufacturer's production part.

The flow divider tested normally and produced results within the manufacturer's limitations.

Photo 8: Fuel Nozzles & Flow Divider

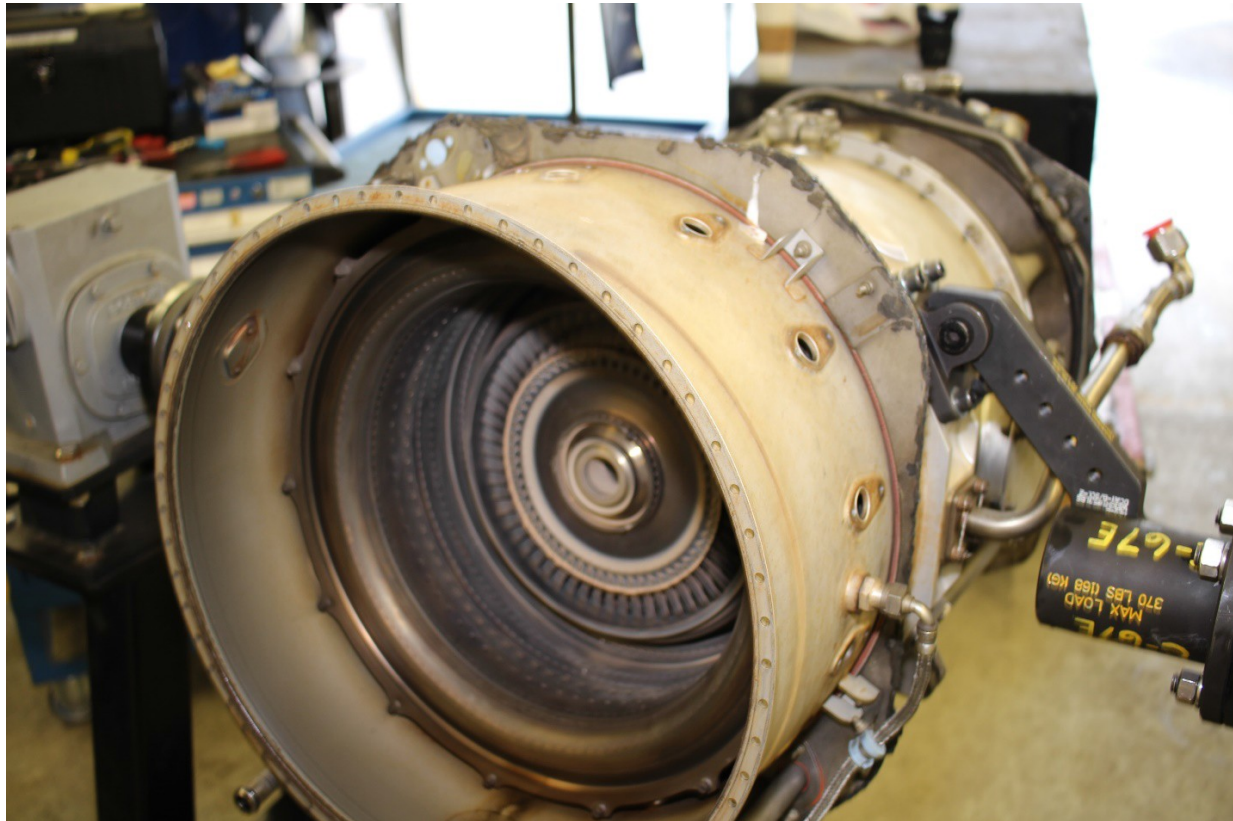
The prop flange, gearbox, and turbine fan blades rotated freely when actuated by hand at the main drive shaft. The fan blades and stator vanes did not display any abnormal wear. Some rotational scoring was observed along the turbine shroud, but the fan blades did not display any visible damage. The left side exhaust case was damaged.

Photo 9: Power Turbine Section
