# **AIRPLANE EXAMINATION REPORT**

**NATIONAL TRANSPORTATION SAFETY BOARD**

**WPR17LA042**  
**Willows, California**  
**December 27, 2016**  
**1553 PST**  
**Air Tractor AT-602; N602L**

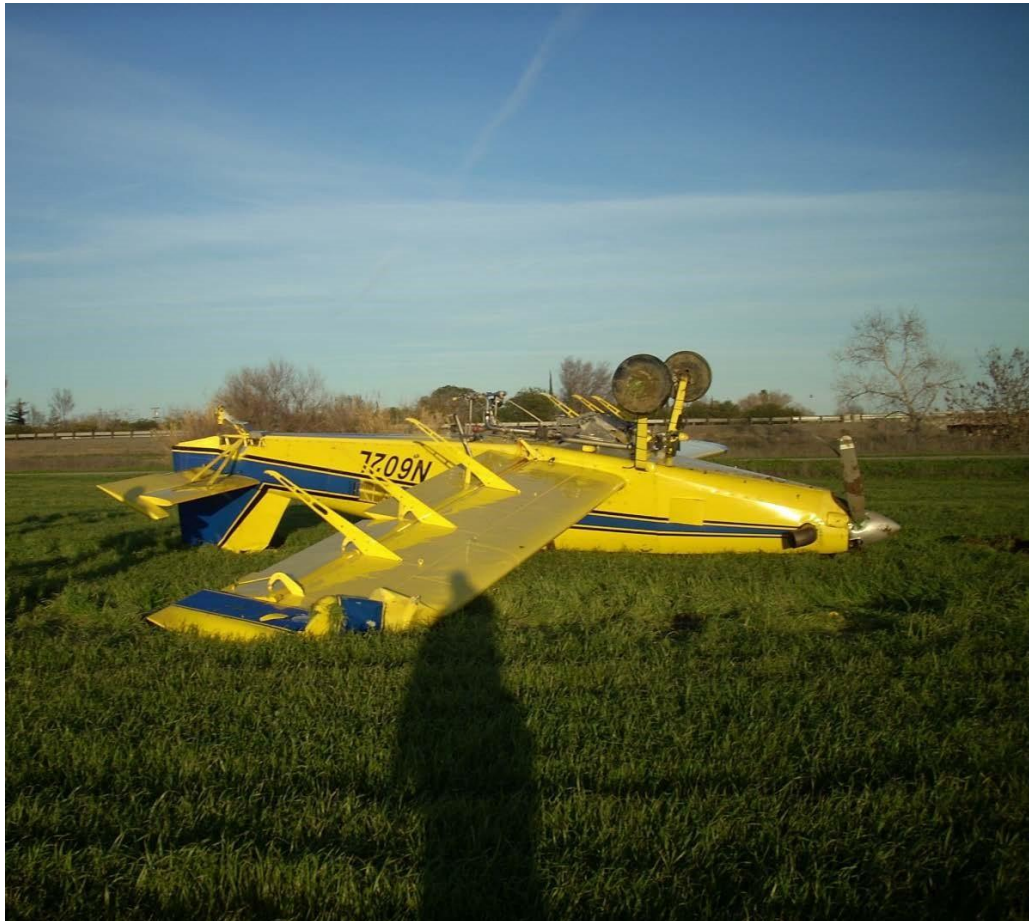
Postaccident examination by a Federal Aviation Administration inspector revealed substantial damage to the rudder and left wing spar.

Photo 1: Airplane at Rest

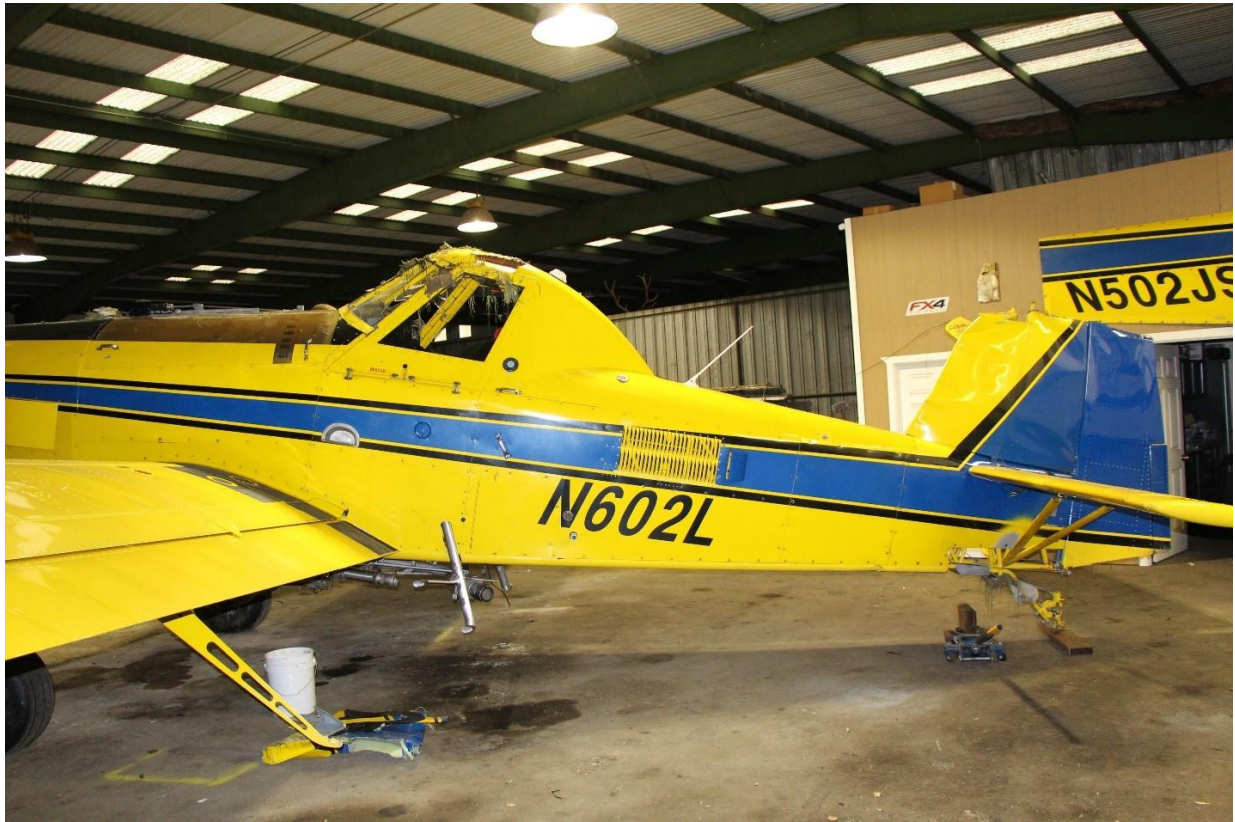
Photo 3: Airplane before Examination

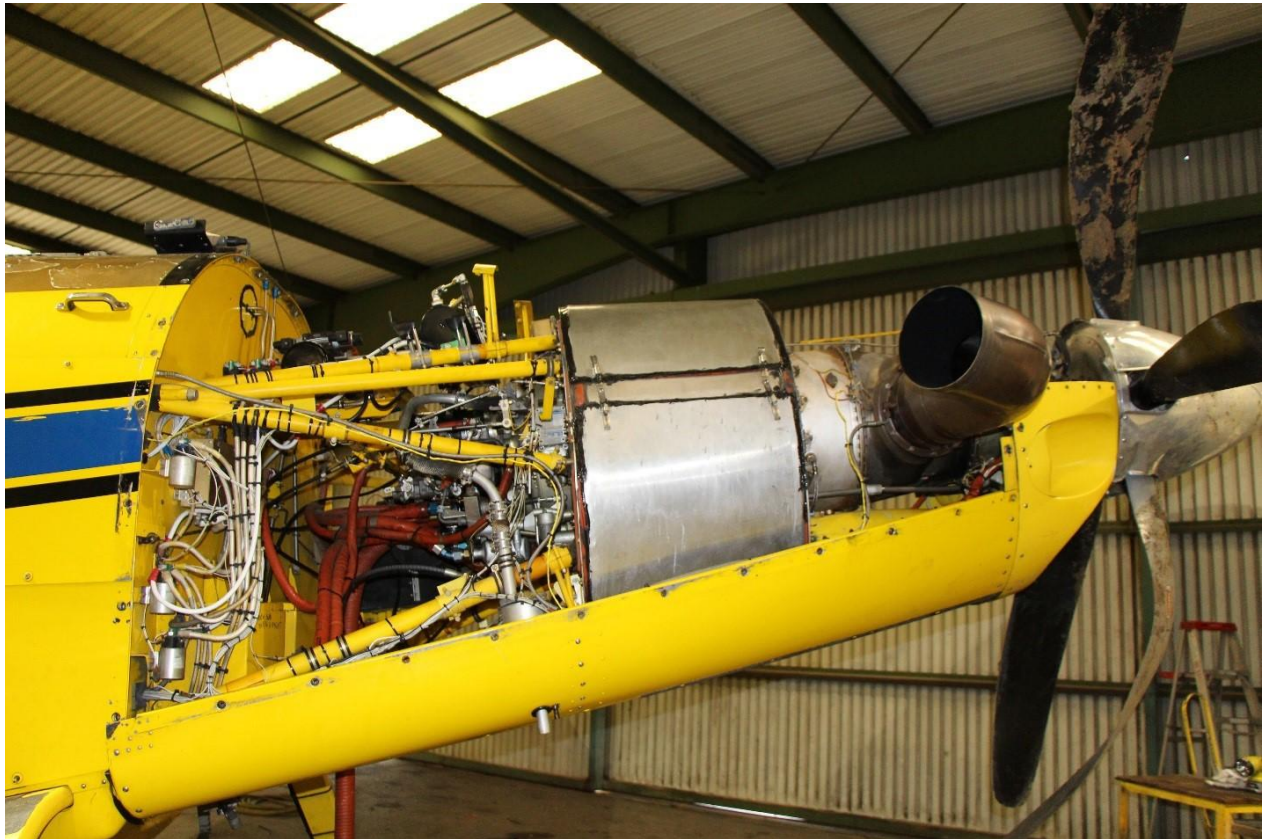
Photo 2: Engine before Examination

The engine sustained minimal damage with the exception of the left side exhaust tube, which displayed some compression wrinkles. The propeller was immovable and exhibited a mechanical sound from the aft portion of the gearbox at the engine power section. Each of the 5 propeller blades exhibited bends and chordwise scratches. Hydraulic fluid leaked from the hydraulic box that operates the hopper lid, located above the fuel controller, which also received some of the liberated hydraulic fluid.

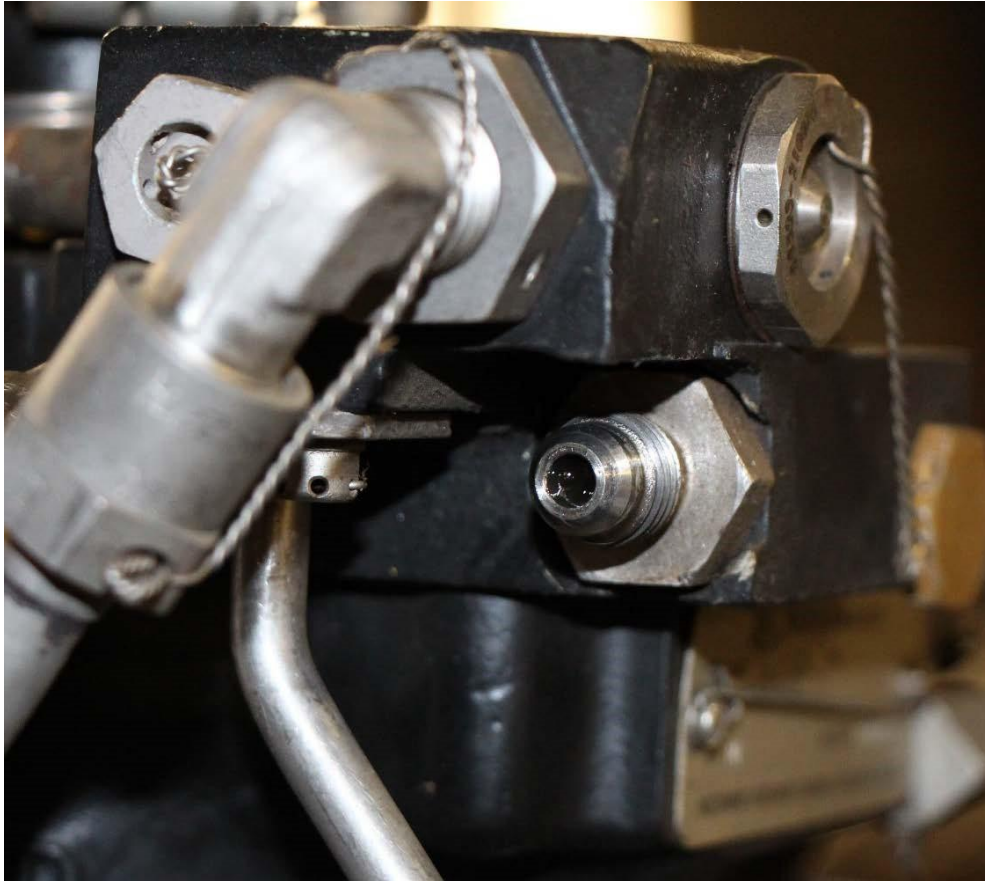
The Py line flexible hose was approved as a Federal Aviation Administration Supplemental Type Certificate (STC), designation SE8652SW, that was issued to Air Tractor, Inc. on January 28, 1997. The Py connection was secure at the connection to the propeller governor and fuel control unit; however, the outer hose rotated freely at the governor end. The Py inlet to the propeller governor displayed some fluid discharge.

Photo 5: Propeller Governor Py Nozzle

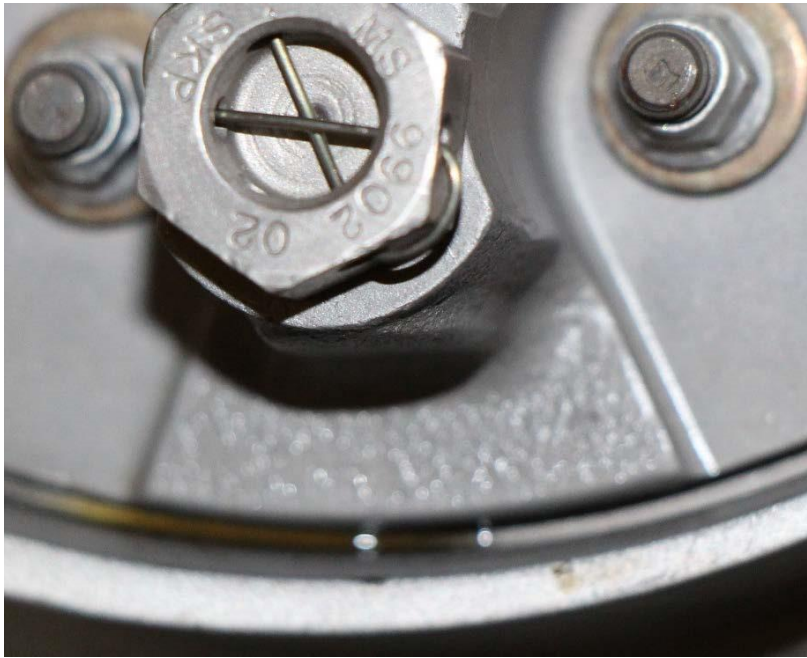
A preliminary inspection of the bleed valve showed that it was installed on the compressor section; however, the two bottom bolts used to secure the valve were finger tight. Each of the valve's 4 bolts were removed; the bolt threads and thread holes did not exhibit any deformation. A black residue with a viscosity that resembled oil was observed in the crevice of a lip normally used to guide the valve during installation and secure the valve's position.

Photo 6: Black Residue at Lip of Bleed Valve

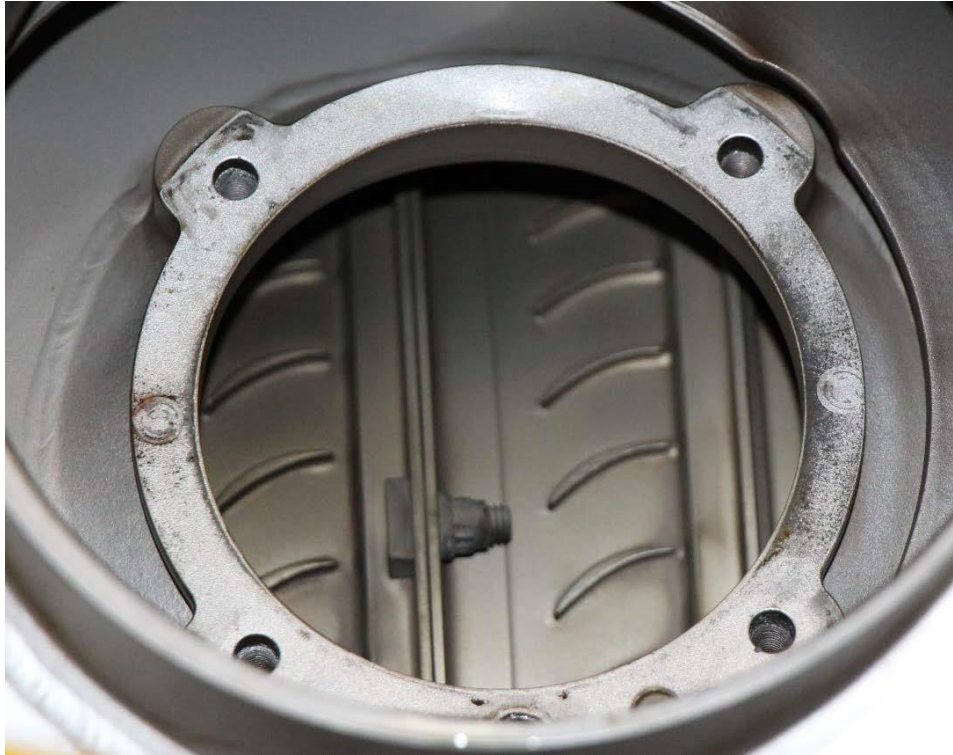
When the bleed valve was removed from the engine, the piston nearly fell to the floor, which indicates that the piston had been liberated from its secure position within the valve body. Examination of the valve mating surface at the engine revealed a black residue that had formed the shape of two of the valve seat screwheads on both the fore and aft sides. Further, the black residue covered the forward portion of the mating surface in a gradient of decreasing intensity.

Photo 7: Black Residue at Valve Mating Surface

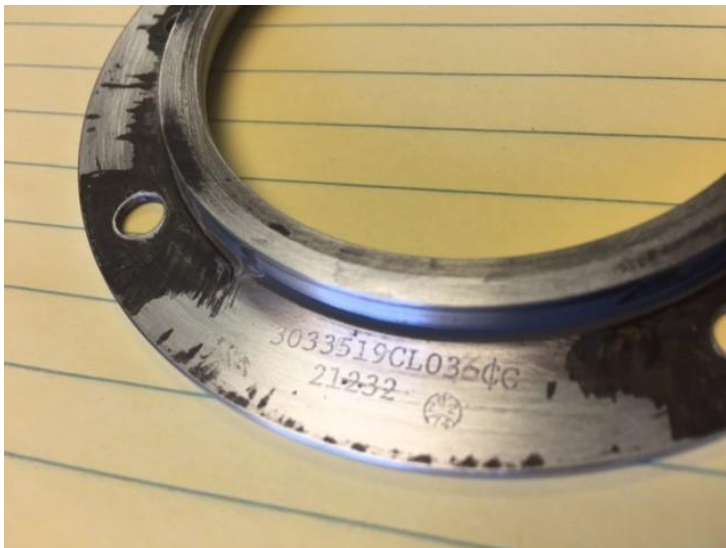
An inspection of the bleed valve showed that the valve filter was intact and free of contamination. A comparison to the unit's corresponding illustrated parts catalogue, No. 3032842, revealed that the valve seat was missing. When prompted, a representative of Prime Turbines subsequently discovered the valve seat was with components that comprised the "old" core unit, which had been shipped to their facility by Grower's in exchange for the overhauled unit.

Photo 8: Image of Valve Seat Submitted to Investigation Team by Prime Turbines

According to section 5(A)(2) of the Compressor Bleed Valve maintenance manual, which contains procedures to remove the valve, the “Compressor bleed valve seat (7) is classified and must remain with gas generator assembly.” The valve installation is covered in section D, page 7, of the manual. The first procedural item, section D(1), states, “Install seat (7, Fig. 201) on replacement bleed valve with screws (9). Tighten screws to 5 to 6 lb. in.”

As part of their procedure, the company’s mechanics do not typically have a copy of the illustrated parts catalogue (IPC) and maintenance manuals (MM) on the service floor. The IPCs and MMs are accessible through a computer located in a nearby office. In response to this accident, the DOM is going to start printing IPCs and MM for his mechanics and may offer tablet PCs in the future. In addition, he plans to start reviewing the IPCs and MMs for new aircraft with his line mechanics before they begin work.

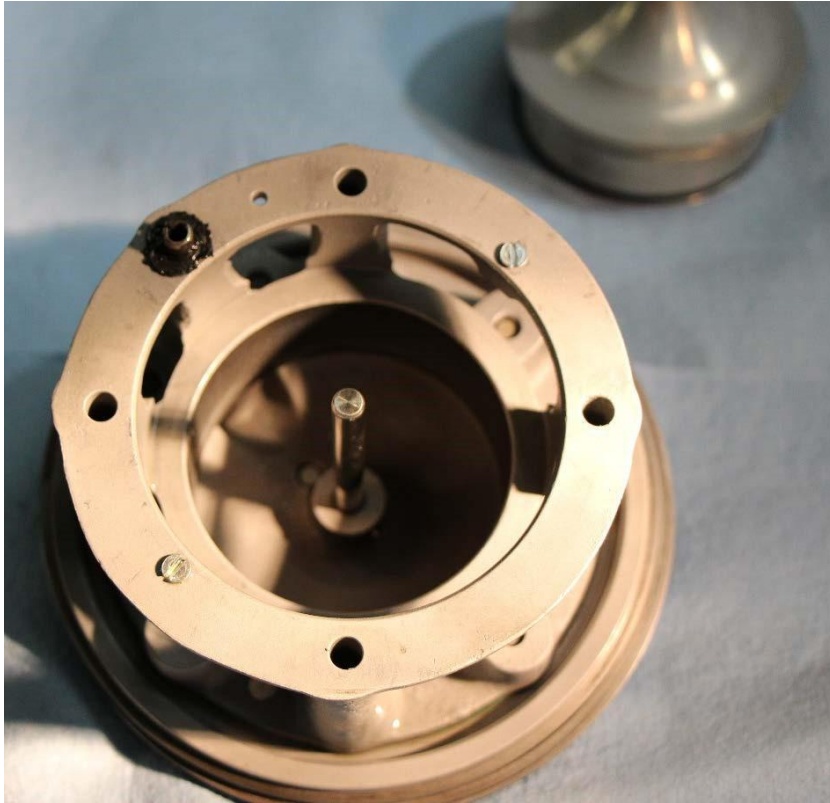
Further, a black residue had been placed around the circumference of the bleed air port in lieu of an “o” ring.

Photo 9: Image of Bleed Valve Body after Unit was Removed from Engine

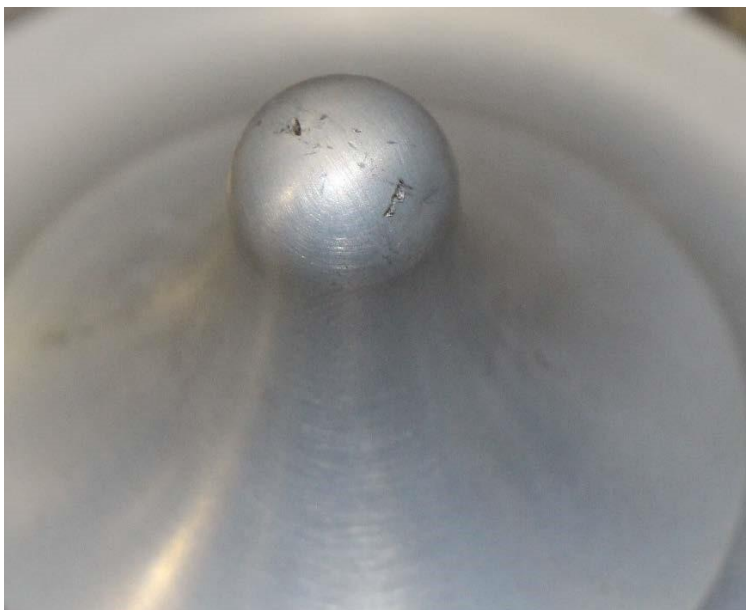
According to the engine manufacturer, under normal operating circumstances the piston will extend to the closed position as it rests against the valve seat. A carbon ring is installed in a canal on the piston and normally secured by compression as the piston is inserted into the valve body, previously referred to as the guide collar. If the valve seat is not installed, P3 air will move the piston towards its closed position in response to an increase in power demand from the operator. In this case, the piston can move beyond the valve body and the carbon ring will then expand, which prevents the piston from returning to an open position. The bleed valve normally discharges excess compressed air when a lower power setting is selected by the pilot. In this case, if the valve piston traveled beyond the seat, the bleed valve would have started to discharge P3 air, thus allowing P2.5 air to prevail and prevent the engine from accommodating any additional power demand.

Examination of the bleed valve piston revealed mechanical damage signatures at the piston tip near the engine side.

Photo 10: Piston Tip
