## **NATIONAL TRANSPORTATION SAFETY BOARD**

### **EXAM REPORT**

WPR17LA046

Aircraft: Softex Investment LLC V-24L, Registration Number: N710XP, Serial #: 14-03-05

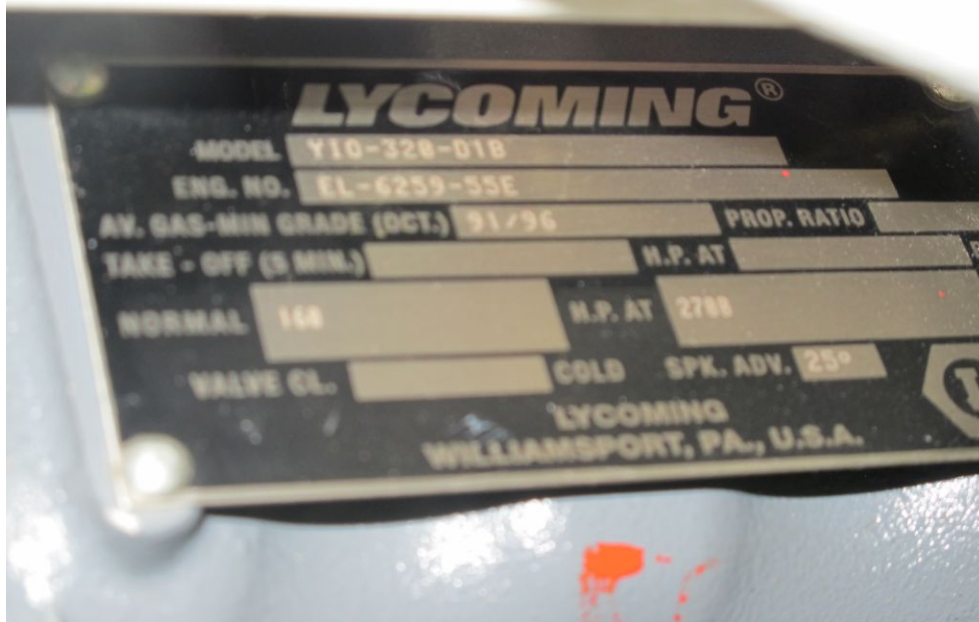
*Figure 1: Left Engine Data Plate*

The left engine was a Lycoming YIO-320-D1B, serial number EL-6259-55E.

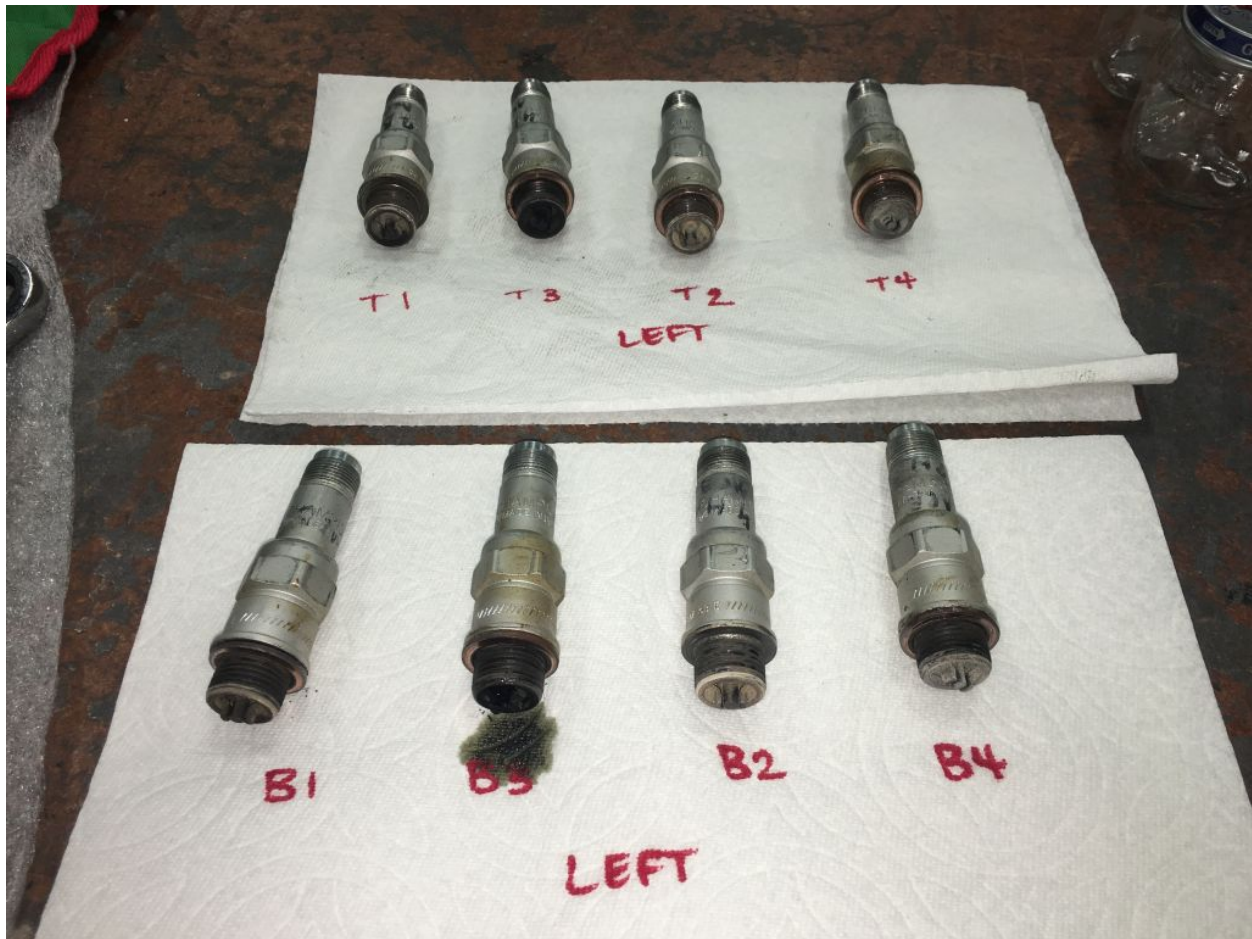
*Figure 2: Spark Plugs from Left Engine*

The investigators also removed the spark plugs, which were Champion REM38E. All center electrodes were circular and clean with no mechanical deformation, except for the top plug on cylinder No. 3, which exhibited black soot, and the bottom plug on cylinder No. 3, which exhibited black soot and was oily. The spark plug electrodes were light gray, which corresponded to normal operation according to the Champion Aviation Check-A-Plug AV-27 Chart.

Investigators connected the spark plugs to their respective ignition leads and grounded the plugs. They manually rotated the magnetos, and both magnetos produced sparks at all plugs except the top spark plug in cylinder No. 2 and the bottom spark plug in cylinder No. 1.

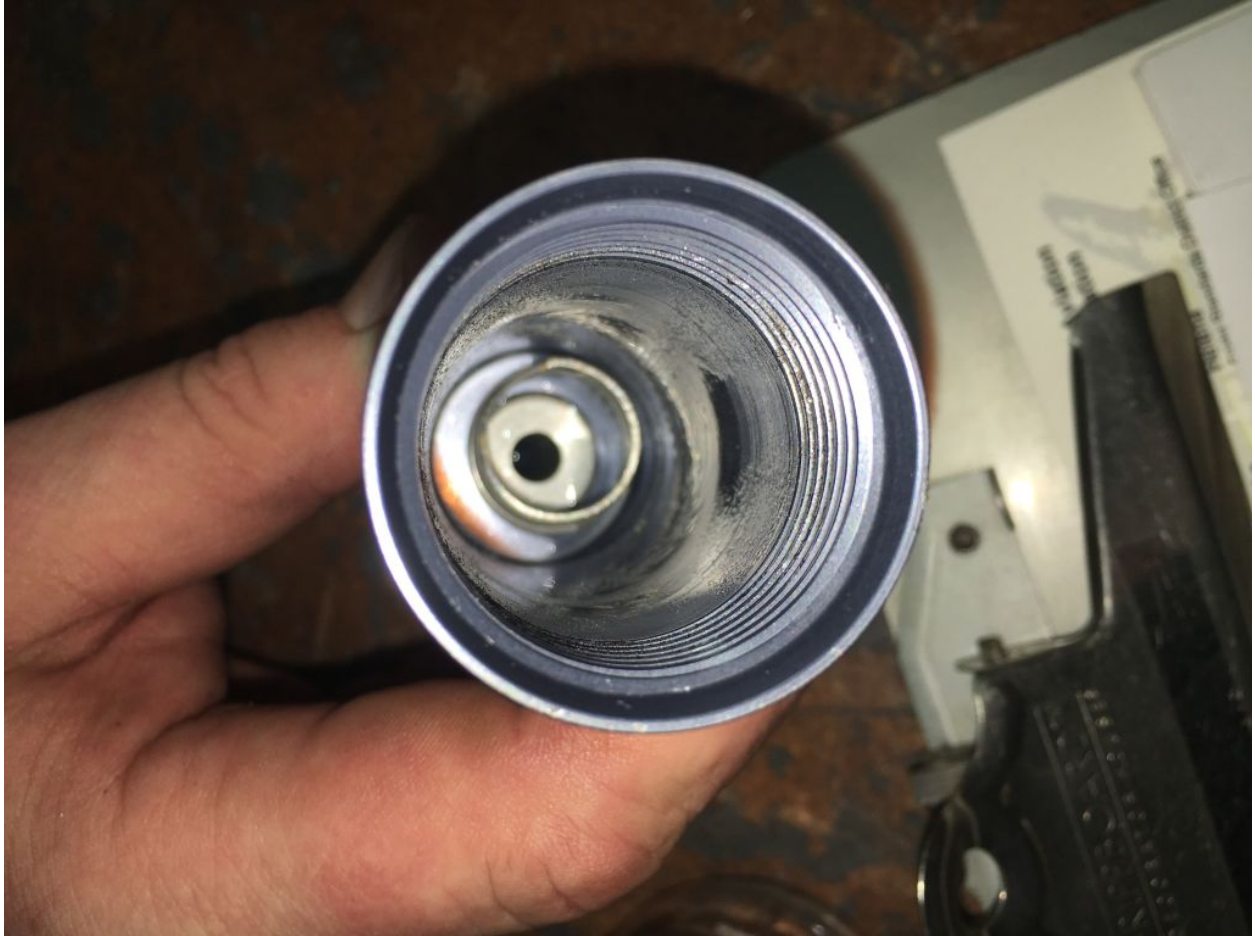
*Figure 3: Fuel Filter from Left Engine*

The fuel filter was disassembled. A pale blue fluid was inside that smelled similar, but slightly different than 100LL aviation fuel contained “sand-like” debris. The same “sand-like” debris remained within the fuel filter container after the fluid was drained. Investigators retained a sample of the fluid for further examination.

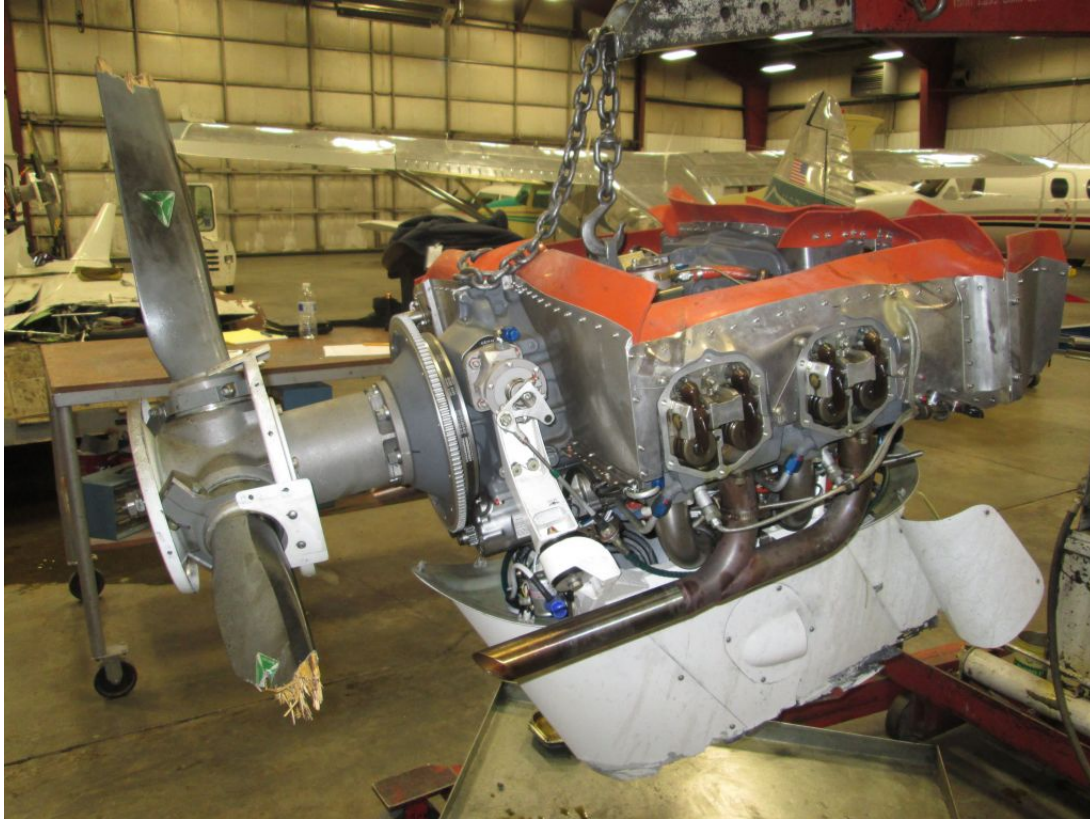
*Figure 5: Right Engine in Hoist*

The right engine was a Lycoming YIO-320-D1B, serial number EL-6260-55E. The engine separated from the right wing during impact; investigators placed it on a stand and slung it from a hoist.

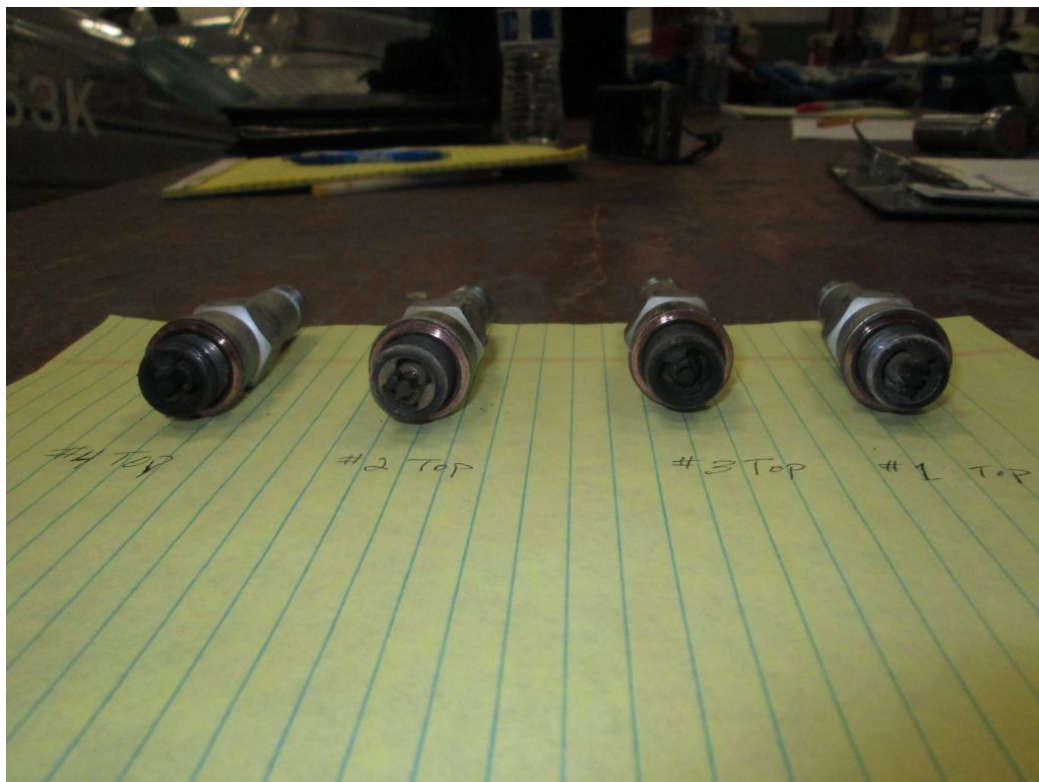
Figure 6: Right Engine Top Spark Plugs

Investigators removed the spark plugs; all center electrodes were circular and clean with no mechanical deformation. The bottom spark plugs on cylinder No. 1 and No. 2 were oily, which is consistent with how the engine tilted during transportation. The spark plug electrodes were gray, which corresponded to normal operation according to the Champion Aviation Check-A-Plug AV-27 Chart.

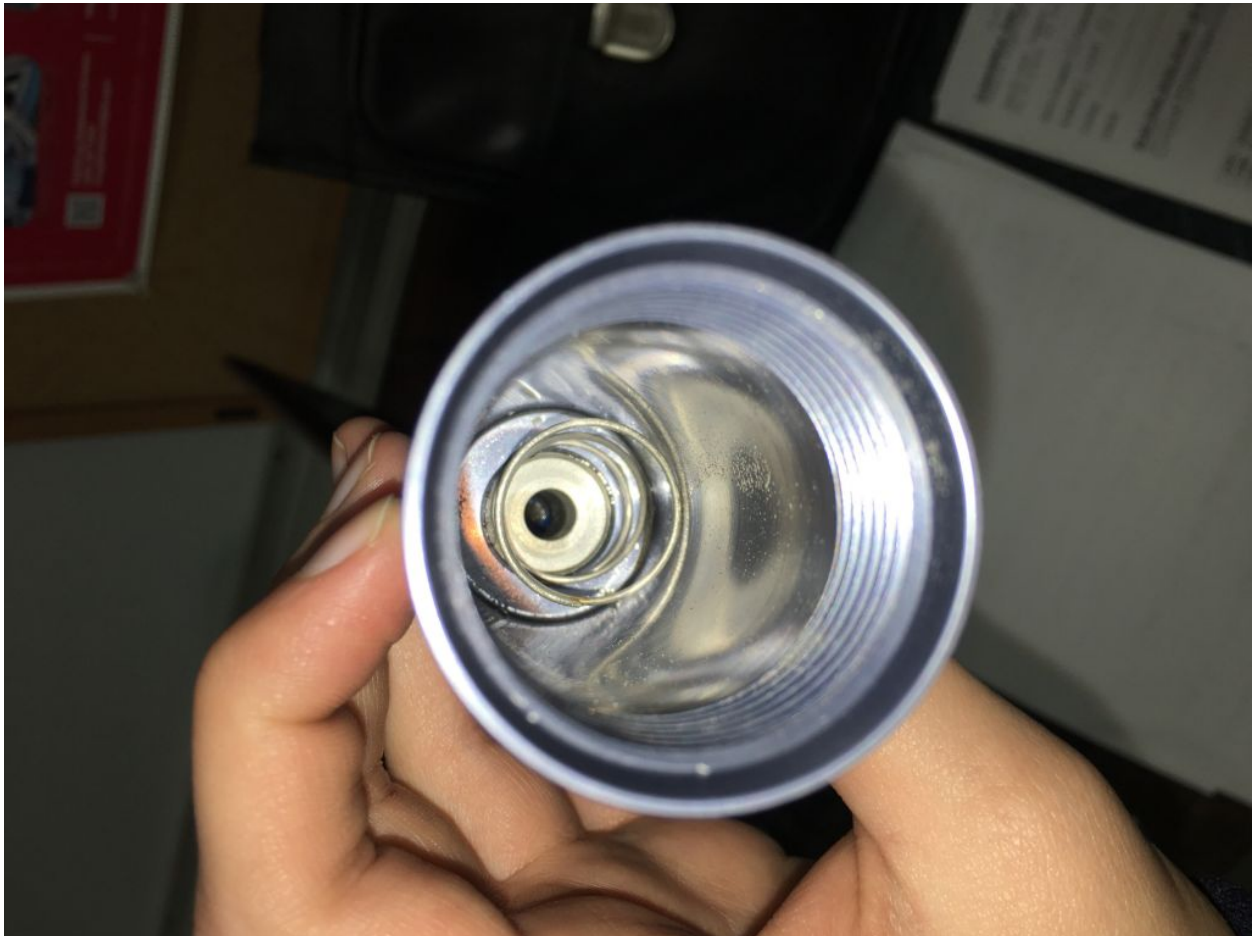
*Figure 8: Right Engine Fuel Filter*

The fuel filter was disassembled. A pale blue fluid was inside that smelled similar, but slightly different than 100LL aviation fuel contained “sand-like” debris, consistent with the left engine. The same “sand-like” debris remained within the fuel filter container after the fluid was drained. Investigators retained a sample of the fluid for further examination.
