# NATIONAL TRANSPORTATION SAFETY BOARD

## MATERIALS LABORATORY FACTUAL REPORT

Report No. 18-062

Place : Jackson, CA  
Date : January 6, 2017  
Vehicle : Cessna 421C, N71RC  
NTSB No. : WPR17LA051  
Investigator : Thomas Little

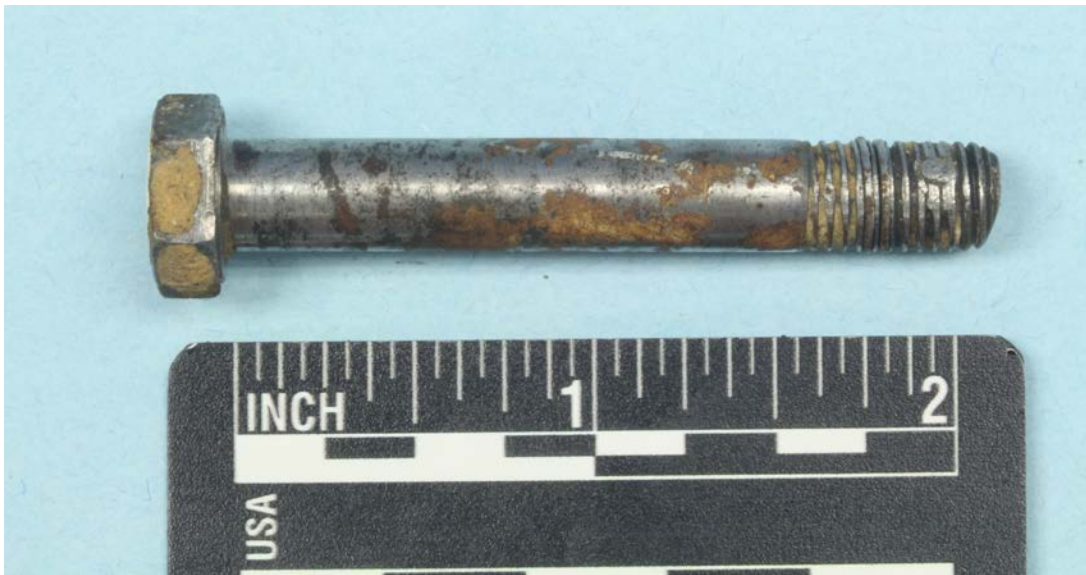
Right main landing gear torque link bolt (figure 1)

Figure 1: Torque link bolt as received.

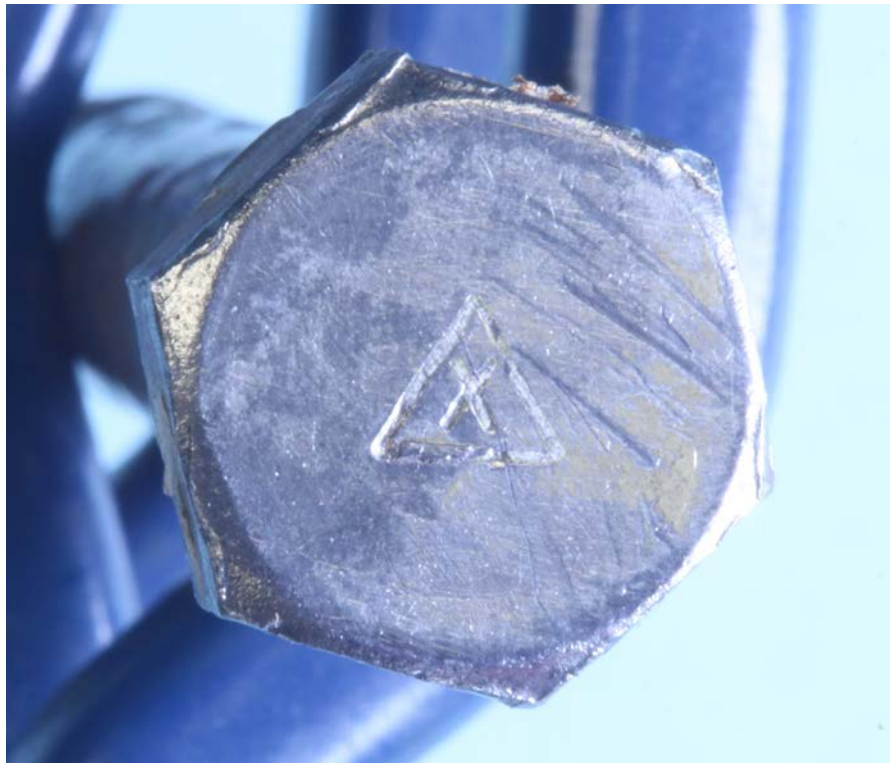
The torque link bolt was approximately two and an eighth inch long with a bare shank length of 1.58 inch and a thread shank length of 0.55 inch. The bolt shank diameter was 0.31 inch. The bolt had a hexagonal head inscribed with a triangle containing an "X" (figure 2).

Figure 2: Bolt head with triangle and "X" inscription.

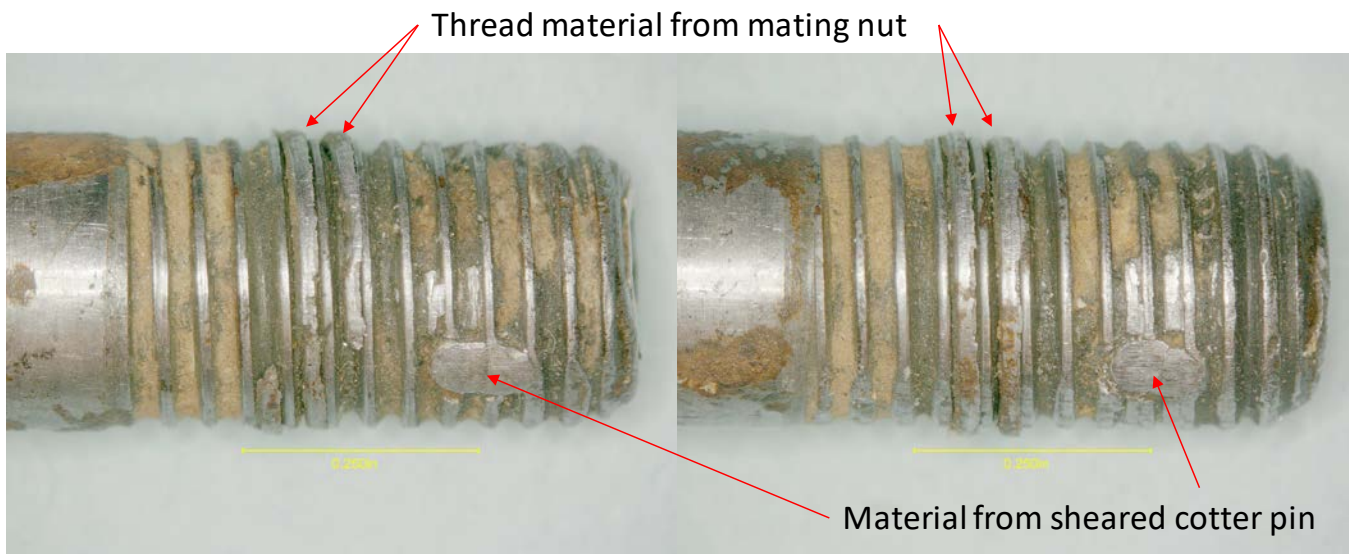
The torque link bolt threads had been rounded over and exhibited remnants of material consistent with the threads of the mating nut (figure 3). Remains of a cotter pin that was installed through the bolt are also visible. The deformation of the cotter pin remains are indicative of a shear overstress fracture.

Figure 3: Rounded bolt threads with remnants of the threads from the mating nut and sheared cotter pin.
