## Service Bulletin

MEB02-12

MAIN LANDING GEAR TORQUE LINK INSPECTION

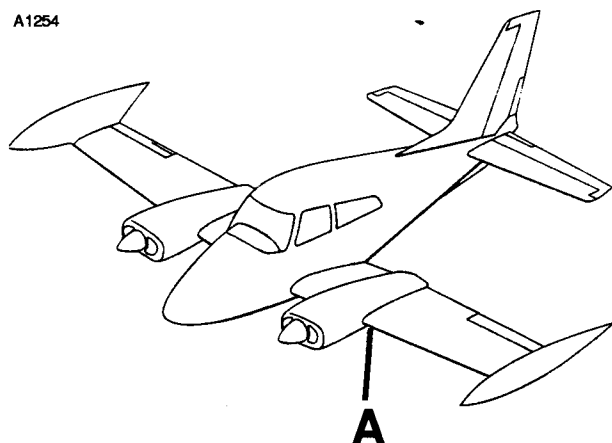
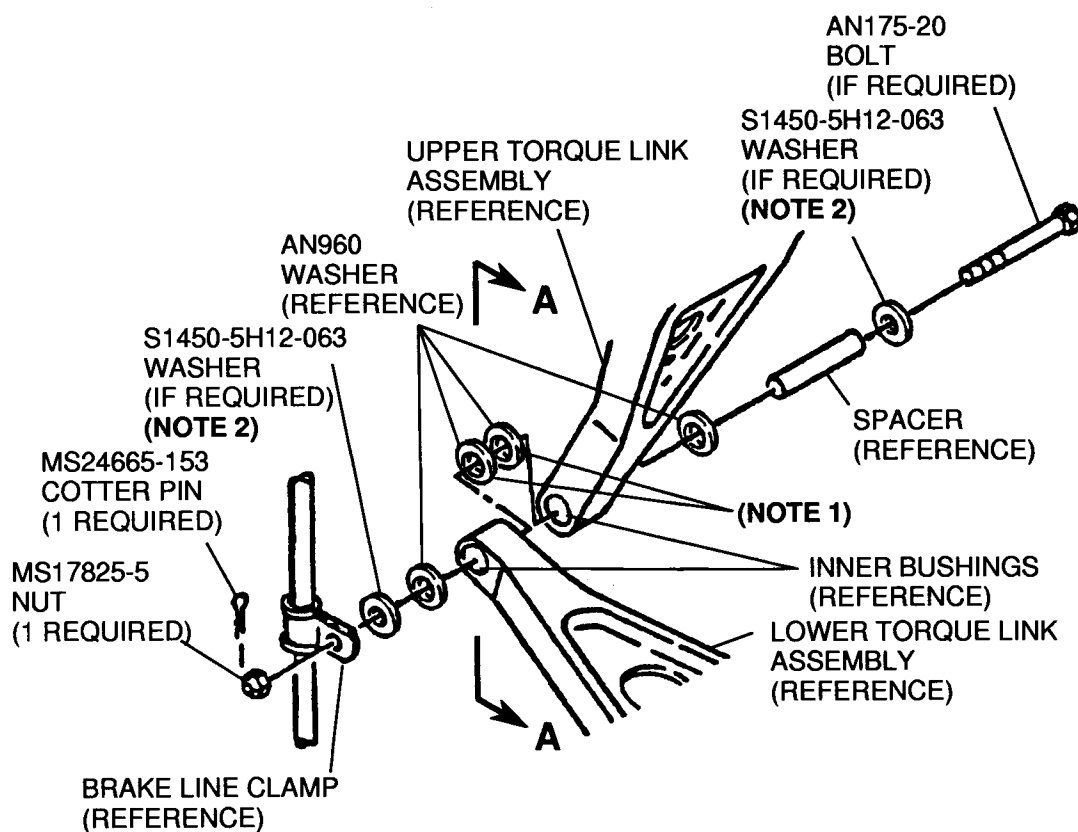
Main Landing Gear Torque Link Washer Inspection/Replacement  
Figure 1 (Sheet 1)

This service bulletin requires an inspection of the main landing gear torque link assembly. The inspection is to make sure the correct thickness washers are installed and to make sure the washers are installed in the correct position. Non-compliance with this service bulletin could allow the retaining bolt and bushings to pull through the torque link assembly. This condition, if not corrected could result in failure of the torque link to hold the main landing gear wheel in proper alignment.

**NOTE 1:** RECORD NUMBER OF WASHERS AT EACH LOCATION BEFORE DISASSEMBLY AND REINSTALL SAME NUMBER OF WASHERS UPON REASSEMBLY.

**NOTE 2:** REPLACE ANY WASHERS AT THESE LOCATIONS THAT HAVE AN OUTSIDE DIAMETER OF LESS THAN 0.75 INCH WITH S1450-5H12-063 WASHERS.

1. Jack the airplane in accordance with the Service Manual.
2. (Refer to Figure 1, Detail A.) Look at the main landing gear upper and lower torque links and record the number of washers installed at each location.

- B. If the outside diameter of the washer(s) is 0.75, keep the washer(s) for reinstallation. Go to Step 5.
5. (Refer to Figure 1, Detail A.) Reassemble the torque link with the parts below.

- A. Install one new or kept AN175-20 bolt, kept spacer and one new S1450-5H12-063 washer or kept S1450-5H12-063, 5045018-1 or 5045018-2 washer under the head of the bolt.

- B. (Refer to Figure 1, Detail A.) Install one new MS17825-5 nut and one new S1450-5H12-063 washer or kept S1450-5H12-063, 5045018-1 or 5045018-2 washer under the brake line clamp as shown.

- (1) Tighten the nut and check for proper cotter pin hole alignment and side play of the torque link assemblies.
    - (2) (Refer to Figure 1, View B-B.) Maintain a 0.004 inch (minimum) to 0.020 inch (maximum) side play of the torque link assemblies.

- (3) Make sure that the spacer washers are centered on the bushing.
    - (4) Torque the nut 100 to 140 inch-pounds.
  - C. (Refer to Figure 1, Detail A.) Install one new MS24665-153 cotter pin.
