## **NATIONAL TRANSPORTATION SAFETY BOARD**

# **AIRFRAME AND ENGINE EXAMINATION SUMMARY**

**WPR17LA053**

| Aircraft: | N6366B; Cessna T210M |

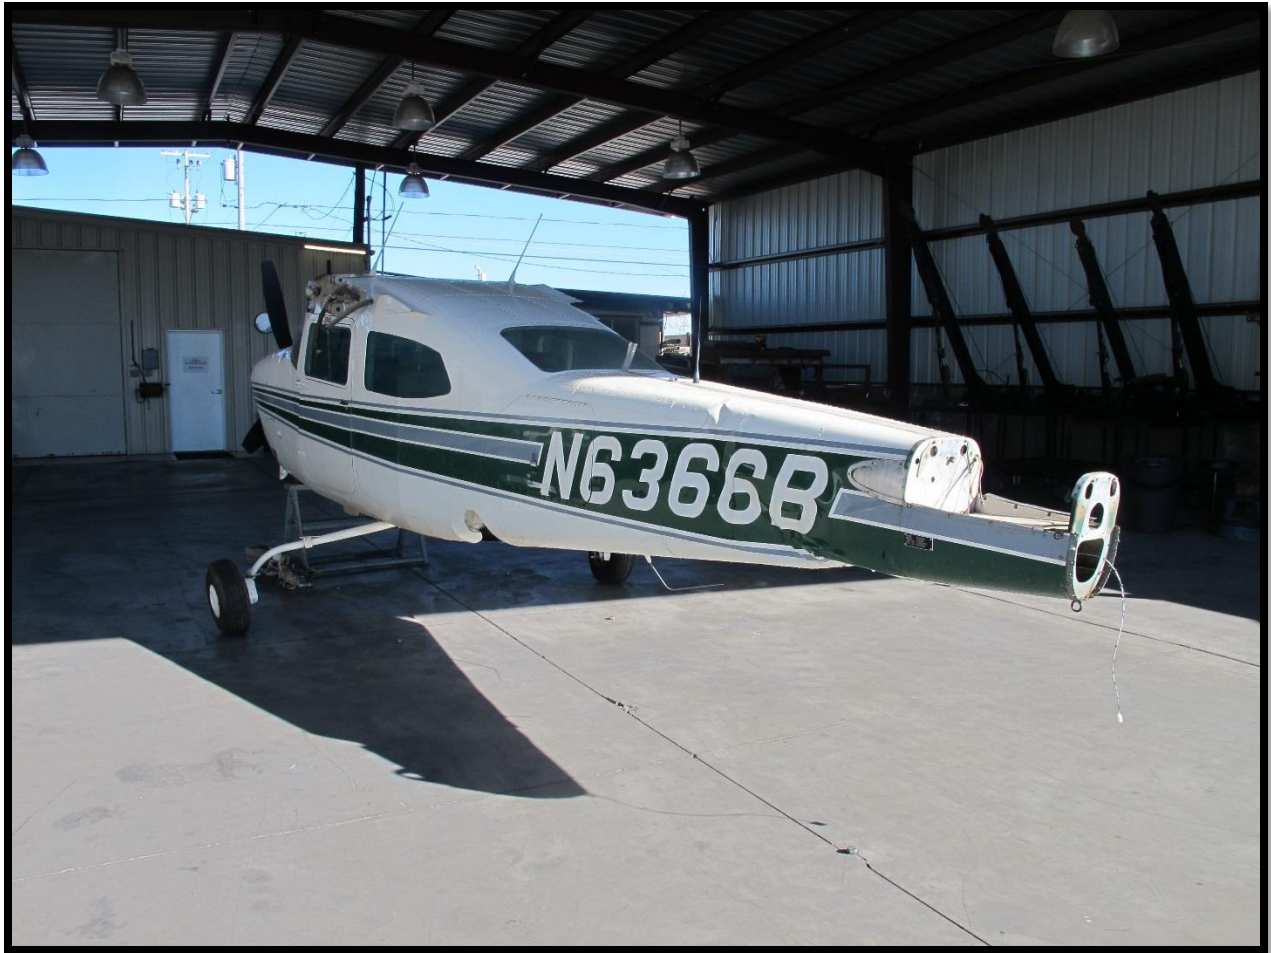
**Figure 1-Follow-up Examination, Main Wreckage**

Examination of the recovered airframe revealed that forward fuselage near the upper side of the firewall and the aft fuselage were buckled. The engine and propeller assembly remained attached to the airplane and the propeller blades had impact damage. The wings, horizontal and vertical stabilizers, elevator and rudder were removed from the main wreckage during the recovery process. The wings were buckled near their midsections and the outboard leading edge of the left wing was bent downward. The rudder and vertical stabilizer were crushed downward during the accident sequence. The left entry door hinges and frame were damaged.

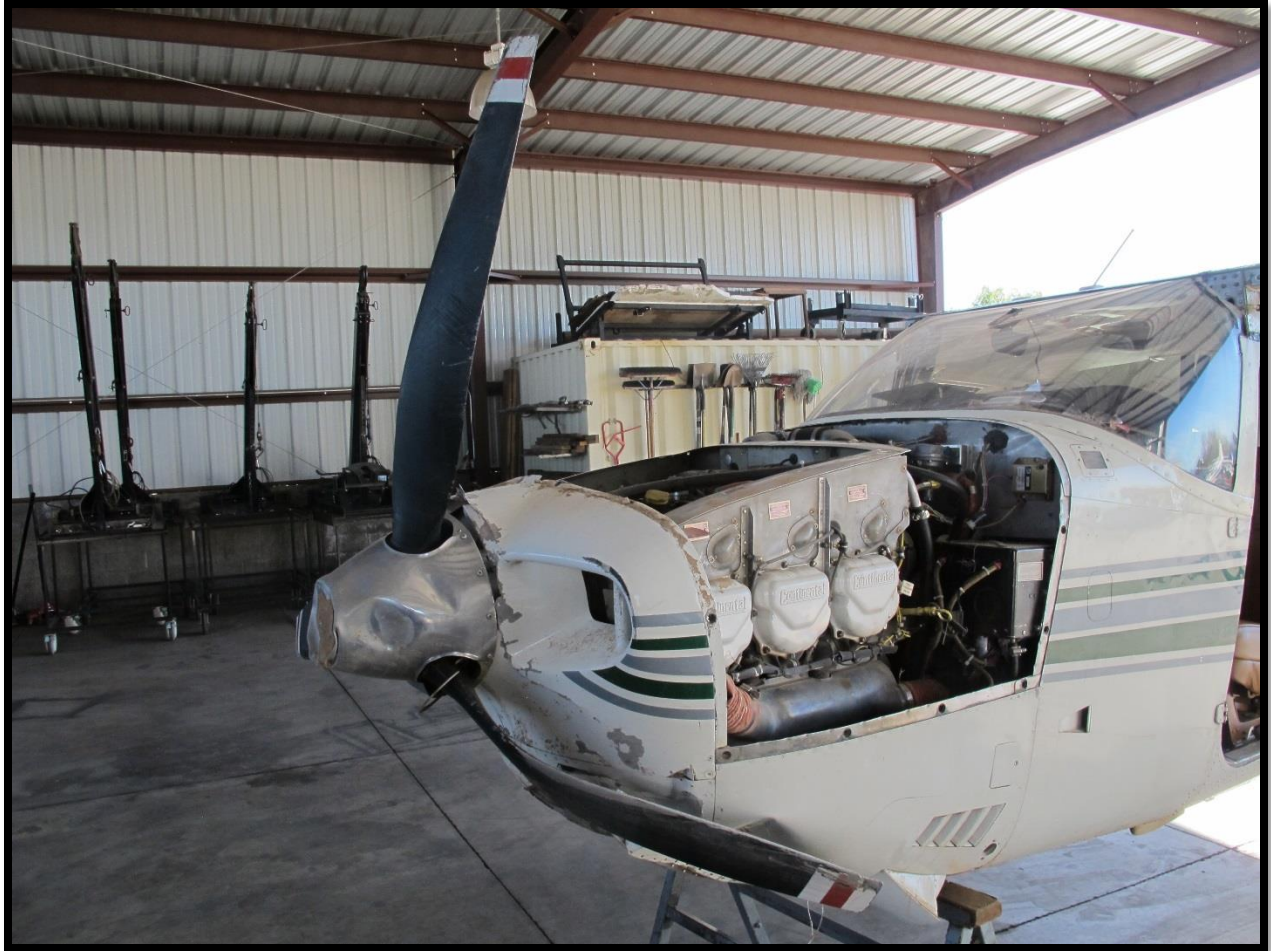
**Figure 2-Engine and Propeller Assembly**

The propeller assembly remained attached to the main wreckage and had impact damage. The spinner was crushed at the tip and the blades had leading edge damage at the tips and were bent aft near the midsections.

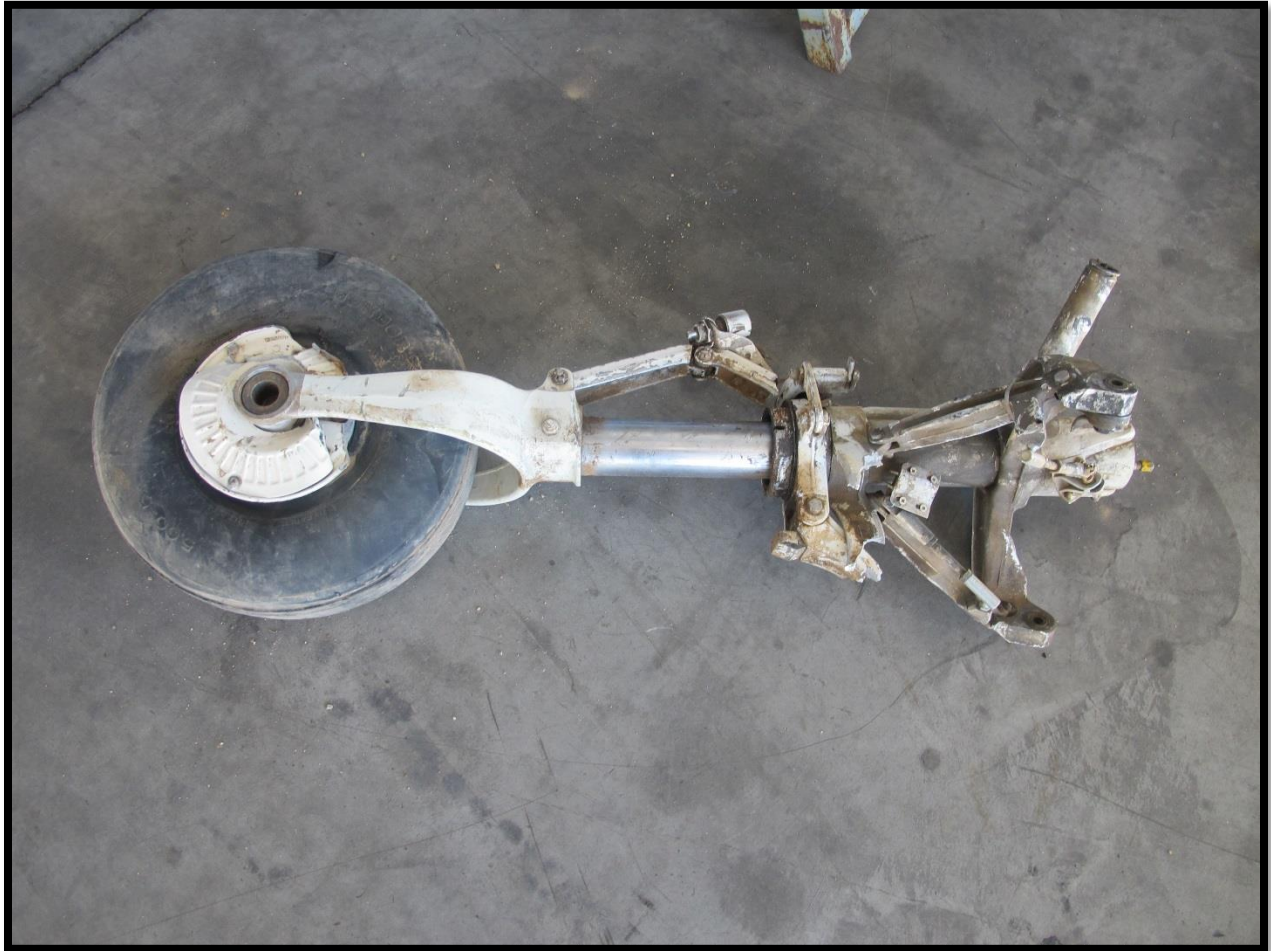
**Figure 3-Nose Landing Gear**

The nose landing gear separated from the main wreckage. The shimmy dampener fracture separated near aft rod end with overload signatures at the separation surface. The lower trunnion and upper trunnion assemblies fracture separated with surface signatures consistent with overload. The torque upper link assembly was also fracture separated with surface signatures consistent with overload. The wheel hub and hub cap had impact damage. The tire was deflated and had impact marks on the sidewall.

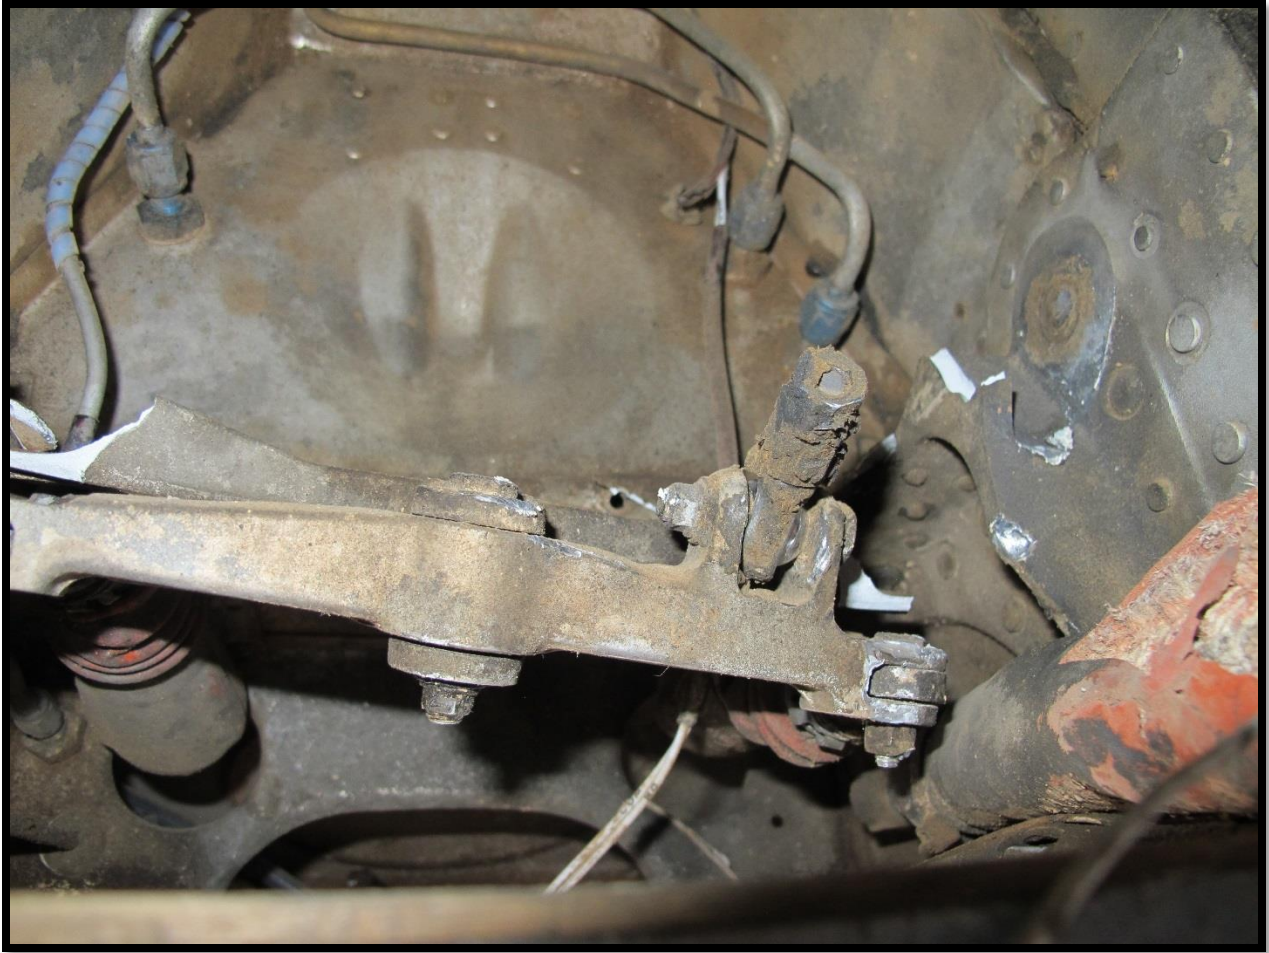
**Figure 4-Nose Landing Gear Steering**

Steering control continuity was established from the rudder pedals controls to the steering whiffletree assembly [control quadrant]. The whiffletree support structure has impact damage. The shimmy dampener rod end remained attached to the whiffletree and is fracture separated at the rod. The nose landing gear upper trunnion support brackets are fracture separated.

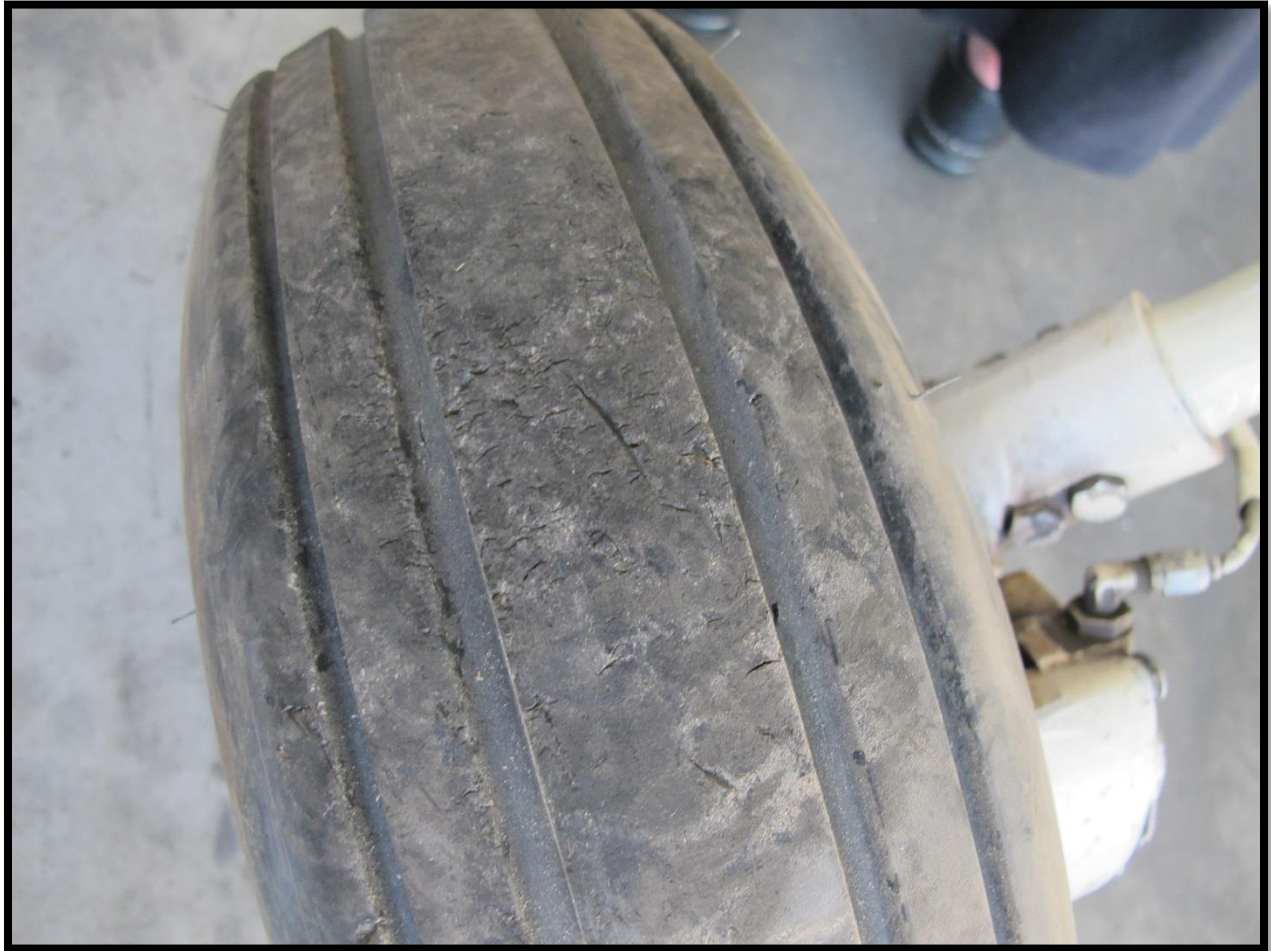
**Figure 5-Left Main Gear**

The tread of the left main tire has minimal wear and damage shown centered in the photo above. The damage is about 3 inches in diameter and consists of small multidirectional lacerations.

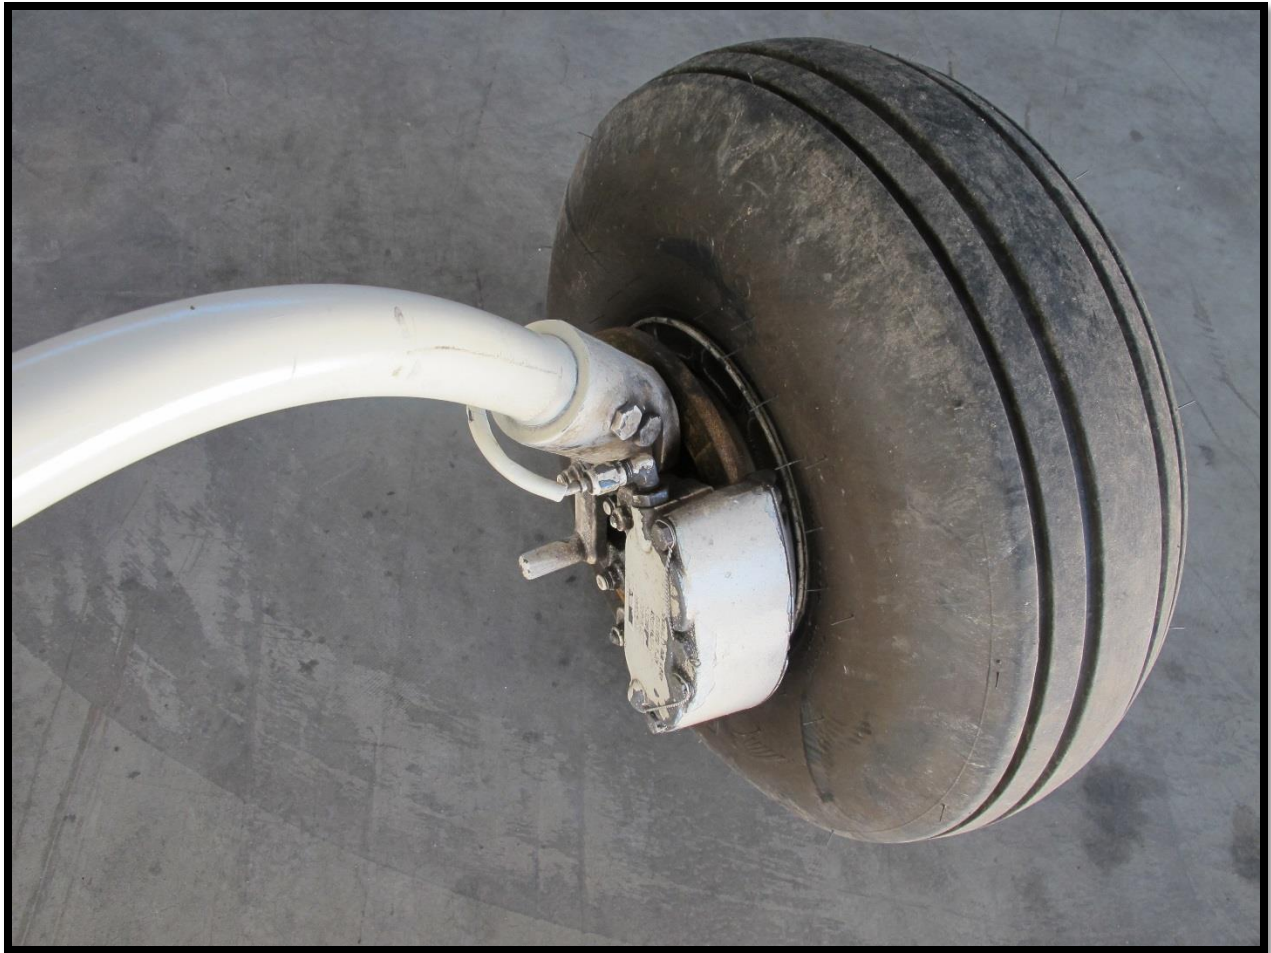
**Figure 6-Right Main Gear**

The right main had minimal wear and was undamaged.

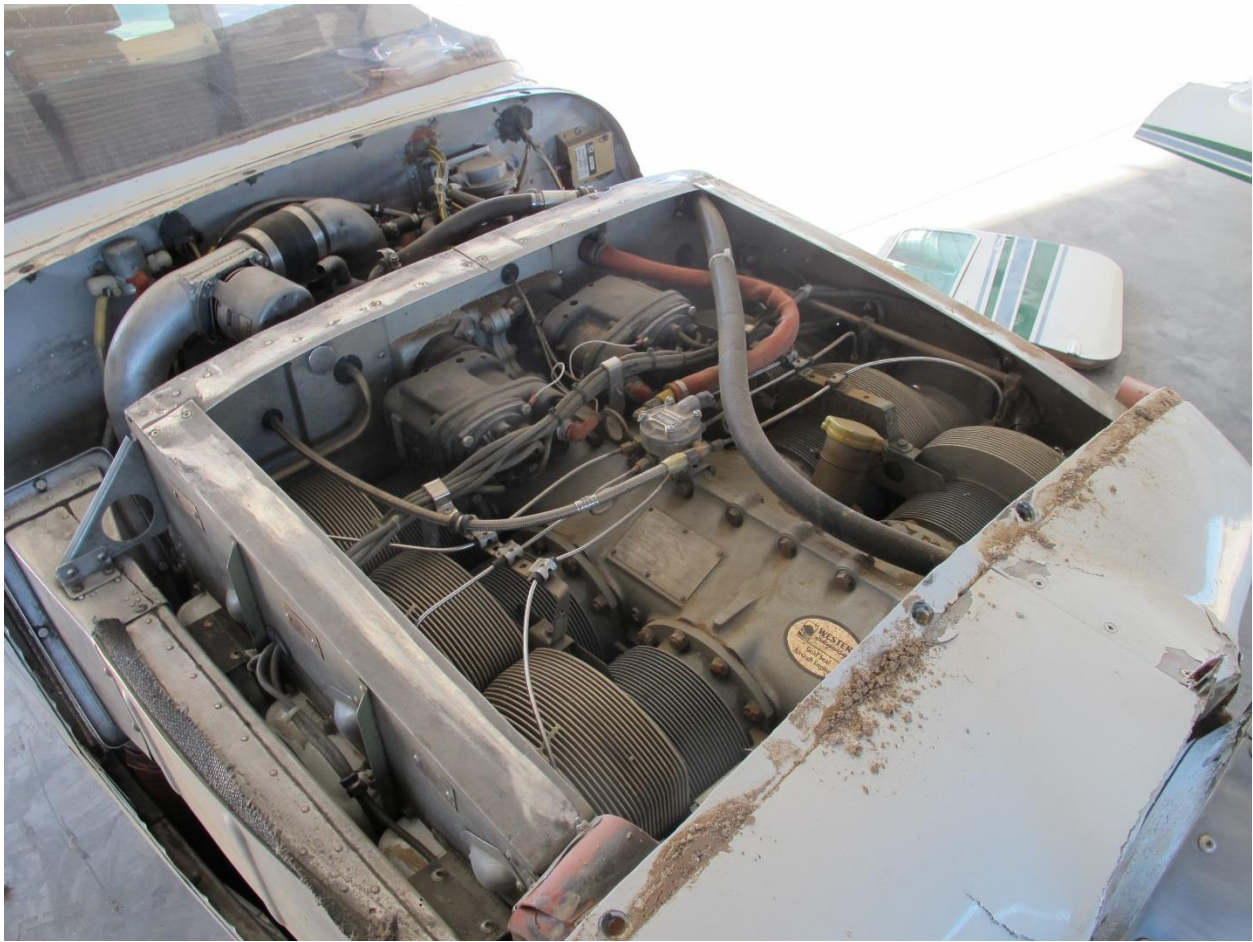
Figure 7-Engine Examination

Examination of the Continental TSIO-520-R engine revealed no anomalies. The upper spark plugs were removed from the engine. The spark plugs electrodes had normal/worn out wear conditions when compared to a Champion AV-27 comparison chart. The electrode areas had light grey deposits. The crankshaft was rotated by hand and magneto impulse coupling engagement was verified. Cylinder thumb compression was obtained from all cylinders during the crankshaft rotation.
