## TESTS AND RESEARCH

## FUEL SERVO

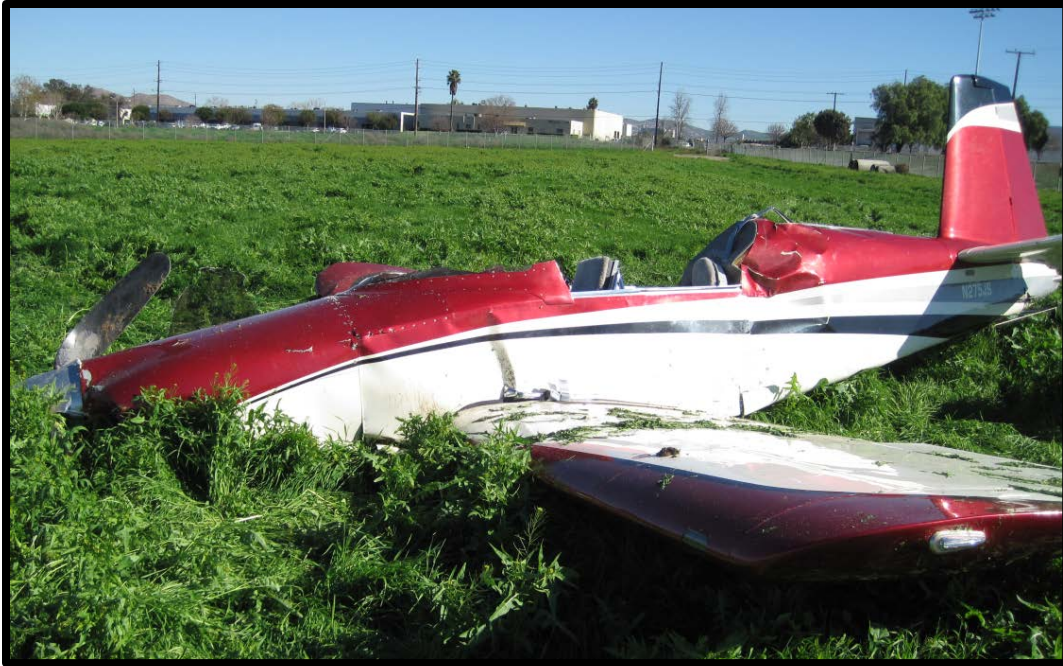
Picture 01: Main Wreckage

The main wreckage came to rest on the airport property on flat, soft vegetation. The accident site was located about 1,650 feet from the departure end of runway 07. The front seat had a control quadrant on the left side; the levers were all bent and folded over to the right. The throttle was positioned in the mid-position and the mixture and propeller controls were full forward.

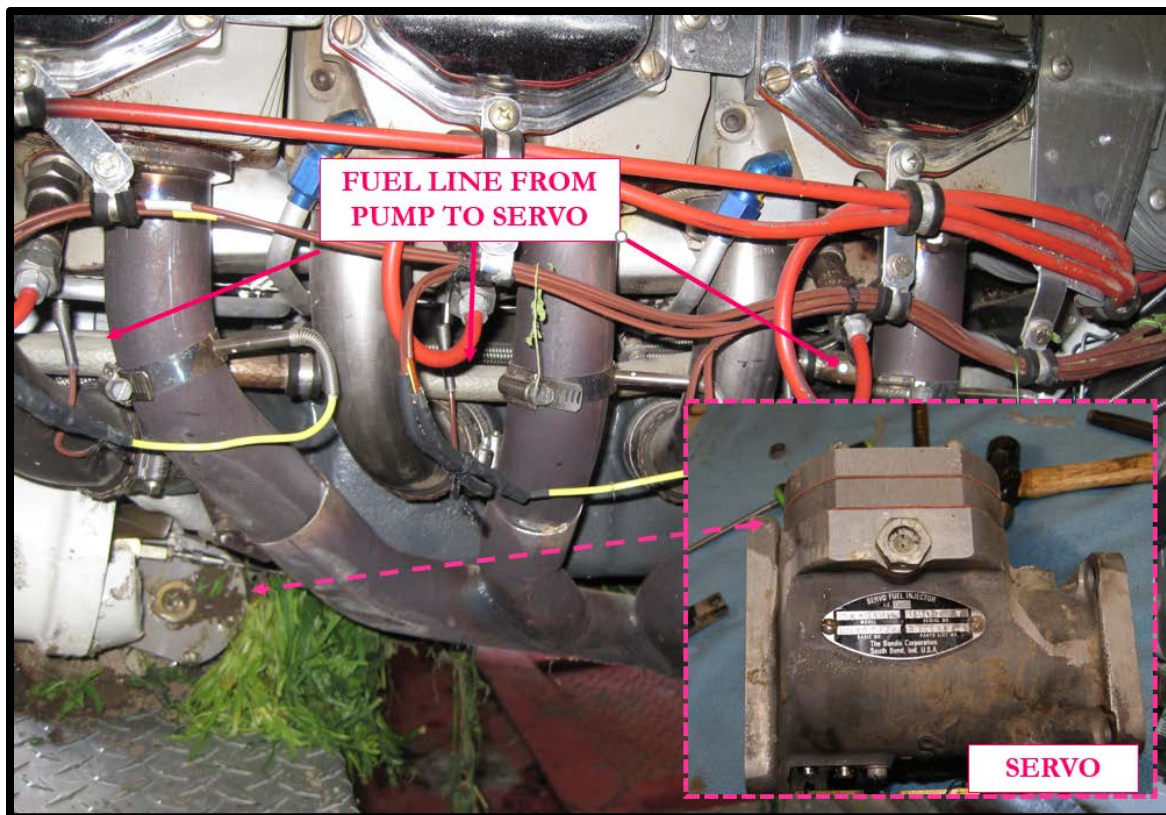
Picture 04: Fuel Servo (on engine)

The fuel servo was a Bendix RSA-5AD1, (part number 2524213-1, serial number 6507-T), manufactured in 1977. The major components of the servo include the airflow section, the flow metering section, and the fuel regulator section. Together, these sections are designed to meter fuel in direct ratio to the volume of air being consumed by the engine.

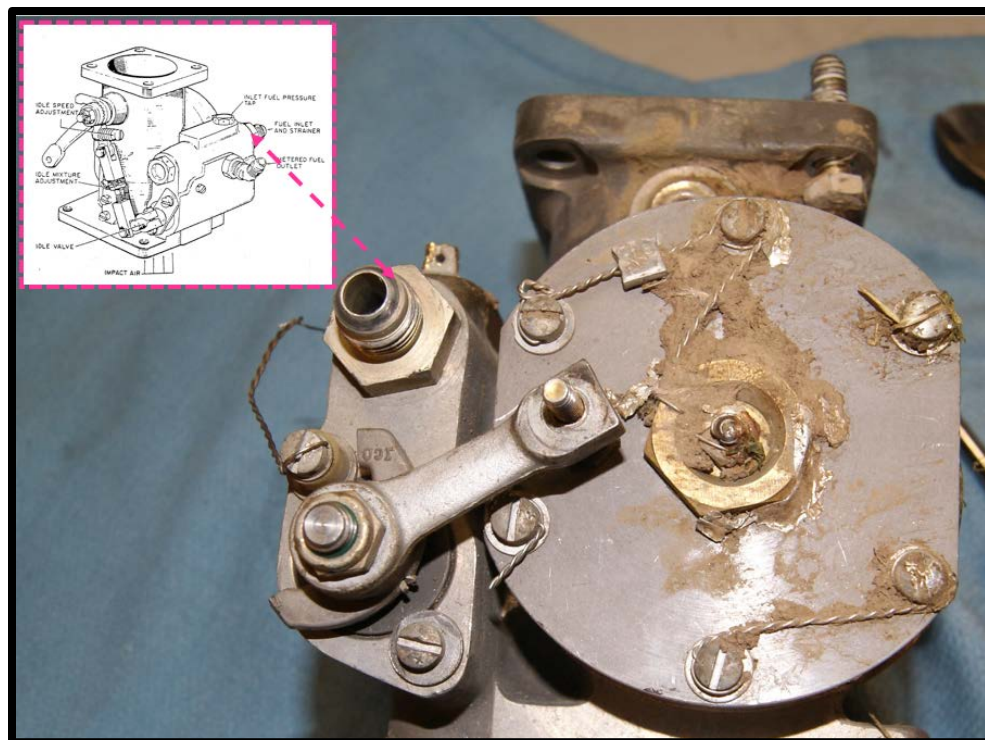
Picture 06: Fuel Servo (upper casing of regulator)

Fuel servo was completely disassembled. The safety wire on the regulator housing had a crimp with a stamp that read "AKB."

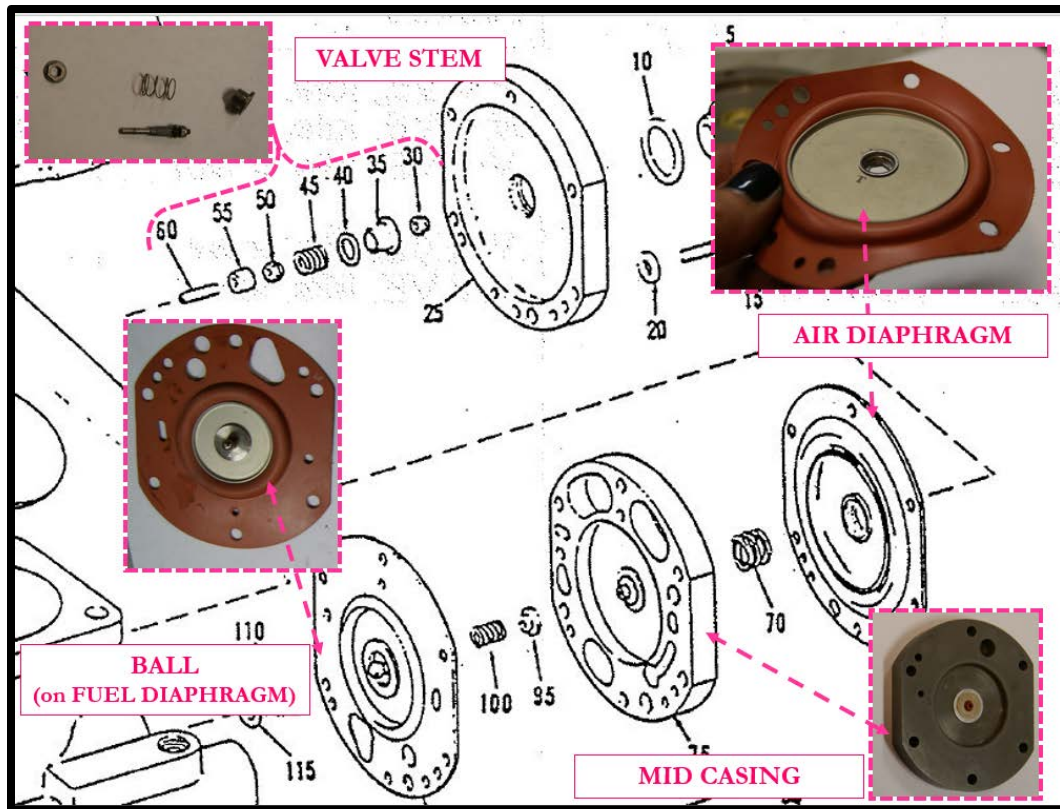
Picture 07: Regulator Section of Servo

Upon disassembly of the regulator, investigators noted that the valve stem was separated from the regulator valve (ball). The accident servo was reassembled and investigators affixed the exemplar servo's regulator section. A fuel source was connected and the servo flowed fuel normally. The accident regulator section was installed on the exemplar servo and tested; the fuel would not flow.

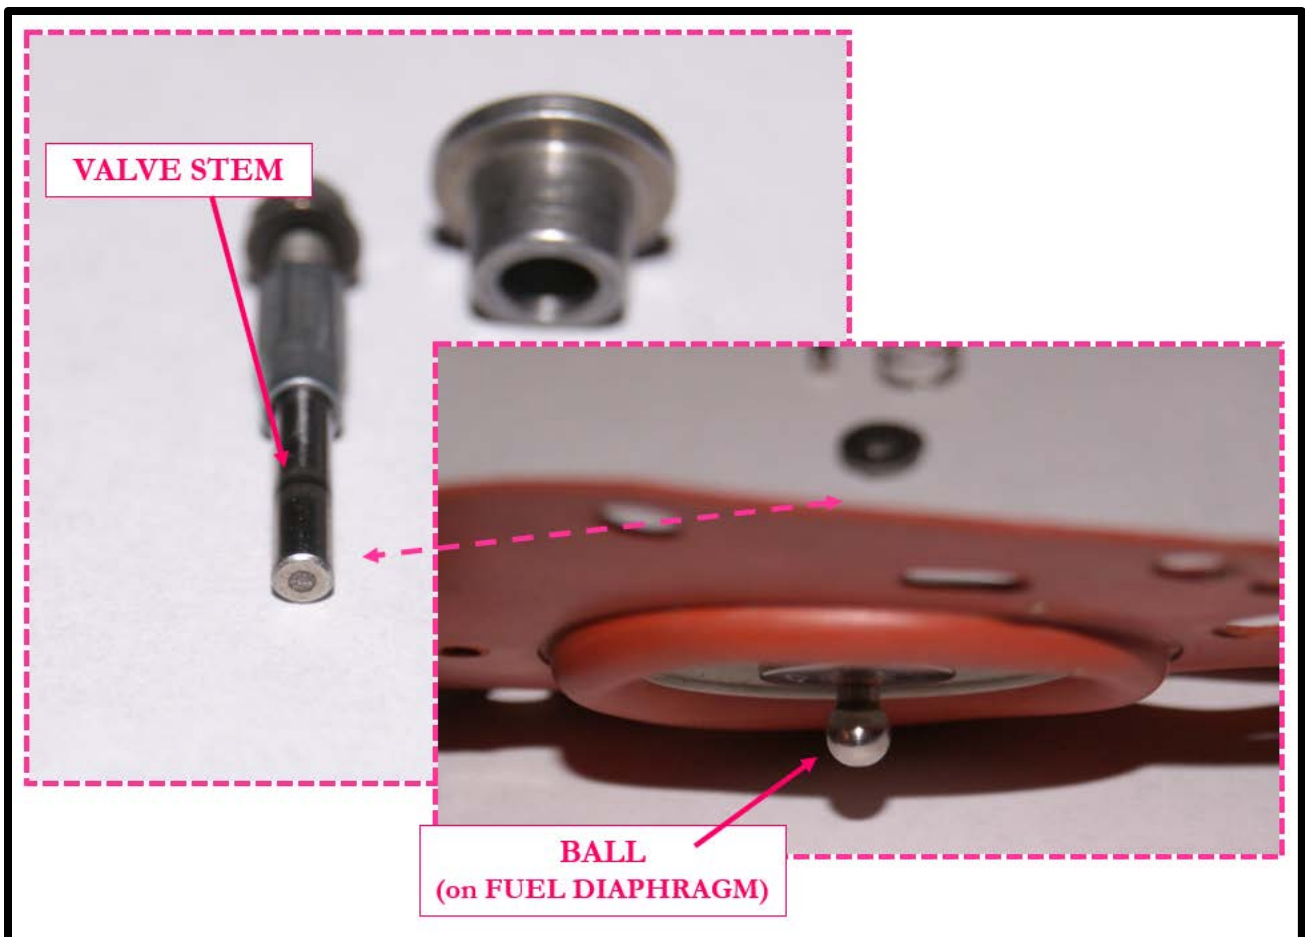
Picture 10: Valve Stem and Ball

Several pictures of the accident servo were provided to a representative from Precision Airmotive. He stated that the internal parts appeared to be original to the servo. He stated that all of the parts inside the regulator side are required replacement items at the time of overhaul. At the time of the servo's manufacture, the overhaul requirements were the same as the TBO (time between overhaul) specified by the engine manufacture. In the 1991, Precision issued a calendar requirement, where the servo must be overhauled every 12 years. After overhaul, the servo should have a yellow data plate attached; the accident servo still had the original black data plate.
