# Continental Motors

## ENGINE RUN REPORT **LEFT**

| AIRCRAFT MAKE & MODEL | Beechcraft E-55 Baron |

| GENERAL INFORMATION | | | |
|---|---|---|---|
| DATE | 7-11-2017 | NTSB ACCIDENT # | WPR17LA059 |

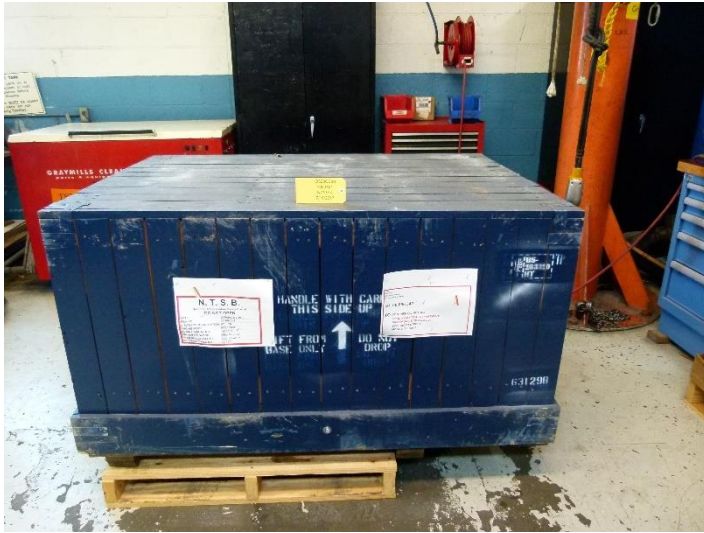
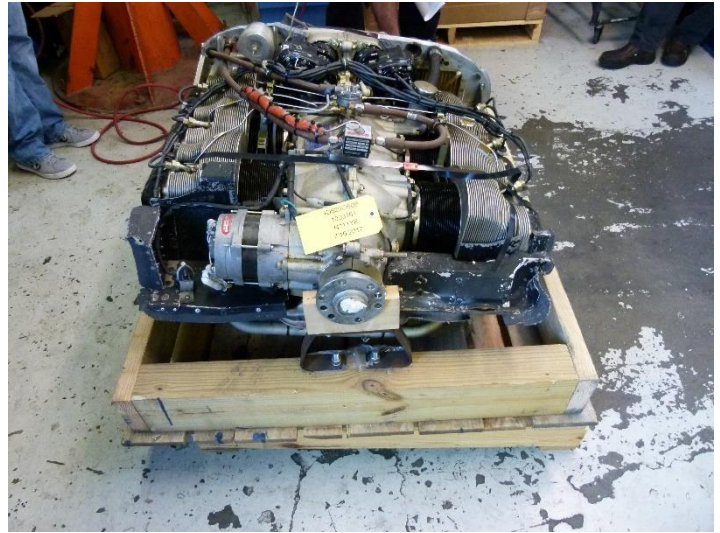
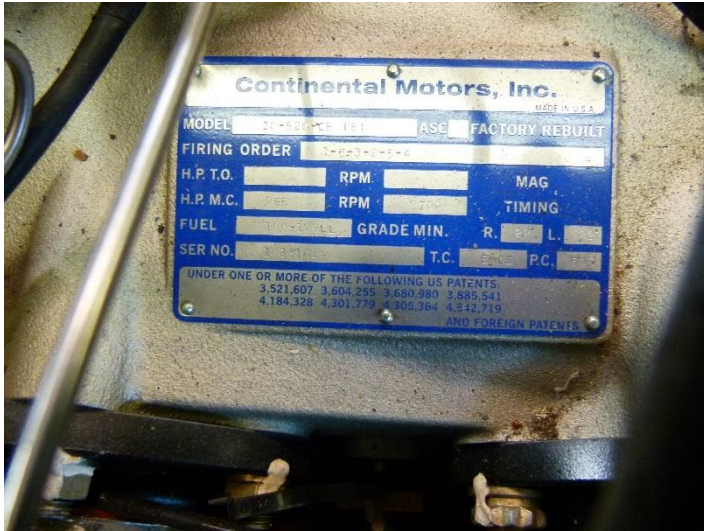
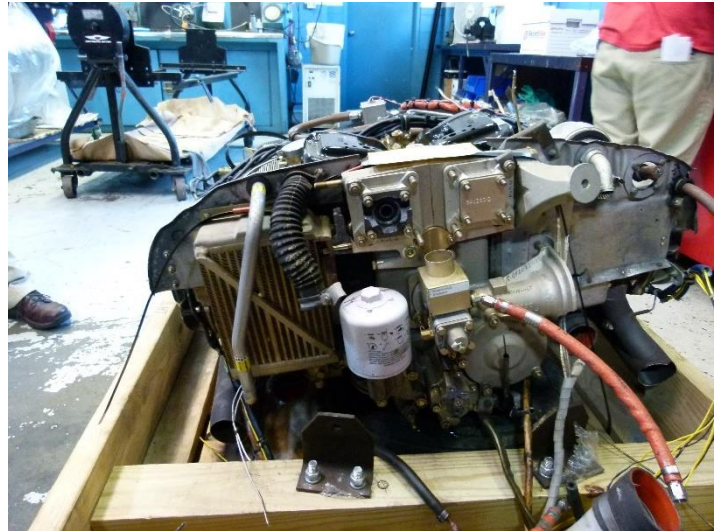
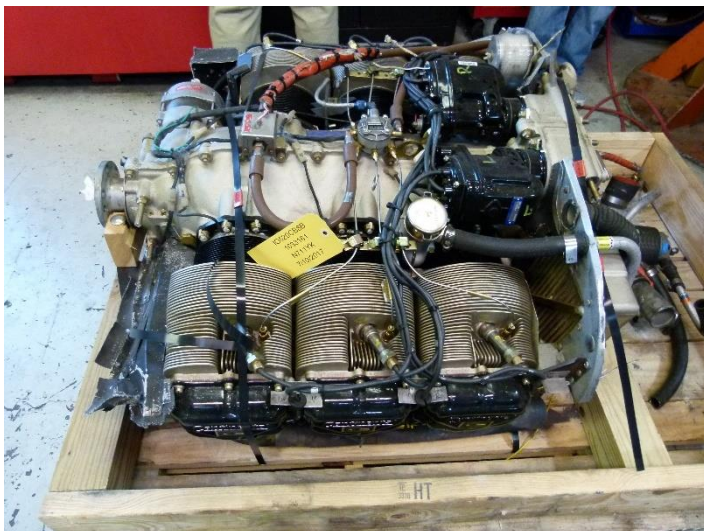
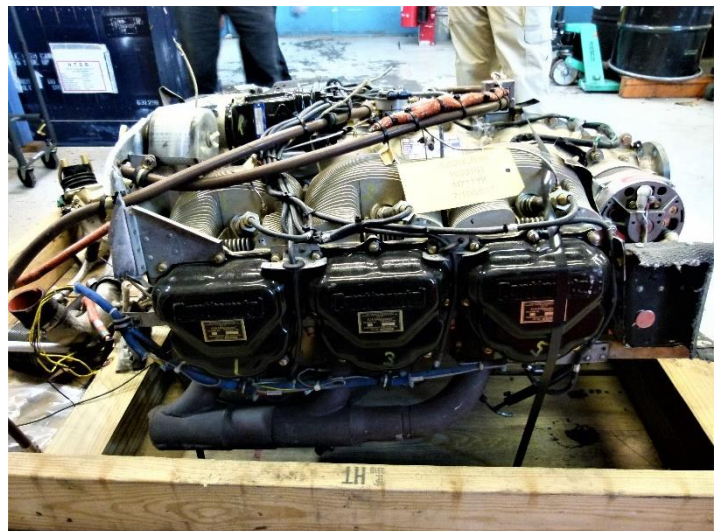
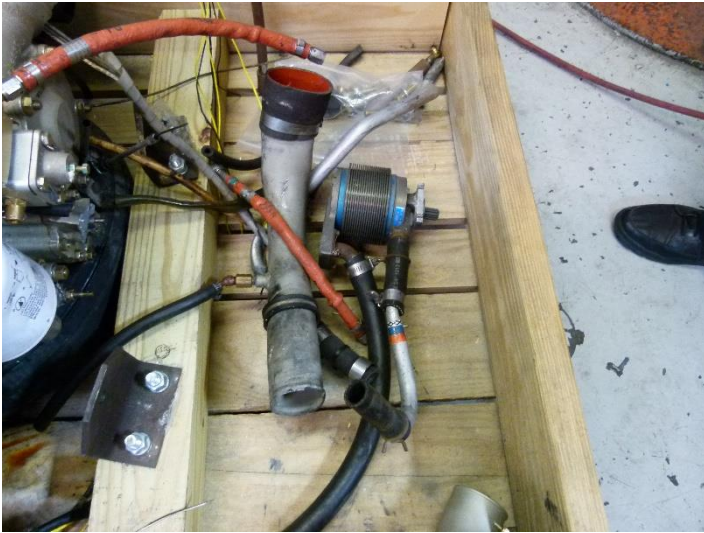
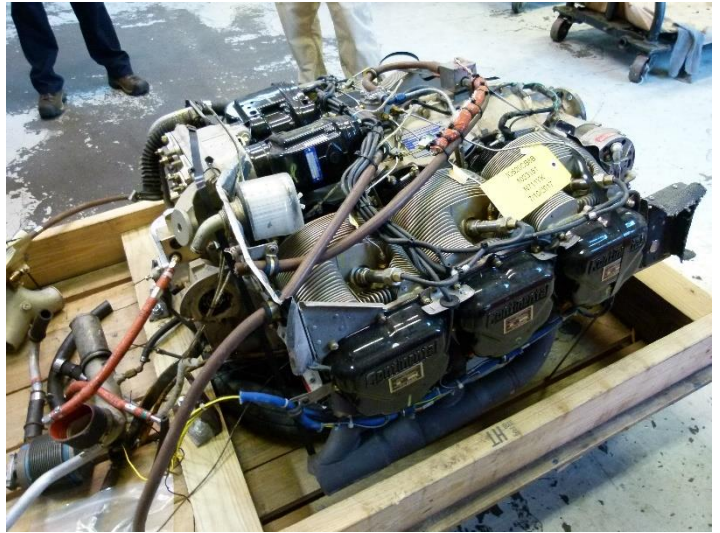
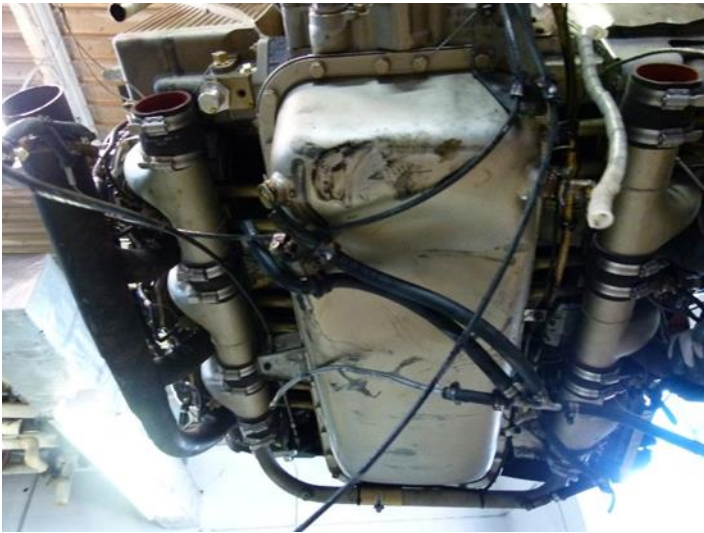
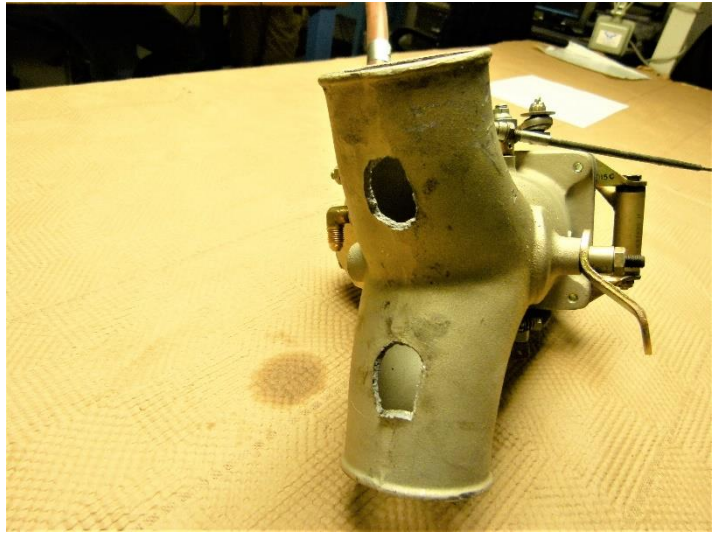
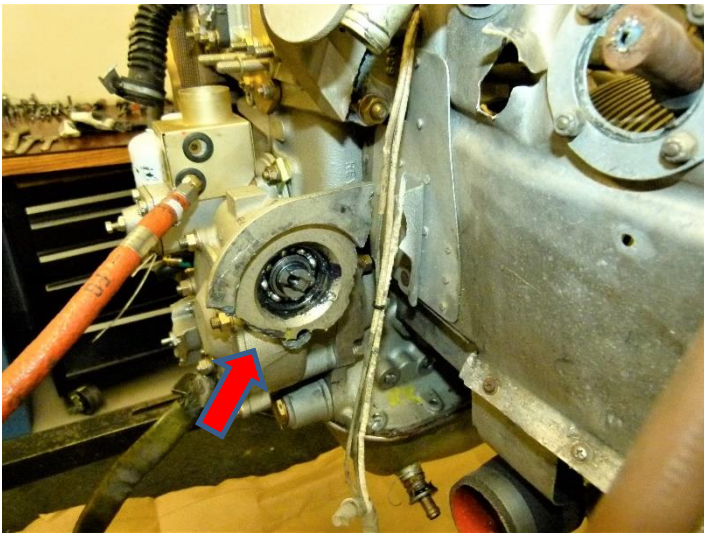
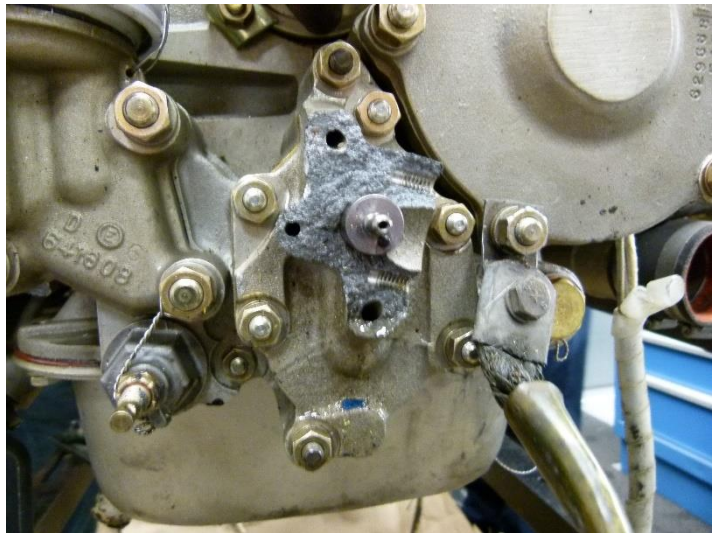
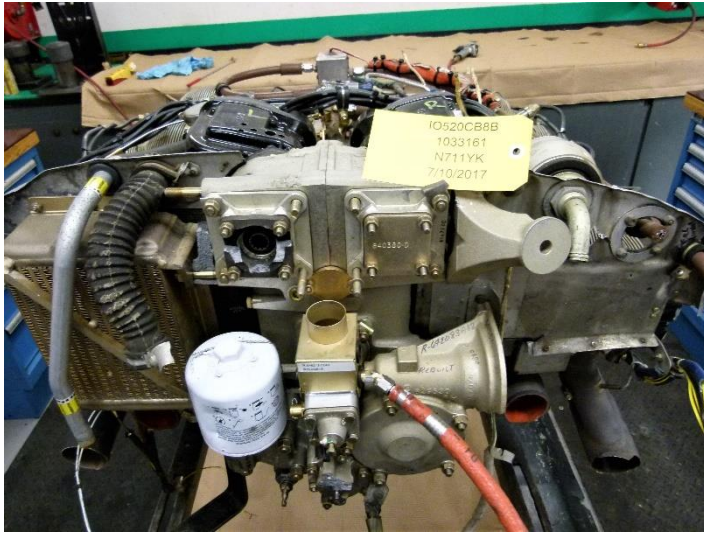
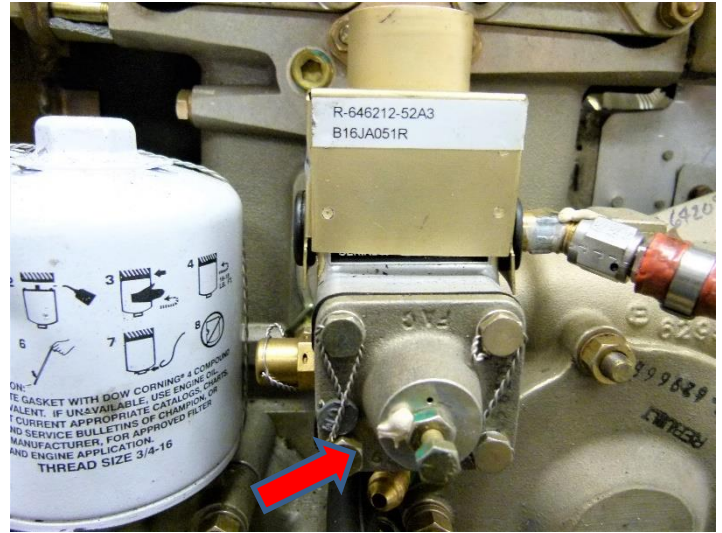
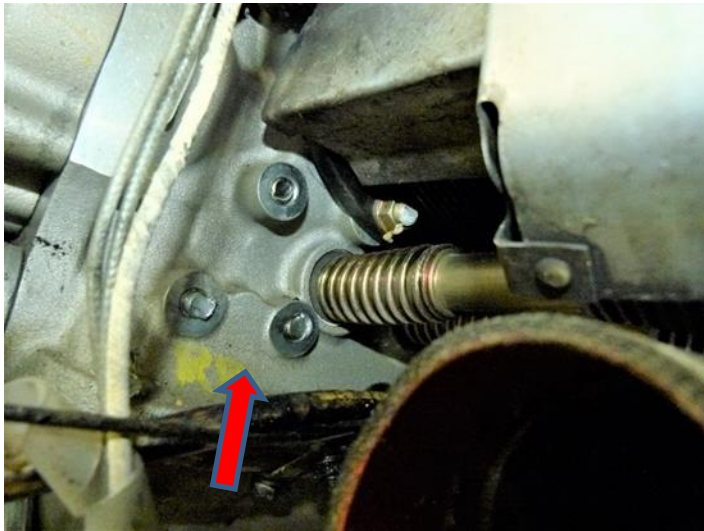
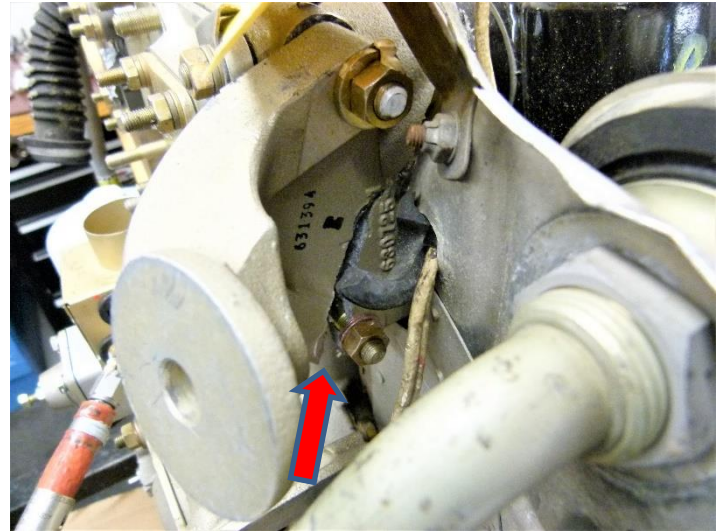
The engine was received in a shipping container furnished by CMI for this purpose. The shipping crate was opened and exhibited an accident engine with a data plate which identified the engine as serial number 1033161. The engine exhibited impact damage to cylinder 6 forward cooling fins, and the right rear and left upper engine mounts were impact damaged. The starter motor was missing and not shipped with the engine. The starter adapter was damaged at the starter motor mount. The right rear intake manifold tube separated and was not shipped with the engine. The impact damaged left rear intake manifold tubes separated and were loose in the shipping container along with the damaged throttle body/metering valve, instrument air pump and various hoses and plumbing pipes. The engine oil sump received impact damage but remained intact. The engine driven fuel pump received impact damage to hose fittings but the unmetered fuel pressure screw was intact and exhibited factory torque putty. The oil pump rear cover was impact damaged.

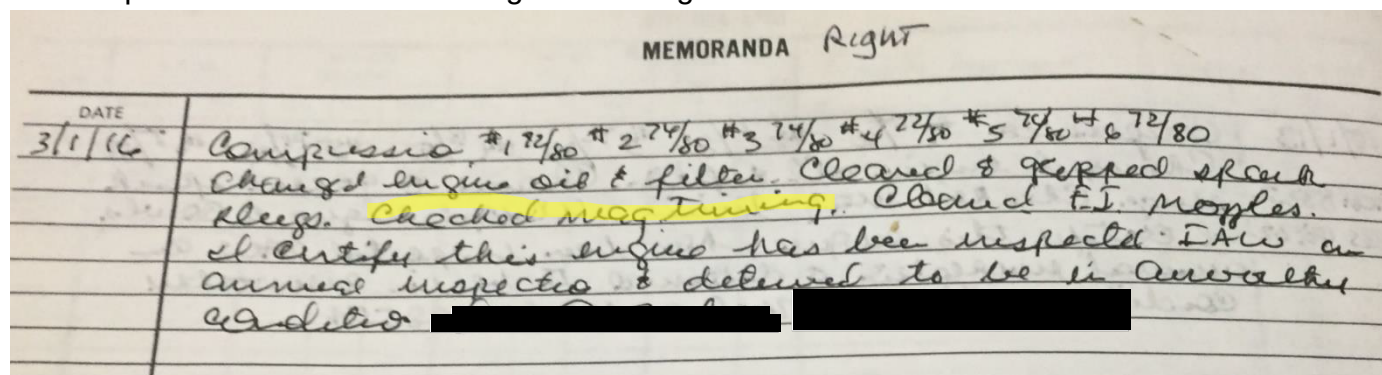
**Significant logbook information:** NOTE: The logbook entry below is from the last annual/100-hour inspection and indicated that ignition timing was checked.

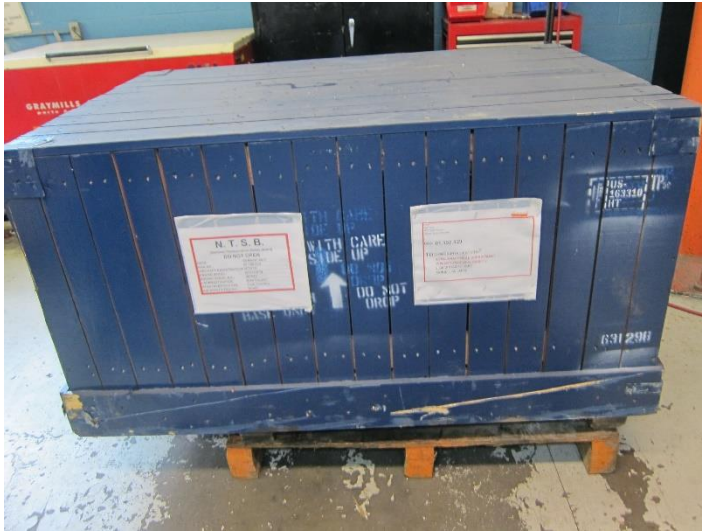
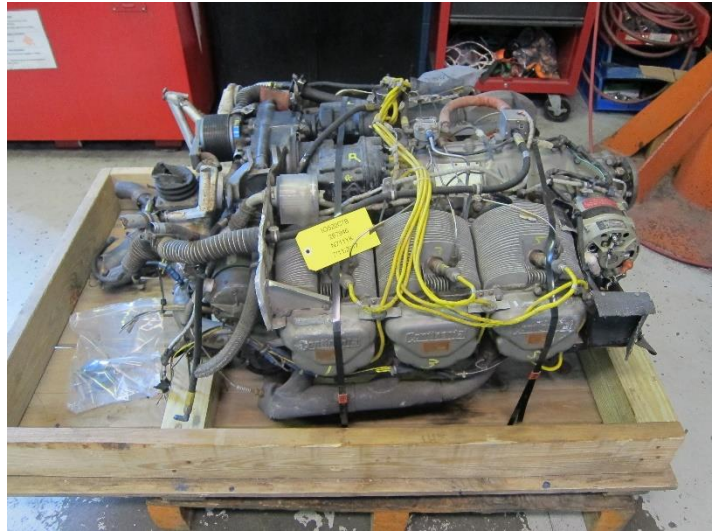
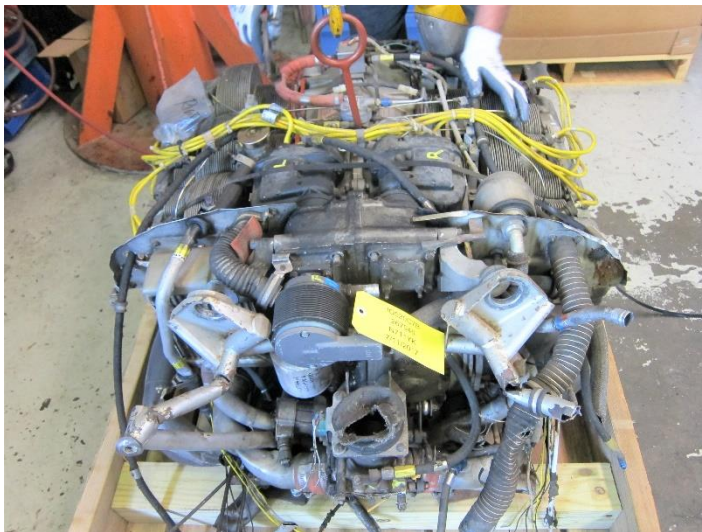
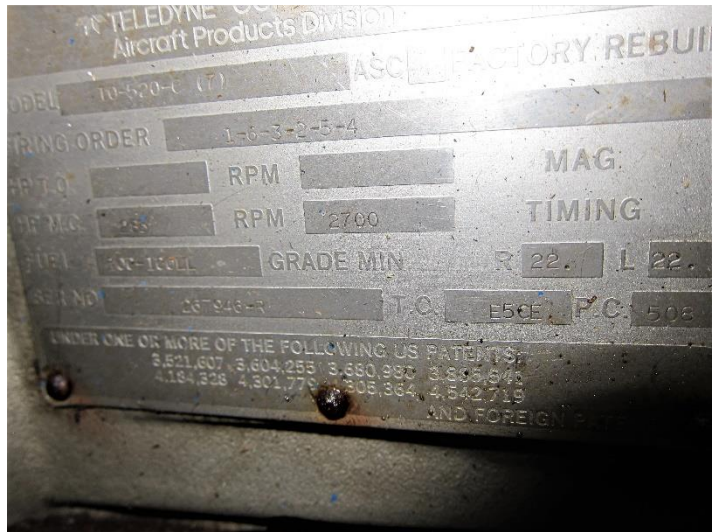
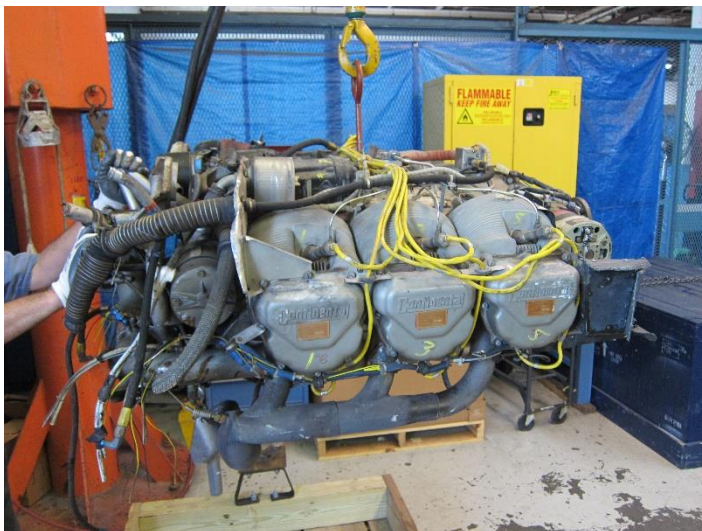
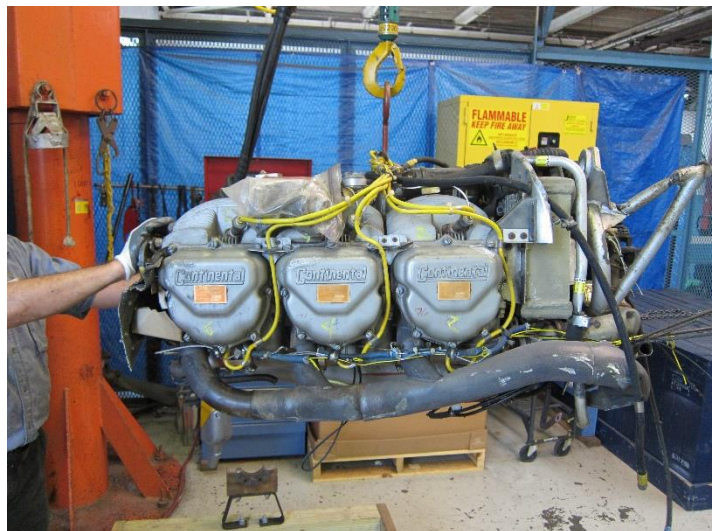
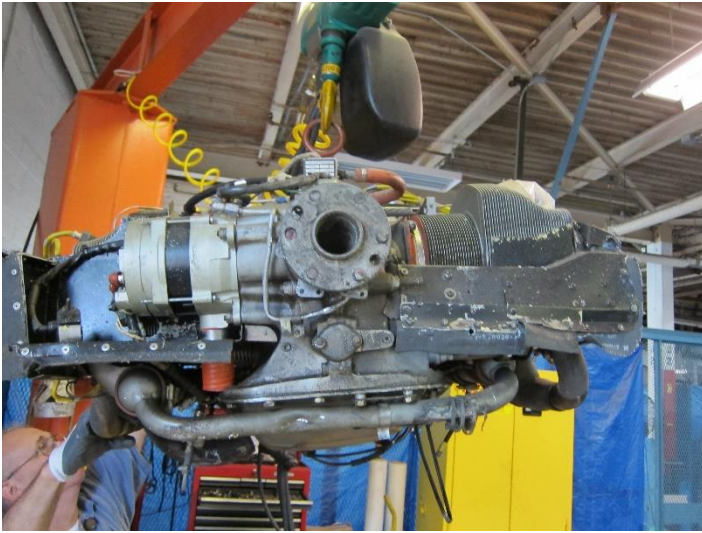
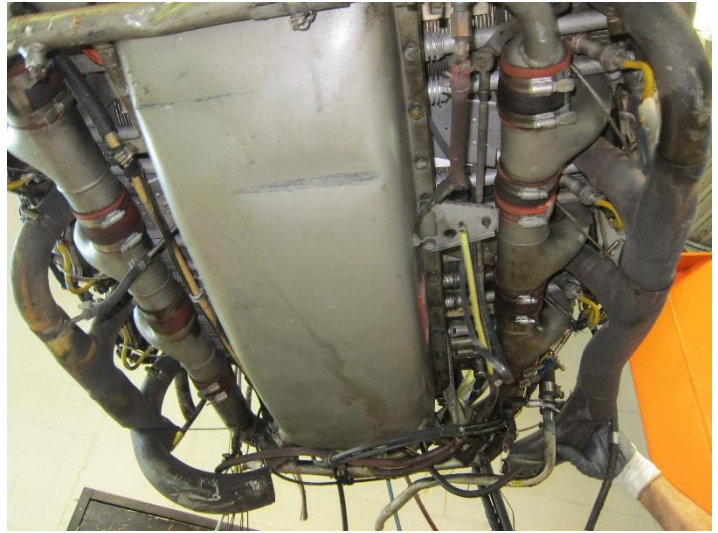
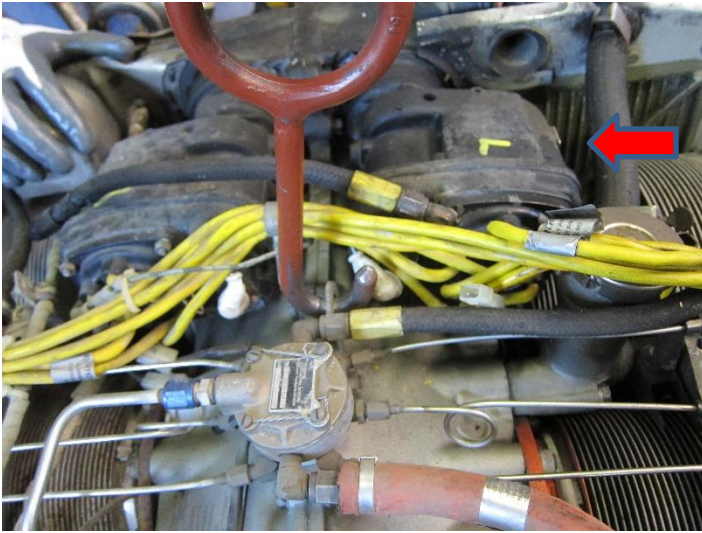
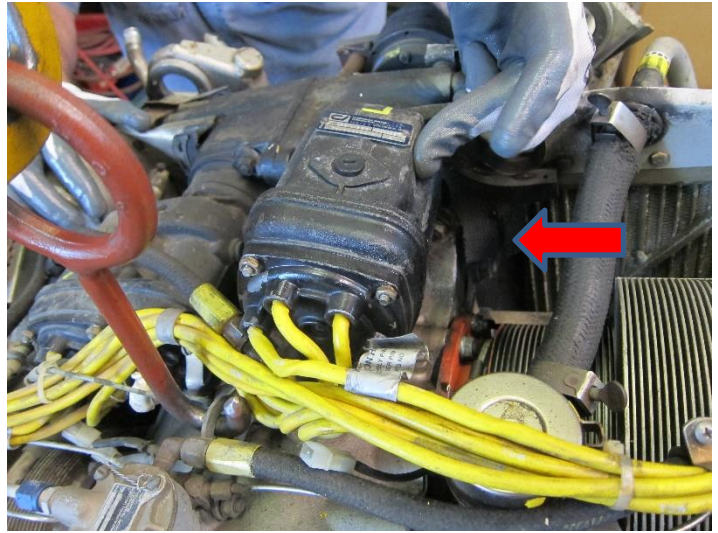
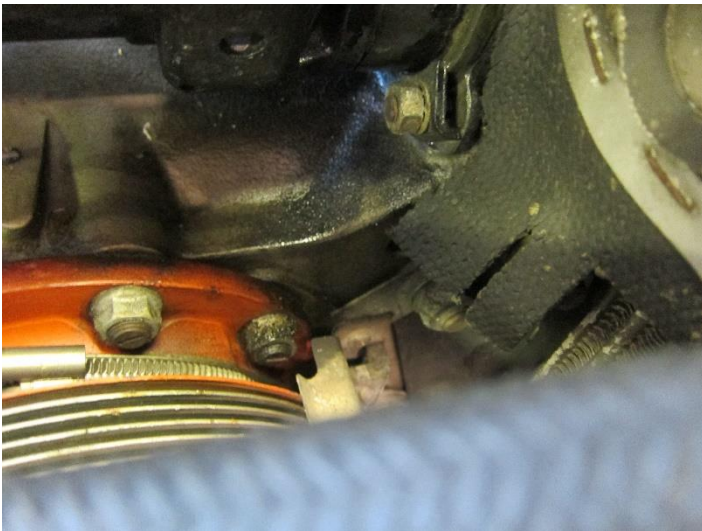
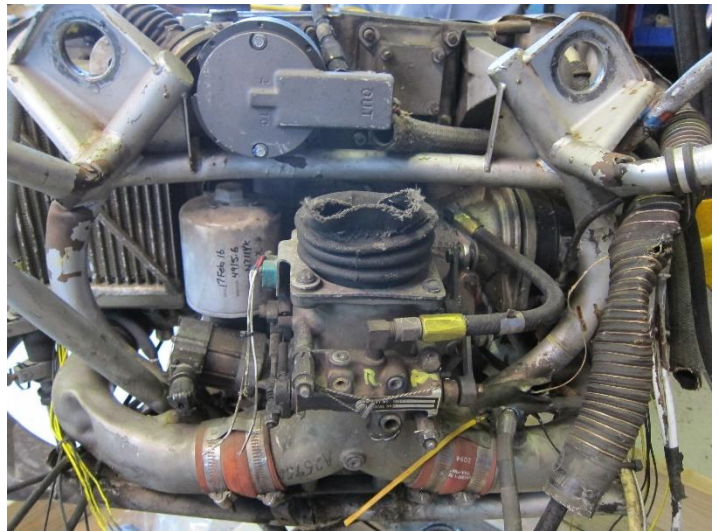
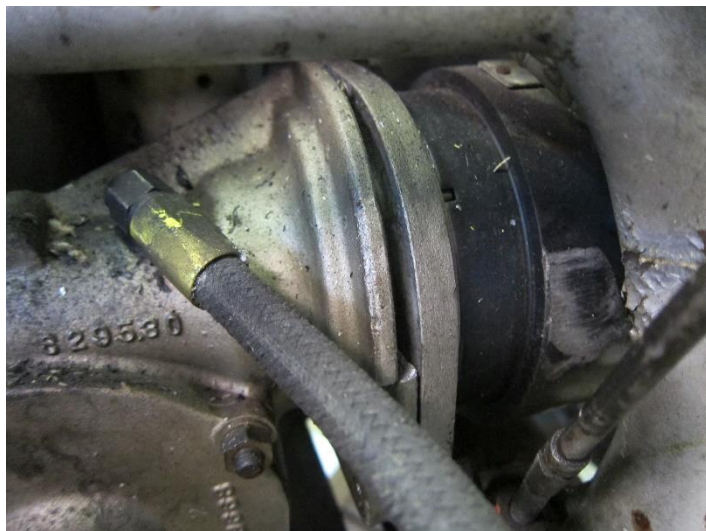
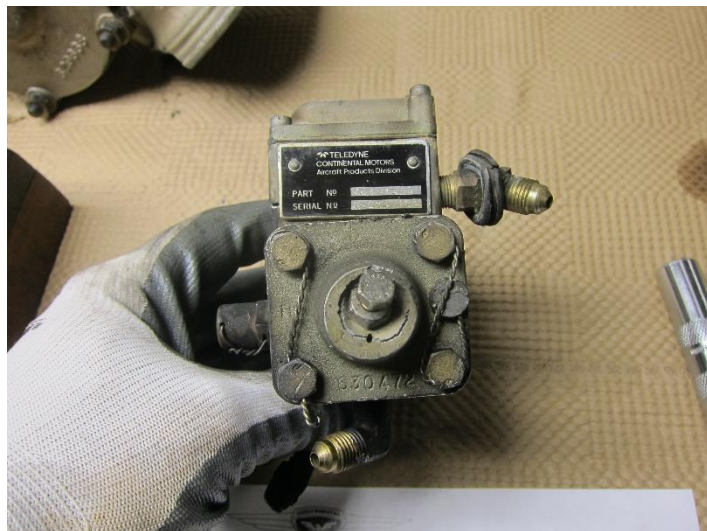
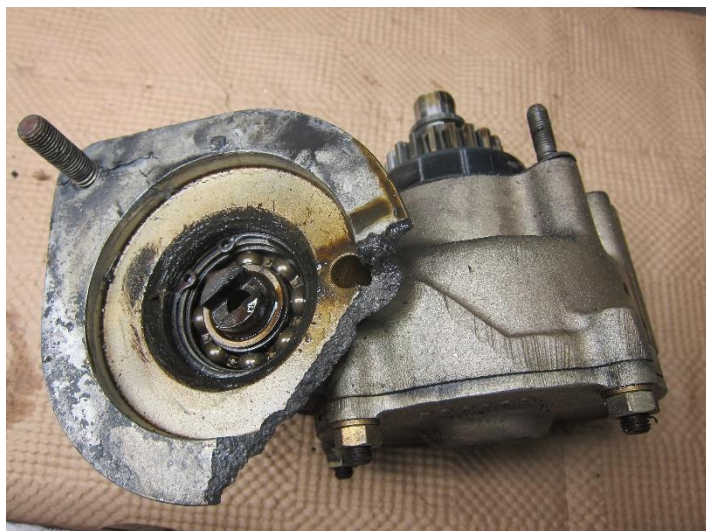
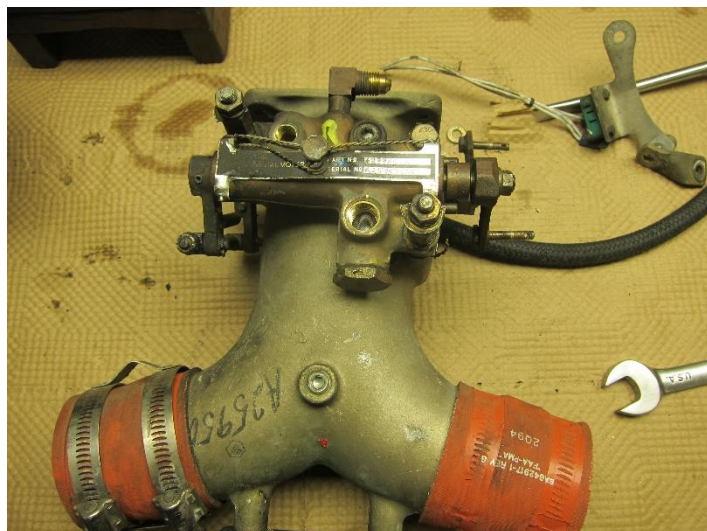
The engine was received in a shipping container furnished by CMI for this purpose. The shipping crate was opened and exhibited an accident engine with a data plate which identified the engine as serial number 267946. The damaged right and left exhaust collectors remained attached but the recovery team had cut and removed the aft sections to allow the engine to be mounted in the shipping crate. The induction forward balance tube exhibited impact damage and the top left and right engine mounts were broken. The lower right engine mount was damaged.

The starter adapter was damaged at the starter motor mount. The right and left rear intake manifold tubes were impact damaged and separated from the engine. Both damaged rear manifold tubes and the throttle body/metering unit were shipped loose in the engine container. The throttle body housing was impact damaged. The metering unit fuel fittings were damaged. The engine driven fuel pump received impact damage to hose fittings and to the unmetered fuel pressure adjustment screw.

The propeller mounting bolts had sheared and remained in the crankshaft propeller flange.

The left magneto was loose at its mount and free to rotate. Caked residual oil beneath the left magneto indicated an oil leak at that location.
