## **NATIONAL TRANSPORTATION SAFETY BOARD**

### **AUXILIARY FUEL PUMP EXAMINATION FIELD NOTES**

**Location:** Bakersfield, CA  
**Date:** January 31, 2017  
**Time:** 1640 PST  
**Aircraft:** N711YK, Beech E-55

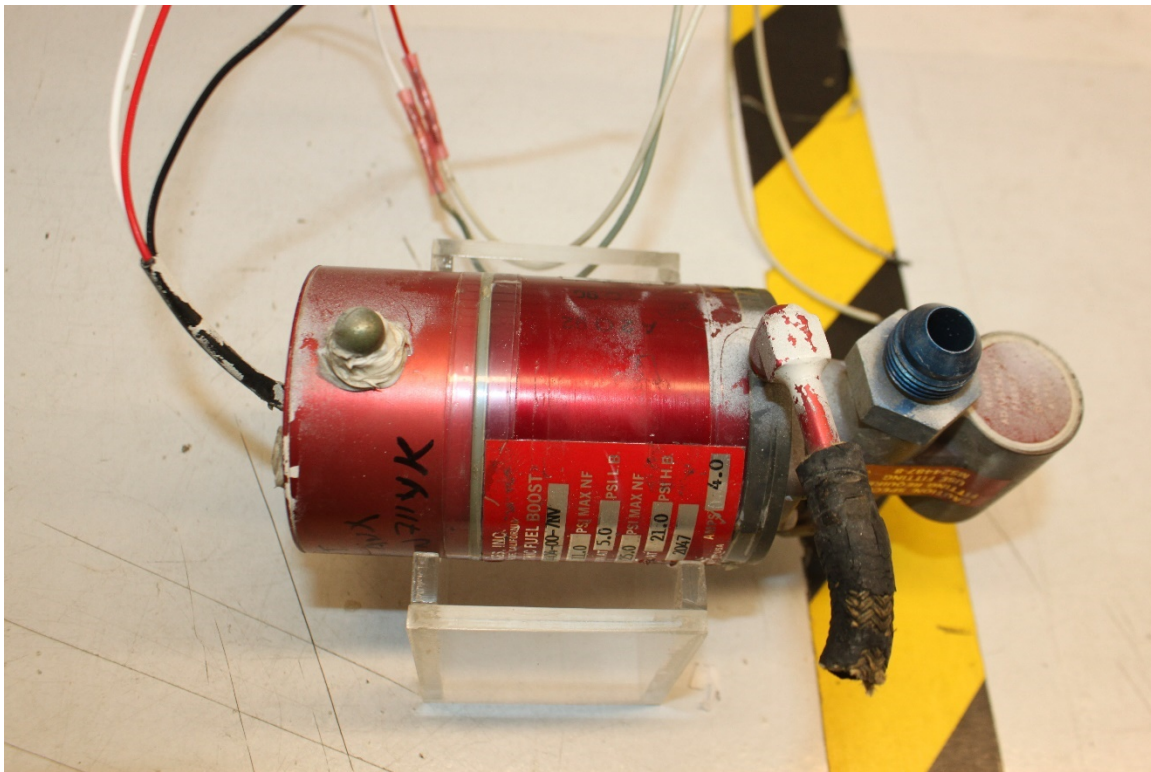
Visual inspection of the exterior of the pump revealed silicone or RTV type material adhering to the screws that secured the cover and rheostat adjustment screw cap nut (Figure 1) appeared to be the same. Evidence of long-term leakage was noted at the outlet fitting (Figure 2). The electrical wire splices at the juncture of the pump and airframe electrical wires were tight.

Figure 1: View Depicting the rheostat adjustment screw cap nut and sealant adhering to cap nut and cover.

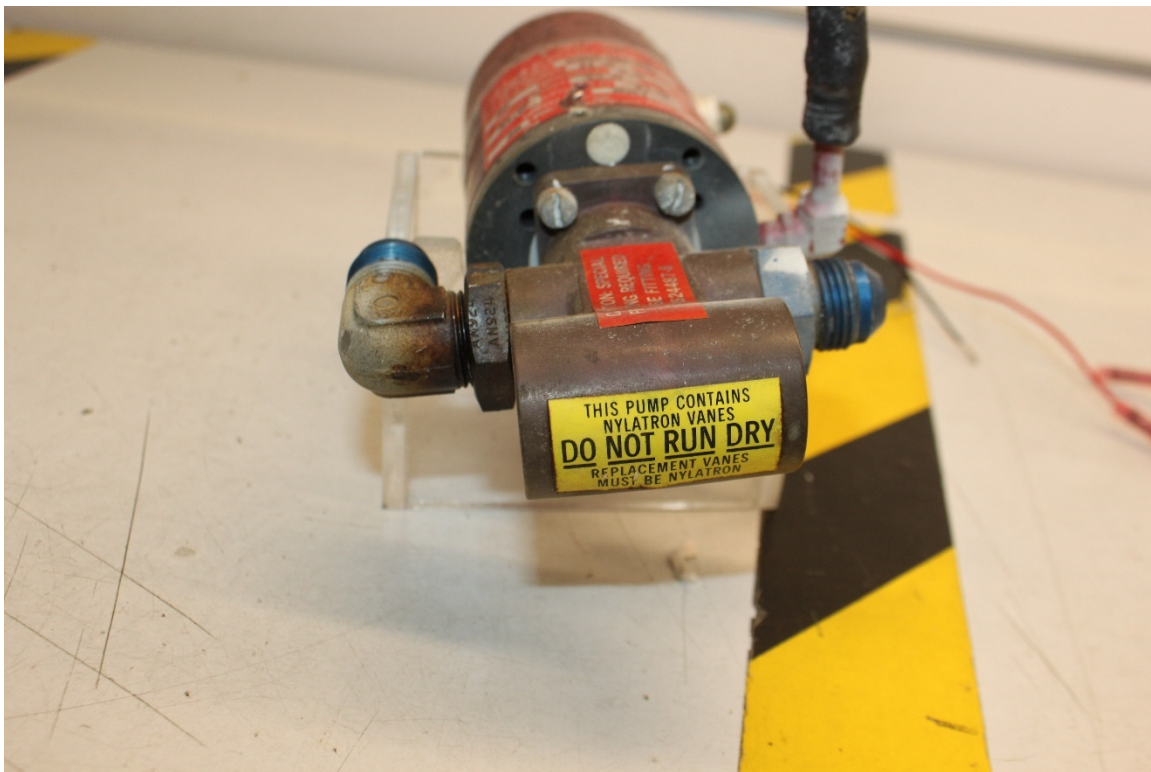
<sup>3</sup> The owner of the repair station indicated that no leakage is allowed. The leakage at the outlet could cause air to be drawn into the system when the auxiliary fuel pump is off.

Figure 2: View Depicting the Staining at the Outlet Port Fitting on Left.

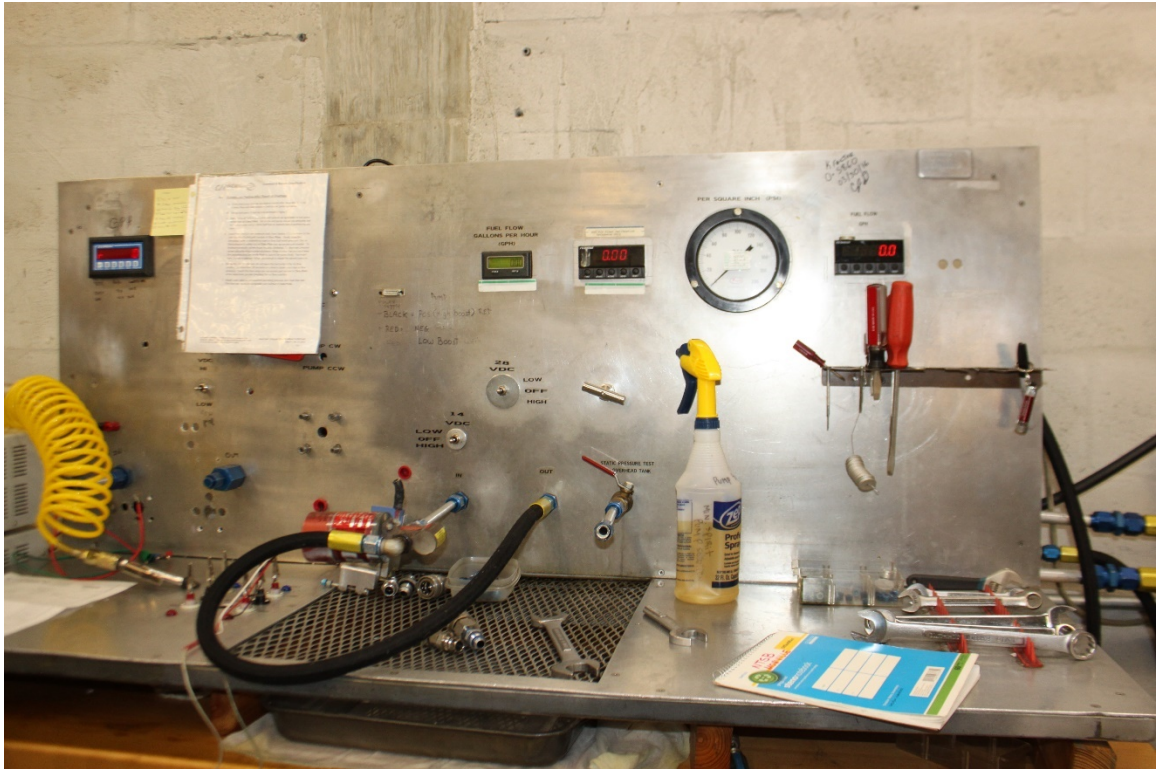
The fuel pump was placed on the test bench as received (Figure 3) and was operationally tested to limits specified on the pump’s data plate<sup>1</sup>. The pump self-primed which took longer than usual. Following self priming, as was the repair stations standard procedure, with the pump selected to high boost and the outlet valve wide open, the pump flowed 81.7 gallons-per-hour (gph) at 6.3 psi.<sup>2</sup>

Figure 3: View of the Auxiliary Pump Installed on the Test Bench

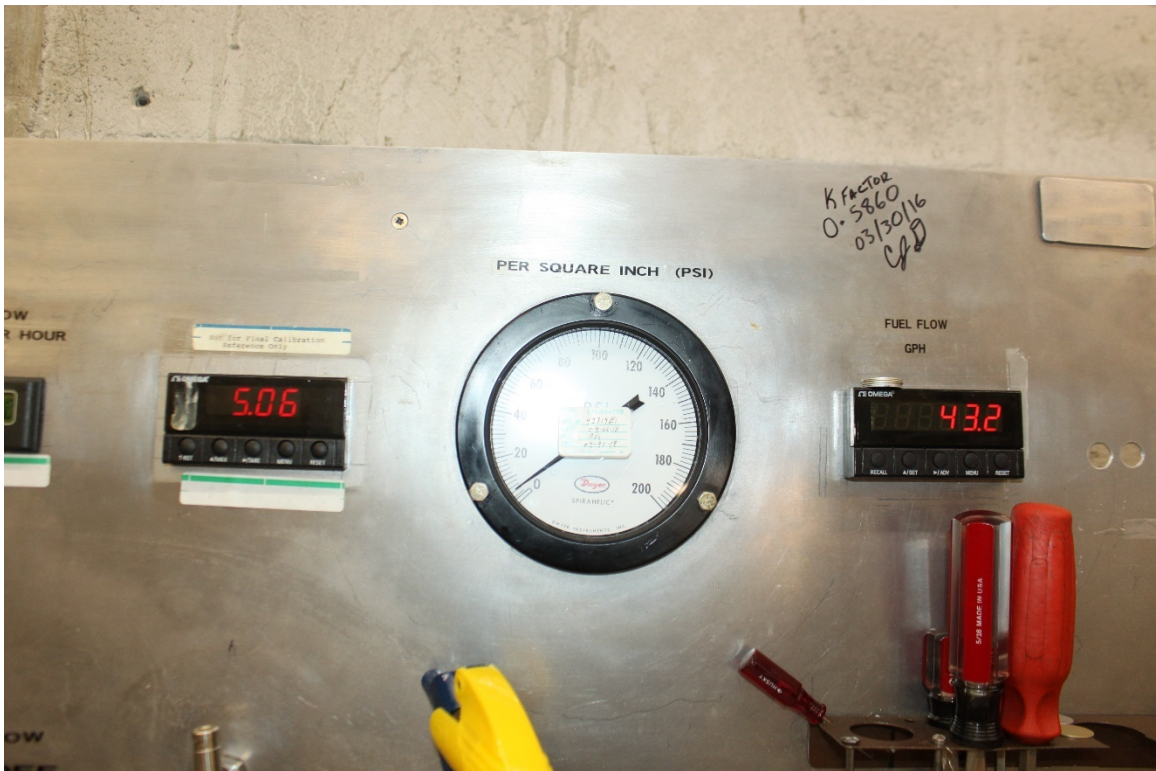
The low boost flow test was performed. Fluid was noted to be leaking from the outlet fitting. With the pressure set to 5.0 psi and the pump selected to low boost, the unit flowed 43.2 gph (minimum specification is 20 gph)<sup>5</sup> (Figure 4). NTSB photograph IMG\_6329 depicted the test bench readings.

<sup>5</sup> The owner of the repair station indicated that there is no maximum low boost fuel flow specified; however, in his opinion, the recorded value would cause the engine to quit due to excessive fuel delivered to the engine-driven fuel pump.

Figure 4: View Depicting the Test Bench Values during the Low Boost Flow Test.

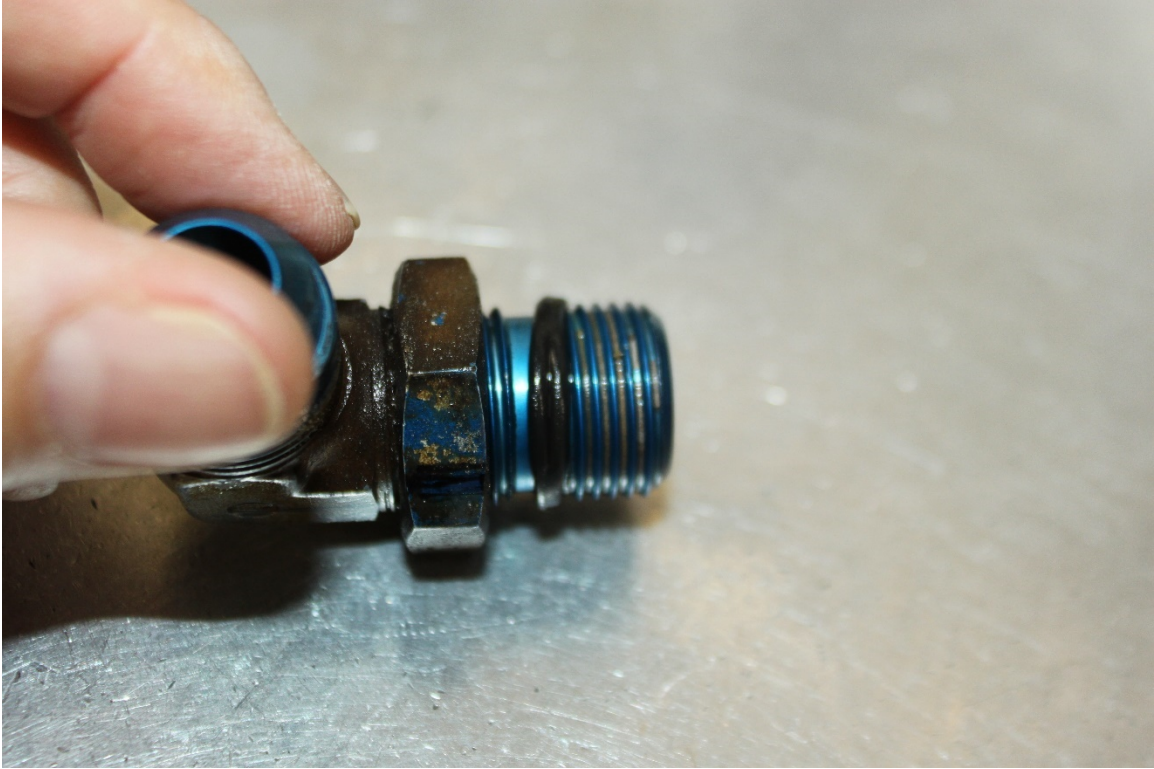
The pump was run an additional 10 minutes to determine if there was any effect on flow or operating characteristics. The outlet fitting was removed and the packing or o-ring was damaged (Figure 5). A new packing or o-ring was installed on the outlet fitting and the fitting was re-installed into the pump.

Figure 5: View of the Damaged Packing or O-Ring on the Outlet Fitting.

The pump was then subjected to the high boost flow test and no fluid was leaking from the outlet fitting with the new packing or o-ring installed. With the pump selected to high boost, and the outlet pressure set at 21 psi, the unit flowed 39 gph (minimum specification is 35.0 gph).<sup>7</sup>

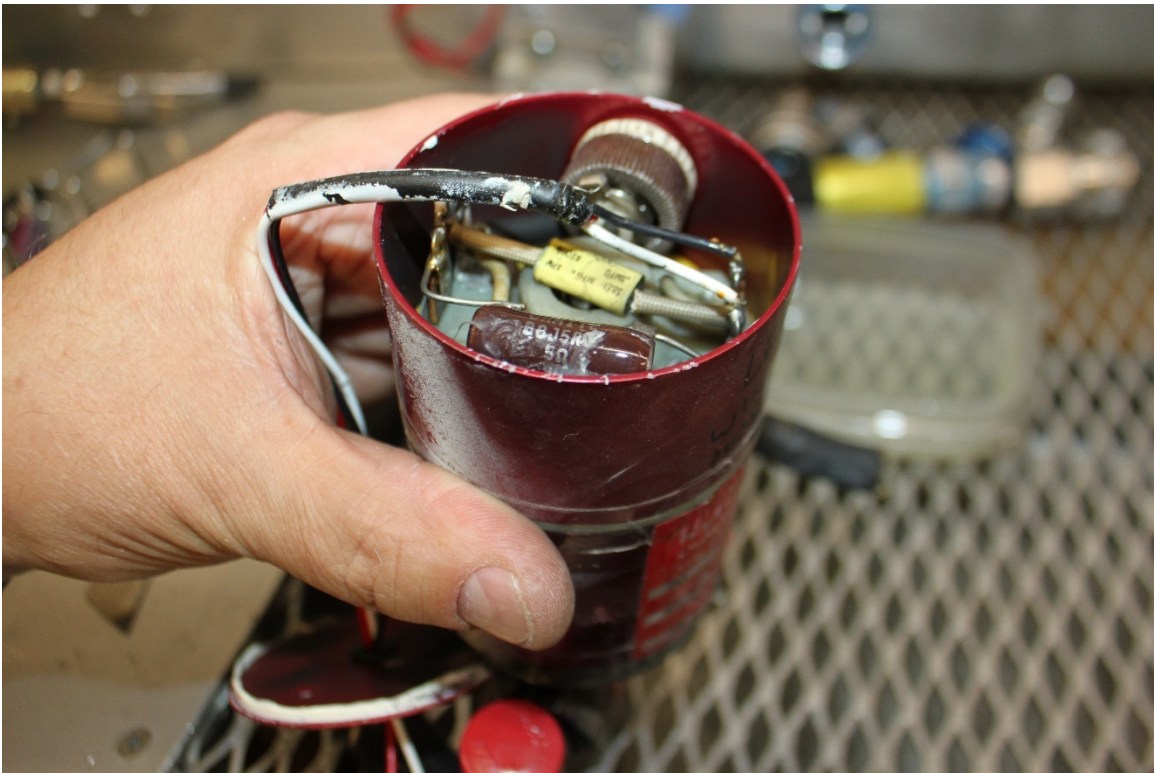
The pump's cover was removed in an effort to locate the resistor. It was a brown colored resistor marked with "Ohmite", " $5\Omega$ ", "B8J5R0", and "8W9046" (Figure 6). It was tested using a calibrated meter and the resistance value was  $5.1\Omega$ . The unit was loosely reassembled with the new packing or o-ring in place. The pump remained in custody of NTSB.

Figure 6: View of the Installed Resistor. Note the Markings.
