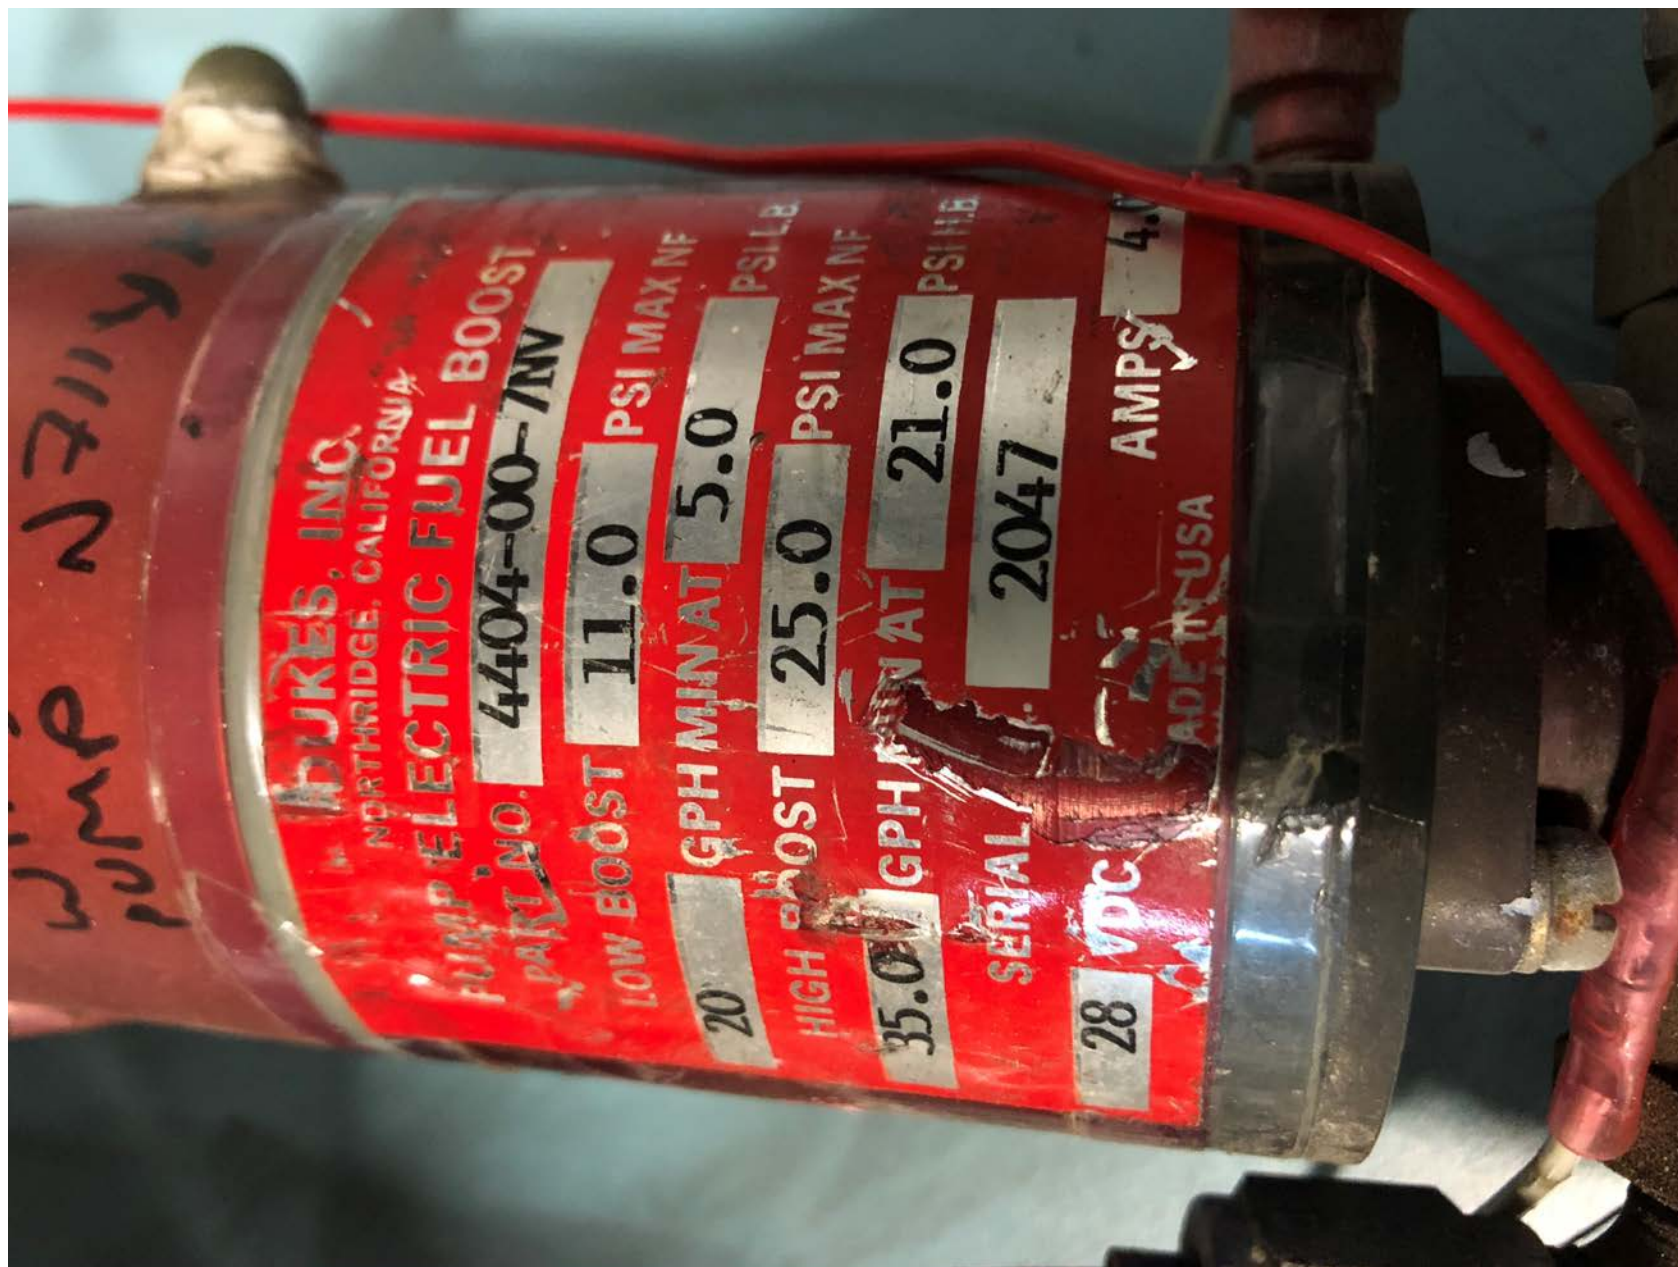
Photo 1 – Left wing fuel pump as removed.

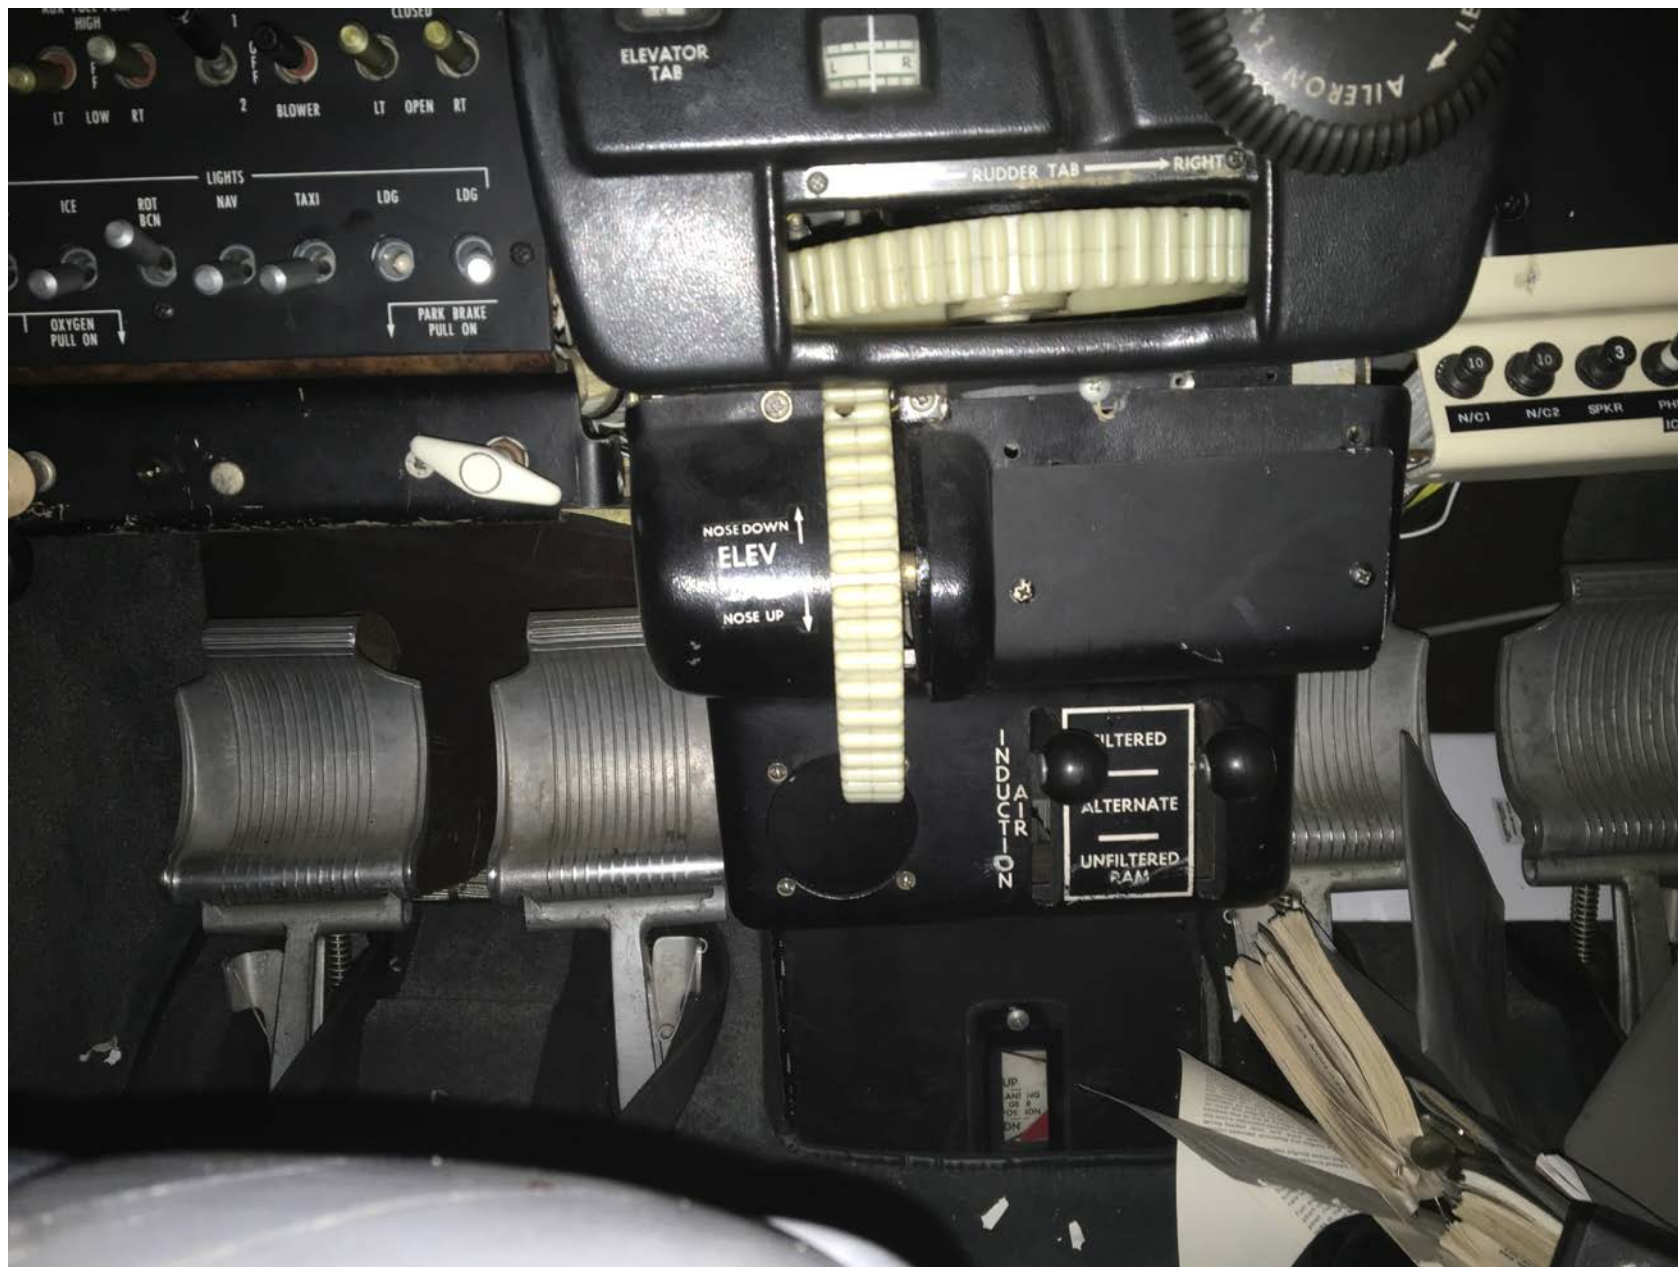
**Photo 2 – Instrument panel photo immediately after the accident. Courtesy of Bakersfield Airport Management**

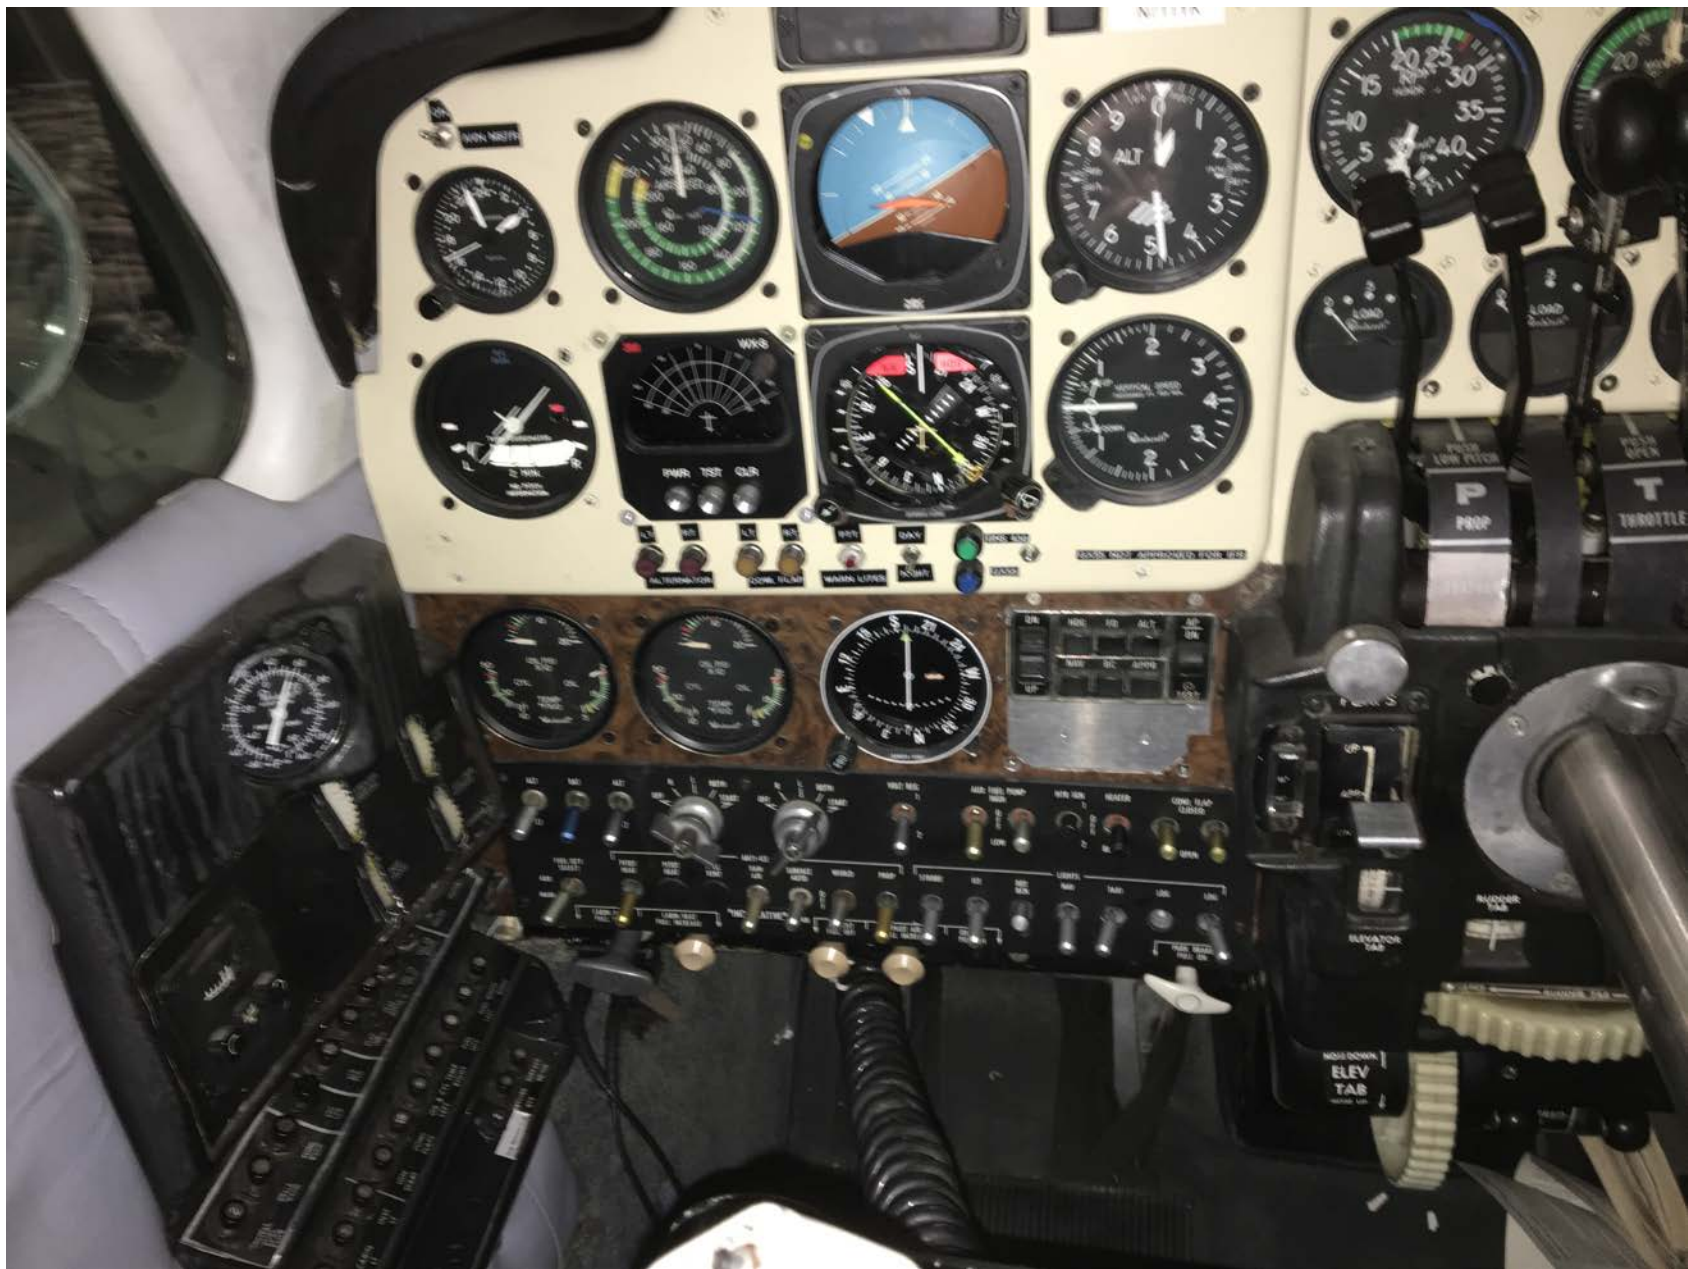
**Photo 3 - Instrument panel photo immediately after the accident. Courtesy of Bakersfield Airport Management**

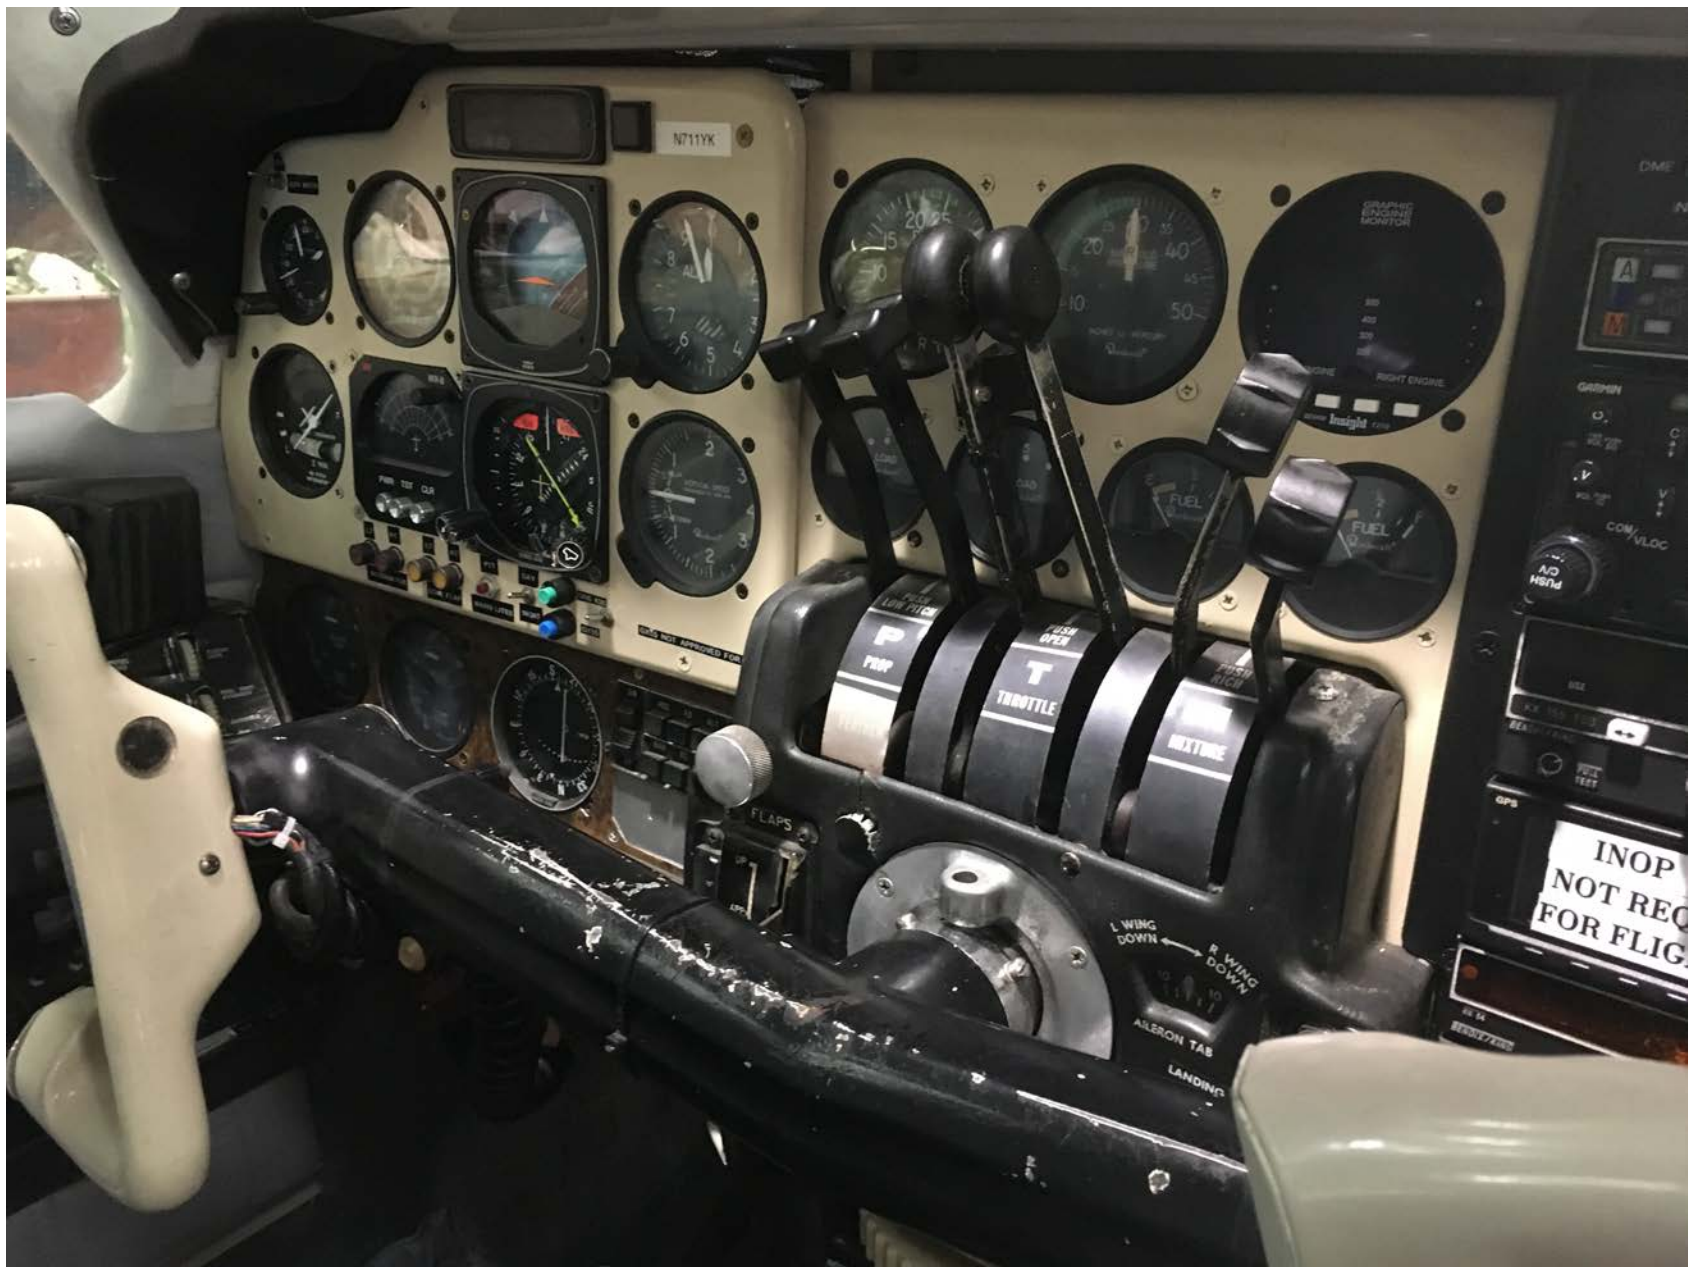
**Photo 4 – Instrument panel during wreckage exam.**

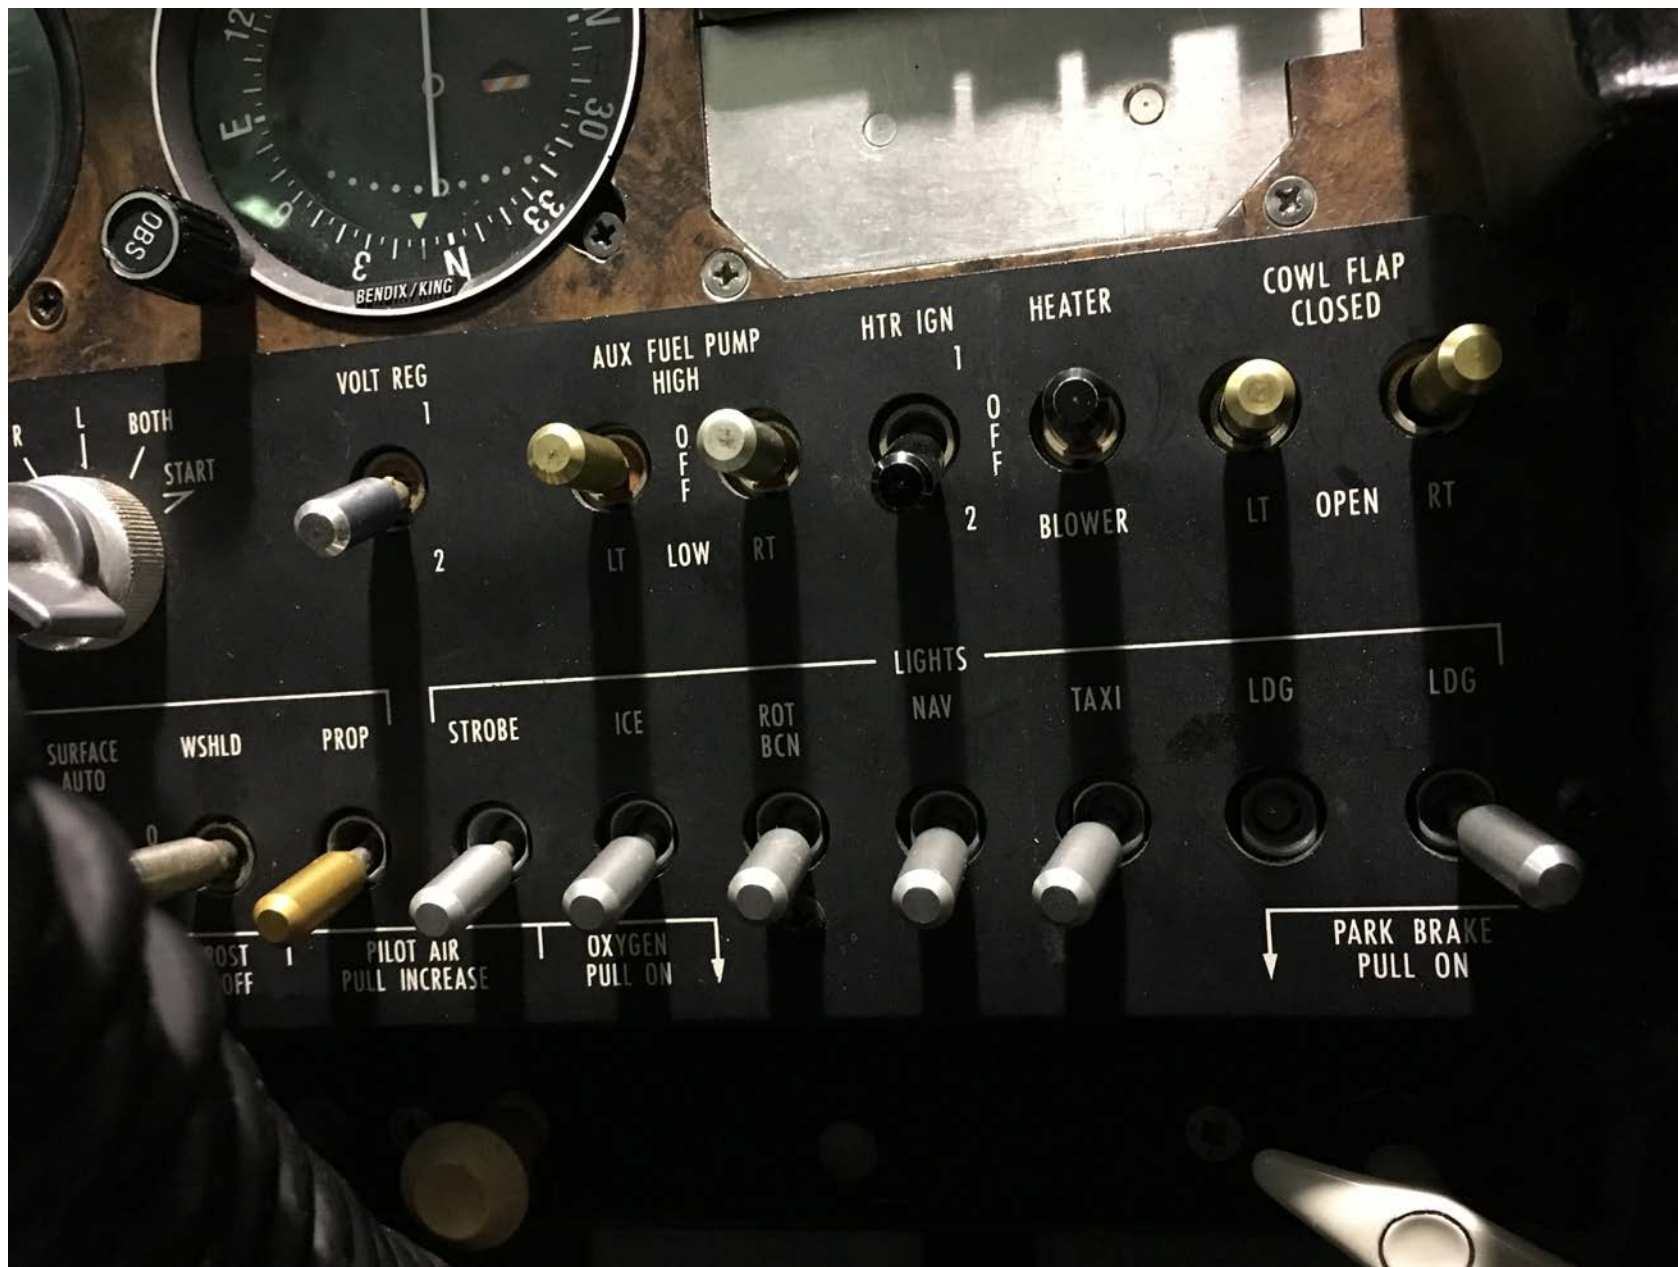
Photo 5 - Instrument panel during wreckage exam.
