**Photos of N321BJ Belly Damage**  
Following a gear up landing.

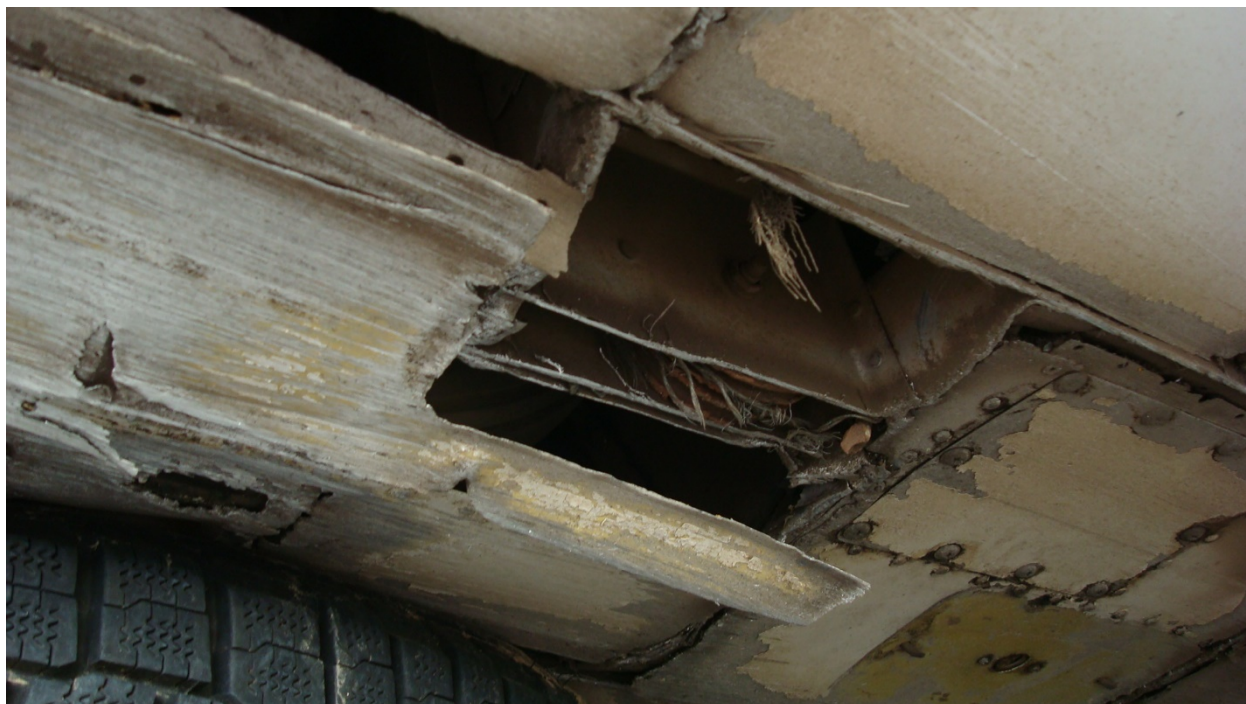
*Figure 1: Overall Damage to Belly*

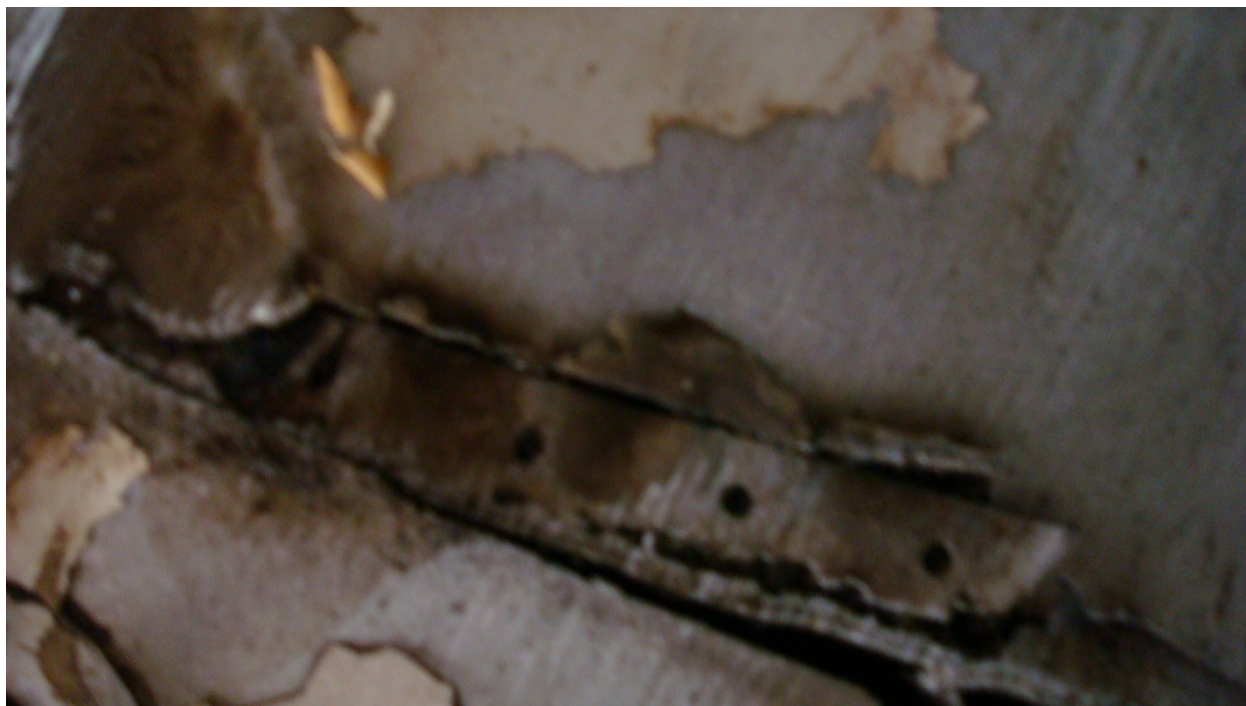
*Figure 2: Underlying Structure*

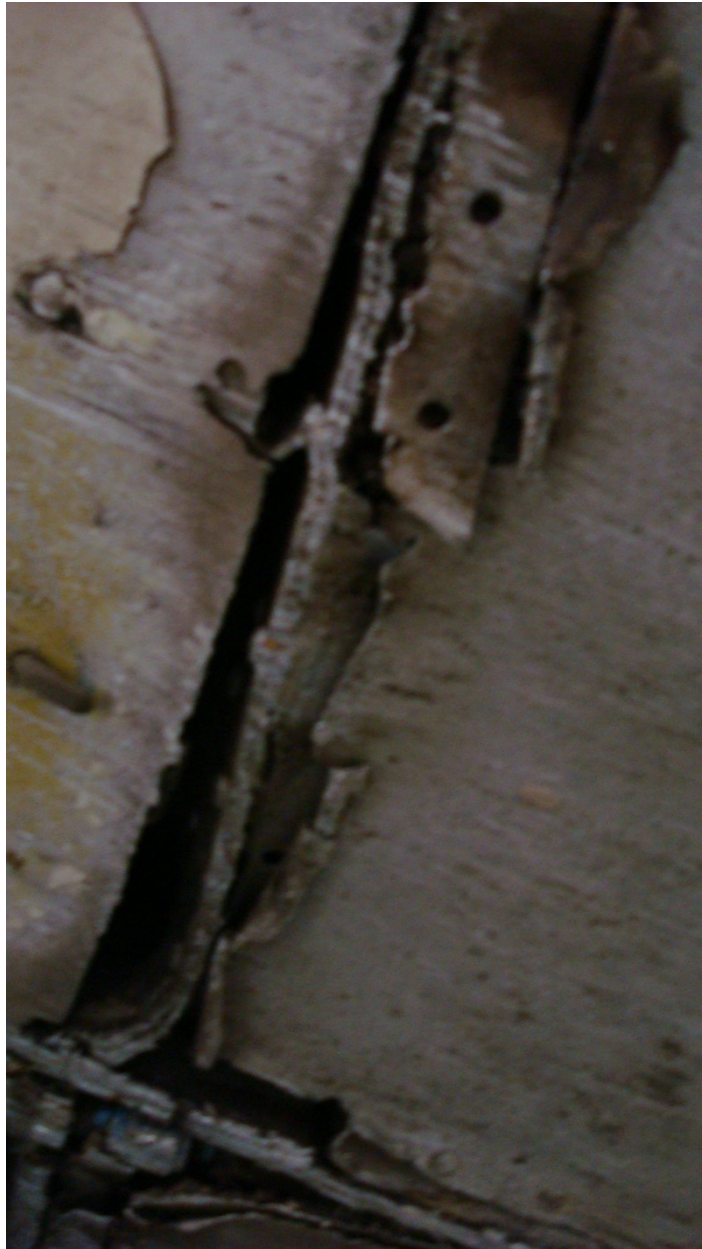
*Figure 3: Exposed Structure*
