## **NATIONAL TRANSPORTATION SAFETY BOARD**

### **SITE and ON-SCENE INFORMATION**

**NTSB Accident: WPR17LA064  
Accident Date: February 23, 2017**

Location: Stevensville, MT  
Date: February 23, 2017  
Aircraft: Beech A36TC, N3803J, Serial # EA-171  
NTSB IIC: Michael Huhn

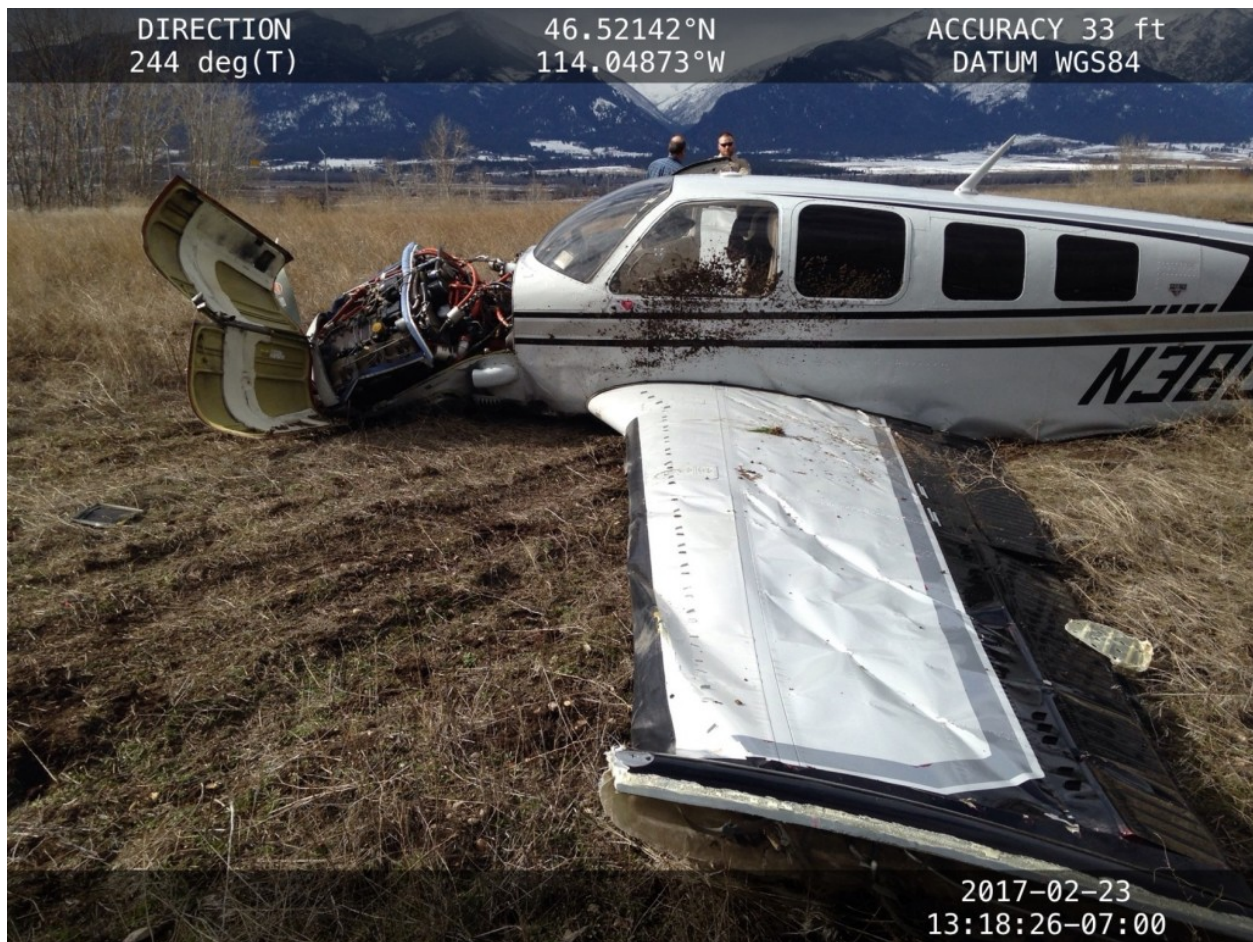
**Figure 1 - Left View**

- The nose and left main landing gear were completely fracture-separated from the airplane
- The right main landing gear was partially separated
- The engine mount was partially separated from the firewall, and the cowling and propeller were significantly damaged.
- The wings and tail aero surfaces all remained attached to the fuselage
- Both wingtip fuel tanks were fractured, and the left wing leading edge incurred crush damage
- The fuselage exhibited some crush, twist and wrinkling deformation, but retained the cabin occupiable volume
- The front seats remained attached to their mounts, and the occupant restraint belts remained intact
- There was no fire
- The flaps were observed to be in the fully retracted position

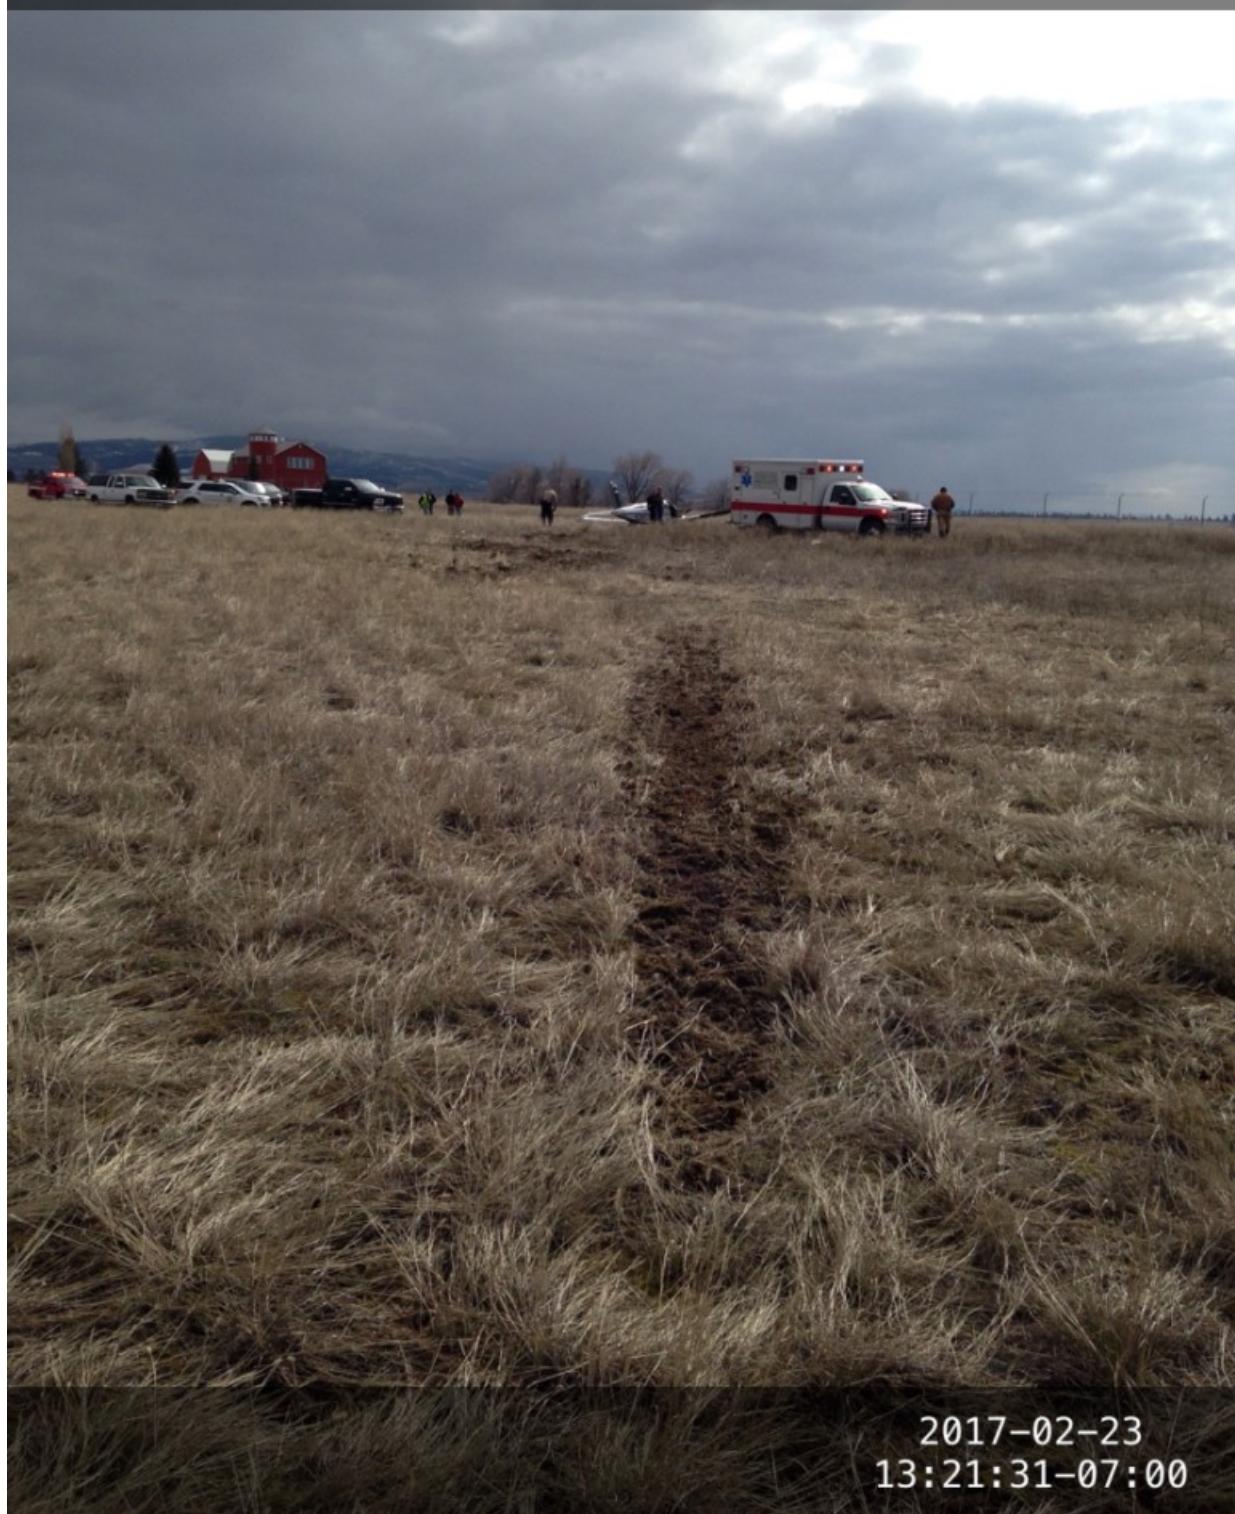
Figure 3 - Ground Scar

- The pilot had attempted to take off from runway 12
- The airplane struck level terrain adjoining the south side of the runway. Ground scars indicated that the airplane traveled only a few hundred feet after initial ground contact
- The airplane came to rest upright, on an approximate heading of about 150 degrees
- The airplane came to rest about 300 feet from the runway centerline, and approximately 3,500 feet along the runway from the 12 threshold end, or about 300 feet prior to the 30 threshold end.
