## **NATIONAL TRANSPORTATION SAFETY BOARD**

### **AIRPORT INFORMATION**

**NTSB Accident: WPR17LA064  
Accident Date: February 23, 2017**

Location: Stevensville, MT  
Date: February 23, 2017  
Aircraft: Beech A36TC, N3803J, Serial # EA-171  
NTSB IIC: Michael Huhn

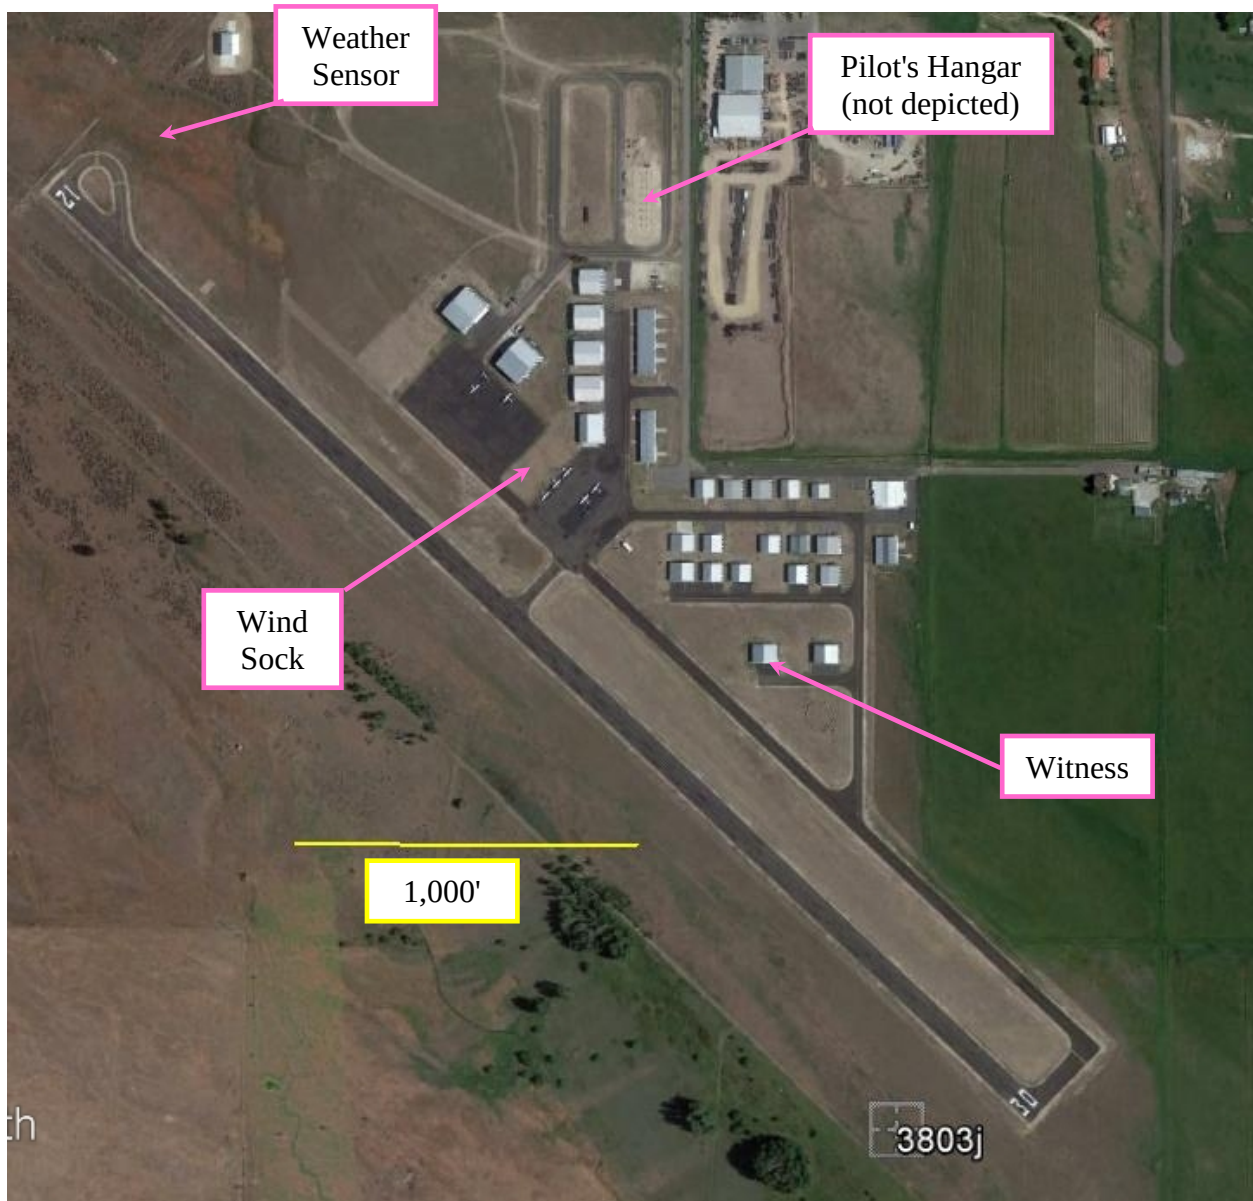
Figure 1 - Airport

The pilot attempted the takeoff from runway 12, which sloped up at a nearly constant 1.94 % in that direction.

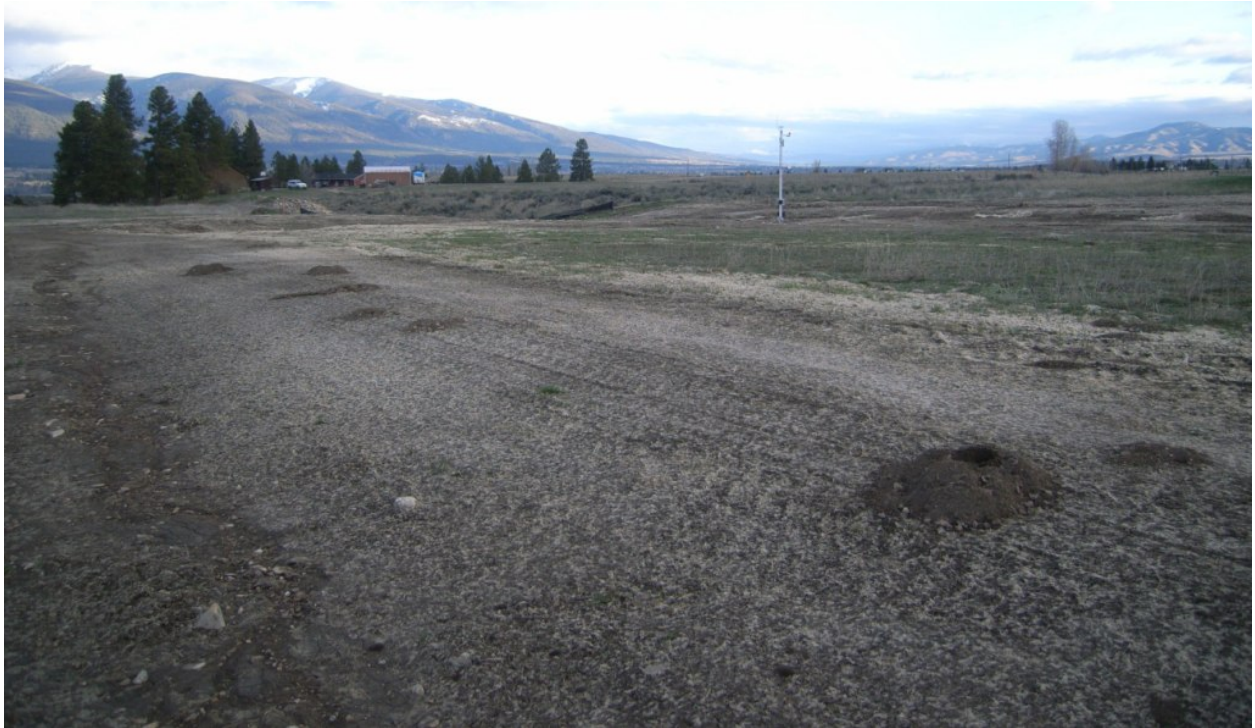
**Figure 2 - Weather Sensor**

The wind speed and direction sensor was located near the approach end of runway 12. The sensor about 300 feet northeast of the runway centerline, and about 100 feet along the runway 12 axis. The sensor was mounted on a mast about 10 feet high, on moderately flat, open terrain with no nearby obstructions.

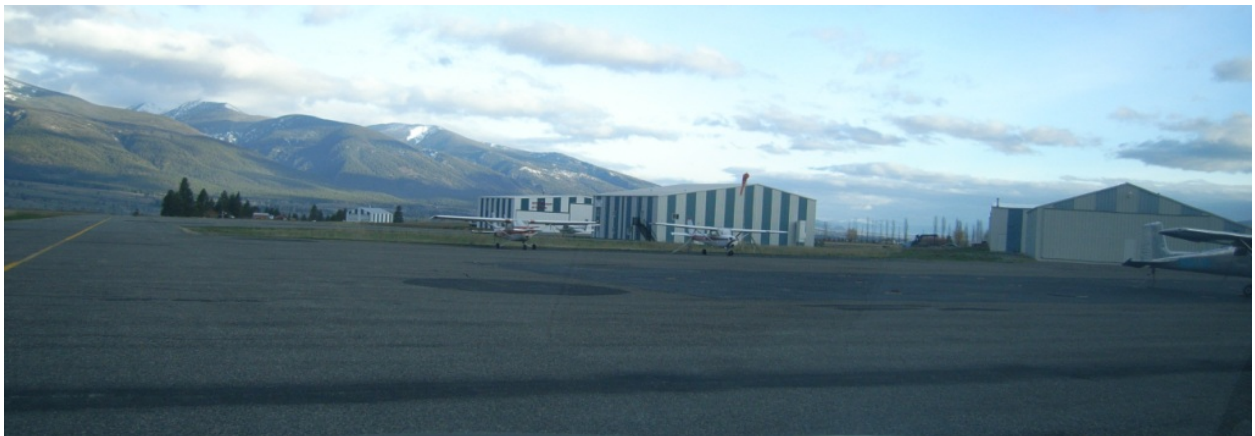
**Figure 5 - Wind Sock**

A wind sock, which the pilot stated he referenced during his taxi-out, was situated about 400 feet northeast the runway centerline, and about 1,500 feet along the runway 12 axis. The windsock was about 100 ft west-southwest of a hangar. It was mounted on a pole about 20 ft high.
