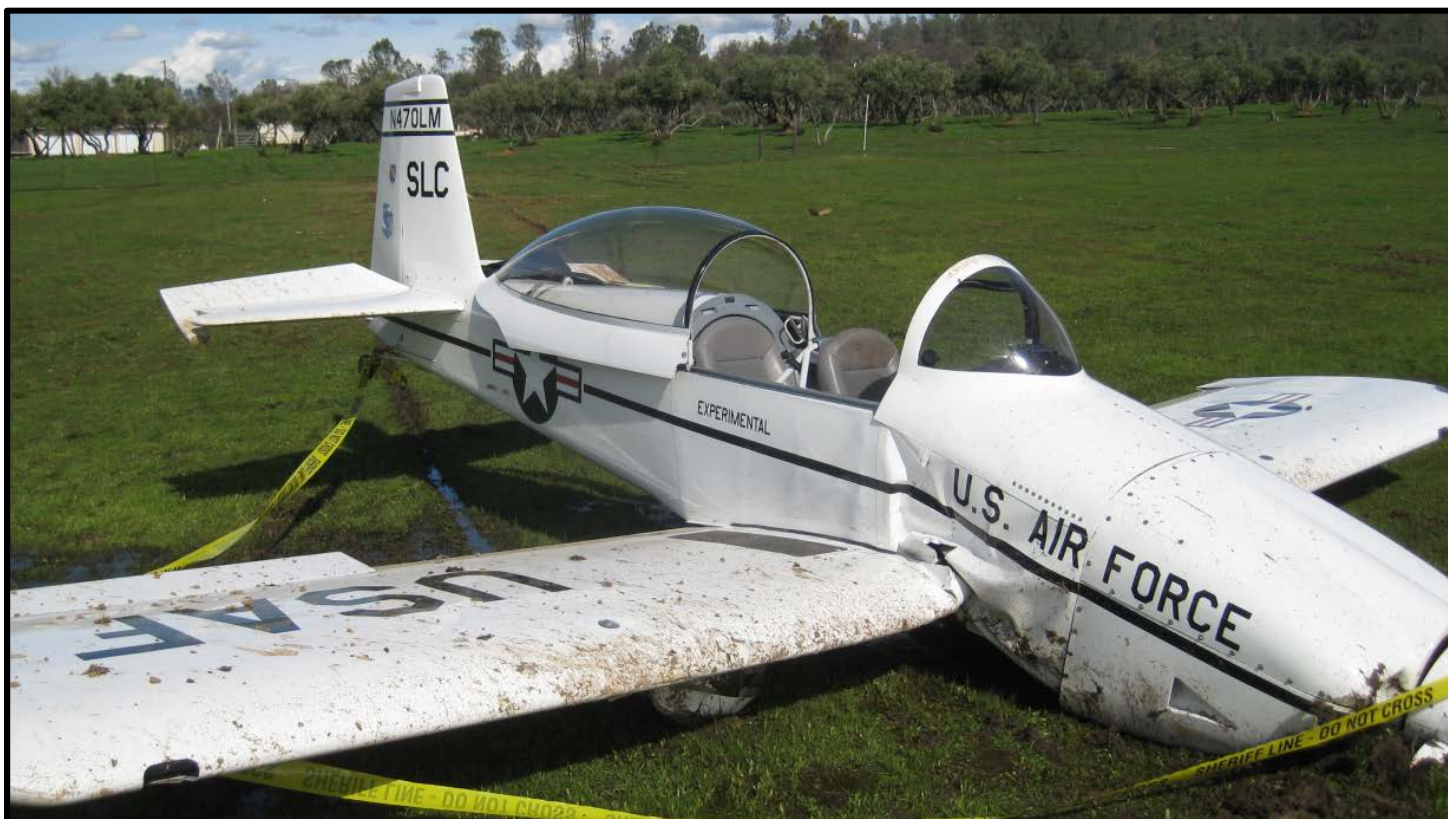
Figure 01: At Accident Site
