## Engine Investigation Report

**Rolls-Royce Model:** 250-C20B  
**Engine Serial Number:** CAE 832024  
**Aircraft Model:** B206B  
**Registration Number:** N211CS  
**Operator:** West Valley Aviation  
**Accident Date:** 1 March 2017  
**On-site Exam Date:** 16 March 2017  
**Engine Exam Date:** 13 June 2017  
**Report Date:** 12 September 2017

Jon-Adam Michael  
Air Safety Investigator  
Rolls-Royce

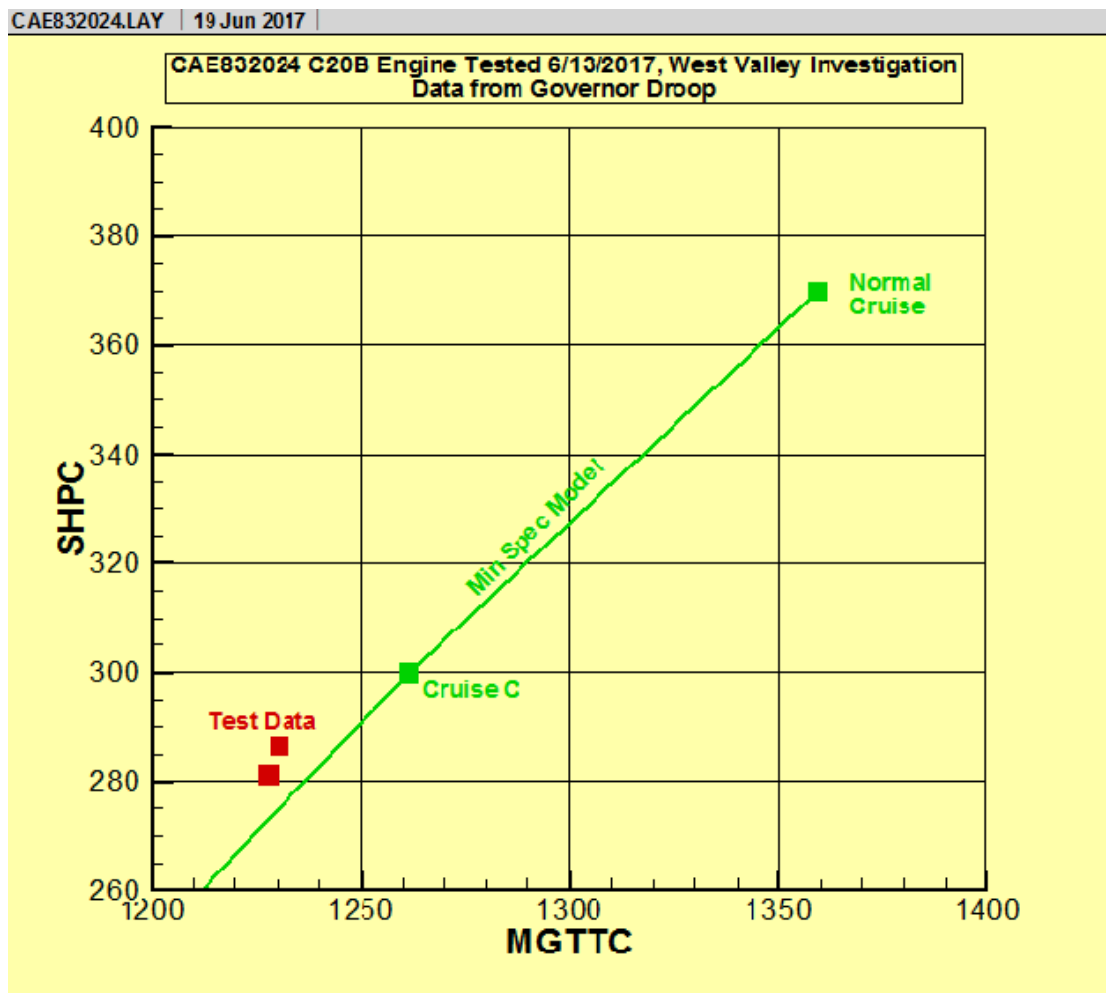
In order to determine the capability of the engine to produce power during the event, Rolls-Royce performance engineering used the limited amount of test data from the aborted engine test to plot the event engine performance versus an engine making minimum specified power. The results are depicted in Figure 1.

Figure 1. Event engine data points are depicted as red blocks.

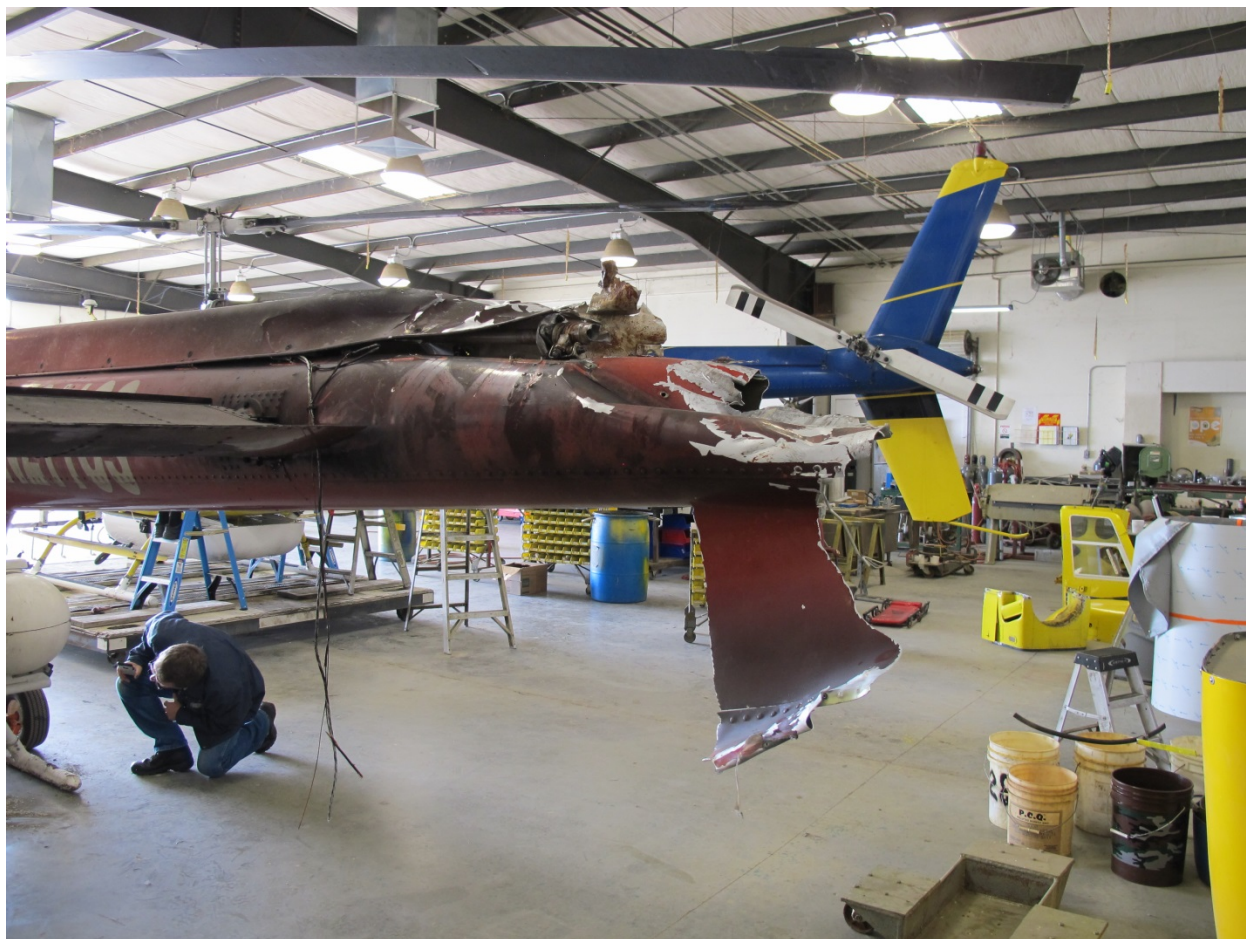
Figure 2. Tailboom Damage

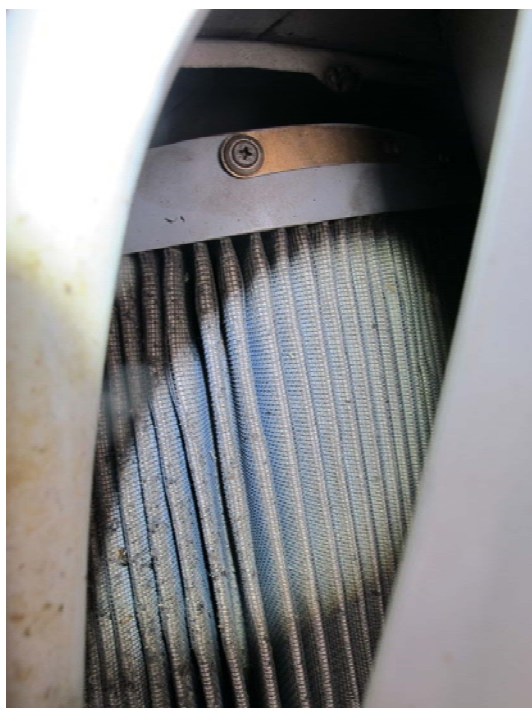
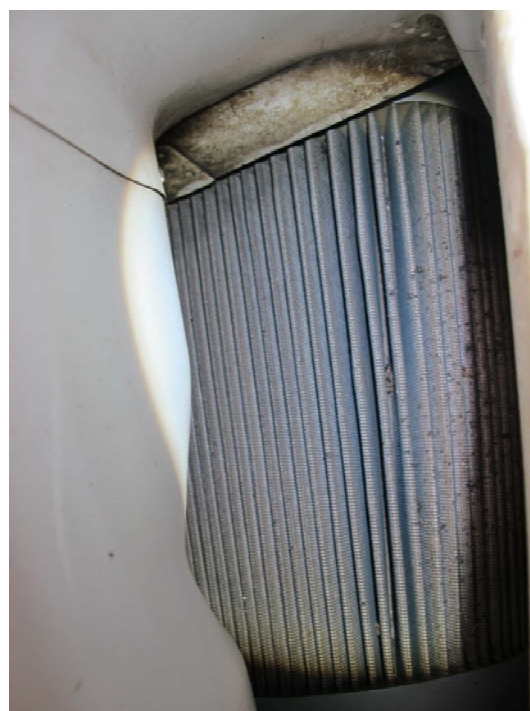
The aircraft was equipped with an inlet barrier filter which was dirty but not obstructed.

Figures 3 and 4. Inlet Barrier Filter

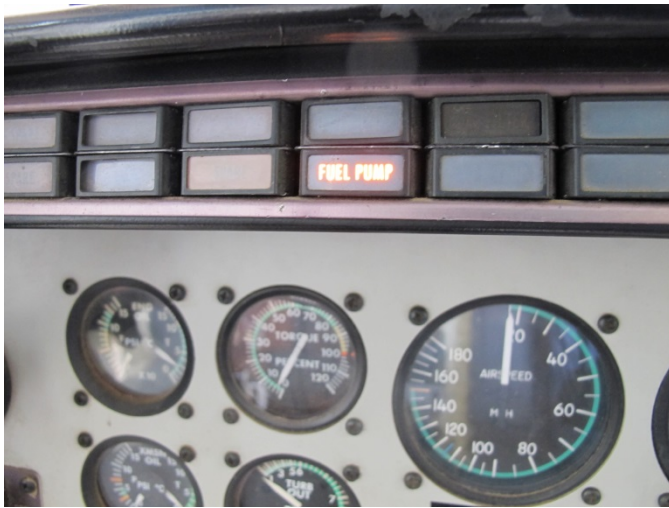
One of the two aircraft boost pumps (the aft pump) was inoperative when tested individually. The fuel pump caution light was illuminated in the cockpit when master power was turned on. Approximately 6.5 gallons of fuel was drained and measured from the tank.

Figure 5. Aircraft Warning Panel Indicating a Fuel Pump Issue

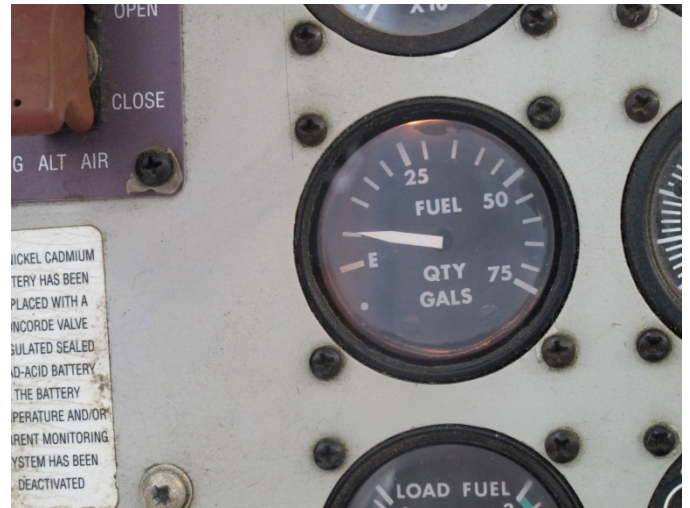
Figure 6. Aircraft Fuel Indicator Depicting Level of Fuel Found in Aircraft

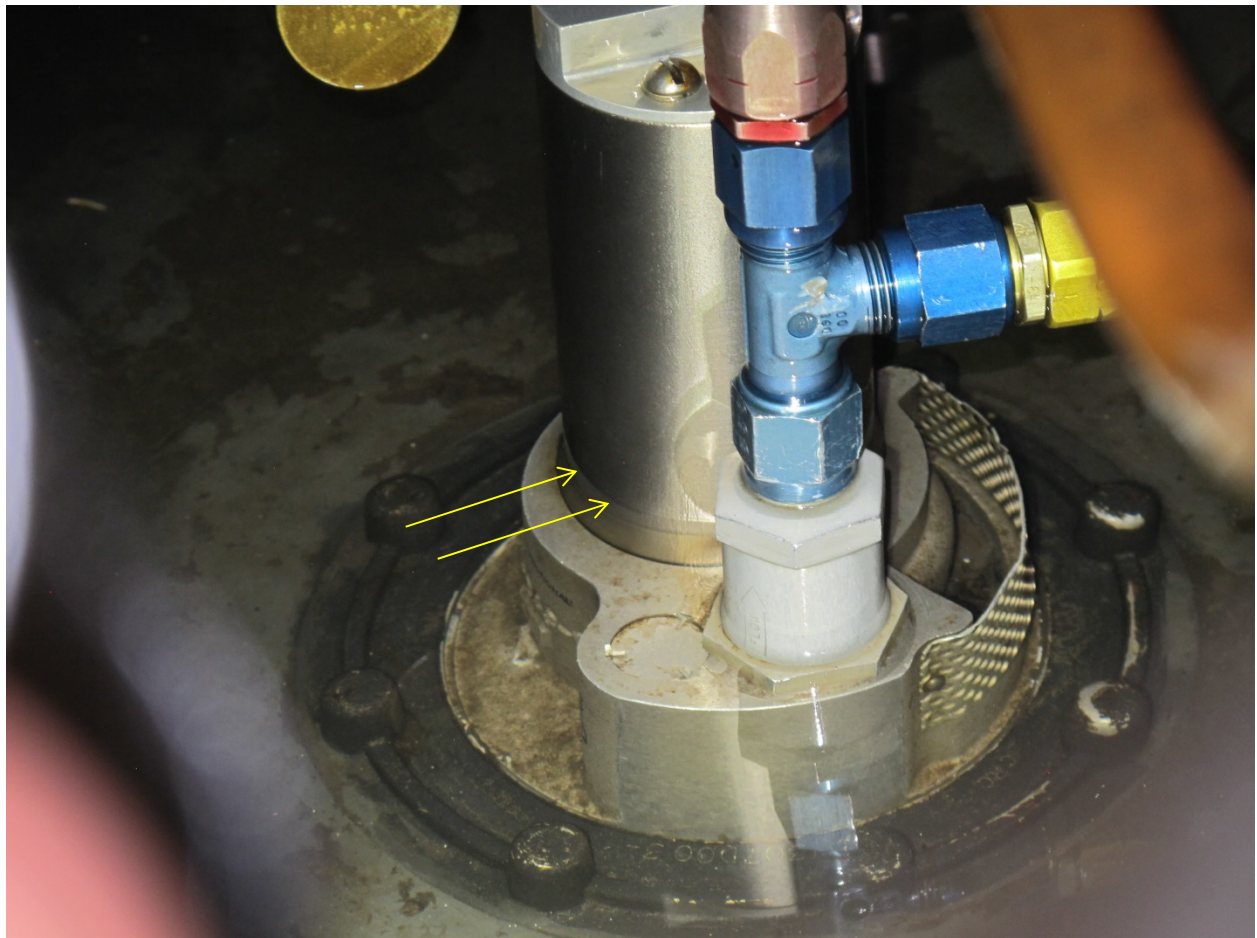
Figure 7. Aircraft Aft Boost Pump Installed in Fuel Cell. Arrows Indicate Fuel Level Found in Aircraft

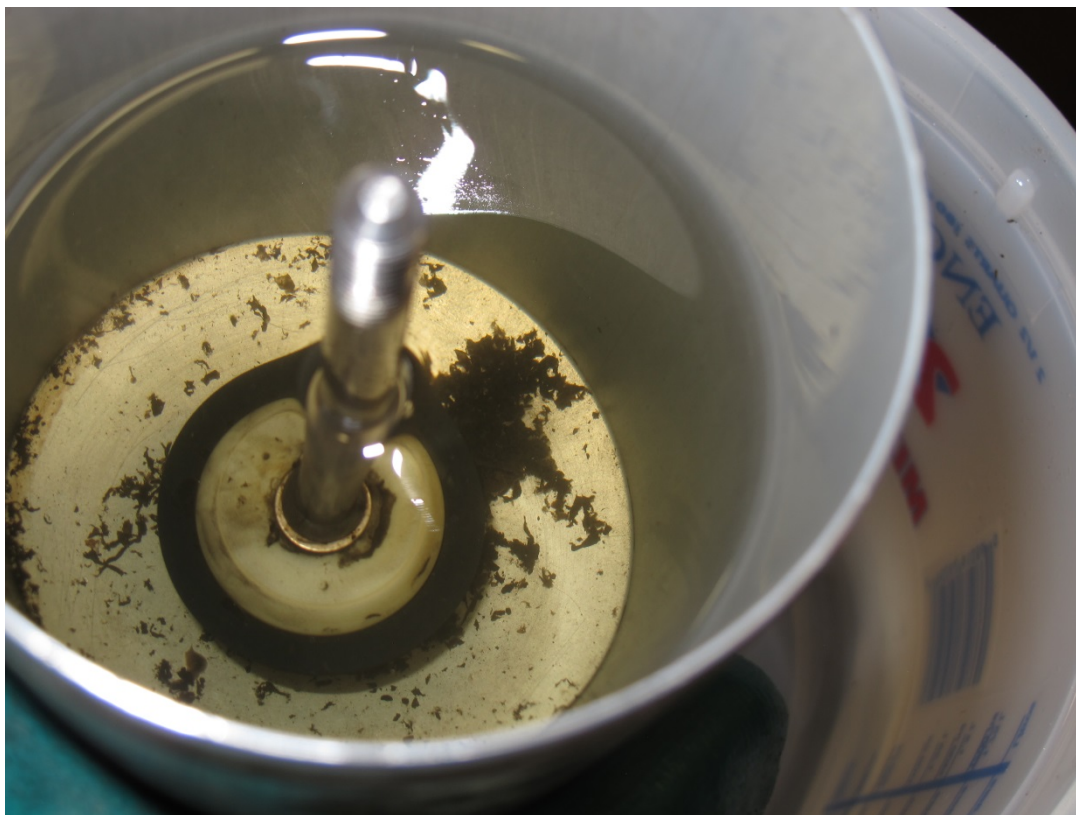
Residual fuel was noted in all of the engine fuel lines. The aircraft mounted fuel filter was full of fuel which contained debris on the input (pre-filter) side. The engine mounted fuel filter was full of fuel which did not display contaminants and was normal in appearance and smell. The fuel nozzle primary and secondary orifices did not appear obstructed and the air shroud displayed normal carbon sooting.

Figure 8. Debris in Aircraft Mounted Fuel Filter Bowl

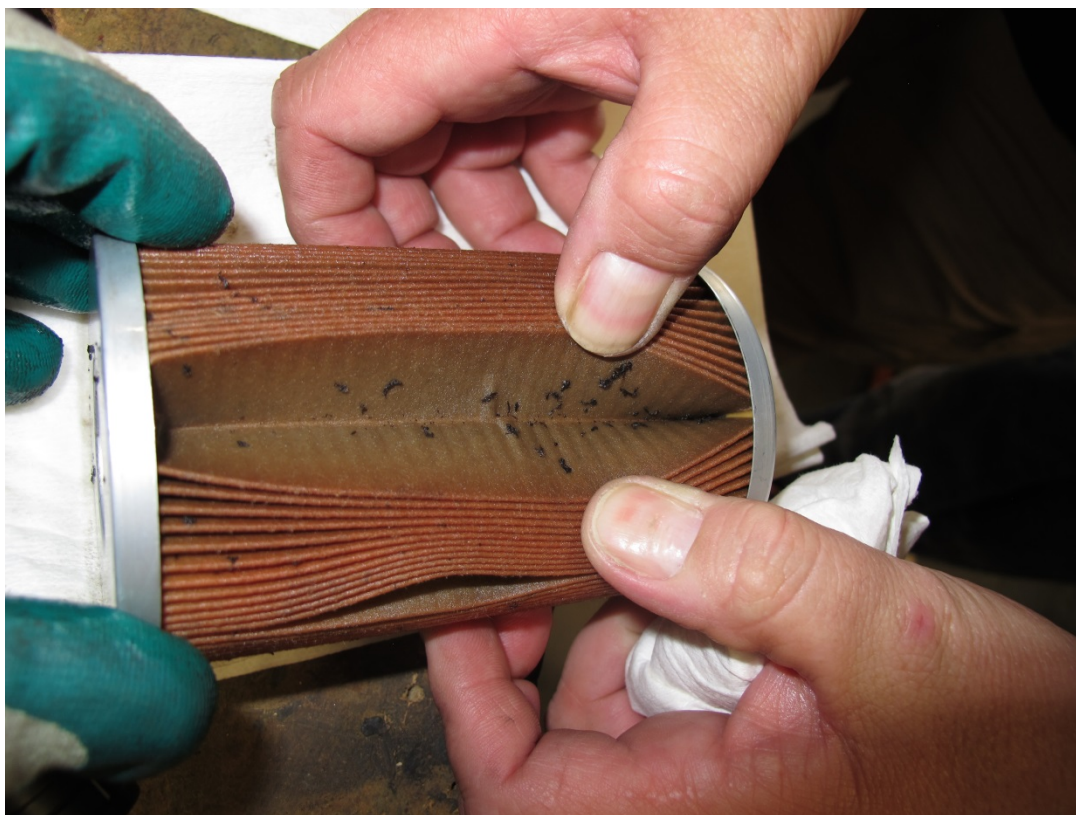
Figure 9. Debris in Aircraft Mounted Fuel Filter Element

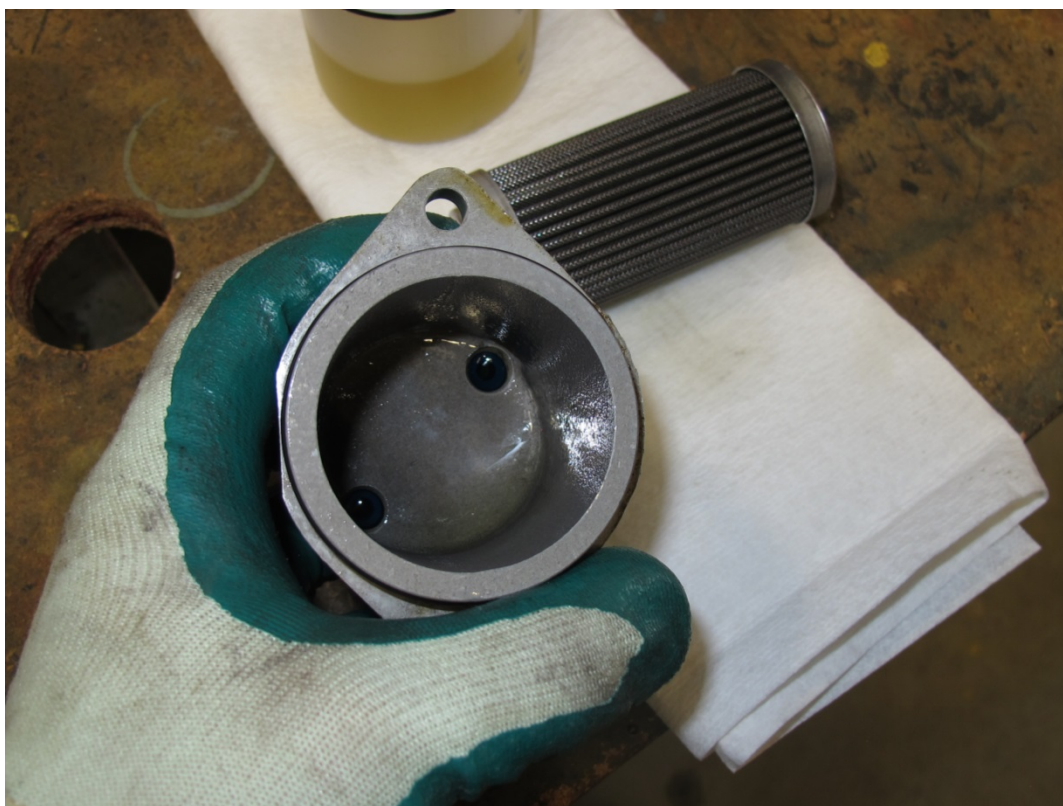
Figure 10. Engine Mounted Fuel Filter Bowl

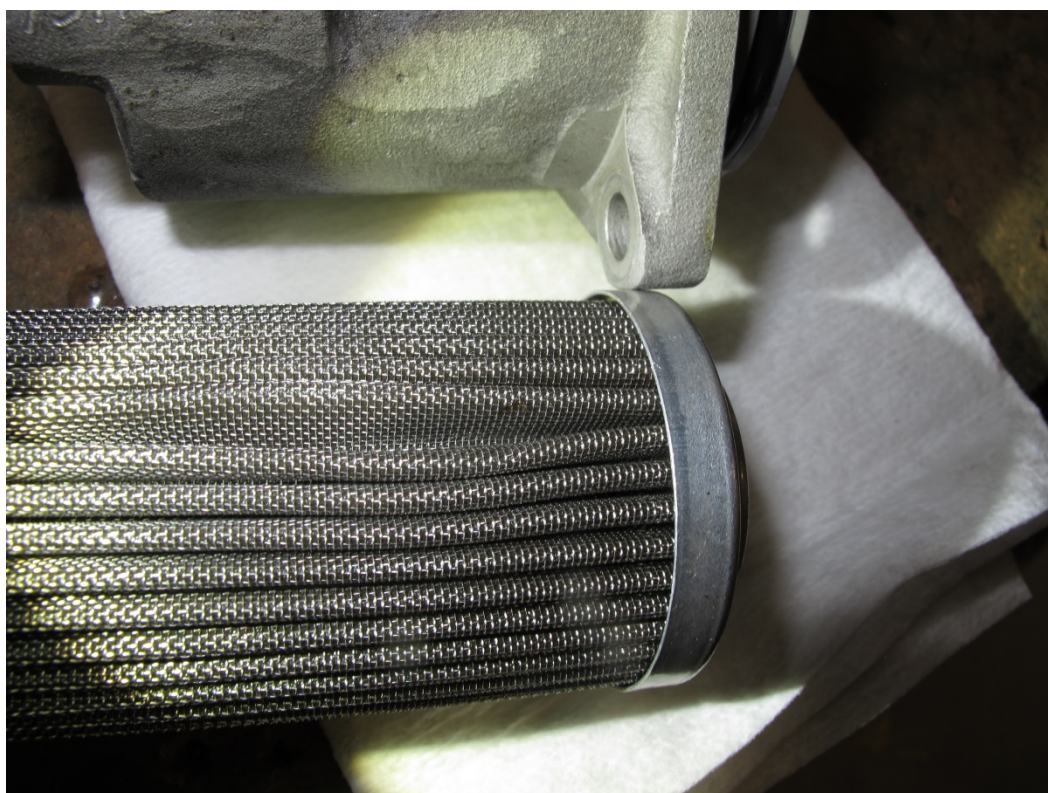
Figure 11. Engine Mounted Fuel Filter Element

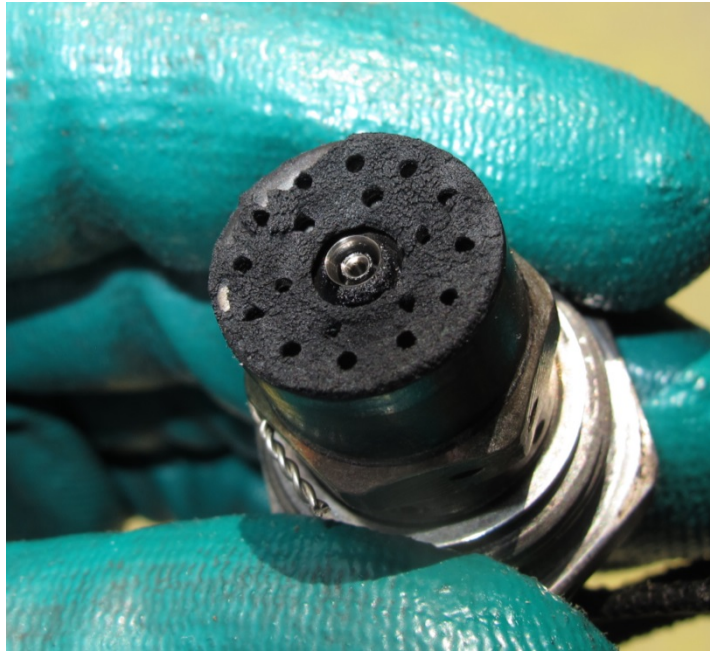
Figure 12. Fuel Nozzle

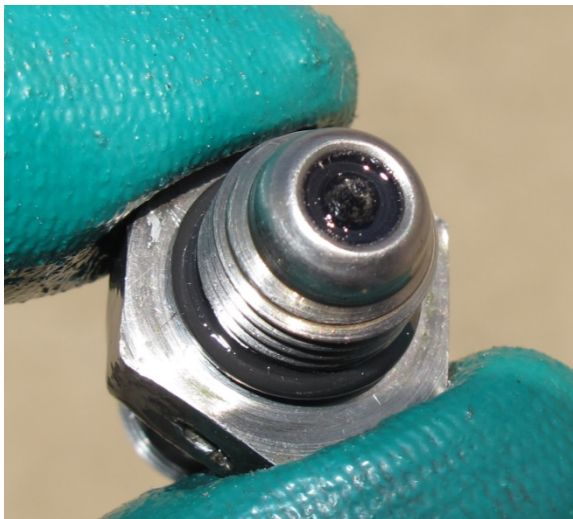
Both the N1 and N2 rotors turned freely and were continuous to the starter generator and main rotor respectively. No Foreign Object Damage (FOD) was noted on the first stage compressor blades, compressor inlet or fourth stage turbine wheel. The lower magnetic chip detector plug was removed to facilitate oil drainage and an appropriate amount of oil (~1/2 liter) was drained from the gearbox. Neither the upper nor lower chip detector displayed ferrous particles.

Figure 13. Lower Magnetic Chip Detector

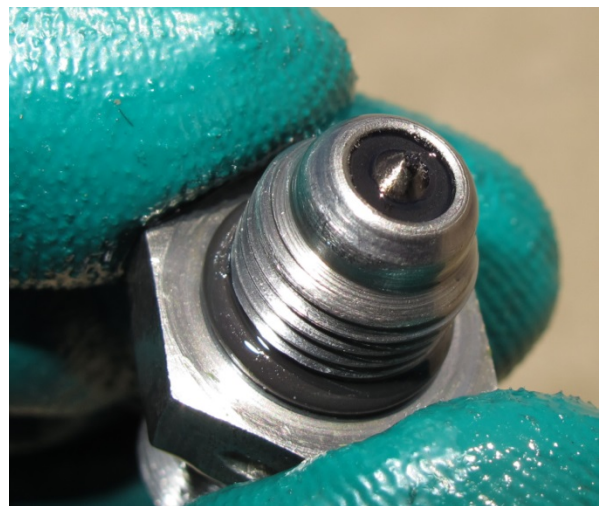
Figure 14. Upper Magnetic Chip Detector

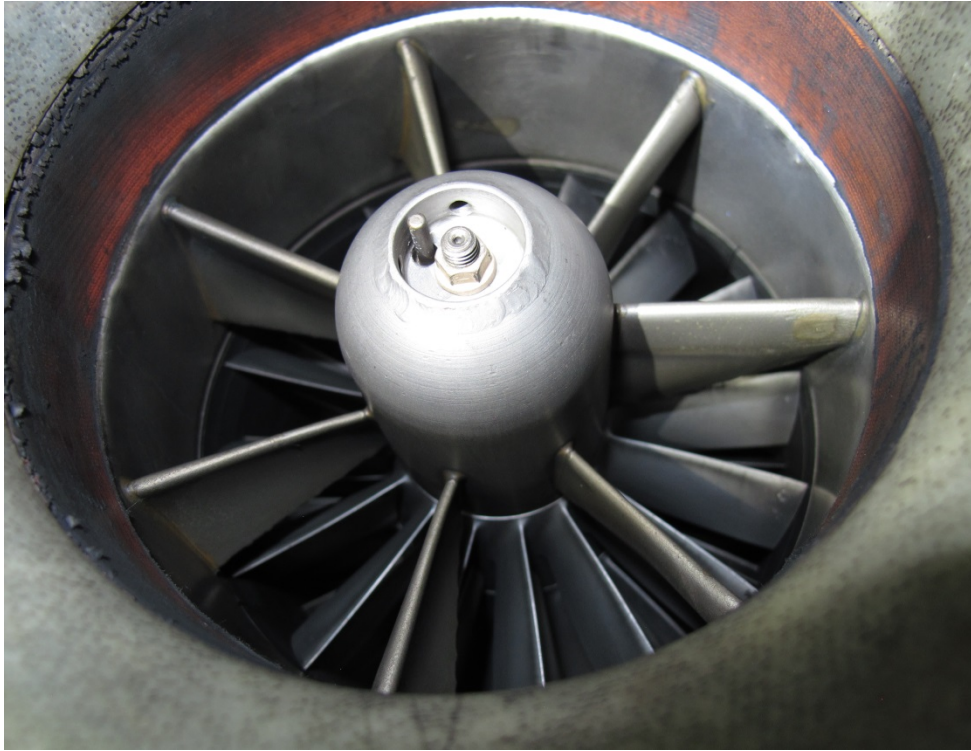
Figure 15. Compressor Inlet

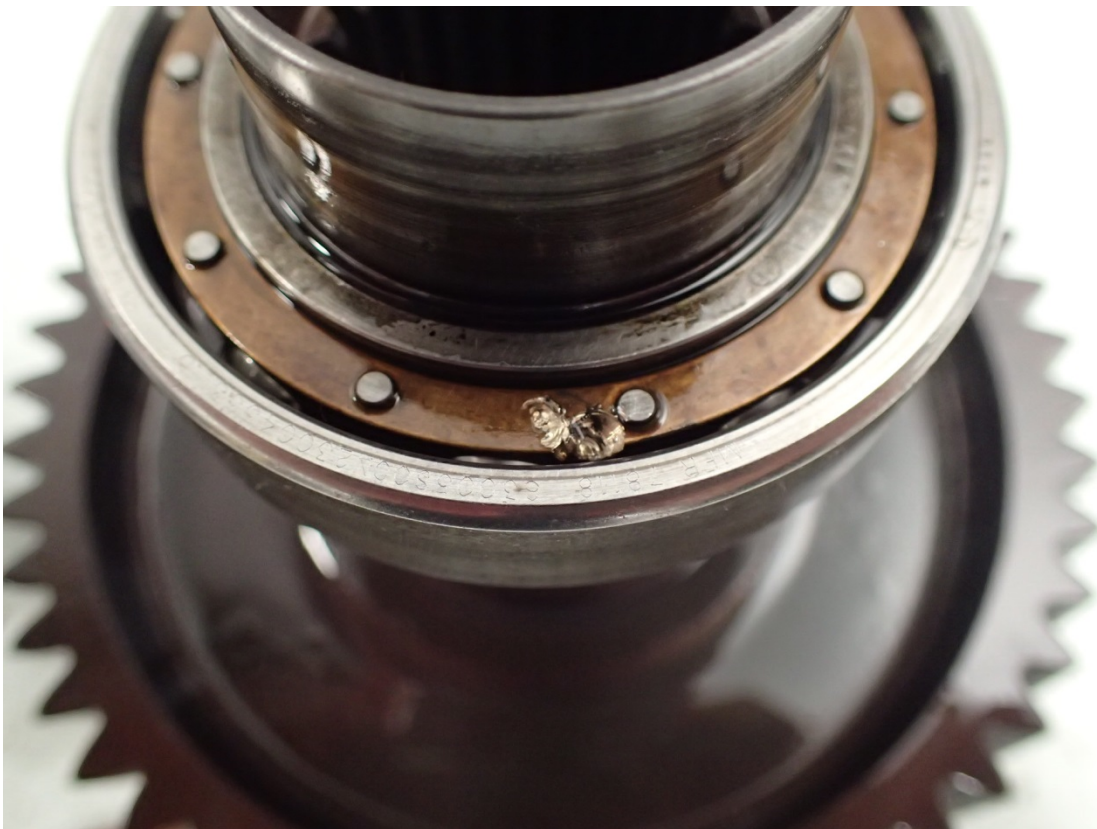
In order to troubleshoot the metallic debris generation, the engine was disassembled to gain access to the gearbox. The gearbox inspection revealed gouging on the forward face of a roller bearing separator. This roller bearing is the forward radial support bearing for the Power Takeoff (PTO) gear. It is likely that this damage occurred during preparation for the engine test when the adjacent double lip seal was replaced with a single lip seal to accommodate test stand vs. aircraft differences. It is suspected that the damaged bearing generated metal which caused the repeated magnetic chip indications during the engine testing. No other gearbox anomalies were noted during the teardown.

Figure 17. PTO Gear Bearing Separator Damage

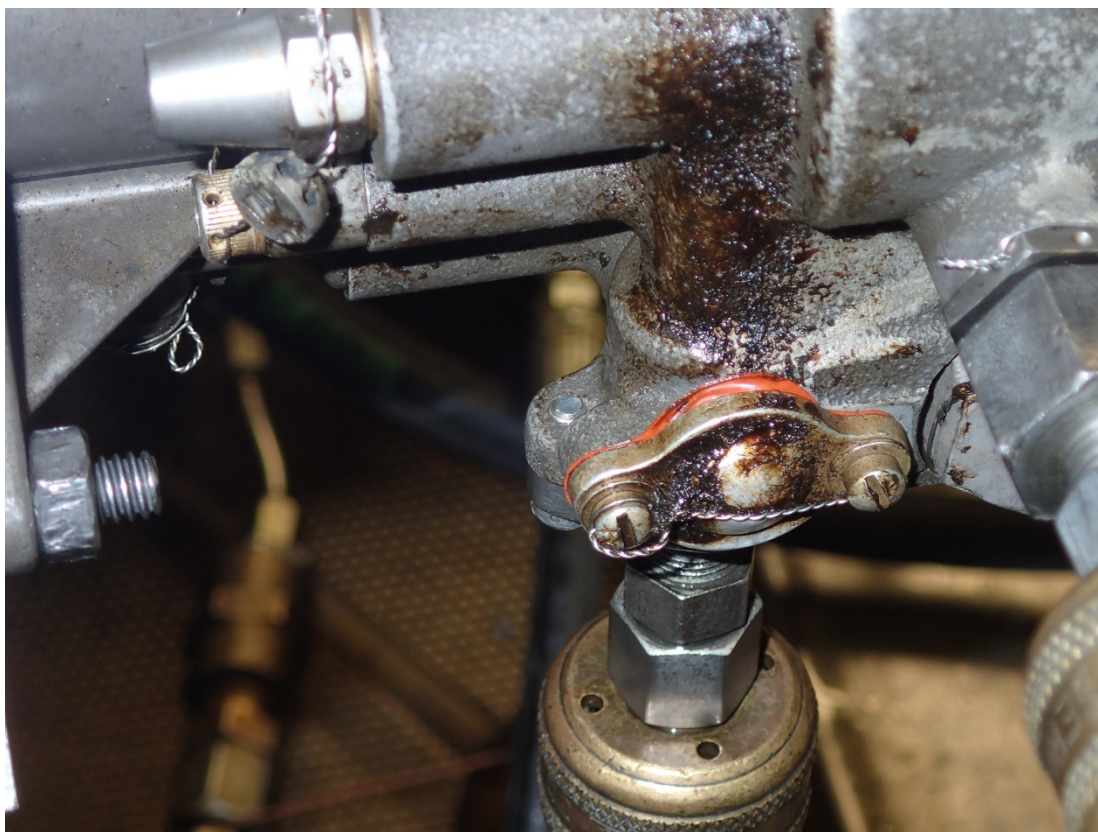
The FCU was tested on a certified bench in accordance with OEM overhaul limits and an anomaly was noted. Specifically, a gasket on the torque shaft housing cover was not sealing properly due to under torqued screws. The safety wire on the screws was secure but the screws broke free with only 3-4 in-lbs. of applied torque (the specified assembly torque is 9-10 in-lbs.). The original gasket was refitted along with the same cover and screws, which were torqued to the specified values of 9-10 in-lbs. After gasket replacement, the unit was retested in accordance OEM overhaul limits and all serviceable limits were met. Logbook records indicate the FCU was last overhauled on 12 Aug 2015. The FCU was then removed after 511 operating hours and reinstalled the same day (27 Oct 2016) for "repair".

Service and performance engineering determined that the leaking gasket would cause a rich fuel delivery condition to the engine. The FCU bench test demonstrated that the leak was due to improper torque on the bolts securing the cover (and underlying gasket) over top of the torsion shaft, which is surrounded by FCU internal control air pressure (known as Px). The leaking gasket, which likely developed over time, would result in lower than expected Px values for a given compressor discharge pressure (referred to as Pc). This disparity between Px and Pc would grow as Pc pressure increases relative to a nominal FCU with no leakage. Therefore, the control would be richer at higher Ng speeds and thus produce higher power than normal. During operation the control system would compensate for this condition as the PTG would reset the FCU to reduce fuel flow in order to maintain the power turbine / main rotor speed at 100% (or the appropriate speed set by the pilot). Therefore, in a flying condition, the pilot would not notice any operational difference.

Figure 18. Fuel Control Unit Px Cover
