**FLUID SYSTEMS DIVISION  
PARKER HANNIFIN CORPORATION  
711 TAYLOR STREET  
ELYRIA, OHIO 44035**

**5 DECEMBER 2017**

**2C27-1 CENTRIFUGAL FUEL PUMP CARTRIDGE  
EXAMINATION**

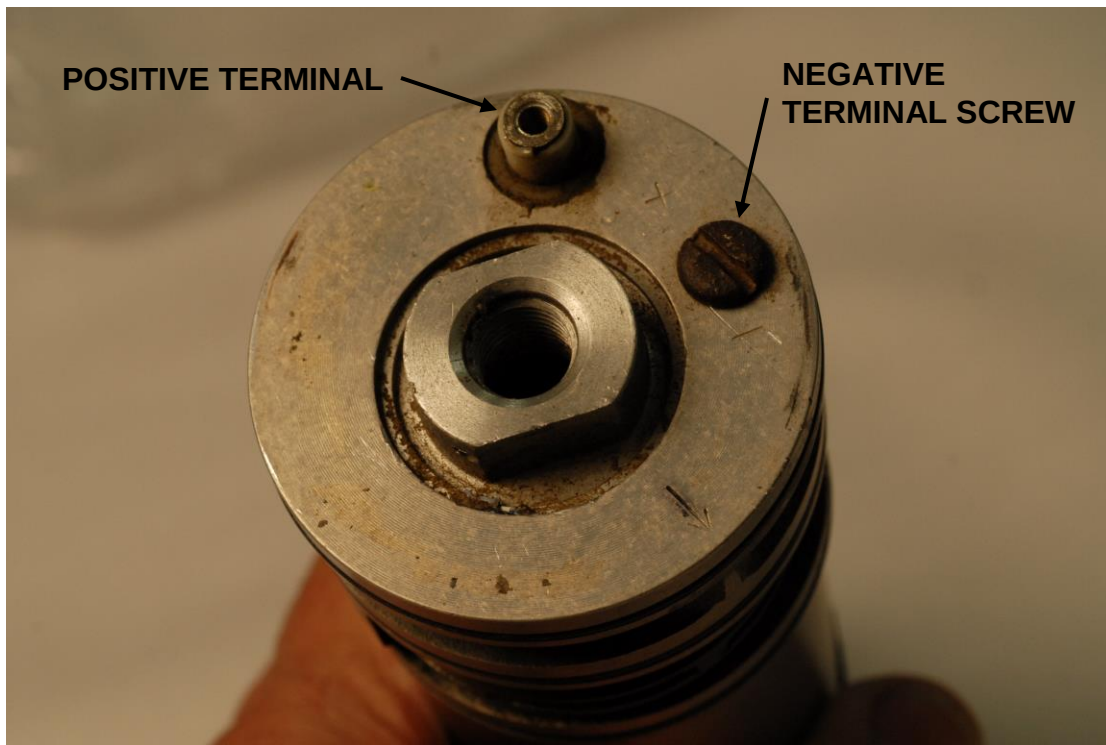
Photos 2C27-1 4H234 31 Aug17\_010 through 2C27-1 4H234 31 Aug17\_022 show the unit as received. Rusty Upper Brush Card fasteners were observed along with the rusty negative terminal screw. Refer to photos 2C27-1 4H234 31 Aug17\_013 and 2C27-1 4H234 31 Aug17\_014. The unit's field tube appeared different in color and surface finish than Parker's unit. Parker's field tubes have a smooth uniform finish around the circumference of the tube and are Cadmium plated with a Yellow Dichromate Dip. The field tube of this unit was more silver in color and had an unusual surface finish shown in photo 2C27-1 4H234 31 Aug17\_015.

2C27-1 4H234 31Aug17\_013 – Rusty Screw Heads

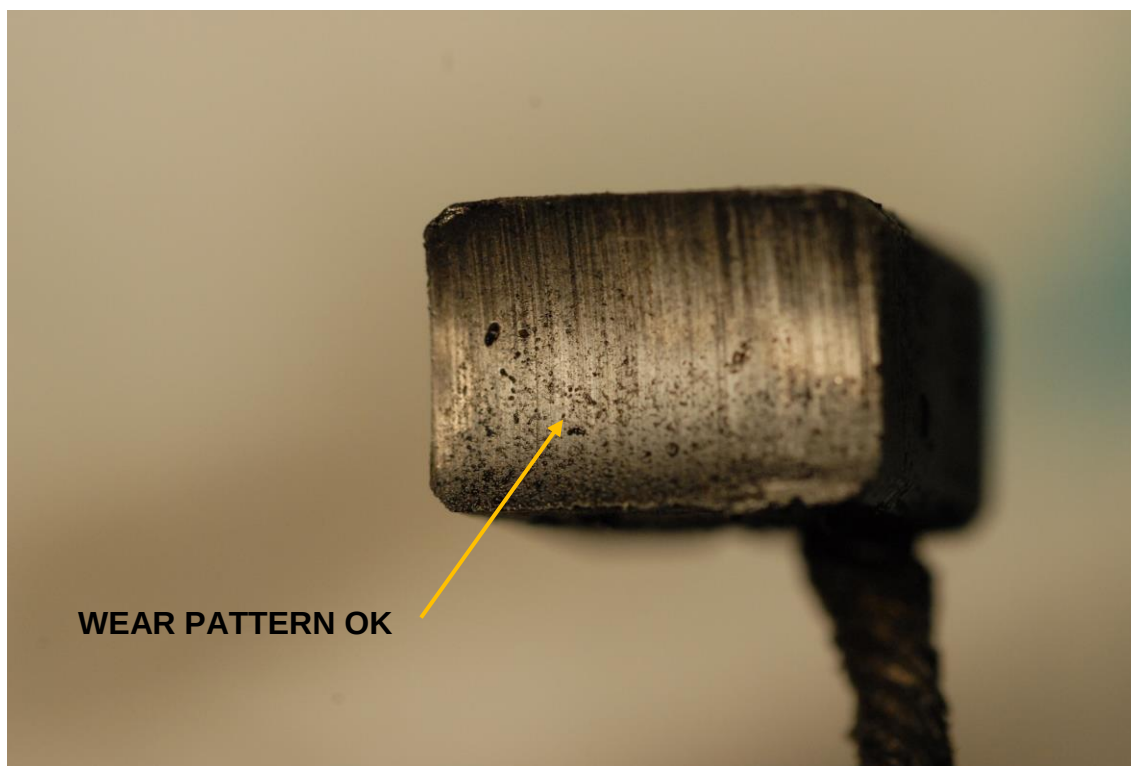
**MOTOR BRUSH NOT  
A PARKER BRUSH**

2C27-1 4H234 31Aug17\_035 – Non-Parker Motor Brush

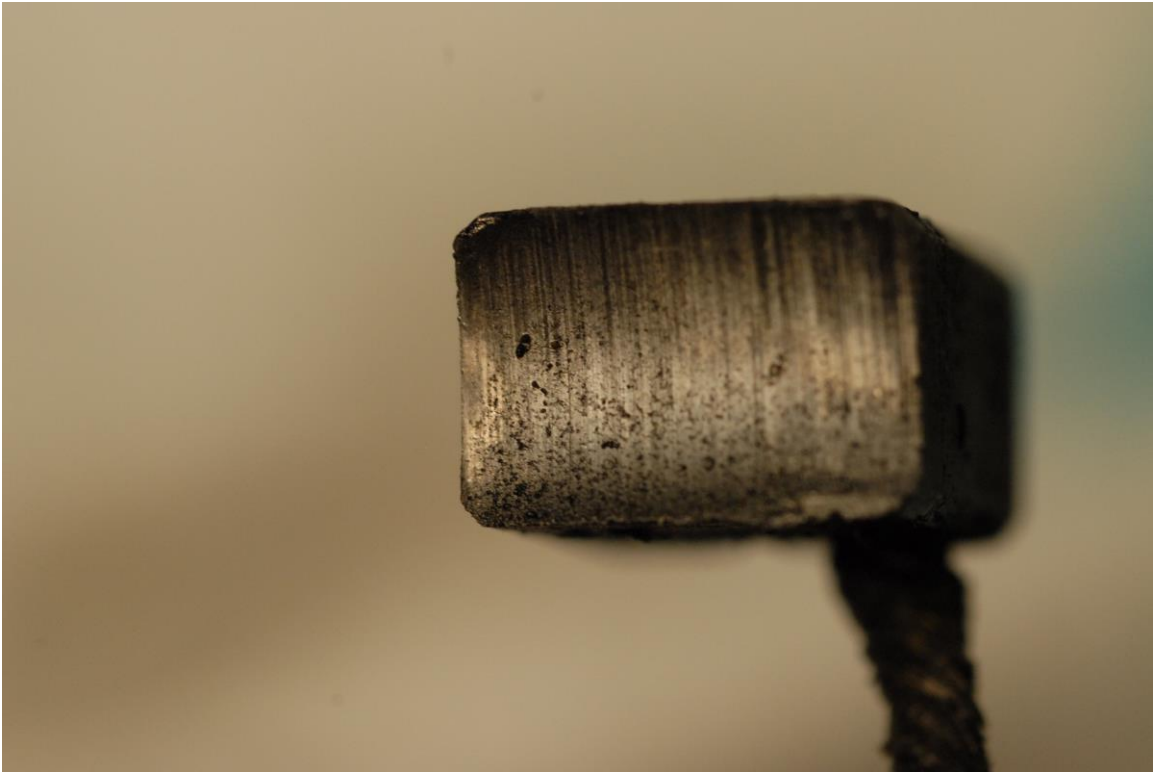
**WEAR PATTERN OK**

2C27-1 4H234 31Aug17\_036 - Motor Brush Wear Pattern - OK

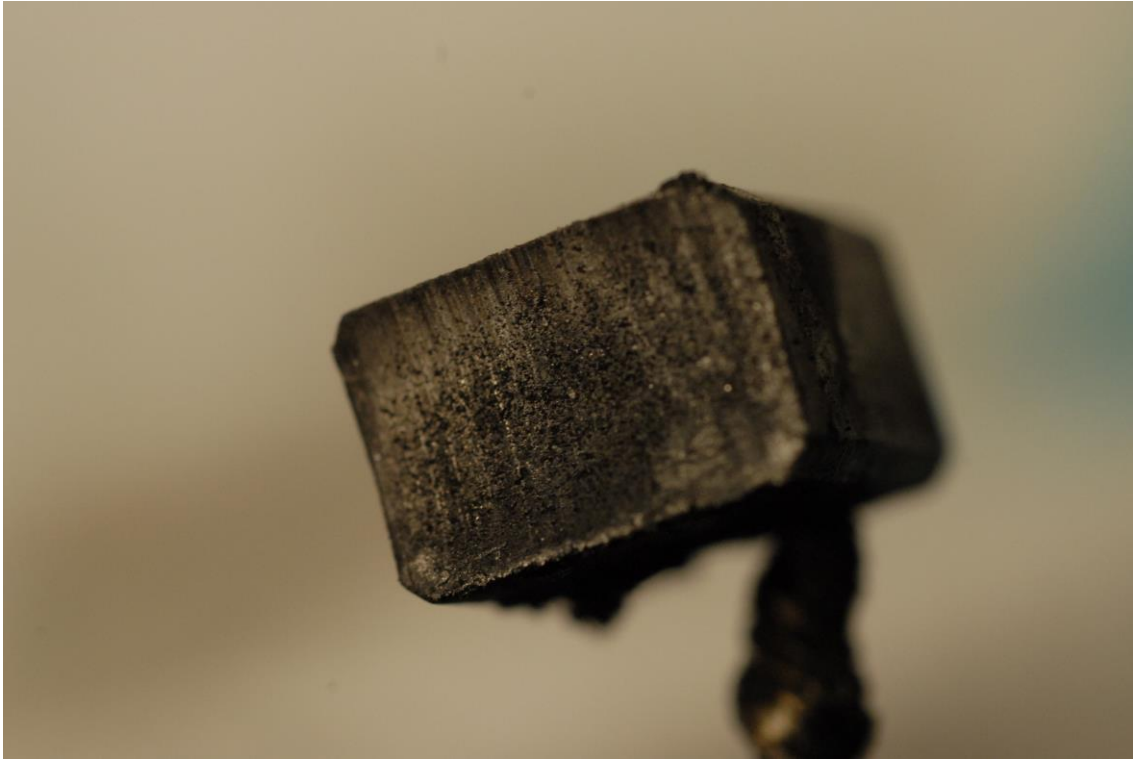
**POOR WEAR PATTERN -  
SIGNS OF ARCING**

2C27-1 4H234 31Aug17\_038 – Motor Brush Signs of Arcing

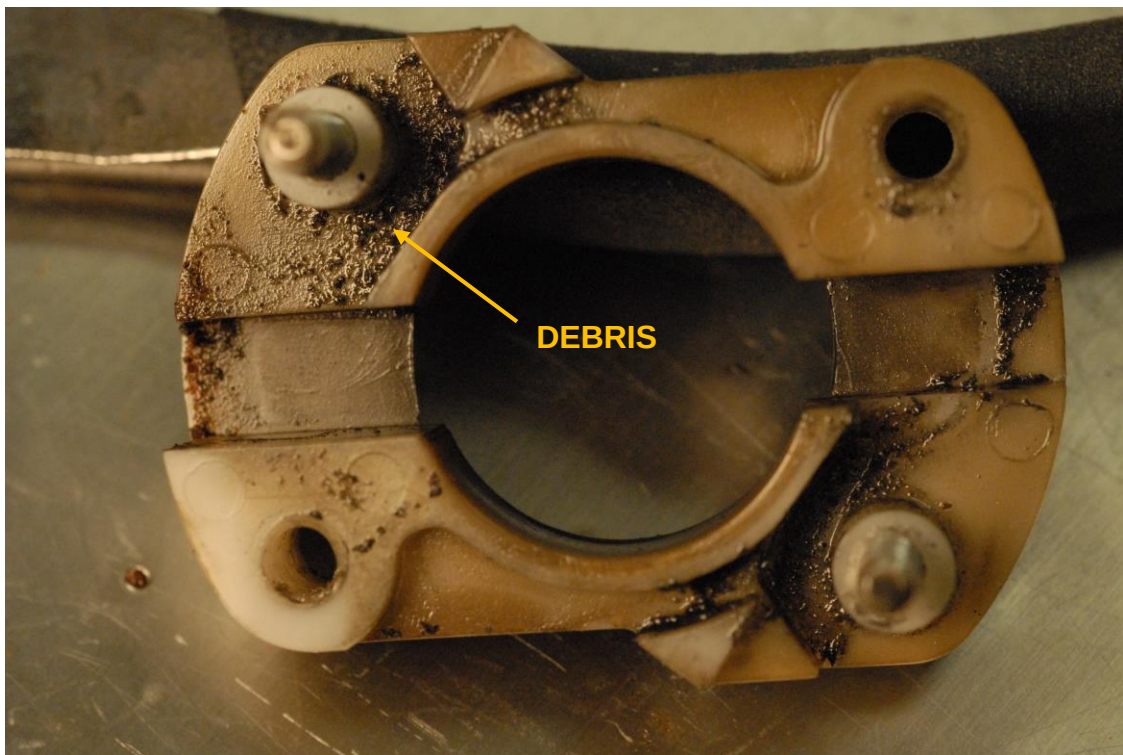
2C27-1 4H234 31Aug17\_039 - Motor Brush Signs of Arcing

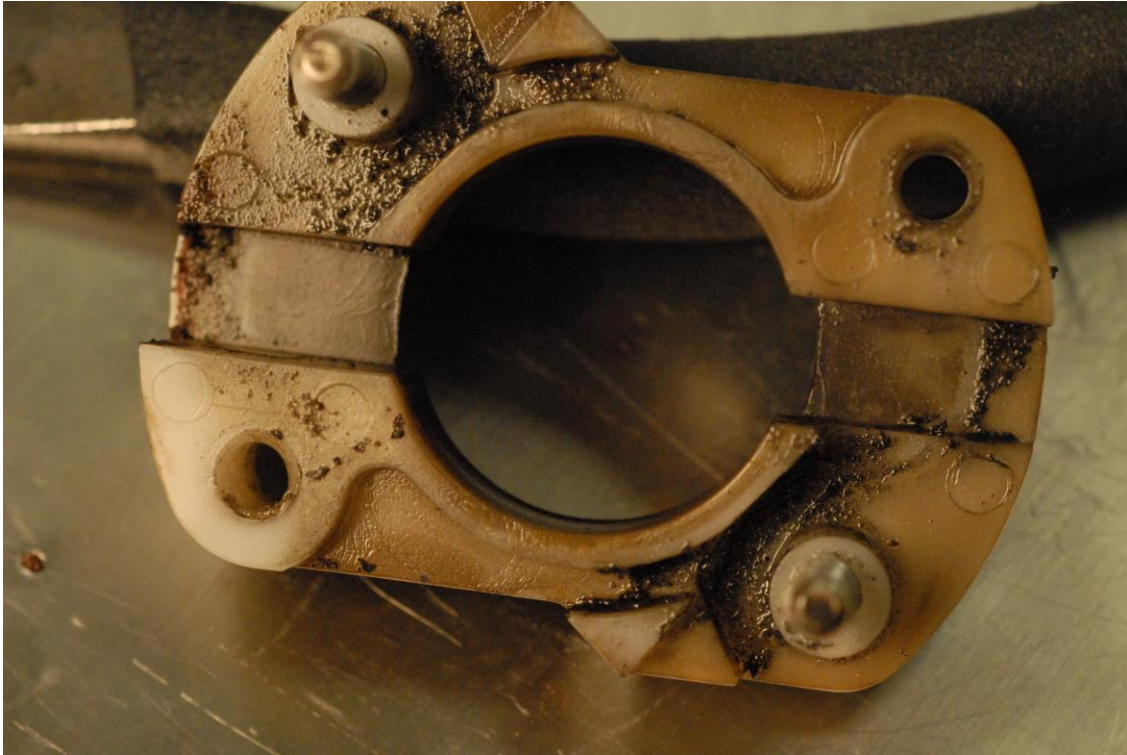
2C27-1 4H234 31Aug17\_040 - Brush Card Debris

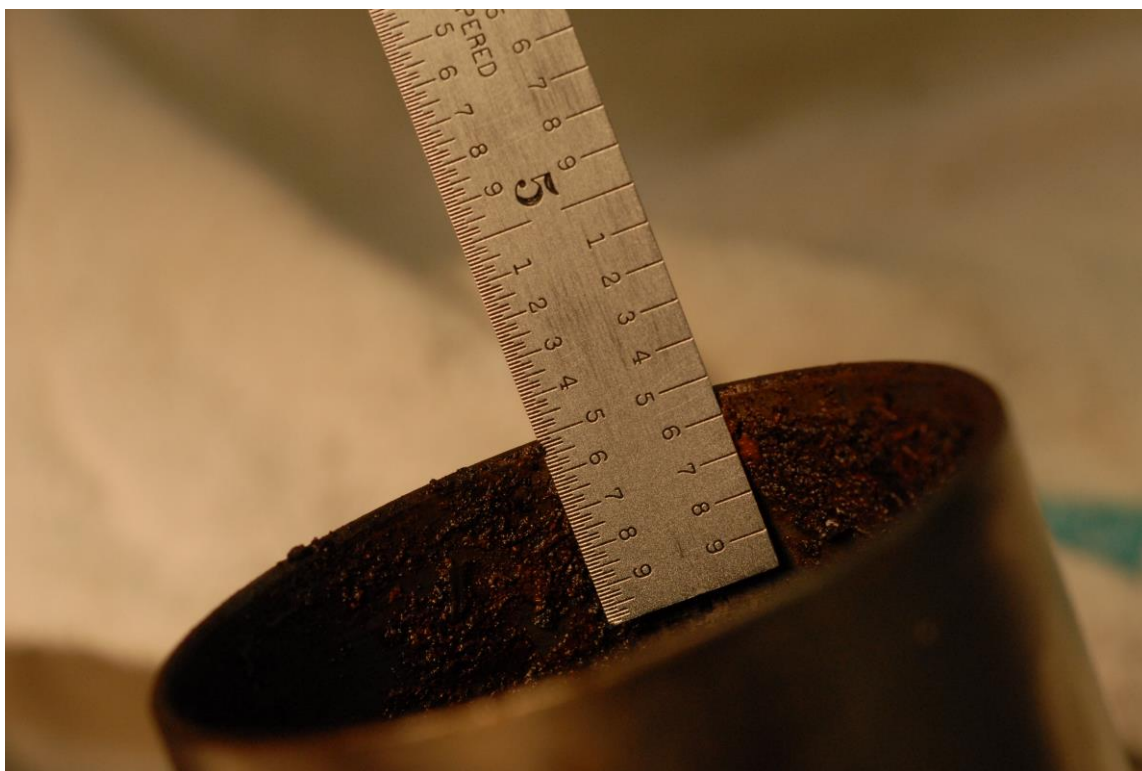
2C27-1 4H234 31Aug17\_042 – Field Tube Heavy Corrosion

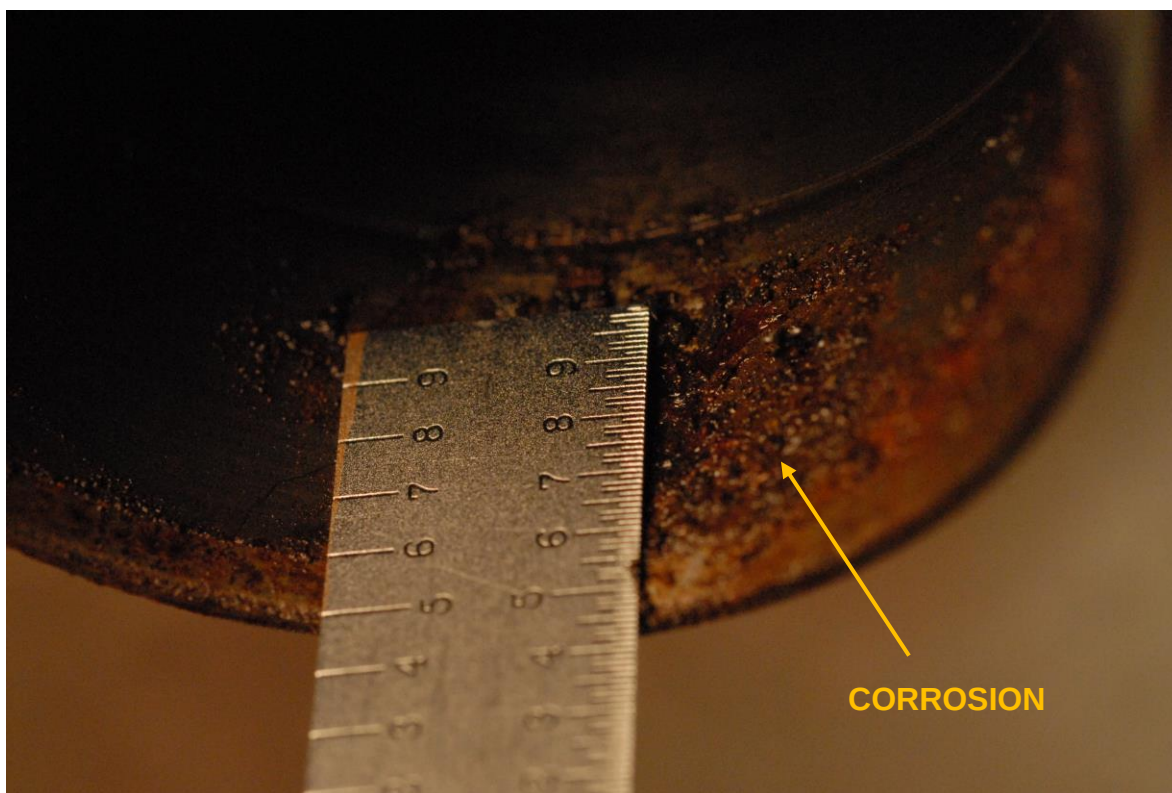
2C27-1 4H234 31Aug17\_043 – Field Tube Heavy Corrosion

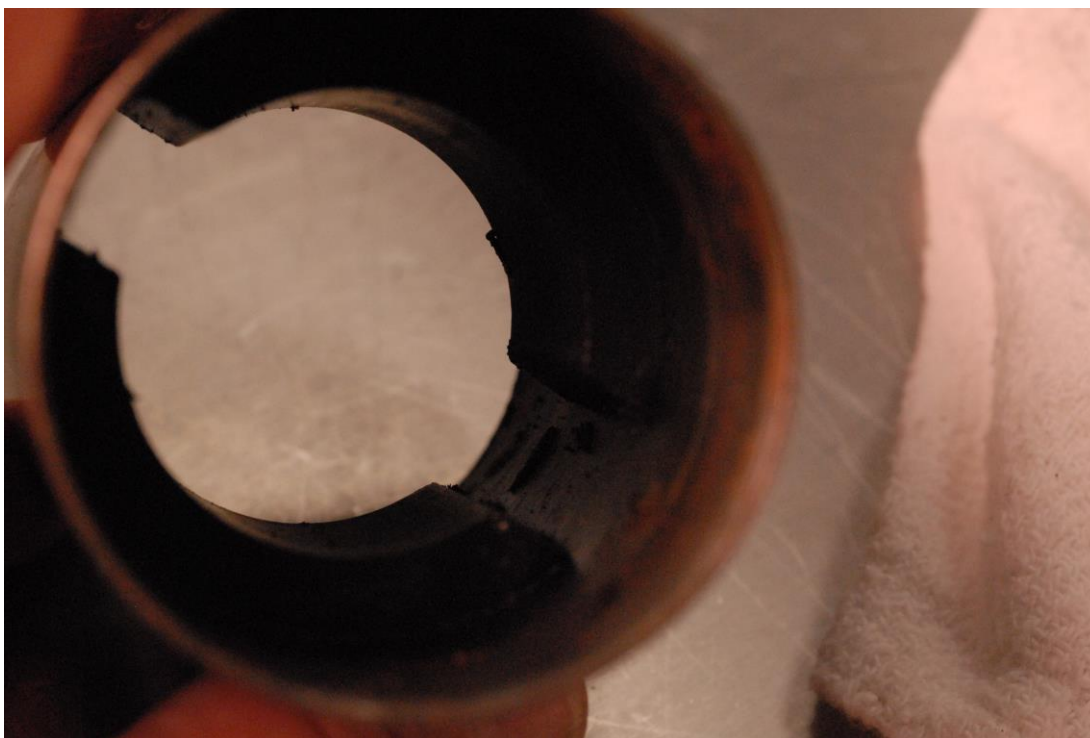
2C27-1 4H234 31Aug17\_044 – Field Tube Heavy Corrosion

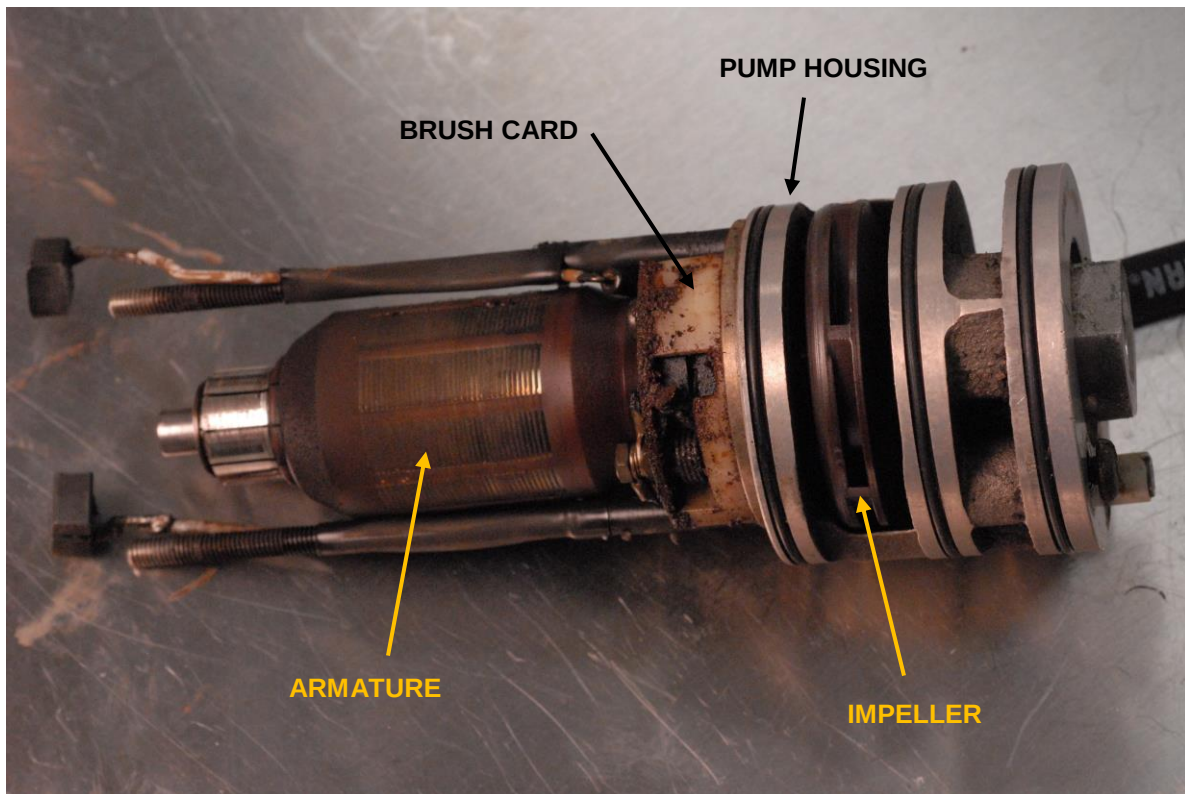
2C27-1 4H234 31Aug17\_047 – Field Tube Heavy Corrosion

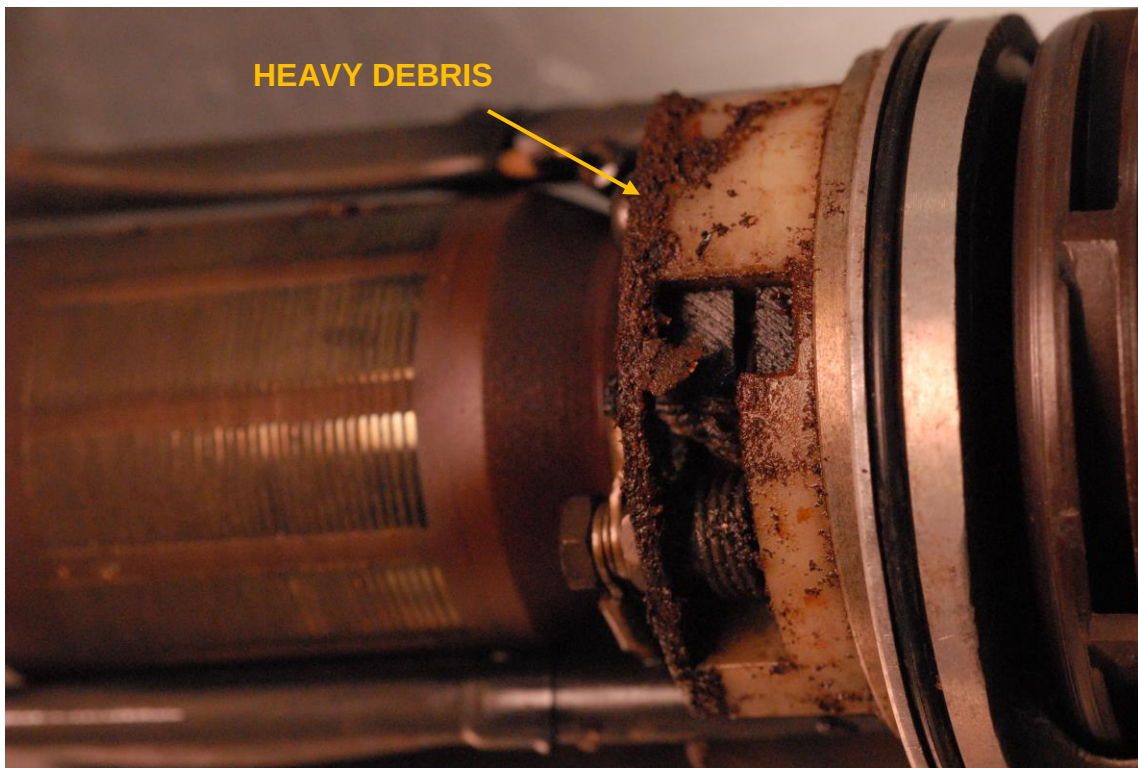
2C27-1 4H234 31Aug17\_049 - Heavy Debris on Lower Brush Card

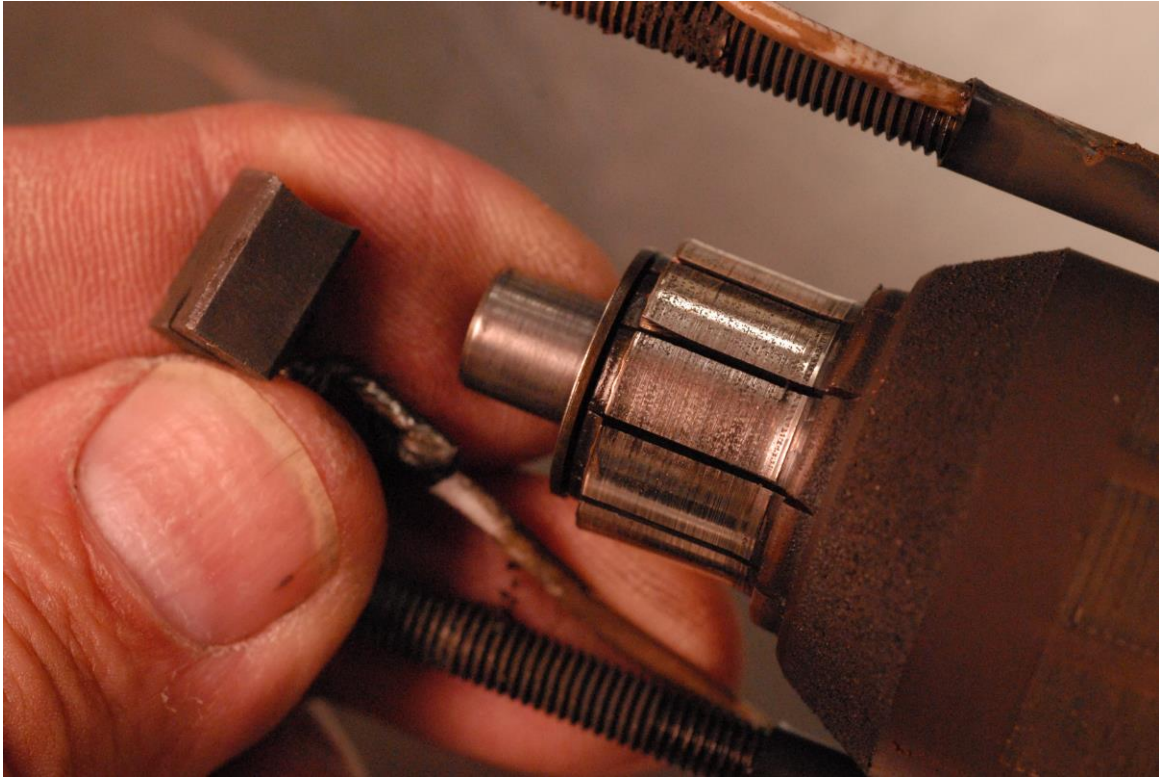
2C27-1 4H234 31Aug17\_052 – Motor Armature Potting Swelled

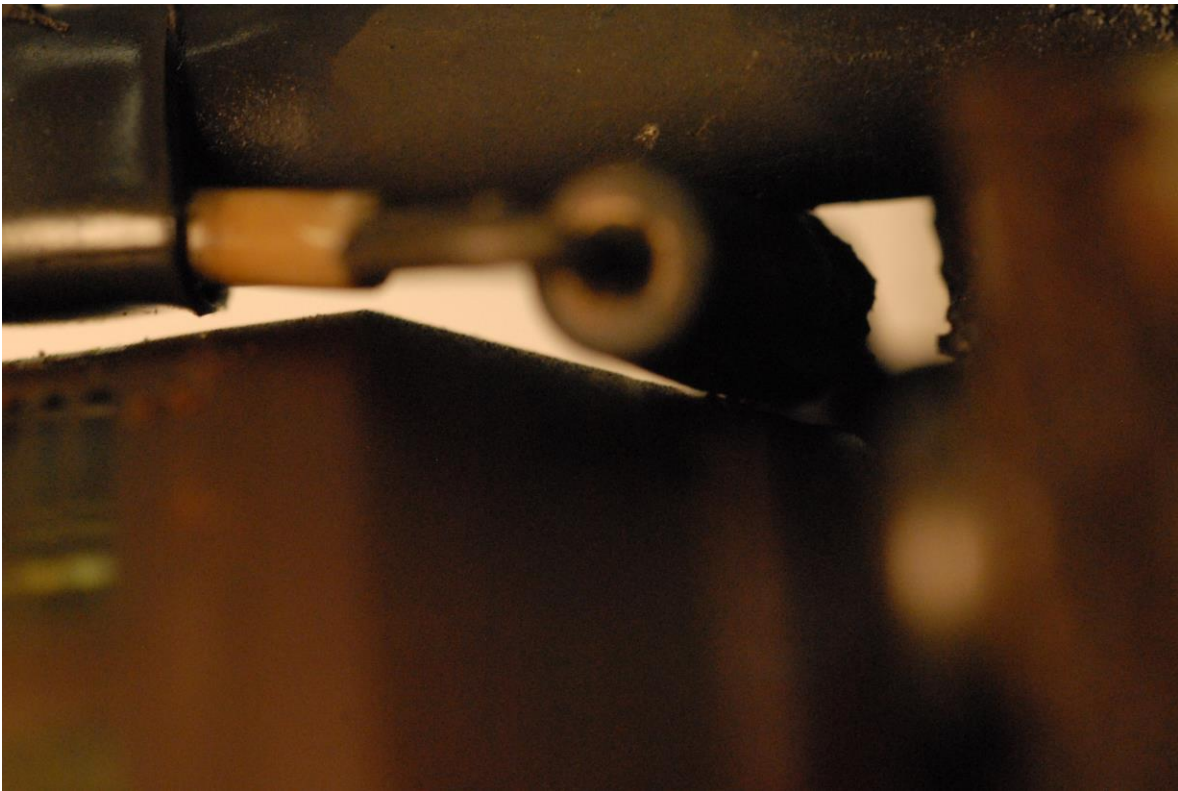
2C27-1 4H234 31Aug17\_053 - Armature Commutator – Signs of Arcing

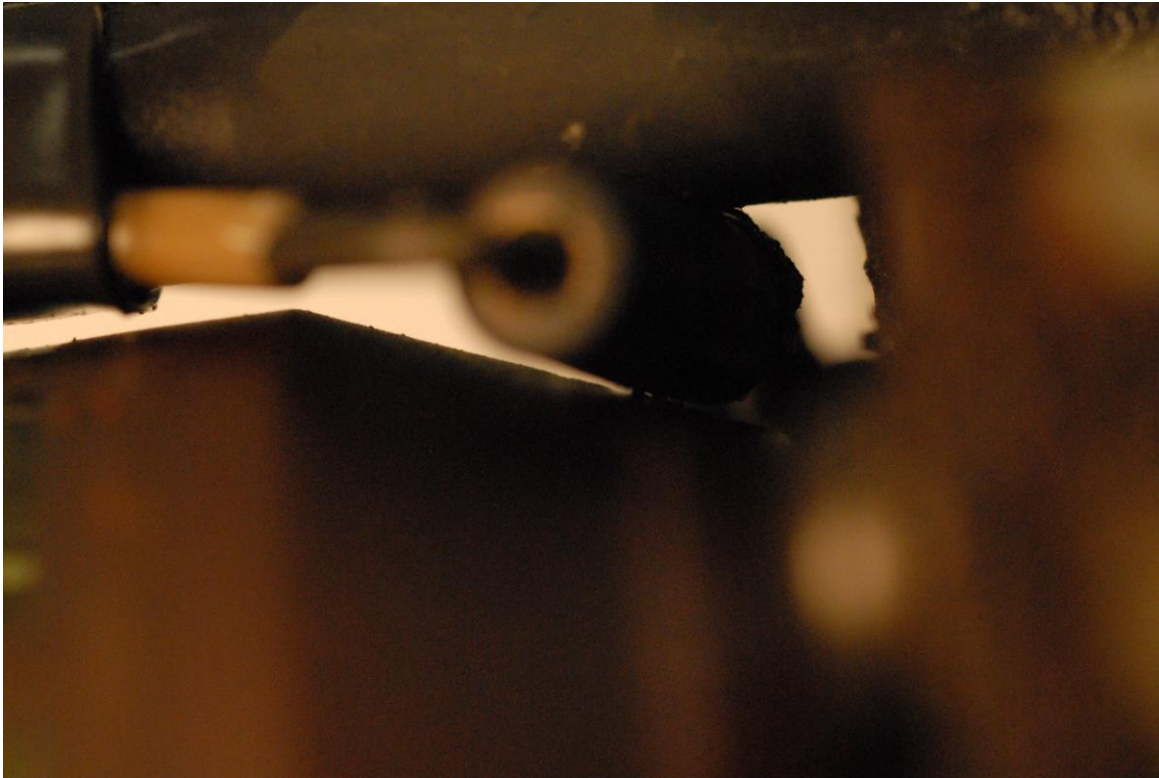
Thermal Fuse was found open from over-heating. Either from Dry Run or Dry Run in combination with the Armature rubbing the Thermal Fuse. The Thermal Fuse performed as designed to shut off the power to the pump before the pump casing could reach the auto-ignition temperature of fuel (approximately 390<sup>0</sup> F).

2C27-1 4H234 31Aug17\_054 – Armature Contacting Thermal Fuse

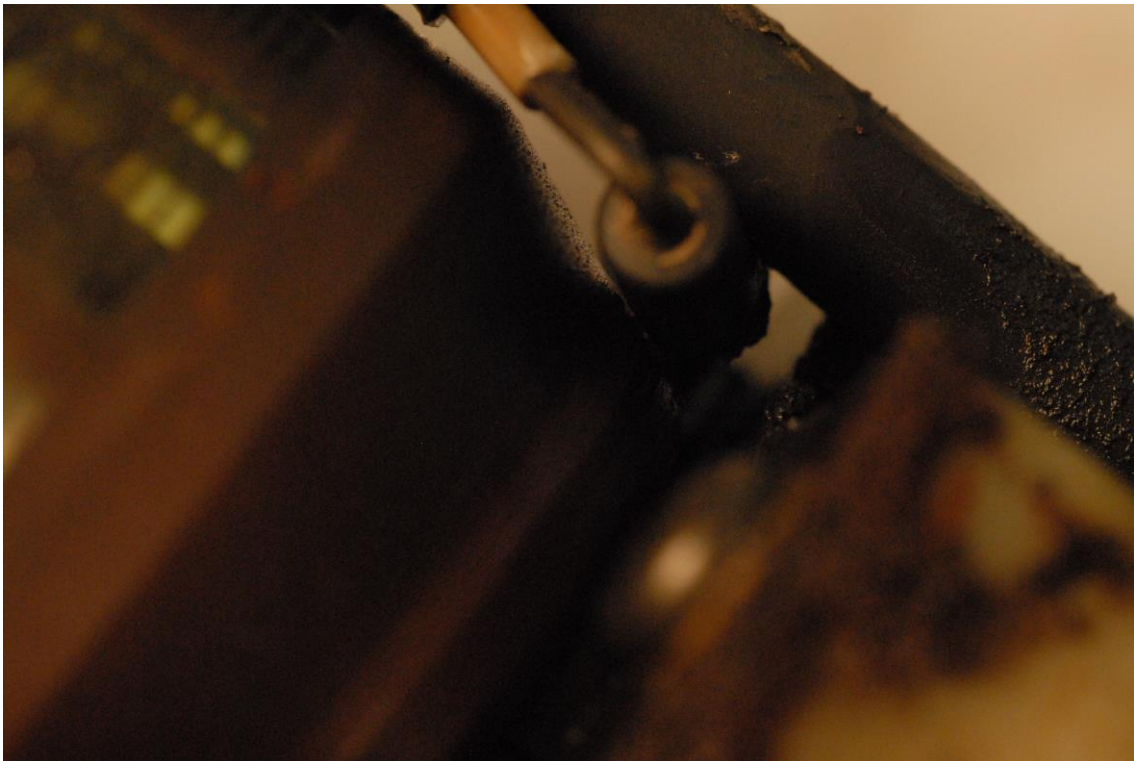
2C27-1 4H234 31Aug17\_055 – Armature Contacting Thermal Fuse

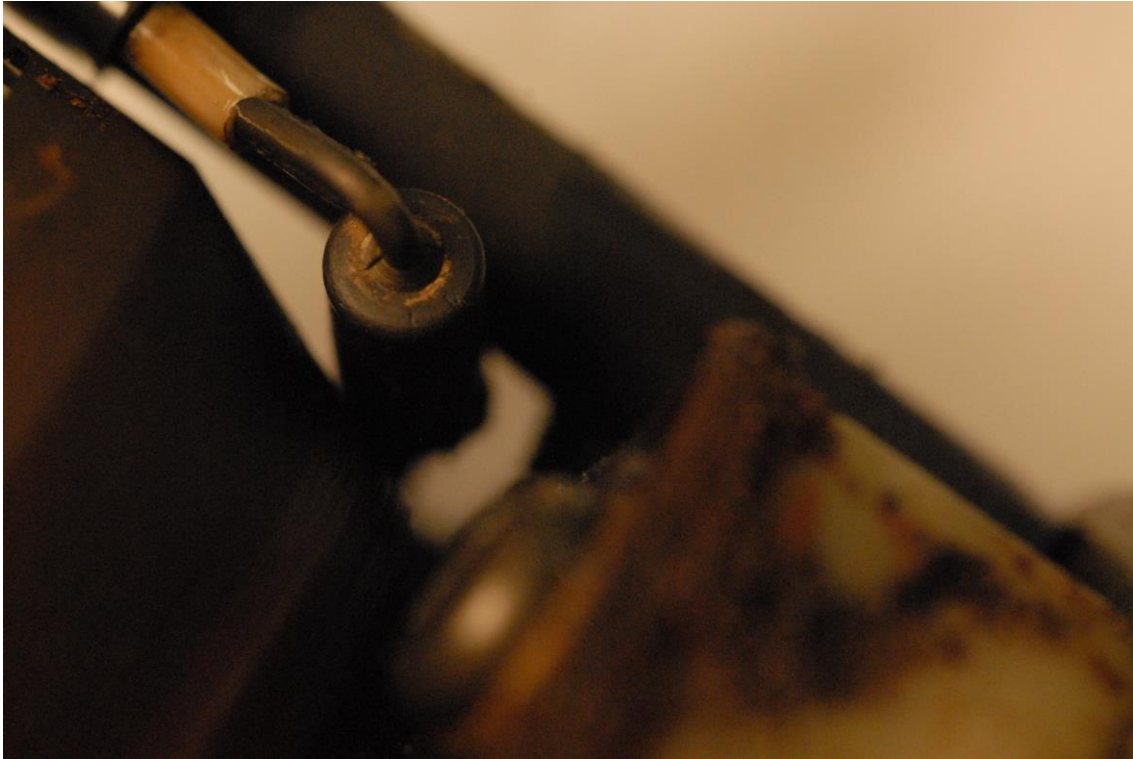
2C27-1 4H234 31Aug17\_056 – Armature Contacting Thermal Fuse

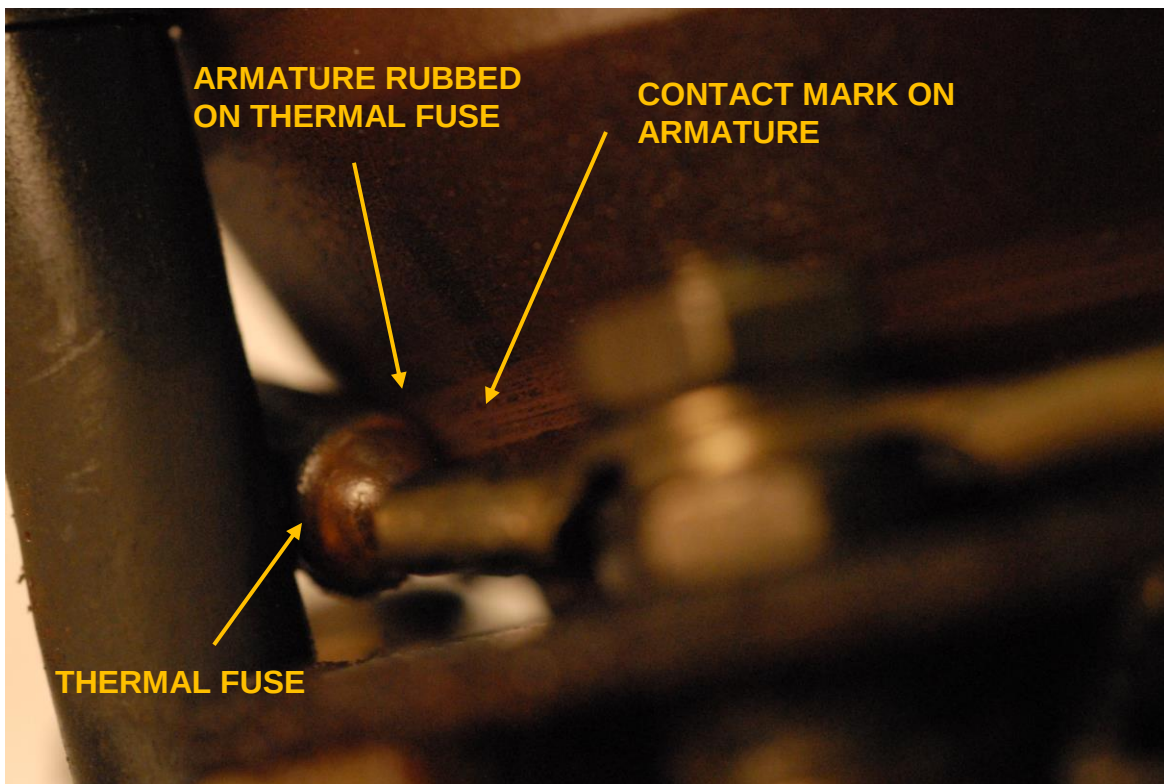
2C27-1 4H234 31Aug17\_057 – Armature Contacting Thermal Fuse

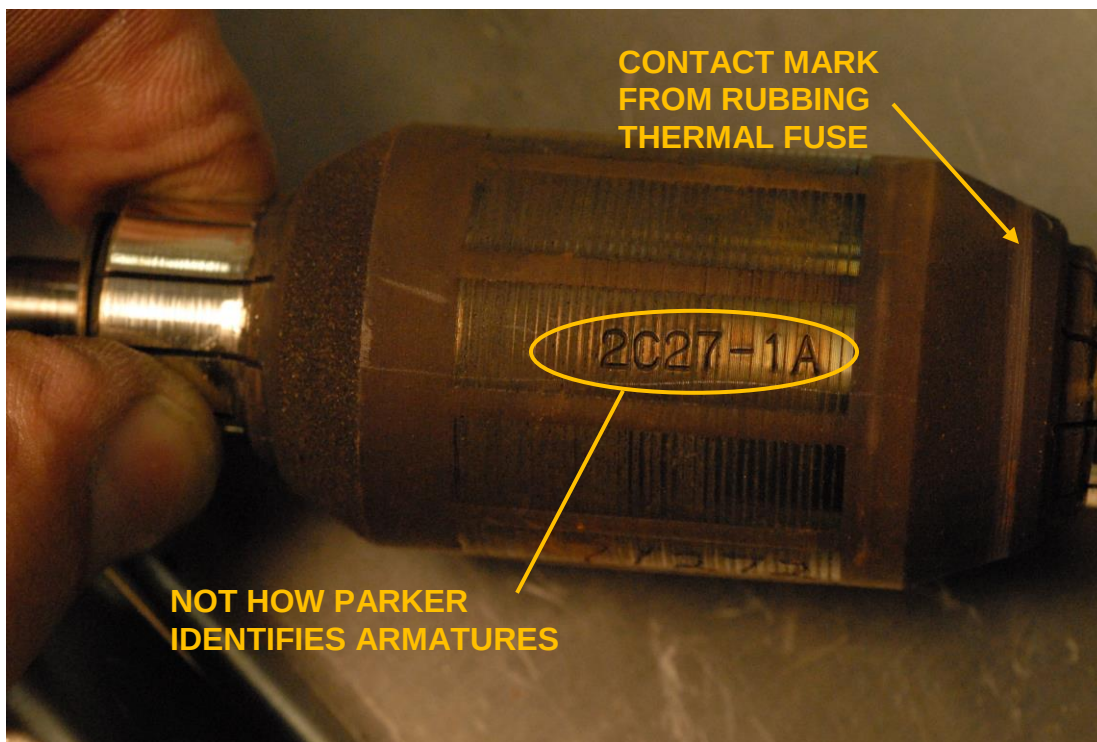
2C27-1 4H234 31Aug17\_058 – Armature Contacting Thermal Fuse

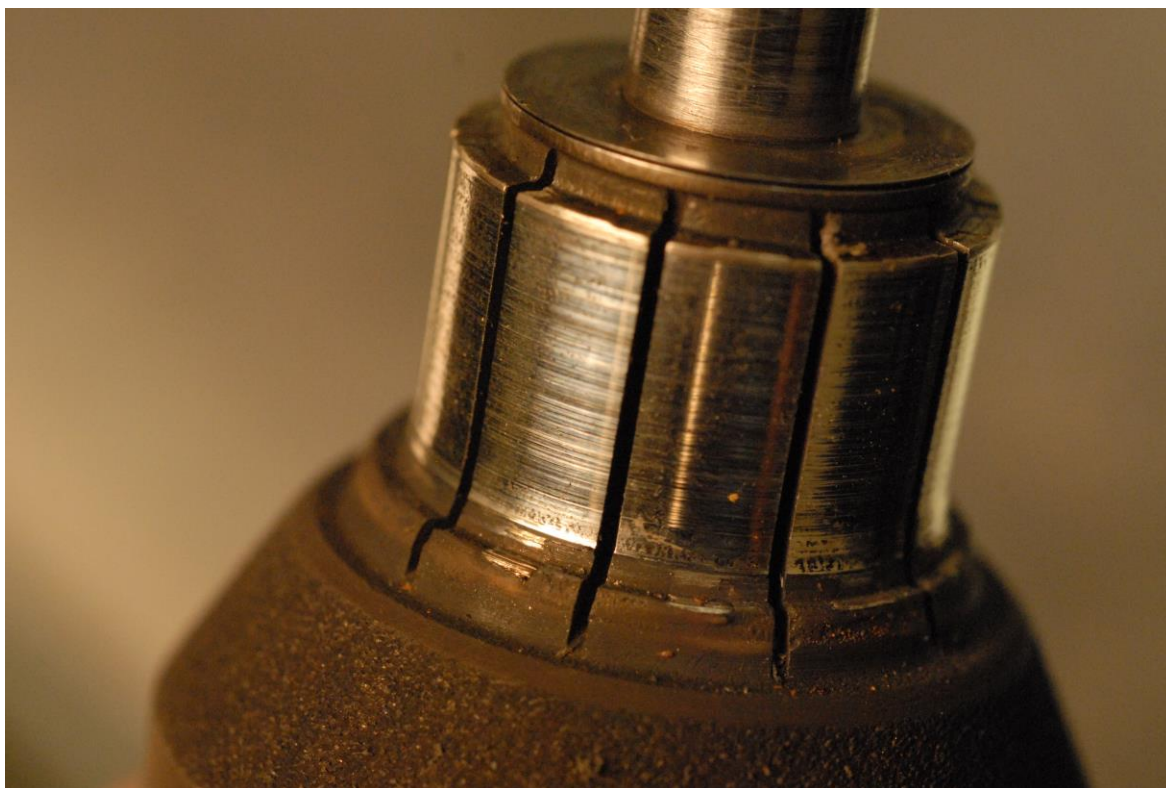
2C27-1 4H234 31Aug17\_059 - Non-Parker Marking on Armature

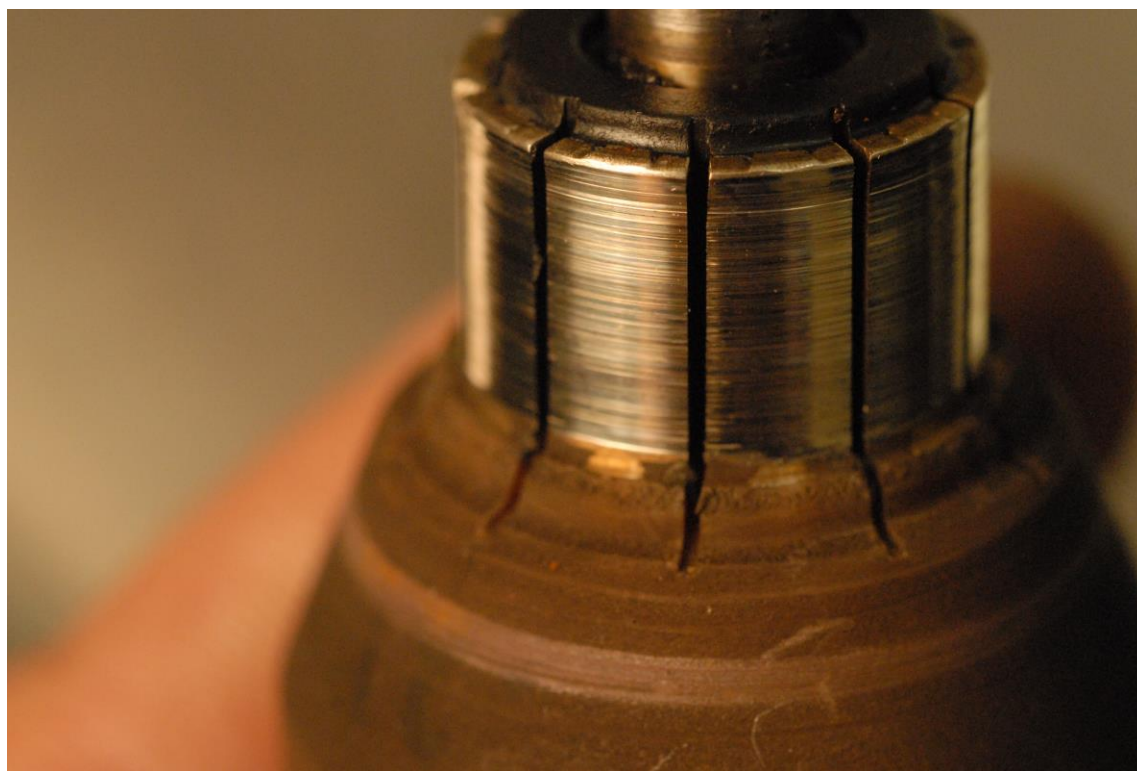
2C27-1 4H234 31Aug17\_061 – Signs of Arcing

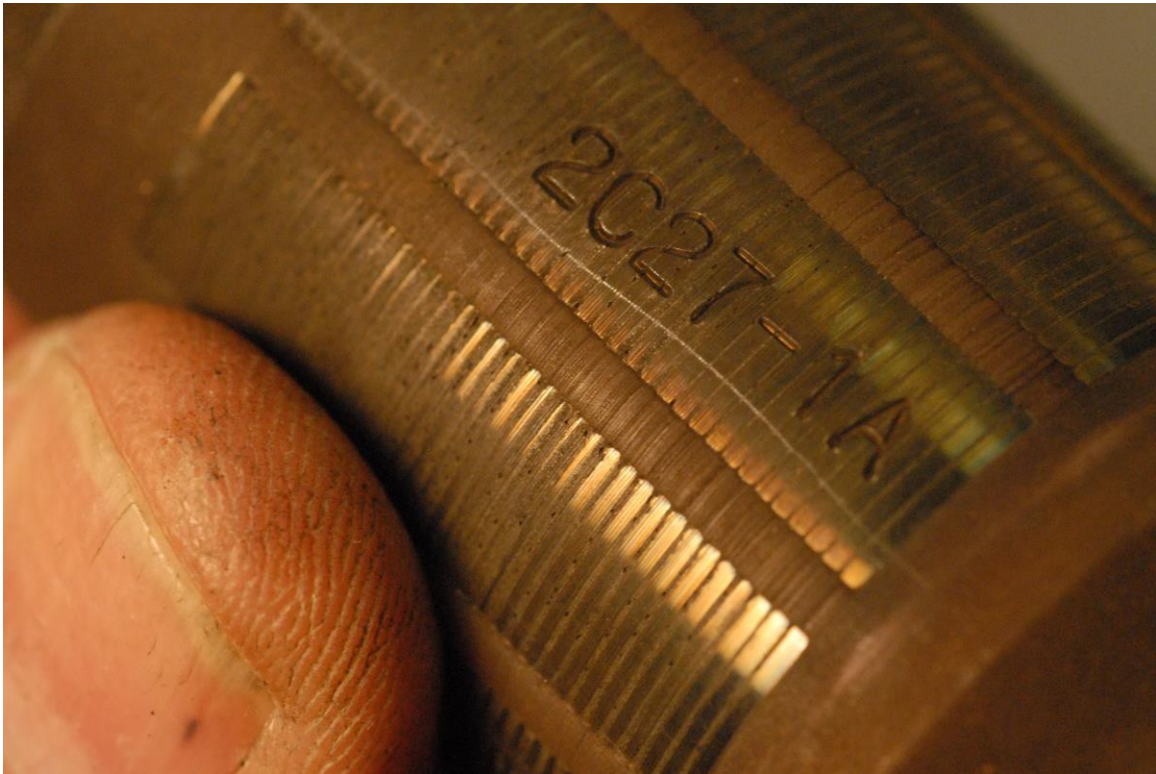
2C27-1 4H234 31Aug17\_064 – Non-Parker Marking

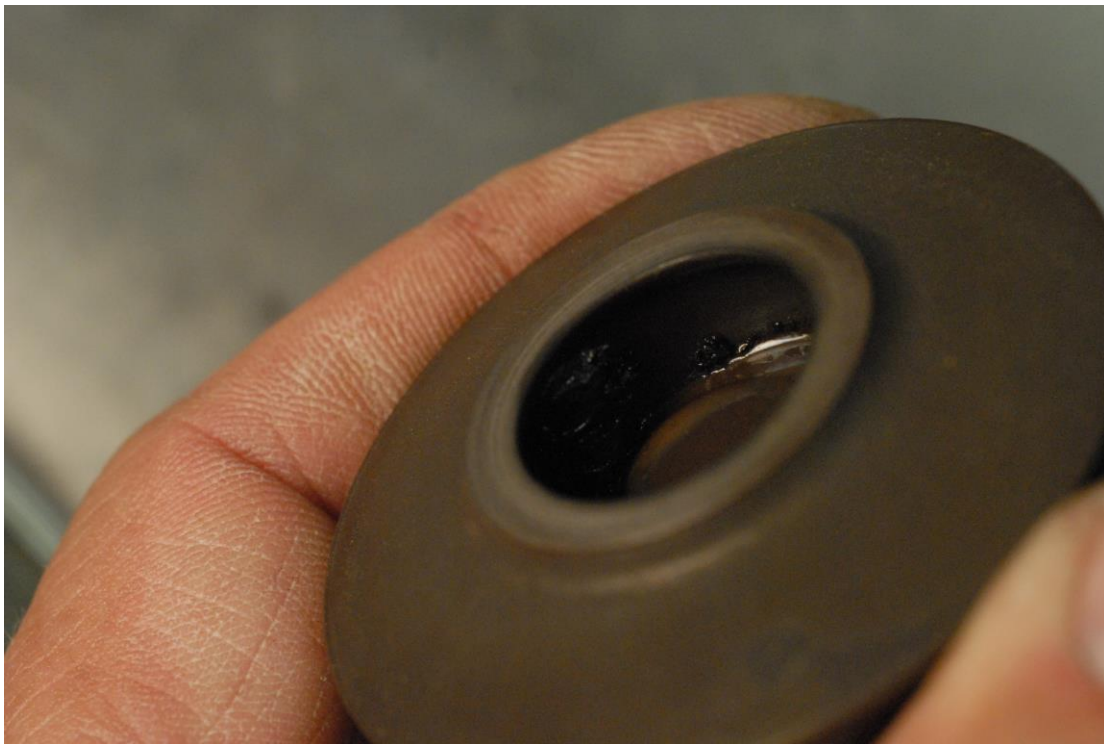
Prior to disassembly the unit's interfaces were marked for examination reassembly if needed. Refer to Photos 2C27-1 4H234 31 Aug17\_023 and 2C27-1 4H234 31 Aug17\_024. Removal of the Motor cover exposed the Brush Card Phenolic Insulator and Upper Brush Card itself. Both of these items were covered with debris (FOD). Refer to Photos 2C27-1 4H234 31 Aug17\_029 and 2C27-1 4H234 31 Aug17\_032. The Motor Brush marked "K194" in Photo 2C27-1 4H234 31 Aug17\_035 is not of Parker design. The Upper Motor Brushes in 2C27-1 4H234 31 Aug17\_036 through 2C27-1 4H234 31 Aug17\_039 show arcing on one of the Brushes. Arcing of this degree will shorten pump motor service life. Debris was found throughout the inside of the motor cavity with the heaviest as corrosion on the inside of the field tube or on adjacent components such as the Lower Brush Card. Refer to 2C27-1 4H234 31 Aug17\_042 through 2C27-1 4H234 31 Aug17\_050. The Motor Armature potting between the laminations had swelled past the lamination diameter indicating that the pump had been run dry. This design pump circulates fuel through the motor to cool the motor and lubricate the bearings. When run dry, fuel will not be available to cool the motor, thus the motor temperature will increase. As the motor temperature increases the copper windings within the armature will expand pushing the potting between the laminations beyond the lamination diameter. Continued increase in pump temperature will open the Thermal Fuse, shutting off power to the pump's motor. Refer to Photos 2C27-1 4H234 31 Aug17\_052 and 2C27-1 4H234 31 Aug17\_066. The Thermal Fuse continuity was checked and the fuse was found to be open. Aside from the motor overheating as a possible cause for the open Thermal Fuse, the Thermal Fuse was contacting the Armature during operation of the pump. As the Armature rotated the friction of the contact added to the temperature of the Thermal Fuse. Refer to Photos 2C27-1 4H234 31 Aug17\_058, 2C27-1 4H234 31 Aug17\_059, and Photos 2C27-1 4H234 31 Aug17\_075 through 2C27-1 4H234 31 Aug17\_077. The Pump's Impeller consists of 3 initial blades that pull fuel into the Impeller Eye, 2 of the 3 were blocked by a black substance. Refer to 2C27-1 4H234 31 Aug17\_071 through 2C27-1 4H234 31 Aug17\_074.

The Impeller blockage on the leading edge of 2 of the 3 leading Impeller Vanes happened prior to the Pump Motor becoming inoperative. When this unit went into idle bypass most if not all the fuel flow would travel through the bypass porting within the Pump Canister.

2C27-1 4H234 31Aug17\_071 – Debris across 1<sup>st</sup> Impeller Blade Inlet

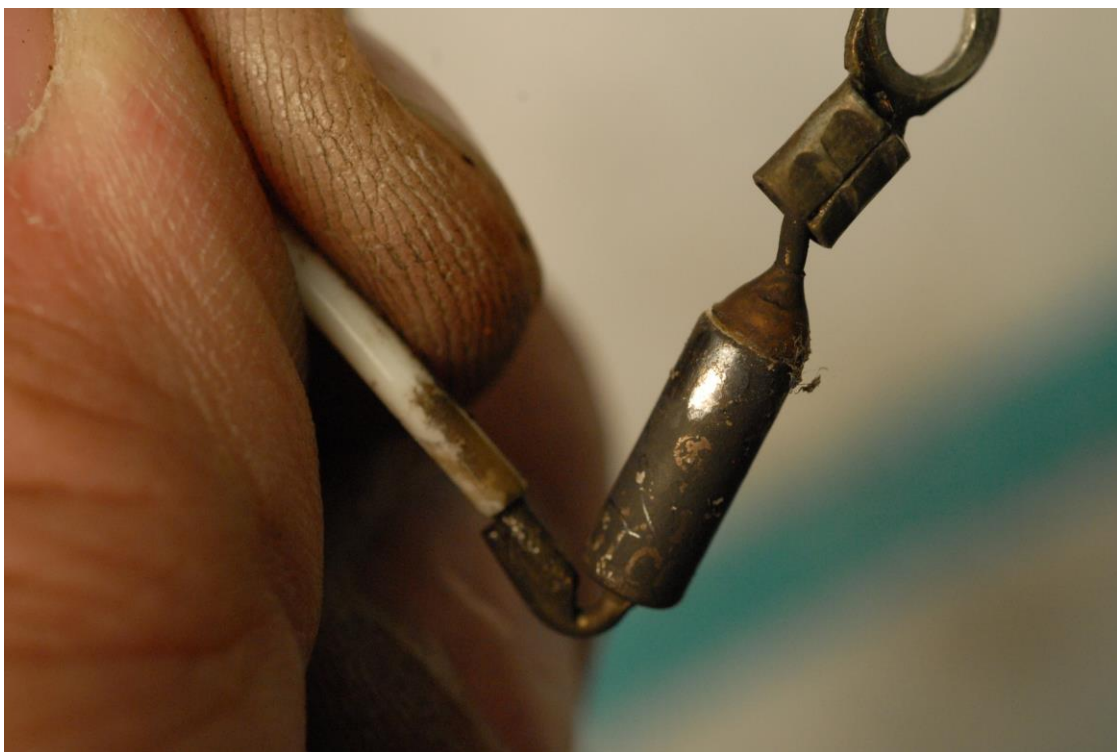
2C27-1 4H234 31Aug17\_075 - Contact Mark from Armature Rubbing Thermal Fuse

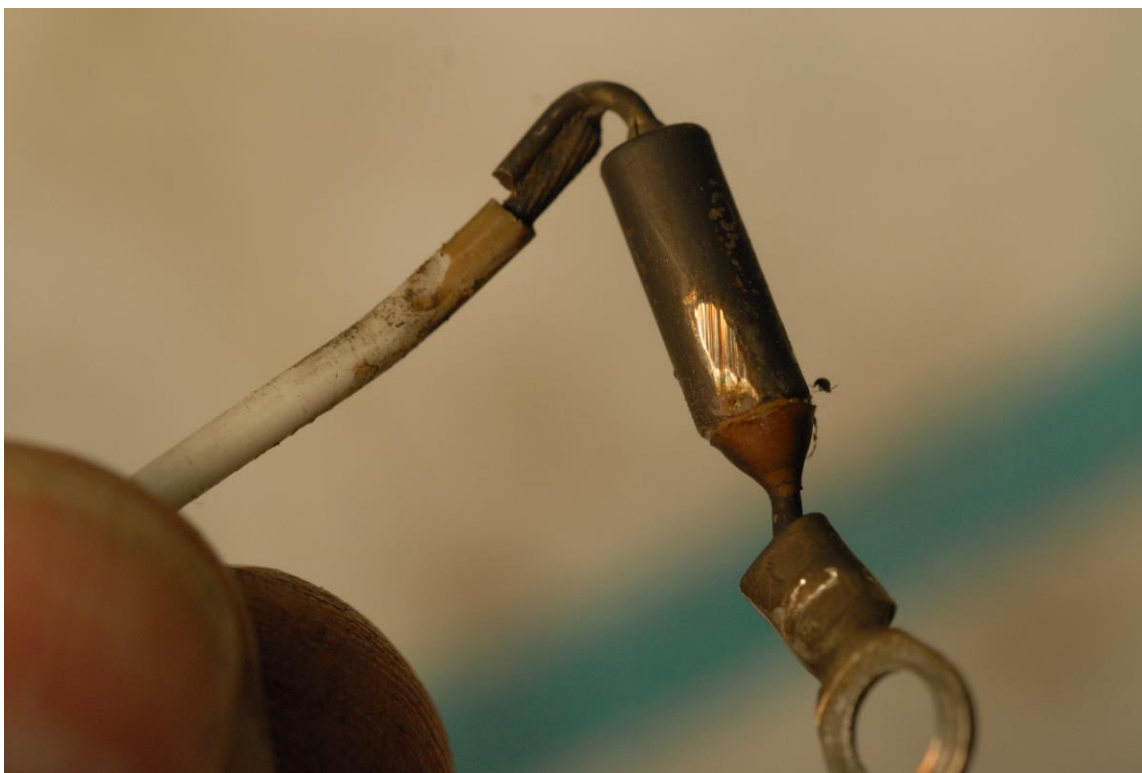
2C27-1 4H234 31Aug17\_076 - Contact Mark from Armature Rubbing Thermal Fuse

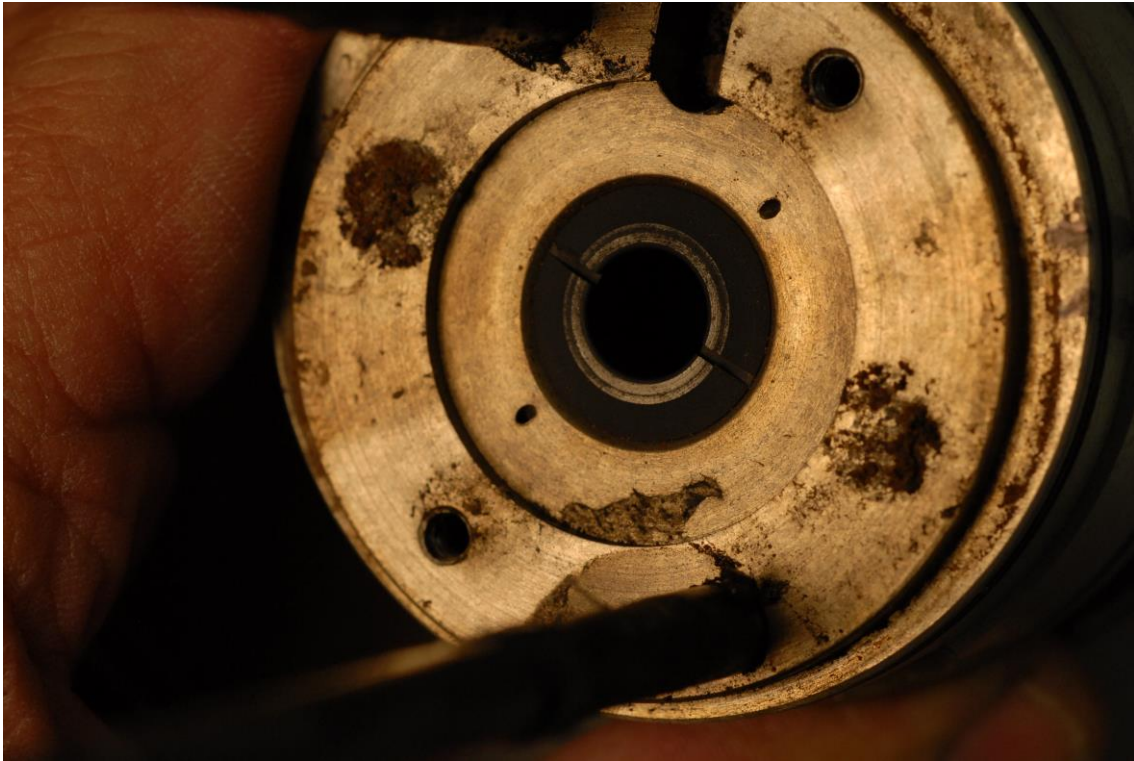
2C27-1 4H234 31Aug17\_78 – Debris on Pump Housing.
