## RECORD OF CONVERSATION

**Date: March 2, 2017**  
**Person Contacted: Mr. Aaron Southerland (Federal Aviation Administration)**  
**NTSB Accident Number: WPR17LA072**

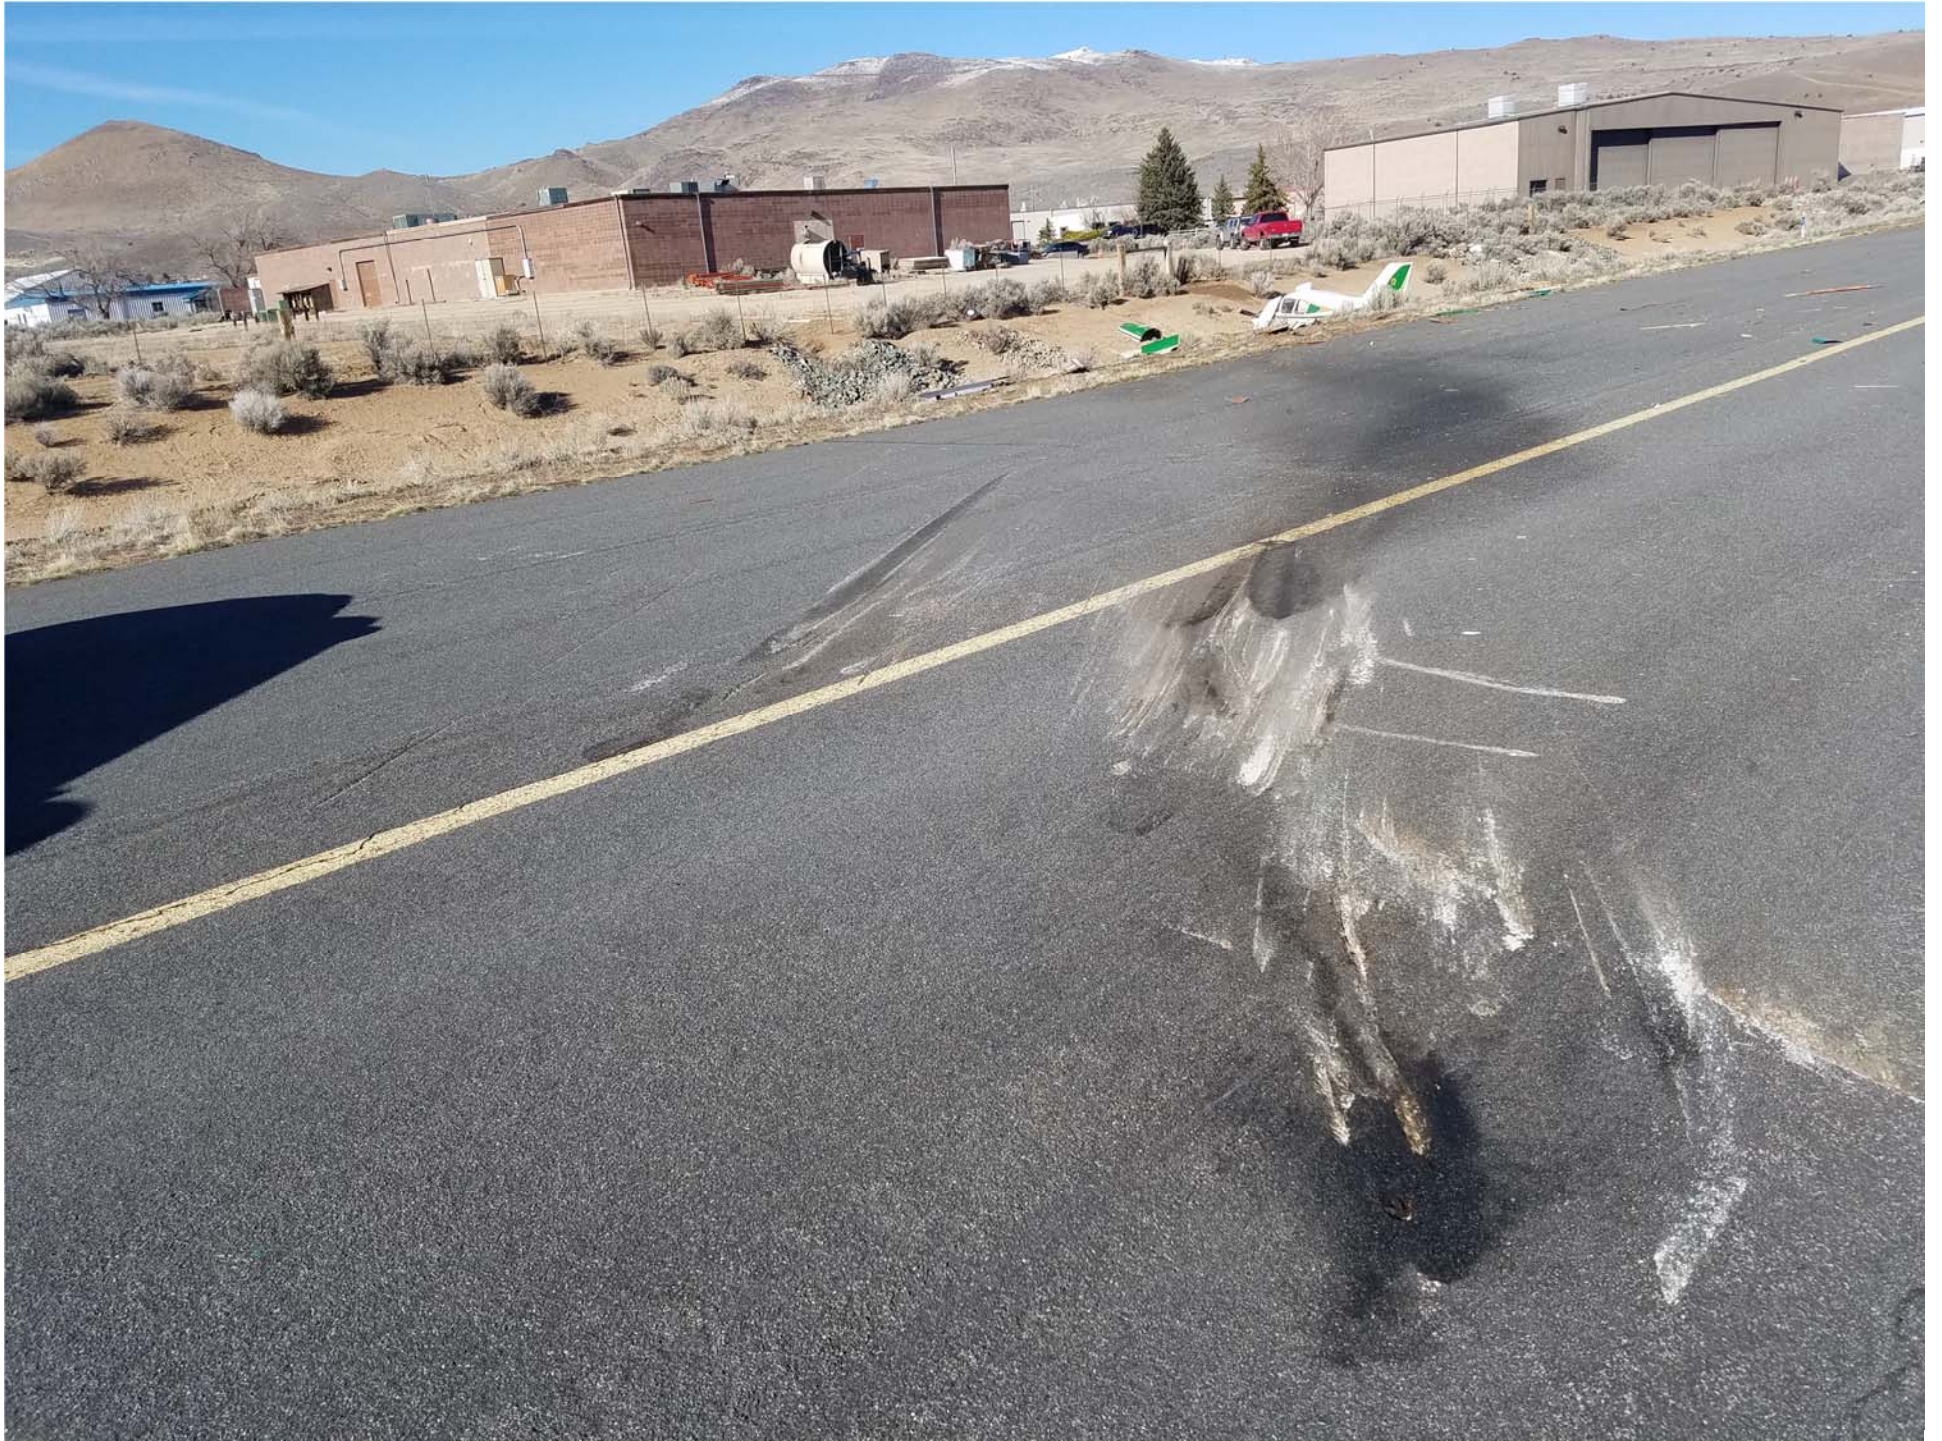
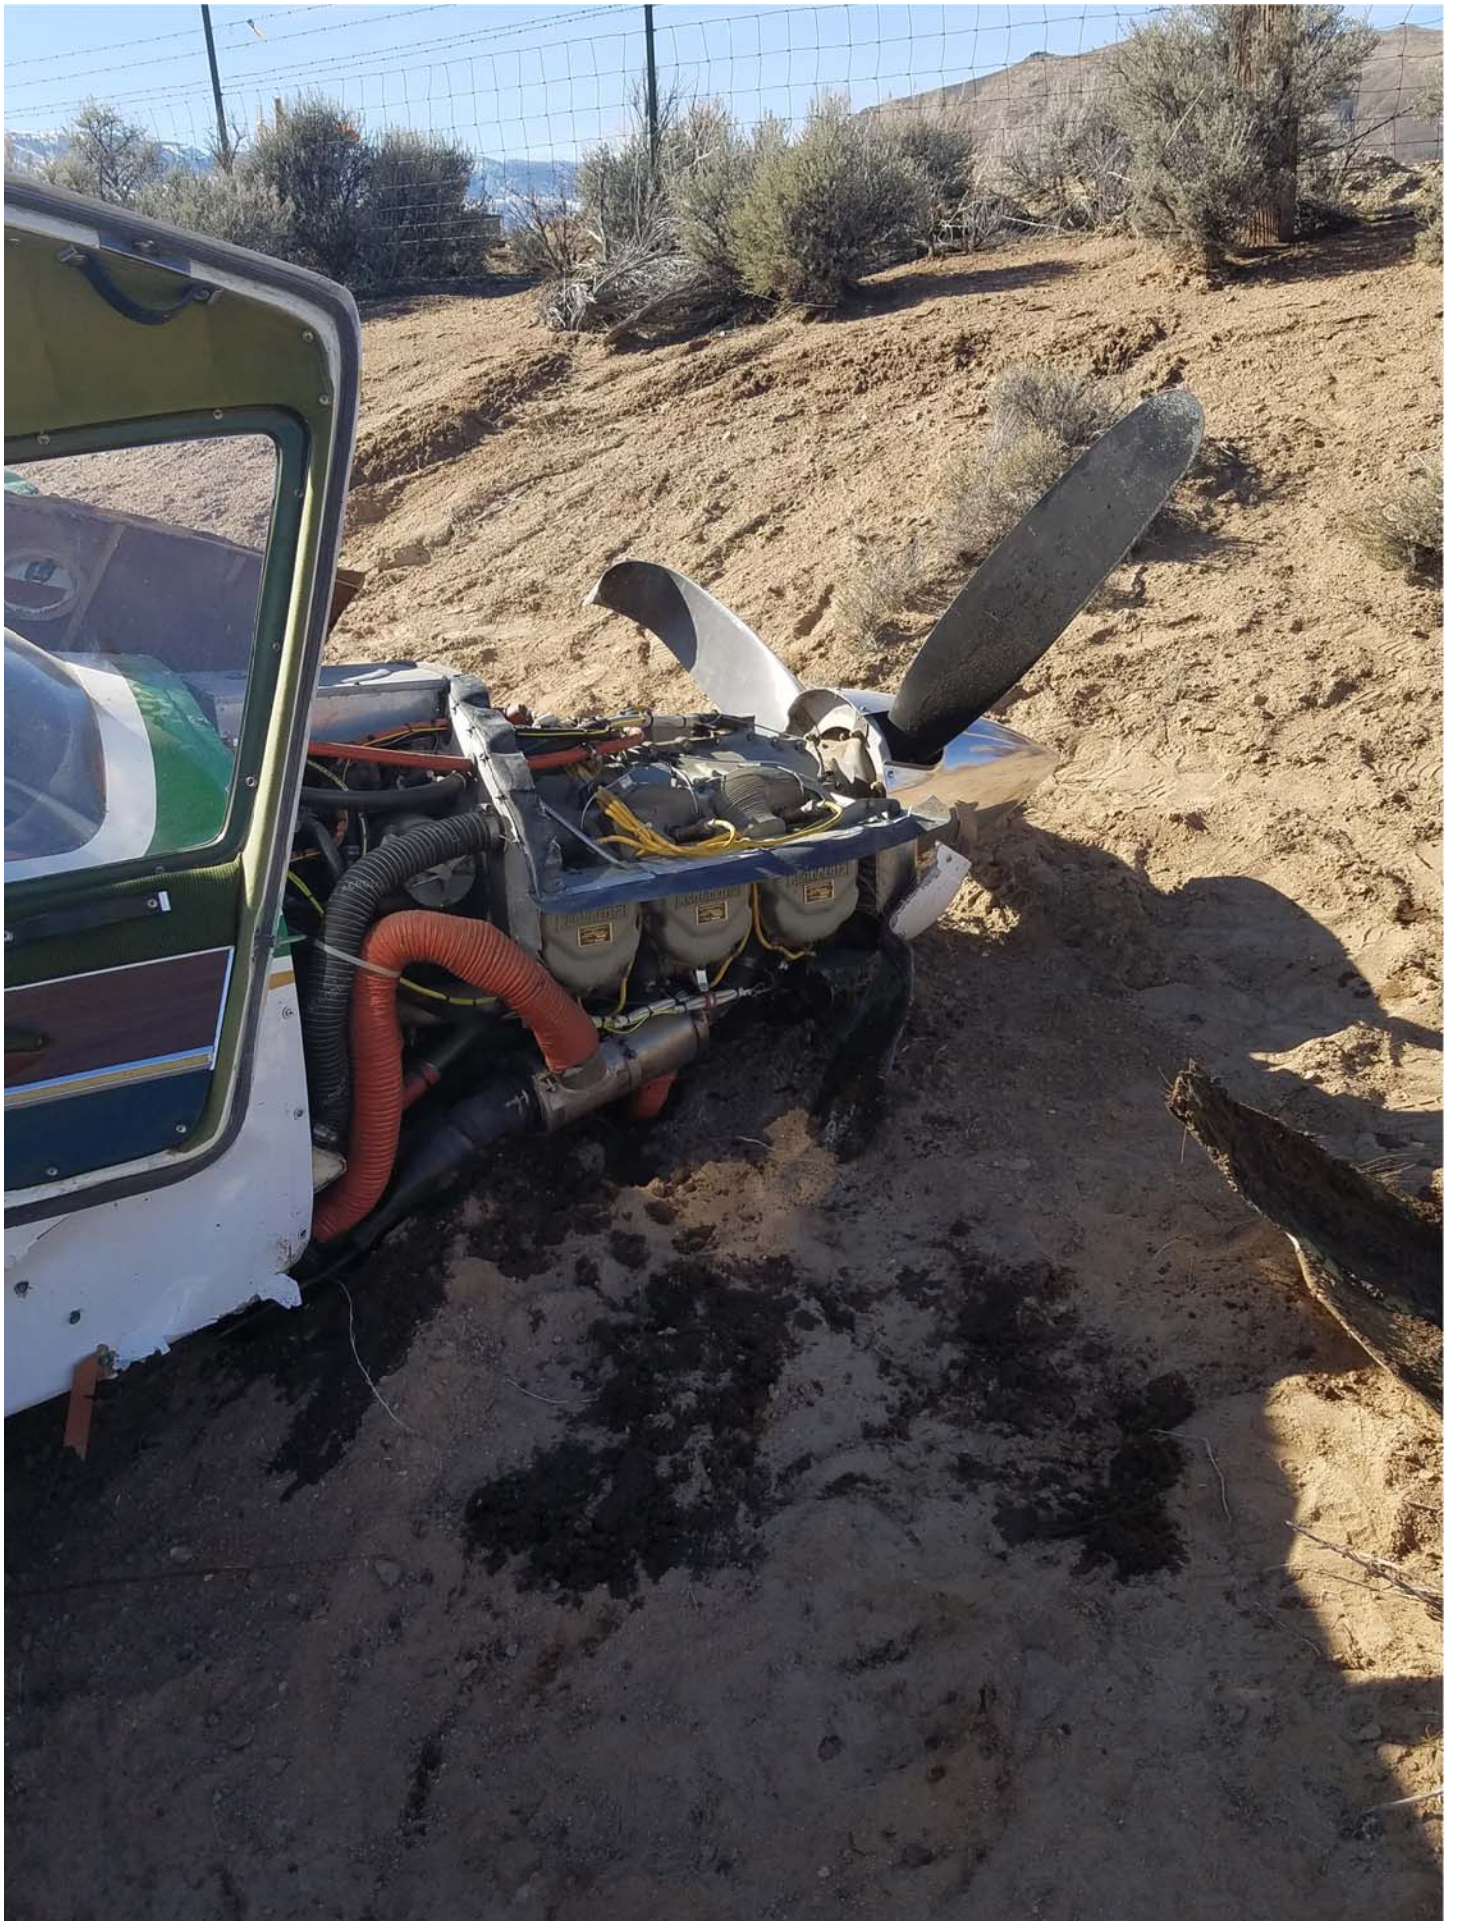
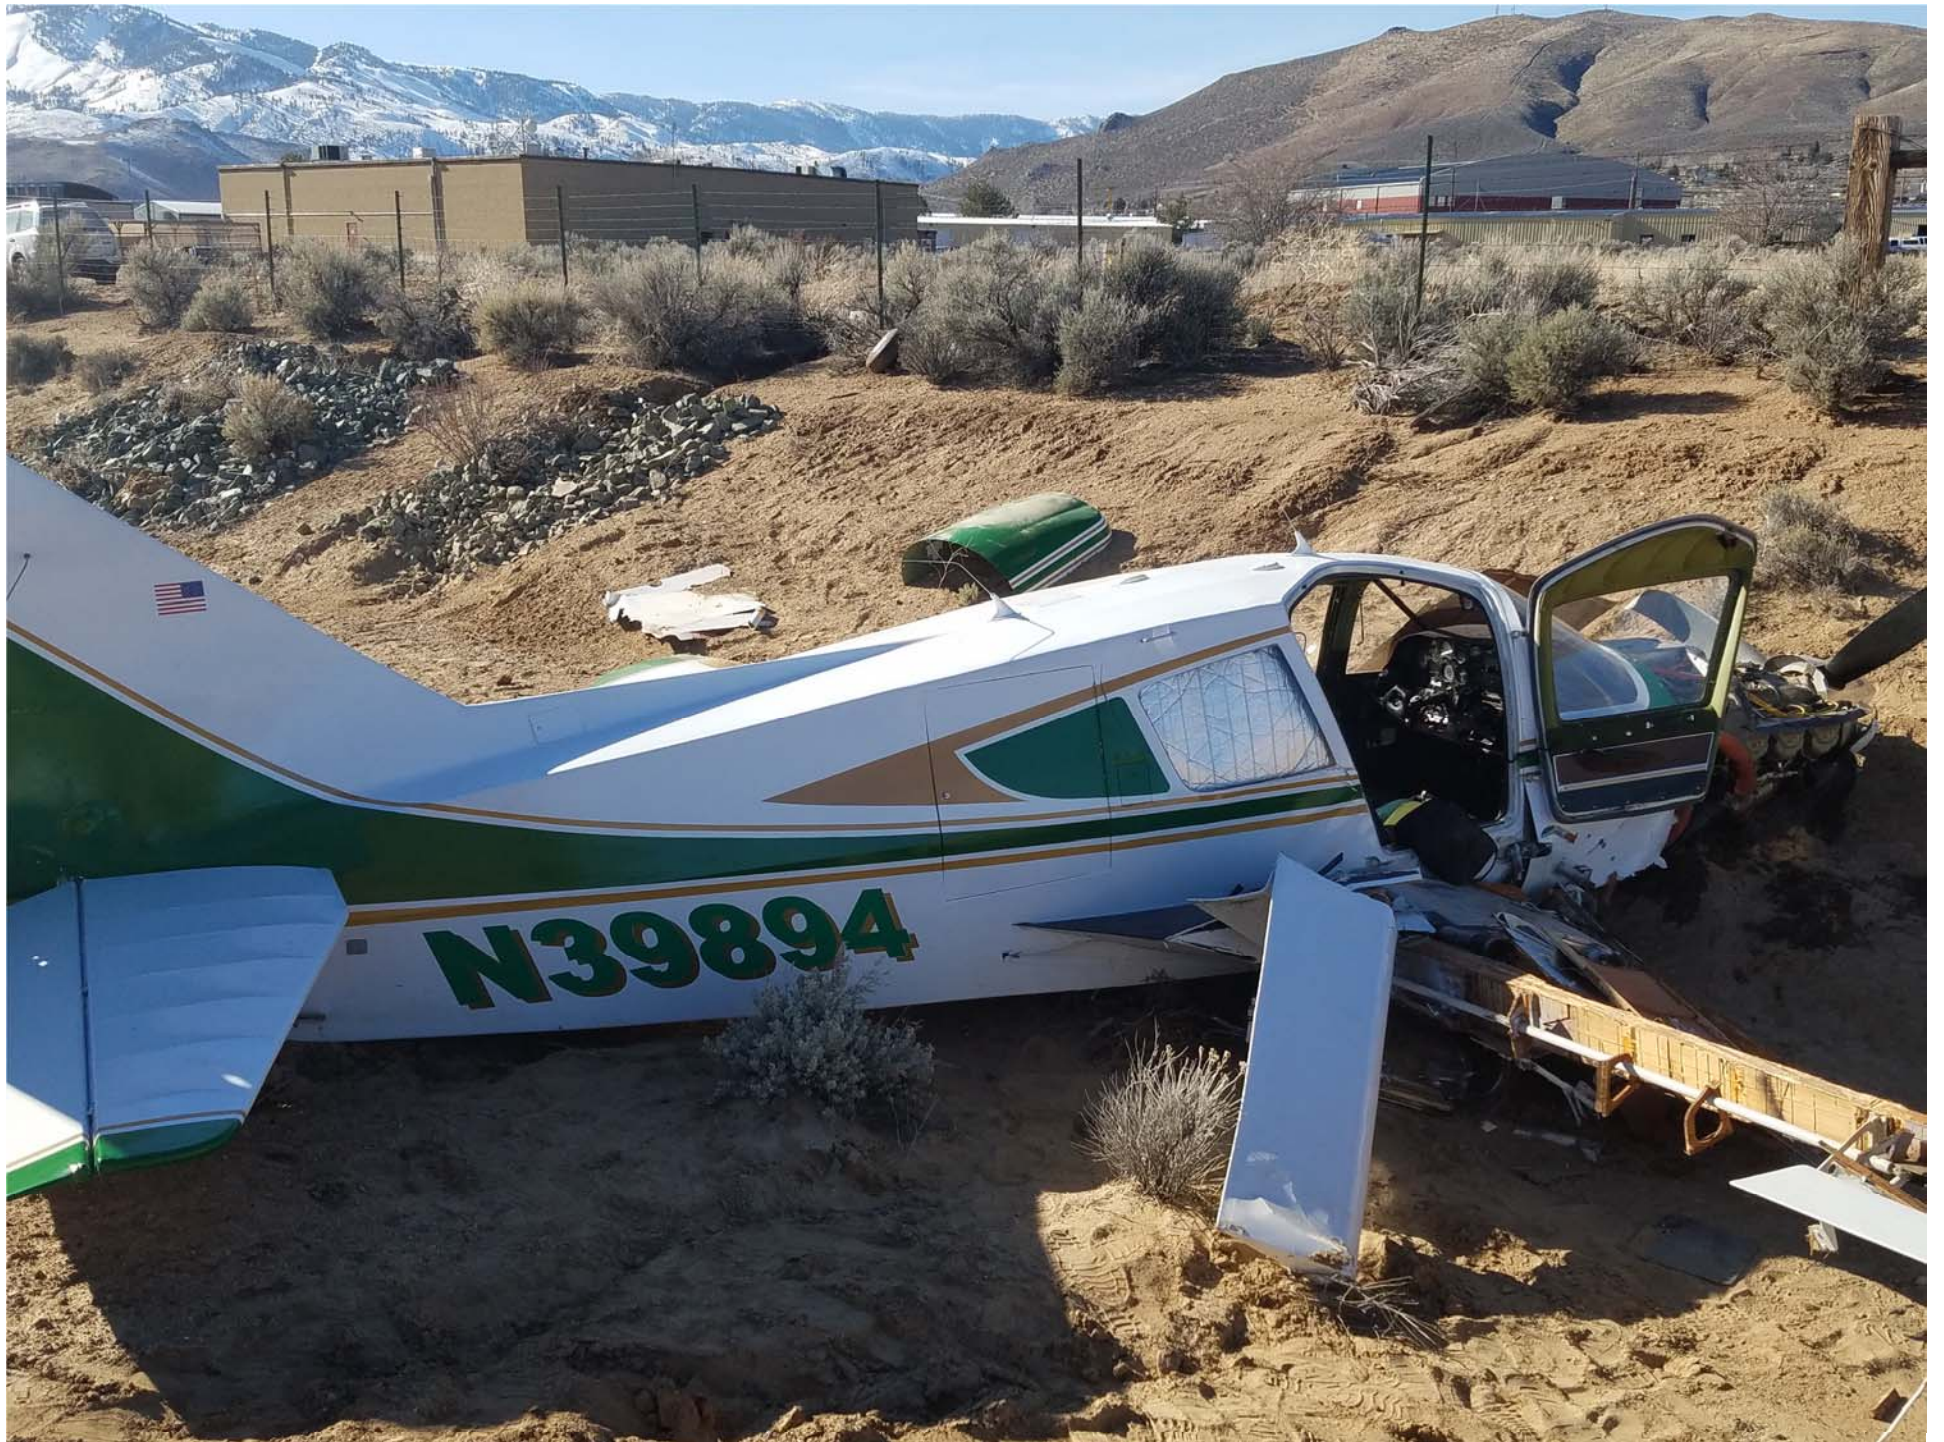
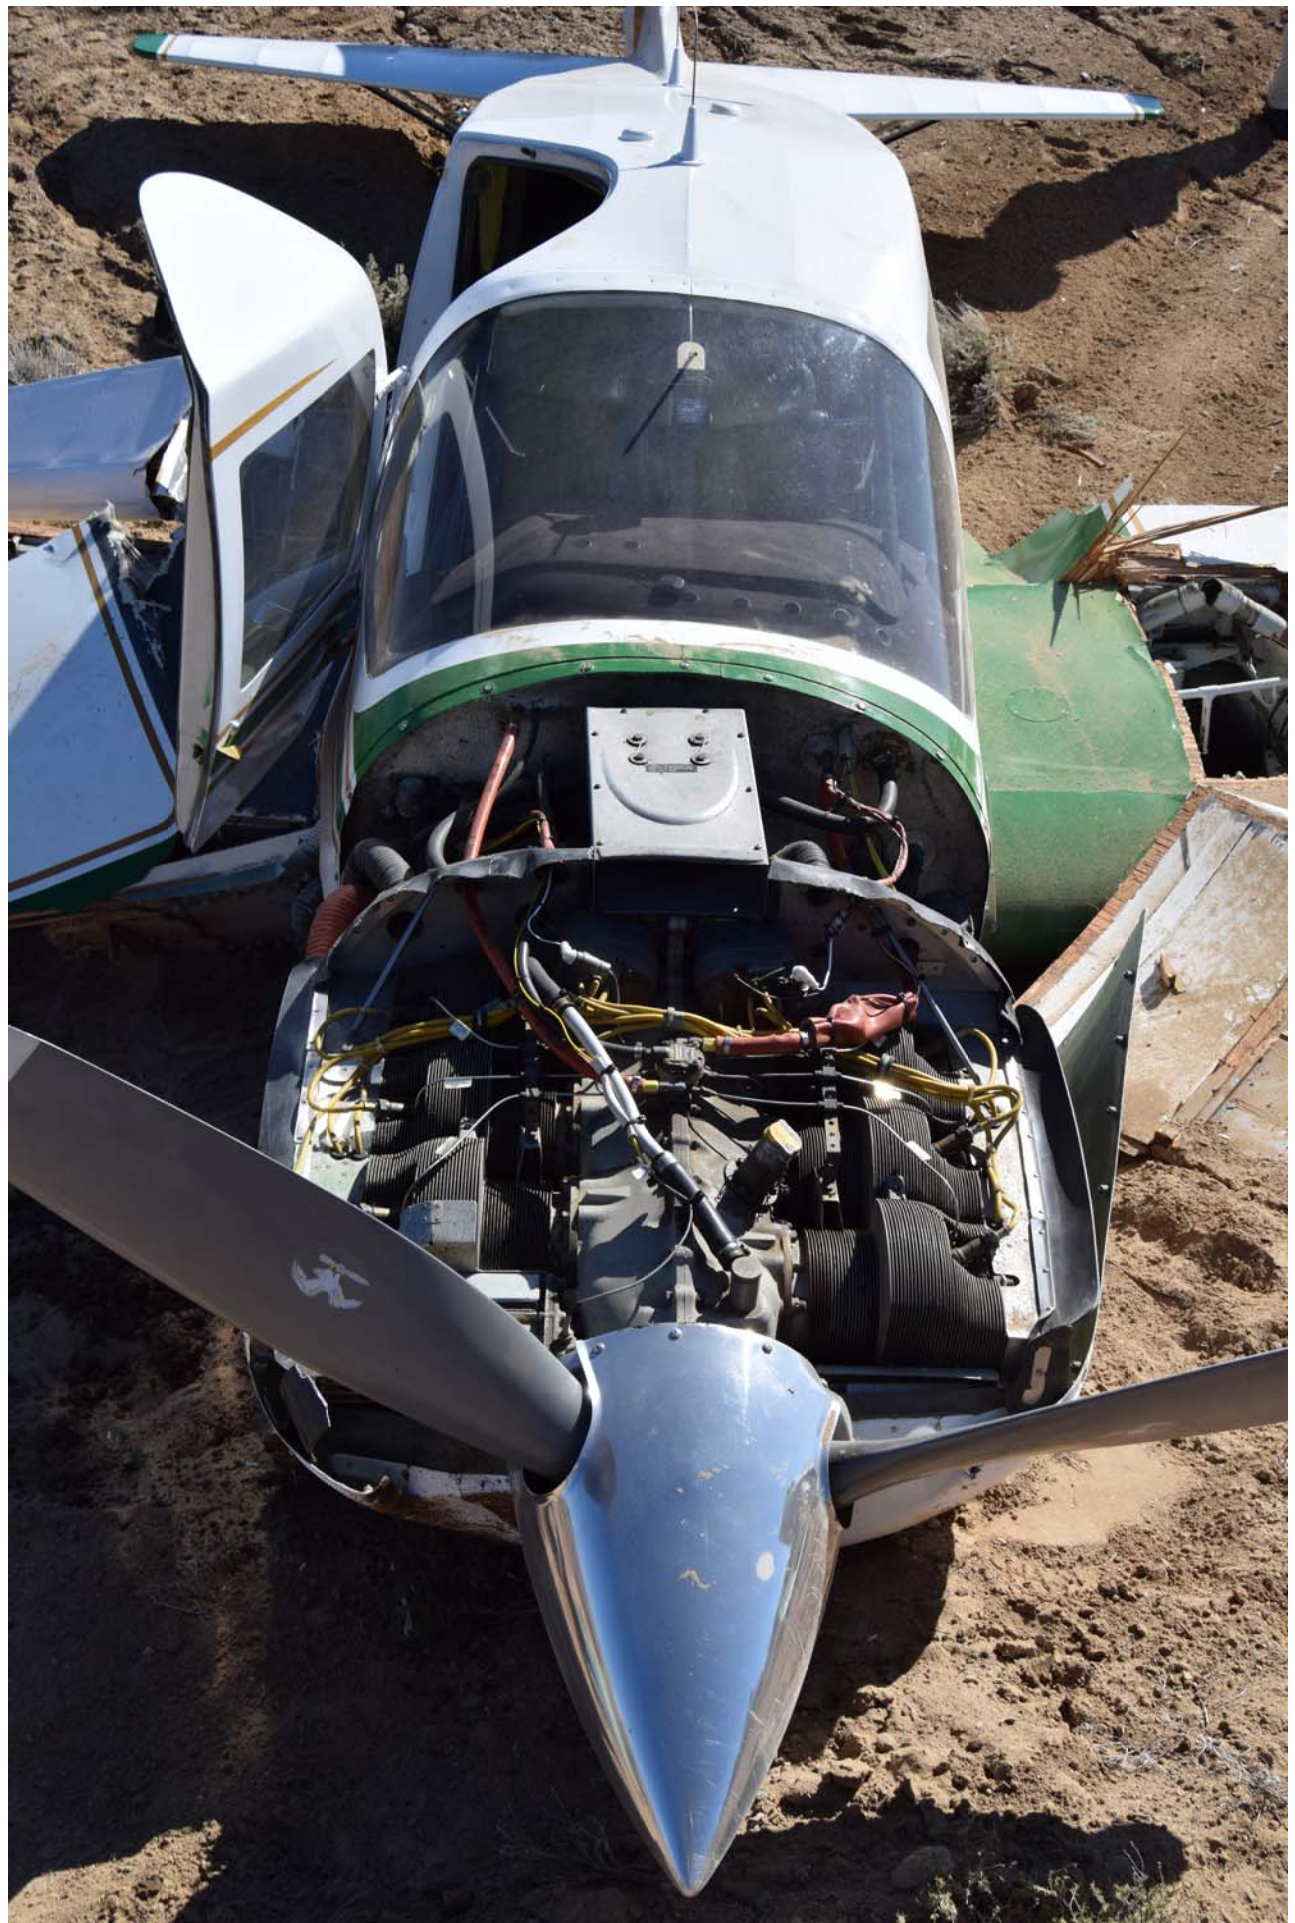
During a telephone with Mr. Southerland, an aviation safety inspector with the Federal Aviation Administration, reported that the airplane impacted the taxiway hard. There are wing, fuselage, and propeller marks in the asphalt. There were also fuel puddles in the area of the left wing impact mark. The airplane slid across the asphalt and came to rest in the adjacent dirt. Both wings were destroyed and the fuselage was heavily damaged. One propeller blade is bent aft, the other is straight, and the third is buried in the dirt. The cowling was removed from the engine and there were no obvious anomalies with the engine. The throttle and mixture linkages remained intact.
