## **NATIONAL TRANSPORTATION SAFETY BOARD**

# **ENGINE EXAMINATION**

**WPR17LA072**

Location: Carson City, Nevada  
Date: March 1, 2017  
Aircraft: Bellanca 17-30A, Registration #N39894, Serial #73-30544  
NTSB IIC: Samantha Link

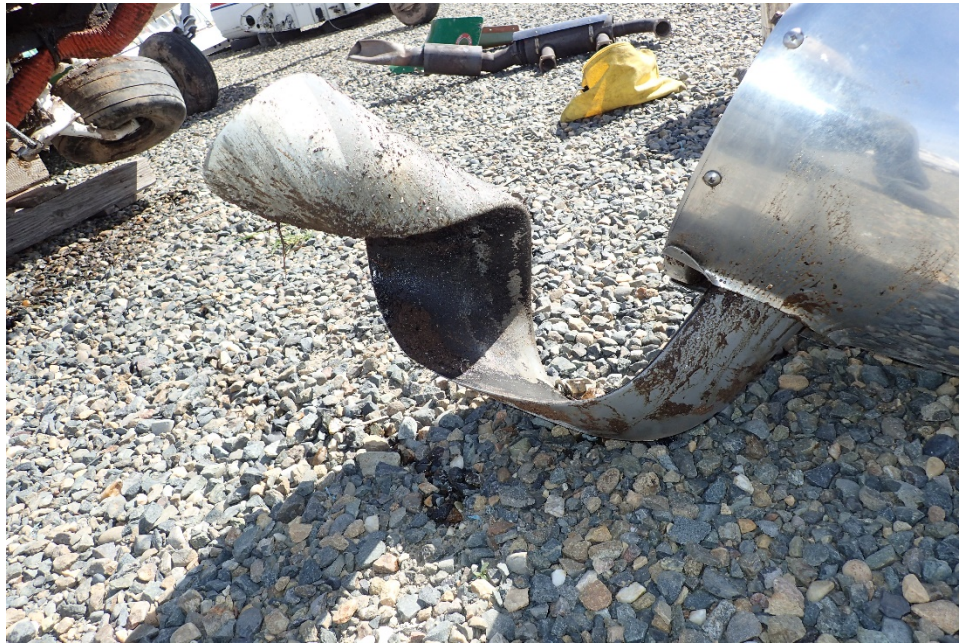
- The third propeller blade was heavily damaged and was curled, similar to a spiral, throughout.
- The top spark plugs were removed and they were “normal” when compared to the Champion check-a-plug chart.

Figure 3: The “third” Propeller Blade

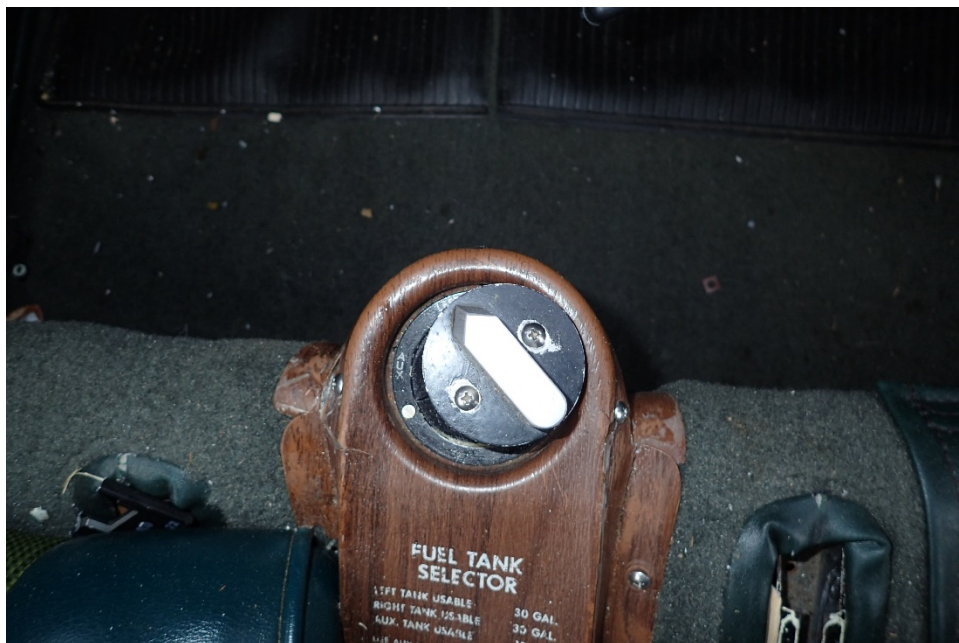
- The cylinders were borescoped and all cylinders exhibited normal operating combustion signatures.
- The fuel selector was seized and unable to be manipulated due to airframe deformation and it was unable to be moved or removed from the airframe.

Figure 4: The Fuel Selector

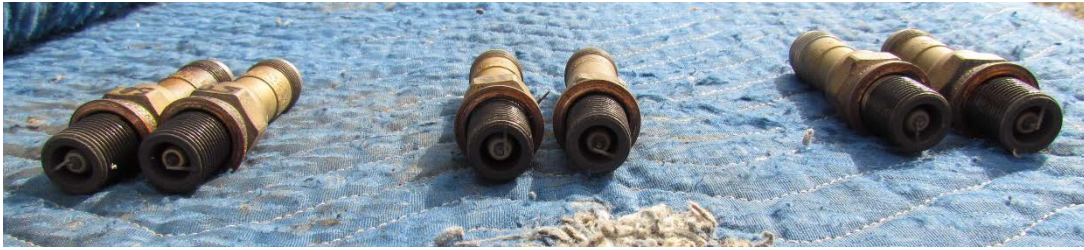
- The lower spark plugs were removed and they were “normal” when compared to the Champion check-a-plug chart.
  - Spark was obtained on all lower spark plugs when the engine was rotated.

Figure 7: Cylinders 5, 3, and 1 upper and lower spark plugs

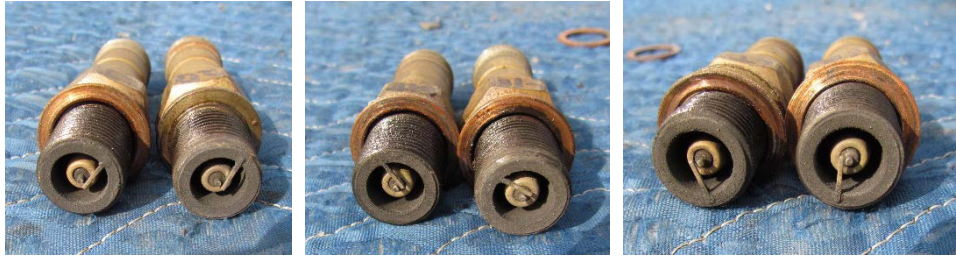
Figure 8: Cylinder 2, 4, 6 top and bottom spark plugs
