## **NATIONAL TRANSPORTATION SAFETY BOARD**

# **ENGINE EXAMINATION AND RUN**

**WPR17FA035**

Location: Carson City, NV  
Date: December 12, 2016  
Aircraft: Bellanca 17-30A, Registration #39894, Serial #73-30544  
NTSB IIC: Samantha Link

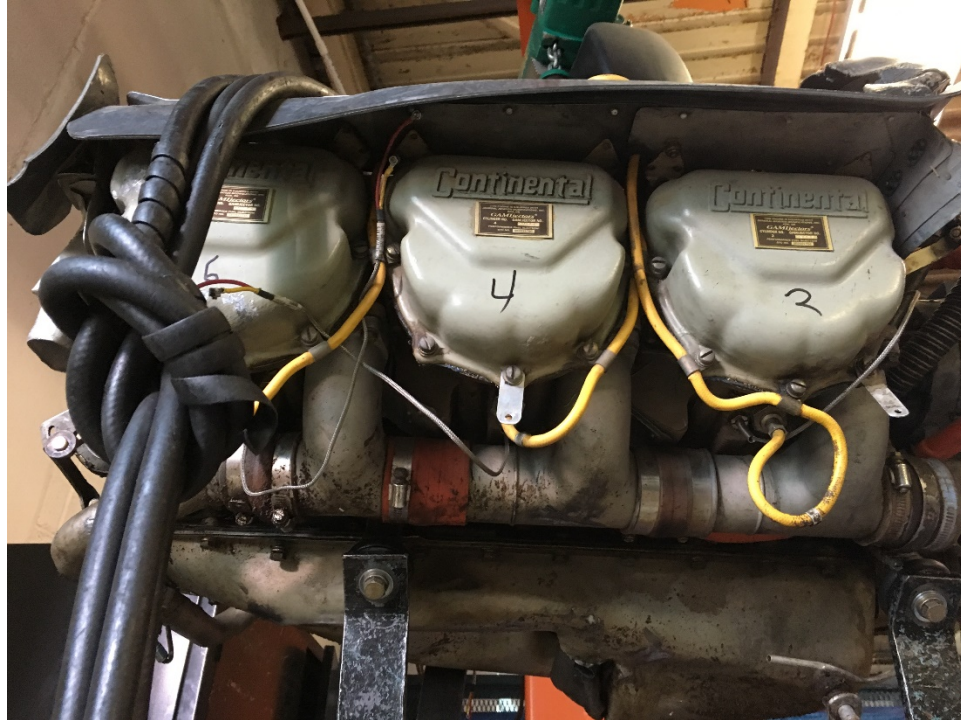
Figure 2: Missing Clamp

- It was observed that one of the clamps for the intake tubes between the #4 and #6 cylinders was missing
  - There was dirt on that intake hose similar to what was on the tubes. There were no breaks in the dirt that resembled the shape of the clamp.

- It was noted that the intake hose was bright orange whereas the other intake hoses were blue.
- A hole was observed in the bottom of the intake tube between the #3 and #5 cylinders

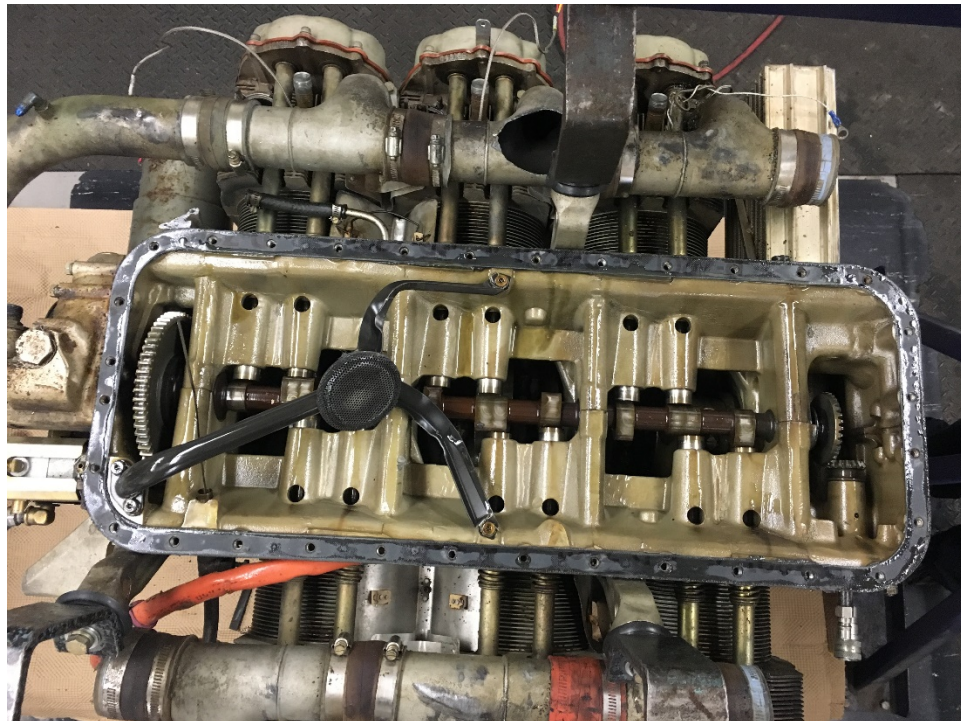
Figure 3: Inside of the Engine from Bottom

- Alternator rotated freely
  - The oil pan sustained crush damage.
    - The inside of the engine was oiled and showed no evidence of heat distress.
    - A new oil pan and oil pick-up tube and screen was installed onto the engine to facilitate an engine run

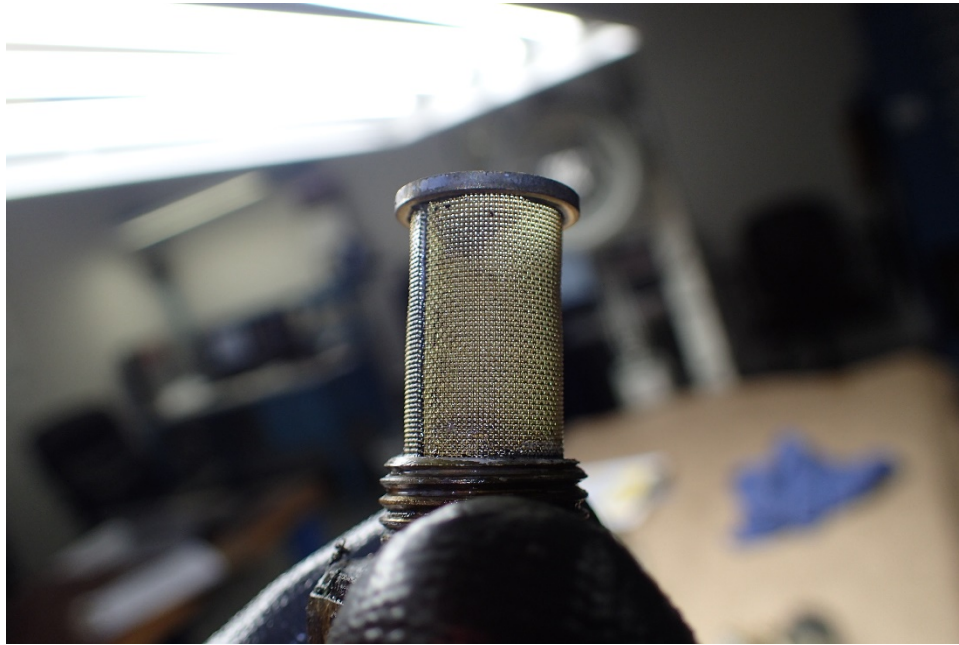
### Figure 6: Throttle Body Fuel Screen

- o Fuel screen was removed and a few specks of debris were noted, but the screen remained clean
  - o The metering unit was disassembled and no anomalies were noted

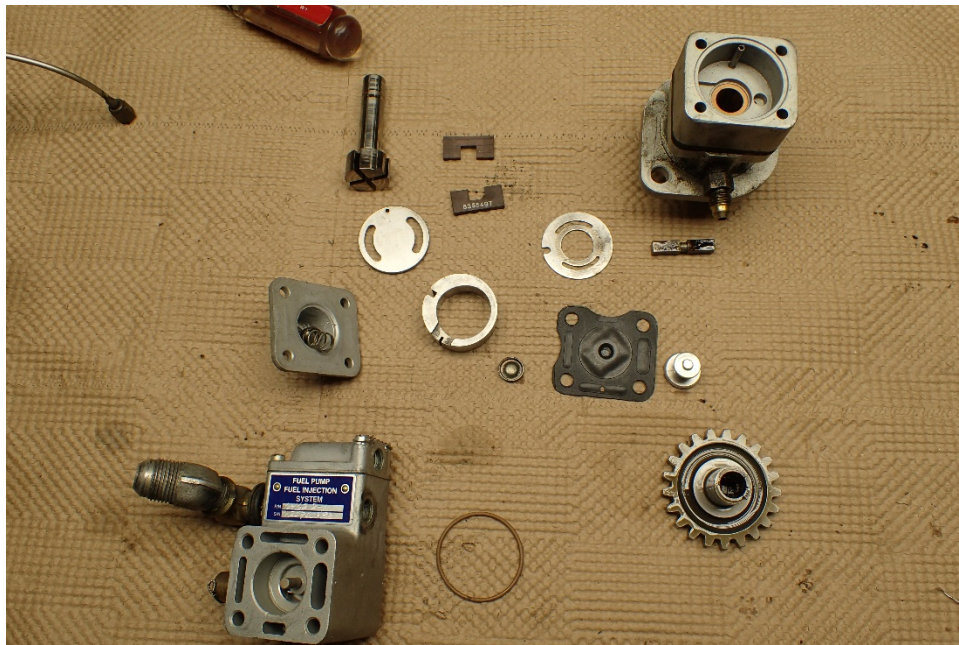
**Figure 7: Fuel Pump Disassembled**

- The fuel pump was disassembled
  - o The pump drive and veins were removed and intact. There was a very small amount of rust on the fuel pump drive.

- o The drive coupling was intact
  - o No anomalies were noted
- The nozzles were removed from the engine and were clear of debris

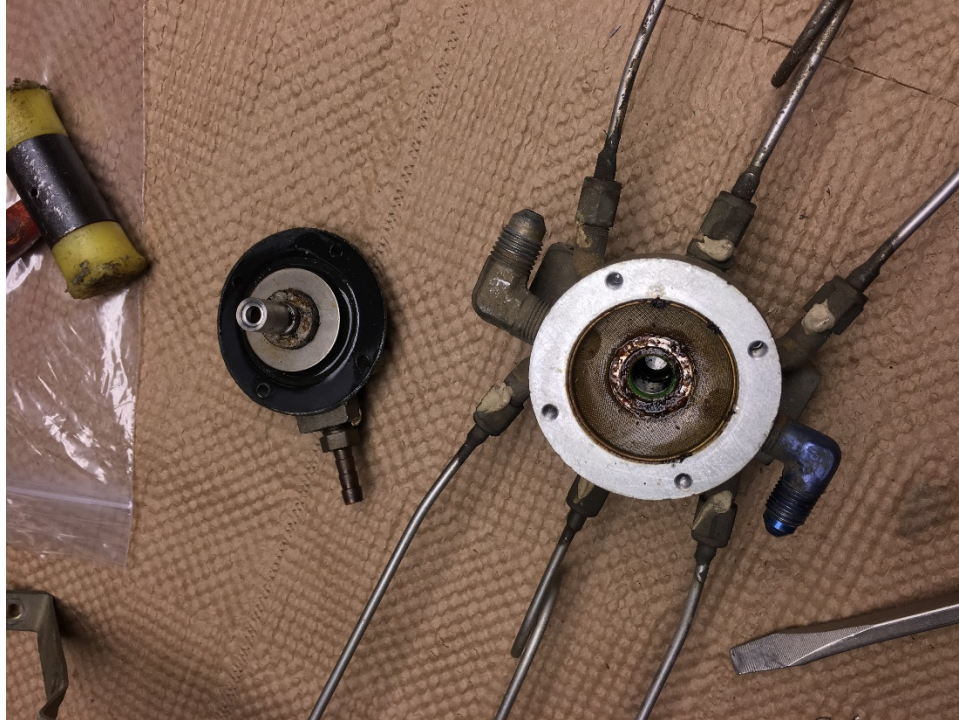
Figure 8: Fuel Manifold Valve

Examination of the engine was conducted on April 20-21, 2017 at the facilities of the Continental Motors in Mobile, Alabama. A significant amount of corrosion was noted in the fuel manifold valve.

- The fuel manifold valve was disassembled
  - o The screen and lower housing of the manifold valve exhibited rust indicative of corrosion
  - o The lower portion of the plunger also exhibited rust indicative of corrosion

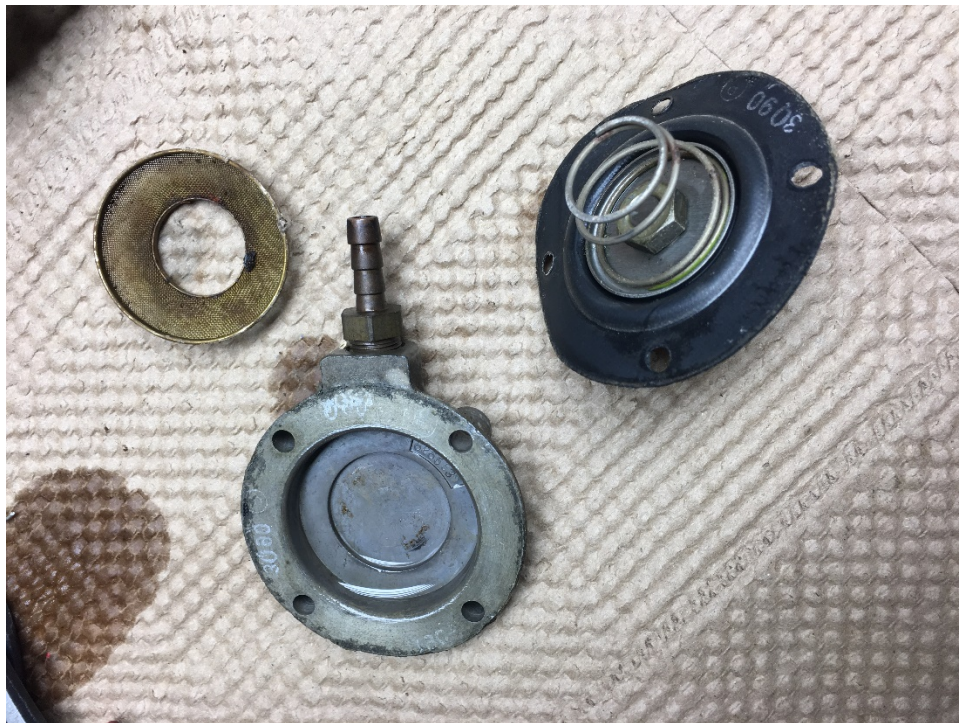
Figure 11: Manifold Valve "Dry" Section

- o The diaphragm was removed and a small amount of fuel was found on the “dry” side of the valve. The vent extending from this section was examined and clear of debris.
