## **NATIONAL TRANSPORTATION SAFETY BOARD**

# **AIRFRAME AND ENGINE EXAMINATION**

**WPR17LA075**

Location: Pacific Ocean, Near Guam  
Date: February 22, 2017  
Aircraft: Hughes -369A, N805LA, S/N 101355  
NTSB IIC: Michael Huhn

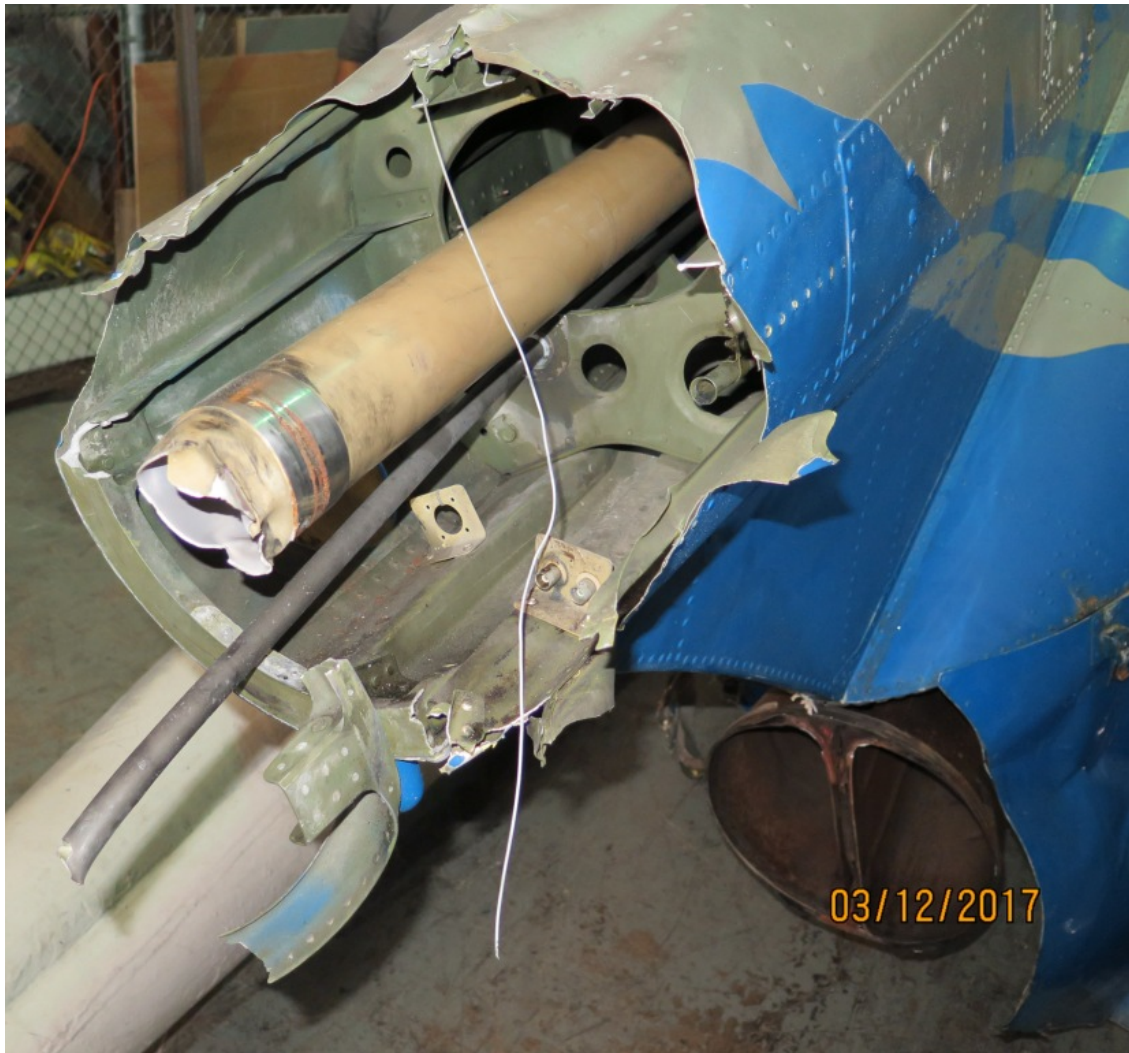
The composite "doghouse" assembly, located aft of the engine inlet, was broken and torn, consistent with main rotor blade contact. A section of the upper aft fuselage was separated at the tailboom attach point, fuselage station (FS) 197.78, with torn and ripped skin, and a fractured tailboom attach frame.

**Figure 4 - FS 197.78 Tailboom Separation Location**

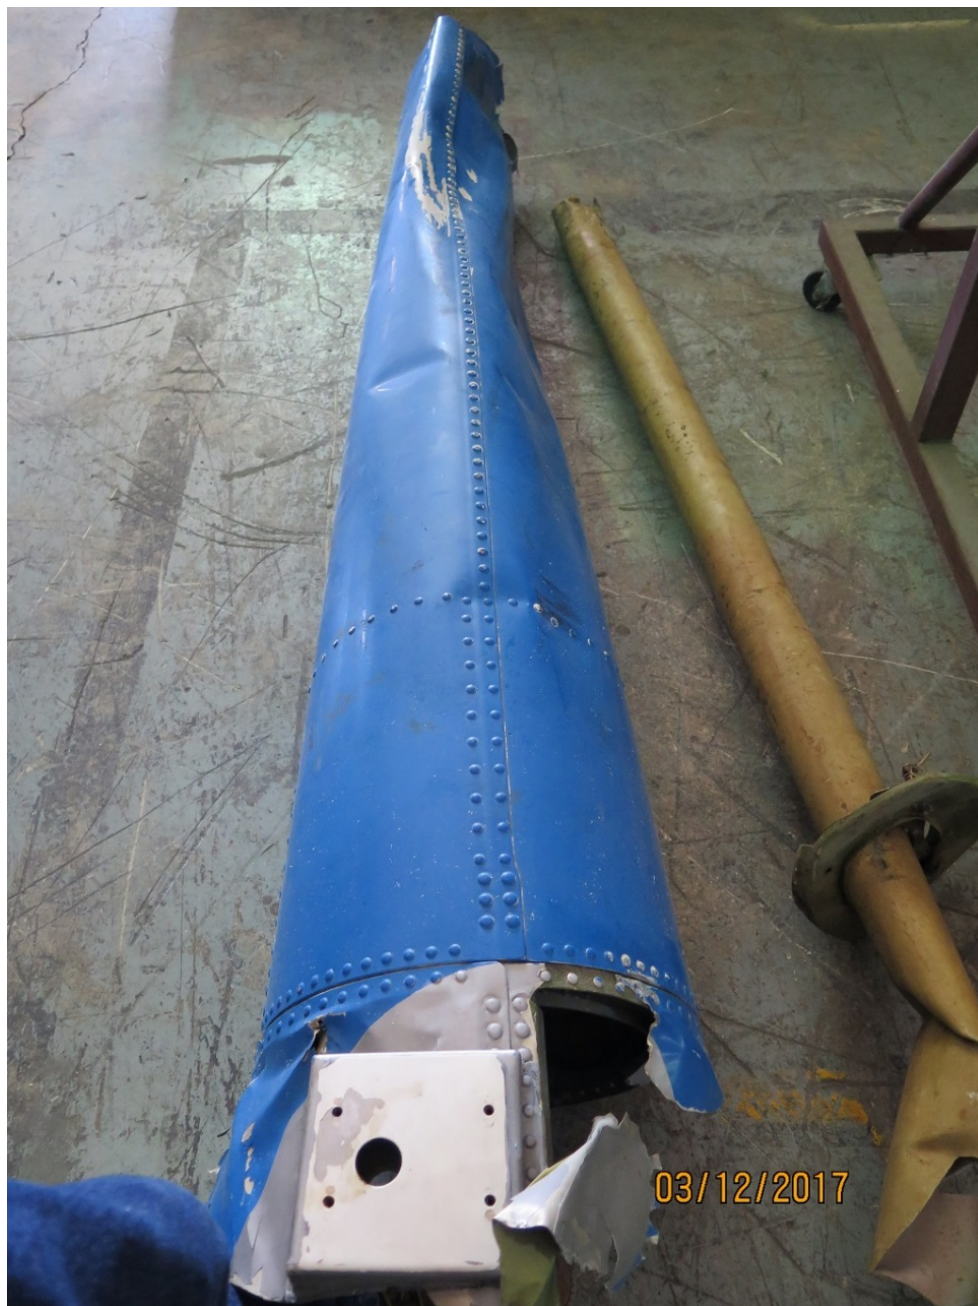
The tailboom was separated into at least two sections, only one of which was recovered. (Figs 4 & 5) The recovered section was separated from the fuselage near FS 197.78, and extended to approximately FS 258.0. The recovered section showed evidence of main rotor blade contact. The tailboom aft of FS 258.0, including the vertical and horizontal stabilizers, tail rotor transmission, and the tail rotor system, was not recovered from the ocean.

Figure 5 - Recovered Tailboom Section (~FS 197 to ~FS 258)

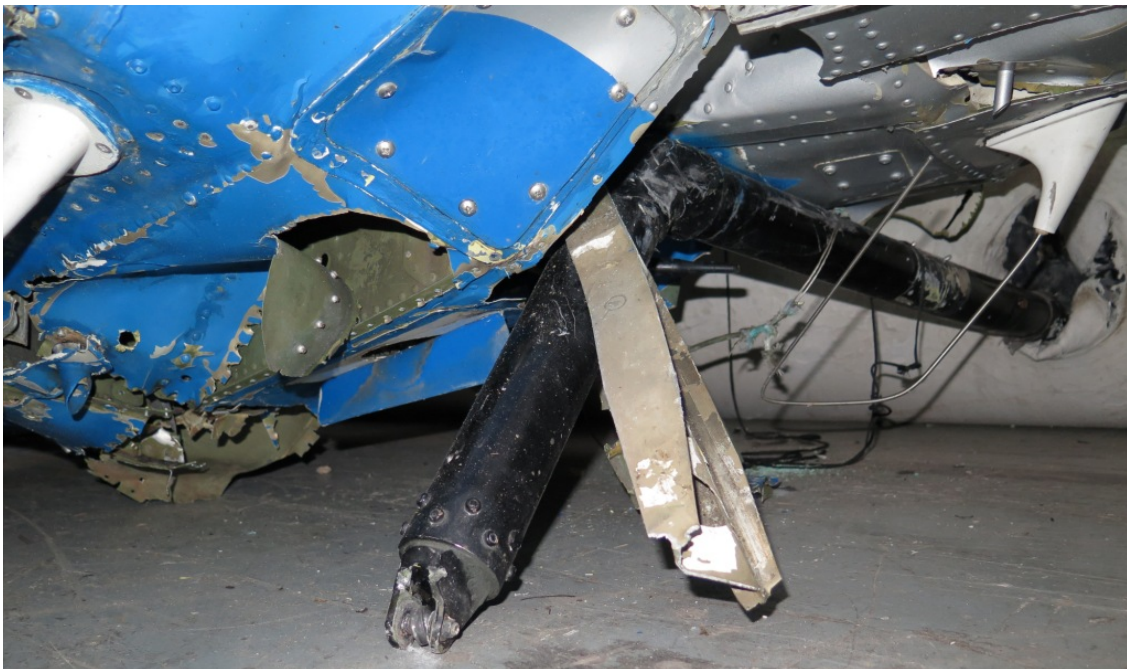
The helicopter fuselage experienced extensive impact damage to the forward fuselage, pilot/copilot seat structure, and aft fuselage. Visual inspection revealed significant damage to the lower fuselage at the landing gear attach structure locations. The four landing gear struts, dampers, and braces all had impact damage and fractures, with the worst damage on the left side. The aft landing gear center beam fitting was fractured. The utility float attachment to the skid tube and landing gear foot showed little visible damage.

**Figure 7 - Landing Gear Strut/Brace Damage**

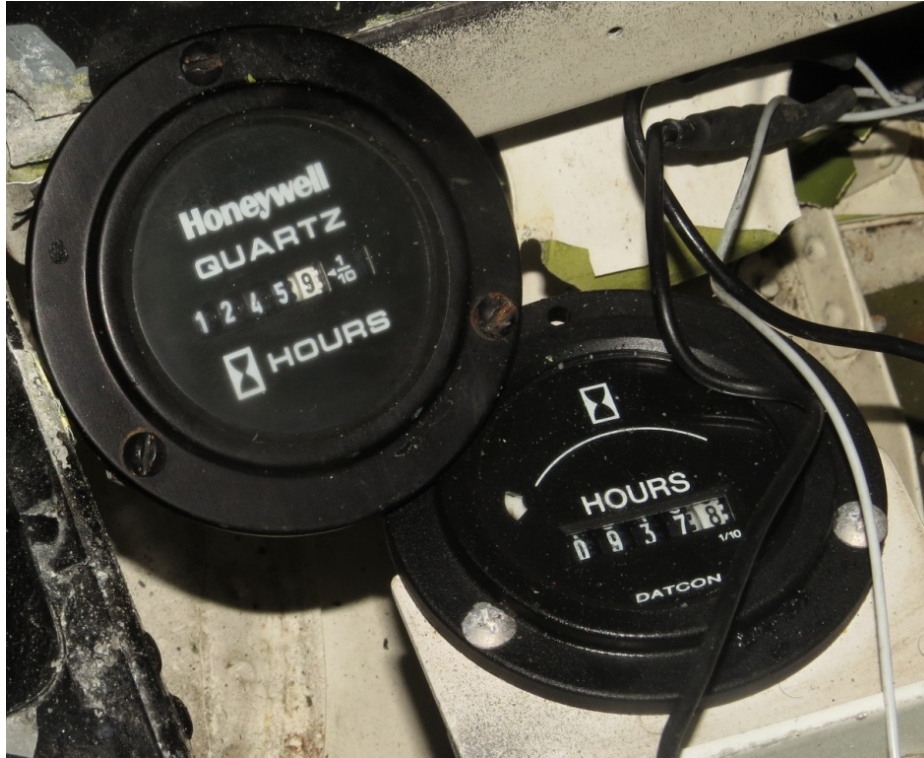
There were two hour meters (Fig 8) in the helicopter. One was mounted to the battery box and registered 0937.8 hours. The other was found in the lower section of the instrument panel, dislodged from its mounting, and registered 1,245.9 hours.

The meter reading of 1,245.9 correlated with the "Hobbs" time entries found in the Monthly Reports (Figs 27, 29, & 30), and that meter/time was likely used for billing purposes. The meter with the reading of 0937.8 appeared to be used to register activation of the collective control, signaled by a collective position switch. This hour meter reading was used by the investigation to determine the approximate helicopter total time of 7,284.8 hours.

Figure 8 - Hour Meters

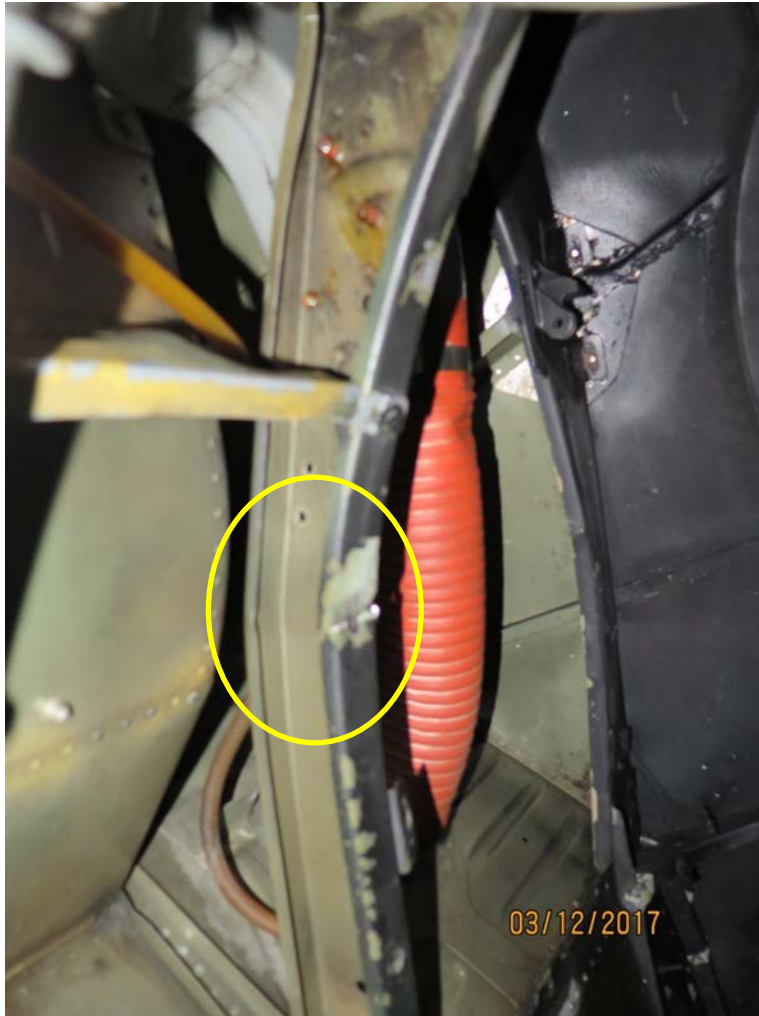
The engine mounts were bent and cracked. The left aft mast support channel near the FS 124.0 canted frame was cracked and deformed.

**Figure 9 - Damaged Aft Left Mast Support Channel**

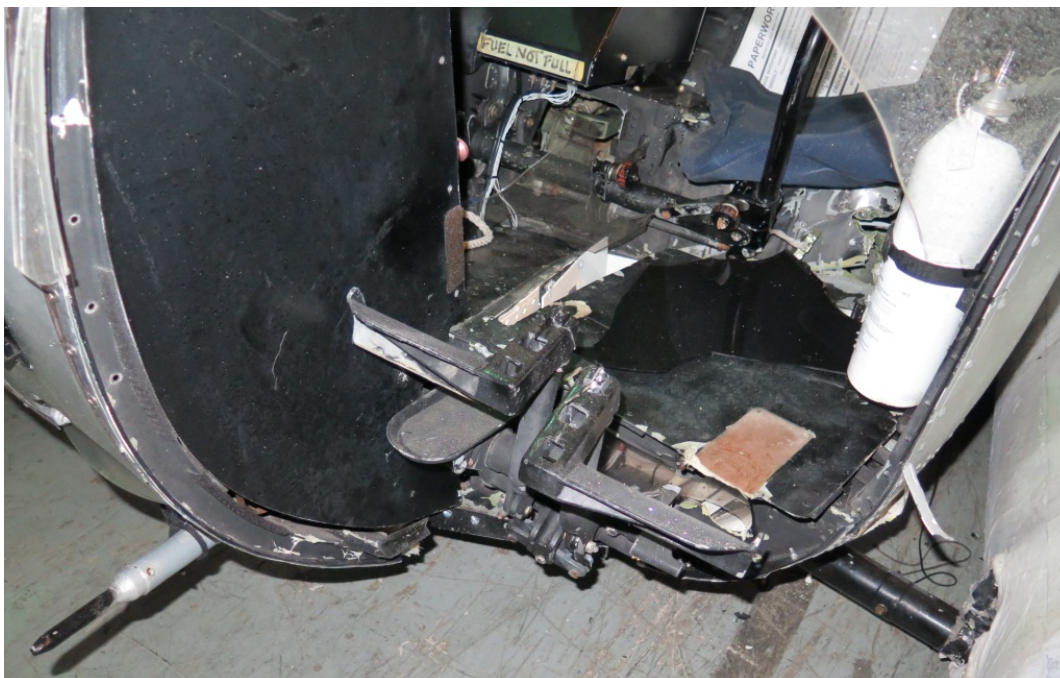
Single pilot, left hand controls were installed. Cyclic and collective control system continuity was confirmed. The cyclic stick was found balanced, near center. This is consistent with the trim actuators being neutral. Anti-torque control continuity was confirmed from the pilot's pedals to the fractured tail rotor control rod at the tailboom fracture. The pilot's pedal bracket was fractured at the attach frame.

**Figure 10 - Pilot's Anti-Torque Pedal Assembly**

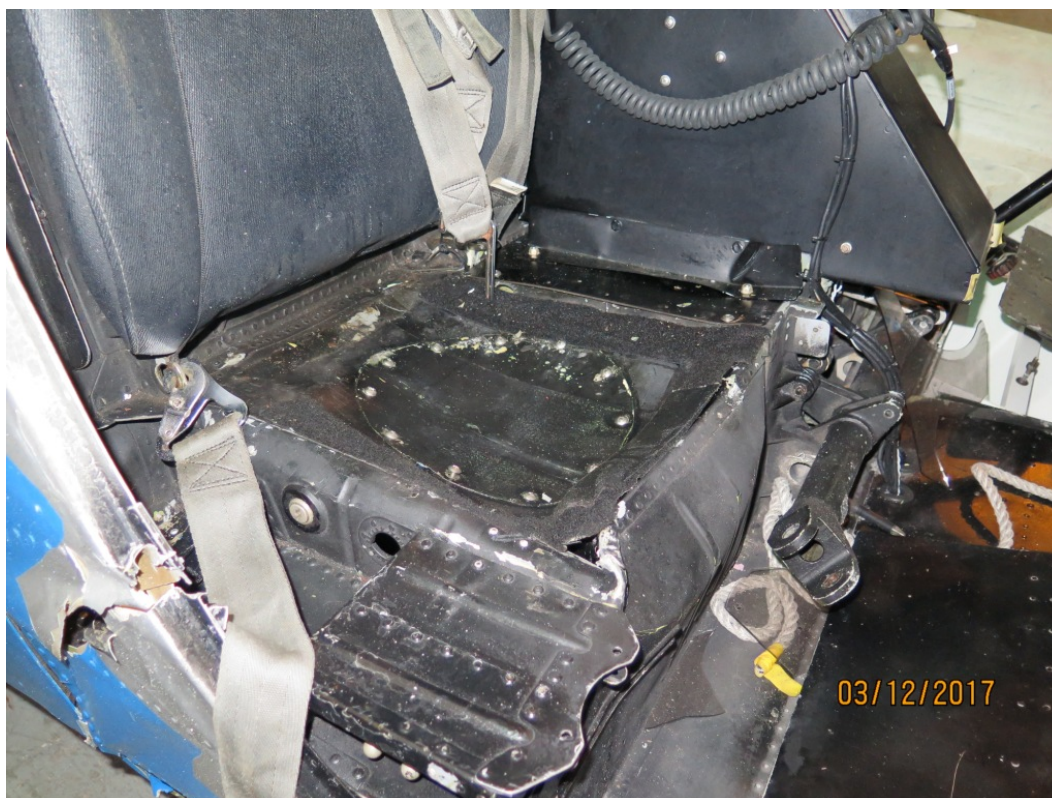
The seat box structure was extensively damaged, with both left and right cockpit seat pans significantly deformed downward and their box structures crushed. The seat restraint systems were intact and functional.

**Figure 11 - Crushed Right (Observer) Seat Bottom**

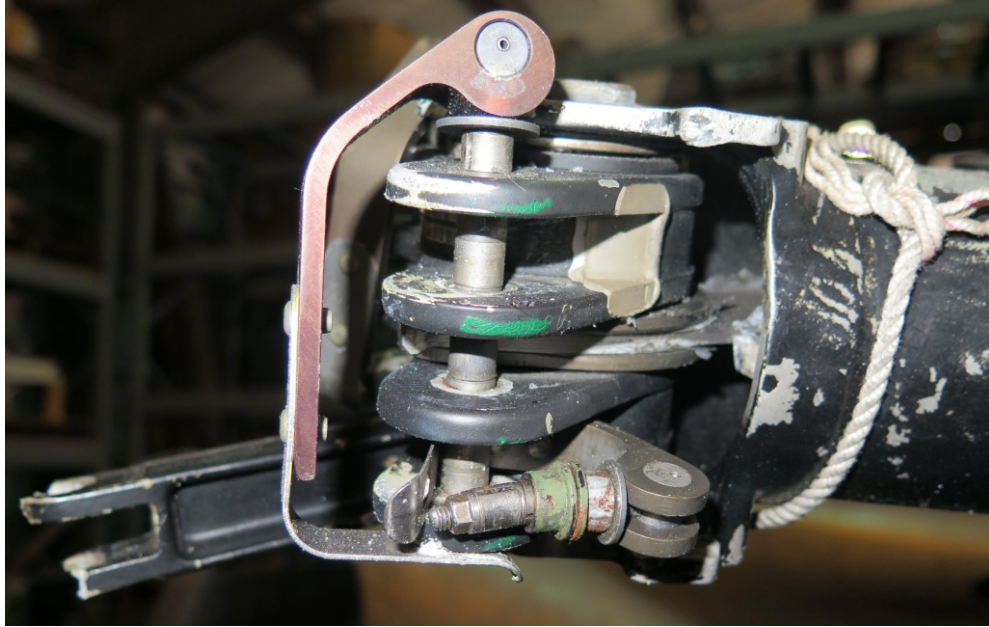
The main rotor system hub assembly and components, strap assemblies, pitch housings, feather bearings, and pitch change links were relatively undamaged. The main rotor head showed damage to one damper arm, but overall was intact with chips and scrapes. The rotor system did exhibit visible hub damage due to excessive lead/lag excursions and high flapping angles. All four main rotor blades (Helicopter Technology Company PN: 500P2100-303, SNs: 0864B, 0865B, 0866B and 0867B) were unbroken, with varying degrees of bends and skin damage. The damage to the main rotor system components was consistent with low rotor RPM, power-off, main rotor blade strikes.

**Figure 12 - Main Rotor Head**

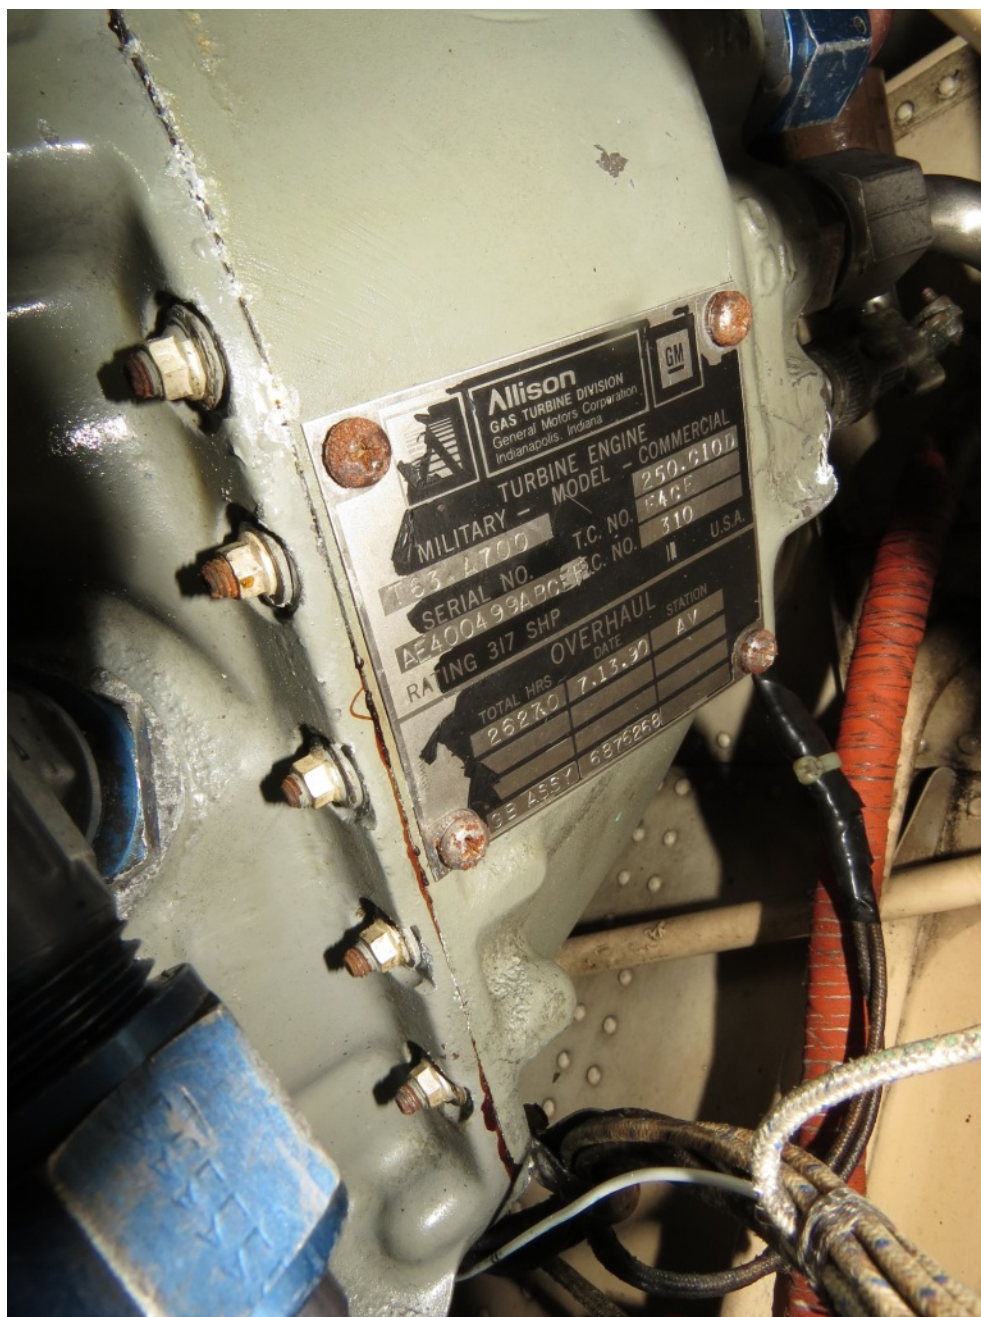
- Operator-supplied engine records indicate the engine was installed with 0 hours time since overhaul (TSOH) and a total engine time 2308.7 hours. However, the TSOH stamped on the engine's data plate indicate 2627.0 hours total engine time at overhaul. (Fig 15)

Figure 15 - Engine Data Plate

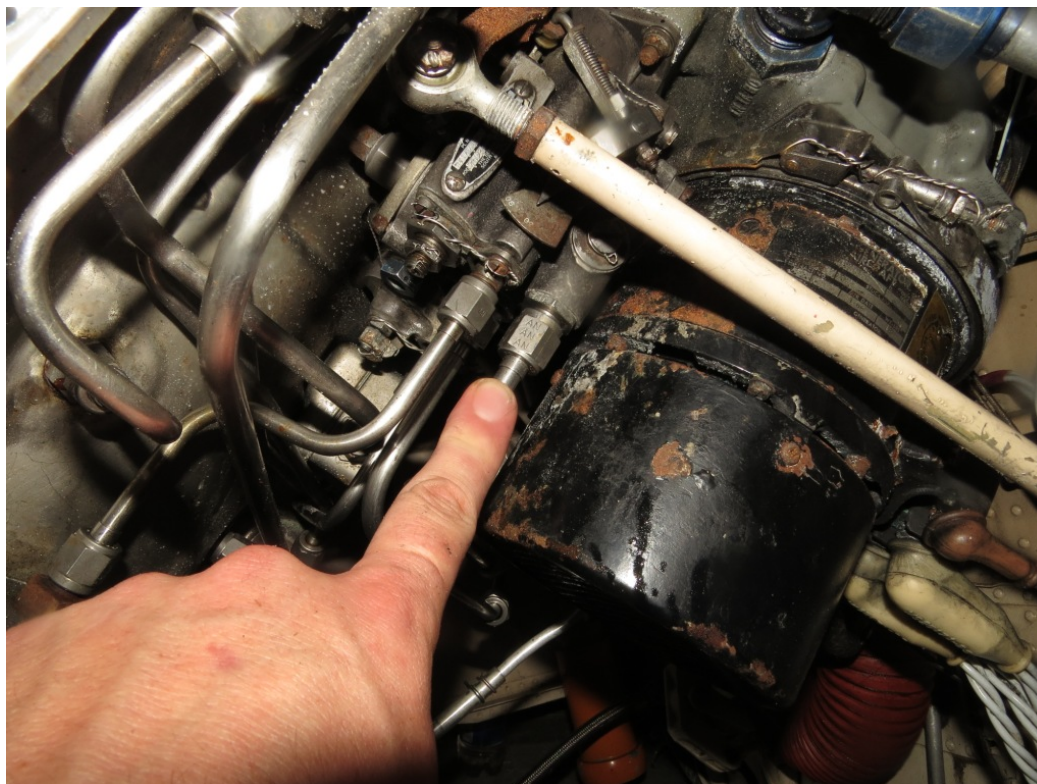
A vacuum check of the engine's fuel system was performed by draining the contents of the fuel filter bowl of the engine-driven fuel pump, and attaching a vacuum source to the filter bowl port. A vacuum of 8 psi was applied to the filter bowl port. The system would not hold that vacuum value for the test requirement period of 2 minutes. Vacuum was lost at a rate of approximately 1 psi every 2 to 3 seconds, indicating that there was a slow leak within the fuel system. Systematic isolation of components traced the vacuum leak to a line connecting the fuel pump to the fuel control. The B-nut on the fuel pump side of this line was found to be excessively tight, and was the most likely leak source. However, visual examination of the B-nut ferrule did not reveal any obvious cracks or damage, and the exact source of the vacuum leak was not determined.

**Figure 17 - Small Vacuum Leak Traced to this B-nut at Engine Fuel Control**

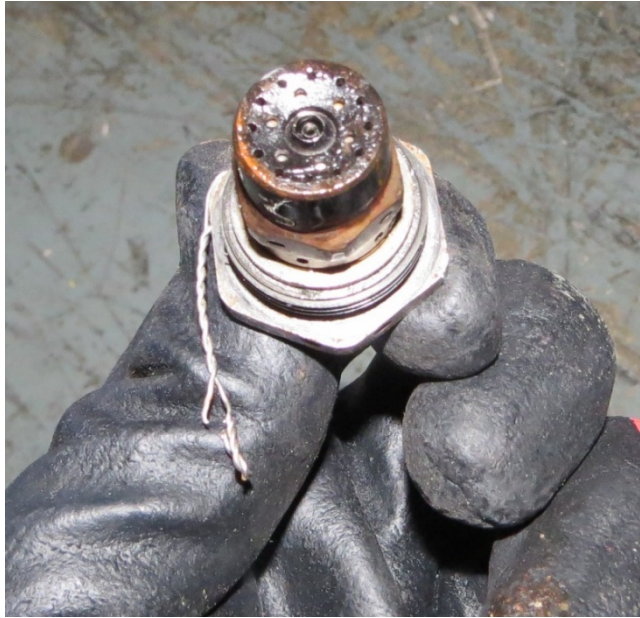
The fuel spray nozzle (FSN) was removed, disassembled, and examined. The spray face exhibited corrosion and typical carbon coating. The FSN filter screen exhibited contamination similar to that found in the fuel pump filter. A borescope was inserted into the fuel spray nozzle

**Figure 18 -Engine Fuel Spray Nozzle**

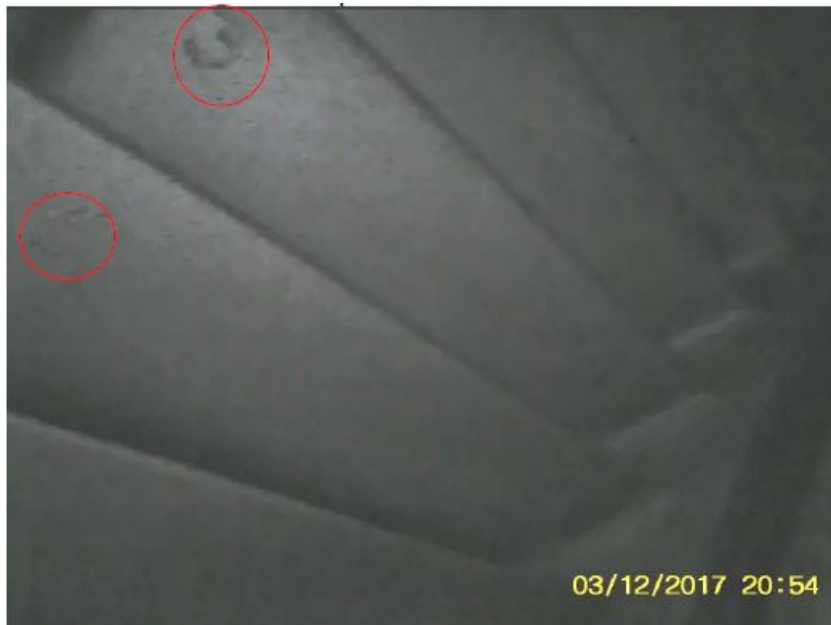
- During manufacture, the 4th stage turbine wheel's serial number is engraved on the convex side of the turbine blades, with one number engraved per blade. Borescope examination of the 4th stage turbine wheel clearly shows the numbers "3" and "5" engraved into the convex sides of the blades.

**Figure 19 - 4th Stage Turbine with Engraved Serial Numbers Circled**

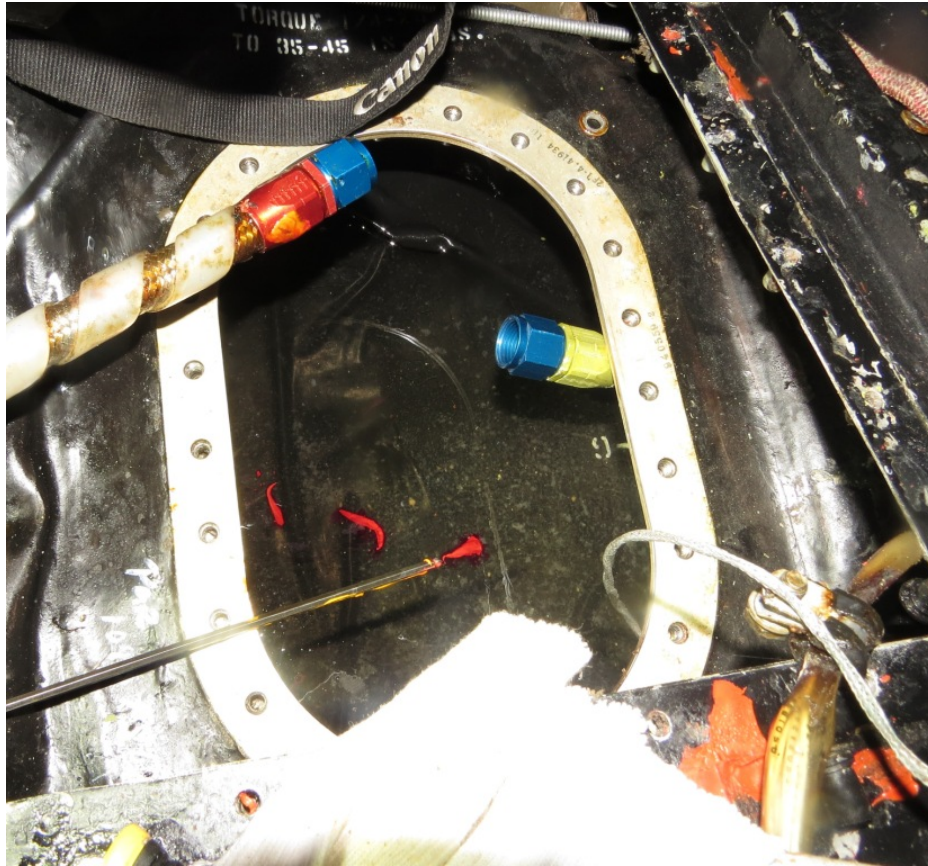
Significant evidence of water contamination was observed in the helicopter's fuel storage and delivery system, including all filters, and the evidence was consistent with the pre-impact presence of the water. The left fuel cell cover was opened and water, with no evidence of fuel, was found inside the cell. Potential water entry points included the fuel vent system, a deficient fuel-cap seal, or tank damage. The investigation considered the possibility that damage, including torn/ripped structure in the area of the fuel cells, might have compromised the fuel cells. However, no evidence of leakage of fuel onto the floor was observed, and no visible holes or tears were noted in the fuel bladder.

**Figure 20 – Activated (red) Water-Detecting Paste in Fuel Cell**

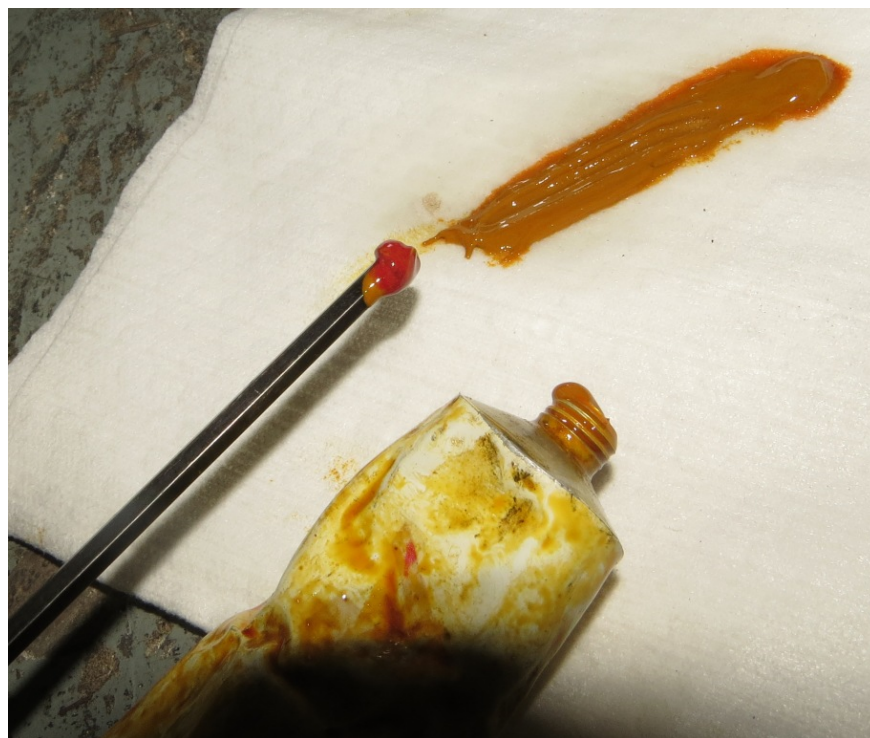
The fuel supply line from the fuel pump filter to the FSN is normally sealed at both ends by spring-loaded check valves, which trap the last fluid about to be introduced into the engine. The fluid from that line was drained and examined. That fluid was observed to be about 30% water, , and the rest milky grey turbine fuel.

**Figure 21 - Positive Water Indication via Water Detecting Paste from Fuel Line Sample**

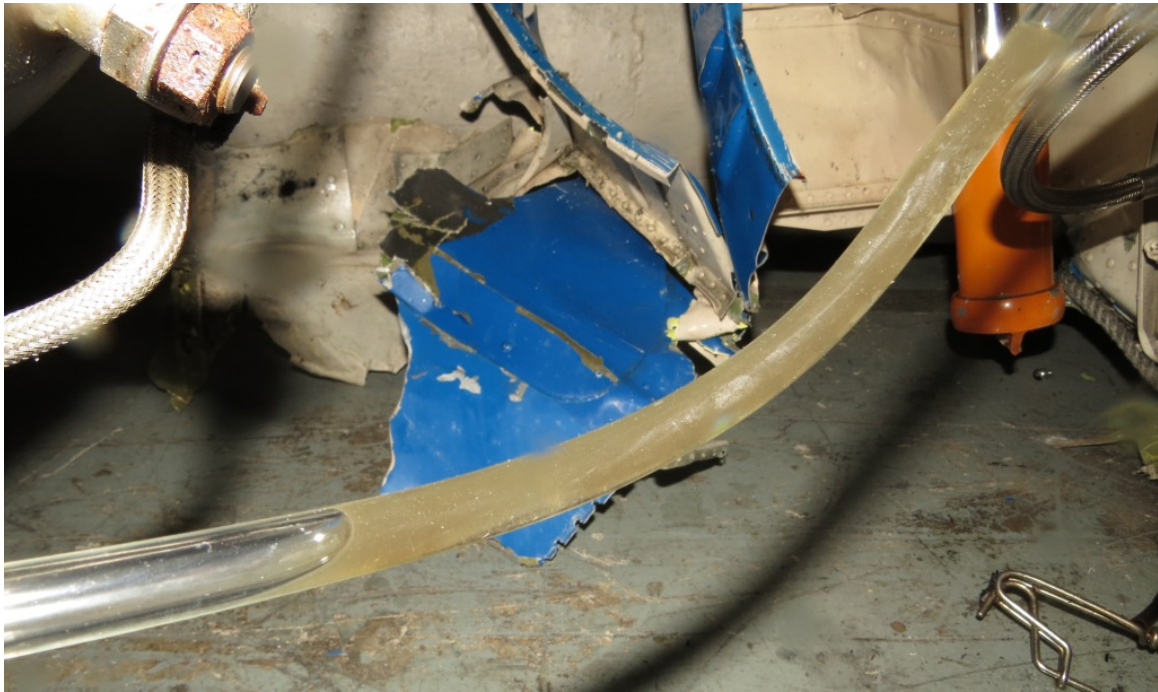
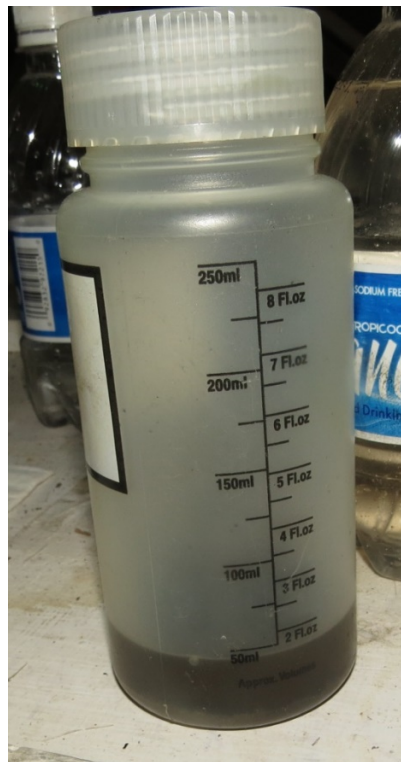
The contents drained from the fuel pump filter bowl contained significant amounts of entrained particulates, and a fluid suspected to be water. Water-detecting paste confirmed the presence of water. The filter bowl in the housing of the engine-driven fuel pump was opened and examined. The filter exhibited significant contamination of unknown particulate matter, a paste-like substance, and what appeared to be plant material.

**Figure 22 –Fuel/Water Mixture Captured from Fuel Pump Fuel Filter Bowl**

**Figure 23 – Fuel/Water Mixture Captured from Fuel Pump Fuel Filter Bowl**
