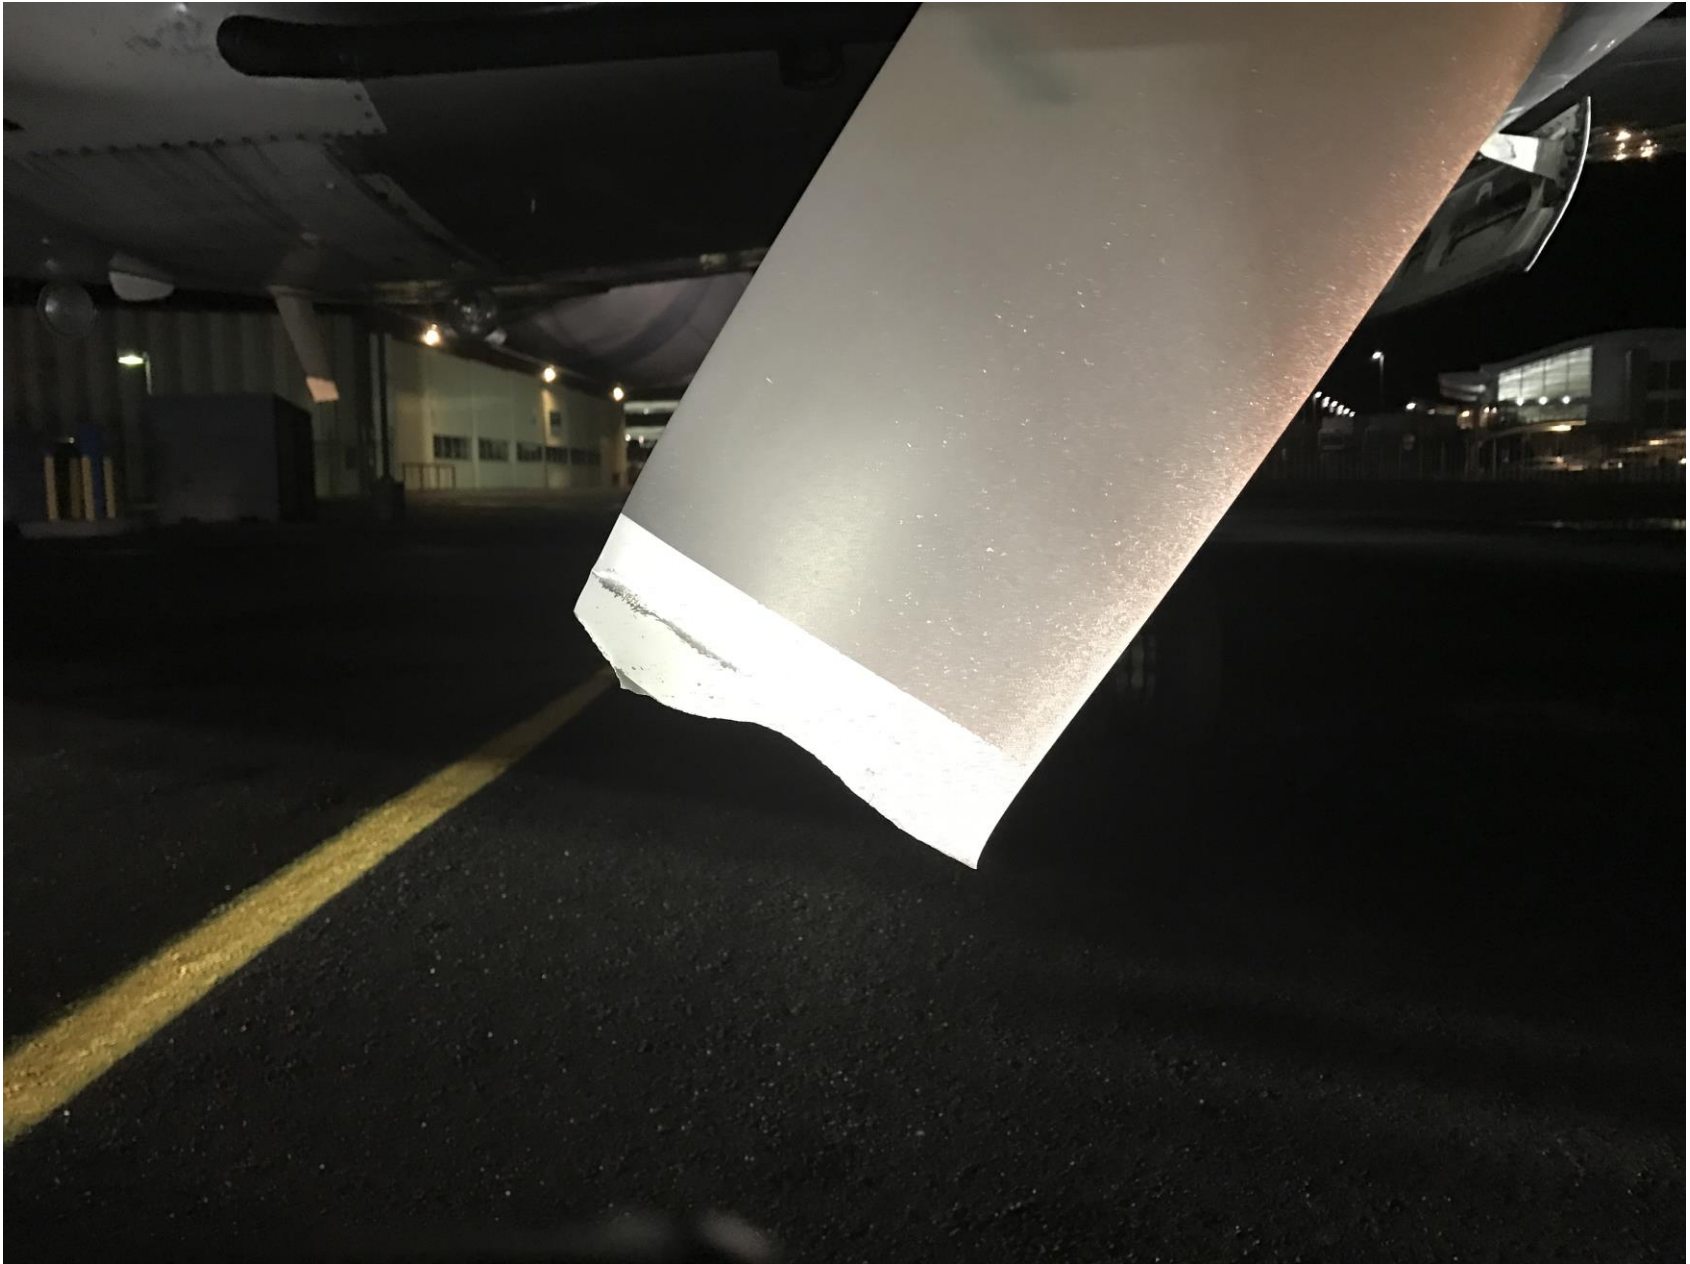
**Photo 1 – view of damaged left propeller blade tip**

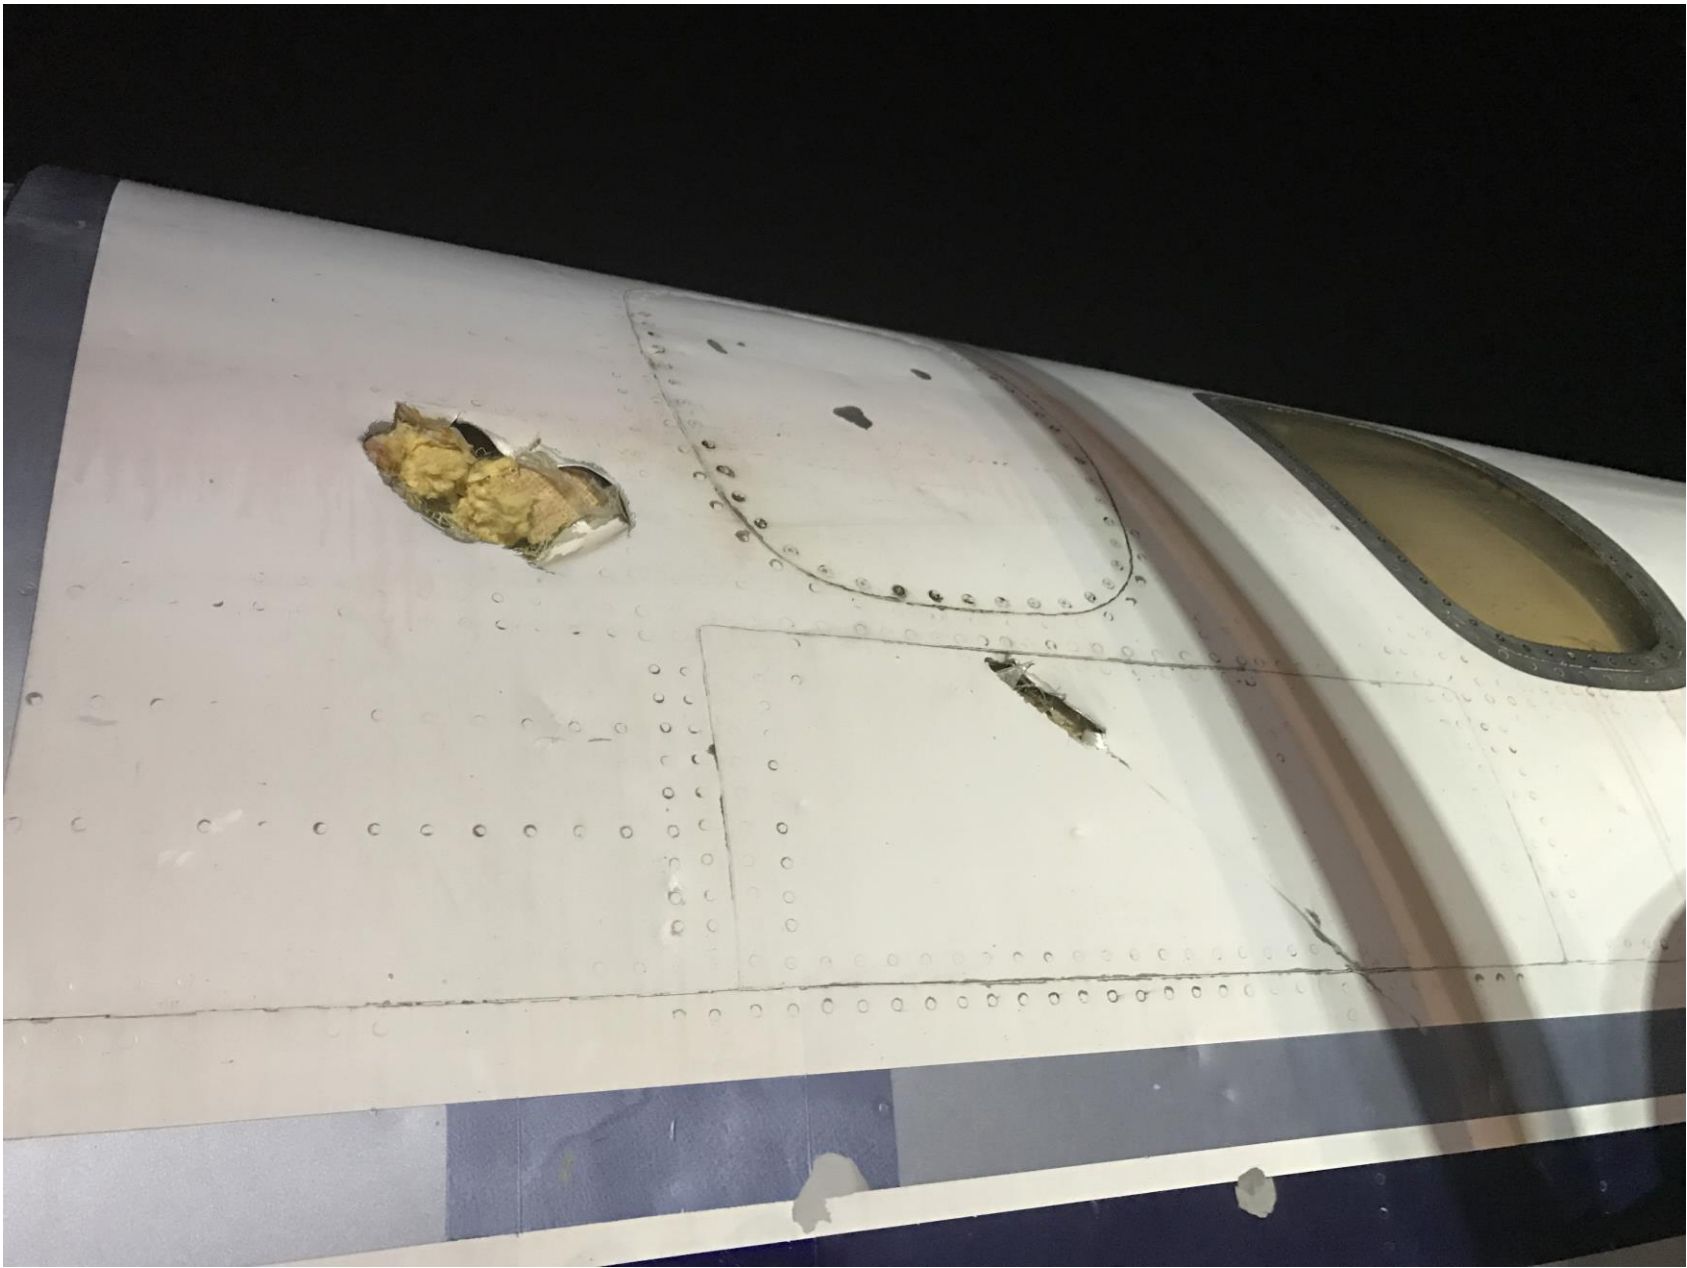
**Photo 2 – view of fuselage damage penetration**

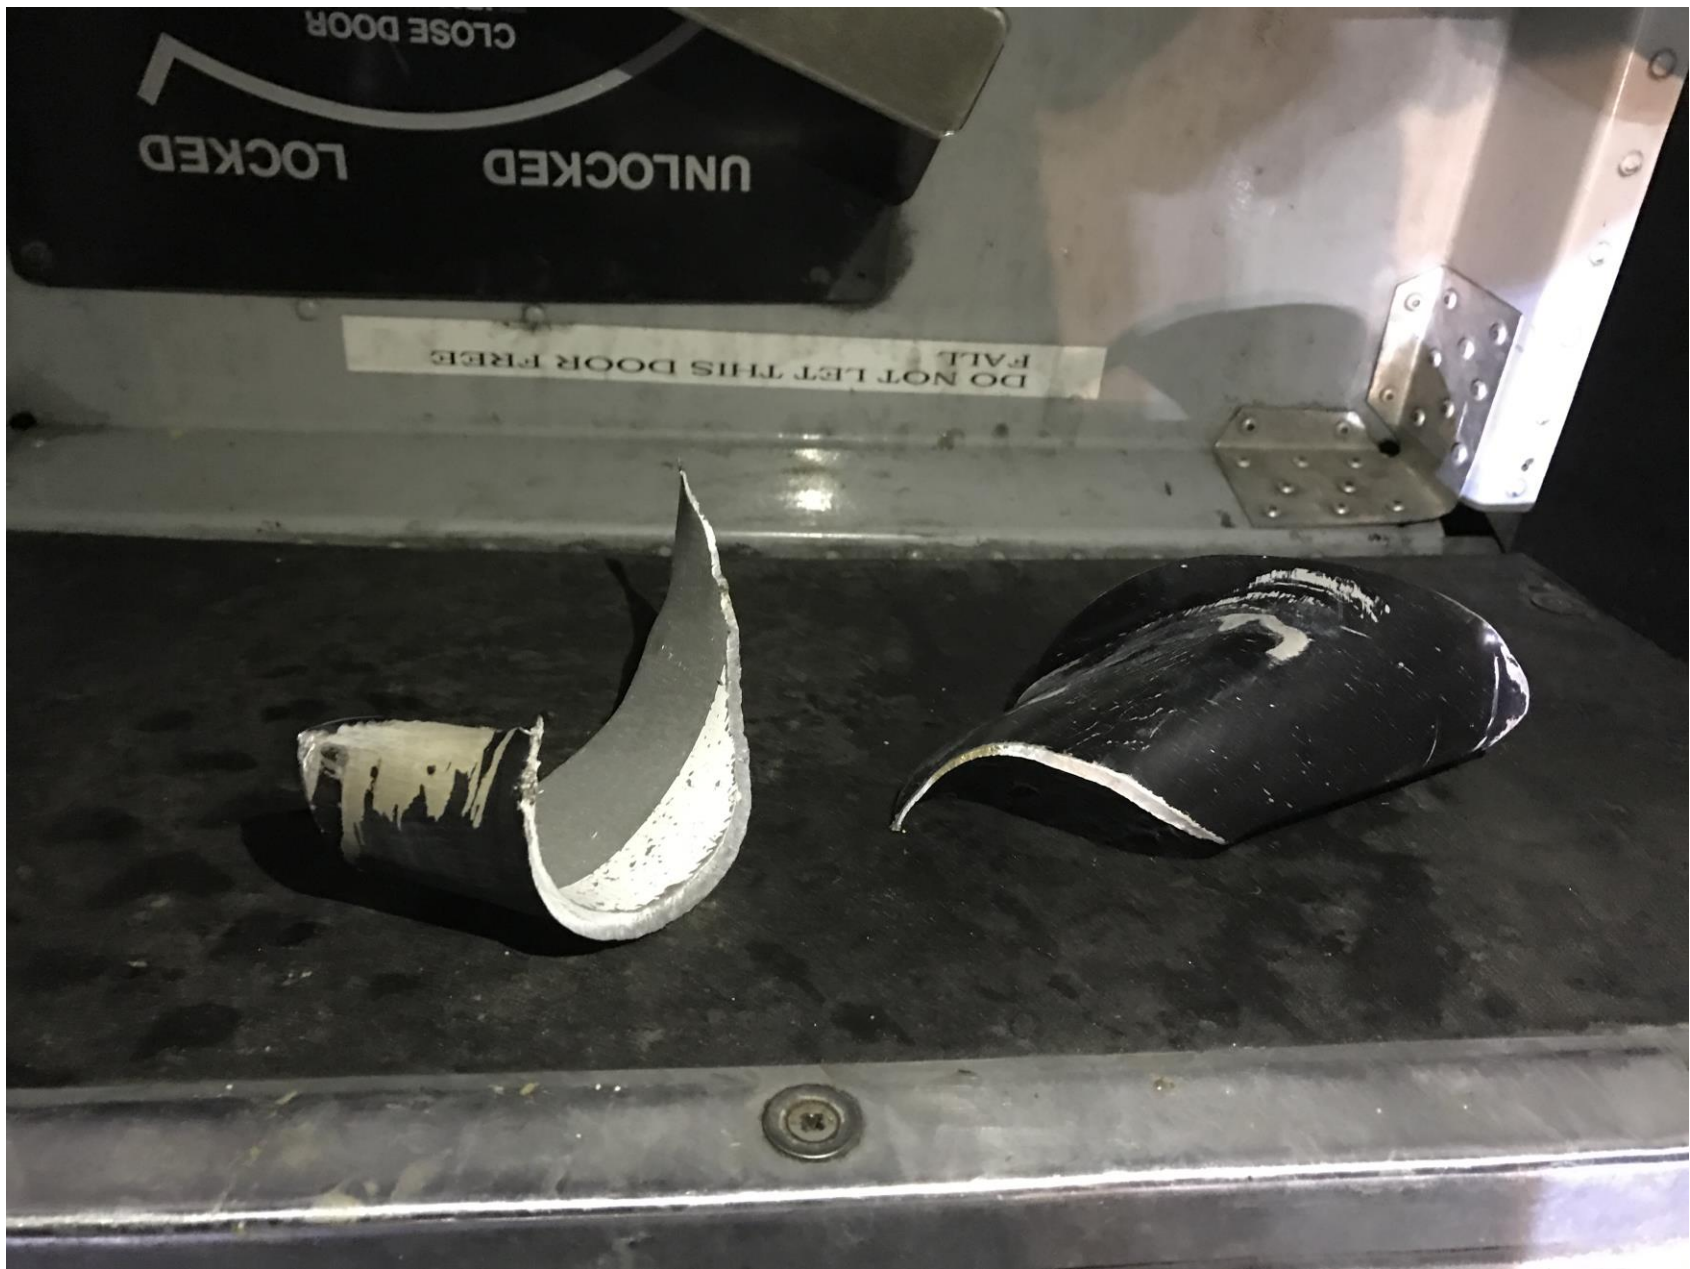
**Photo 3 – remnants of blade tip at rest in cabin of airplane**

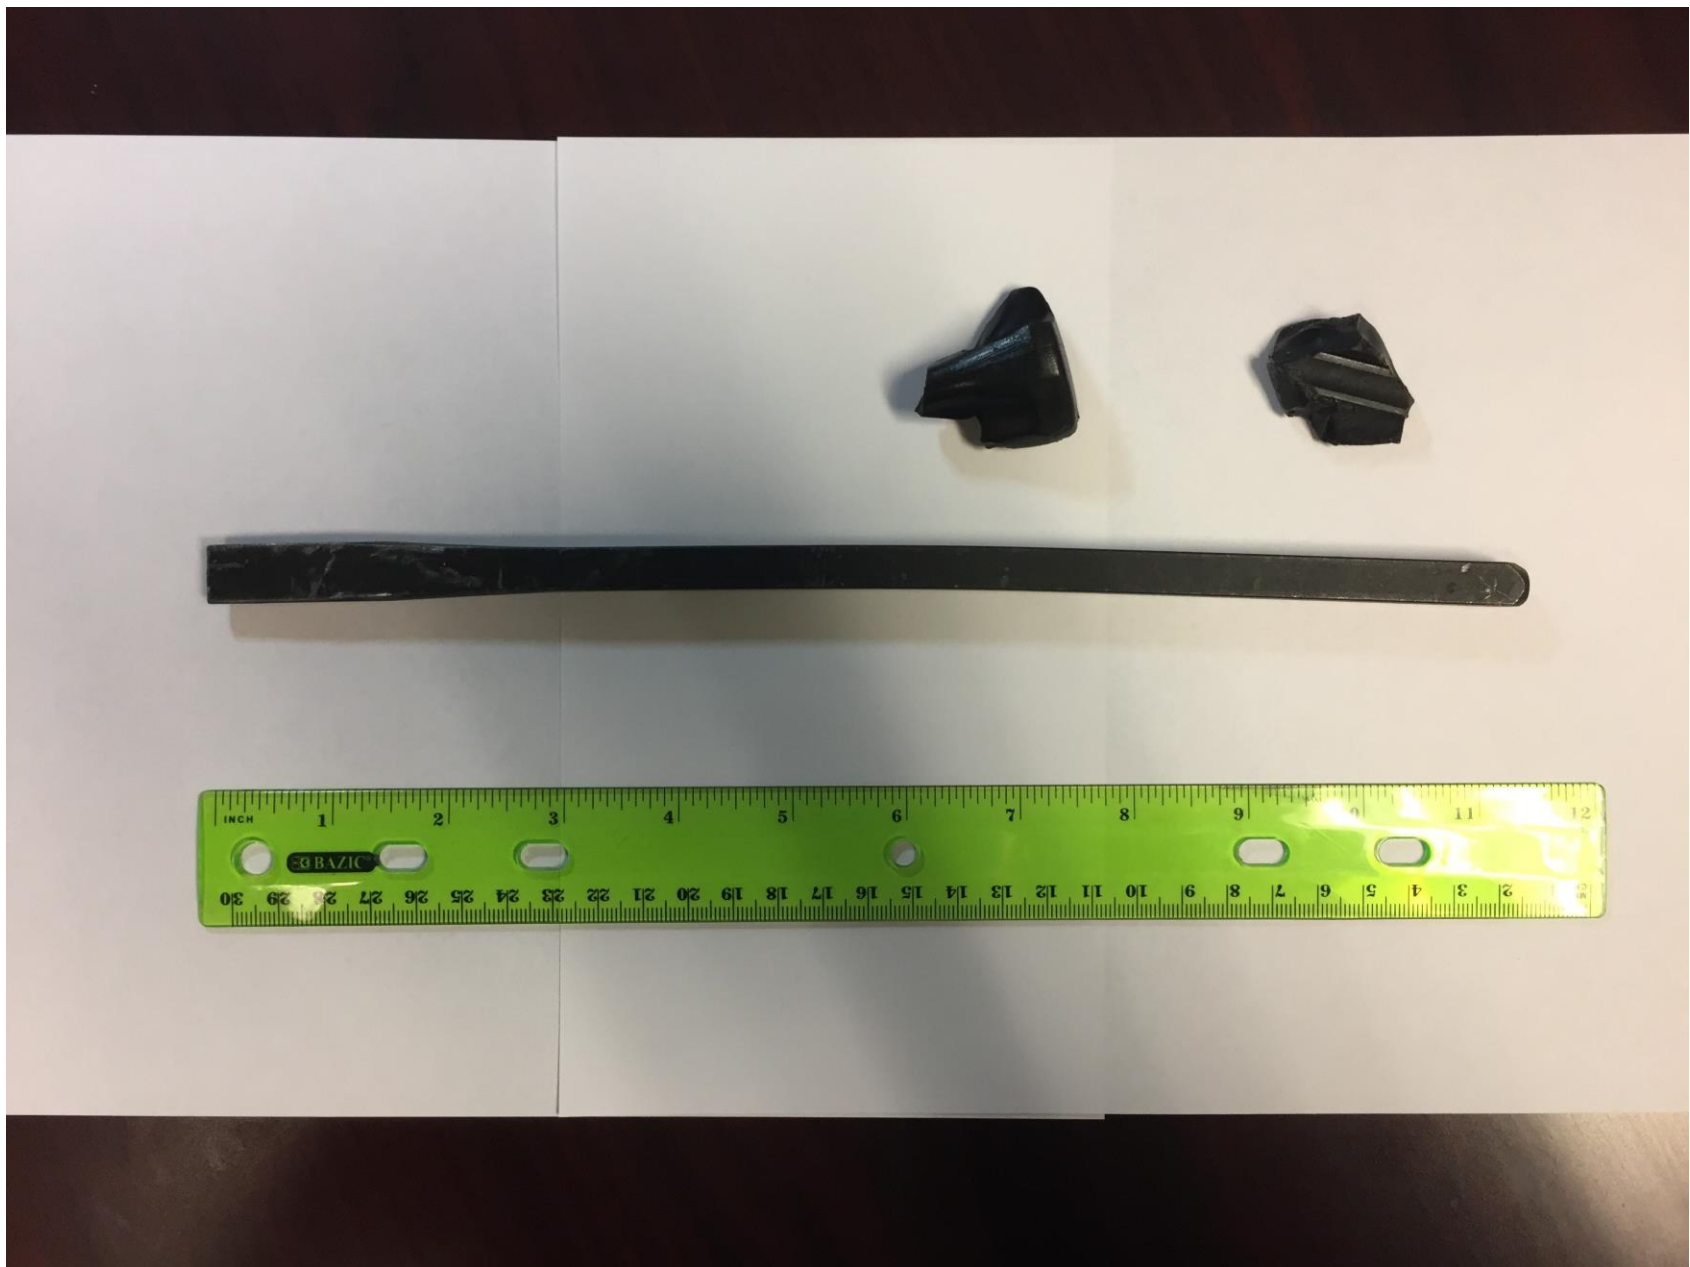
Photo 4 – screwdriver as recovered from departure runway
