# NATIONAL TRANSPORTATION SAFETY BOARD

## MATERIALS LABORATORY FACTUAL REPORT

Report No. 17-064

Place : The Dalles, Oregon  
Date : March 31, 2017  
Vehicle : Zenith 601XL-B, N610TT  
NTSB No. : WPR17LA082  
Investigator : Samantha Link, AS-WPR

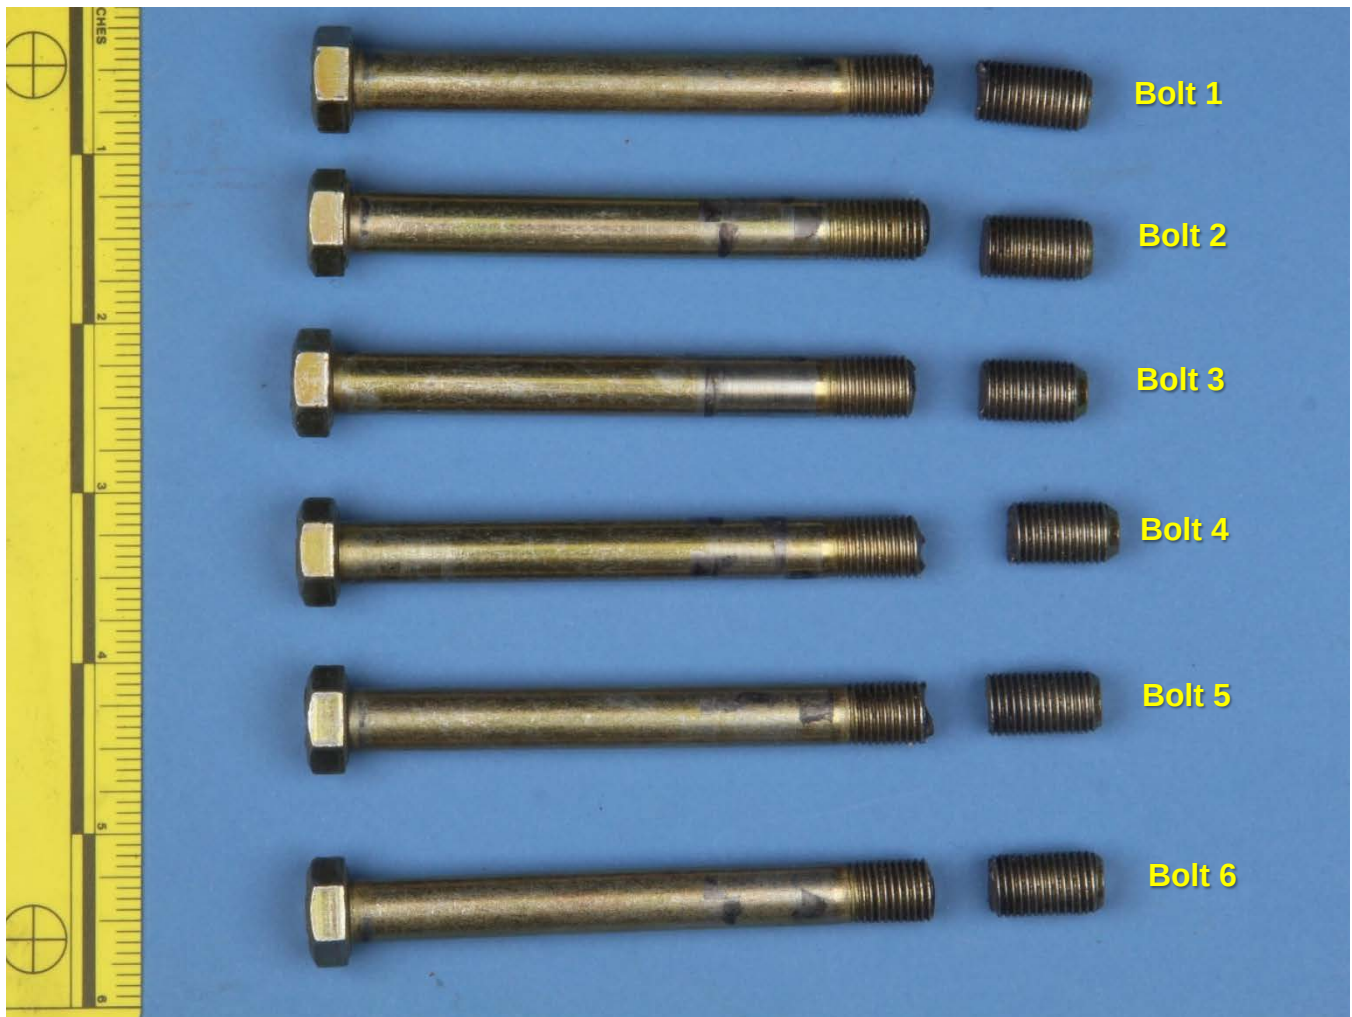
The six propeller bolts were sent to the NTSB Materials Laboratory for examination. Figure 1 shows the six bolts, as received. The bolts were labeled 1 through 6 for the purposes of this report.

All of the submitted bolts had fractured in the 13<sup>th</sup> to 15<sup>th</sup> thread root from the base of the bolt. This was, on average, 0.69 inches from the base of each bolt. The fracture surfaces were oriented 90° to the longitudinal direction of the bolt, with no gross plastic deformation present adjacent to the fracture surfaces.

Figure 1 – The six fractured propeller bolts, as received.

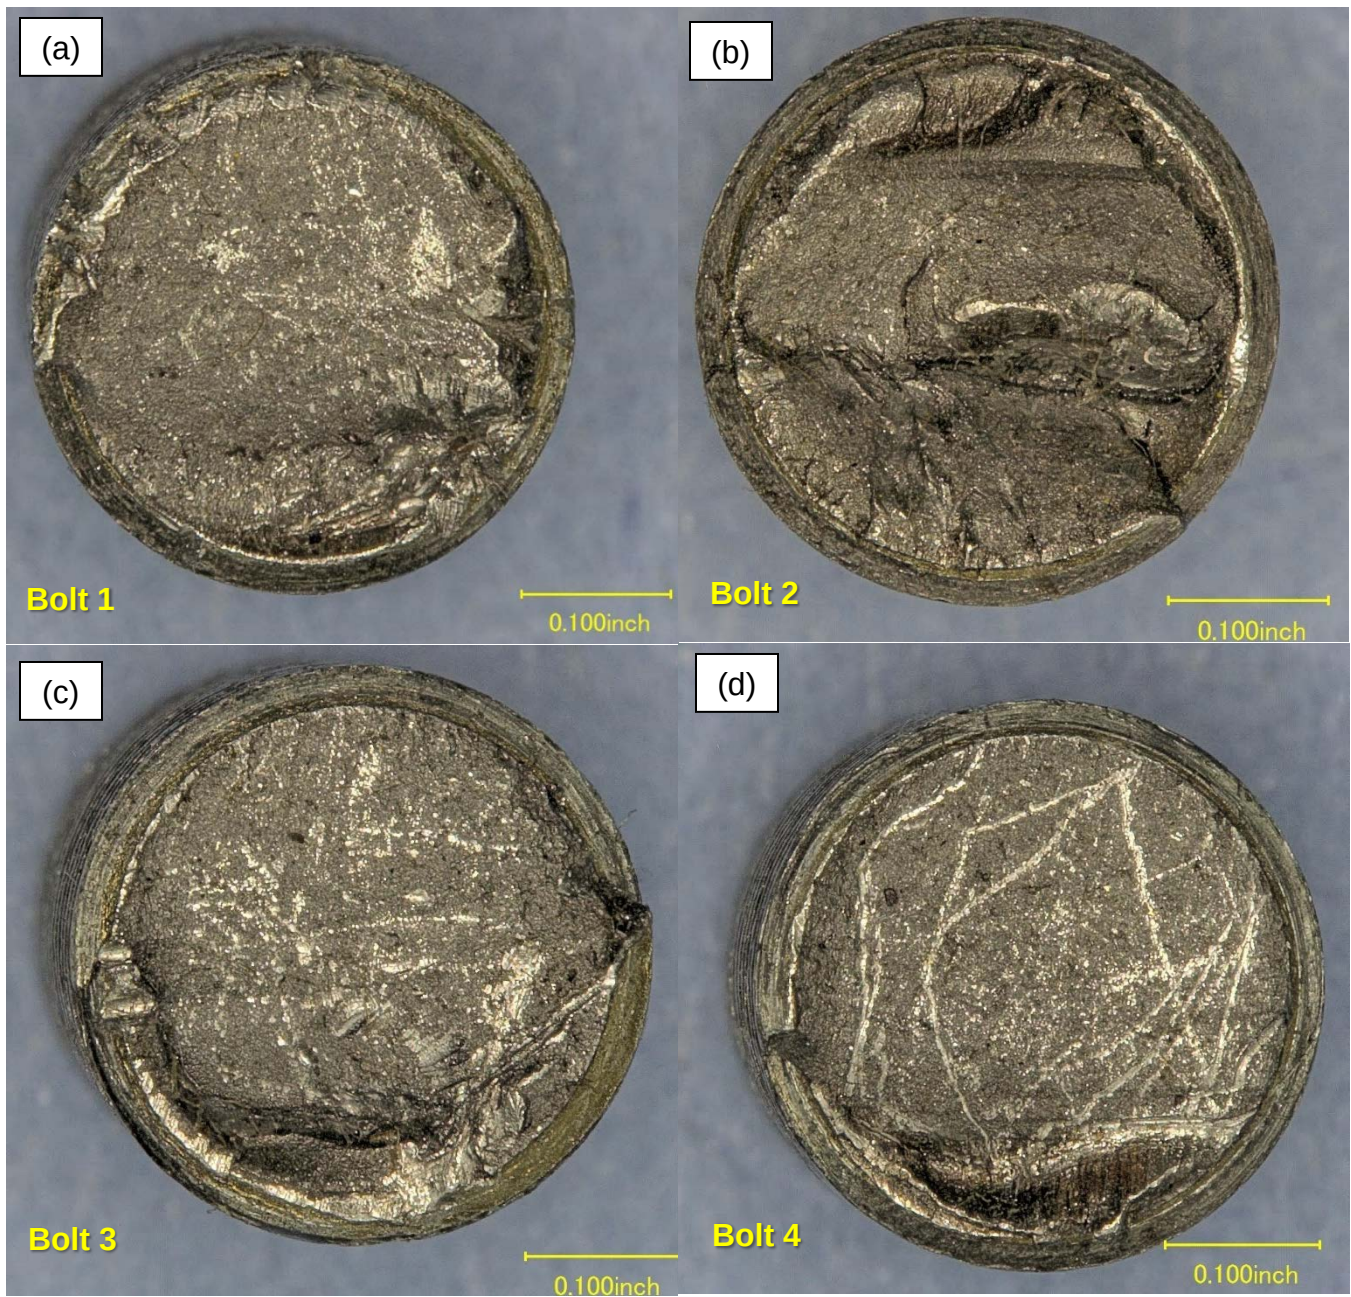
Figure 2 shows representative bolt fracture surfaces, as received. The general features of each of the six fracture surfaces were consistent with each other. As typified in Figure 2b (Bolt 2), the fracture surfaces exhibited opposite-facing flat thumbnail-shaped regions with a middle rougher region.

The thumbnail regions exhibited crack arrest, or beach, marks. The orientation of these crack arrest marks was consistent with propagation inward from the surface of the

thread roots. The thumbnail regions also exhibited ratchet marks near the thread root surfaces, consistent with multiple crack initiation sites. These features were all consistent with fatigue in reverse bending.

Figure 2 – Selected bolts fracture surfaces of bolts 1 through 4, as received.

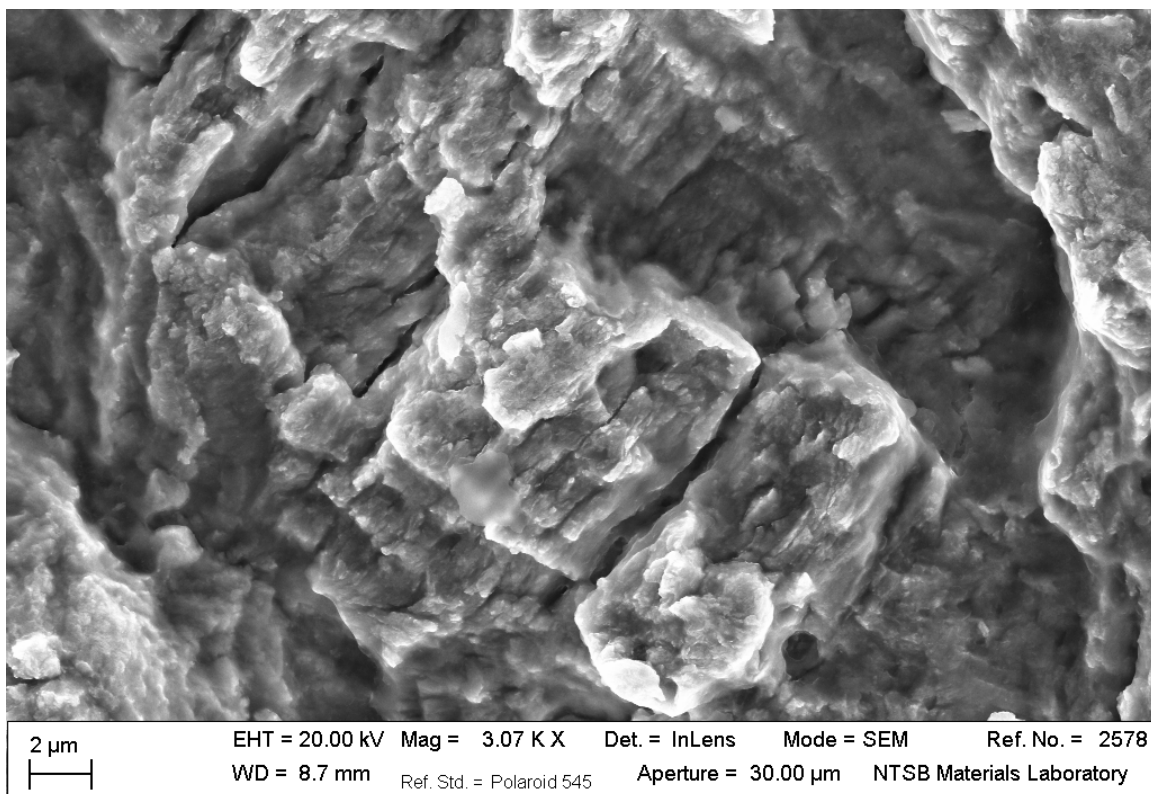
The fracture surface of Bolt 2 was examined using a scanning electron microscope (SEM). The thumbnail regions exhibited fatigue striations, consistent with fatigue crack propagation from the surface of the bolt (thread root) inward (see Figure 3). The intermediate region exhibited dimple rupture, consistent with overstress failure. These features were consistent with fatigue cracks initiating at the thread root surface, propagating inward due to reverse bending stresses, until the remaining cross-section succumbed to overstress. This pattern was consistent on all of the bolt fracture surfaces.

Figure 3 – Secondary electron (SE) micrograph of fatigue striations on the bolt 2 fracture surface.

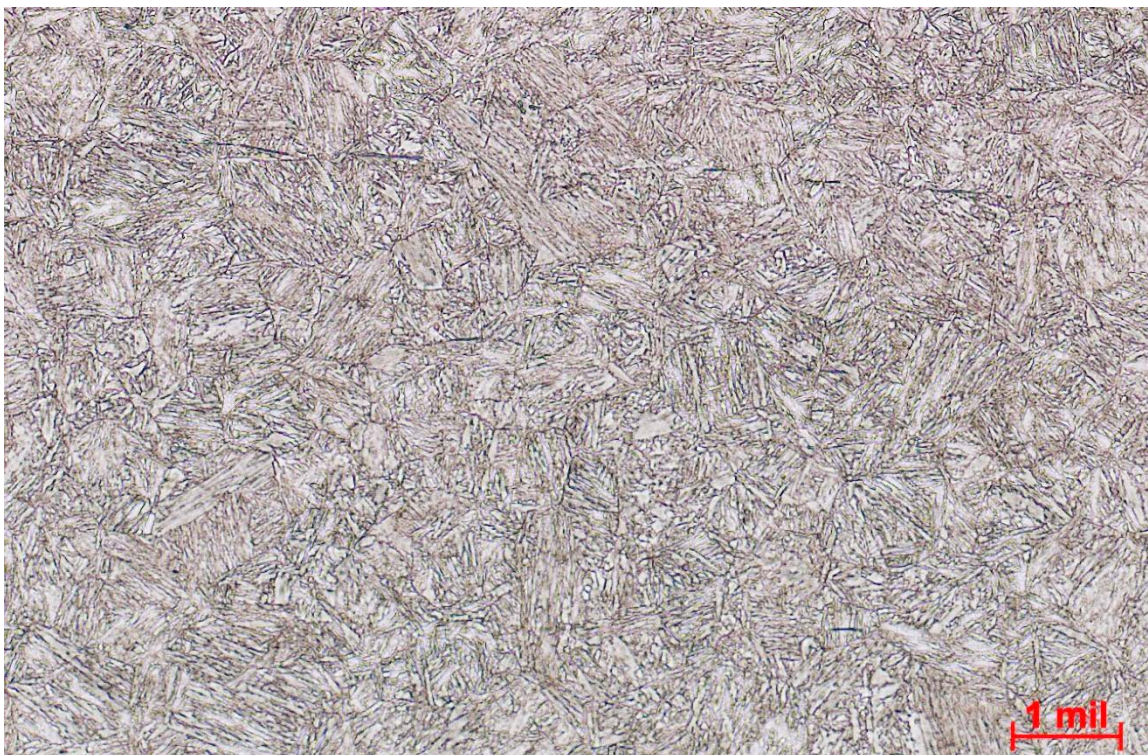
A metallurgical cross section of Bolt 6 was prepared and examined by optical microscopy. Figure 4 shows a typical region of the bolt microstructure. The microstructure shows a lath structure with uniformly-dispersed fine carbide precipitates, consistent with a tempered martensite structure. Occasional manganese sulfide inclusions were also present.

The chemical composition of the bolt was examined using x-ray fluorescence. The chemical composition was consistent with an alloy steel. The hardness was inspected per ASTM E18.<sup>1</sup> The hardness averaged 36 HRC, which was consistent with values typically reported for this alloy composition and microstructure.<sup>2</sup>

Figure 4 – Bright field (BF) optical micrograph showing the tempered martensite microstructure of bolt 6 (~500X, etched 2% Nital).

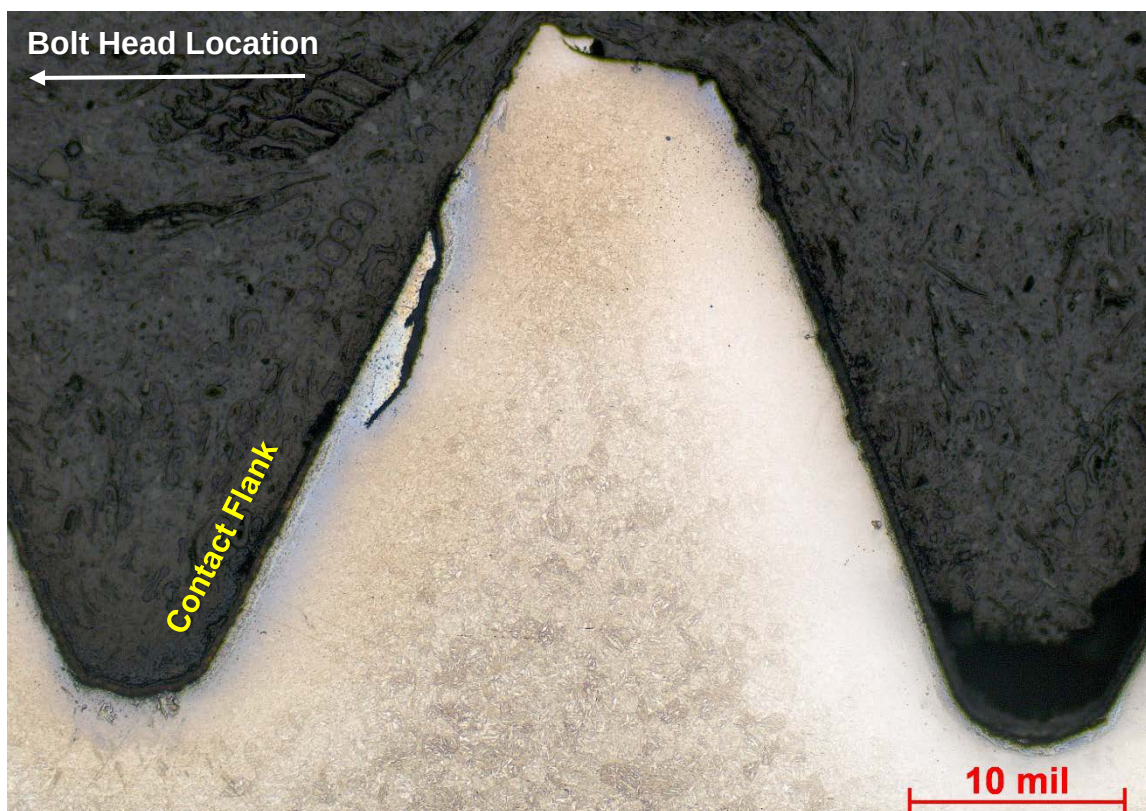
One of the bolt threads is illustrated in Figure 5. The contact face shows a crack on the flank that would have been in contact with the attachment nut. This thread flank faced the bolt head (labeled in Figure 5). Most of the threads exhibited this type of cracking, consistently located on the contact flank.

Figure 5 – BF optical micrograph of a thread cross-section in bolt 6, showing a crack on the contacting face (~100X, etched 2% Nital).

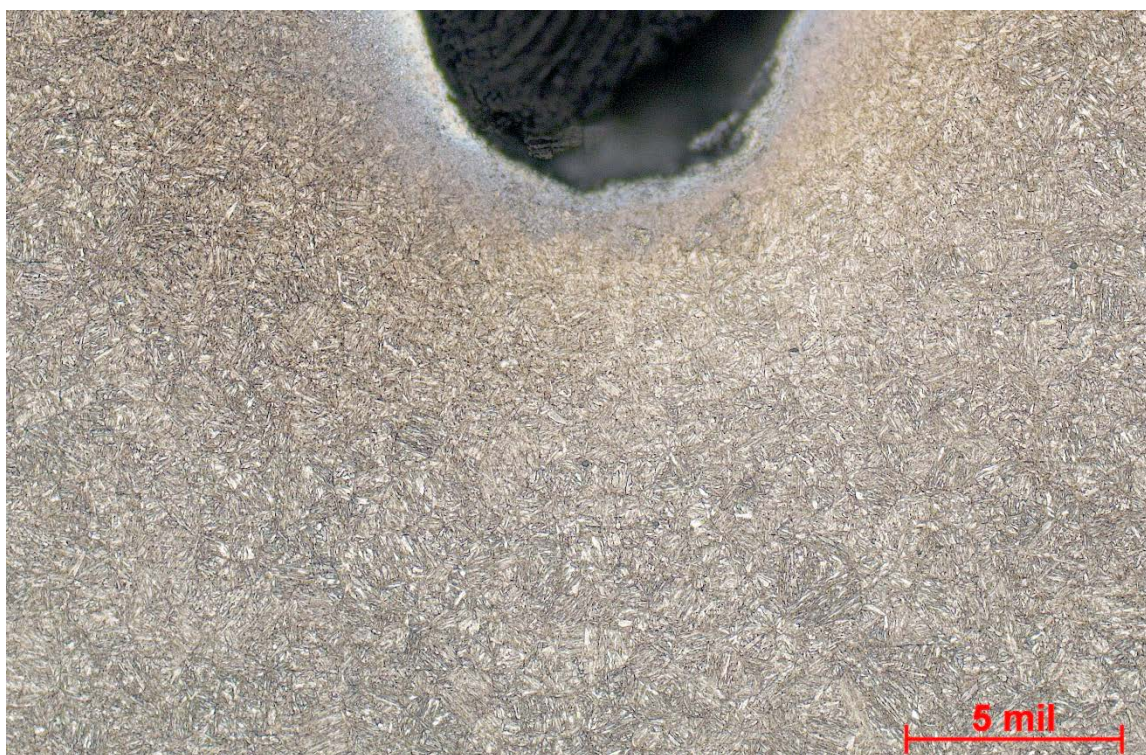
Figure 6 shows an area near a thread root. The microstructure exhibited flow lines around the root, consistent with the threads being rolled into the bolt.

Figure 6 – BF micrograph showing a bolt 6 thread root flow lines (~200X, etched 2% Nital).
