N610TT Engine inspection accomplished 9 May 2017 at the owner's hangar located at Columbia Gorge Airport, Dallesport, Washington. Inspection conducted by the owner and builder, Louis Ott with FAA airworthiness inspector Thomas Borland observing.

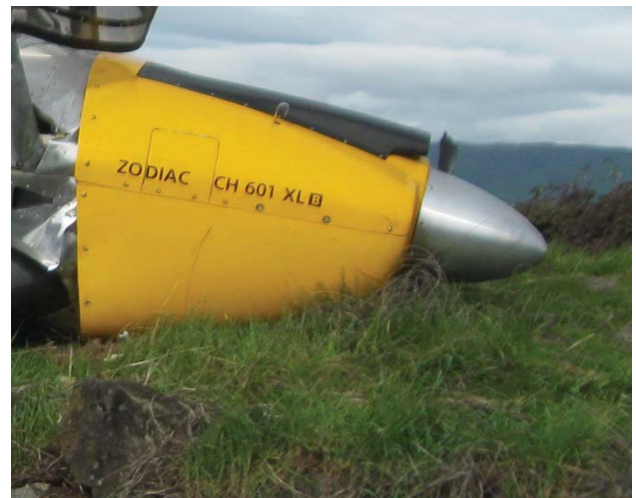
The engine compartment did not incur any notable damage from impact with the ground. All three of the propeller blades were broken off upon impact but the spinner unscathed.

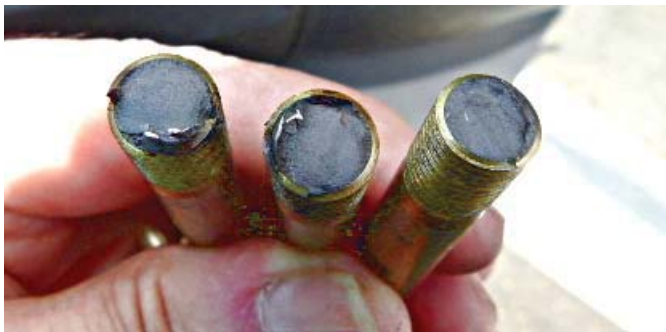
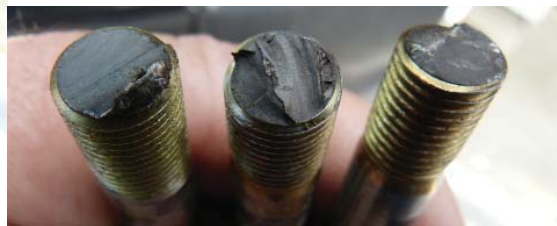
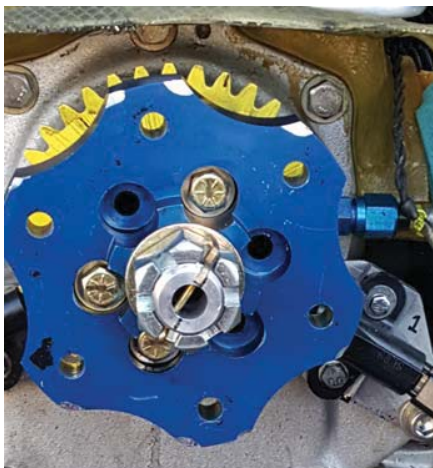
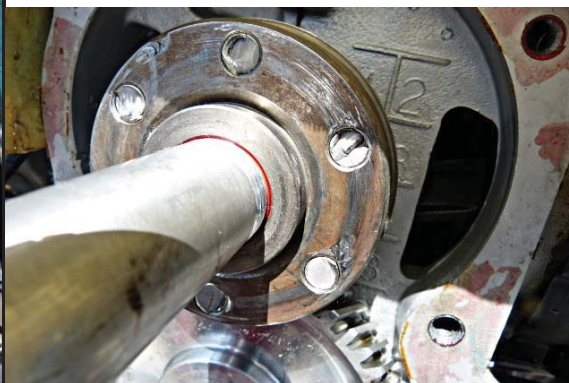
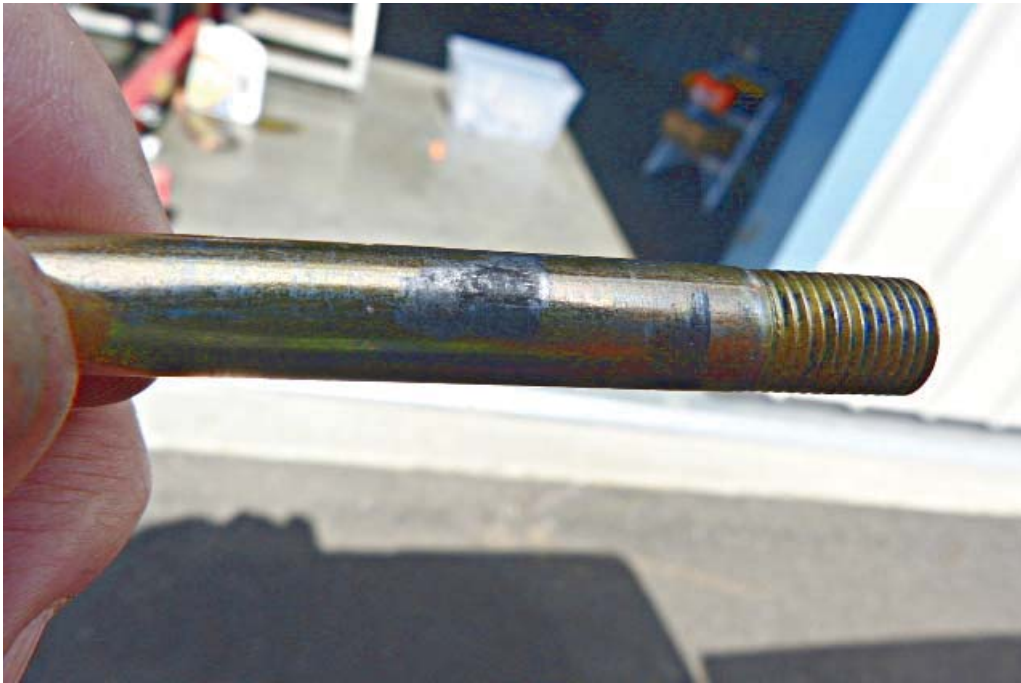
The six bolts holding the prop hub to the drive hub were found to have all broken off. The large safety nut on the drive shaft was effectively the only thing holding the prop hub to the engine.

The bolts were visually examined and showed signs of stress fractures and cracking. There was some wear noted on the sides of these bolts as well

The bolts were industrial, grade 8 bolts, not aircraft hardware.

There was no evidence indicating that the bolts were improperly installed.

Failure of the bolts securing the propeller, and in turn the magnetic pickup target plate, caused a rotation of the plate to effectually retard the ignition timing of the engine. This resulted in significant loss of engine power. While continuing to operate in the diminished capacity the engine failed to perform as expected when called upon to correct the low altitude condition on approach to the runway.

I looked at the bolts again and took some pictures. I checked the back side of the bolts in the flange. They project out from the drive hub about 1 thread. Still an eighth of an inch from bottoming on the cam gear. I think the break pattern on some of the bolts is that of a stress fracture and not simple shearing. The pattern shows the fracture starting at a point on the edge and progressing across to the other side where it fails. Some of the bolt ends are a bit polished looking too. Also, all the bolts show a wear pattern on the shank of the bolts where they go through the prop hub. Wear on each side which indicates to me that the prop hub was rotating very slightly in relation to the drive hub. The bolts were all torqued correctly and the 1" aluminum shaft nut was torqued to 100 lb ft. This engine has no harmonic dampener or flywheel, which is a departure from most conversions. It could be that the 3 power pulses per revolution and the 3 times per revolution the prop has to drive the engine was just too much for this drive design. Some flex caused wear which caused more loosening and that cascaded until it was too loose.
