## **NATIONAL TRANSPORTATION SAFETY BOARD**

### **Field Notes**

**WPR17LA087**

Aircraft: Titan Tornado I, Registration Number: N5131H, Serial #: T9XXXCPJLO177

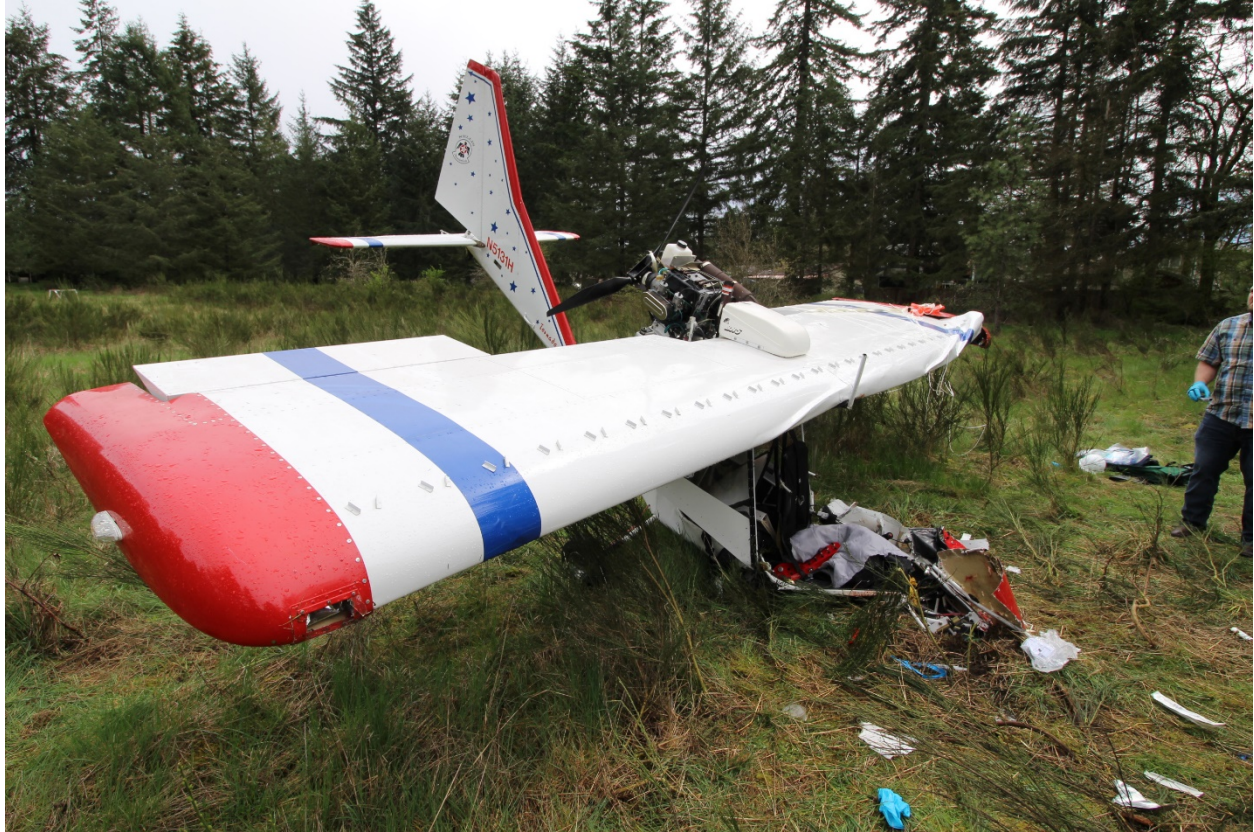
Figure 2: View of Cockpit area

Examination of the accident site revealed that the airplane impacted generally flat terrain. The airplane was oriented on a magnetic bearing of about 270 degrees. The cockpit, engine, both wings, and empennage remained attached to the fuselage. The parachute was found deployed. The cockpit and cabin structure forward of the fuel tank was destroyed. The fuel cap remained attached to the fuel cell. The numbers on the outside of the fuel cell indicated that there was about 7.5-9.0 gallons of fuel on board.

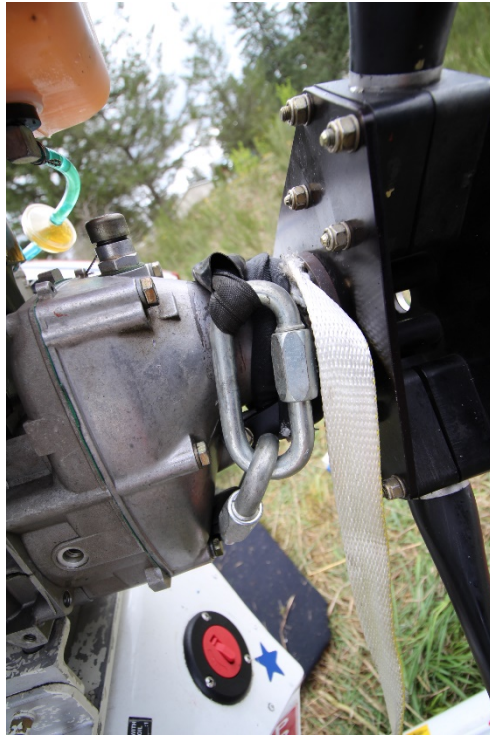
The engine remained attached to the engine mounts. A small quarter-sized hole was noted on the bottom aft section of the engine. The propeller remained attached to the engine. The parachute line was wrapped around the propeller about 5 times. The propeller was not able to move freely.

**Figure 3: View of parachute line wrapped around propeller shaft.**

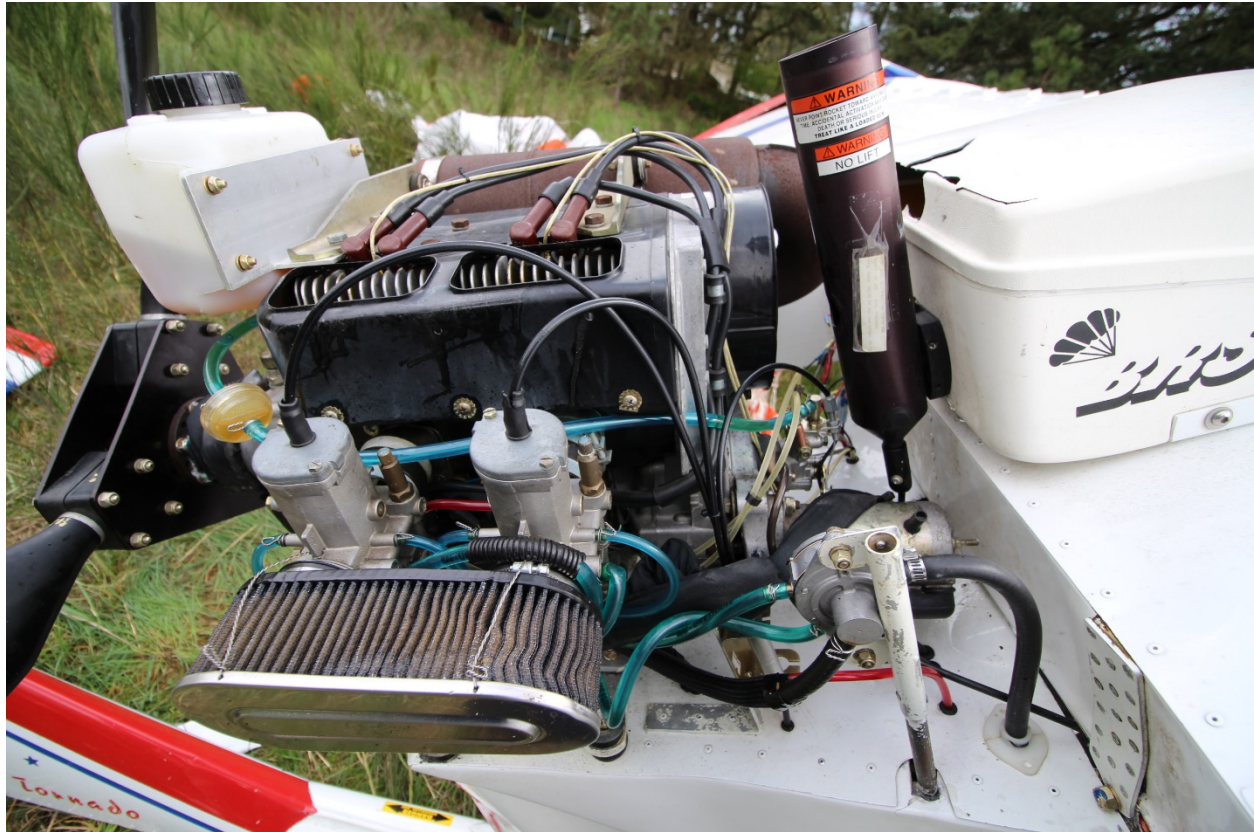
Figure 4: BRS Location

The BRS , model number T2 300, Serial Number T2B03690 was located just forward of the engine and was found deployed at the accident site. The activation handle inside the cockpit appeared to be activated, and was placard “Aircraft engine must be shut off prior to deploying parachute. Failure to do so may result in death or serious injury.” On the outside of the launch tube a white piece of paper indicated that the BRS parachute system should not be used after May 2015. The canopy, suspension lines, and slider remained intact and no damage was noted. About three feet of the riser was wrapped around the base of the propeller.

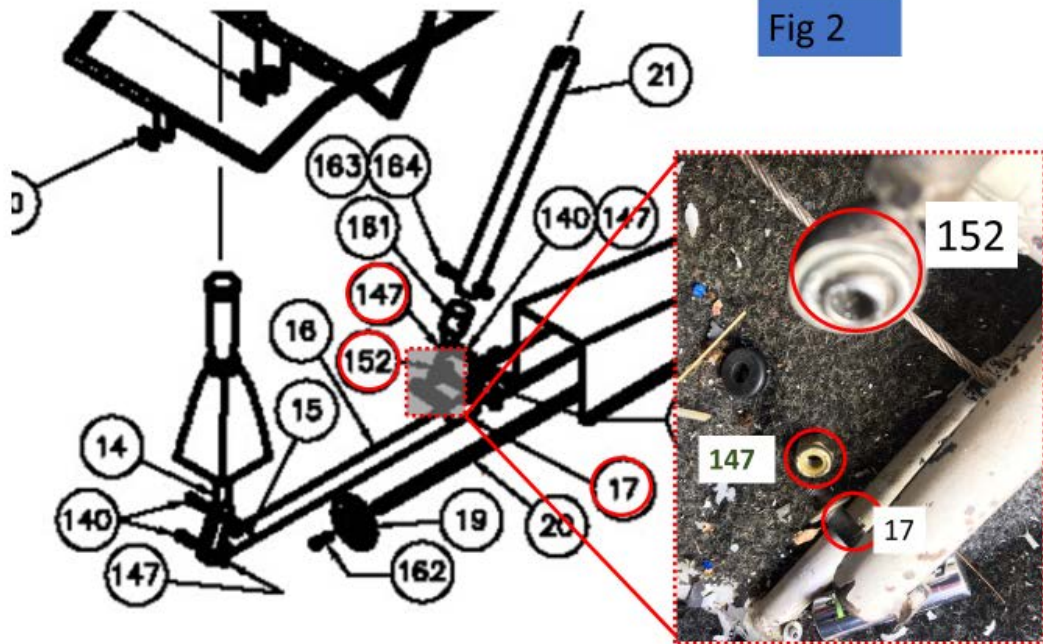
The rudder cable assembly remained attached from the rudder control peddles aft to the rudder connection points. The elevator push/pull tube remained attached from the control yoke to the elevator. Flight control continuity for the ailerons could not be stabled because the male ball joint (Ref 152) was separated from the control mixer weldment (Ref 17), and the stop nut (Ref 147) was found about five inches from the ball joint on the cabin floor.
