## **NATIONAL TRANSPORTATION SAFETY BOARD**

### **AIRFRAME AND ENGINE EXAM REPORT**

**WPR17LA090**

Location: Banning, CA  
Date: April 24, 2017  
Aircraft: Cessna T201N, Registration Number: 6218Y  
NTSB IIC: Michael Huhn

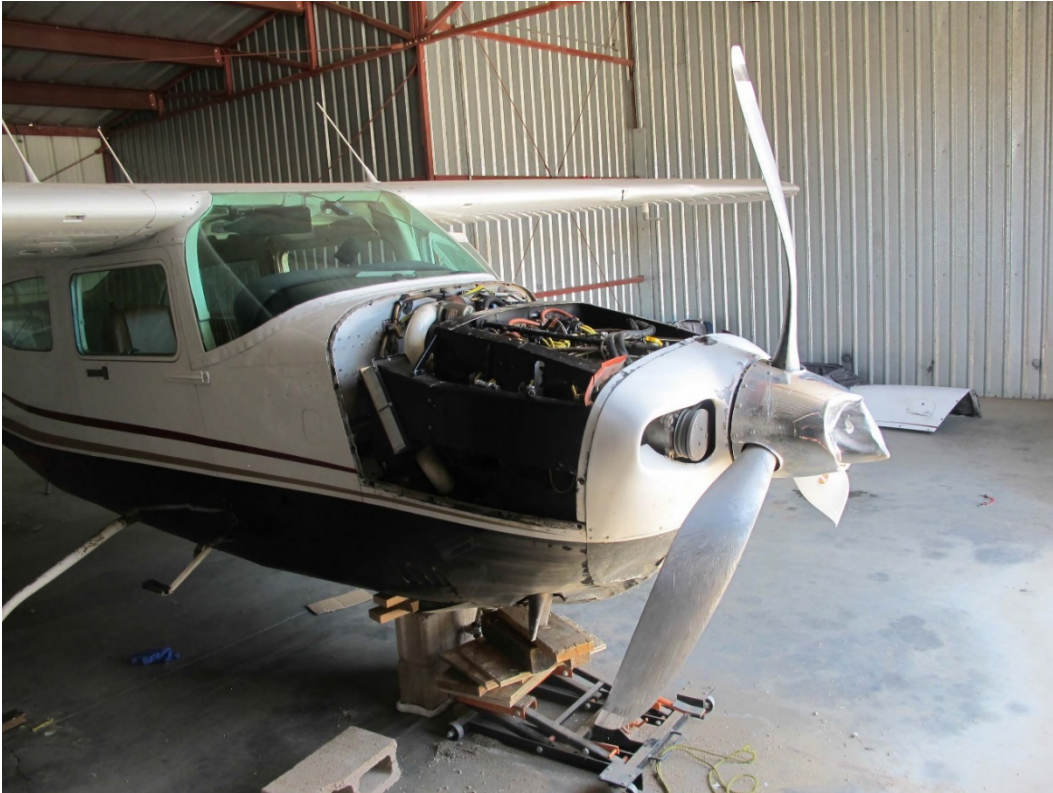
**Figure 1 - Right Front View of Airplane**

Examination of the recovered airframe and engine was conducted on May 23, 2017, in the same hangar at BNG. The nose gear had separated/collapsed during the accident. The airplane was found resting on its main gear, in an approximately level pitch attitude, its nose supported by miscellaneous hangar equipment/articles.

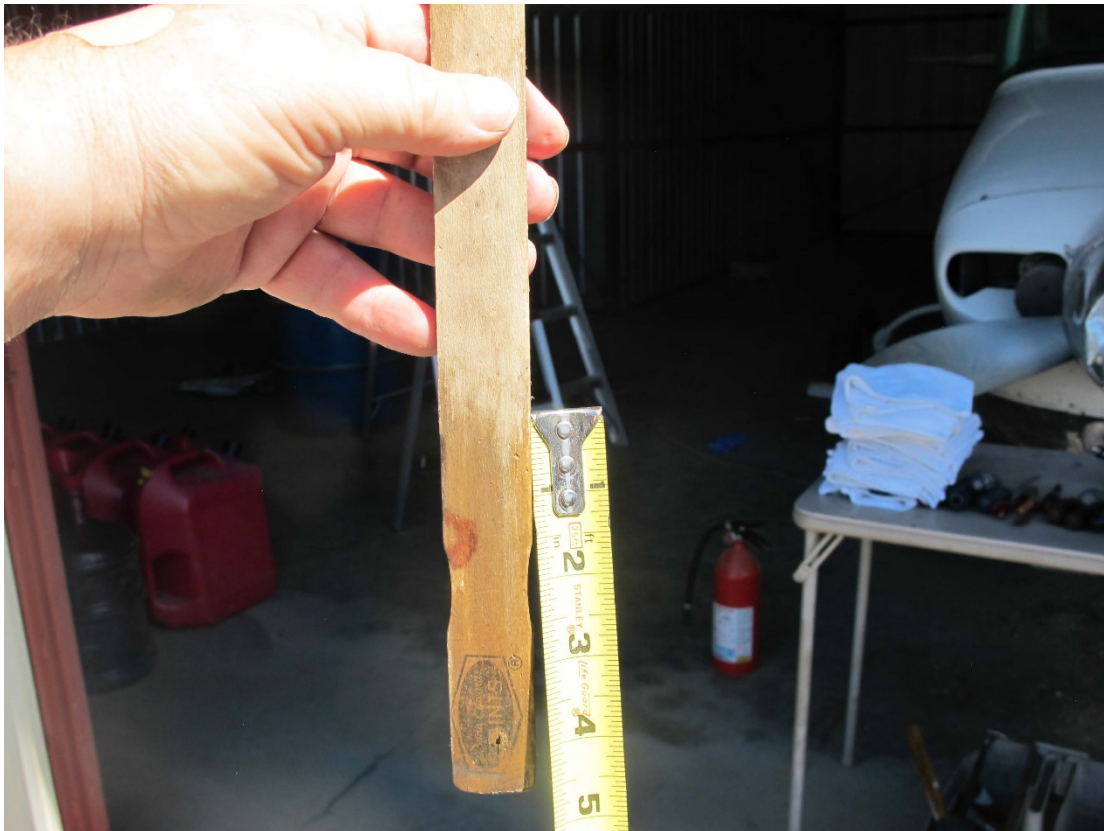
**Figure 4 - Right Wing Fuel Measurement**

The wooden stick was dipped into the right wing fuel tank, and it came out wet; the wet area of the stick measured about 4.5 inches long. A total of about 27 gallons of a light blue fluid that smelled like aviation gasoline was drained from the right wing tank.

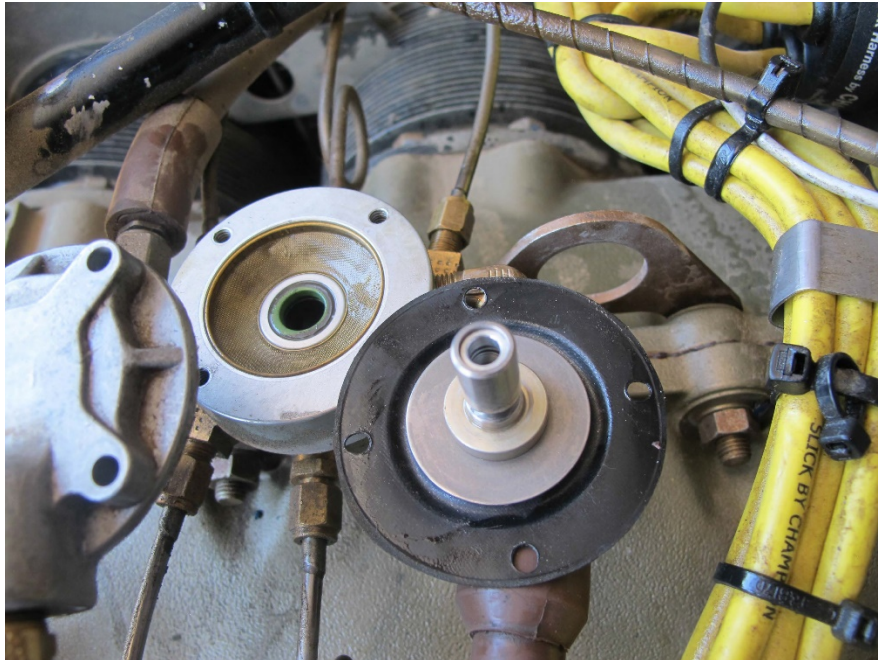
**Figure 5 - Screen and Diaphragm of Fuel Manifold Distribution Valve**

The fuel manifold distribution valve ["spider"] was opened/disassembled, and clear, light blue fluid that smelled like aviation gasoline was present. The rubber diaphragm was pliable and not torn; the screen was clean and moist.

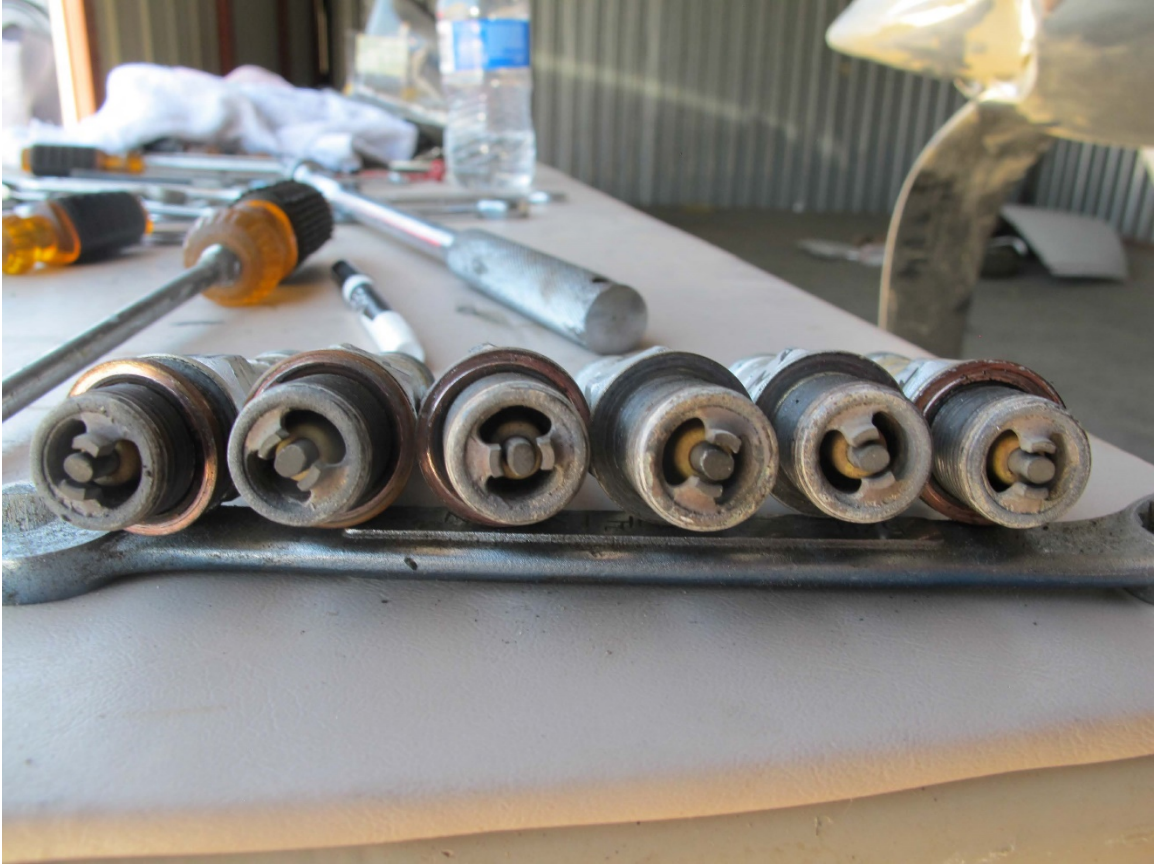
**Figure 7 - Top Spark Plugs (Cyl Nos. 1-6, from Right to Left)**

The engine remained in place on the airframe. The top spark plugs were removed. The center electrodes for all cylinders were elliptical and clean with no mechanical deformation. The spark plug electrodes were gray, which corresponded to normal operation according to the Champion Aviation Check-A-Plug AV-27 Chart.
