## **NATIONAL TRANSPORTATION SAFETY BOARD**

# **AIRFRAME AND ENGINE EXAMINATION**

**WPR17LA096**

Location: Mukilteo, Washington  
Date: May 2, 2017  
Aircraft: Piper PA-32-260, Registration Number: N3457W, Serial #: 32-326  
NTSB IIC: Elliott Simpson

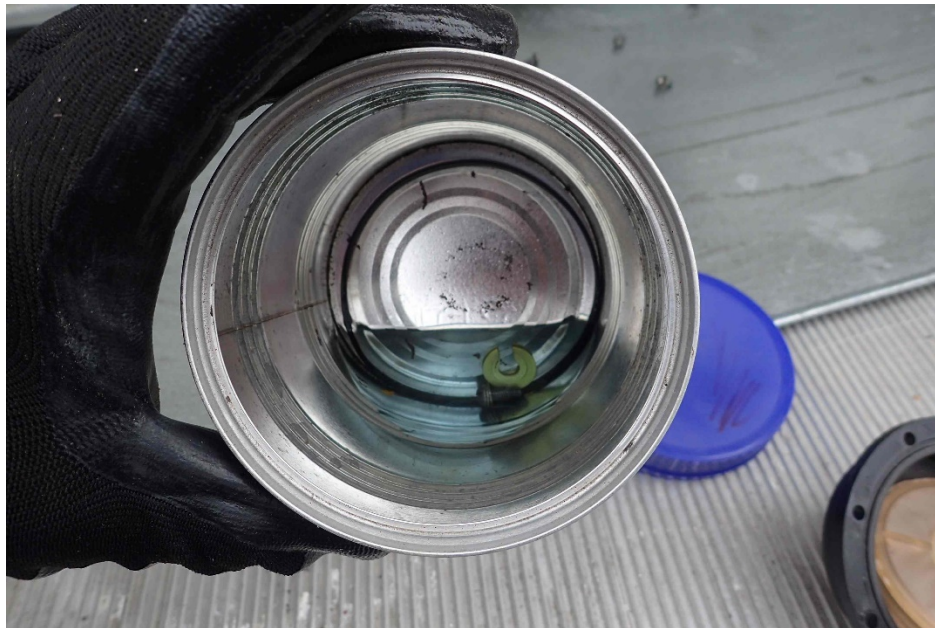
The fuel selector valve cover was removed from the belly, revealing the selector bowl. There was no indication of fuel staining or streaks to any of the belly skins in the vicinity of the selector drain port. The screws attaching the bowl to the valve case appeared to be held in place with minimum torque and were removed from the bowl for examination. The bowl contained about ¼ cup of clean, bright, light-blue colored fuel (Photo 1). The O-ring, spring, and retaining washer were in place, and the white plastic screen was clear. The valve was observed in the left tip tank position, which corresponded to the valve handle in the cabin. The fuel selector valve moved freely through its range, and the detents were positive. There was no fuel staining on the inside cabin belly skins in the area of the fuel selector valve.

The fuel from the bowl was tested with water detecting paste, and no water was found.

Photo 1 – Fuel Recovered from Selector Valve

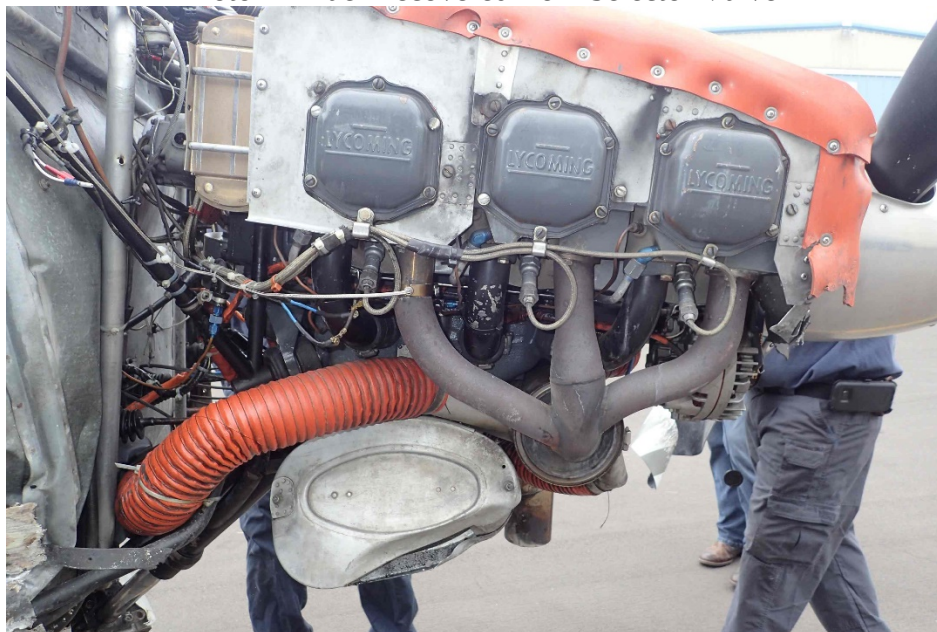
The engine sustained minimal damage and remained partially attached to the firewall (Photo 2), with the upper left engine mount broken. The airbox sustained crush damage and the Bendix starter gear had extended, making contact with the ring gear. The propeller remained attached to the crankshaft, with both blades exhibiting about 360° of tip curl, and chordwise scratches at the curled areas (Photo 3). One blade tip had detached, leaving a jagged separation surface (Photo 4).

Photo 2 - Engine

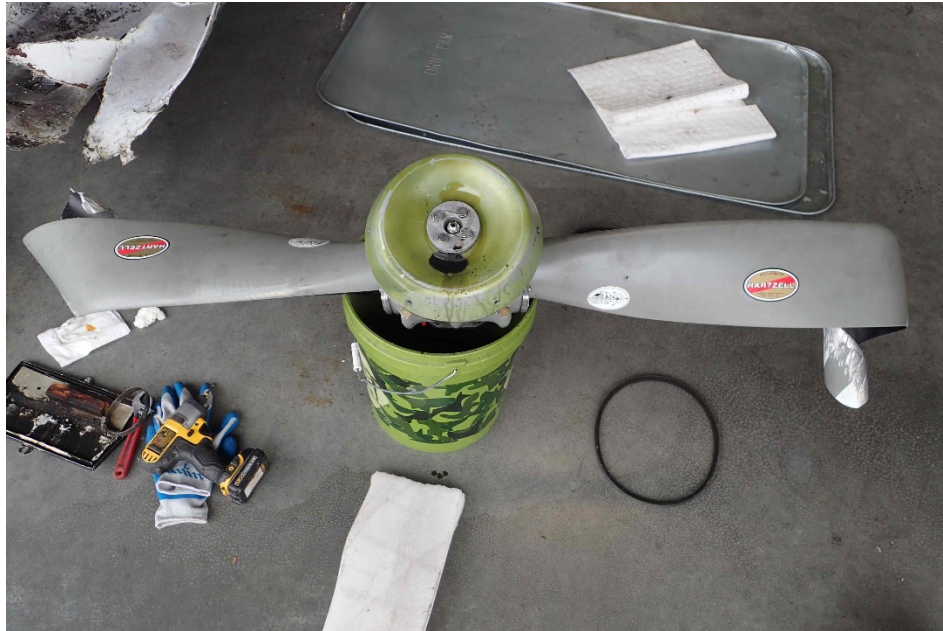
Photo 3 - Propeller

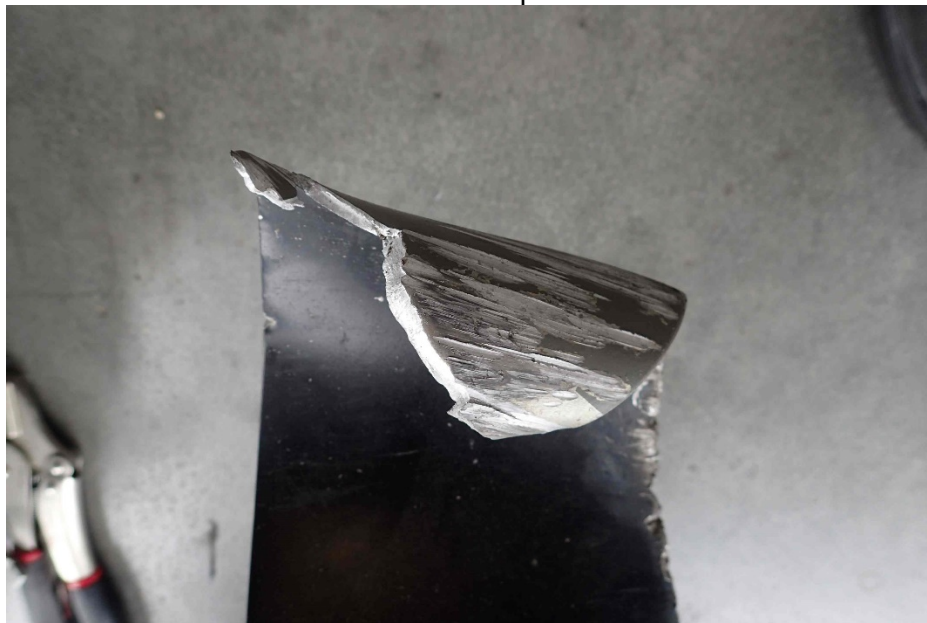
Photo 4 – Propeller Blade Tip

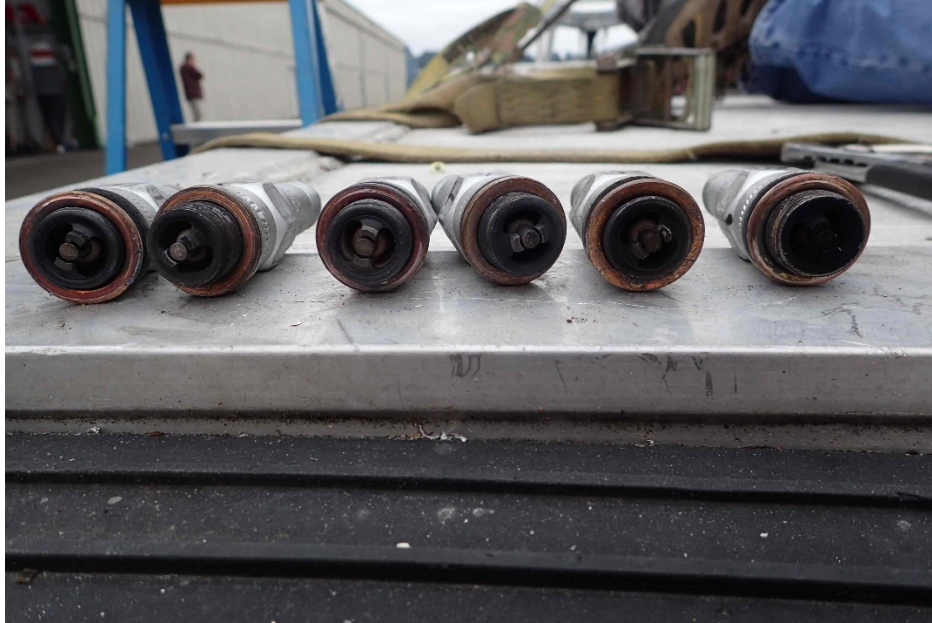
The electrodes of plugs 1 through 4 were dark grey in color. The electrodes of plug 5 were coated in dark grey/black soot (Photo 5), and plug 6 was coated in black soot (Photo 6). The electrodes of the lower spark plug for cylinder 6 exhibited similar black sooting.

Photo 5 – Top Spark Plugs

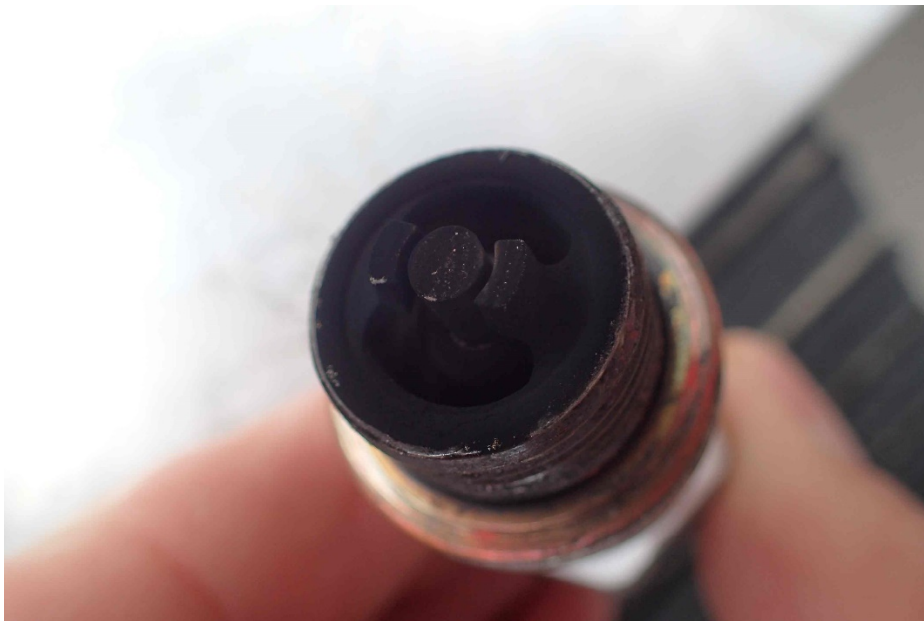
Photo 6 – Top Cylinder 6 Spark Plug

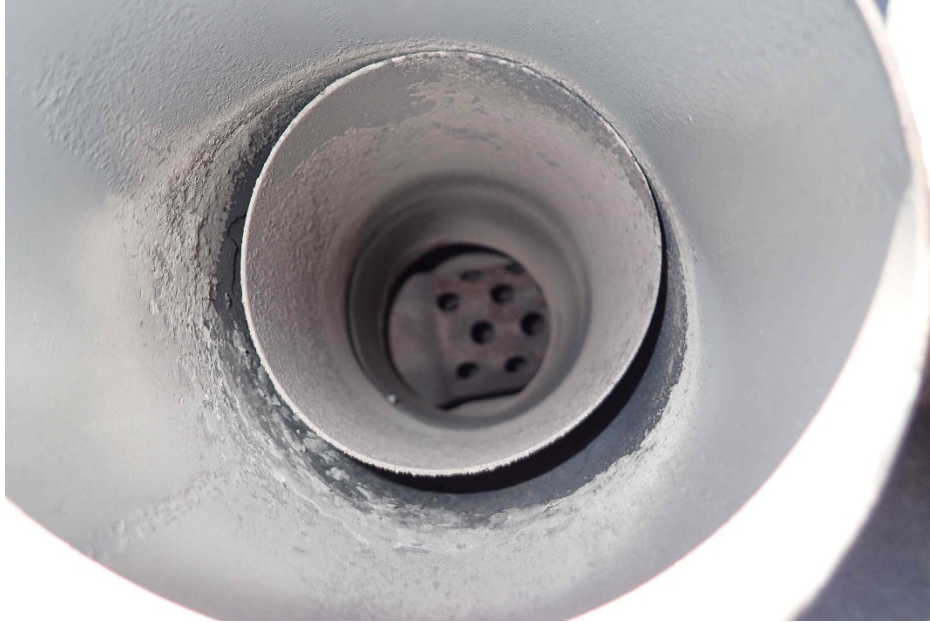
The muffler was removed, and all exhaust down-pipes were free of obstruction, with their inner surfaces coated in light tan deposits. The internal components of the muffler were intact (Photo 7).

Photo 7- Internal Muffler Baffling after the Engine Run
