## **NATIONAL TRANSPORTATION SAFETY BOARD**

# **MAGNETO AND CARBURETOR EXAMINATION**

**WPR17LA096**

Location: Mukilteo, Washington  
Date: May 2, 2017  
Aircraft: Piper PA-32-260, Registration Number: N3457W, Serial #: 32-326  
NTSB IIC: Elliott Simpson

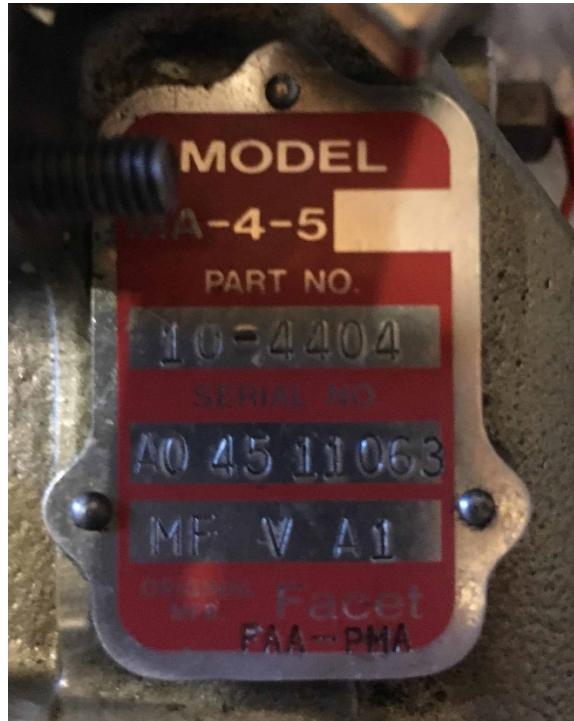
Photo 1 – Data Tag

The carburetor had a red data plate, which indicated the original manufacturer to be Facet. An “MF” was stamped next to the serial number, which according to AvStar Fuel Systems Inc. documentation, indicates a brass float was installed (Photo 1). Maintenance records indicated that the carburetor was installed in 1997, coincident to engine overhaul. The records did not document the serial number or facility the carburetor was purchased from, instead simply referencing the part number, 10-4404. No other carburetor related maintenance entry was found beyond the replacement of the sump plug in 2006, and the repair and removal of the carburetor inlet air box.

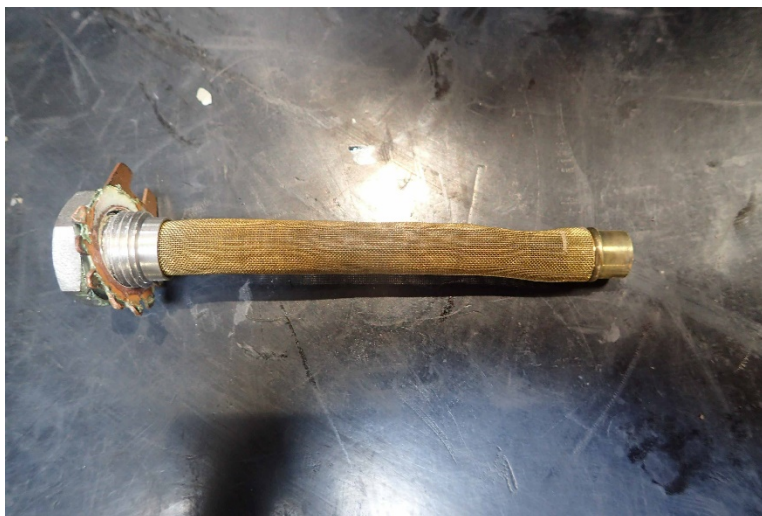
Photo 2 – Inlet Screen

The carburetor appeared undamaged, and all fittings were intact. The fuel inlet screen was removed, appeared slightly deformed, and was free of debris (Photo 2). The throttle and mixture control arms could be freely moved by hand. Resistance was felt with movement on one direction of the throttle, consistent with an adequate seal and operating check valve for the accelerator pump.

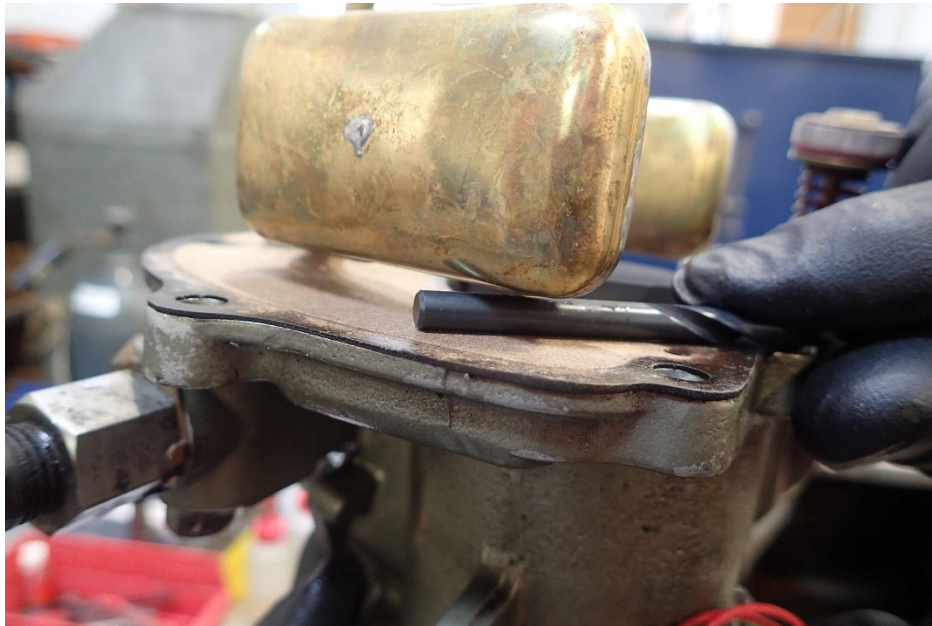
Photo 3 – Float Clearance

All carburetor body to bowl screws were secure and tight, and remained affixed with a lock-tab washer. There was no evidence of fuel leak and discoloration at the body and bowl interface. The carburetor bowl was separated to facilitate internal examination. The brass float assembly was intact, and the clearance from the throttle body to bowl gasket and float was measured to be 13/64 inches on both sides (Photo 3), in accordance with maintenance documentation.

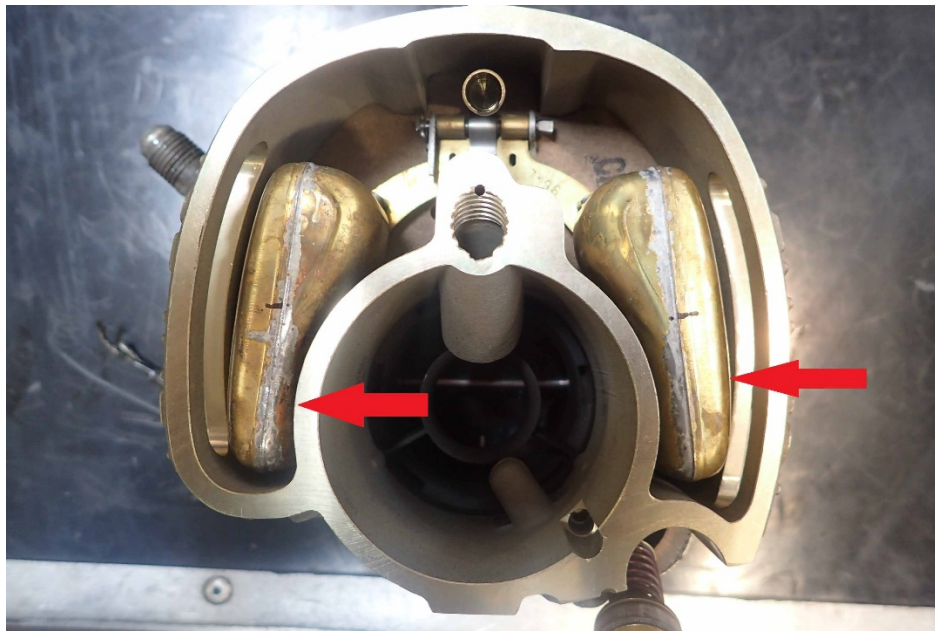
Photo 4 – Float Sidewall Clearance

The float-to-bowl clearance was then measured utilizing the M-510 gauge and a gauge pin. According to maintenance documentation, the clearance should be 0.081 inches. The gap was less than 0.081 inches (approximately half the value) on the outboard surface of the accelerator pump float, and the inboard surface of the other float (Photo 4). Marvel-Schebler Service Bulletin SB-4 Rev. B documents the measurement of this dimension, and required that a "FC" be stamped on the carburetors body flange, adjacent to the throttle shaft. No such annotation was noted.

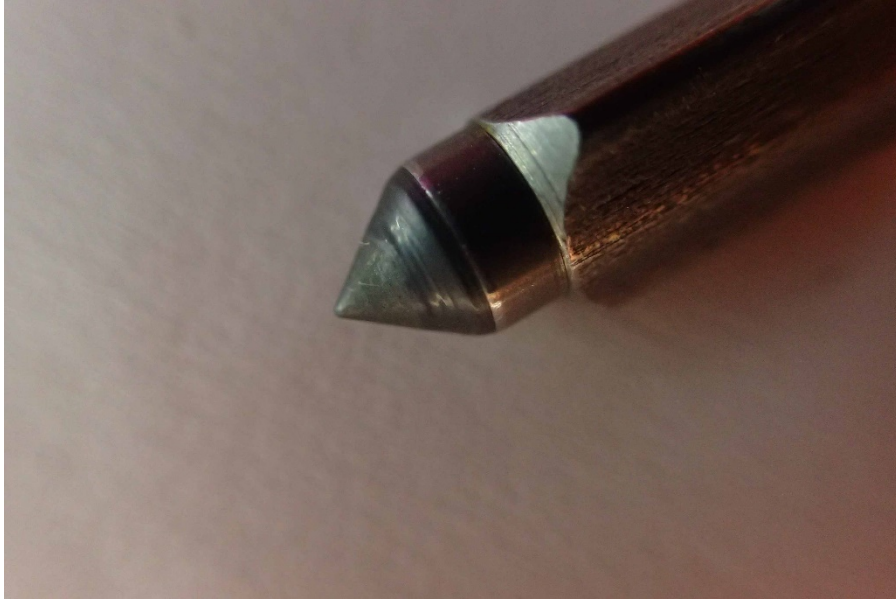
Photo 5 – Float Valve Tip

The float valve was intact, and its rubber tip was pliable but firm. A slight radial indentation was observed to the tip (Photo 5). The valve seat was clear and free of debris.

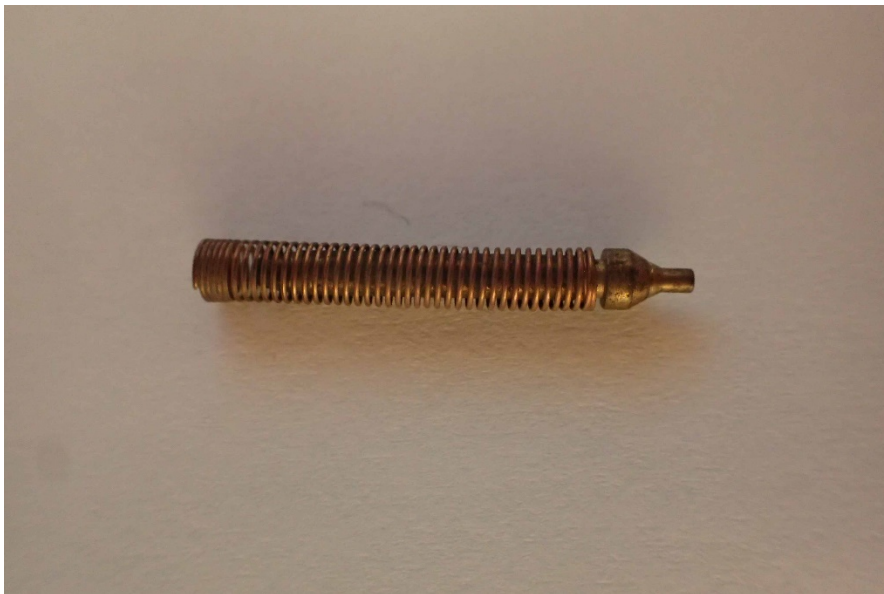
Photo 6 – Accelerator Pump Discharge Valve

The accelerator pump discharge valve was of the spring type, and was intact (Photo 6).

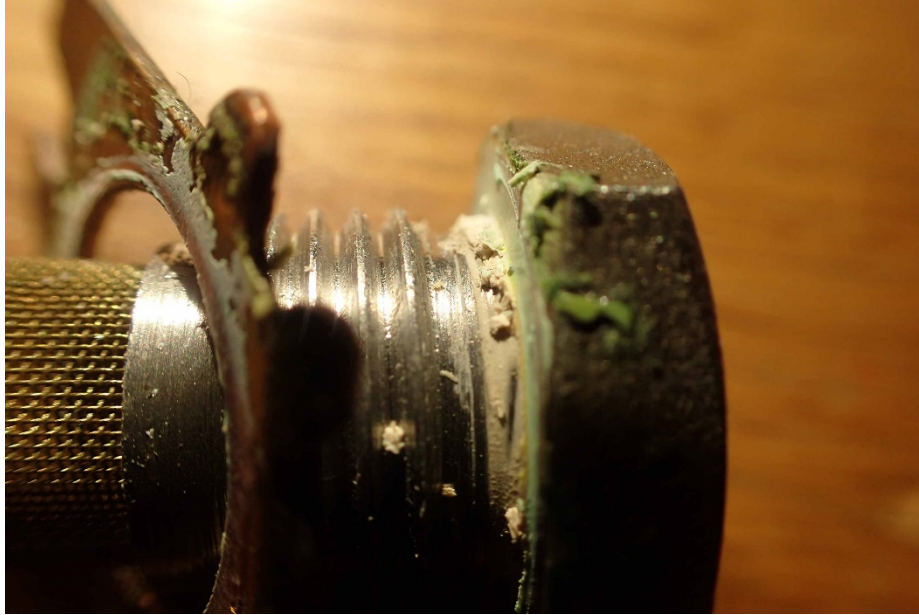
Photo 7- Fuel Inlet Screen Sealant

White material consistent with thread sealant compound was found on multiple bolt threads throughout the carburetor fitting, including the inlet filter screen (Photo 7), in deference to Service Bulletin: SB-10 Rev B.

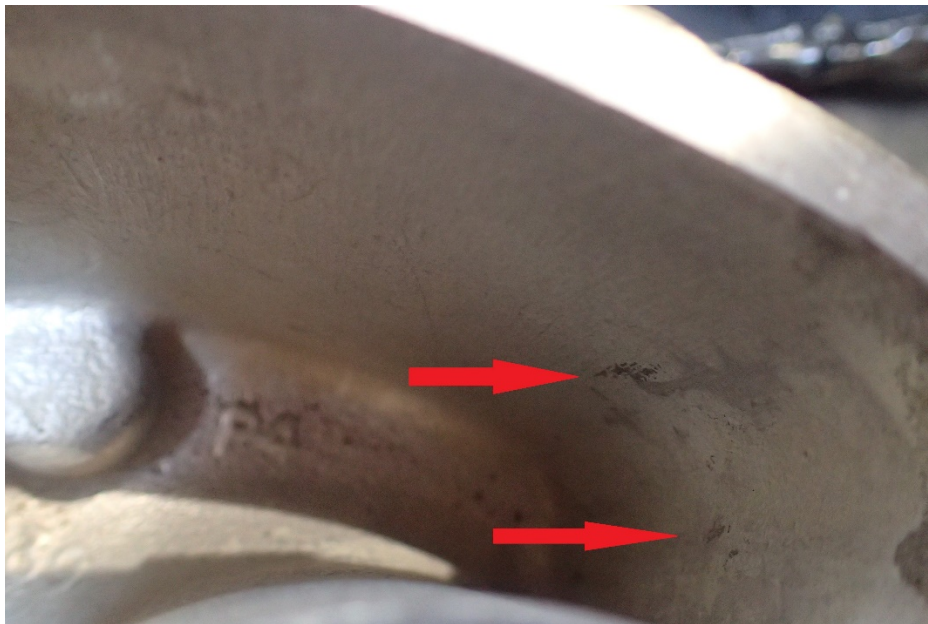
The float shaft attach bracket remained firmly attached to the carburetor body, and the float pivoted freely on its shaft. The float assembly was disassembled. Various scratches and chafe marks were located within the bowl assembly adjacent to the floats (Photo 8). No significant corresponding chafing was noted on either of the floats. The float assembly had the stamped numbers 7-69 and SC 30-764 on its attachment bracket. When laid on a flat surface, the floats appeared to be twisted relative to each other, with one float resting about 1/16 inch above the other at its tip.

Photo 8 – Chafe Marks within Carburetor Bowl
