# NATIONAL TRANSPORTATION SAFETY BOARD

MATERIALS LABORATORY FACTUAL REPORT

Report No. 17-085

Place : Santa Barbara, California  
Date : May 5, 2017  
Vehicle : Robinson R44  
NTSB No. : WPR17LA097  
Investigator : Elliott Simpson, AS-WPR

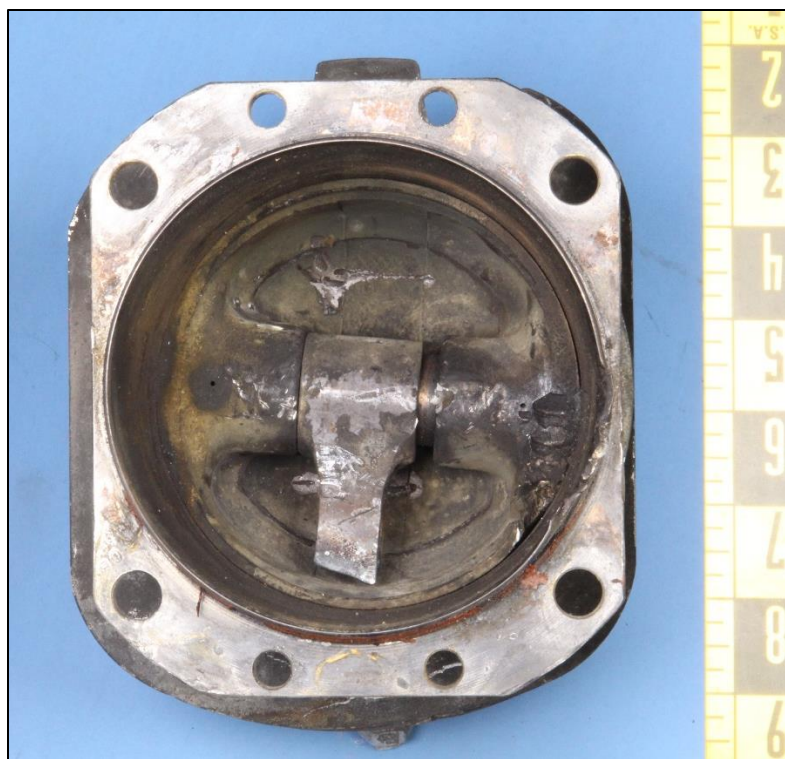
Figure 2. View of the inboard end of the number 4 cylinder assembly showing the piston and cut connecting rod end contained within the cylinder barrel.

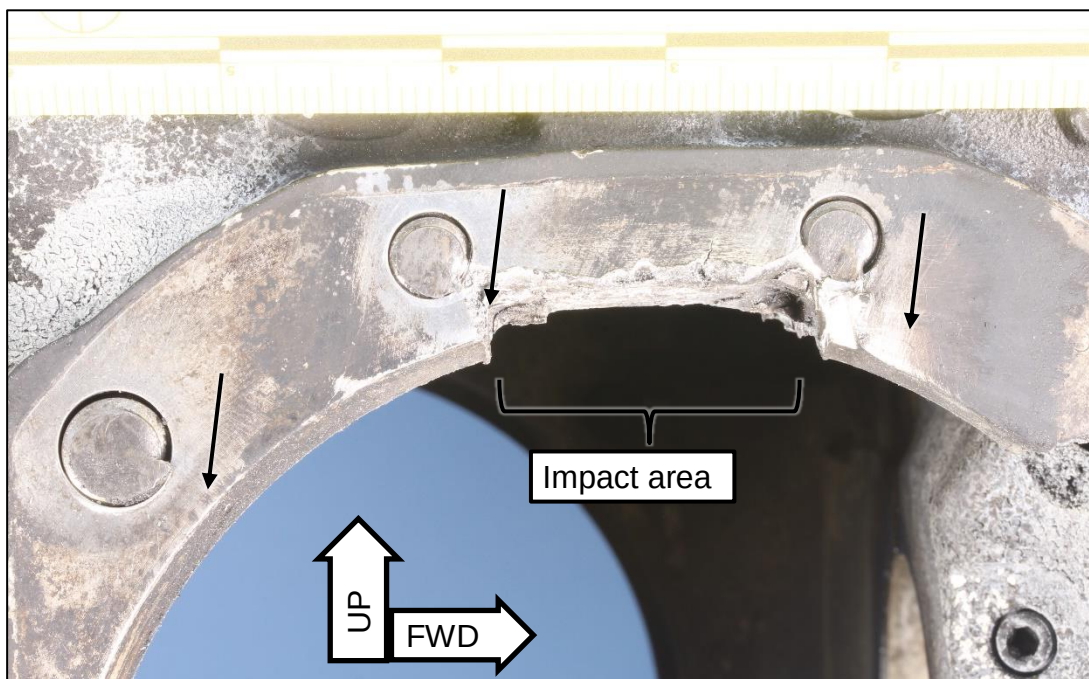
The number 3 cylinder had been attached with 6 studs and 2 throughbolts. Fractured ends from the three upper studs remained in the case as shown in figure 5. The two throughbolts that had been installed at the forward side of the number 3 cylinder (based on a review of photographs taken during the engine teardown) were bent and fractured. At the lower side of the number 3 cylinder port, the portion of the case where the two middle lower studs were attached was fractured and missing, and the fracture in the case intersected the holes for the lower aft stud and the lower throughbolt. One of the lower middle studs was intact and remained trapped in its hole on the number 3

Close views of the fracture surfaces for the 3 upper studs for the number 3 cylinder are shown in figures 6 through 8. The studs showed relatively smooth fracture surfaces with smearing deformation consistent with ductile overstress fracture under shear loading. Deformation of the stud and adjacent surfaces of the crankcase were consistent with the mating sides of the studs moving downward and slightly aft as indicated with arrows in figure 5.

Figure 5. Fractured cylinder attachment studs at the upper side of the number 3 cylinder port on the crankcase. Arrows indicate the relative direction of movement for the mating piece based on deformation to the remaining stud.

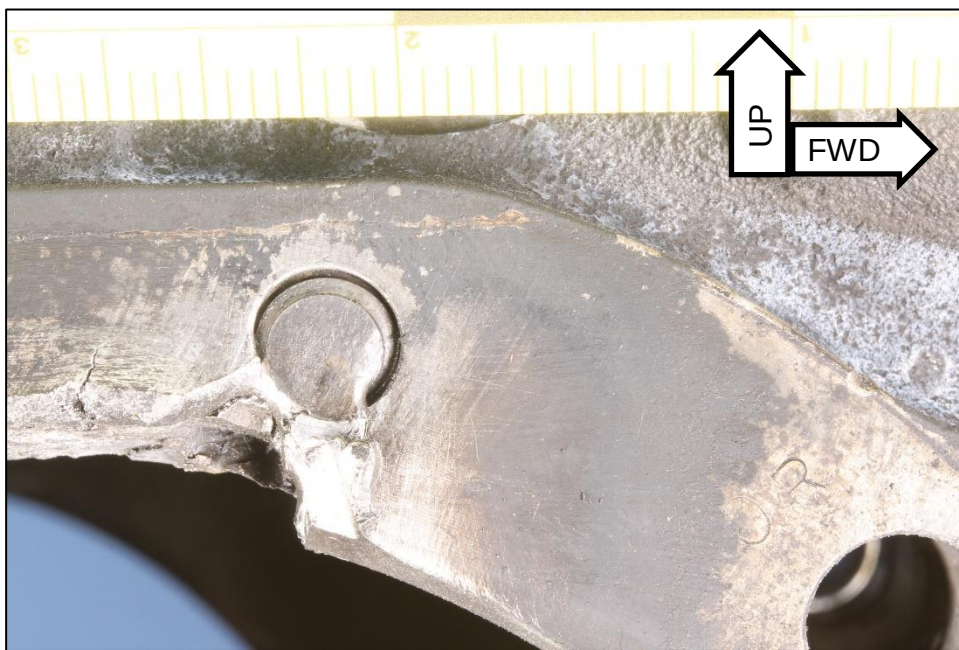
Figure 6. Close view of the stud fracture at the upper middle forward attachment location for the number 3 cylinder.

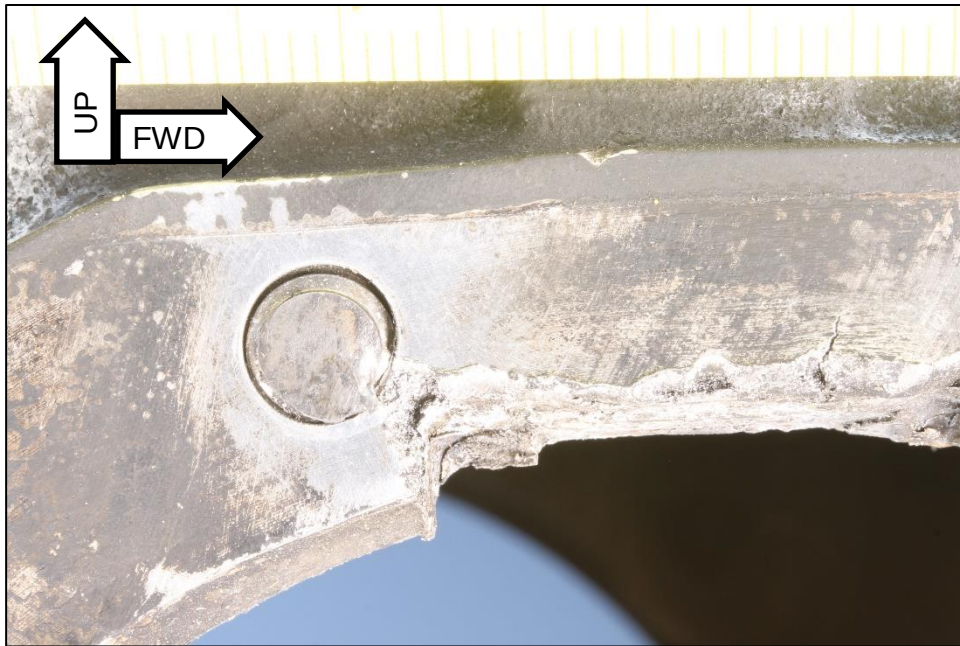
Figure 7. Close view of the stud fracture at the upper middle aft attachment location for the number 3 cylinder.

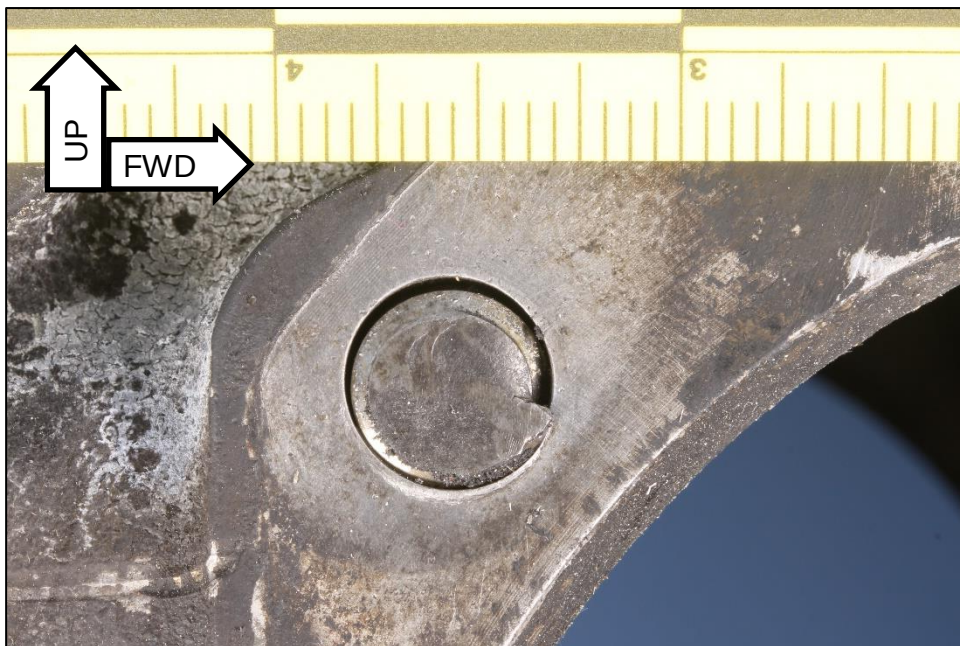
Figure 8. Close view of the stud fracture at the upper aft attachment location for the number 3 cylinder.

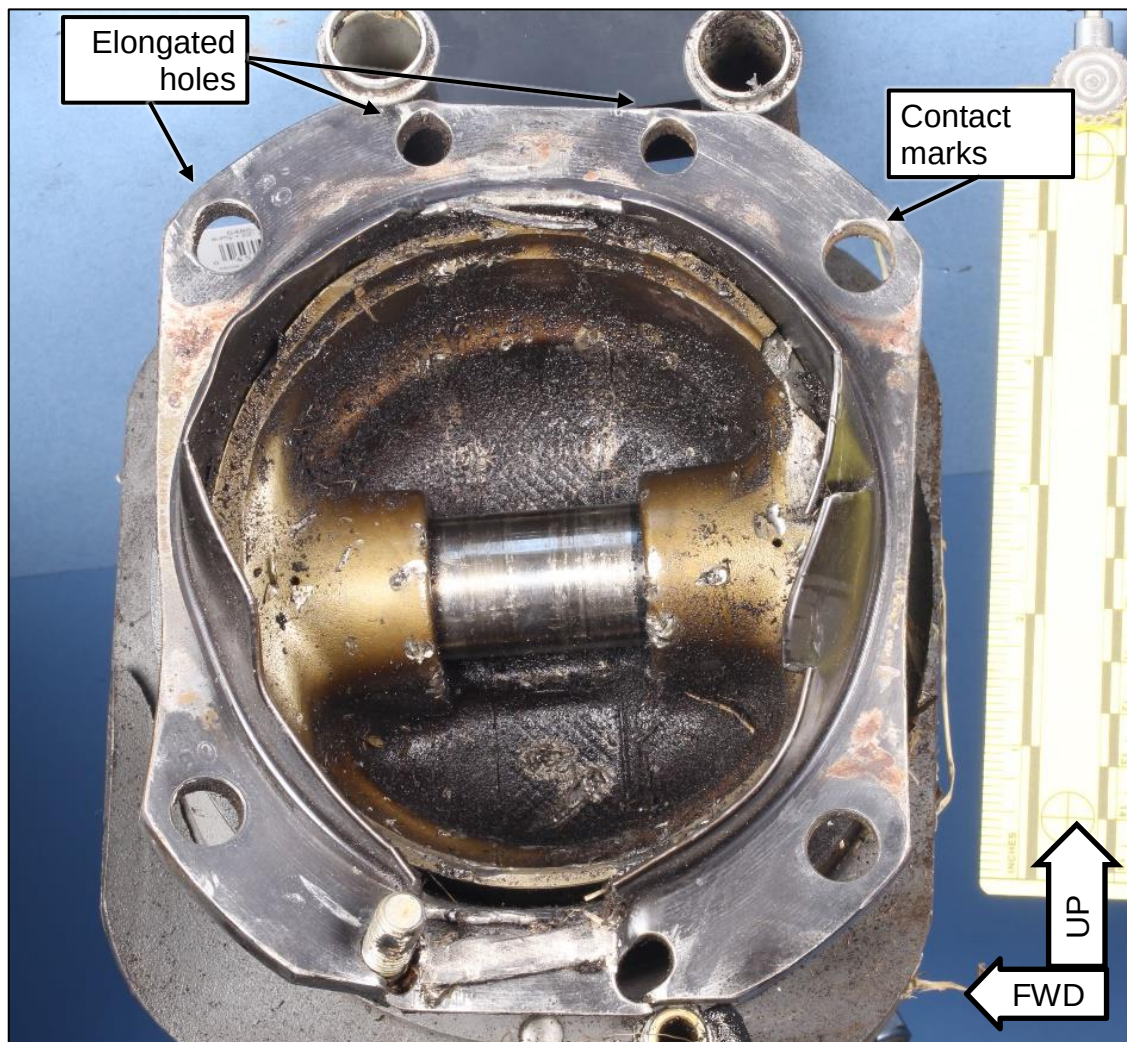
The inboard end of the number 3 cylinder assembly is shown in figure 9. The piston for the number 3 cylinder was mostly intact, and the wrist pin for attaching the connecting rod was in place. The piston had multiple impact marks on the interior surfaces and on the piston skirt. The barrel skirt was deformed inward at the forward and aft sides, trapping the piston within the barrel. A segment of the upper side of the piston skirt was fractured and missing, and the shape of the missing area was consistent with contact with the number 3 connecting rod. A segment of the skirt at the lower side of the barrel was fractured and flattened against the cylinder attachment flange, also consistent with contact with the number 3 connecting rod.

Figure 9. Inboard end of the number 3 cylinder assembly with the mostly intact and trapped piston assembly.

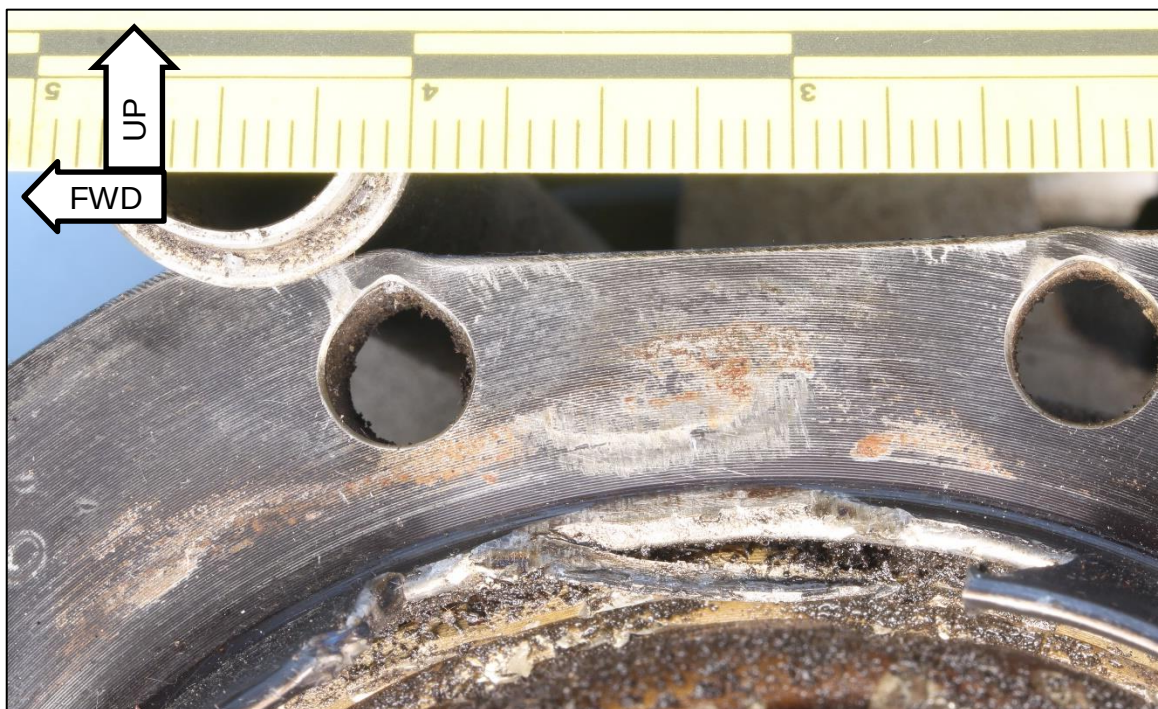
At the upper side of the number 3 cylinder flange, the holes corresponding to the 3 fractured studs were elongated with deformation at the upper side of the hole as indicated in figure 9 and as shown in a closer view in figure 10. The location of the hole elongation was consistent with the direction of shear deformation observed in the studs shown in figure 6. Contact marks were also observed at the upper side of the upper throughbolt hole as indicated in figure 9. At the lower side of the cylinder shown in figure 11, the flange was bent, and the flange was cracked through the middle two attachment holes. The cracks were associated with deformation, consistent with ductile overstress fracture.

Figure 10. Elongated holes at upper side of the number 3 cylinder flange showing deformation consistent with the cylinder moving downward relative to the attachment studs.

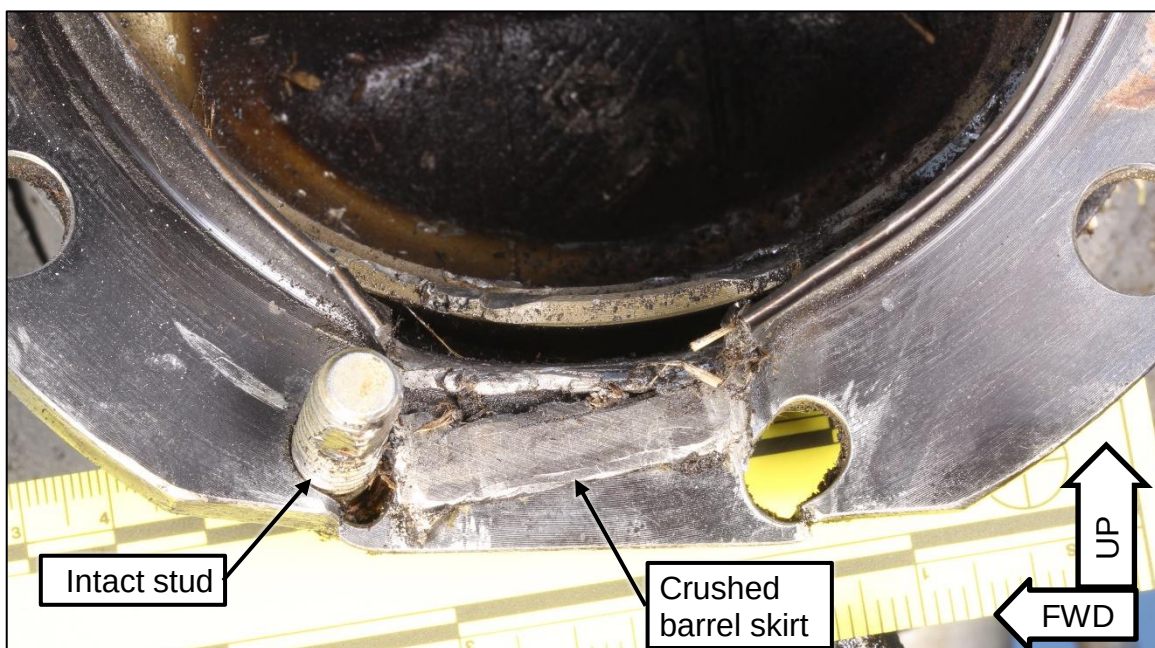
Figure 11. Closer view of damage at the lower side of the number 3 cylinder attachment flange.

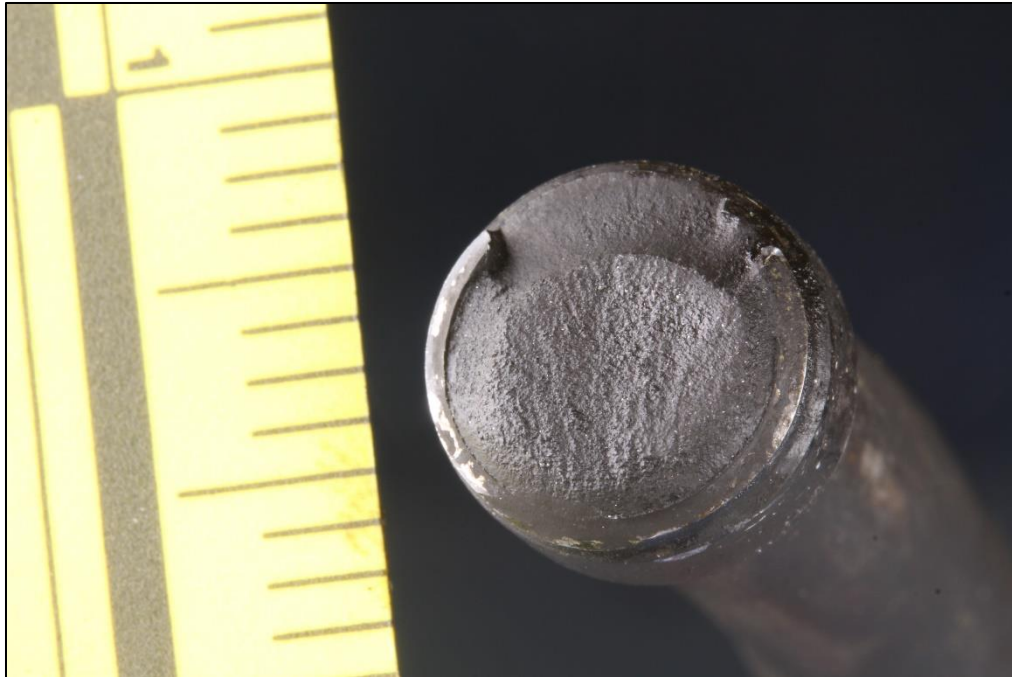
Views of the fractured throughbolts for the number 3 cylinder are shown in figures 12 and 13. The upper throughbolt was fractured in the threaded section. Fracture features were rough and matte gray, consistent with ductile overstress fracture. The lower throughbolt was fractured in the smooth portion of the shank and showed necking deformation adjacent to the fracture, also consistent with ductile overstress fracture.

Figure 12. Overstress fracture of upper throughbolt at the forward side of the number 3 cylinder.

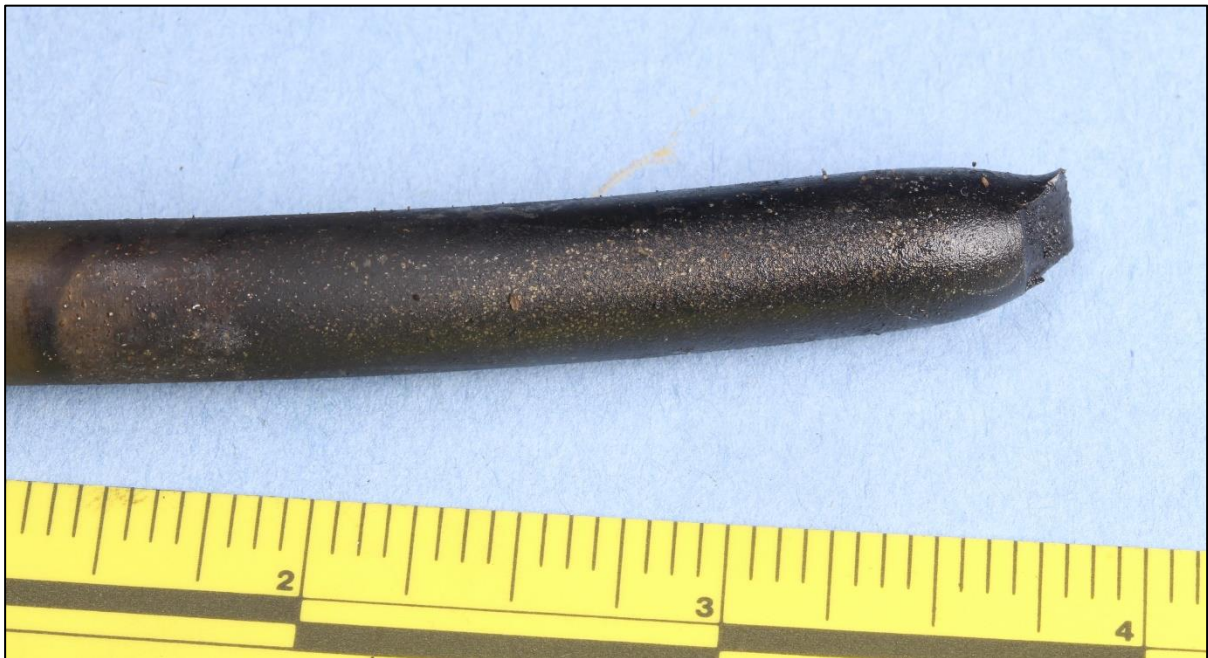
Figure 13. Overstress fracture of the lower throughbolt at the forward side of the number 3 cylinder.

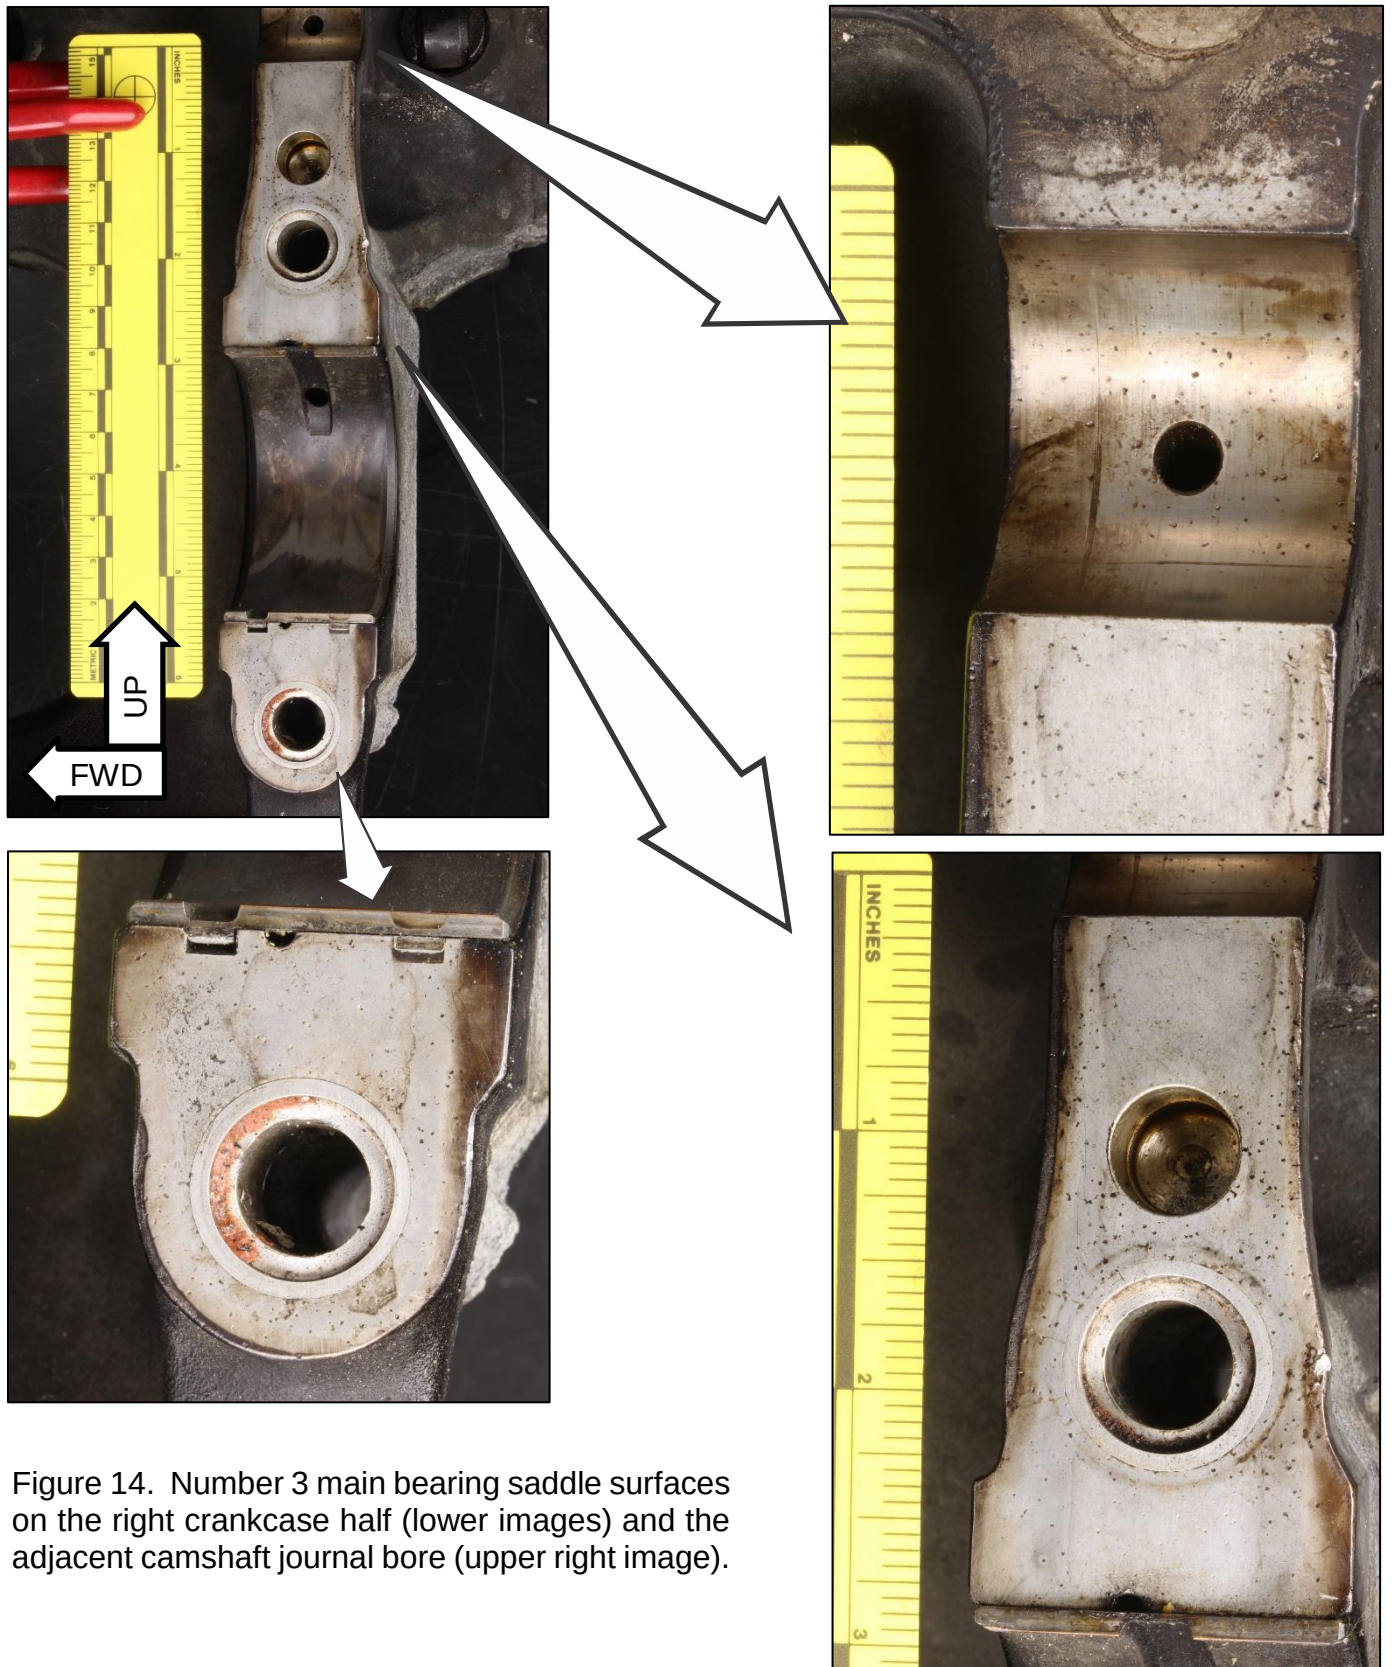
The crankcase was separated to reveal the mating sides of the crankcase halves. The mating surfaces for the crankcase had a smooth, polished appearance with scattered pits. Views of the saddle surfaces for the number 3 main journal bearing with typical surface features are shown. The dark specks on the surface are the pits. Similar pit

features were also observed on other machined surfaces including the saddle surfaces supporting the main journal bearings and the camshaft journal bore surfaces such as the camshaft journal bore surface shown in figure 14.

The pits on the machined surfaces of the crankcase were generally scattered as shown in figure 14. However, an area with a greater concentration of pits was observed at the number 2 main journal saddle boss as indicated in figure 15. The pits in this area appeared similar in depth and width as pits in other areas, but the pits in this area were elongated.

Figure 14. Number 3 main bearing saddle surfaces on the right crankcase half (lower images) and the adjacent camshaft journal bore (upper right image).

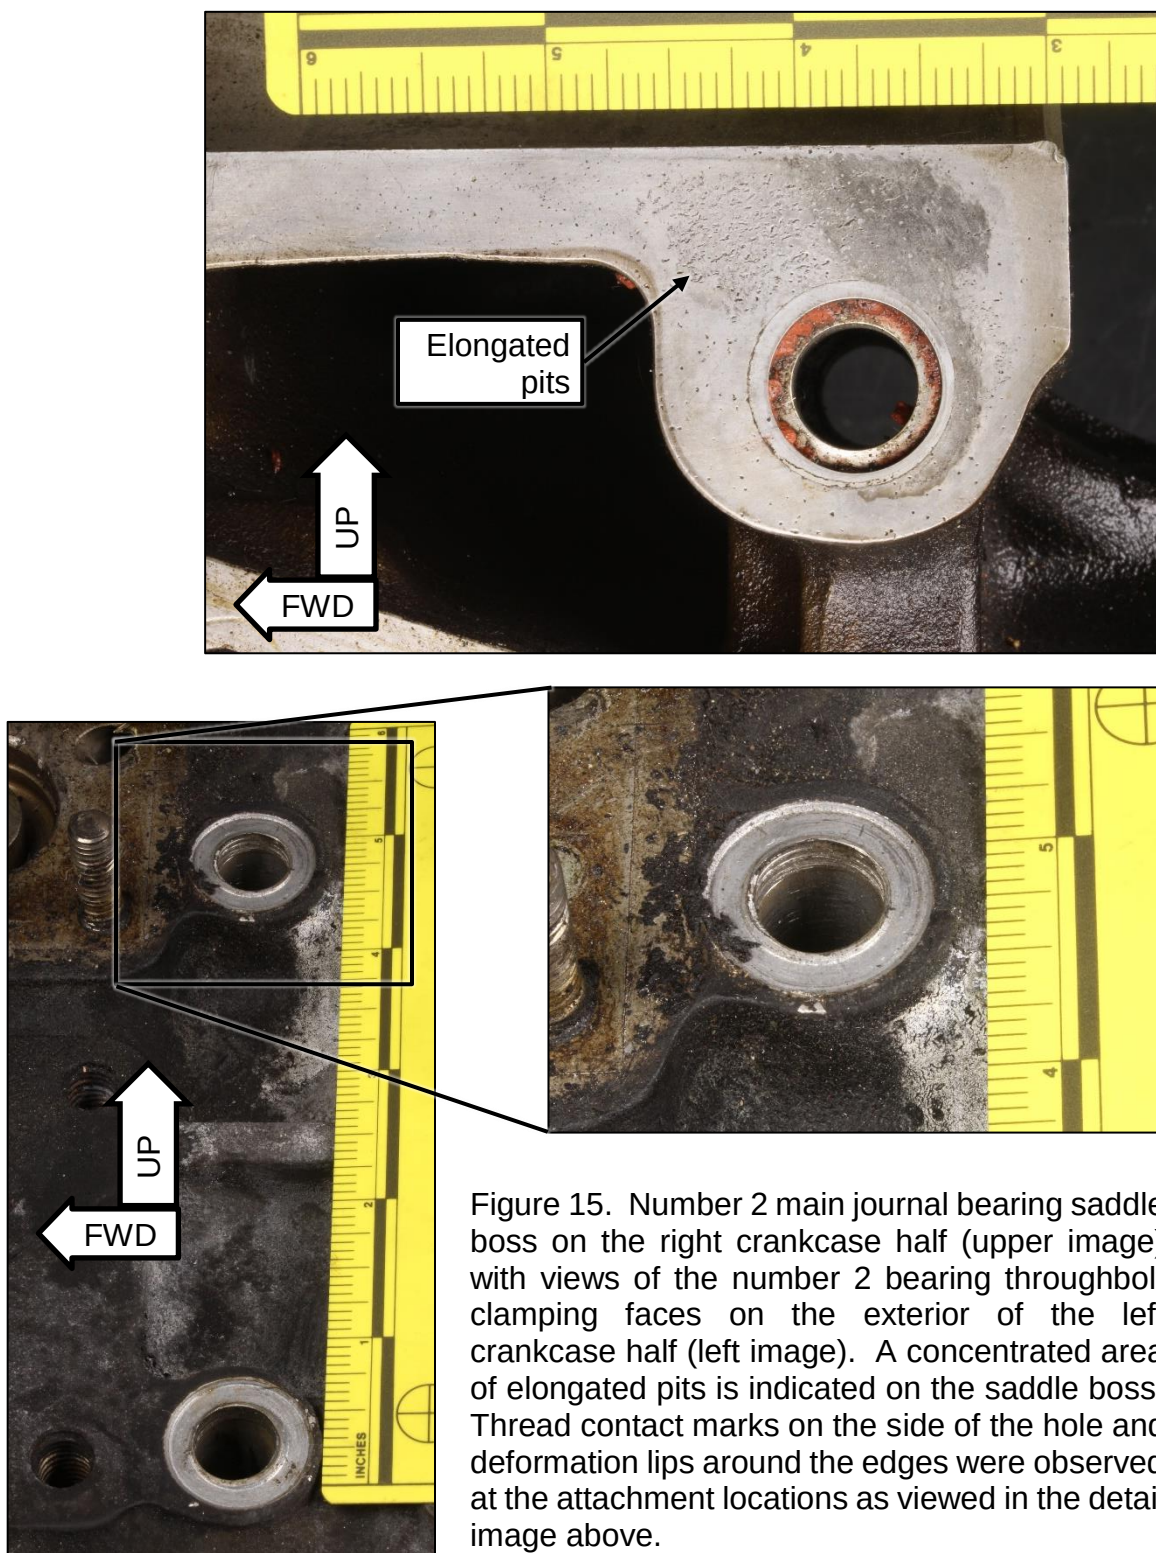
Views of the exterior of the left crankcase half at the number 2 main bearing throughbolt holes are shown in figure 15. The area around the holes had a raised deformation lip, and thread contact damage was present on the interior surfaces of the holes.

Figure 15. Number 2 main journal bearing saddle boss on the right crankcase half (upper image) with views of the number 2 bearing throughbolt clamping faces on the exterior of the left crankcase half (left image). A concentrated area of elongated pits is indicated on the saddle boss. Thread contact marks on the side of the hole and deformation lips around the edges were observed at the attachment locations as viewed in the detail image above.

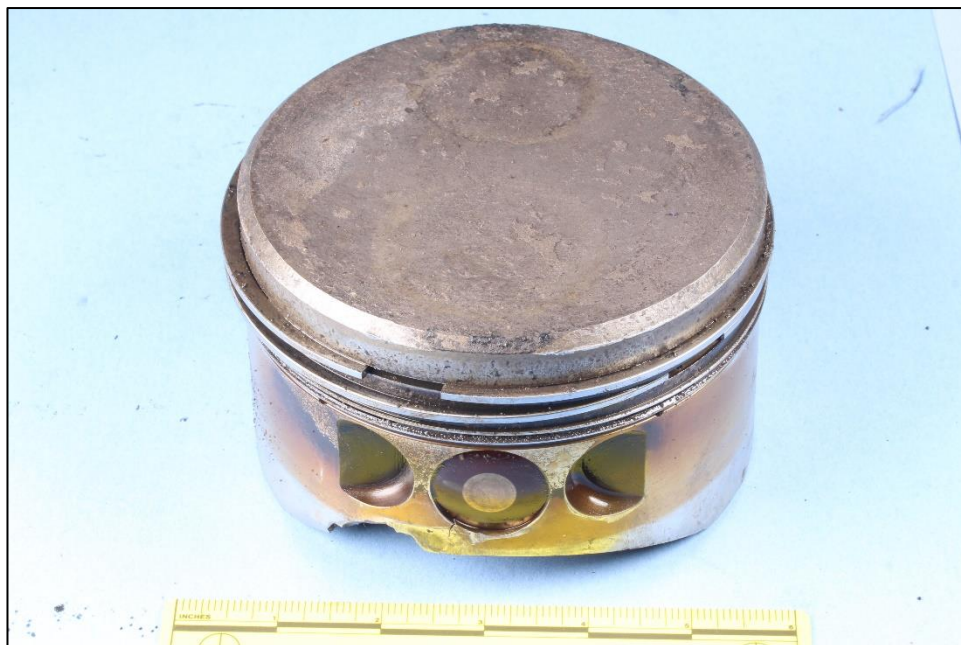
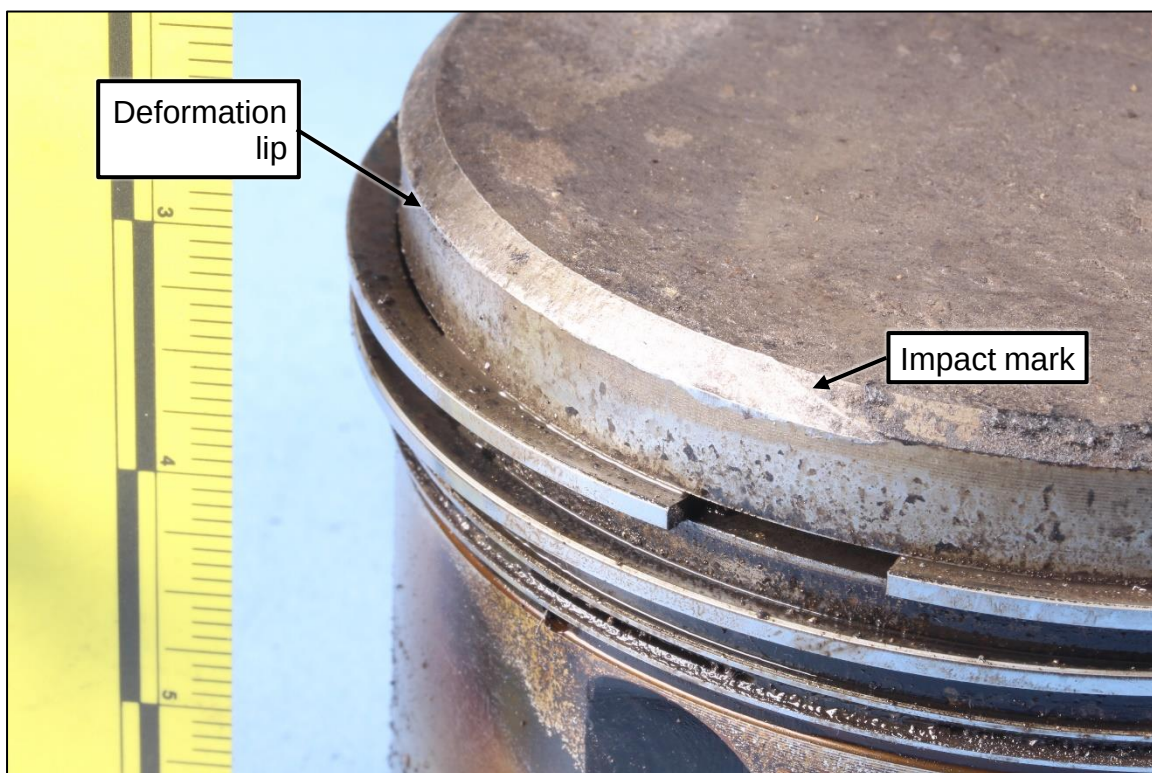
An overall view of the number 3 piston is shown in figure 16 with a closer view of impact marks and a deformation lip at the edge of the piston crown. The shape and location of the impact marks and the deformation mark were consistent with the piston impacting the cylinder head dome.

Figure 16. Number 3 piston after removal from the cylinder barrel. Deformation lips and impact marks corresponding to contact with the cylinder head dome were observed around the edges of the piston crown.

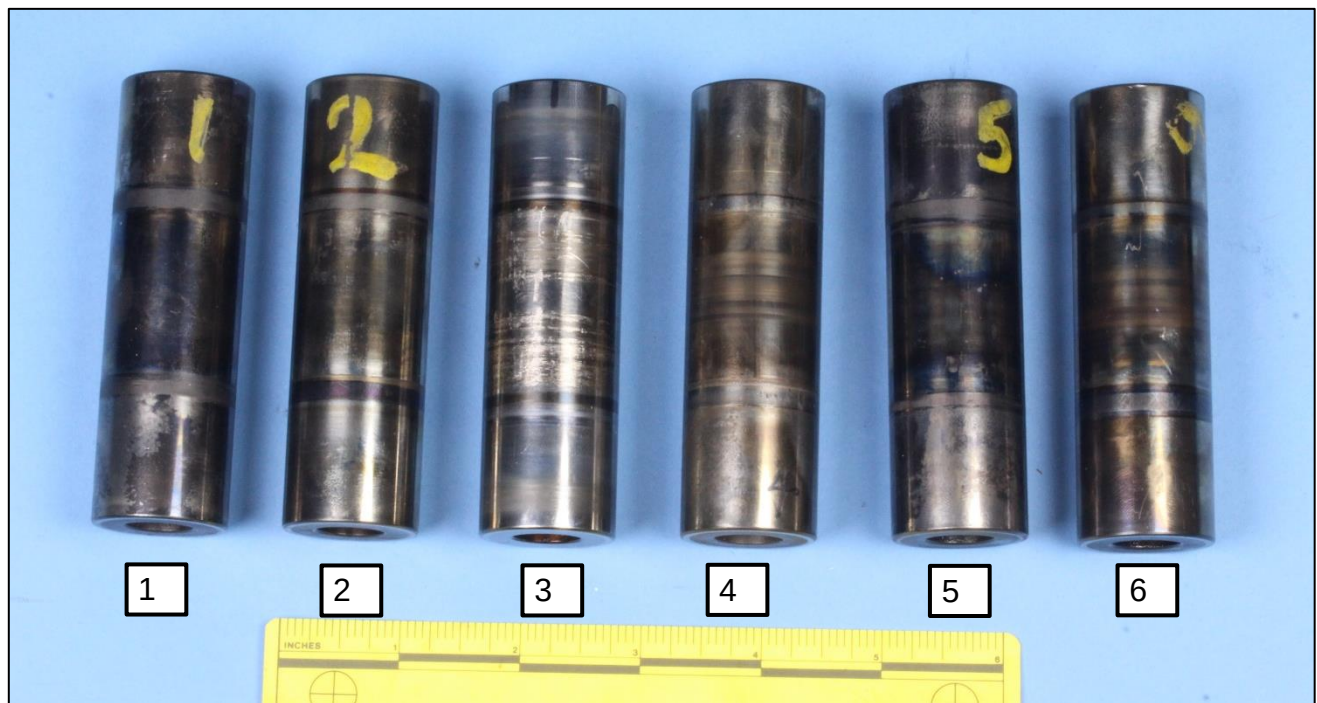
The wrist pins were removed from the numbers 3 and 4 pistons using a hydraulic press, and a view of the wrist pins from all cylinders are shown in figure 17. The wrist pins from cylinders 1, 2, 4, 5, and 6 were mostly free of mechanical damage, but were tinted brown, bluish gray, and black consistent with heat exposure. By comparison, the number 3 wrist pin had mechanical damage in the area corresponding to the connecting rod attachment and was light gray in color across most of the surface.

Figure 17. Wrist pins from all cylinders after the cylinders 3 and 4 pins were disassembled from their respective pistons.

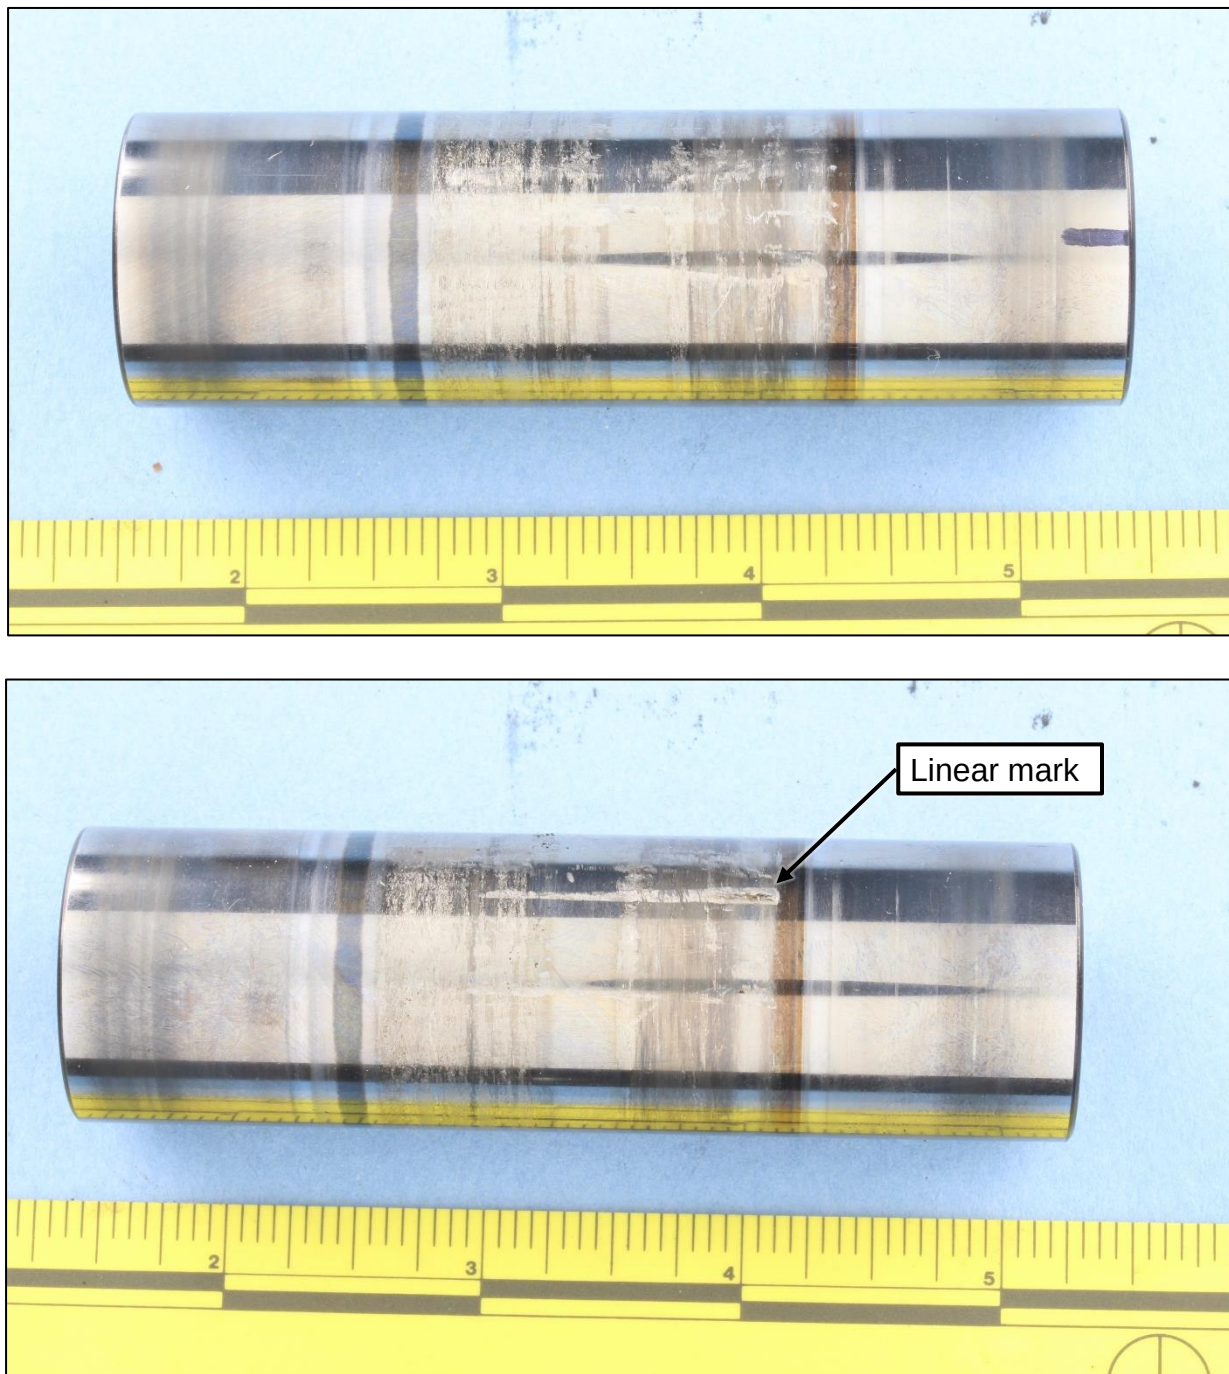
Closer views of the inboard and outboard surfaces of the number 3 wrist pin are shown in figure 18. The wrist pin had a bluish gray circumferential tint band on one side where it intersected the boss on the piston, and a brown circumferential tint band adjacent to the other boss. Circumferential gouges and galling was present on the surface between the two tint bands. A longitudinal mark with galled material was present on the outboard side of the wrist pin (side not visible in figure 9) as indicated in the lower image in figure 18.

Figure 18. Closer views of the number 3 wrist pin showing the inboard side visible in figure 6 (upper image) and the outboard side (lower image). Circumferential marks with pitting and galled material were present around the circumference. A linear mark with galled material was observed on the outboard side at approximately 180 degrees from the inboard side.

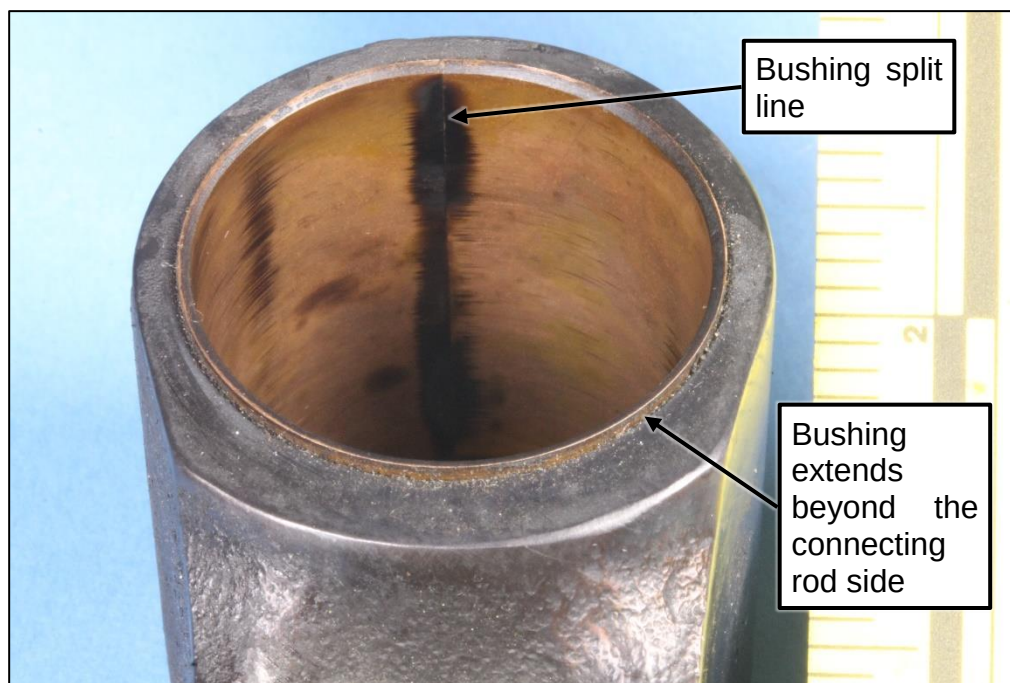
connecting rod. The split line for the bushing was located at the 1:30 clock position<sup>1</sup> in connecting rods 1, 2, and 4. In connecting rod 5, the split line was located at the 5:15 clock position, and in the number 6 connecting rod, the split line was located near the 12 o'clock position (see figure 19). In connecting rods 1, 5, and 6, the bushing was displaced laterally relative to the connecting rod. This displacement in the number 6 connecting rod is noted in the close views in figures 19 and 20 where the bushing extended beyond the side of the connecting rod as shown in figure 19 and was inset from the opposite side shown in figure 20.

Figure 19. Outboard end of the number 6 connecting rod showing the bearing split line and lateral displacement.

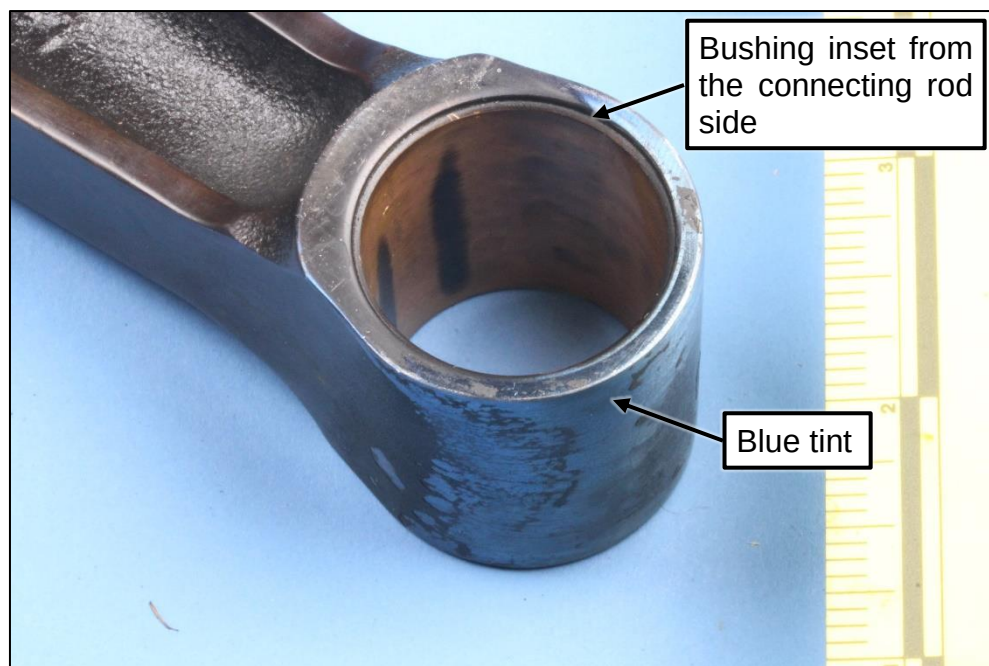
Oily deposits were present on much of the surfaces of the remaining 5 connecting rods. Many of the deposits were removed using a soft bristle brush with a solution of Alconox detergent and warm water. After cleaning, the outboard ends of the number 2, 4, and 6 connecting rods had a bright blue color. The outboard end of the cleaned number 6 connecting rod noting the blue tint is shown in figure 20. A slight blue tint was also noted at the outboard ends of connecting rods 1 and 5.

Figure 20. Outboard end of the number 6 connecting rod after cleaning showing blue tint on the surface and lateral displacement of the bushing.

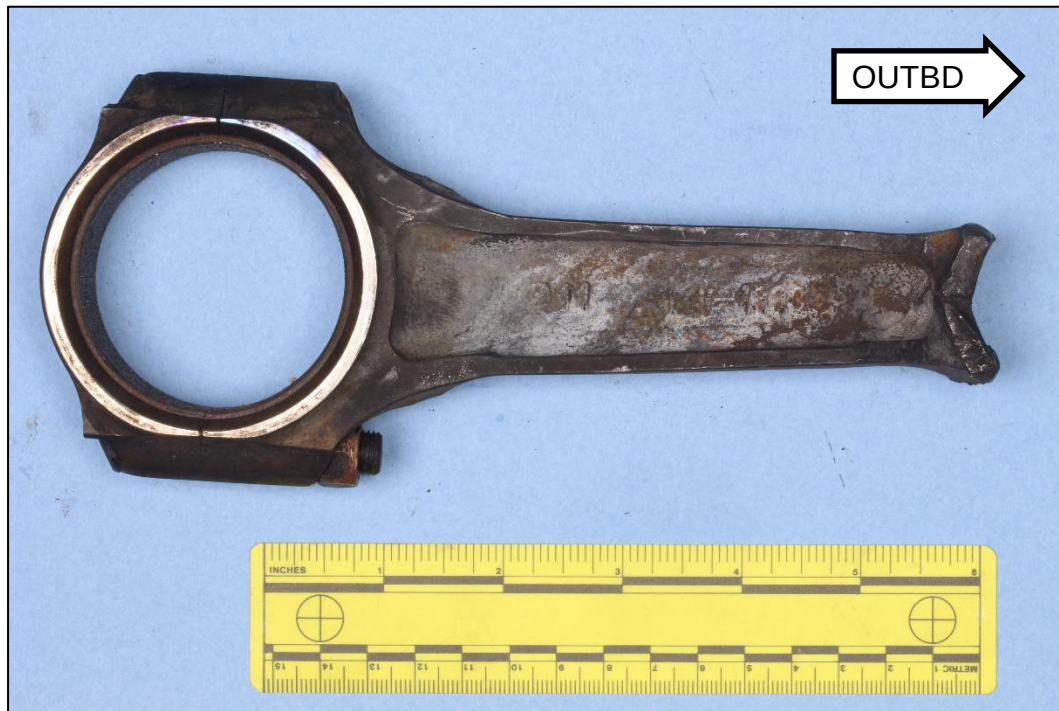
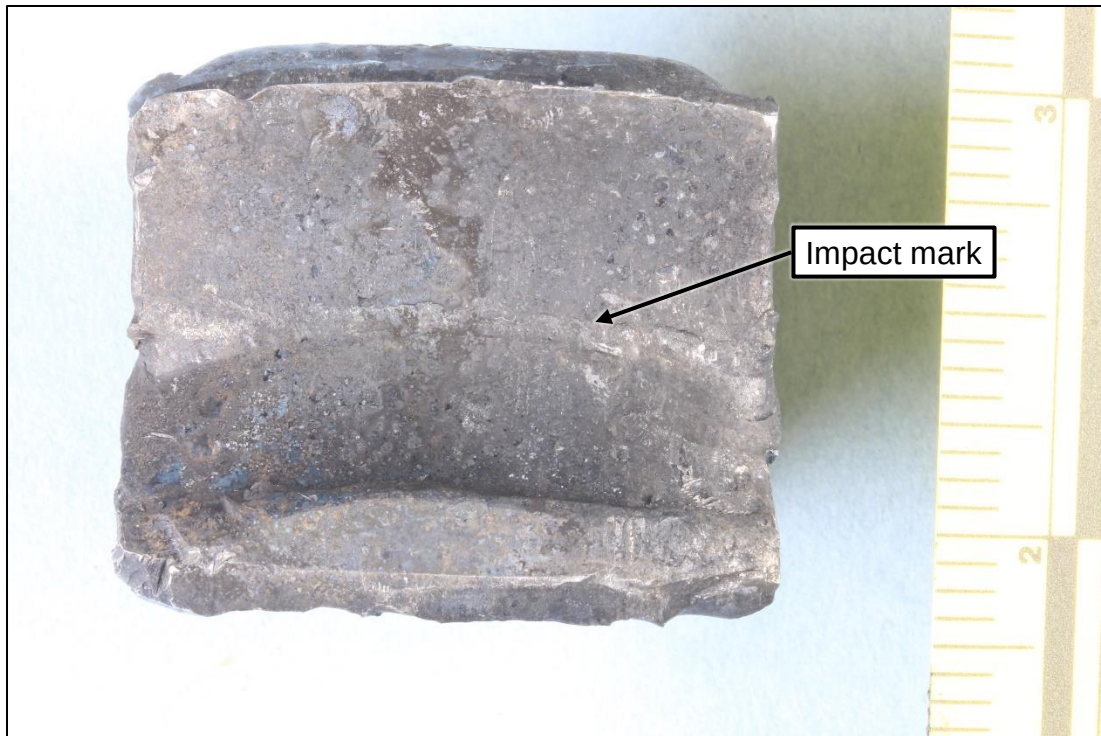
An overall view of the number 3 connecting rod is shown in figure 21. The web of the beam section of the rod had raised characters "11 LW-13305" on one side and "N" on the opposite side. At the crankshaft end of the connecting rod, "K100" and "011" were dot imprinted on one side of the saddle and strap. Characters "7247" and "04/08/08" were dot imprinted on the opposite side of the strap. A scribed digit "3" was also observed on the side of the saddle and the strap.

The connecting rod was fractured where the wrist pin bore intersected the beam section of the rod. The fracture surfaces of the rod were oxidized and had substantial impact damage. The outboard end of the connecting rod was cut from the rest of the rod to facilitate a detailed examination of the fracture surface. An end view of the cut piece is shown in the lower image in figure 21. A curved impact mark was observed on the outboard end of the connecting rod as indicated in the lower image in figure 21. The shape of the impact mark was consistent with the inboard end of the cylinder barrel skirt.

Figure 21. Connecting rod from the number 3 cylinder. The outboard end shown in the lower image had a curved impact mark with a geometry consistent with contact with the inboard end of the cylinder barrel skirt.
