## **NATIONAL TRANSPORTATION SAFETY BOARD**

### **ENGINE EXAMINATION**

**WPR17LA097**

Location: Santa Barbara, California  
Date: May 5, 2017  
Aircraft: Robinson R44, Registration Number: N981RR, Serial #: 0961  
NTSB IIC: Elliott Simpson

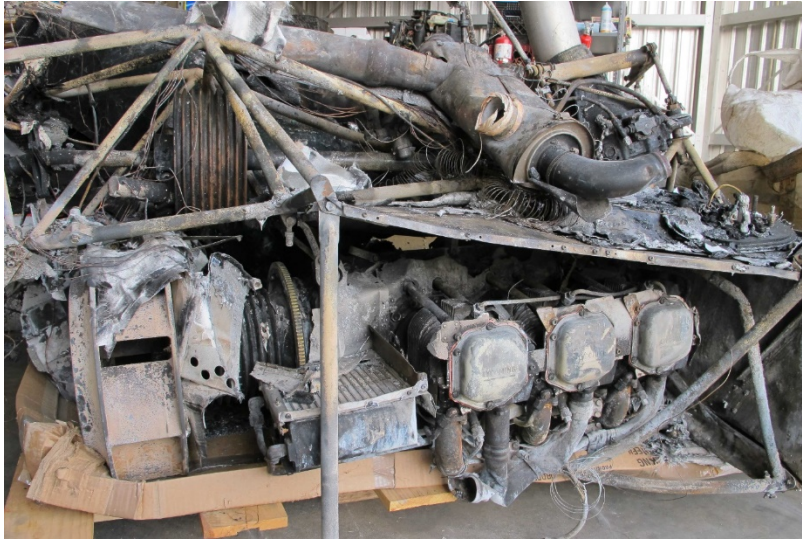
Photo 1 – Engine in Airframe

The engine remained attached to the aft frame engine support assembly and the forward engine mounts. The frame was generally compressed in a downward direction, with the upper firewall resting against the magnetos (Photo 1). The engine sustained thermal damage, partially consuming most of its ancillary components. The lower sheave and fanwheel assembly remained attached to the crankshaft. The spring pin and safety wire for the nut connecting the fanwheel to the lower sheave shaft and bearing assembly, appeared offset about 20 ° clockwise (when viewed from the rear of the helicopter), relative to the torque seal reference lines (Photo 2).

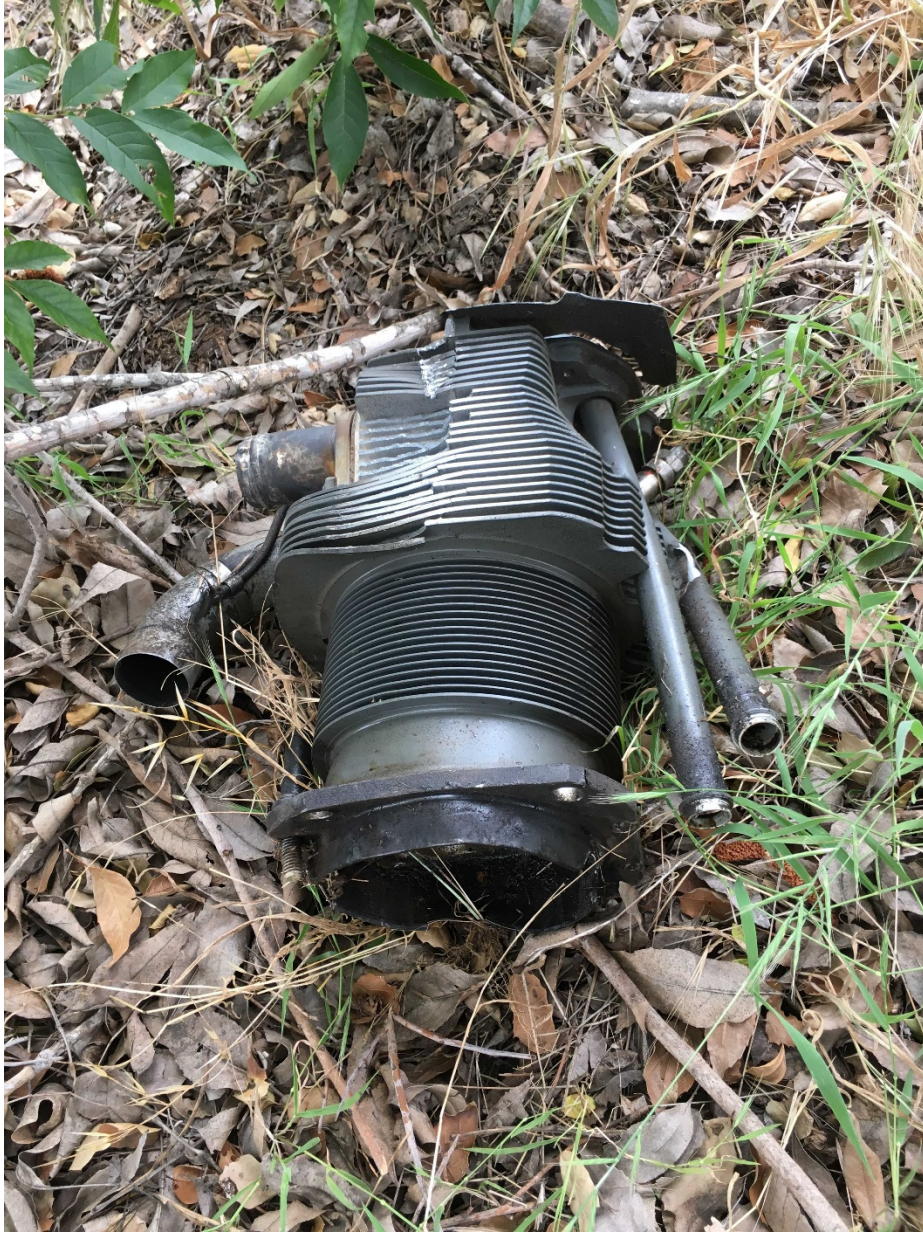
Photo 3 – Cylinder Number 3

The entire cylinder number 3 assembly had separated from the engine, and was located about ¼ mile from the accident site (Photo 3).

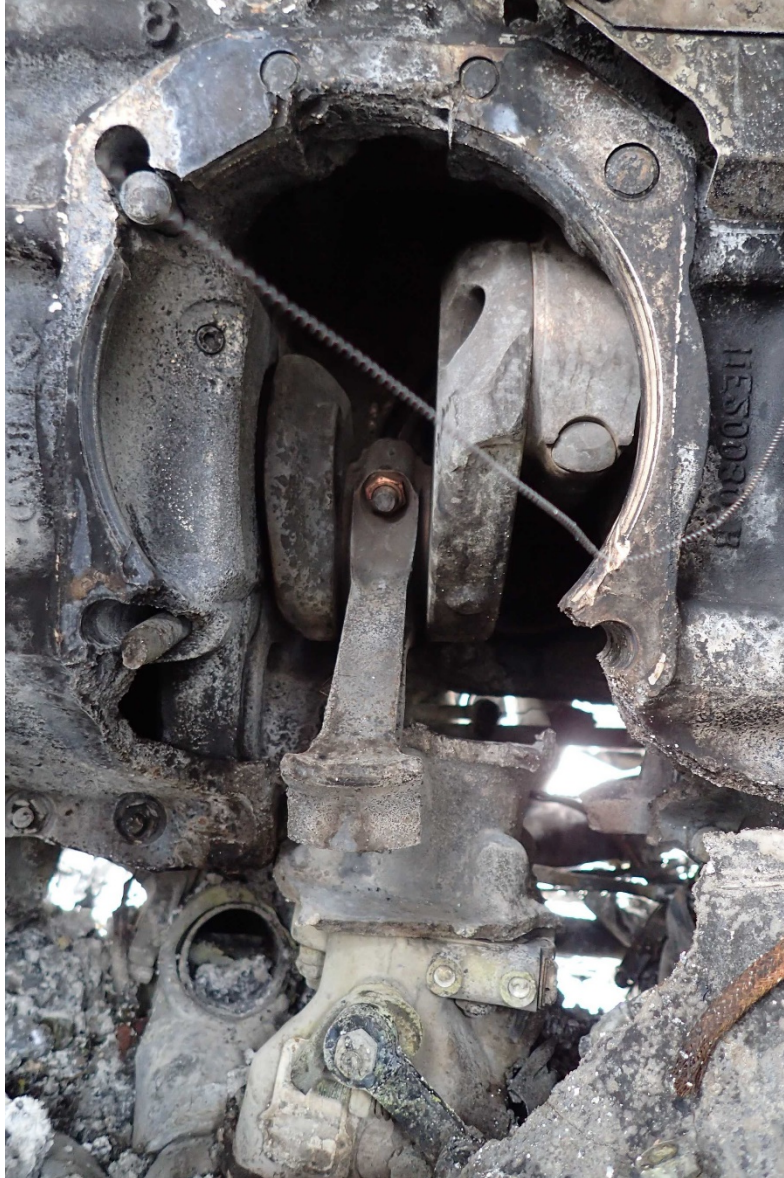
Photo 4 – Number 3 Connecting Rod

The upper portion of the crankcase deck, at the interface with the flange at the base of cylinder number 3 remained intact, and included the remnants of the top forward stud and the two center studs. (Photo 4) The top threaded portion of the aft carry-through bolt had detached; the remainder of the bolt was present, but had moved towards the center of the piston area, breaking away the flange of the deck (Photo 4). A square-shaped imprint on the inner radius of the upper deck was of a size that matched the approximate width of the connecting rod (Photo 4). The lower section of the deck, adjacent to the underside of the crankcase, along with the entire oil sump assembly was not present. The lower carry-through bolt had separated about flush with the deck, with the bolt remnants exhibiting downward bending and necking deformation (Photo 4).

The crankshaft could be viewed through the opening, and appeared intact. The number 3 connecting rod remained attached to the crankshaft, and protruded from the opening (Photo 4). The small end of the rod was not present, and the obliterated inner radius at the rod end was all that remained (Photo 5).

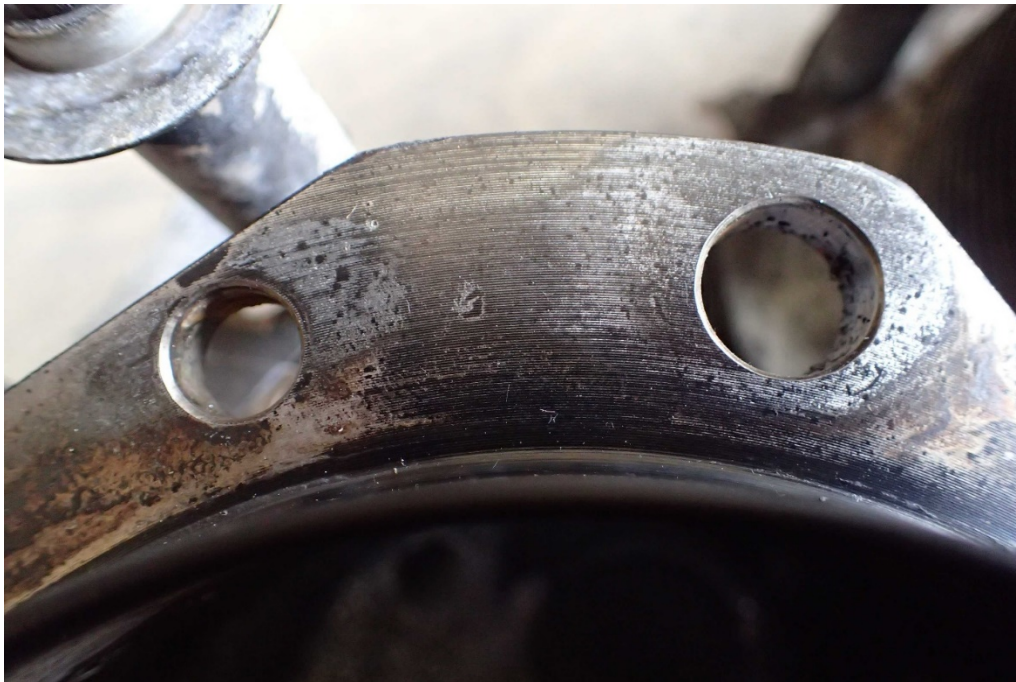
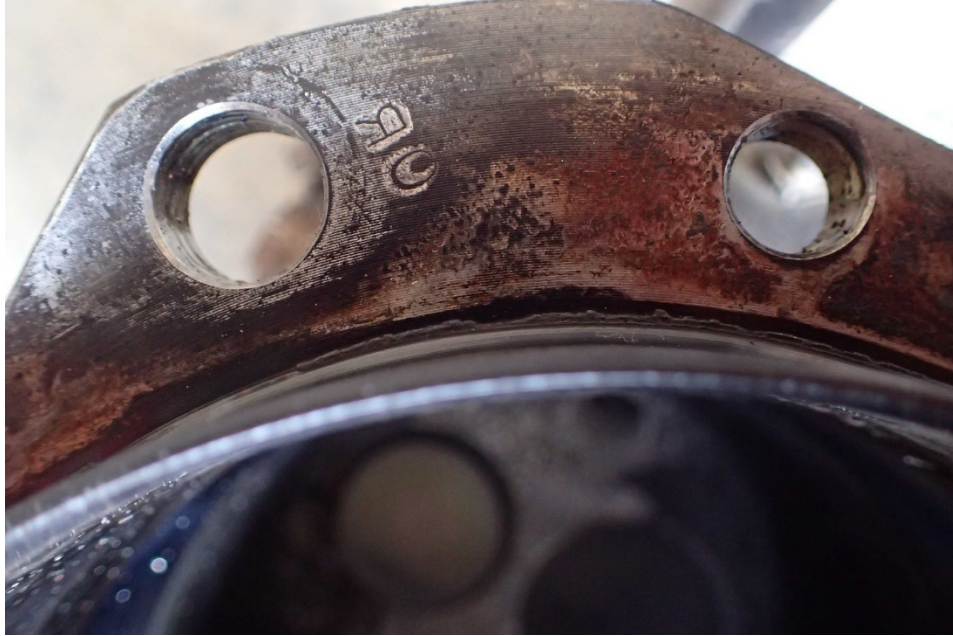
Examination of the cylinder flanges for all removed cylinders revealed similar signatures in the area of deck contact including polishing of the machined surfaces, pitting, and brown corrosion deposits (Photos 6,7). The corresponding contact surfaces on the crankcase deck exhibited similar but signatures, along with gouges up to 1 mm deep in the deck surfaces at the edge of the cylinder flanges (Photos 8,9,10).

Photo 6 – Cylinder Flange

Photo 7 - Cylinder Flange

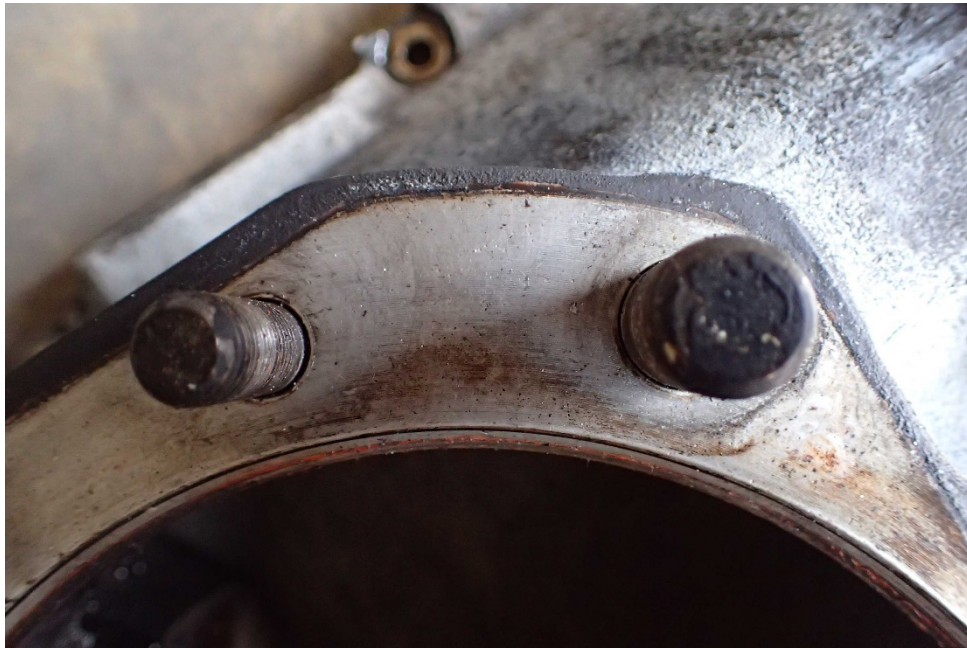
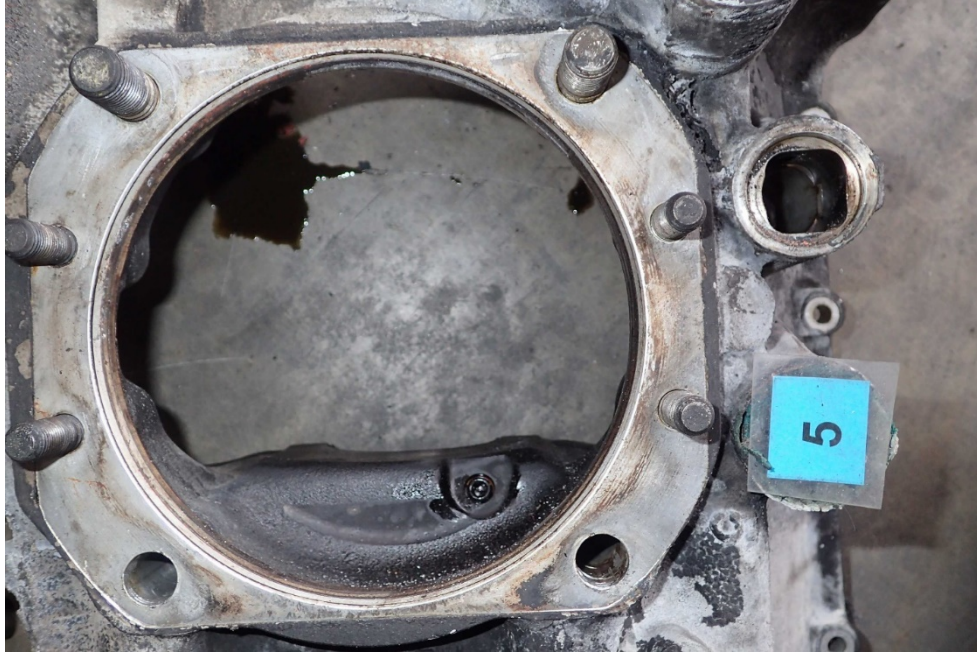
Photo 8 – Crankcase to Cylinder Flange Deck Surface

Photo 9 – Cylinder 5 Crankcase to Cylinder Flange Deck Surface

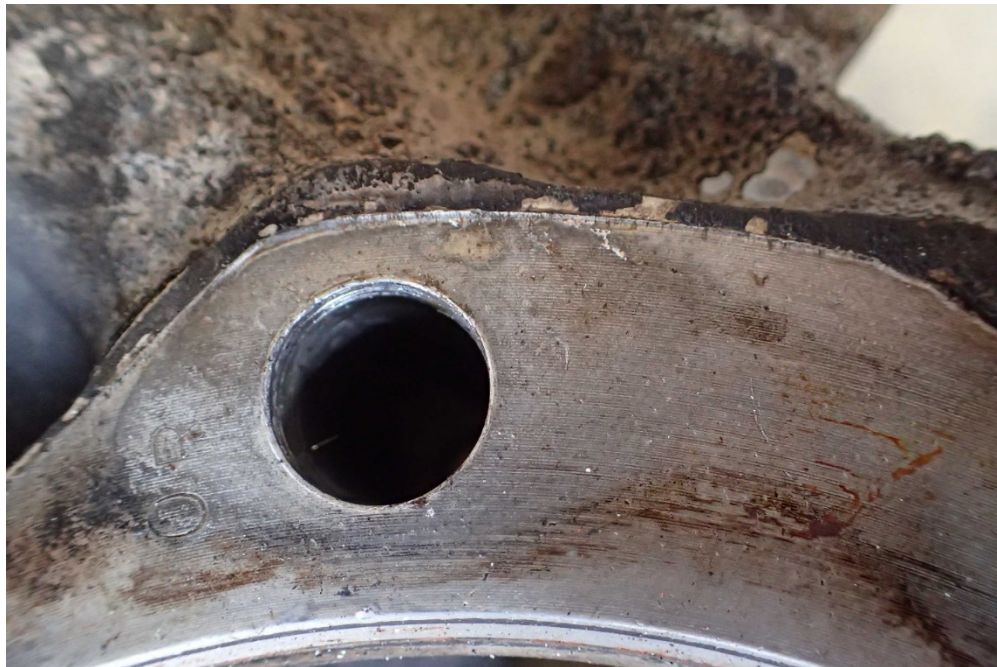
Photo 10 – Gouging on Crankcase to Cylinder Flange Deck Surface

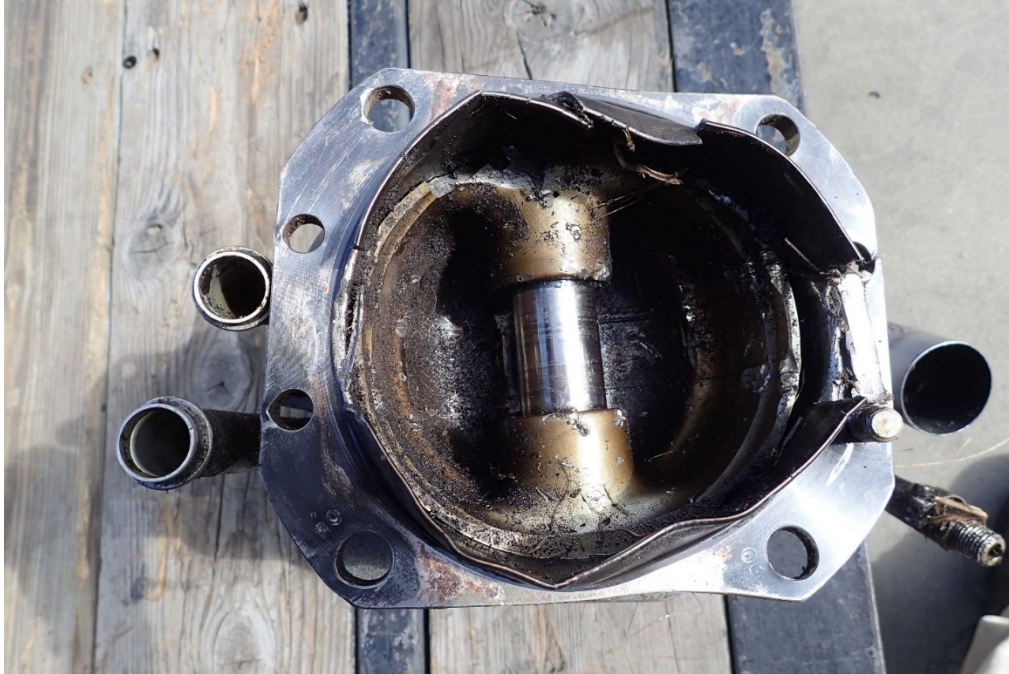
Photo 11 – Number 3 Cylinder

The piston remained within the detached cylinder number 3. The piston pin was in place, and sustained minimal damage. The raised flanges of the cylinder sleeve exhibited outward bending and material separation consistent with connecting rod contact (Photo 11). The spark plugs were removed, and the piston crown and head were examined with a borescope. The crown exhibited light grey deposits, and both valves were intact and undamaged. Both spark plugs exhibited bending damage to each center electrode, bringing them in contact with their respective case electrodes. Neither of the pushrods were recovered.

The upper mounting holes on the piston skirt flange did not contain any studs, and all holes were elongated in the upwards direction (Photo 11). A separated stud head remained within the mounting

hole at the left center position of the lower flange hole, all other flange holes were empty, and the entire lower flange was bent (Photo 11).

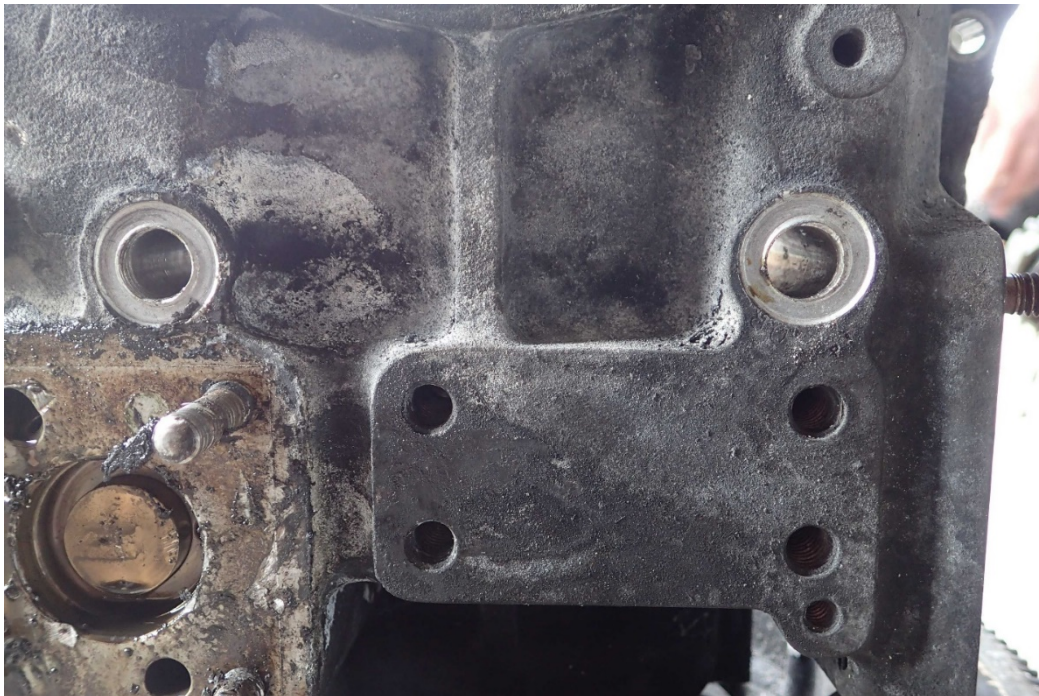
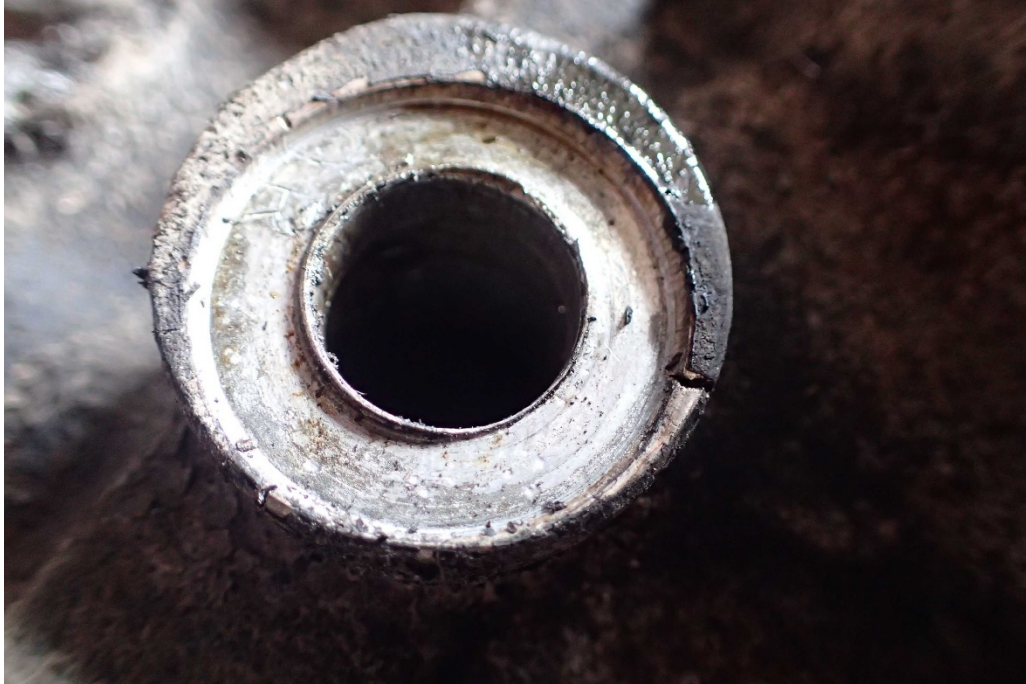
The accessory housing assembly was removed; the crankshaft, camshaft, and both crankshaft idler gears were intact and undamaged. The remaining two forward carry-through bolts at the rear end of the forward crankshaft bearing and their associated nuts were removed, and the crankcase was opened. The crankcase contact area for the two bolts exhibited significant galling damage, which had cut about 2 mm into the crankcase material (Photo 12,13).

Photo 12 – Forward Carry-Through Bolt Holes

Photo 13 – Forward Carry-Through Bolt Hole

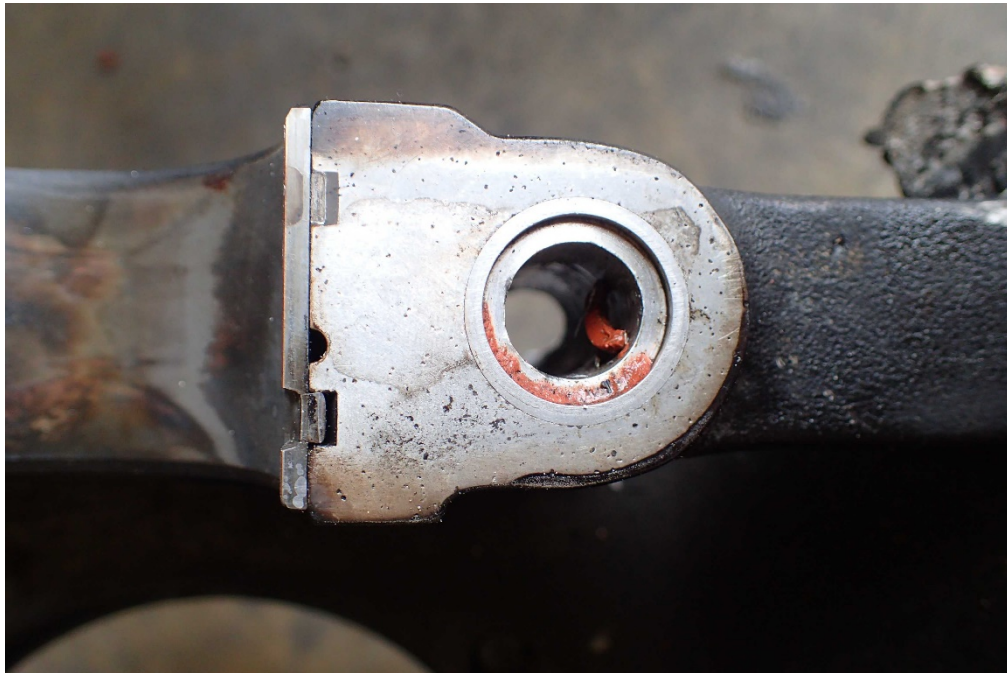
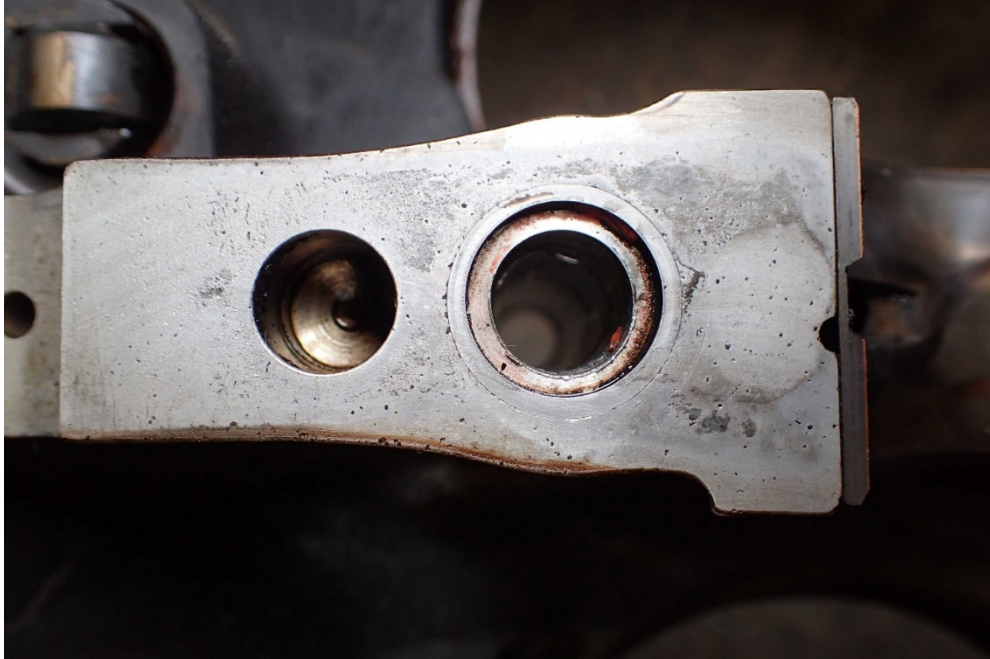
The crankcase-to-crankcase contact areas exhibited light pitting and polishing throughout (Photo 14,15), with more exaggerated pitting, polishing signatures concentrated at the rear end of the forward crankcase bearing saddle area (localized primarily at the upper clamping area of the carry-through bolts that had created galling damage to the crankcase (Photo 16)), and all of the crankshaft bearing webs.

Photo 14 – Pitting at Crankcase Web

Photo 15 – Pitting at Crankcase Web

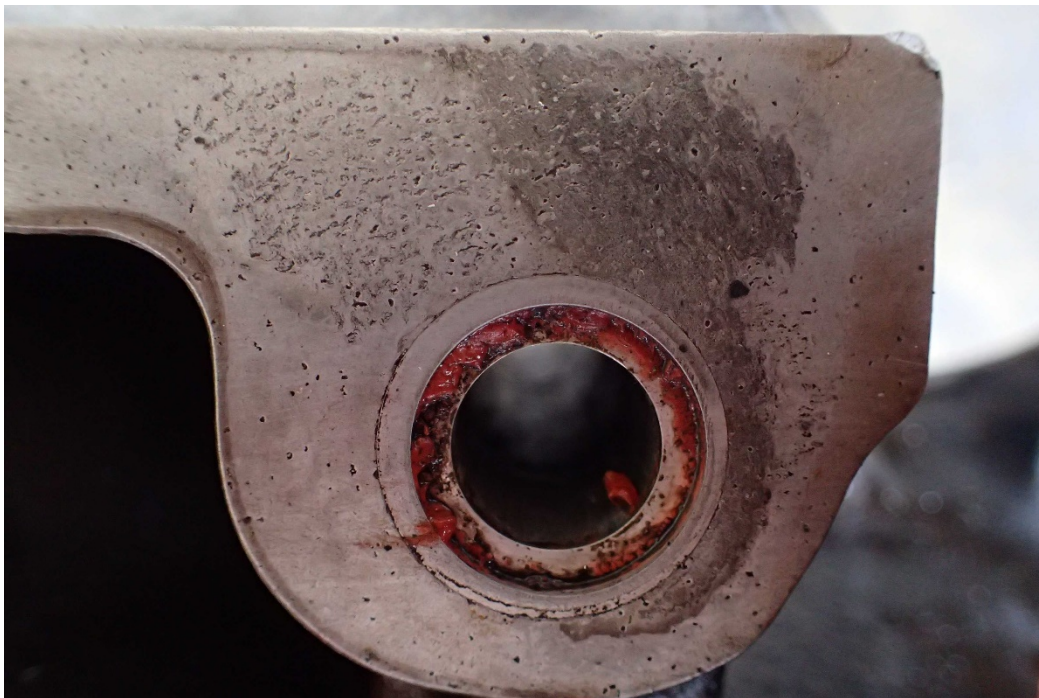
Photo 16 - Pitting at Forward Bearing Crankcase Saddle

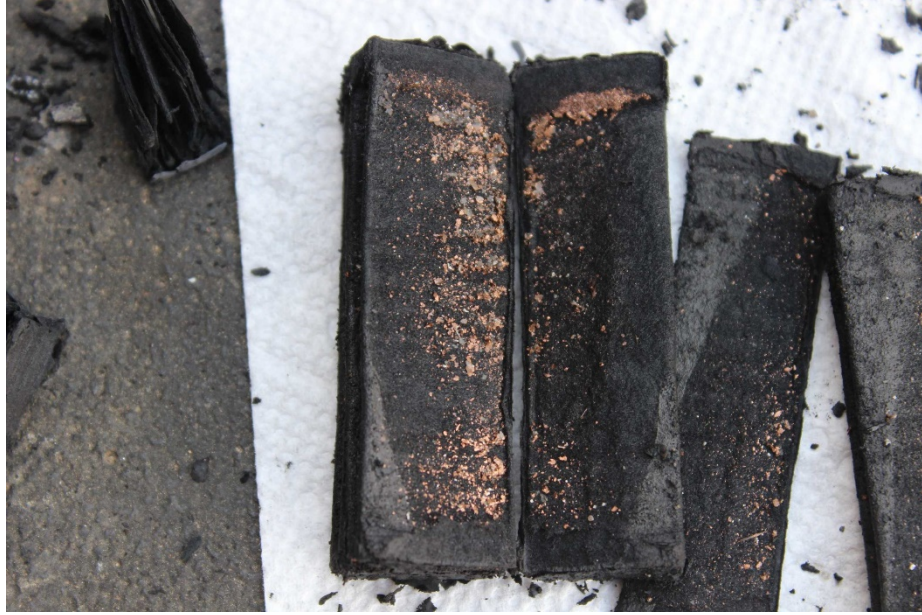
The oil filter had sustained thermal damage and was removed from the housing and disassembled. The filter element was black and charred, and contained bronze-like debris similar in appearance to connecting rod (piston-end) bearing material (Photo 17). The camshaft was intact, and all lobes and bearing surfaces were shiny in appearance and free of score marks.

Photo 17 – Oil Filter Remnants

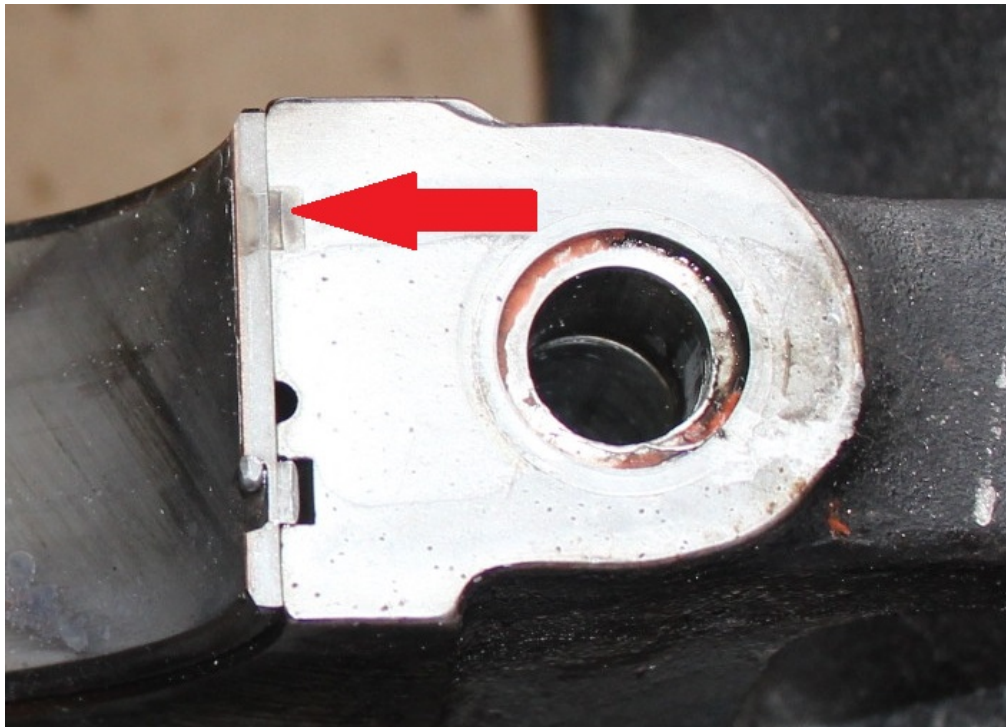
The crankshaft could not be rotated through virtue of the seized number 4 piston. All counterweights were intact, and all main journals were either shiny and smooth in appearance or coated in burnt oil. The associated bearing surfaces were all shiny in appearance, and free of radial gouges, with the surface for bearing number 5 exhibiting globular molten features. The number 3 and 4 journal bearing webs exhibited indentations adjacent to the contact area of the outer keyway of each reciprocal bearing half (Photo 18). No such indentations were observed on any of the other journal bearings.

Photo 18 – Crankcase Plain Bearing Notch
