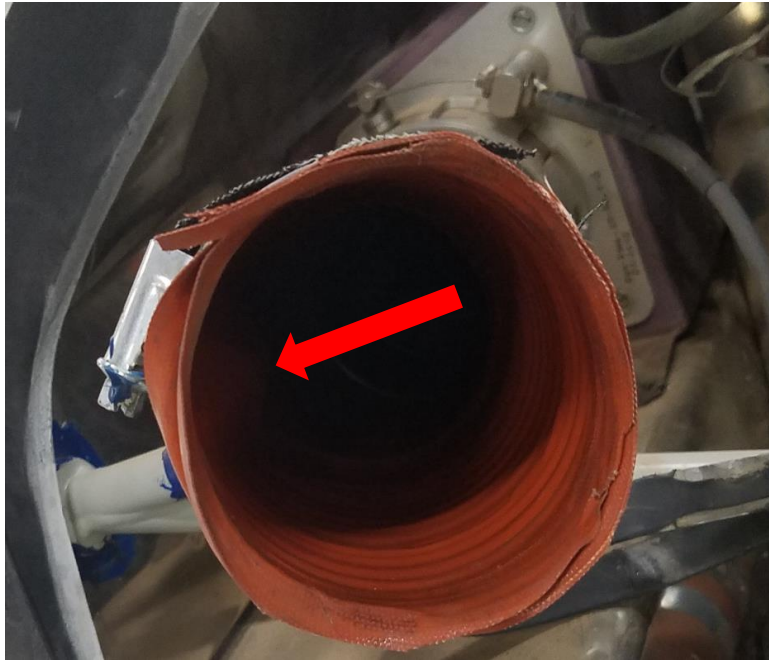
The induction system hose between the air-box and the turbocharger inlet. The bulge indicated is evidence of delamination (collapse) or the hose that has begun to correct itself due to the elastic properties of the hose material. Any delamination when the turbo was active would quickly result in the airflow coming into the turbo being reduced and therefore the turbocharger unit become ineffective.
