WPR17LA102 Right rudder control examination.

The pilot reported a loss of right rudder control during takeoff. On July 20, 2017, the airplane was examined at a secure facility by an NTSB Senior Air Safety Investigator accompanied by an FAA Inspector.

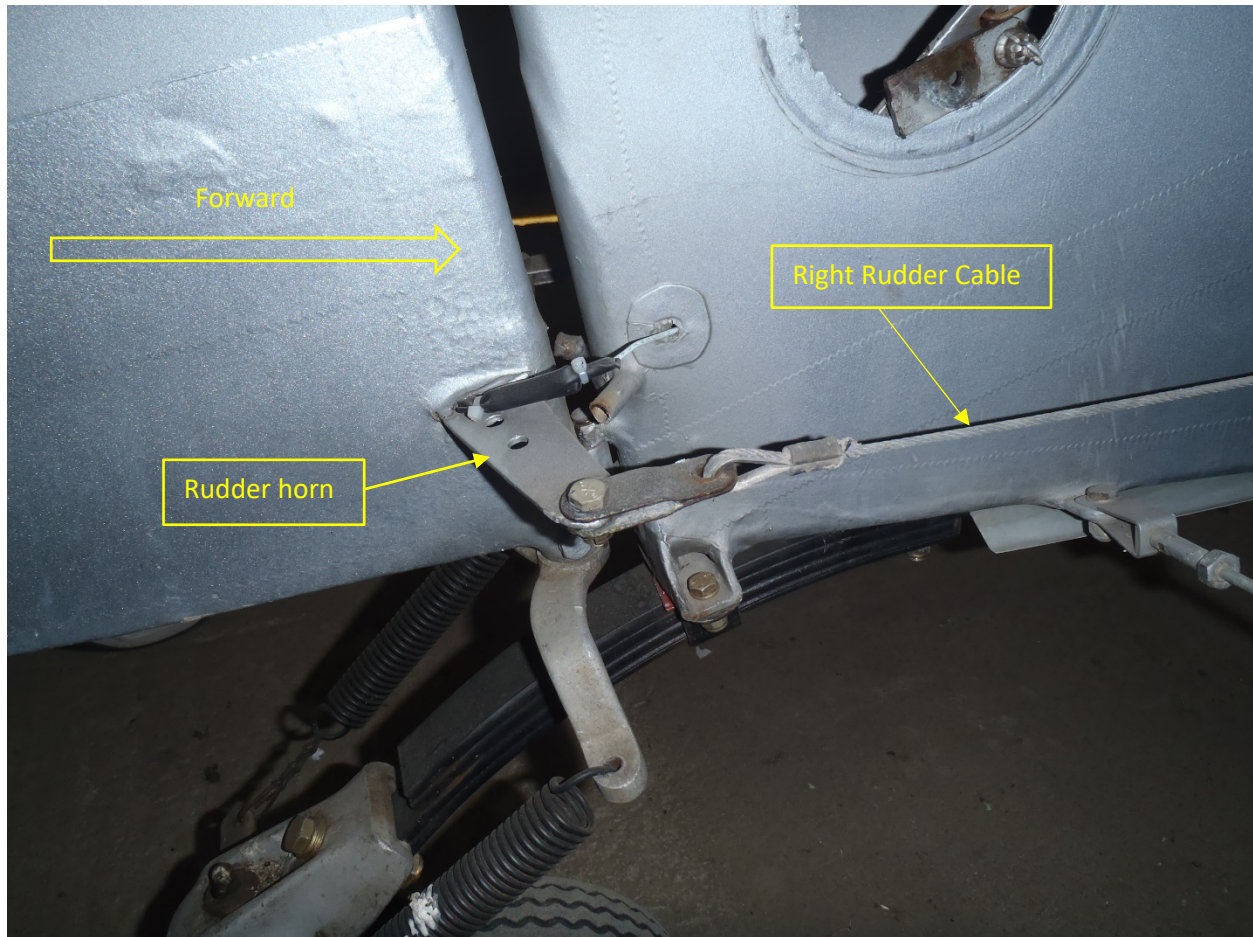
Photo 2. Right rudder cable attached at the rudder horn.

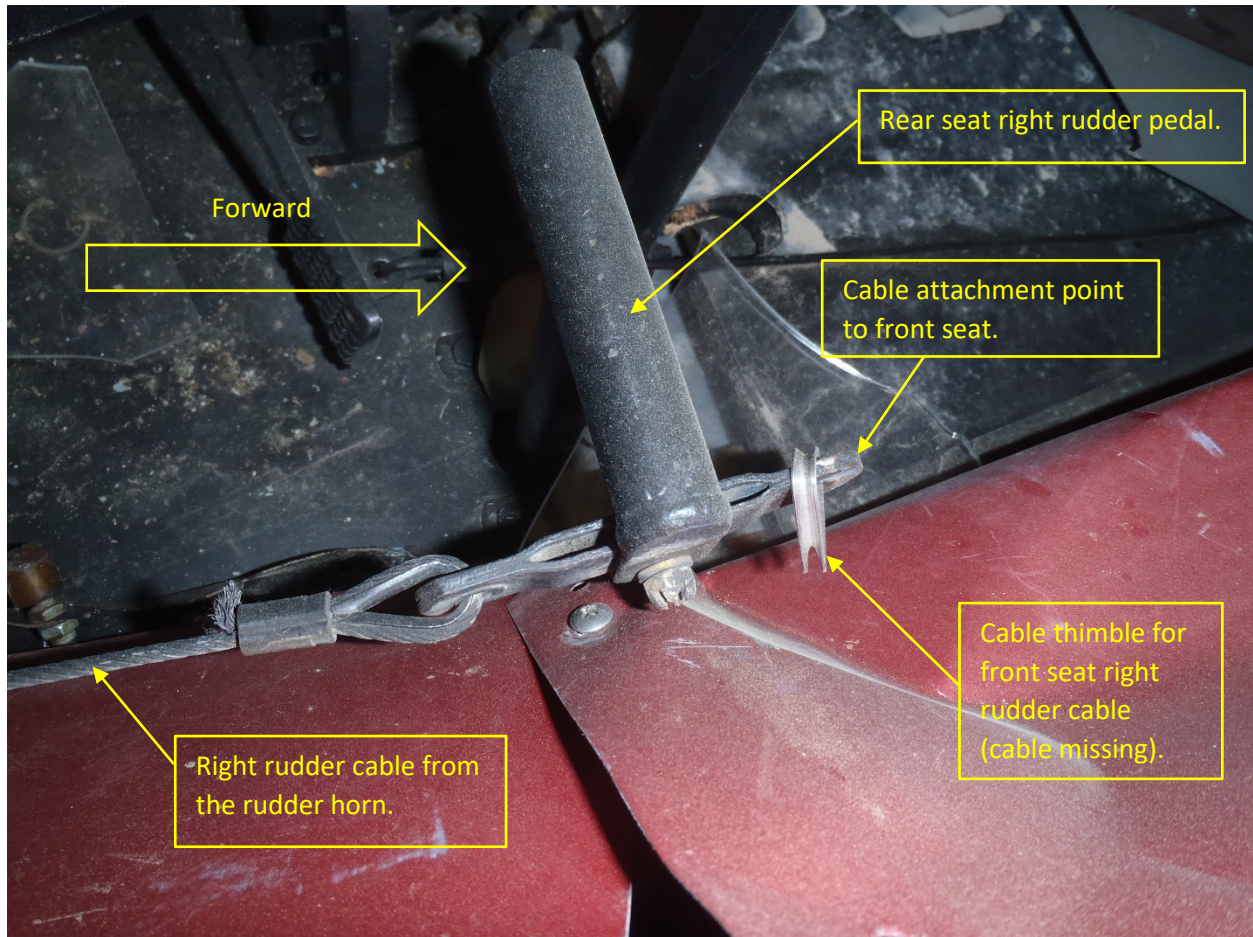
The right rudder cable, between the front and rear seat, was found detached at the rear seat connection. The thimble remained attached to the rear seat pedal assembly, and the free end of the cable was loosely threaded through the swage sleeve.

Photo 3. Right rudder cable from rudder horn intact. Cable thimble to front seat attached, cable missing.

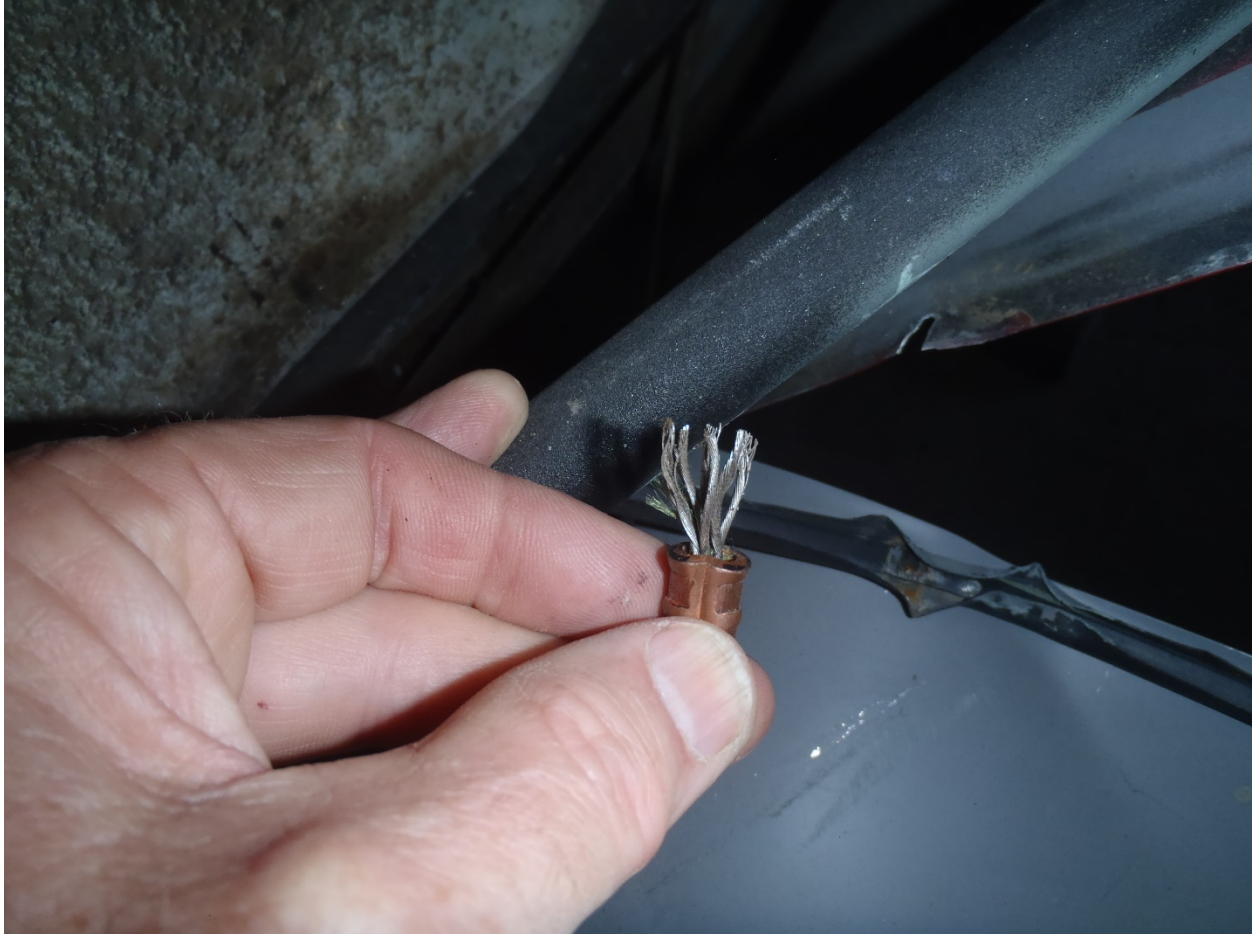
Photo 4. Front seat right rudder cable end with swage sleeve. Cable is attached at the front seat rudder pedal.

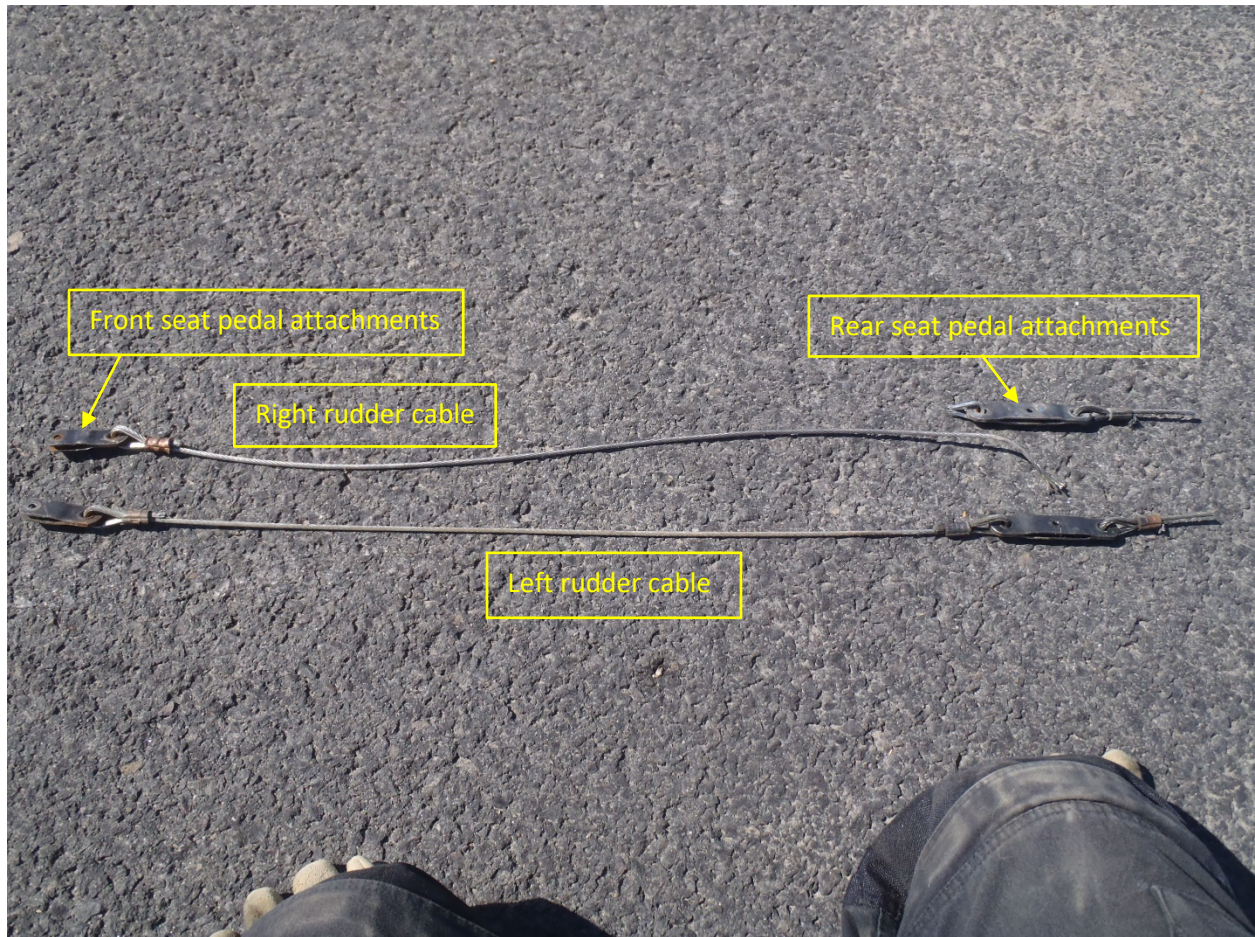
The left and right front seat rudder cables were removed and compared. The right cable was approximately the same length as the left and showed no signs of cutting, tearing or other external damage.

The right and left cables did not have the same appearance of age, condition, or patina, and the swage sleeves were of different styles and crimp patterns. However, the right rear rudder cable from the rear seat pedal to the rudder horn did have the same appearance of age, condition, and patina as the left cable assembly, as-well-as the same swage sleeve type and crimp patterns.

Photo 5. Front seat left (lower) and right (upper) rudder cables removed.

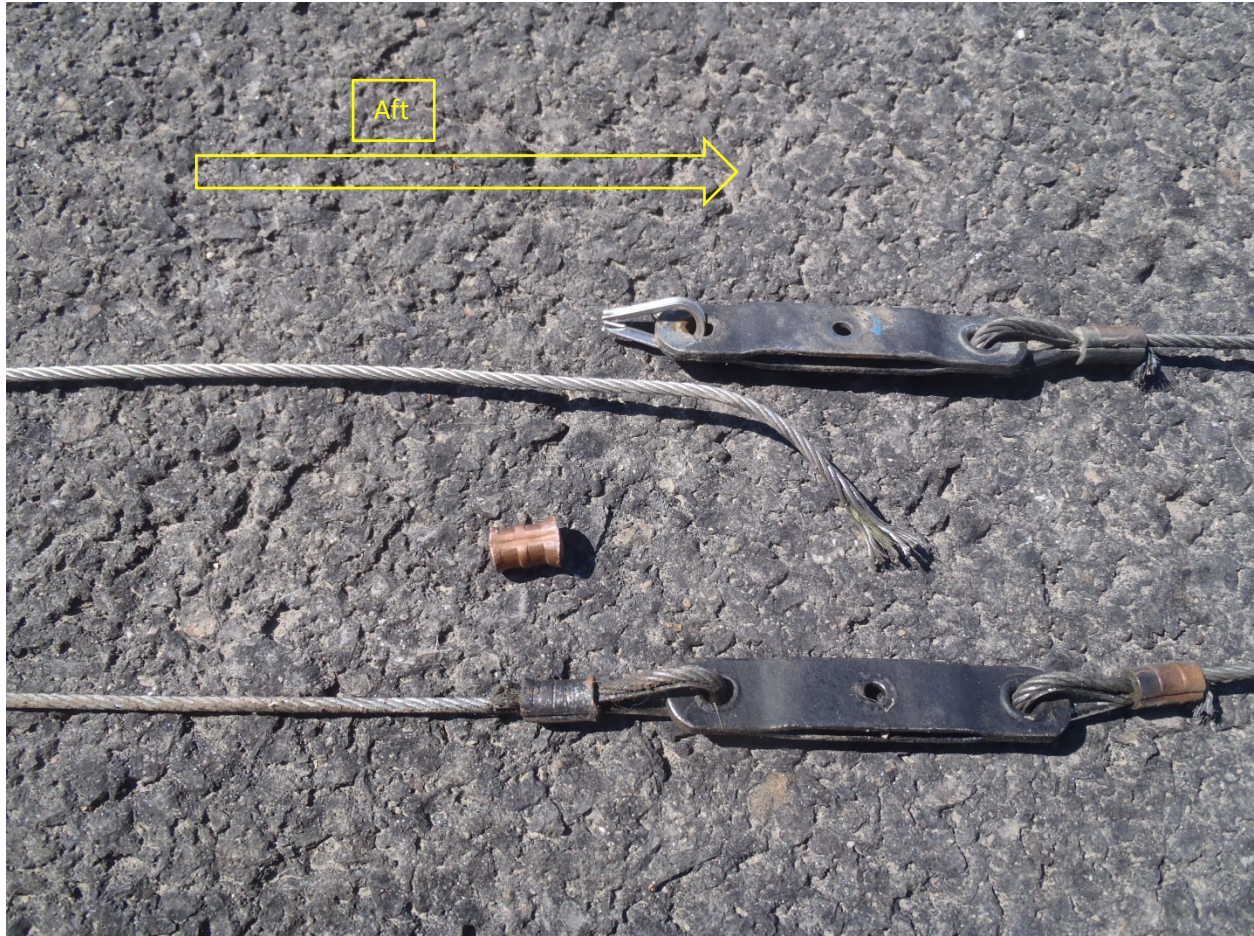
Photo 6. Rear seat left (lower) and right (upper) rudder cable assemblies.

Condition, patina, style (of the swage sleeve) suggests that the front, right rudder pedal cable has been replaced. There were no annotations in the maintenance logs provided, for the replacement of the cable. The right rear seat cable aft to the rudder horn has the same patina and style swage sleeves as the left rudder cable assembly.

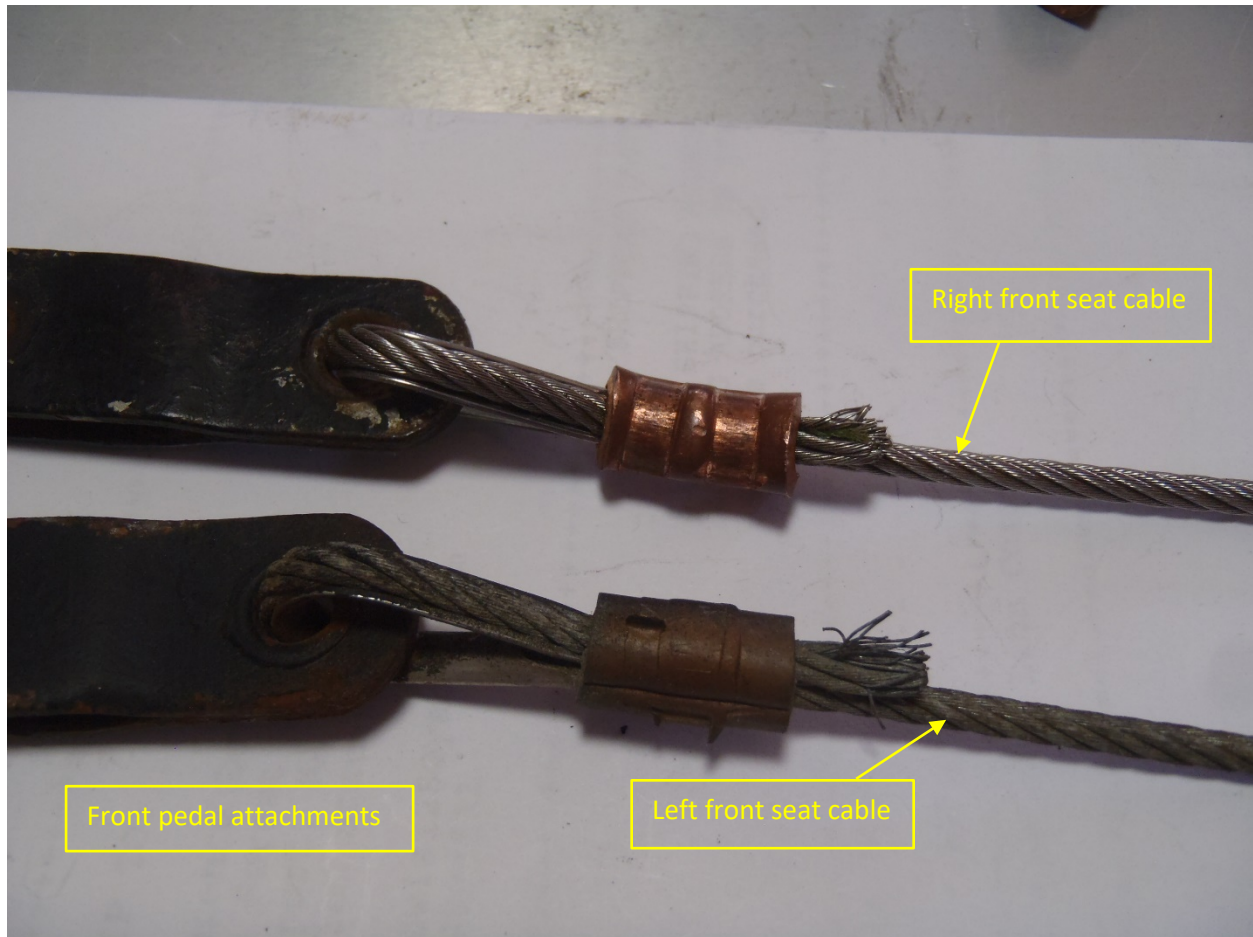
Photo 7. Left (lower) and right (upper) front seat rudder pedal attachments and cables.

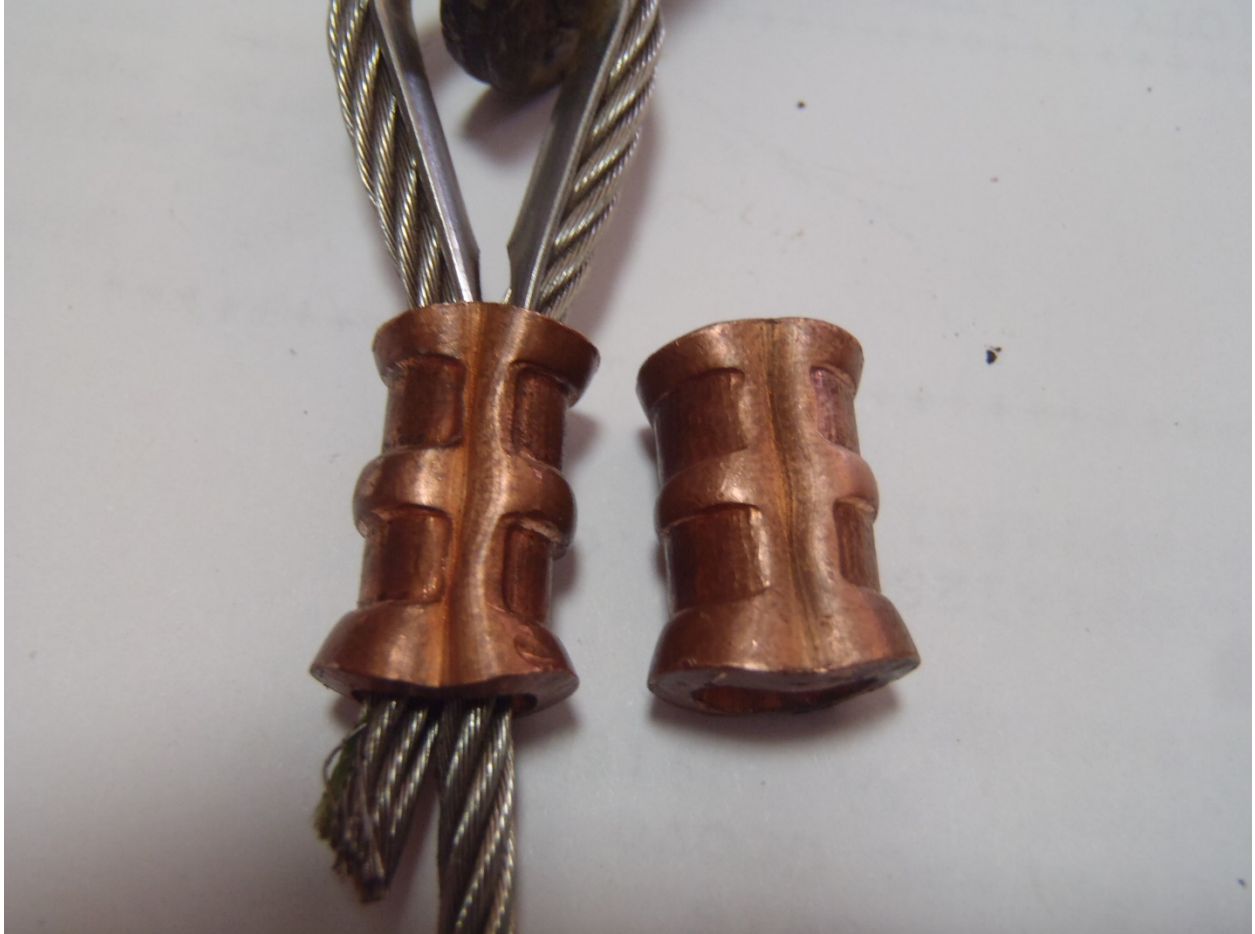
Comparison of the swage crimp patterns on the forward and aft ends of the right rudder pedal cable showed much deeper crimps on the forward end than the aft end.

Photo 8. Crimp pressure comparison of the front seat right rudder fore (left) and aft (right) swage sleeves.
