# Continental Motors

## ENGINE FIELD INSPECTION REPORT

| ENGINE MODEL | O-470-S(1B) |
| FILE NUMBER | 16-604 |

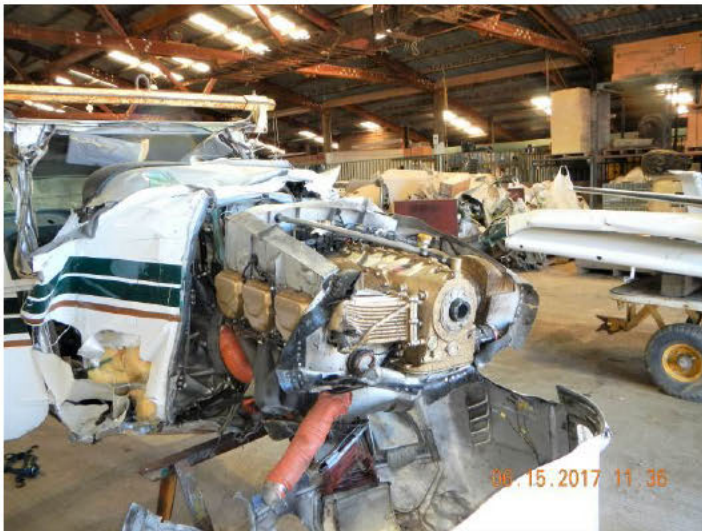
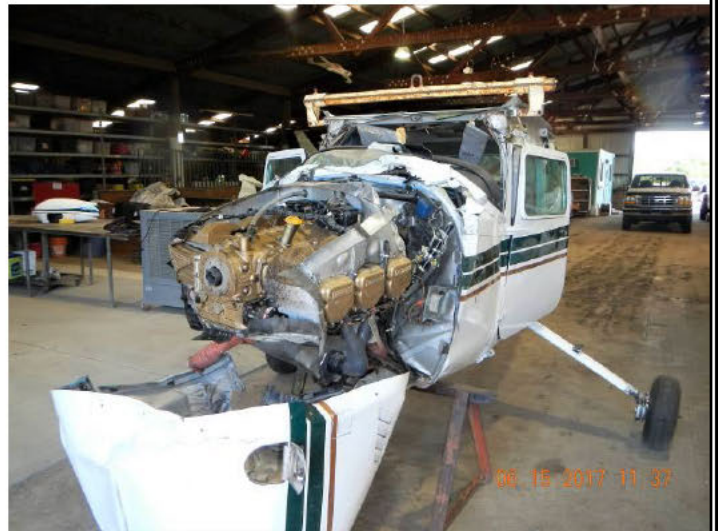
The engine cowling was removed to allow access to the engine and accessory components. All engine components were accounted for and only minor impact damage was noted.

The right and left exhaust collectors were impact damaged. The right exhaust collector was semi-separated at the muffler attachment clamp. The muffler heat outer heat shield exhibited minor impact damage.

The induction forward balance tube assembly exhibited minor impact damage. The carburetor separated due to impact forces at the rear manifold riser assembly (wye induction pipe). The carburetor remained attached to the carburetor attachment flange and control cables. The carburetor assembly exhibited only minor impact damage.

The outboard lower corner of the engine oil cooler exhibited impact damage. The oil filler cap remained attached but received impact damage. The spin on type oil filter exhibited impact damage.

The engine starting motor separated from the starter adapter. The starter adapter was impact damage at the starter attachment flange.

The crankshaft propeller flange separated due to impact forces. The propeller separated and retained the crankshaft propeller flange.

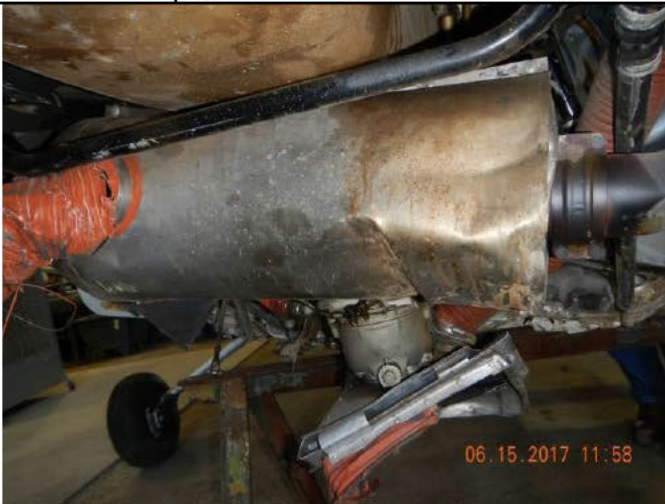
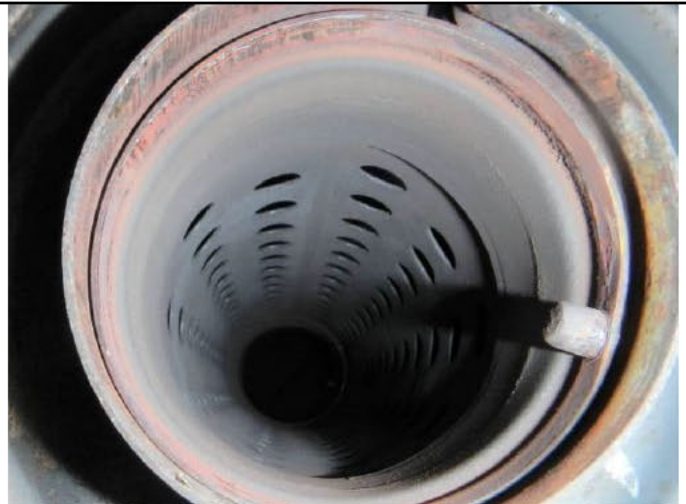
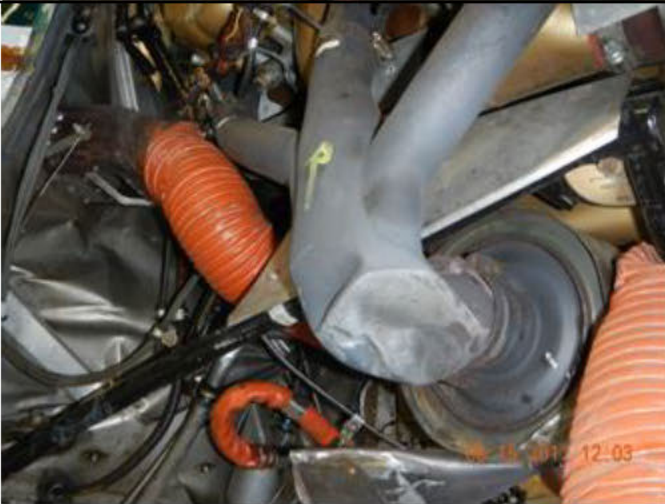
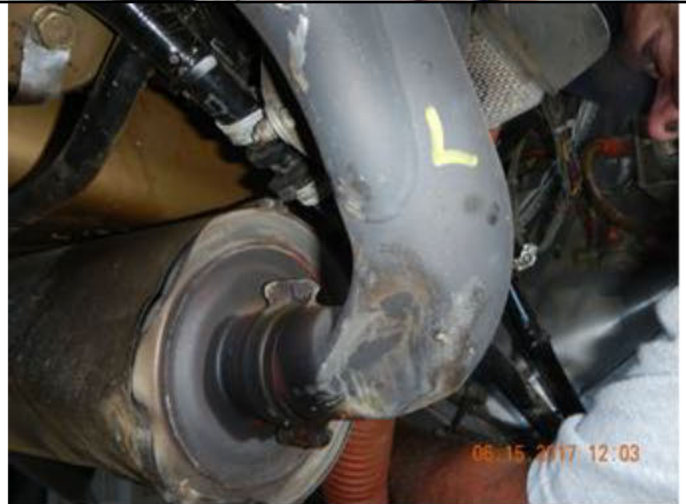
#### EXHAUST SYSTEM

The muffler received minor impact damage. The right and left exhaust collectors were impact damaged. The right exhaust collector was semi-separated at the muffler attachment clamp. The damaged right exhaust collector was cut away to facilitate examination of the muffler. The muffler internal flame cone/exhaust tube was intact and there was no obstruction inside the muffler.

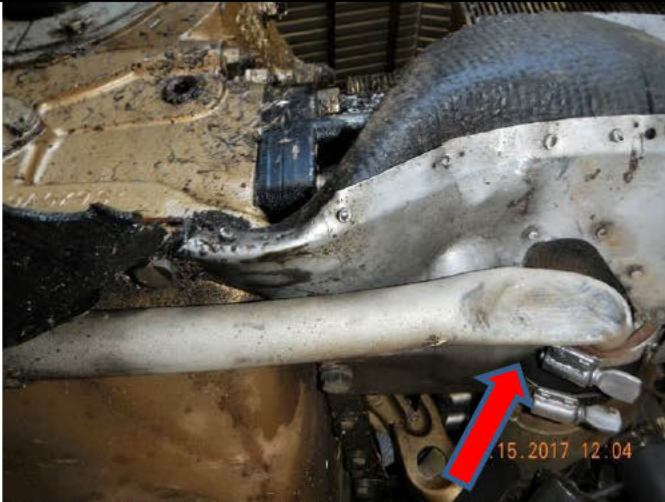
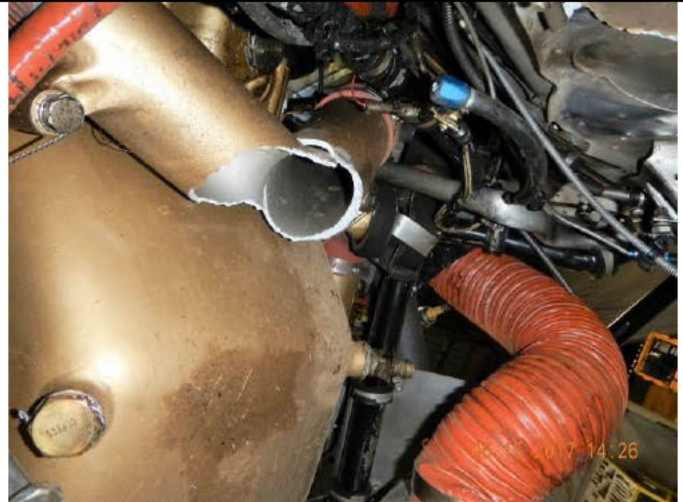
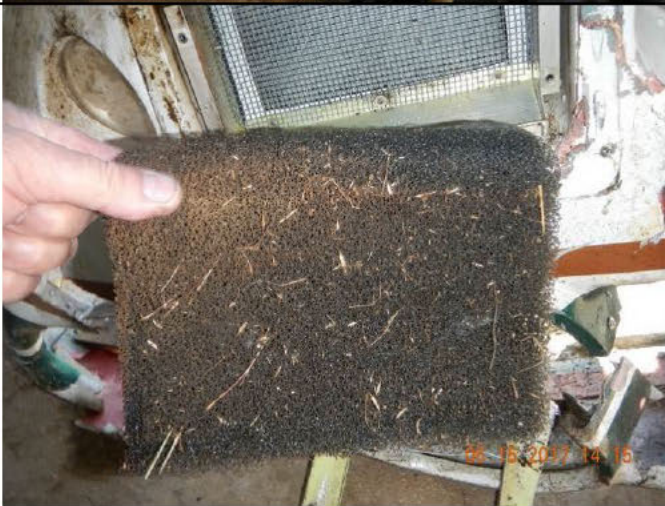
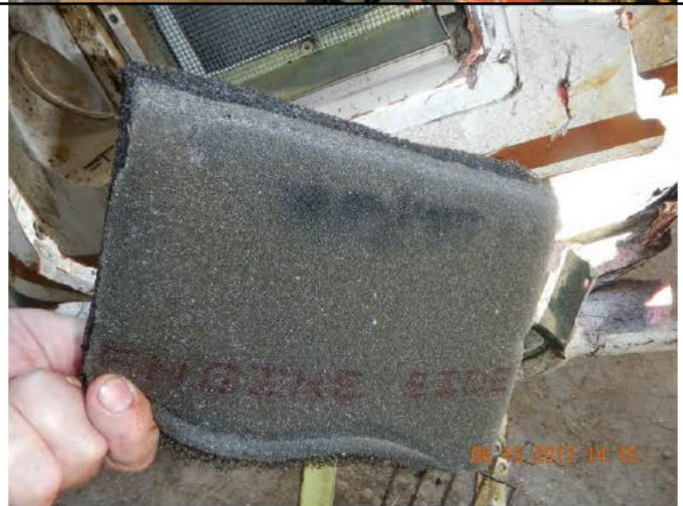
## INDUCTION SYSTEM

The induction system was intact except for minor impact damage to the forward balance tube assembly (see red arrow) and a separation of the carburetor due to impact damage at the rear manifold riser assembly (wye induction pipe). The outboard portion of the induction filter was contaminated with dirt. The filter element was removed and inspected.

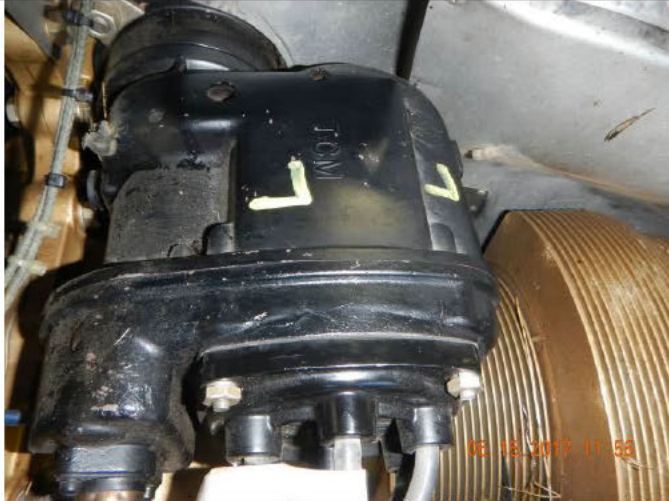
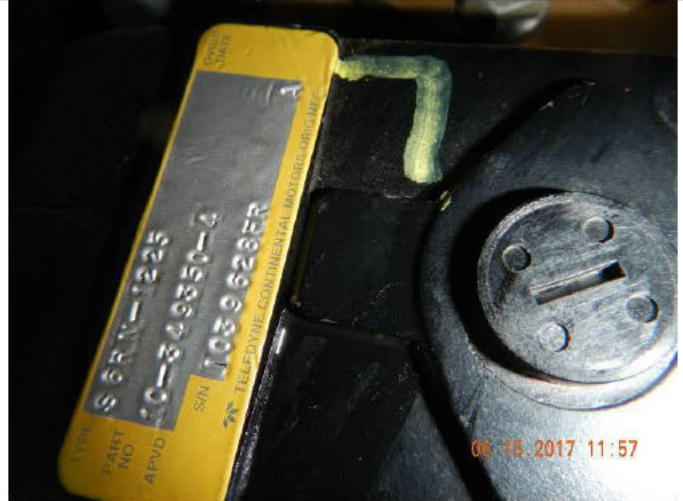
### LEFT MAGNETO

The magneto did not exhibit any physical damage. The magneto produced spark when the crankshaft was manually rotated and the impulse coupling produced an audible snap.

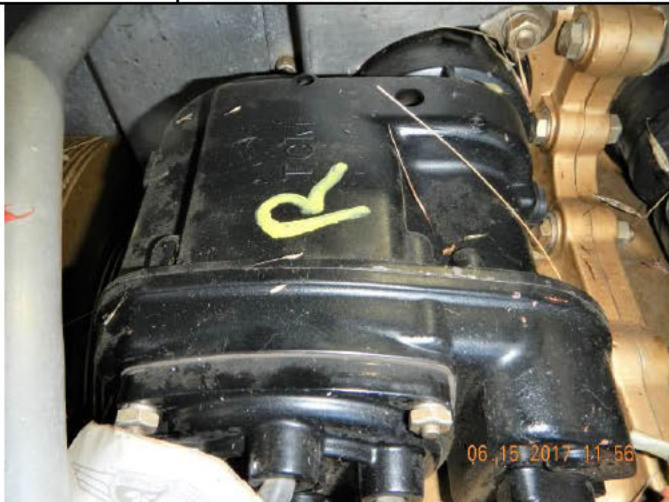
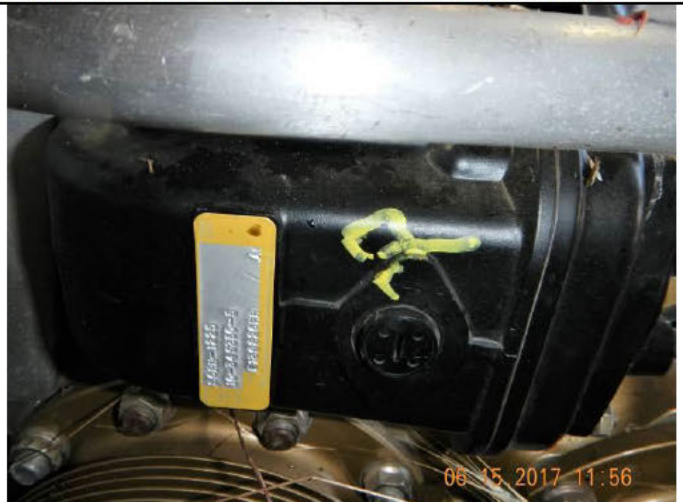
### RIGHT MAGNETO

The magneto did not exhibit any physical damage. The magneto produced spark when the crankshaft was manually rotated and the impulse coupling produced an audible snap.

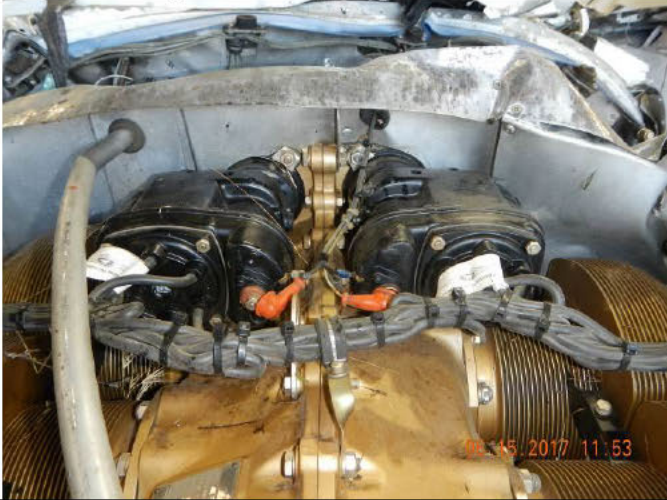
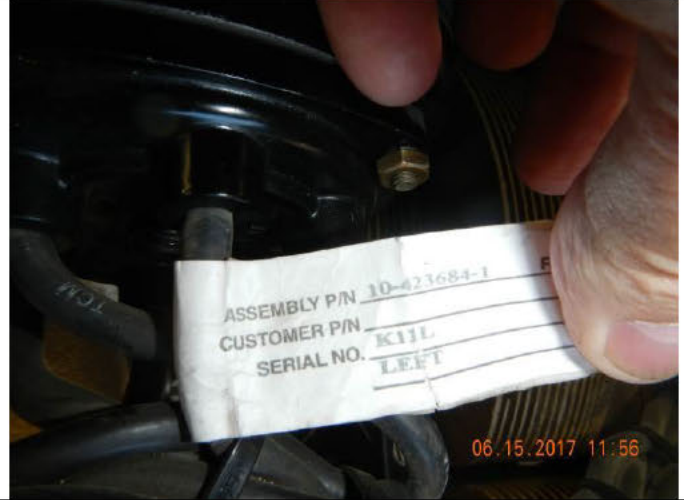
## IGNITION HARNESS

The ignition harness did not exhibit damage and operated normally when the crankshaft was manually rotated and the ignition system continuity was confirmed.

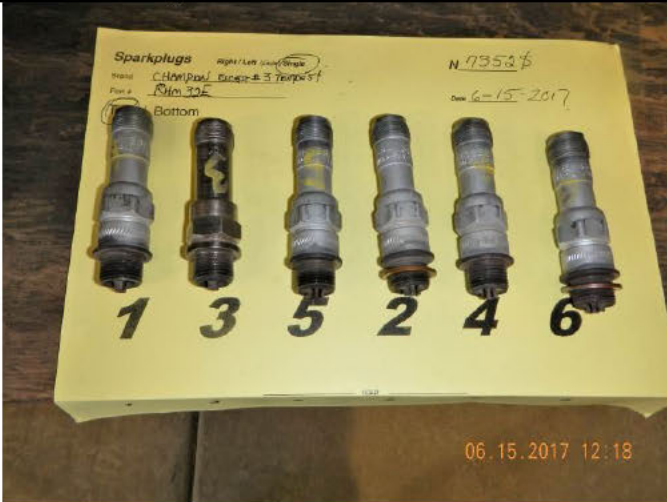
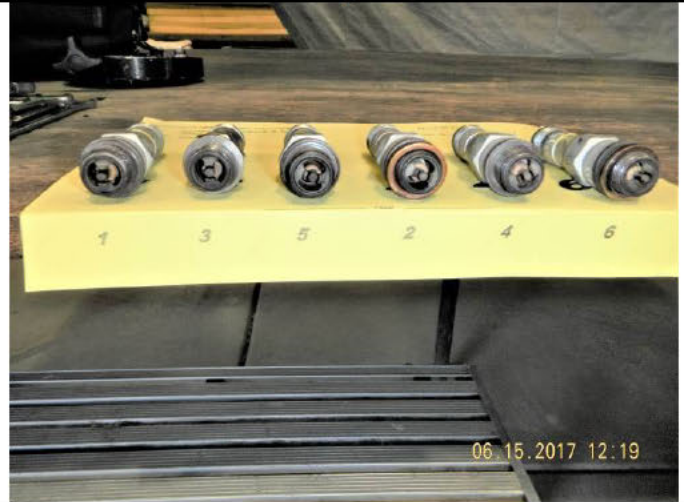
## SPARK PLUGS

NOTE: All sparkplugs were Champion brand except upper # 3 which was a Tempest brand.

When compared to a Champion Check-A-Plug chart, the condition of the sparkplugs was worn-out to worn-out normal. Coloration and combustion deposits were normal.

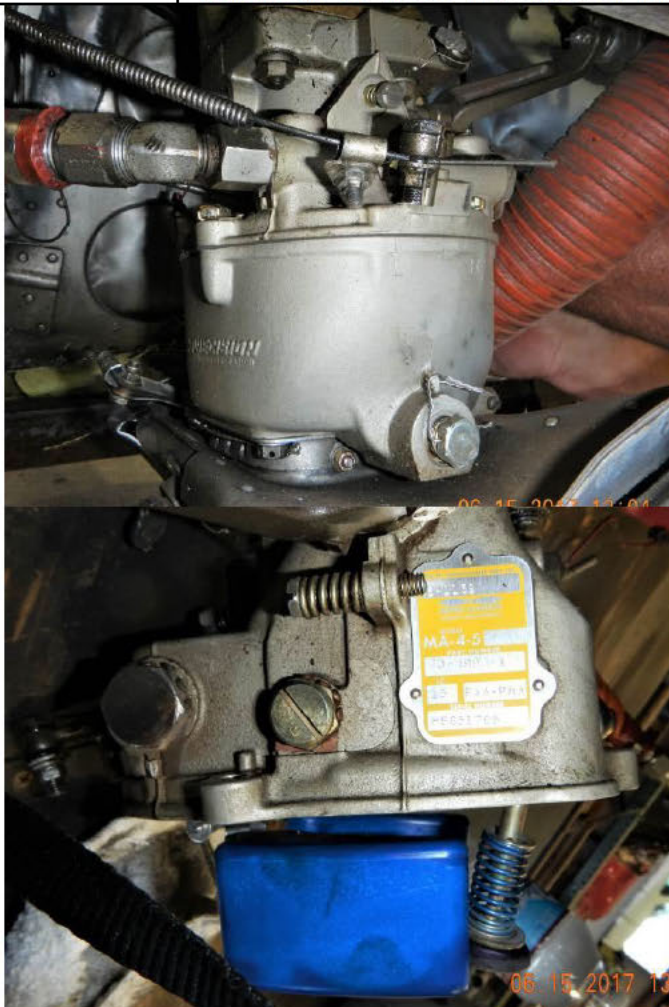
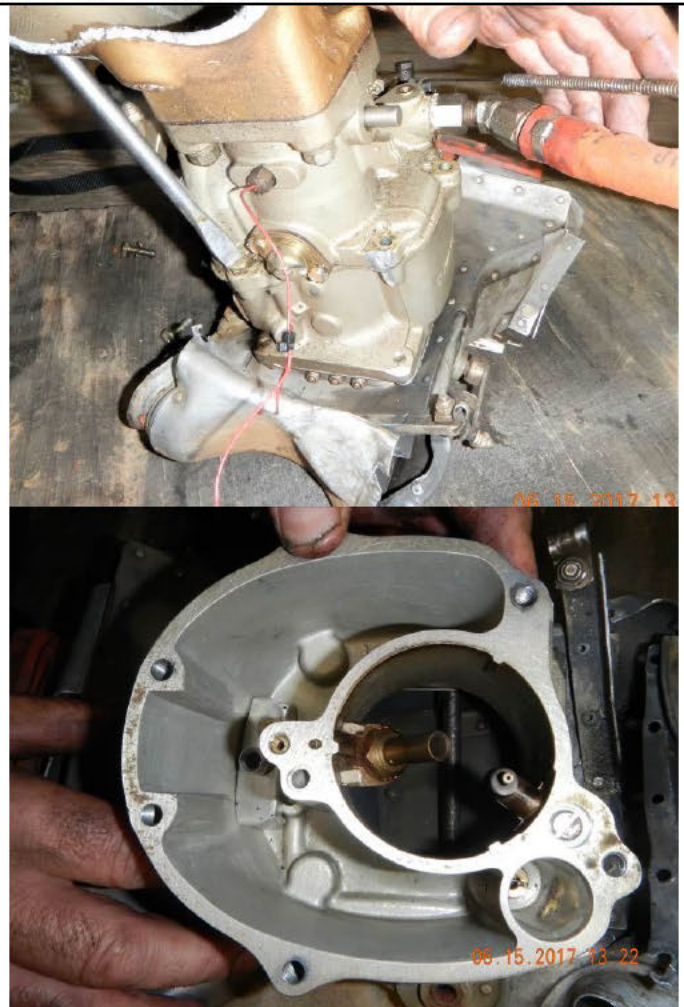
### CARBURETOR

All control cables were secured properly and continuity of cockpit control cables was confirmed. The accelerator pump did not expel fuel when the throttle arm was articulated. No fuel or contamination was present in the carburetor bowl. The float assembly was intact and functioned properly when moved manually; however the bracket that holds the floats was twisted. It is not clear if the twist resulted in float/bowl contact.

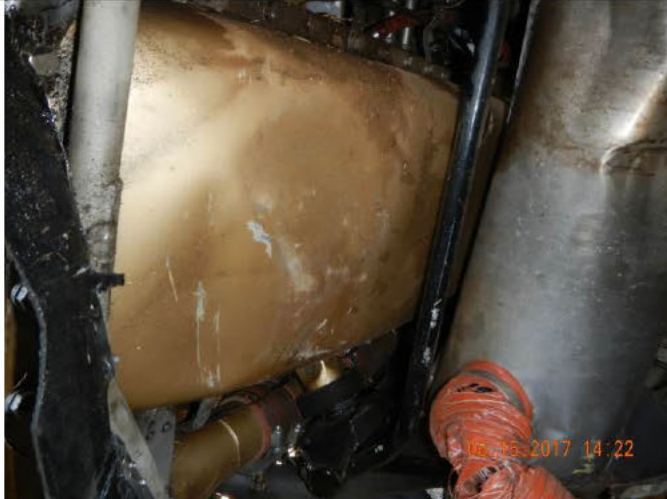
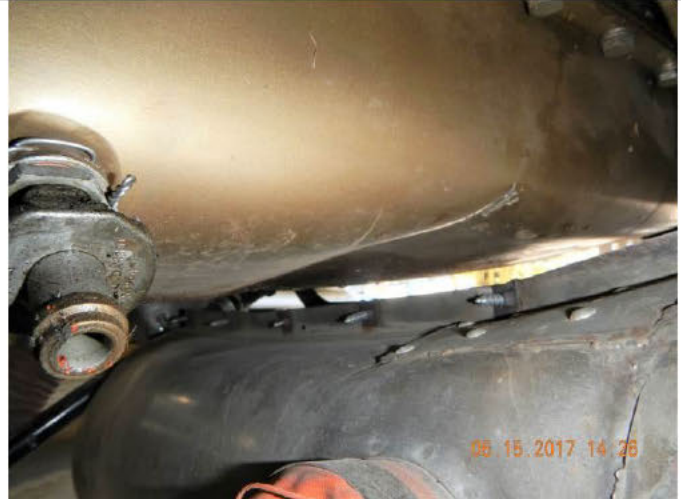
### OIL SUMP

The oil sump received only minor impact damage. The quick drain valve was intact. The oil rod indicated only a small amount of oil was contained in the oil sump.

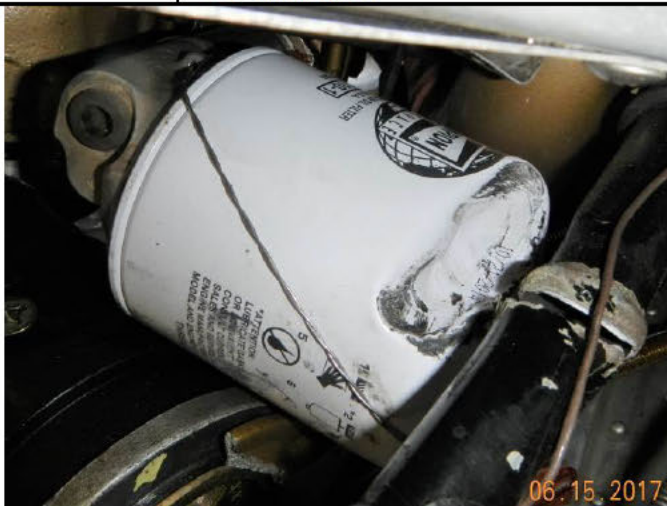
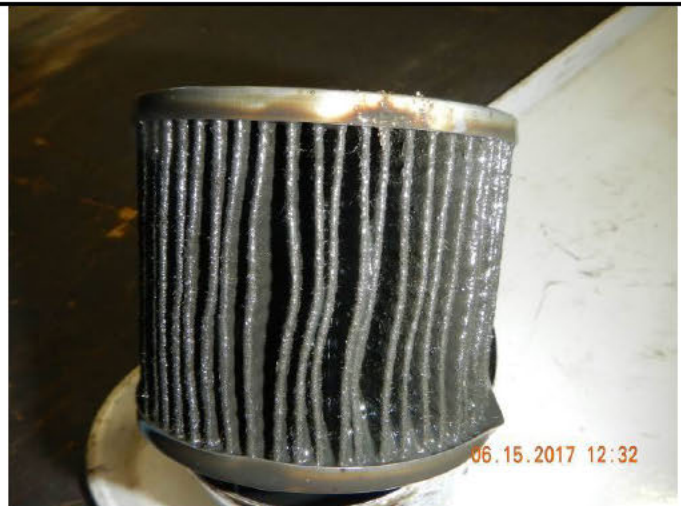
### OIL FILTER

The oil filter received impact damaged. The filter was cut and the paper filter pleats exhibited a small amount of ferrous metal when a magnet was used to check for contaminants.

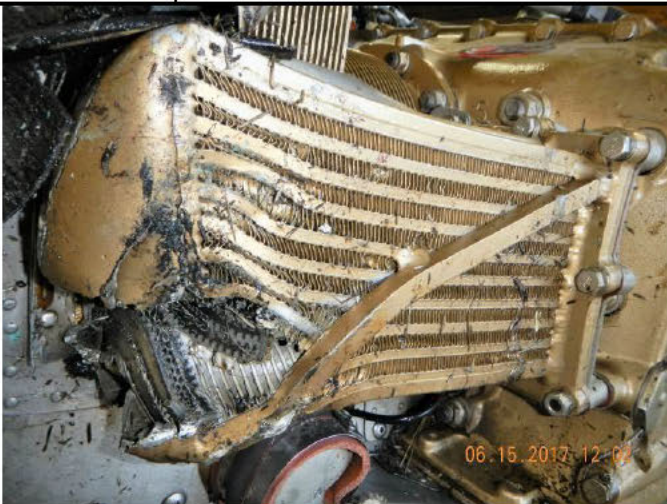
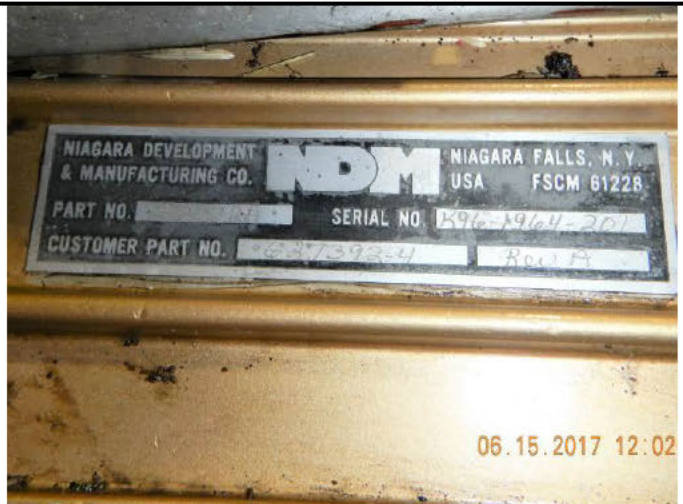
**OIL COOLER**

The oil cooler received impact damage.

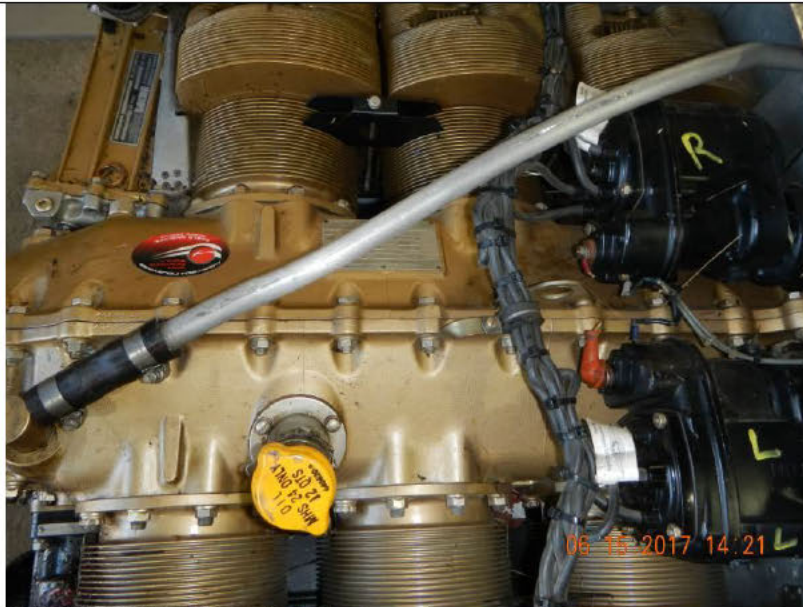
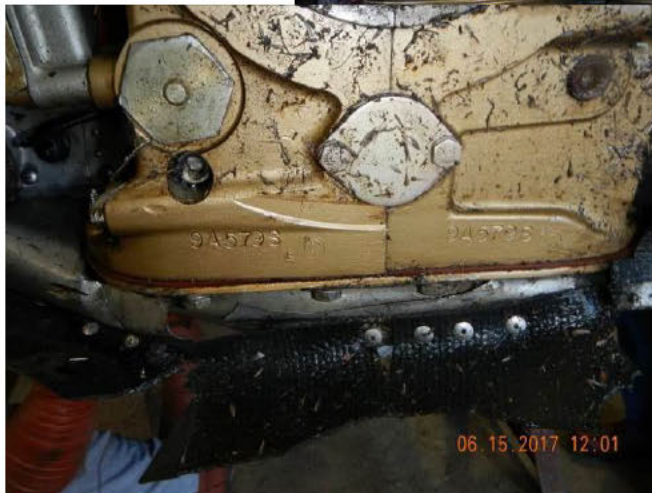
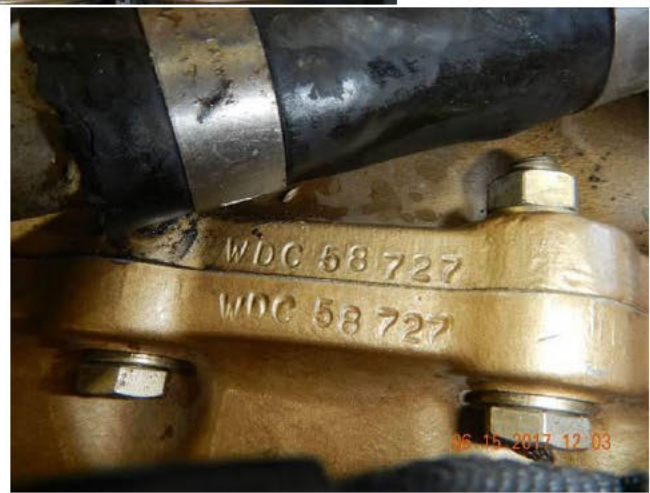
CRANKCASE

No visible damage was exhibited

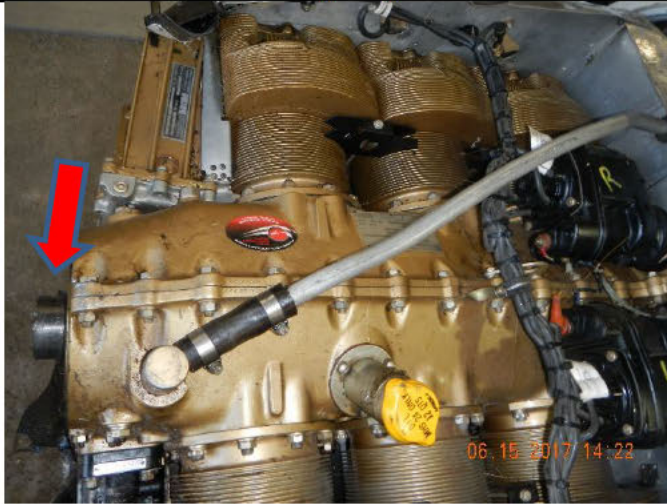
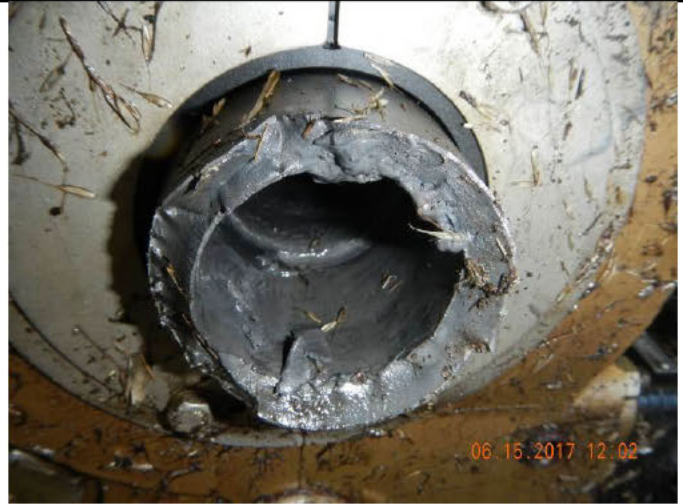
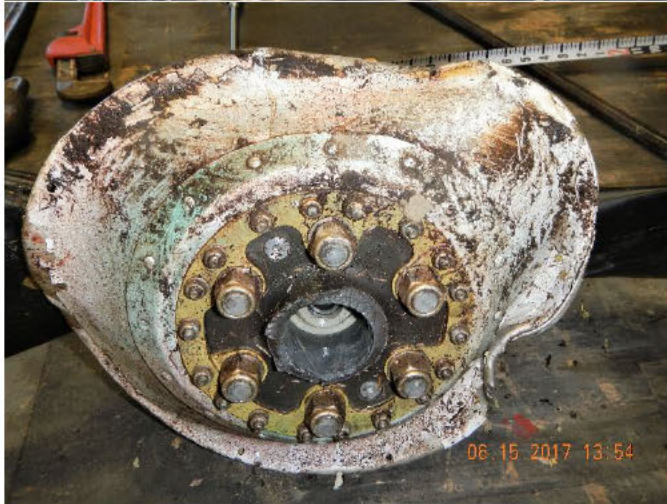
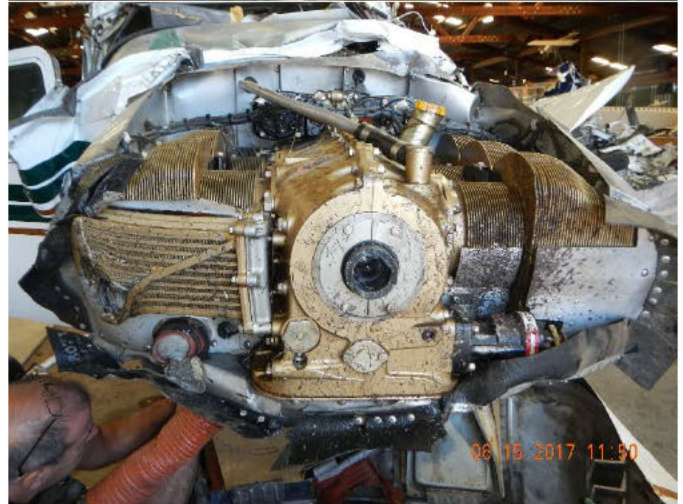
### CRANKSHAFT

The crankshaft propeller flange separated due to impact forces. The propeller separated and retained the crankshaft propeller flange. Crankshaft/camshaft continuity was confirmed by manually rotating the crankshaft and witnessing magneto and valve function.

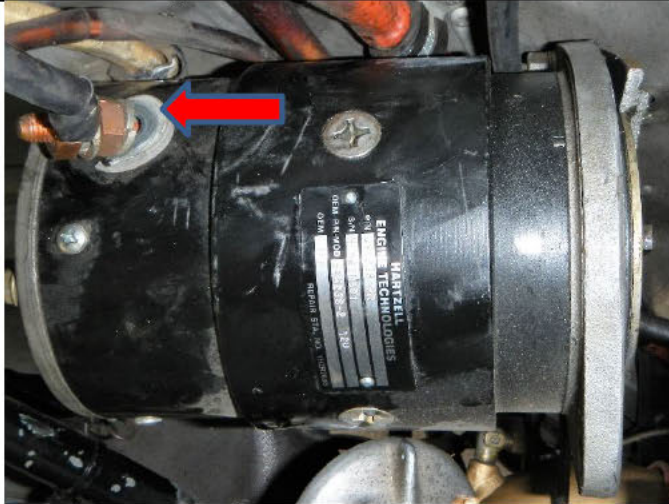
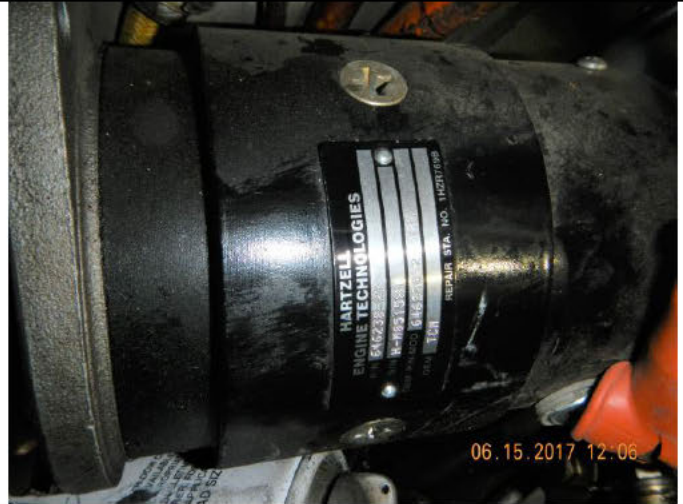
### STARTER

The starter motor exhibited impact damage at the cable terminal lug. See red arrow.

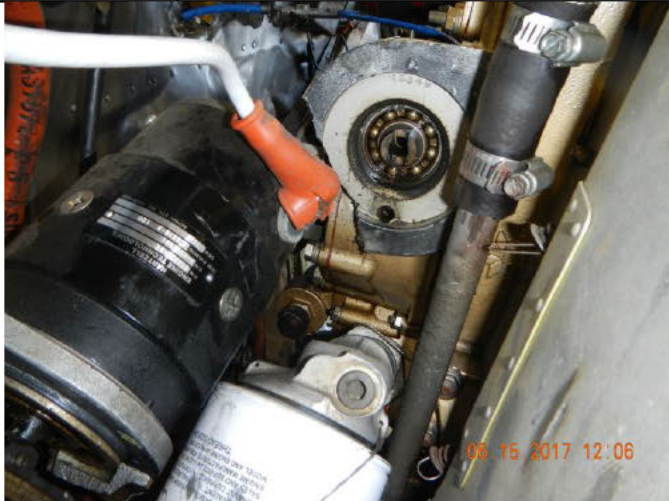
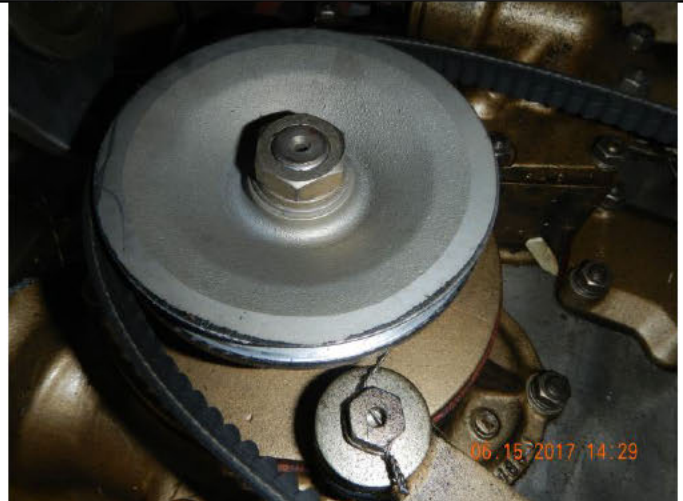
### STARTER ADAPTER

The starter adapter exhibited impact damage at the starter motor mount.

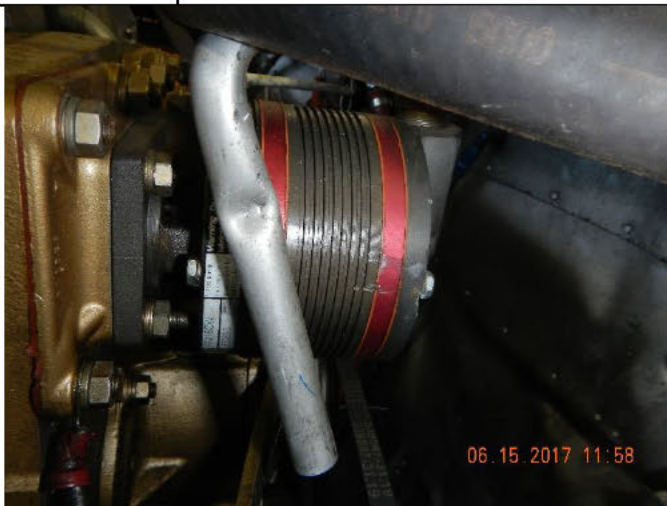
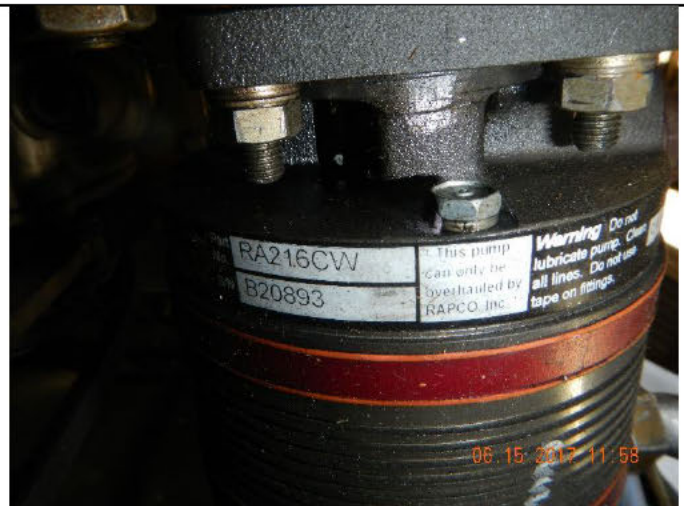
**VACUUM  
PUMP**

The pump case exhibited impact damage.

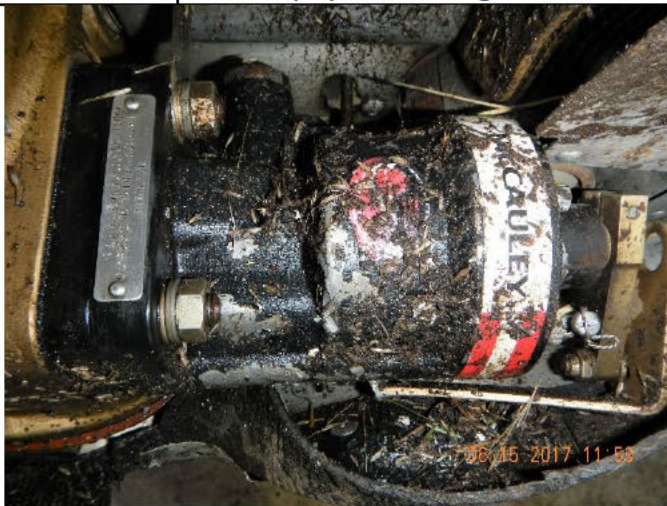
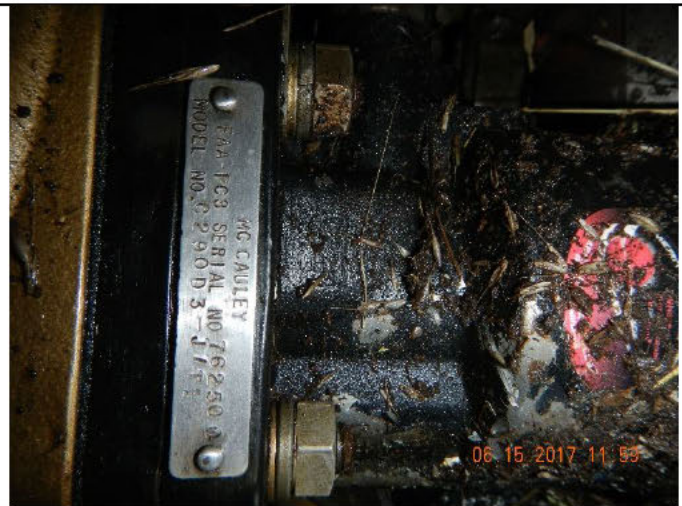
| Condition: | The propeller governor was contaminated with dirt from the accident site but did not exhibit physical damage. | | |

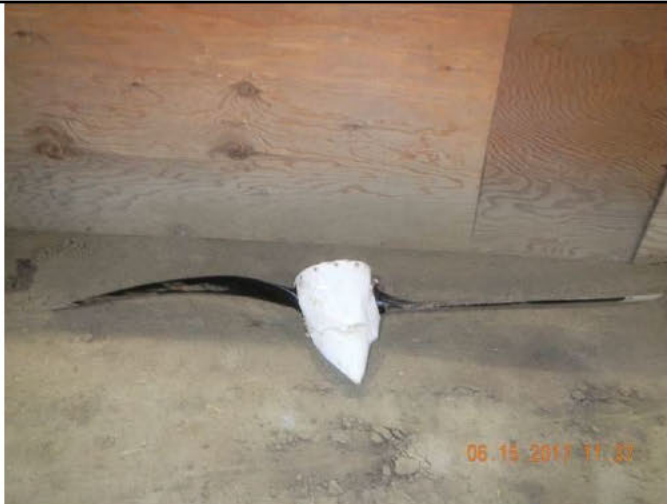
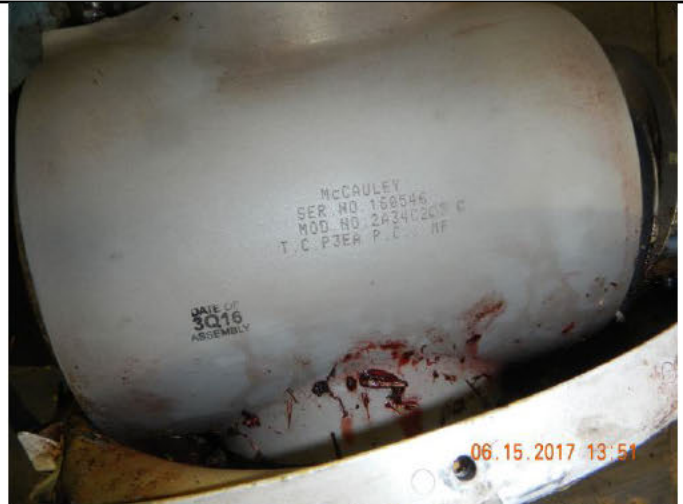
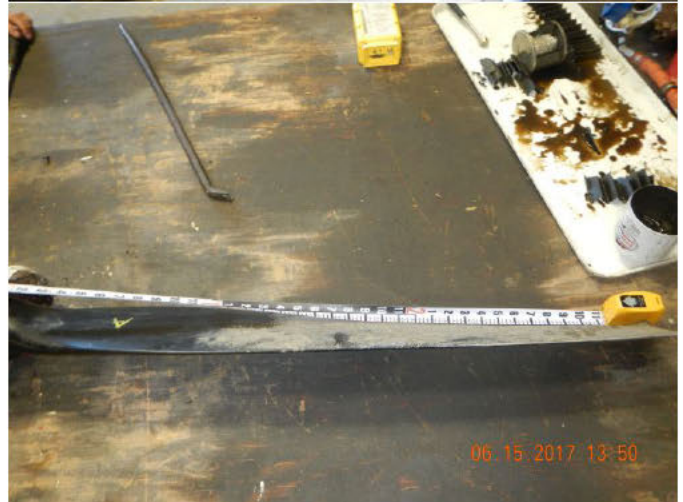
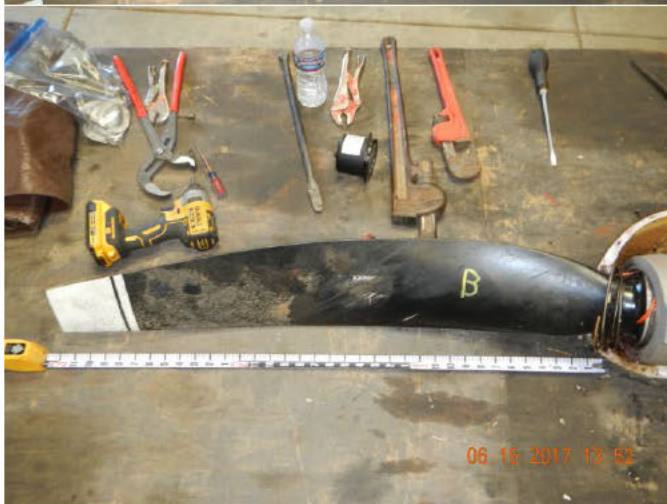
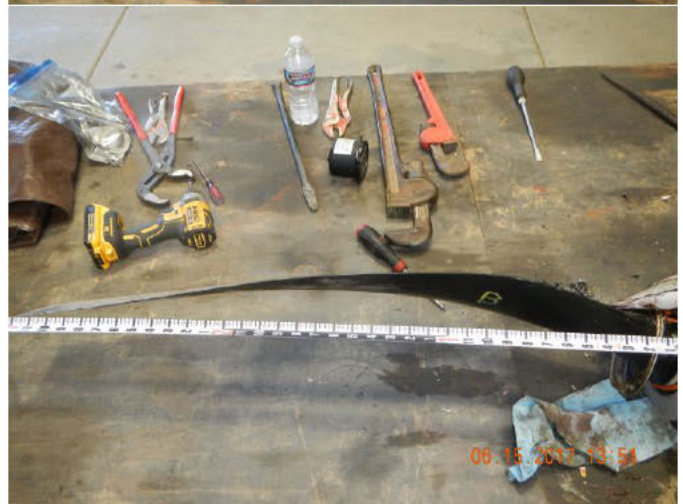
| Condition: | The propeller spinner was impact damaged but did not exhibit rotation crushing. The spinner was removed and the propeller was examined. Red dye was present on the propeller hub. The propeller blades were marked using the letter "A" or "B" for photo identification. Blade A exhibited only minor impact damage to the painted surfaces and leading edges. Otherwise, blade A appeared to be undamaged. Blade B exhibited a smooth rearward orientation possibly due to damage inside the propeller hub allowing movement of the blade inside the hub. The blade seal was displaced where blade B enters the propeller hub. Beginning at approximately 8" outboard of the propeller hub, blade B begins a smooth forward bend ending approximately 22" outboard of the blade root. Light diagonal cordwise scratches appeared in the paint on the cambered surface of blade B. | | |
