# NATIONAL TRANSPORTATION SAFETY BOARD

## MATERIALS LABORATORY FACTUAL REPORT

Report No. 18-001

Place : Rockville, Idaho  
Date : May 26, 2017  
Vehicle : Bell 206B, N24FS  
NTSB No. : WPR17LA113  
Investigator : Joshua Cawthra, AS-WPR

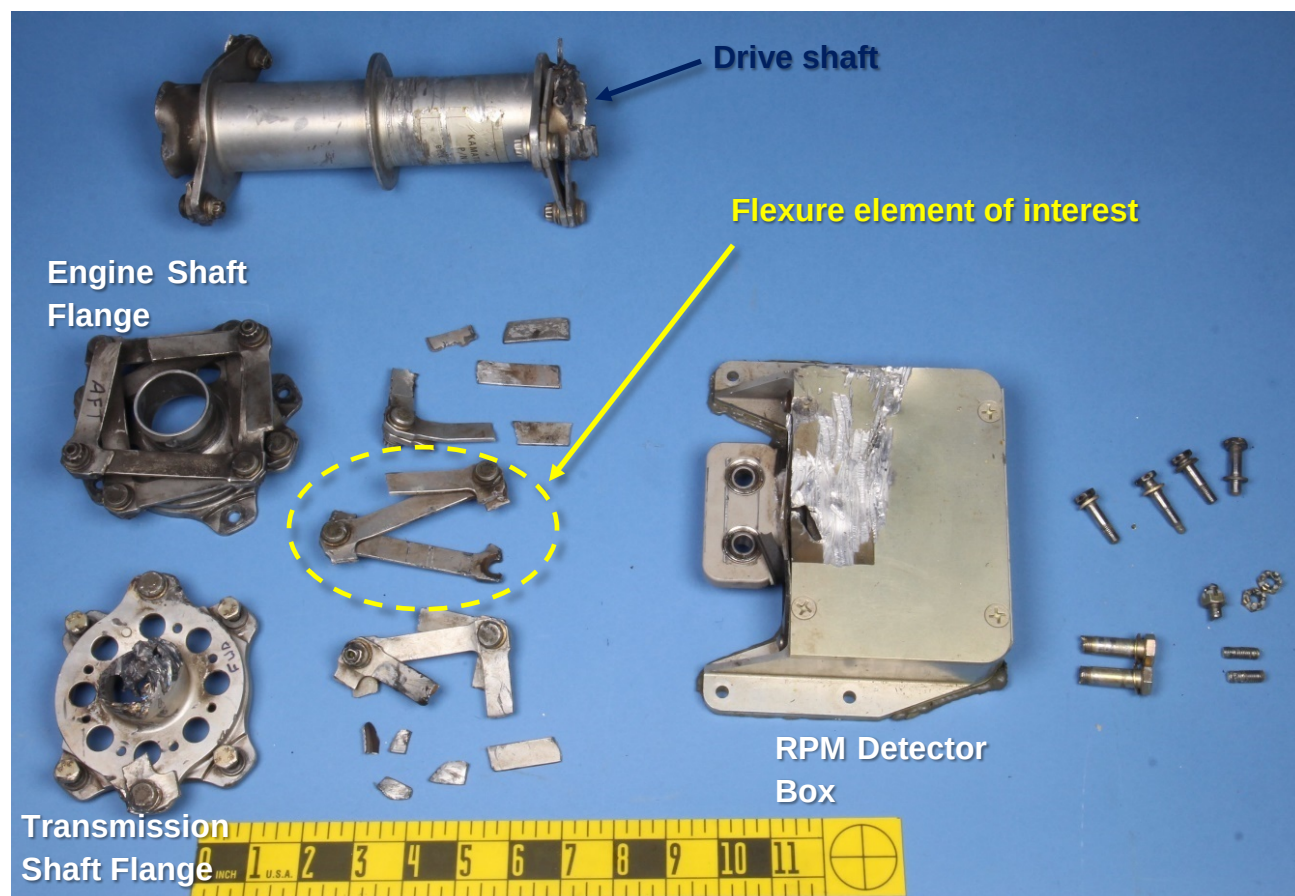
Figure 1 shows the pieces from the helicopter accident, as received. In the figure are components of an engine-to-transmission driveshaft, manufactured by Kamatics.<sup>1</sup> The driveshaft components submitted include the main shaft body assembly, the aft transmission shaft flange, the forward engine shaft flange, and multiple fractured flexure elements from the flexure coupling(s). In addition, an electronic RPM detector box was submitted.

Figure 1 – The pieces of the KAflex main rotor driveshaft, as received.

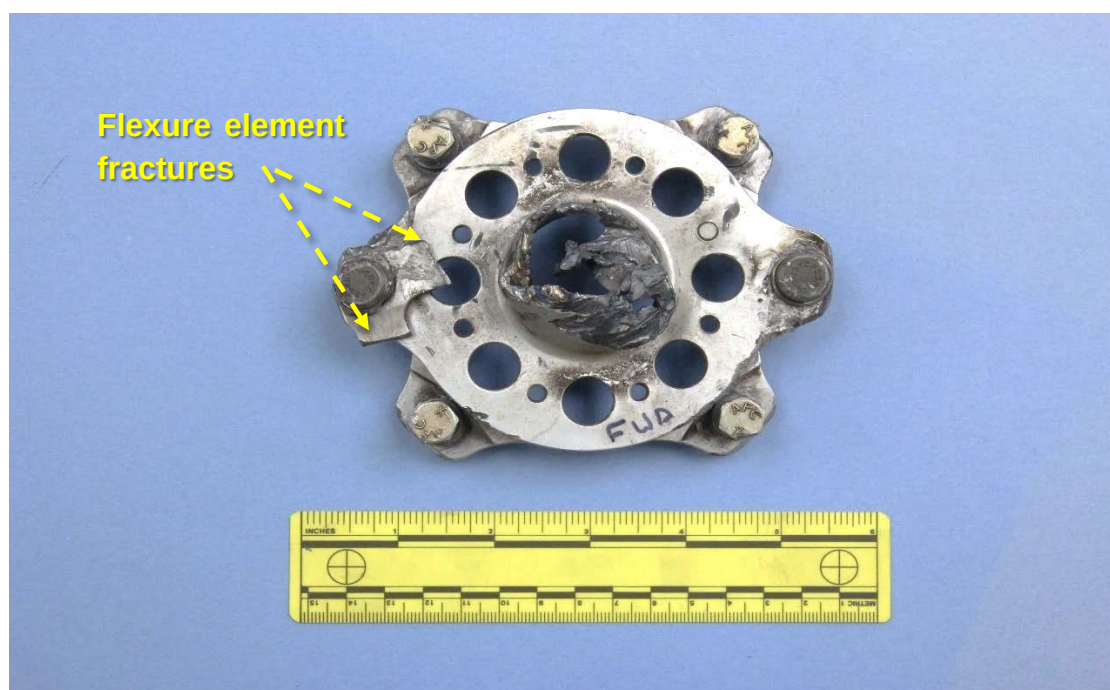
The shaft portion section of the transmission shaft flange, facing the flex-coupling, had fractured between 0.5 and 1 inches from the flange radius, as shown in Figure 2. The shaft exhibited circumferential wear and gouge marks, consistent with contact with an adjacent component, post-fracture. The fracture surface was obliterated by this post-fracture contact. The areas adjacent the fracture surface exhibited buckling and twisting consistent with rotational or torsional loading.

The bolts, as received, were intact and still connected to the flange. Of note was an affixed flexure element that had fractured in two locations, still attached to the flange. These fractures were located approximately 0.4 inches from the bolt hole. The fractures exhibited a general cup-like profile, with a general rough texture and dull luster. The areas adjacent the fractures on the flexure element had thinned or necked. These fracture features were consistent with overstress failures.

Figure 2 – Closer view of the forward transmission shaft flange, showing shaft fracture and gouging, as well as a flexure element fracture (arrows).

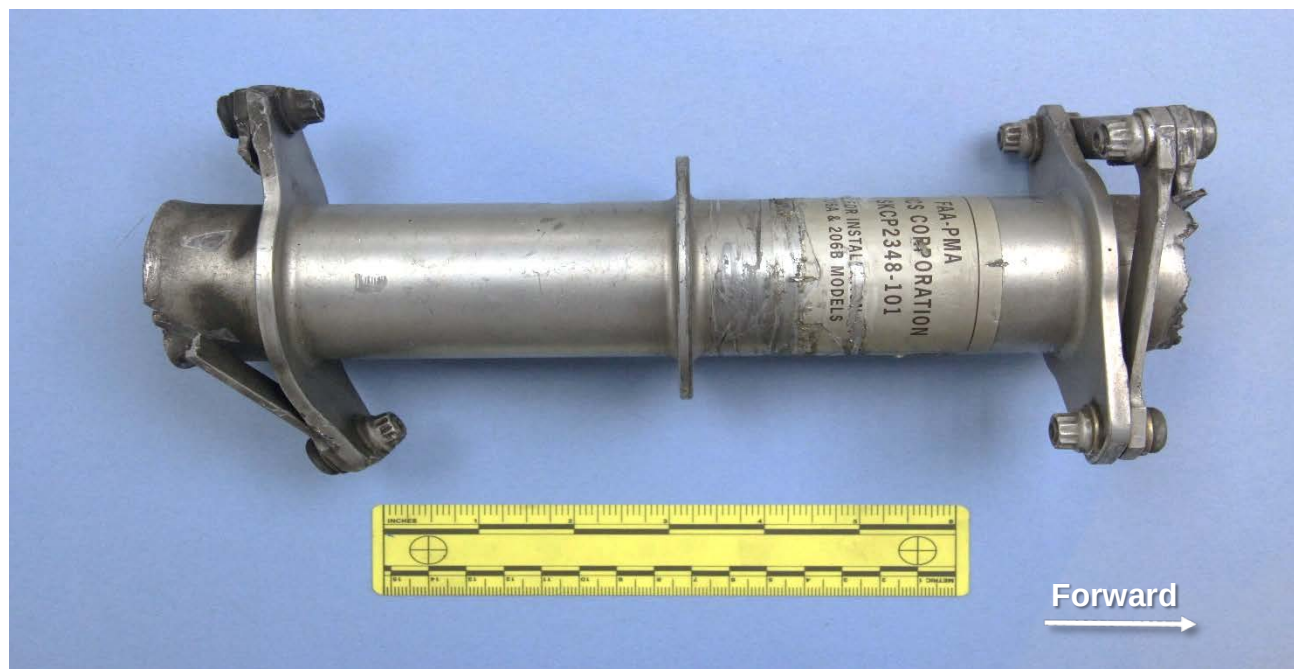
The shaft body of the engine-to-transmission drive shaft is shown in Figure 3. The outer surface of the shaft body was marked:

The remainder of the markings were damaged from gouging and scraping, consistent with post-fracture contact damage with an adjacent component. The shaft body itself exhibited circumferential wear and gouge marks near the center flange on the bottom of the marking label. The forward side of the shaft body exhibited inward buckling, deformation, and obliteration consistent with repeated impact and smearing with an adjacent component. These marks were consistent with those present on the mating transmission flange.

Figure 3 – Closer view of the main shaft, showing the markings and the circumferential gouge marks.

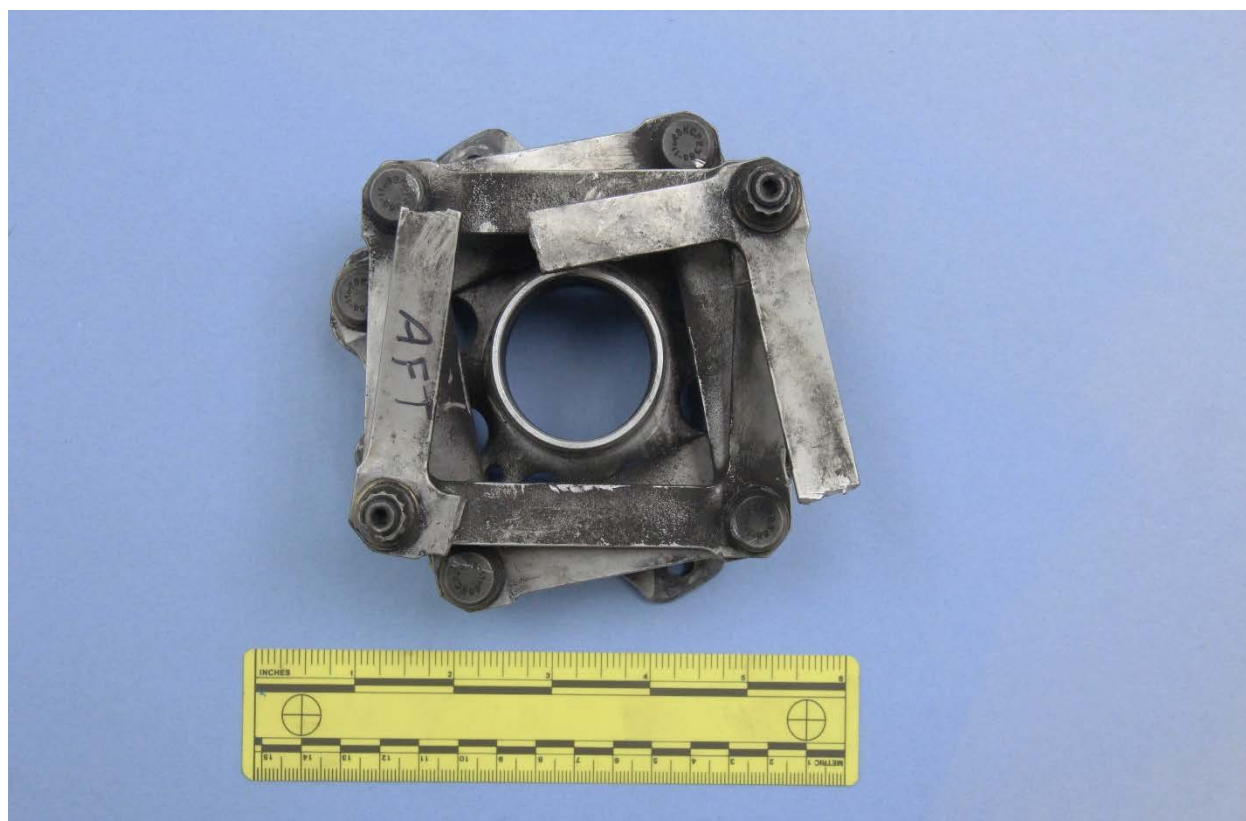
In addition, on the aft side of the shaft body, the element remnant fractures mated with those on the engine shaft flange (shown in Figure 4). These four fracture surfaces were located away from the bolt holes, and exhibited similar features. The fracture surfaces were rough textured, with either a cup or cone shape, or a 45° angle orientation. The areas adjacent to the fracture surfaces exhibited local deformation and necking, as well as small parallel cracks. These features were consistent with overstress fracture.

Figure 4 – The remnant of the aft engine shaft flange coupling flexure elements.

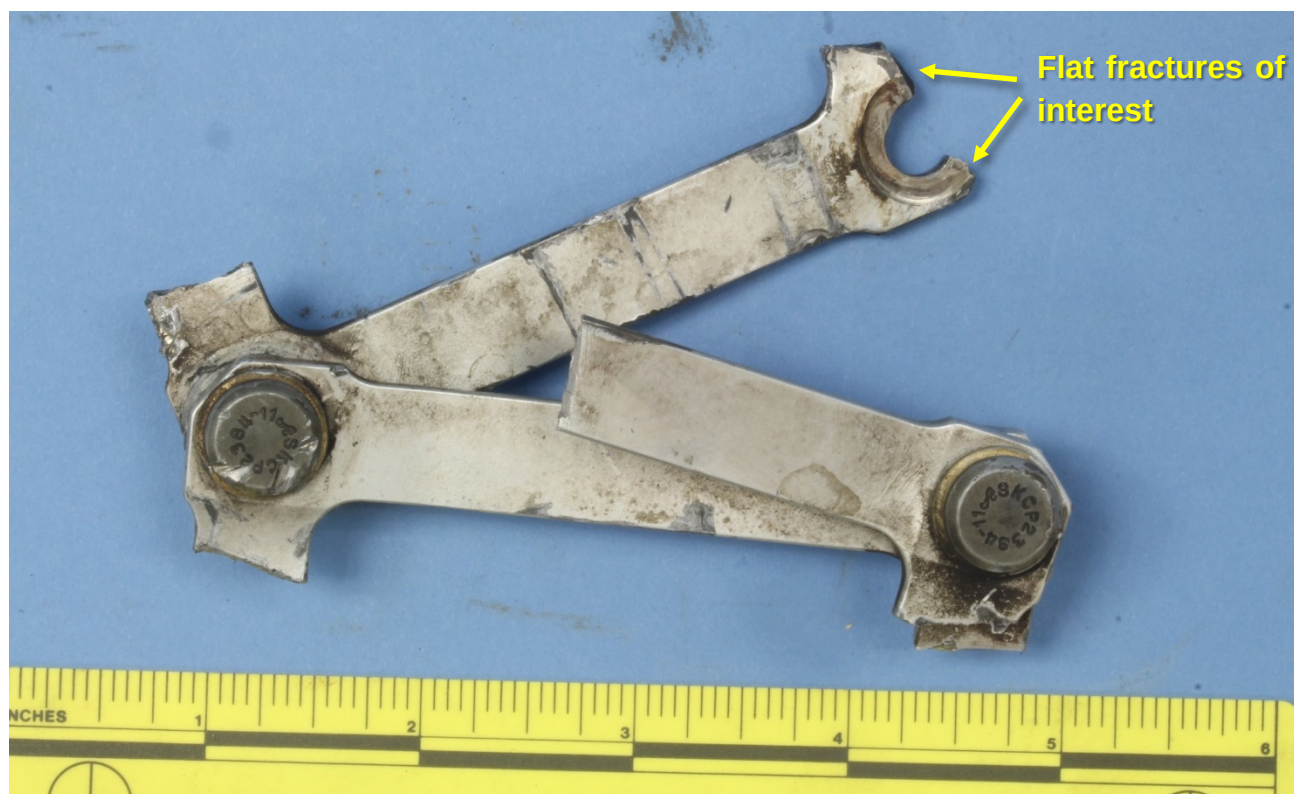
Of note, as shown in Figure 1, was a flexure element that had fractured along a bolt hole. This element is highlighted in Figure 5 and Figure 6. The fractures were flat, with no indications of localized material deformation or necking. The pair of fracture surfaces about the bolt hole is shown edge on in Figure 7.

Figure 5 – Some of the fractured flexure elements, showing two flat fractures around a bolt hole of interest.

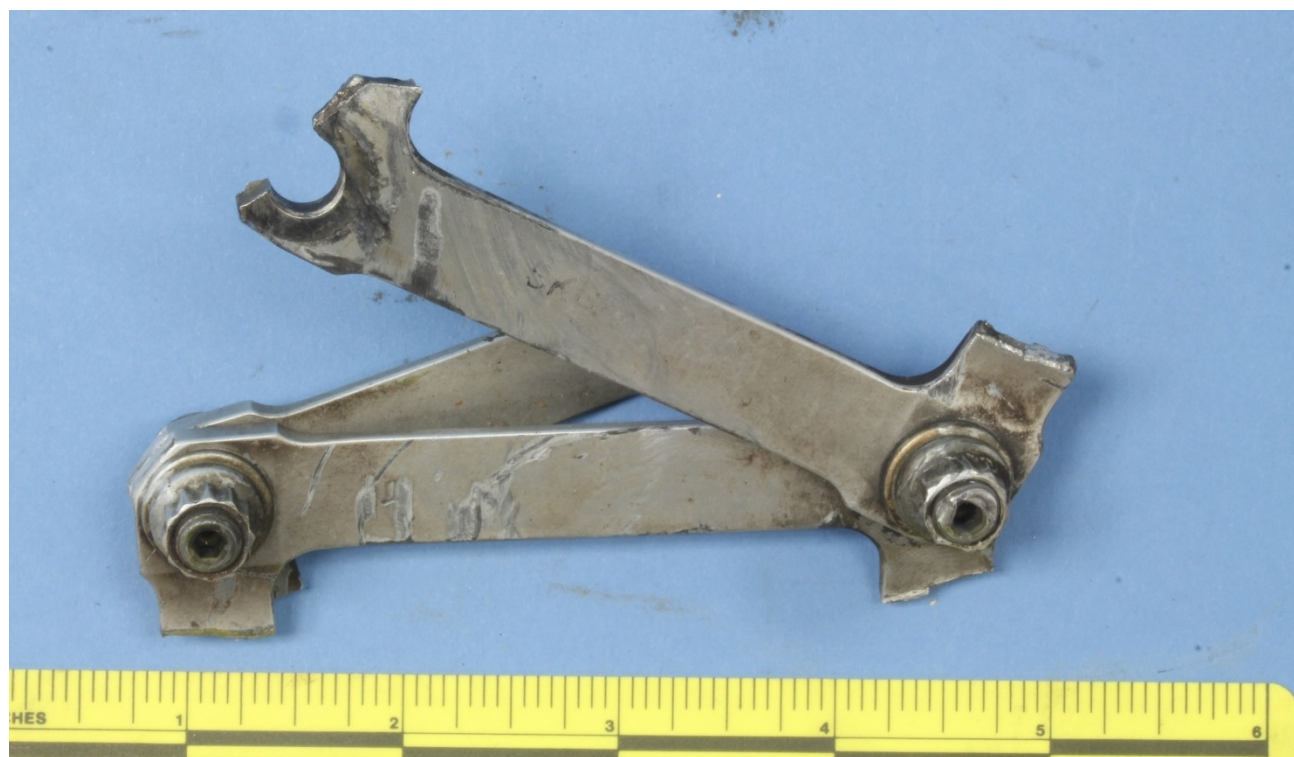
Figure 6 – The fractured flexure elements from Figure 5, viewed from the reverse side.

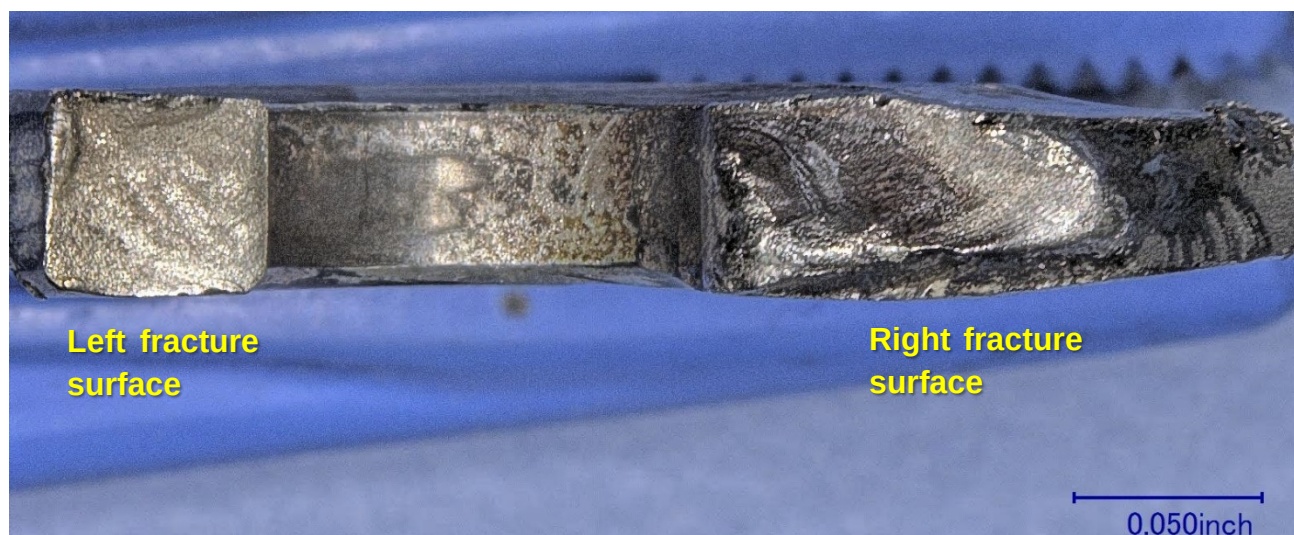
Figure 7 – The flat fracture surfaces of note from the flexure elements, after sectioning and cleaning.

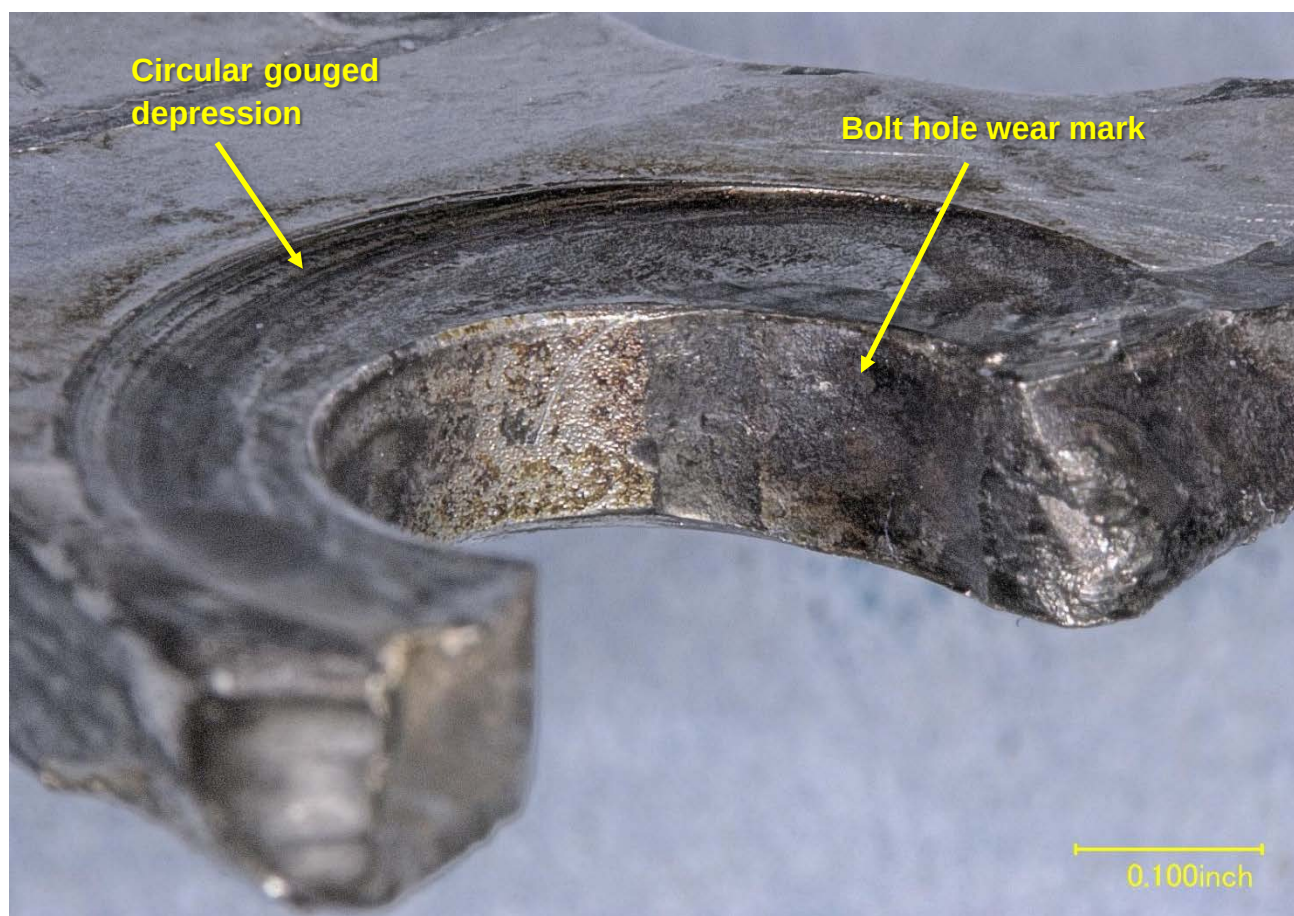
An angled view of the element at the fractured bolt hole is shown in Figure 8. The flat surface exhibited a smooth, circular-shaped depression. The inner surface of the bolt hole also exhibited wear on a portion of the wall (identified in Figure 8). This wear was significant enough to create material loss on the bolt hole wall (see Figure 9). The flexure element thickness was measured with calipers. The thickness of the unworn areas of the flexure element were 0.150 inches. The thickness of the element in the circular-shaped worn depression was 0.136 inches.

Figure 8 – The fracture surfaces of the flexure element in Figure 7, tilted at a 45° angle to show the gouged washer depression.

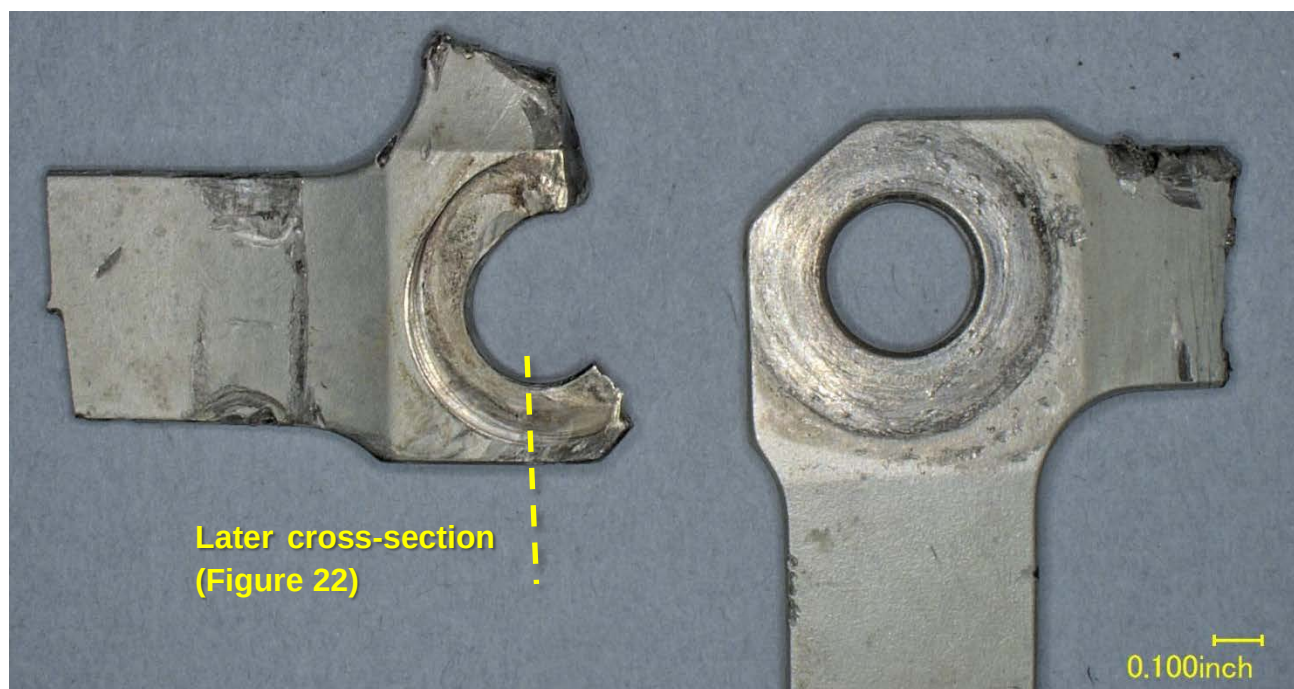
Several of the other flexure elements that were still fastened, as received, were disassembled to inspect for similar wear. The type wear leading to material loss was not observed about the other disassembled element bolt holes, as exemplified in Figure 9. The circular-shaped depression of the fractured flexure element was compared with a washer from a disassembled bolt. As shown in comparing Figure 10a and Figure 10b, the size and shape of the depression was consistent with the adjacent washers that had been installed. The peripheral wear marks in this depression shown in Figure 8 were consistent with rotational contact with an adjacent washer.

Figure 9 – The circular worn surface of the fractured flexure element (left), compared to an adjacent disassembled flexure element bolt hole, showing wear but no depression (right).

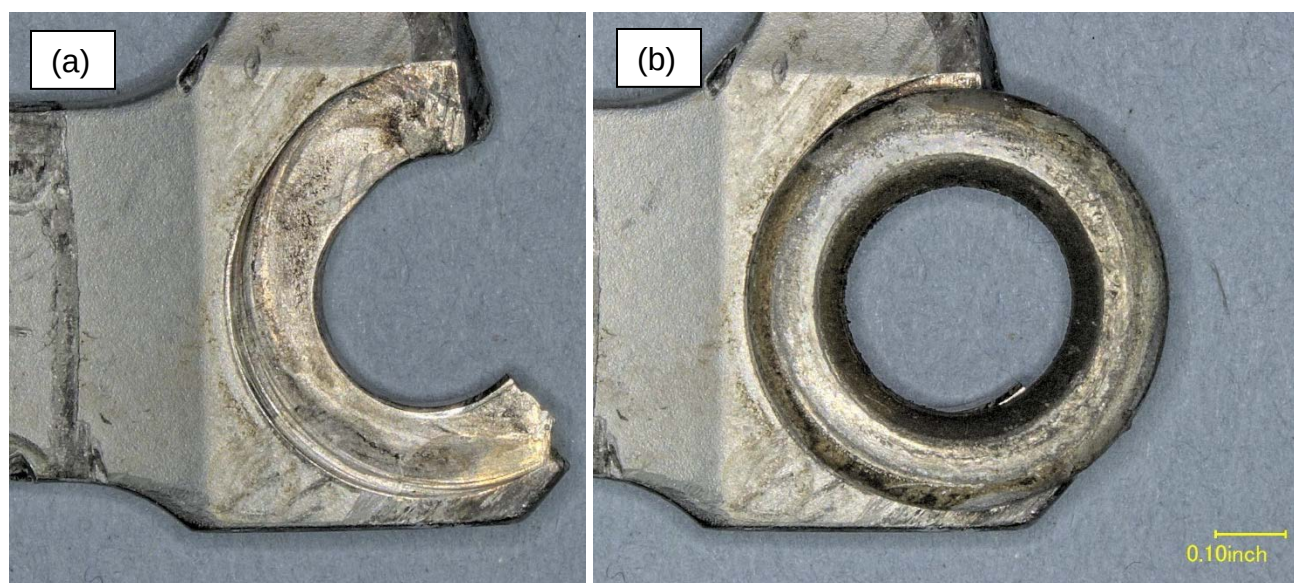
Figure 10 – The circular worn surface of the fractured flexure element (a) as fractured after cleaning and (b) with a washer placed in the circular depression.

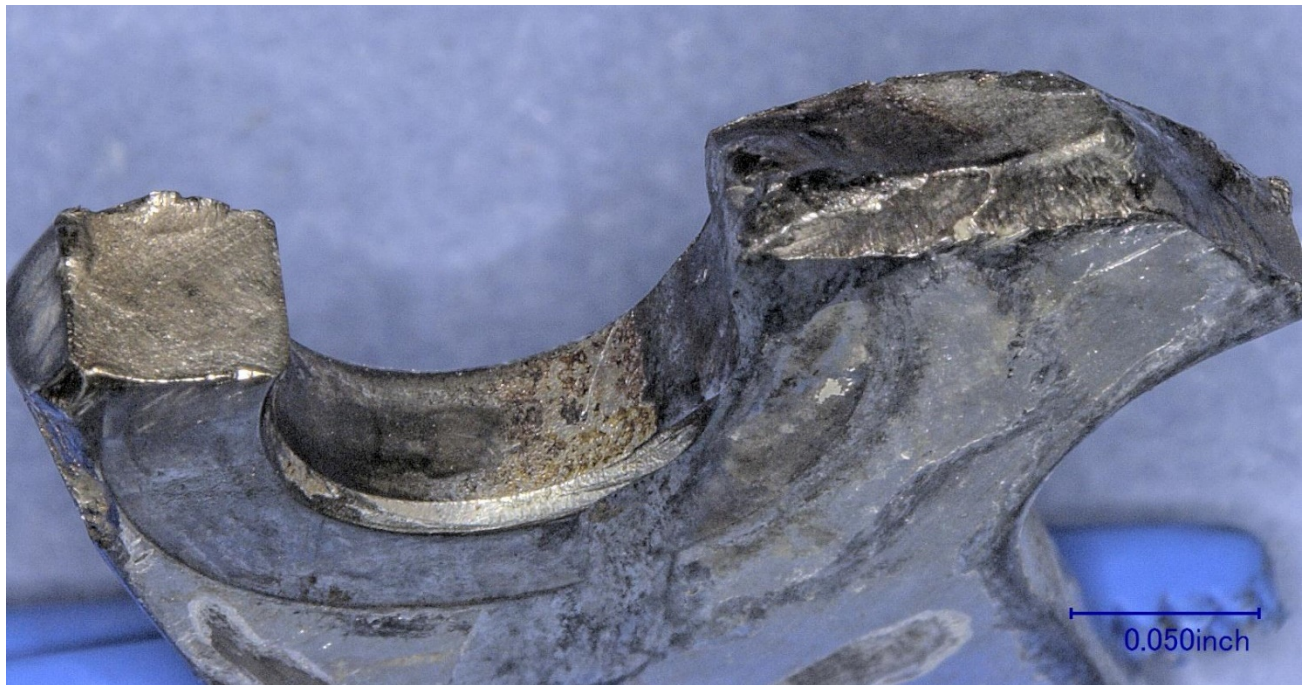
Figure 11 – An angle view of the flexure element fracture surfaces, viewed opposite Figure 8.

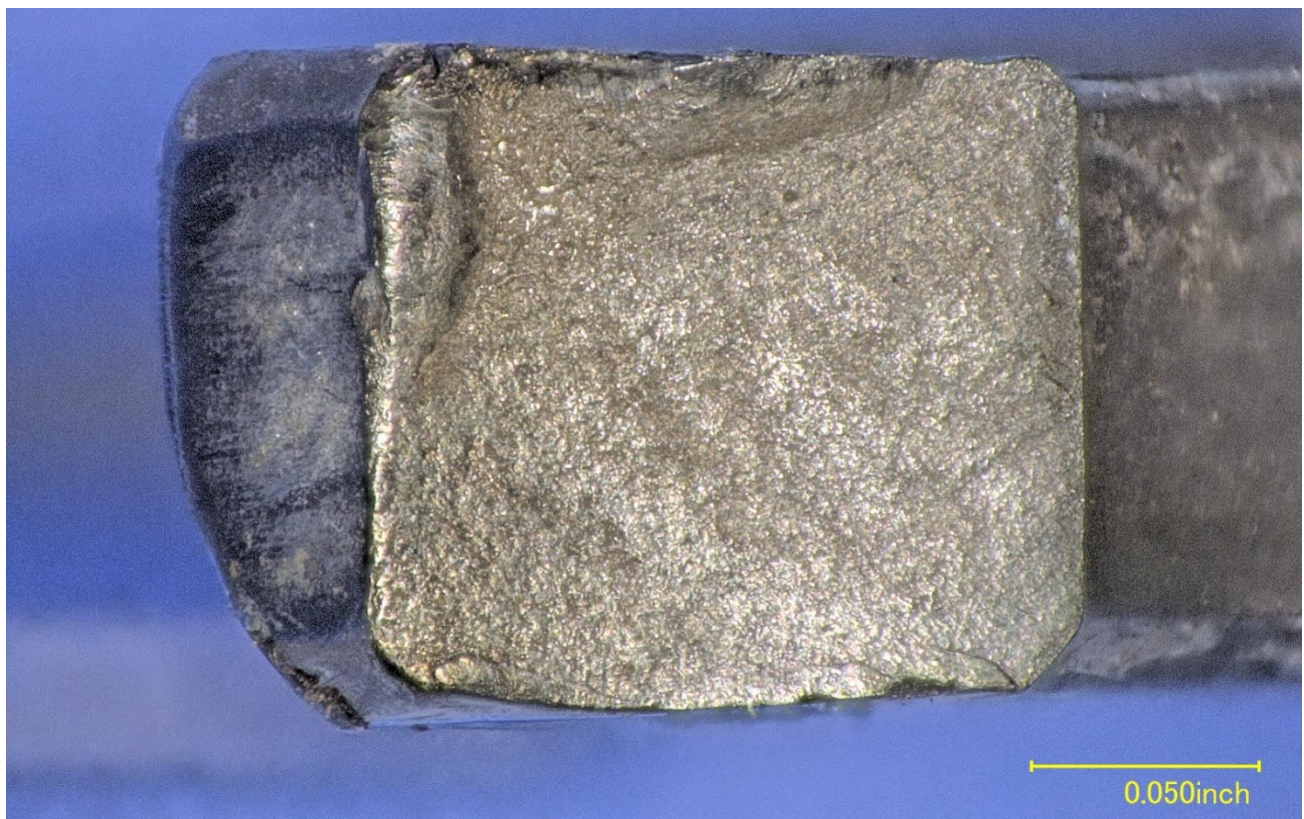
For the purposes of this report the flexure element fractures about the bolt hole were labeled “left” and “right” fracture, based on their orientation in Figure 11. The left fracture is shown in Figure 12 and is shown as examined using a scanning electron microscope (SEM) in Figure 13. The left fracture surface exhibited crack arrest marks consistent with progressive cracking from the lower portion of Figure 13 upward. A closer examination of this fracture surface found fatigue striations, consistent with fatigue fracture, as illustrated in Figure 14.

Figure 12 – A closer view of the left fracture surface in Figure 11.

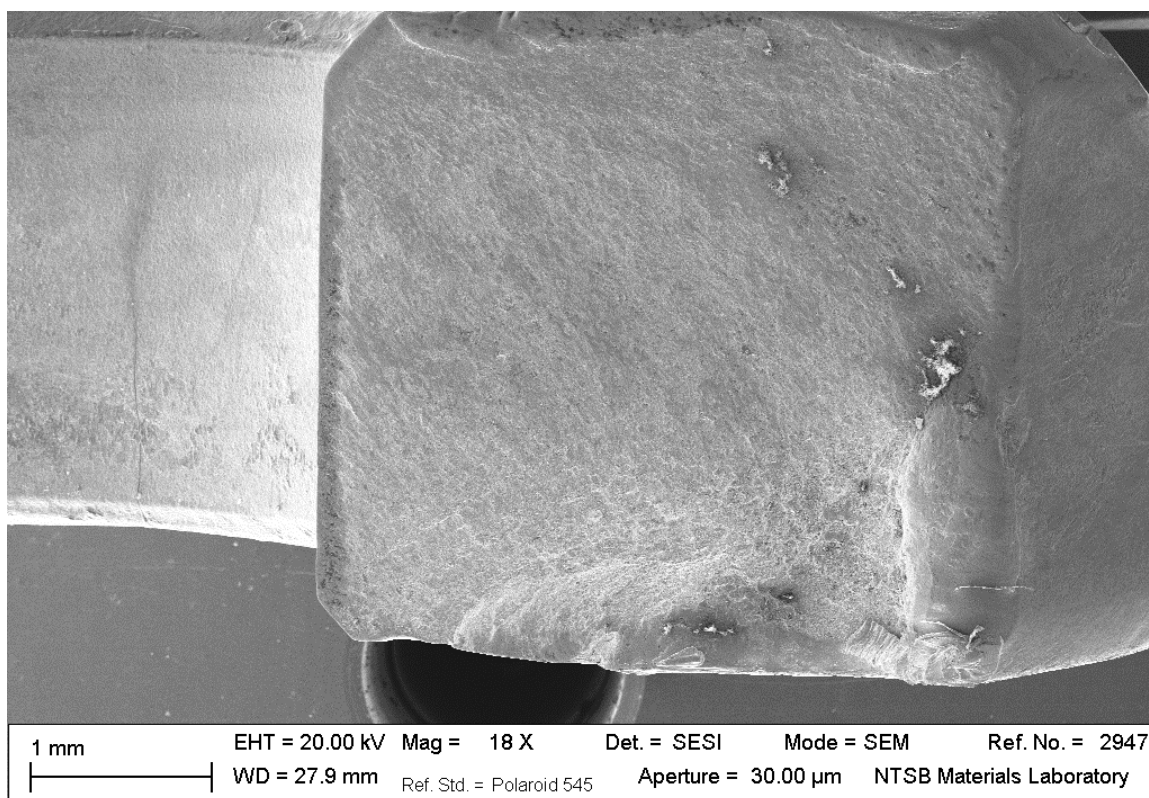
Figure 13 – Secondary electron (SE) micrograph of the left fracture surface.

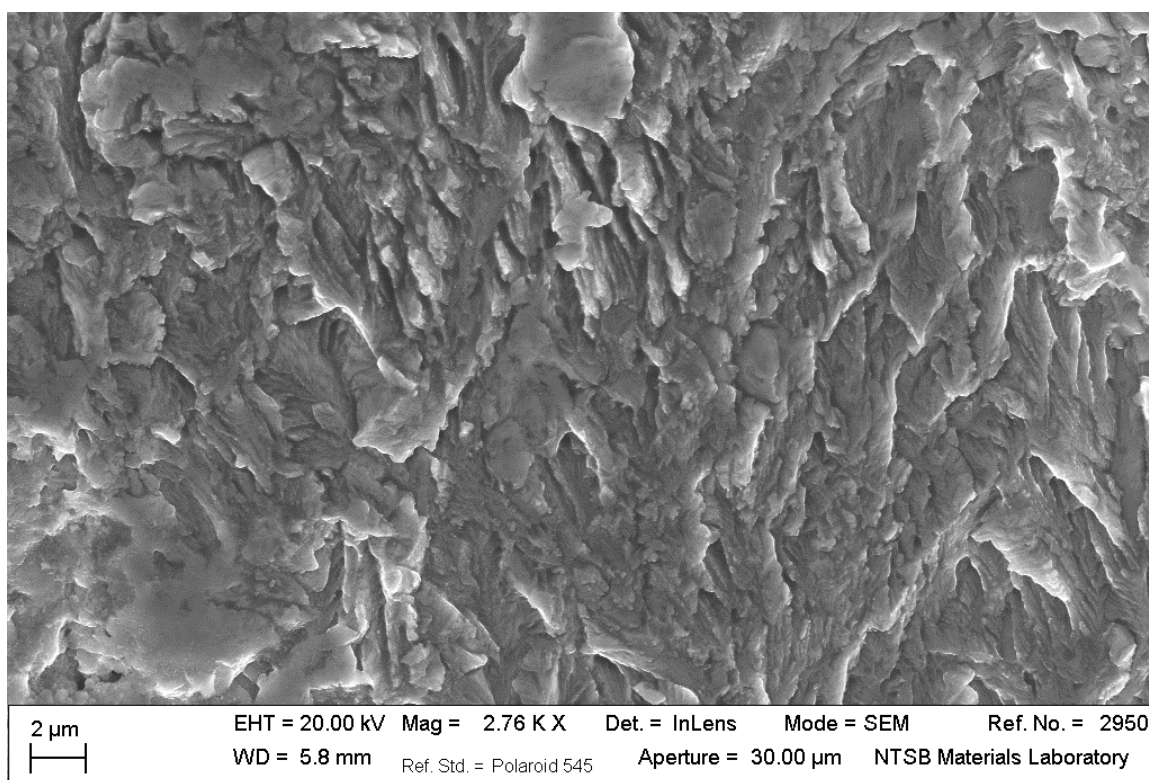
Figure 14 – SE micrograph of a typical area of the fracture surface in Figure 13, showing fatigue striations.

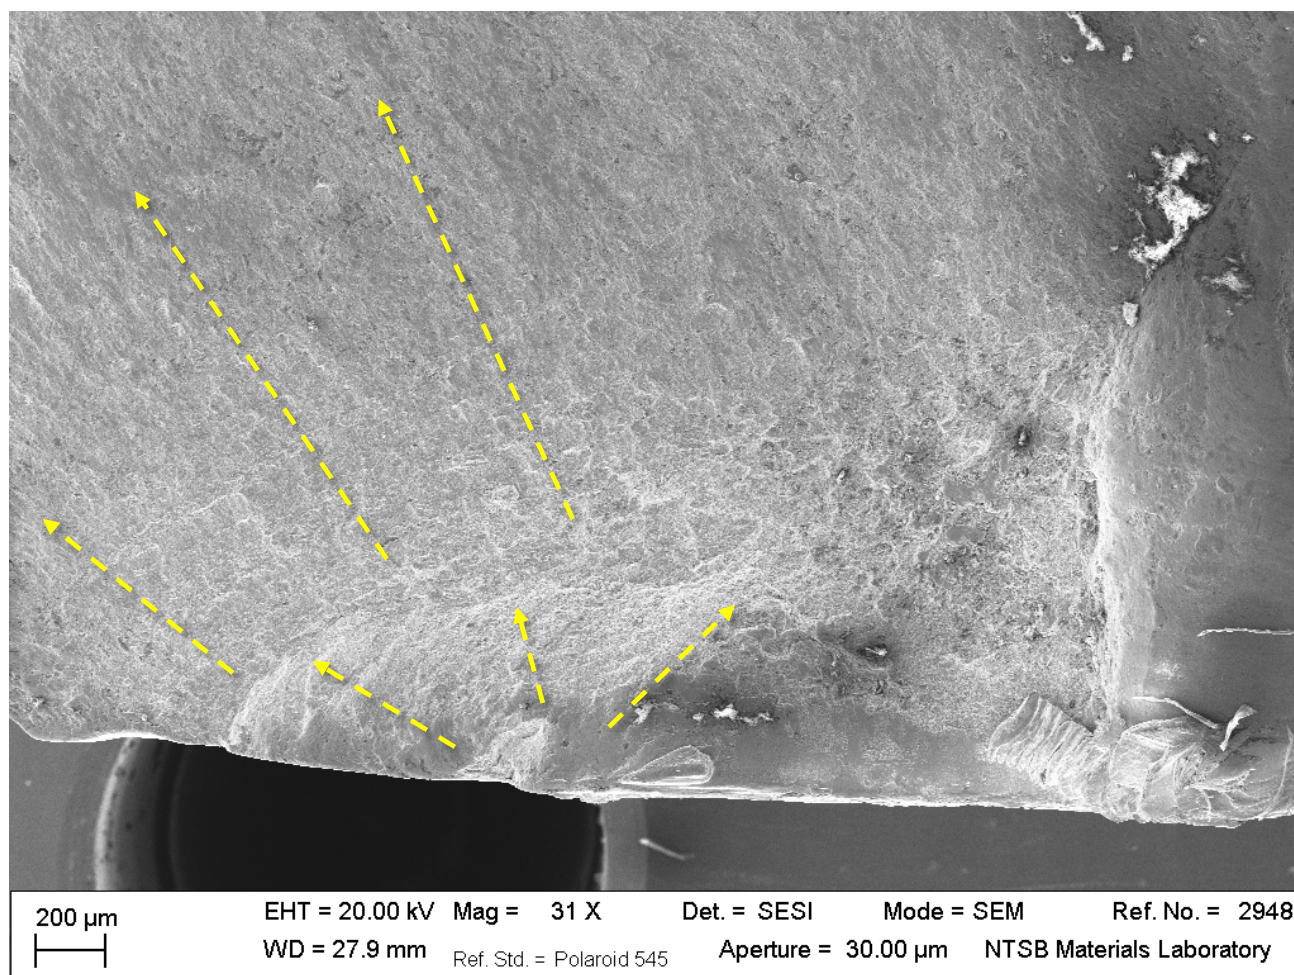
Figure 15 shows the general crack initiation site of the left fracture. The exact initiation site(s) could not be determined, due to post-fracture damage. However, as shown in Figure 16, the fatigue crack initiation site corresponded to the location of the washer-shaped depression. Plastically deformed material was also present at the fatigue crack initiation site on the left fracture.

Figure 15 – SE micrograph of the crack initiation site of the left element fracture surface. The arrows denote the general crack growth direction.

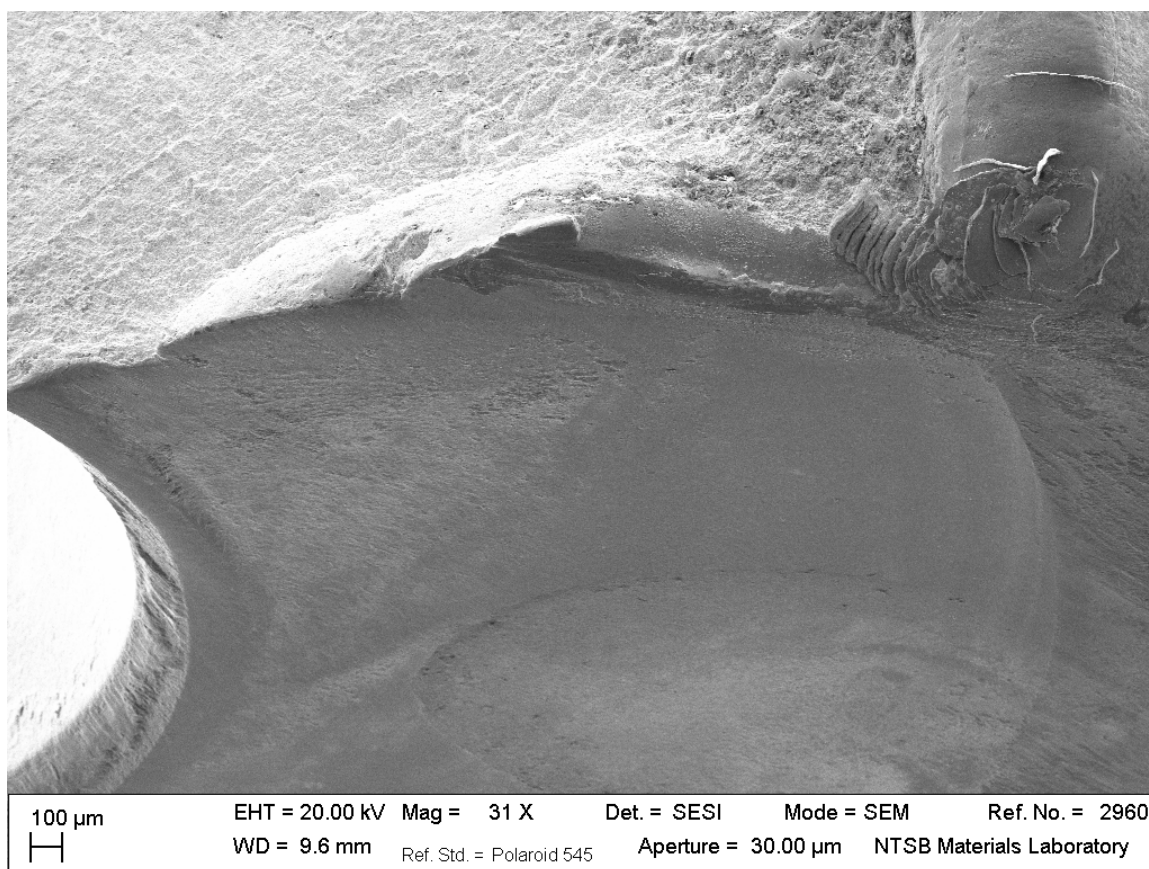
Figure 16 – SE micrograph of an angled view of the element fracture surface.

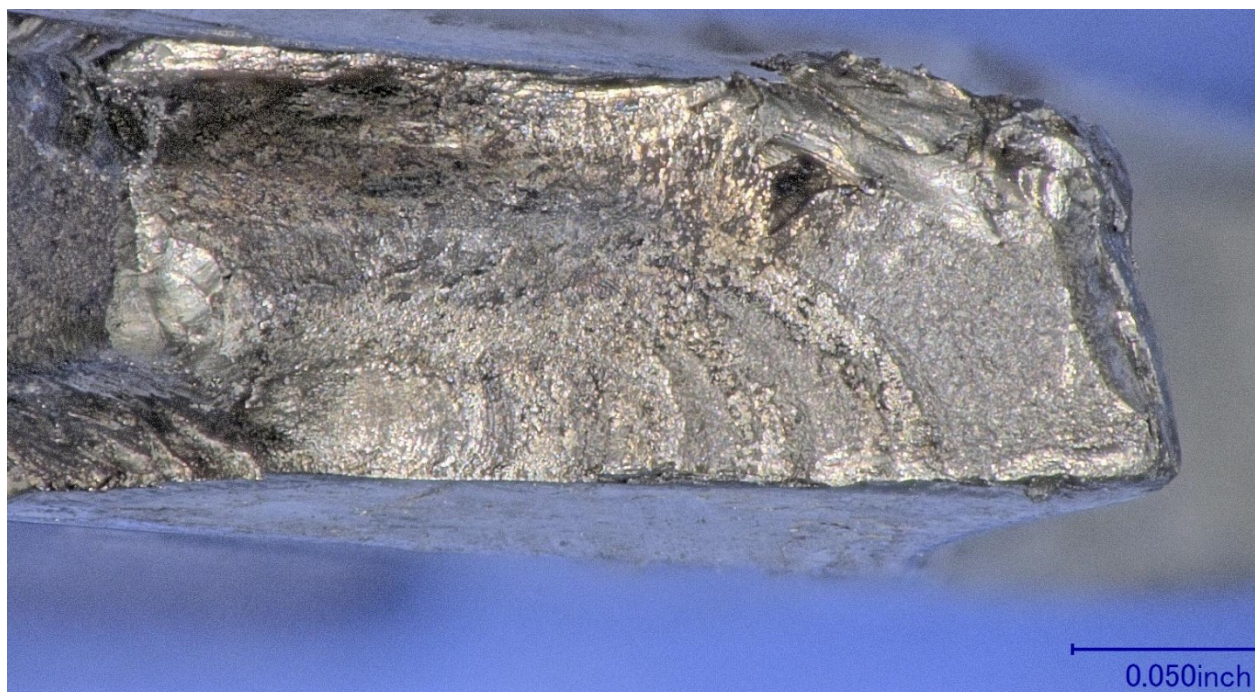
The right fracture is shown in Figure 17, and as observed in a SEM in Figure 18. While the right fracture surface was more damaged than the left, prominent crack arrest marks were present on this fracture surface. As with the left fracture surface, fatigue

Figure 17 – The right fracture surface of the fractured flexure element in Figure 11.

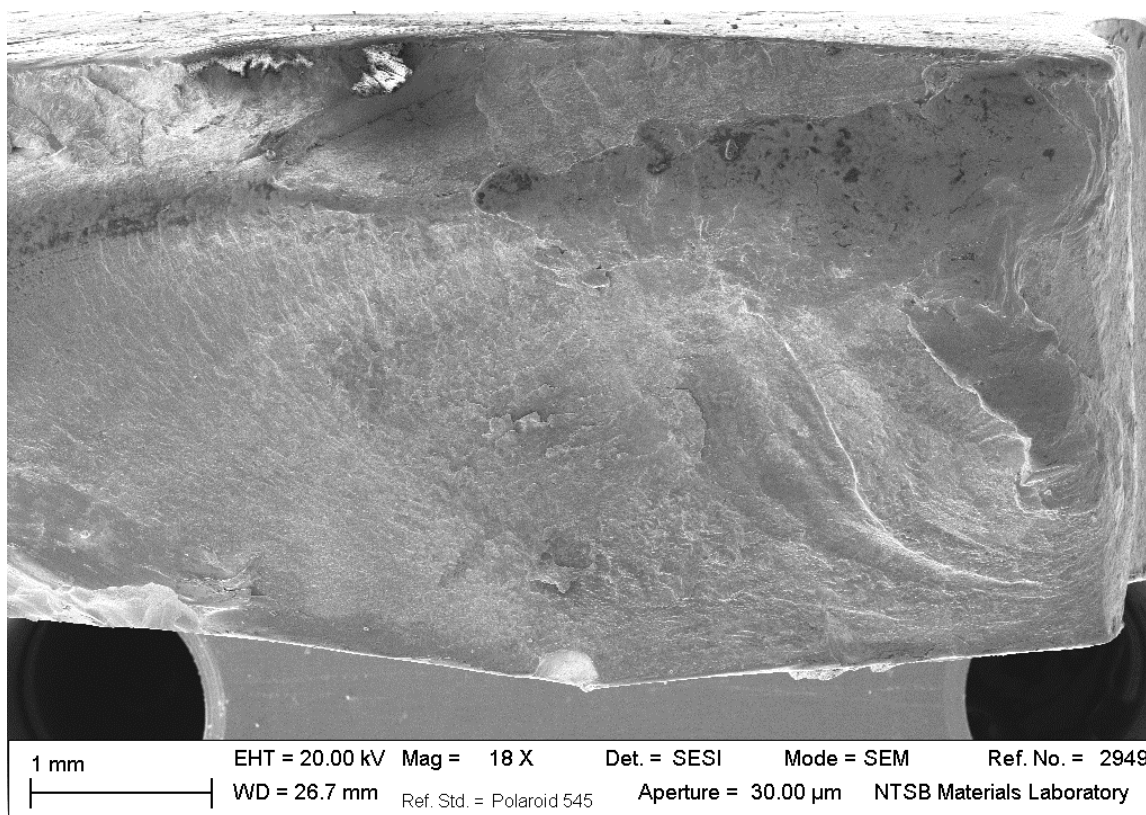
Figure 18 – SE micrograph of the element fracture surface in Figure 17.

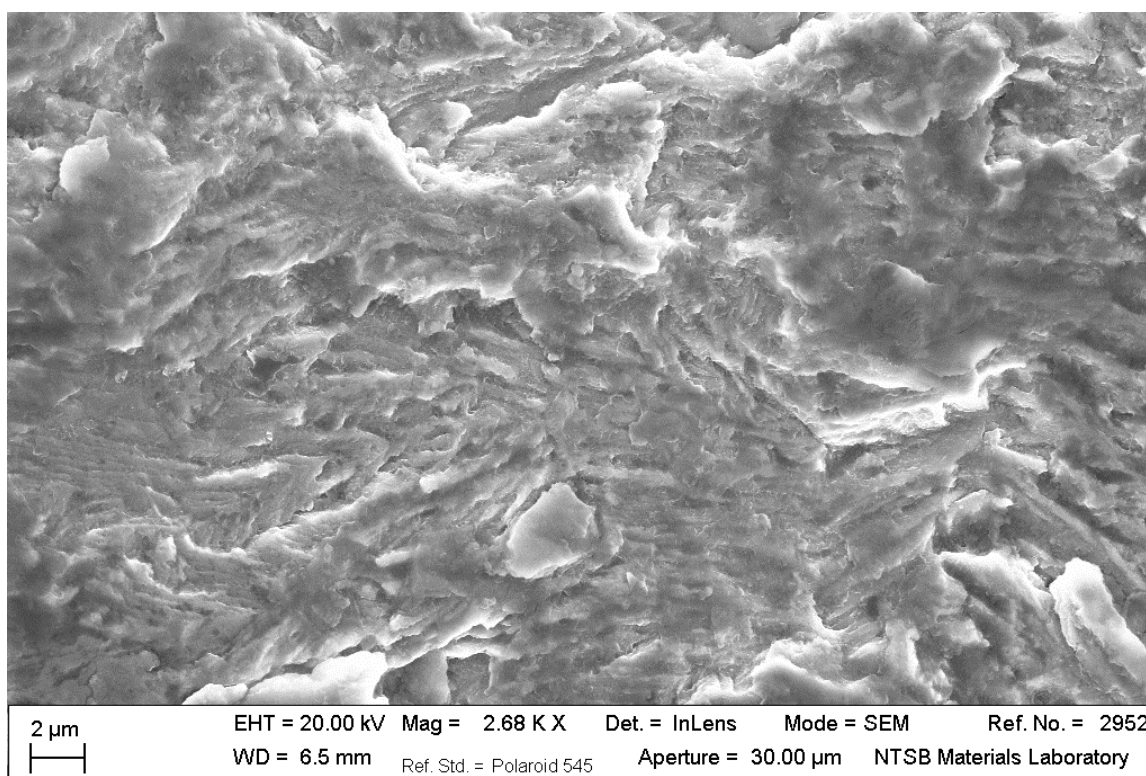
striations were prevalent over much of the right fracture surface (see Figure 19). Outside the fatigue crack regions, the rest of the undamaged right fracture surface exhibited dimple rupture, consistent with subsequent overstress fracture, as illustrated in Figure 20.

Figure 19 – SE micrograph of fatigue striations on the right fracture surface.

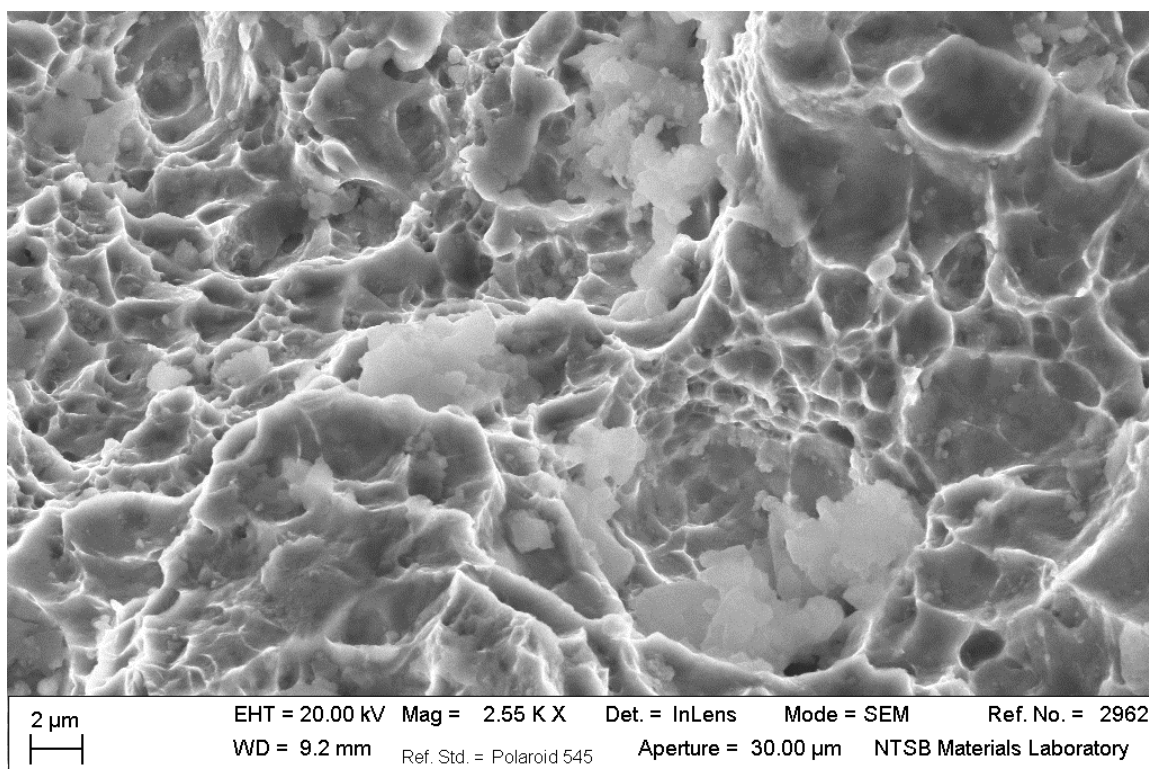
Figure 20 – SE micrograph showing dimple rupture outside of the fatigue regions on the right element fracture surface.

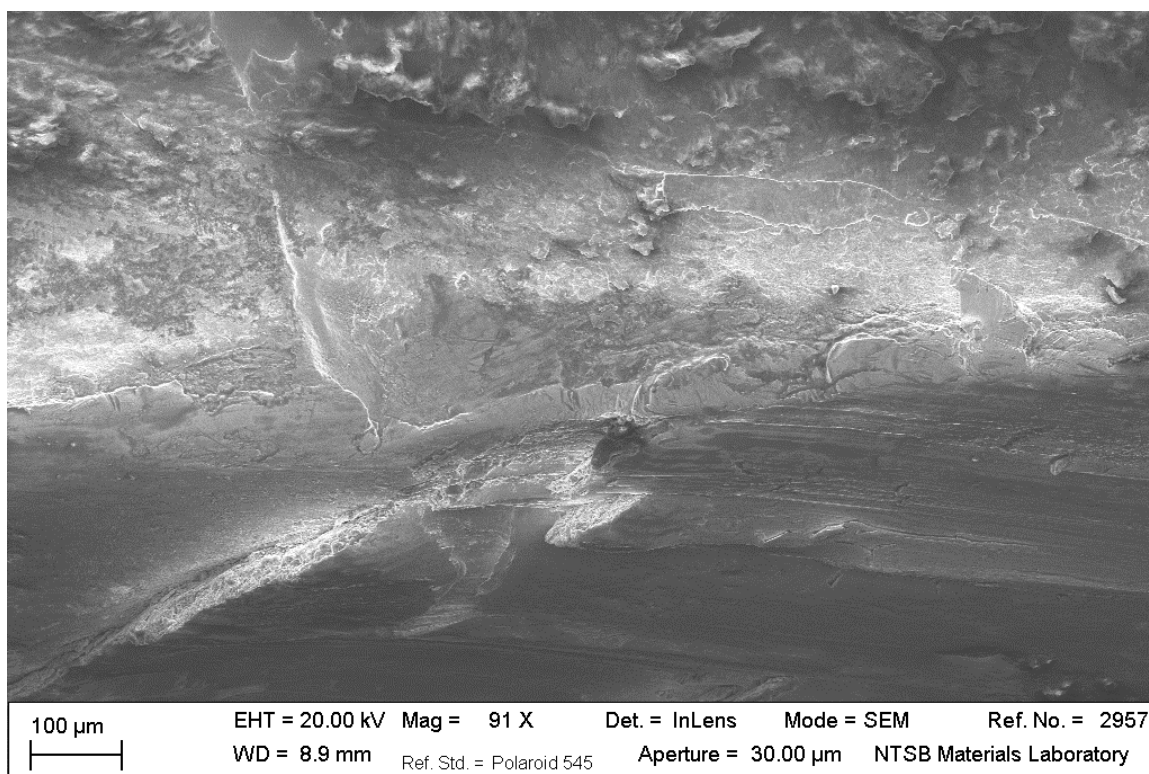
The fatigue crack initiation site of the right fracture was partially damaged. However, there were no indications that the initiation site contained any material discrepancies such as corrosion pits or oxide inclusions (Figure 21). The location of the right fatigue crack initiation site was at an area of local deformation, consistent with the edge of the washer-shaped depression.

Figure 21 – SE micrograph showing the fatigue crack initiation site of the right element fracture surface.
