# NATIONAL TRANSPORTATION SAFETY BOARD

## MATERIALS LABORATORY FACTUAL REPORT

Report No. 18-001

Place : Rockville, Idaho  
Date : May 26, 2017  
Vehicle : Bell 206B, N24FS  
NTSB No. : WPR17LA113  
Investigator : Joshua Cawthra, AS-WPR

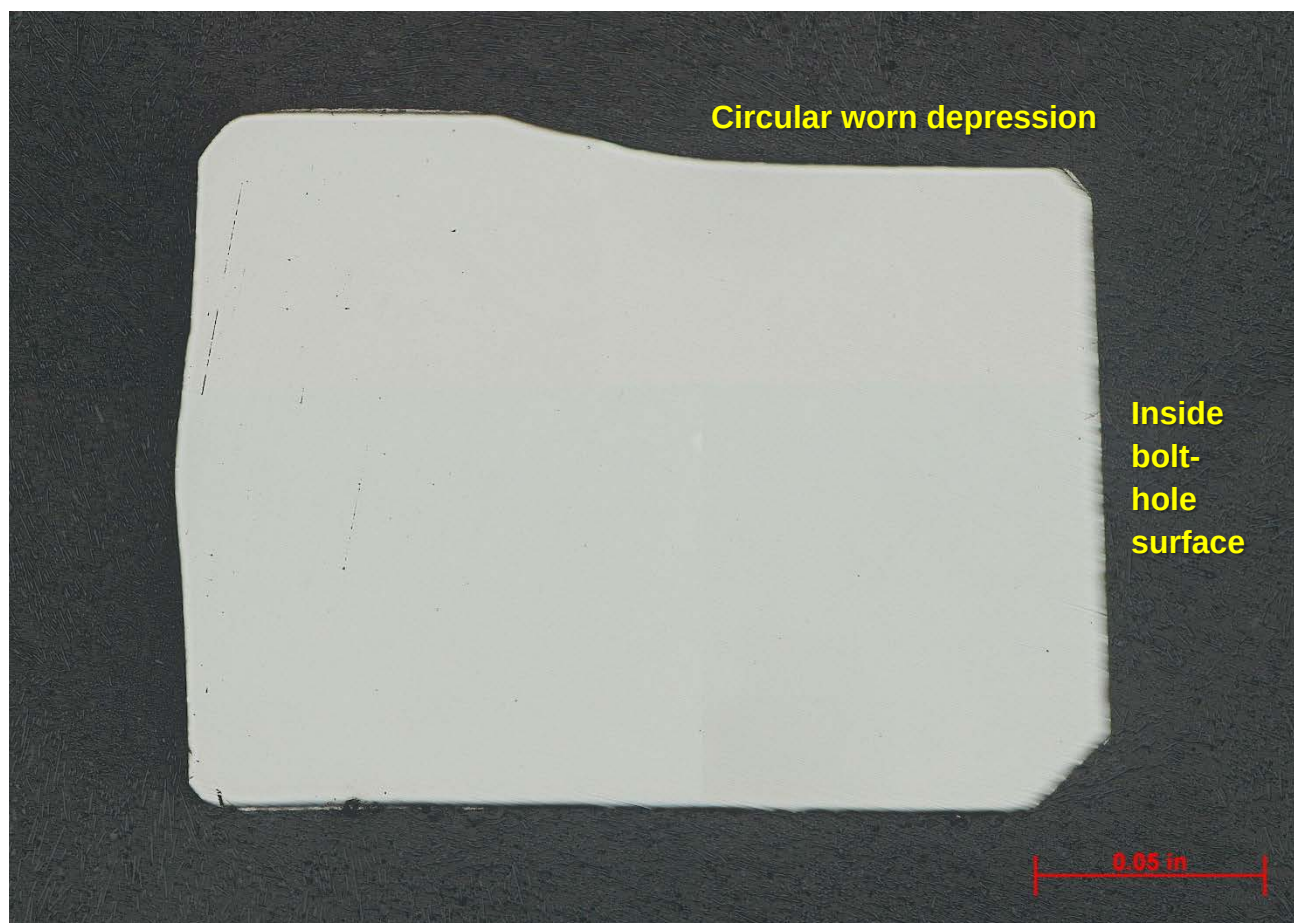
One of the walls of the flexure element that fractured at the bolt hole was sectioned, mounted and polished. The location of this cross-section is annotated in Figure 9. The polished cross-section is illustrated in Figure 22. As shown in the cross section, the circular-shaped depression was evident in the upper right side. The transition of the depression wear is highlighted in Figure 23. Of note in the depression was the lack of an outer coating, consistent with prolonged wear and material loss. When inspected using energy dispersive x-ray spectroscopy (EDS), the coating was found to be consistent with cadmium plating. Inspection of the inside bolt hole wall revealed several small cracks, up to 0.005 inches deep. One such crack is illustrated in Figure 24.

Figure 22 – Bright field (BF) optical micrograph of a cross-section of the side of the fractured flexure element bolt hole (location shown in Figure 9) (as-polished, ~25X).

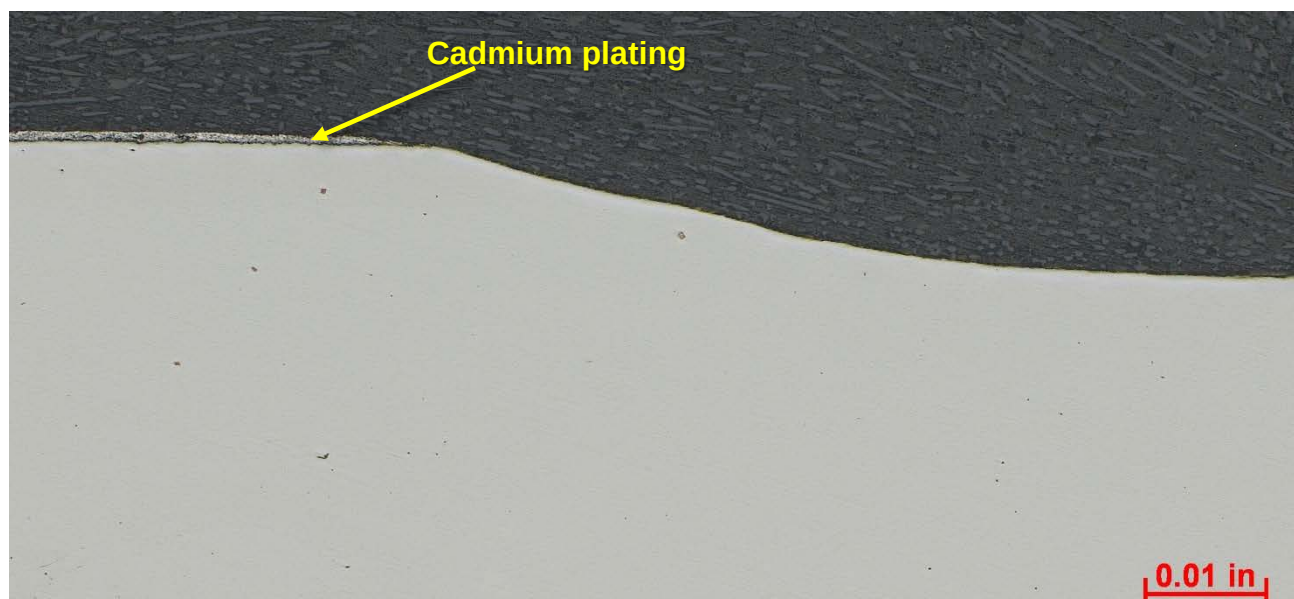
Figure 23 – BF optical micrograph showing the worn surface of the circular-shaped worn depression (right side) from the upper surface of Figure 22 (as-polished, ~50X).

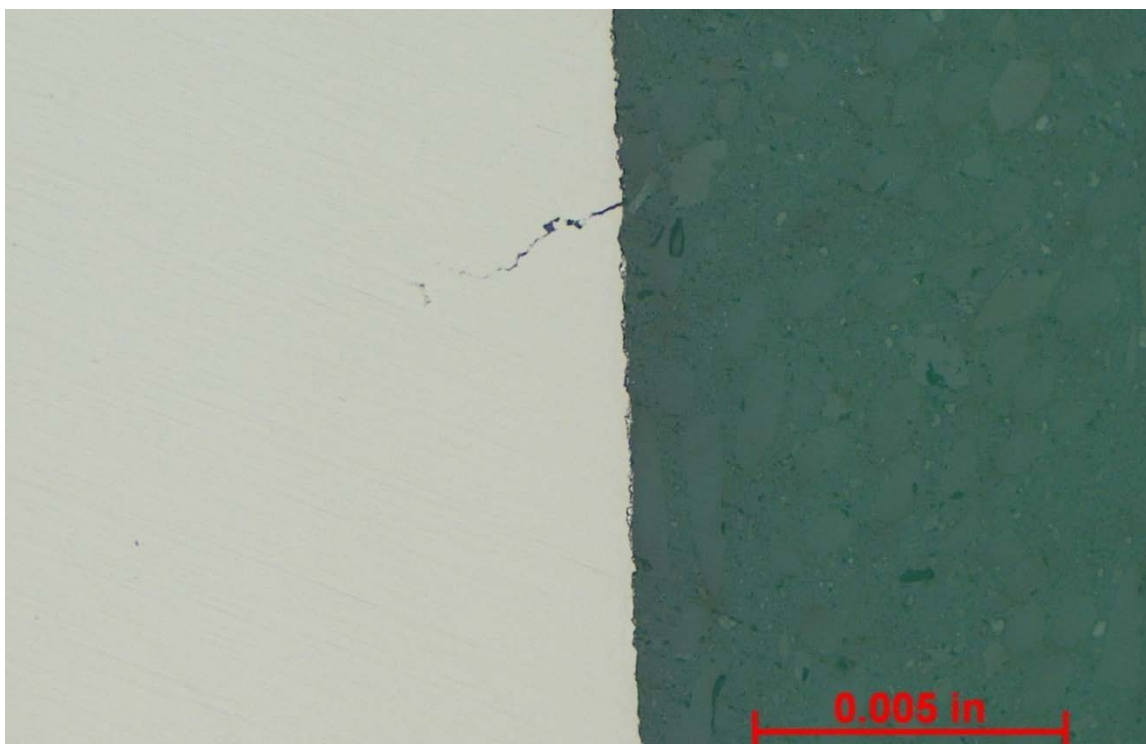
Figure 24 – BF optical micrograph showing the inside bolt hole surface of the flexure element, showing a small crack (as-polished, ~200X).

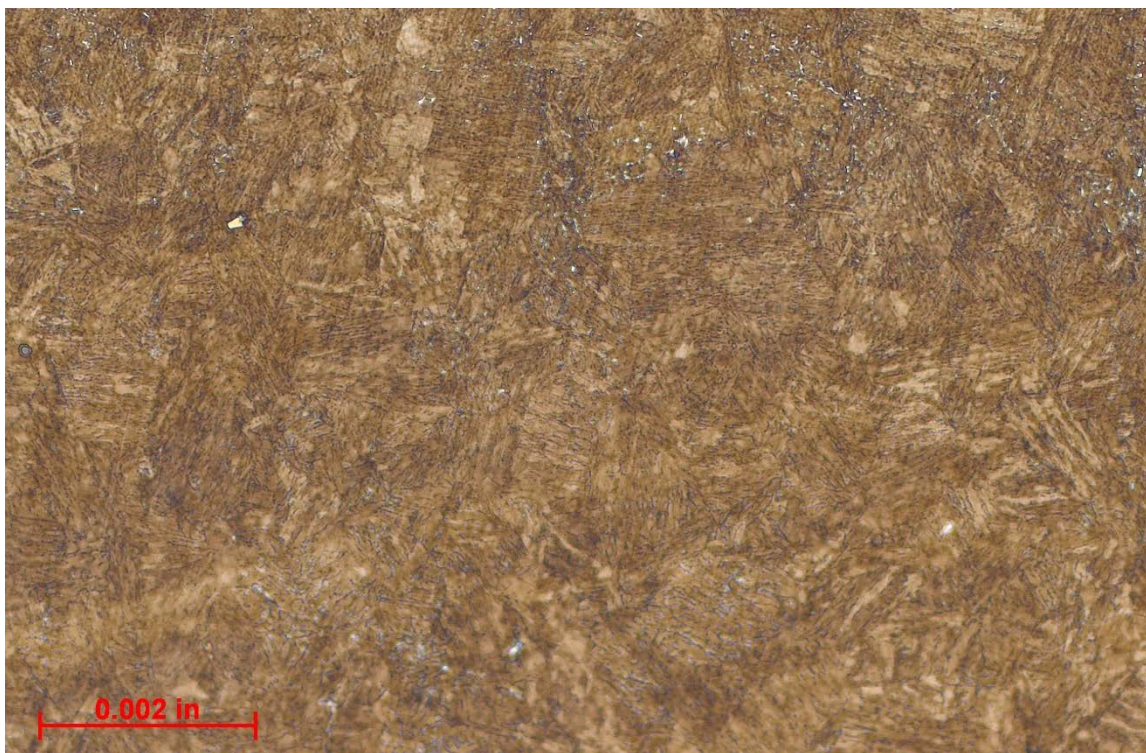
The chemical composition of the fractured element was inspected using EDS and x-ray fluorescence (XRF). The chemical composition was found to be consistent with a maraging steel.<sup>2</sup> The microstructure of the flexure element is shown in Figure 25. The microstructure exhibited martensite and second-phase intermetallic precipitates, consistent with typical constituents in microstructures for this chemical composition. The hardness was inspected per ASTM E18.<sup>3</sup> The hardness averaged 51 HRC, which was consistent with values typical of maraging steels.

Figure 25 – BF optical micrograph of a typical area of the flexure microstructure, exhibiting martensite laths and intermetallic precipitate phases (~500X, etched 2% Nital).
