## **Engine Investigation Report**

**Rolls-Royce Corporation  
Model 250-C20B**

**Pauley's Helicopter Services, Inc.  
Jordan Valley, Oregon**

**Accident date: 26 May 2017  
Investigation date: 29 June 2017  
Engine exam date: 4 October 2017  
Report date: 16 February 2018**

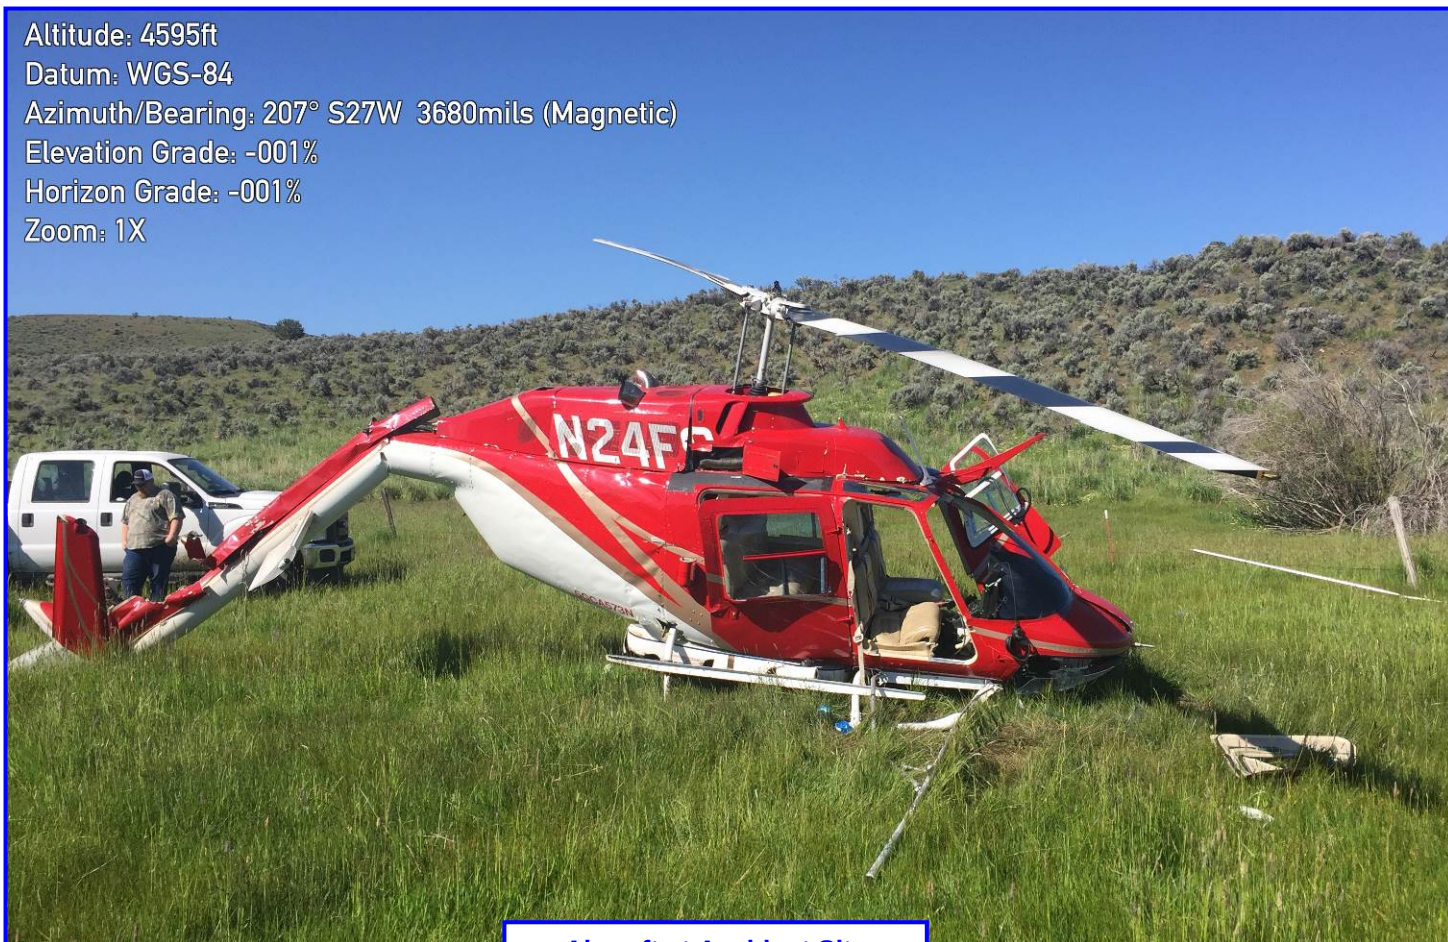
**Aircraft at Accident Site**

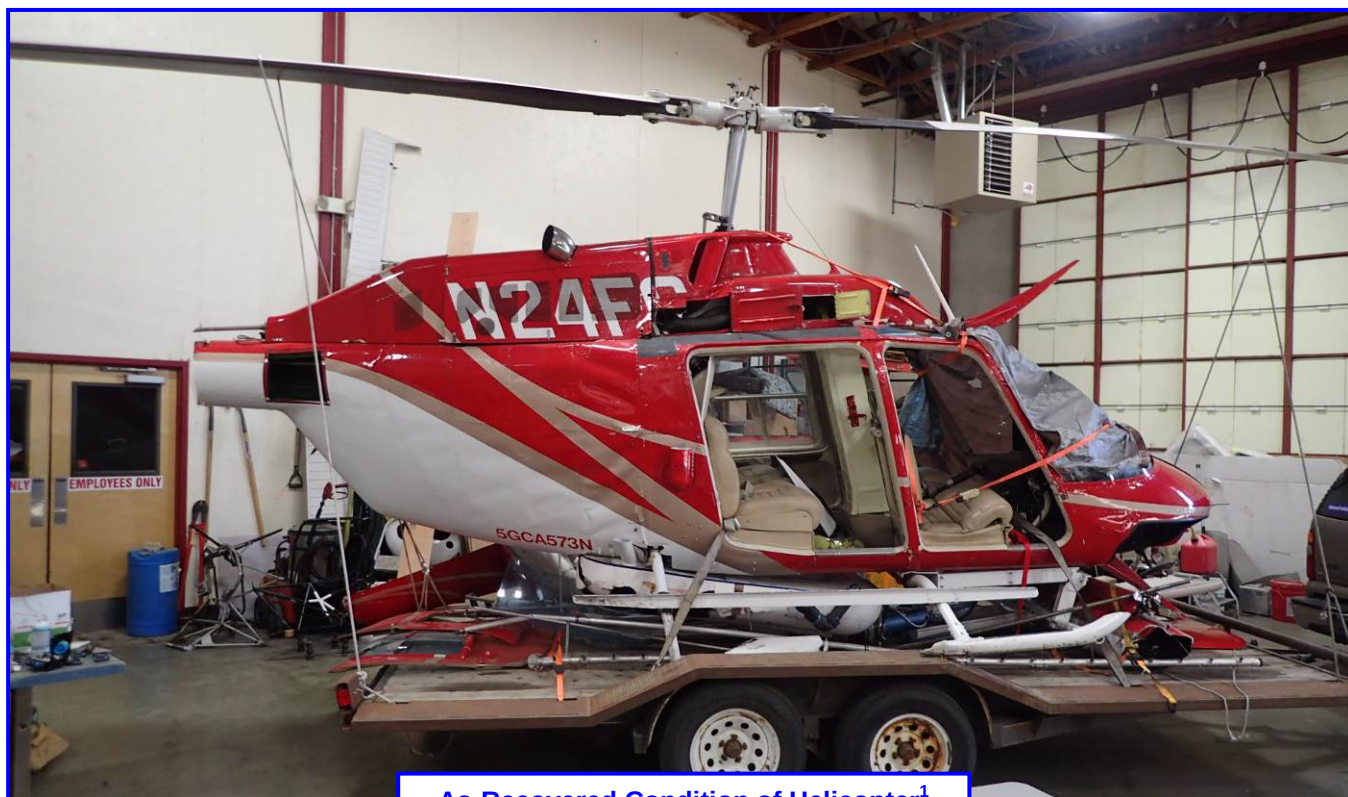
As-Recovered Condition of Helicopter<sup>1</sup>

The aircraft exhibited damage consistent with impacting level terrain and nearly vertical forces. The right hand skid had fractured aft of the front cross-tube connection and completely separated from the aft cross-tube. The right front strut was splayed outward. The fuselage structure contained several locations of buckling damage, wrinkled skin, and broken Plexiglas. The belly-mounted chemical tank sustained vertical crush damage.

The main rotor mast was tilted forward from its original position and the forward end of the main rotor transmission had partially collapsed the forward cabin ceiling structure. The main rotor blades were still attached to the blade grips and appeared undamaged. The tail boom sustained buckling damage approximately 12-inches aft of the fuselage attachment point and 10-inches forward of the tail rotor output drive shaft.

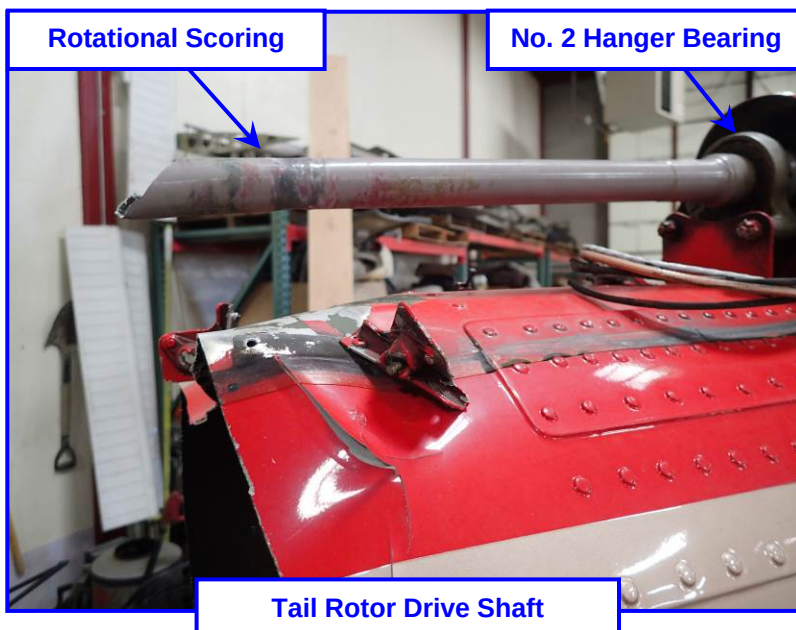
Rotational Scoring

No. 2 Hanger Bearing

Tail Rotor Drive Shaft

The tail rotor drive shaft sustained a total of 3 fractures along its length with evidence of torsional breakage and rotational scoring.

A mid-span section of drive shaft had liberated from its hanger bearing allowing leading to significant rotational whipping damage to the tail boom and drive shaft sheet metal cover adjacent to the horizontal stabilizer.

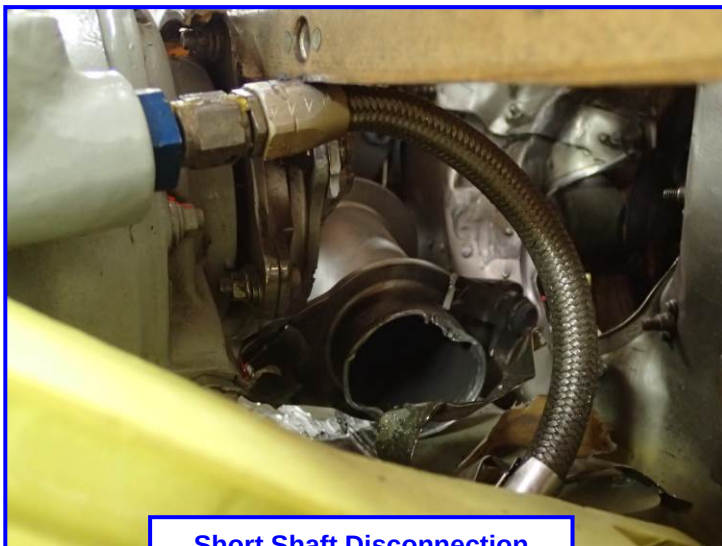
The engine to transmission drive shaft (short shaft) had separated by fracture at the KAflex® coupling frames forward of the freewheeling unit and at the main rotor transmission connection.

Short Shaft Disconnection

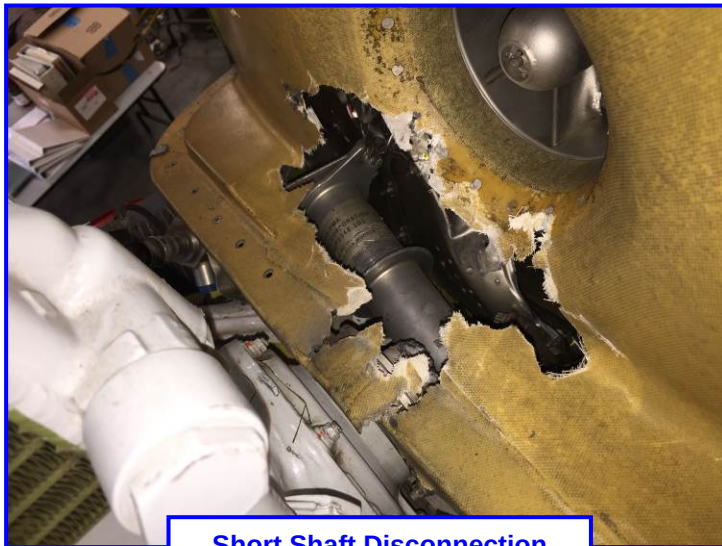
Short Shaft Disconnection

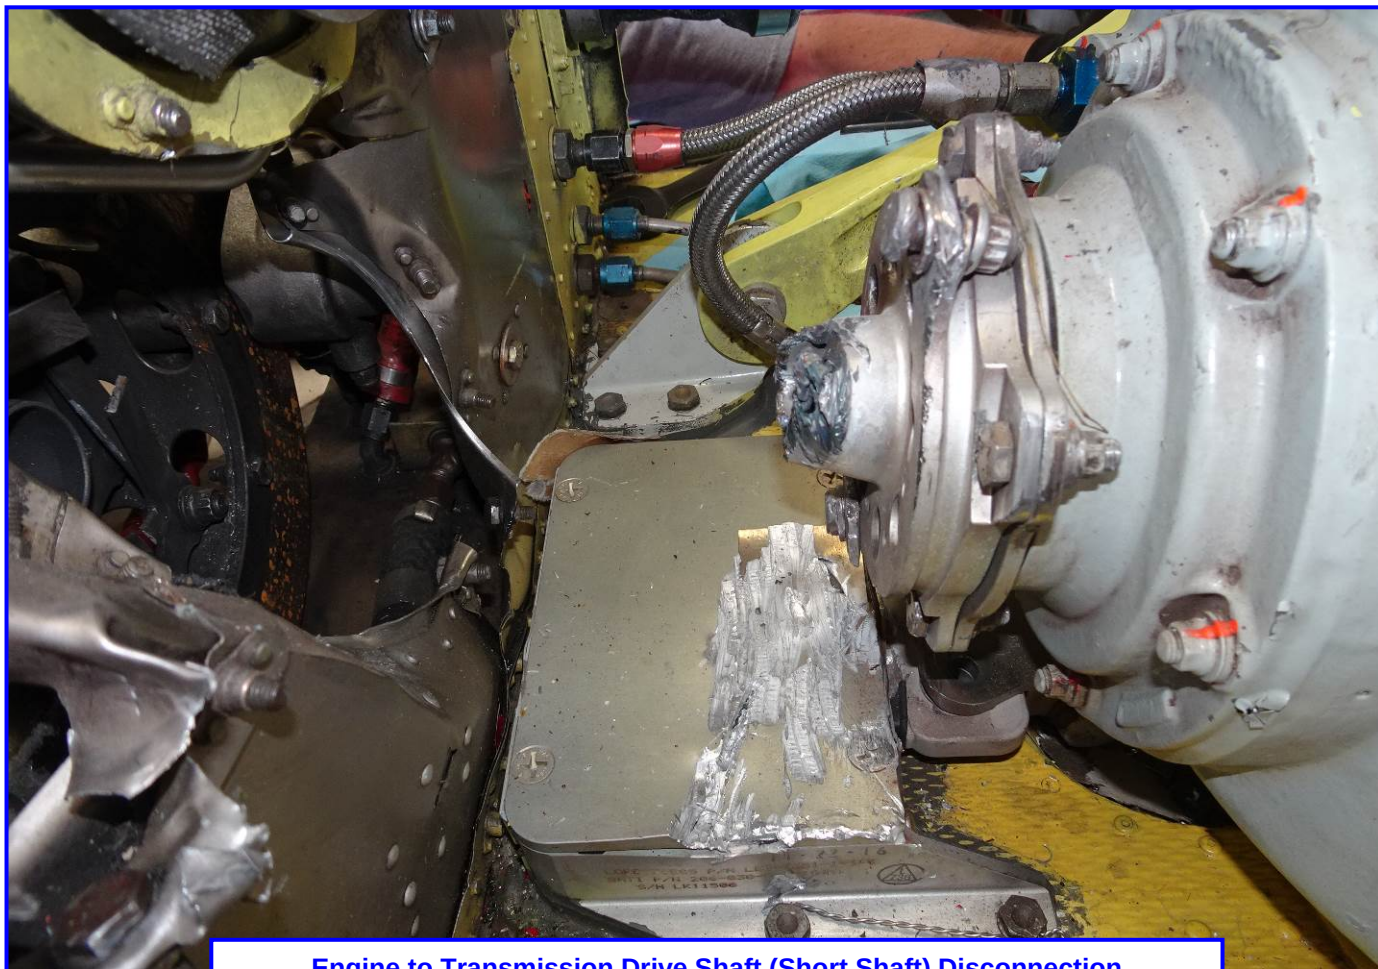
Engine to Transmission Drive Shaft (Short Shaft) Disconnection

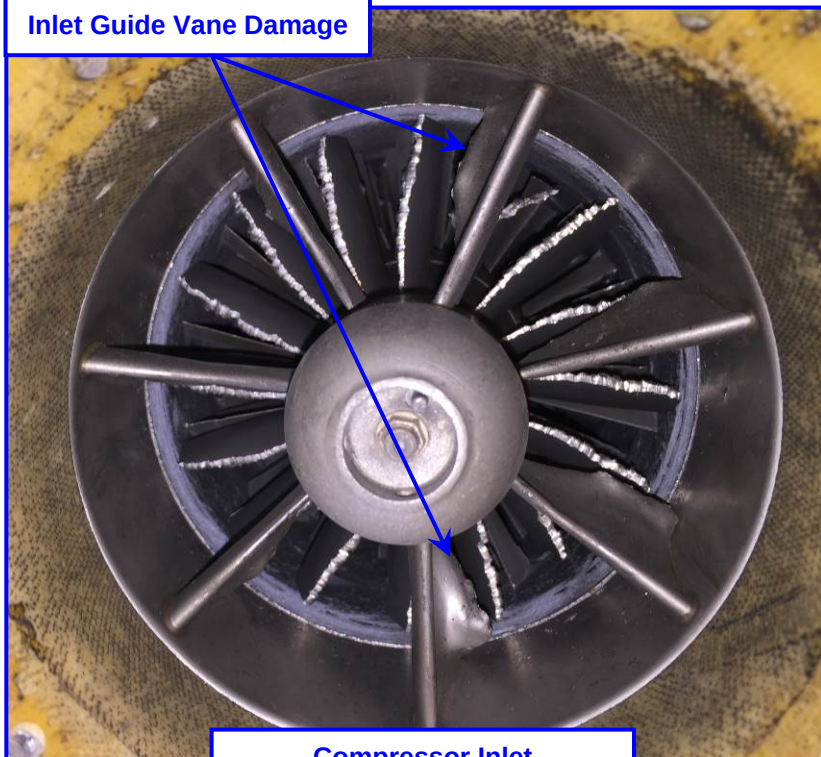
The compressor inlet was accessed exhibiting extensive evidence of damage to the inlet guide vanes and 1<sup>st</sup> stage blades. A borescope was used to examine further into the compressor rotor. Additional damage was noted to at least stage 3.

Inlet Guide Vane Damage

Compressor Inlet

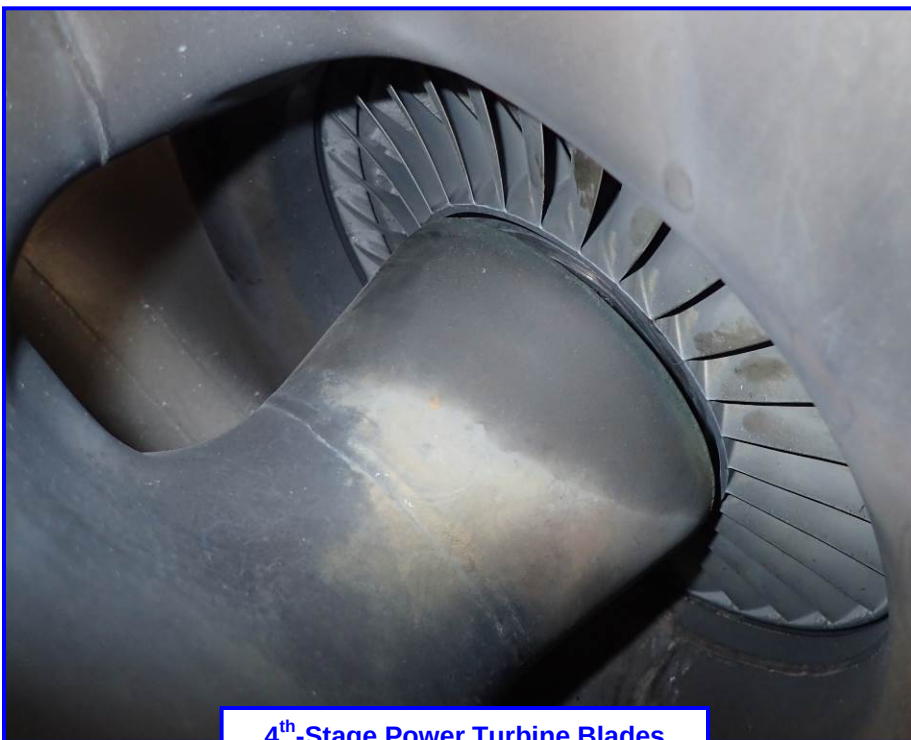
Continuity was confirmed throughout the N1 rotor system from the compressor rotor to the starter-generator cooling fan. The 4th-stage turbine blades appeared undamaged as did the surrounding turbine sections and exhaust plenum.

4<sup>th</sup>-Stage Power Turbine Blades

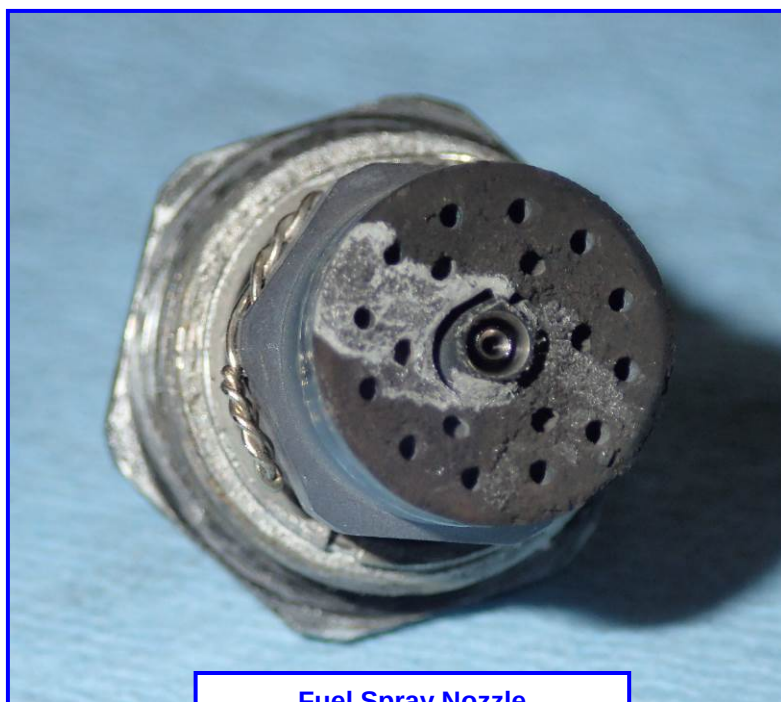
Fuel Spray Nozzle

The fuel spray nozzle was removed and examined. The spray face exhibited a heavy carbon and soot appearance. There did not appear to be any blockage within the air distribution holes. The nozzle was not disassembled further.

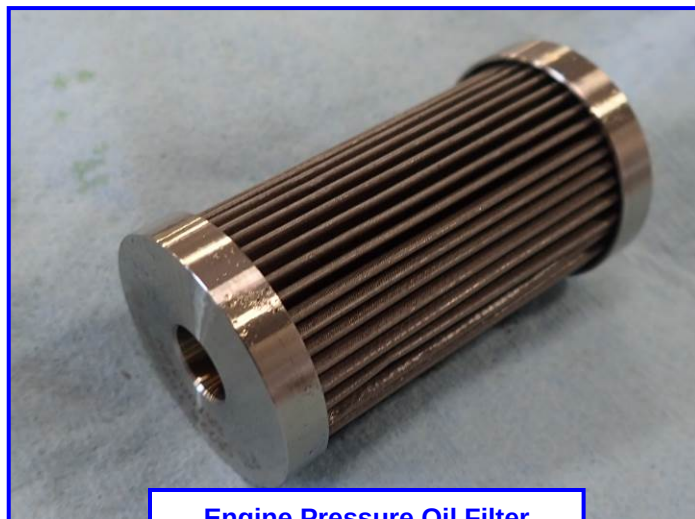
Engine Pressure Oil Filter

The aircraft was equipped with an airframe mounted external engine oil scavenge filter and was found to be free of contamination or ferrous metal. The engine pressure oil filter was removed and inspected clean of ferrous metal, foreign debris, or similar contamination. The oil reservoir registered full on the dipstick, and contained clean, bright oil with no suspended debris. Oil was present in the inlet and outlet lines to the engine accessory gearbox.

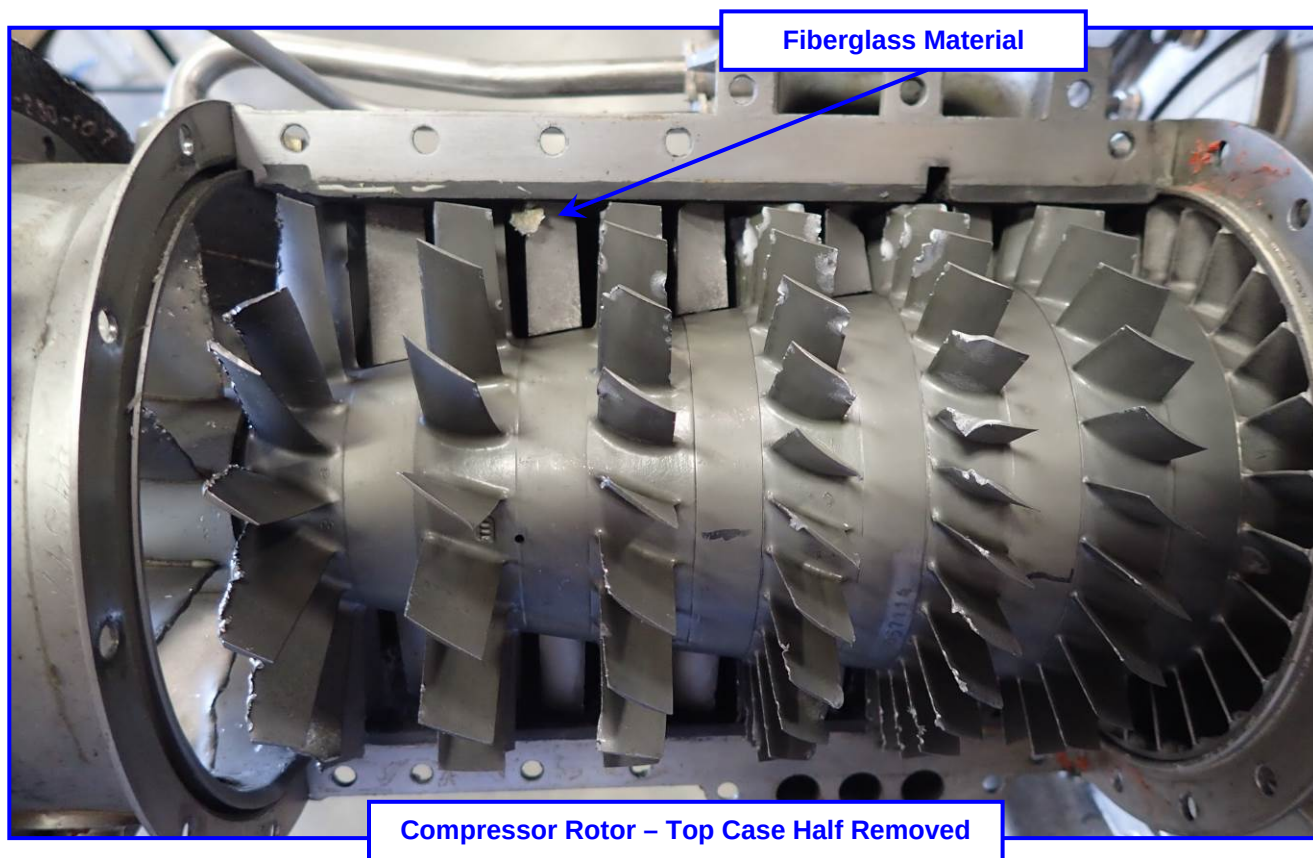
Compressor blade damage was noted back thru stage 6. The majority of the damage appeared sharp and jagged with varying amounts of missing material and curl blade tips. Numerous areas of blade damage displayed material deformation in the direction opposite engine rotation. The 1<sup>st</sup>-stage blades were heavily damaged with nearly all blades exhibiting missing material presenting a tapered profile from the base to the tip of each blade. Several of the 1<sup>st</sup>-stage blades contained span-wise twisting and bending.

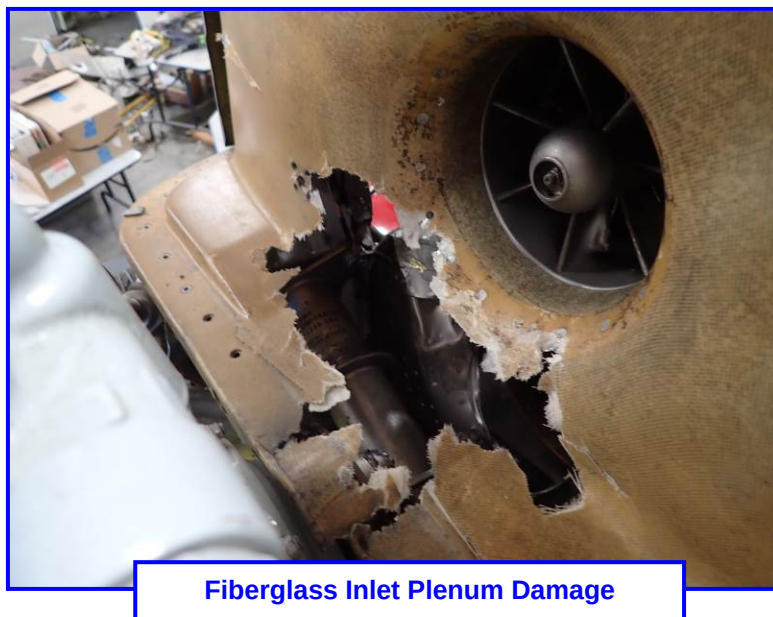
A few pieces of fiberglass material were detected between the 2<sup>nd</sup>-stage blades and vanes. These pieces appear to have come from the fiberglass inlet plenum structure.

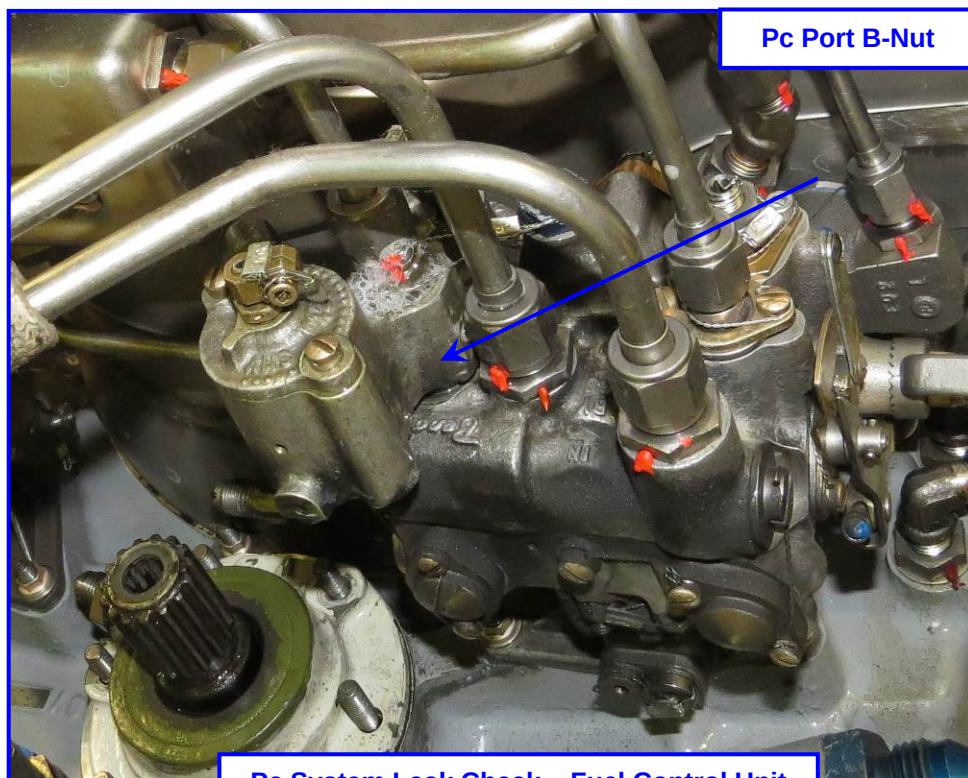
Prior to disassembly for compressor swap, the Pc system was leak checked. Bubbling was detected at the B-nut connection with the Pc port on the fuel control unit.

All of the fuel control and power turbine governor b-nut connections were stripped with torque paint including the subject location. The Pc port B-nut at the FCU was at least wrench tight and could not be loosened with finger pressure.

Pc System Leak Check – Fuel Control Unit

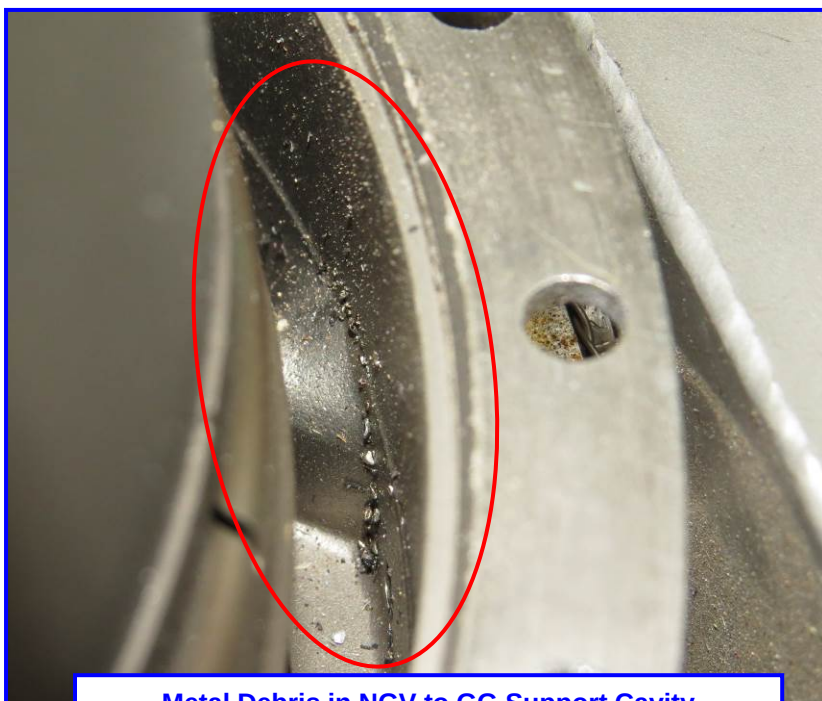
Small amounts of metal debris flakes were noted in the cavity between the OD of the NGV and GG support at the 6:00 position. It was concluded that the most likely source of the debris was from the compressor rotor damage.

Metal Debris in NGV to GG Support Cavity
