# Service Instruction Number SIN2348 Revision K

Installation, Maintenance, and Repair of the KAflex®  
Driveshaft for the Bell 206A and 206B Helicopter.

**KAMATICS CORPORATION SERVICE INSTRUCTION NUMBER 2348**

Subject: KAflex Main Driveshaft Retrofit in accordance with Supplemental Type Certification Number SH7767SW.

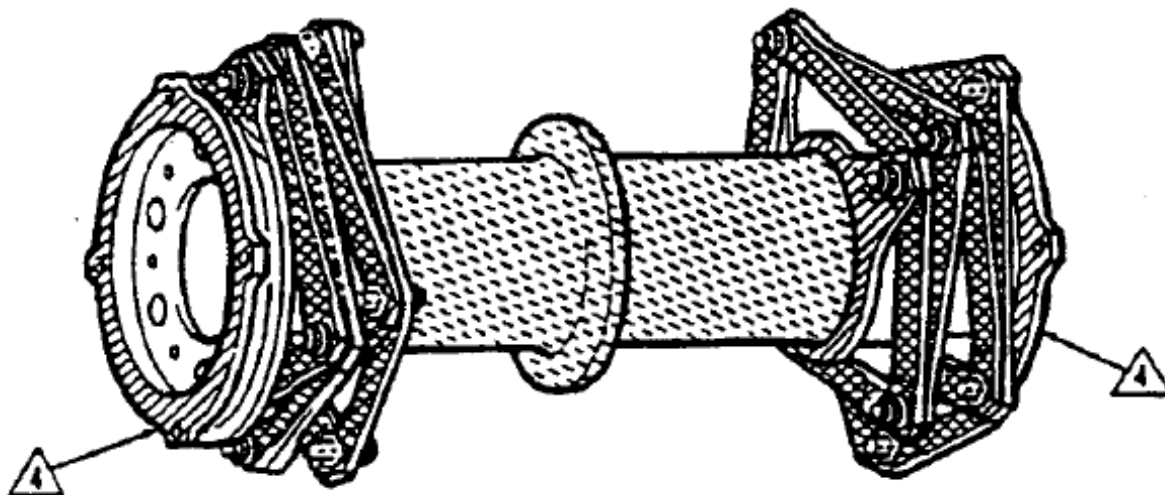
**FIGURE 5: Damage Limits – KAFlex Driveshaft**

1. Refer to Figure 5 for repair criteria. All blends shall be smooth at maximum depth and smoothly blended with surrounding surfaces.
2. The KAflex Driveshaft is not field overhauled. The KAflex Driveshaft can only be disassembled for inspection at Kamatics Corporation.
3. The KAflex Driveshaft is to be removed at 6,000 hours and sent to Kamatics Corporation for complete factory overhaul and inspection as required.

| Type of Damage | Maximum Damage and Repair Depth | | | |
|---|---|---|---|---|
| MECHANICAL | 0.001" before and after repair | 0.005" before and after repair | 0.005" before and after repair | 0.015" before and after repair |
| CORROSION | Surface, no pits | 0.005" before and after repair | 0.005" before and after repair | 0.010" before and after repair |
| MAXIMUM AREA PER FULL DEPTH REPAIR | 0.05 in <sup>2</sup> | 0.10 in <sup>2</sup> | 0.25 in <sup>2</sup> | 0.25 in <sup>2</sup> |
| NUMBER OF REPAIRS | One per leg | | | |

1. No cracks are permitted
2. Repairs must be no less than 1.000 inch apart.
3. Repairs not to be within 0.500 inches of bolt hole.
4. Faying surfaces must be free of any raised metal areas.

areas.
8. If damage results from contact with transmission isolation mount, proceed as follows:

- a. If contact with Lord (Barry) mount (P/N 206-030-539-303) occurs, return driveshaft to Kamatics for evaluation.
  - b. If contact with Lord (Barry) mount (P/N 206-030-539-101 or -005) occurs during unusual and severe condition and depth of damage to top cover does not exceed .025", lightly stone smeared aluminum/ceramic coating on corners of flex frames, end fittings and interconnect ears to remove raised material and sharp edges. Restore coating per Note 6 as necessary. If damage to top cover exceeds .025", return driveshaft to Kamatics for evaluation.

5. All repairs to be smooth at maximum depth and smoothly blended with surrounding surface.
6. Exposed bare metal may be touched up with Sermetel Product 1122 or 196 available from Praxair Surface Technologies, 1550 Polco St. Indianapolis In. 46222. Zinc Chromate, primer color T, even though it does not blend cosmetically with Sermetel coating, can be used if Sermetel touch-up products are unavailable.

9. If damage exceeds limit specified in this section, return driveshaft to Kamatics Corporation. Include description of reason for return and copy of Historical Record Card with the driveshaft.

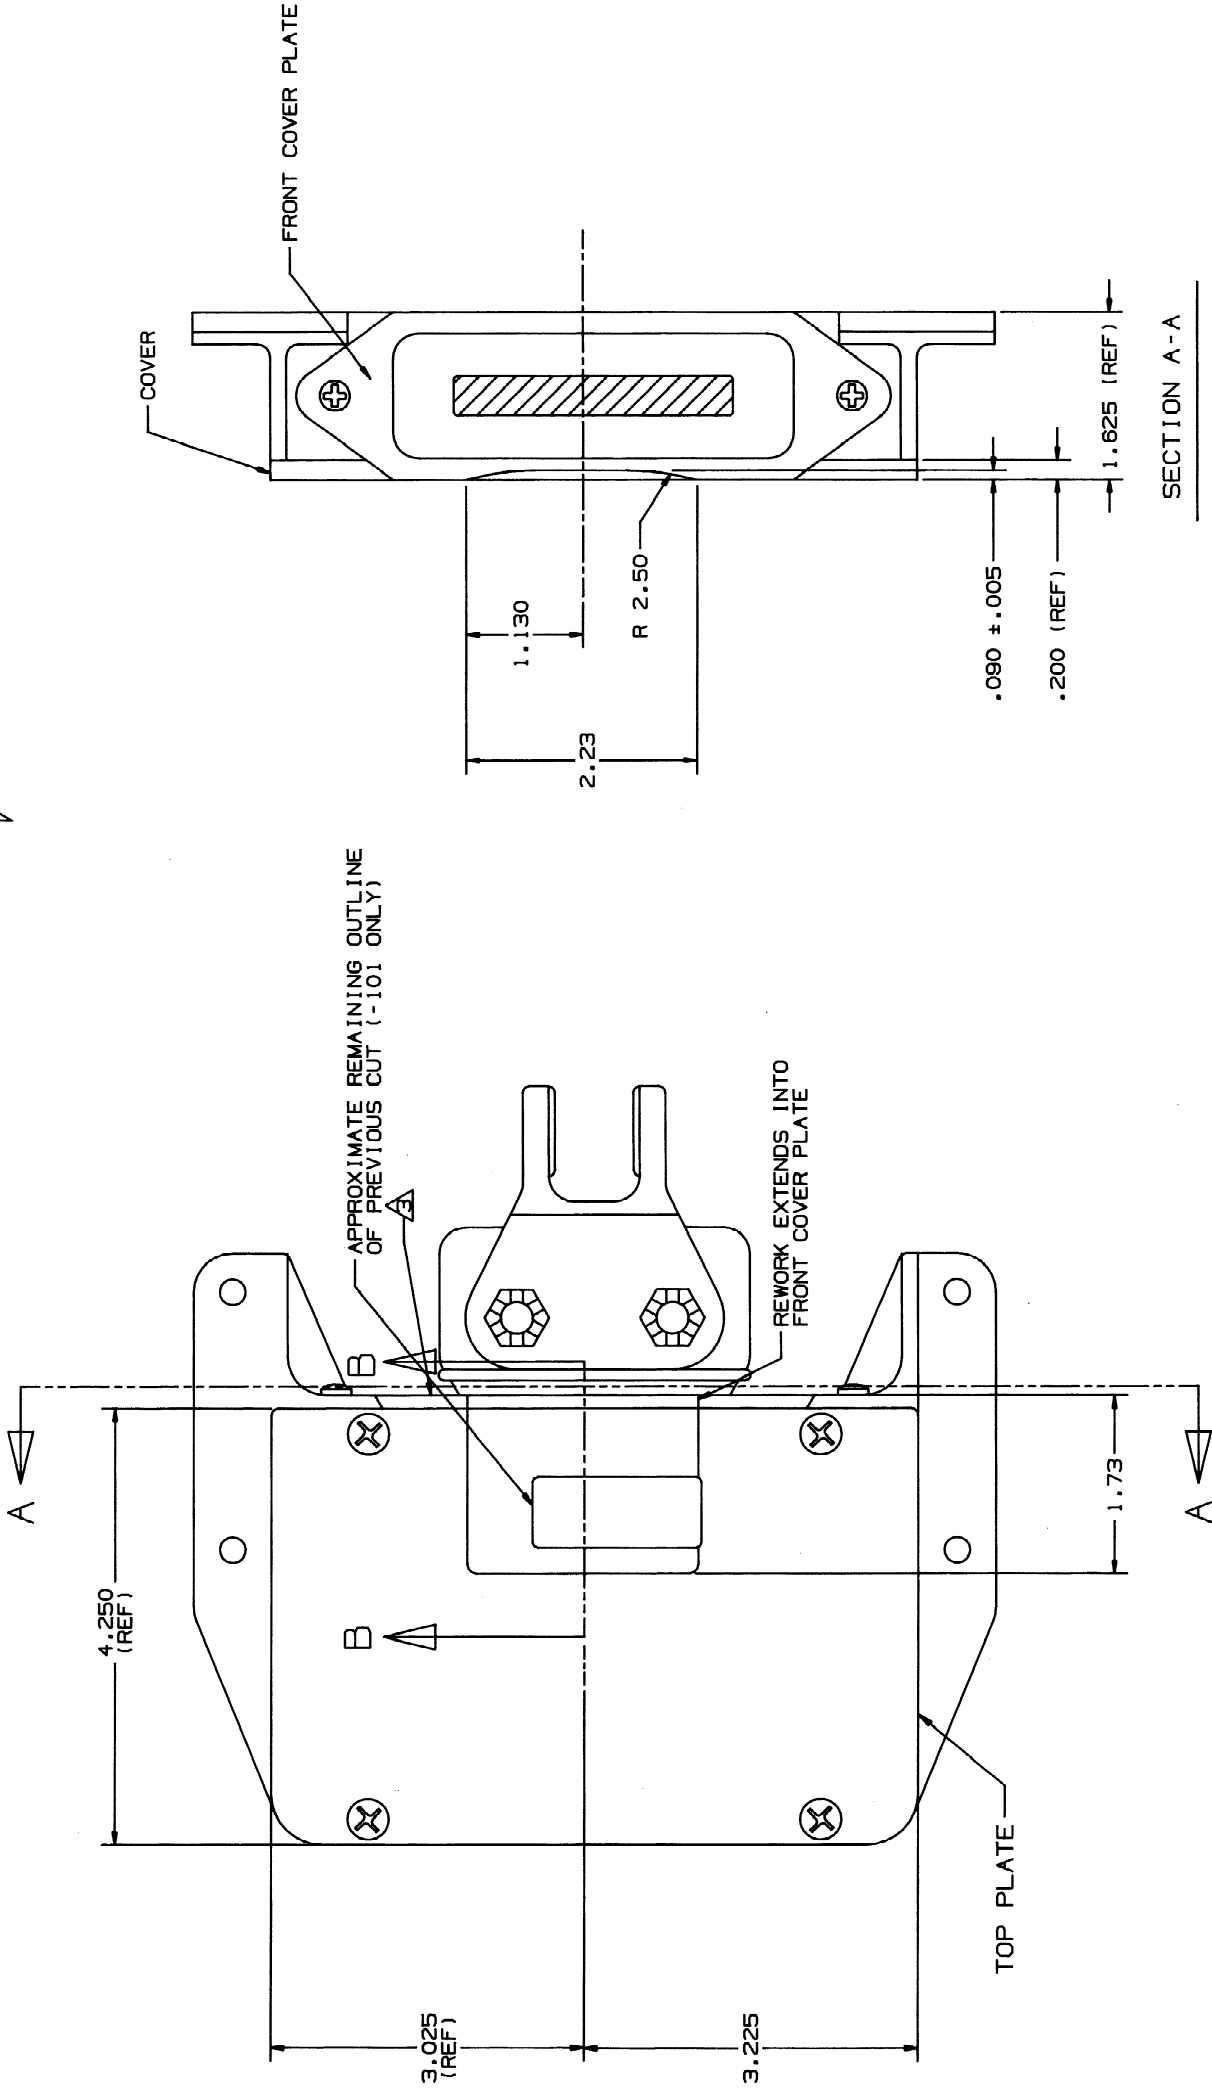
## SECTION A - A

5. REASON FOR REWORK: TO REDUCE PROBABILITY OF INTERFERENCE BETWEEN KAFLEX DRIVESHAFT SKCP2348-101 AND LORD (BARRY) TRANSMISSION ISOLATION MOUNT.
  4. REINSTALL ISOLATION MOUNT IN ACCORDANCE WITH THE MAINTENANCE AND OVERHAUL MANUAL. DO NOT USE UNAUTHORIZED SHIMS, ADHESIVES OR SEALANTS BETWEEN THE LORD (BARRY) MOUNT AND THE CABIN ROOF. REFER TO BHTI TECHNICAL BULLETIN 206-77-14 IF INTERFERENCE EXISTS BETWEEN THE LORD (BARRY) MOUNT AND THE ROOF TOP RIVETS.
