Re: Mishap 3 June 2017 Garfield WA N255BZ

Thank you for the opportunity to look at the photographs from the investigation at Sonex 255/Aerovee Engine 398. I have looked in my files for both text and pictures that might be helpful to you.

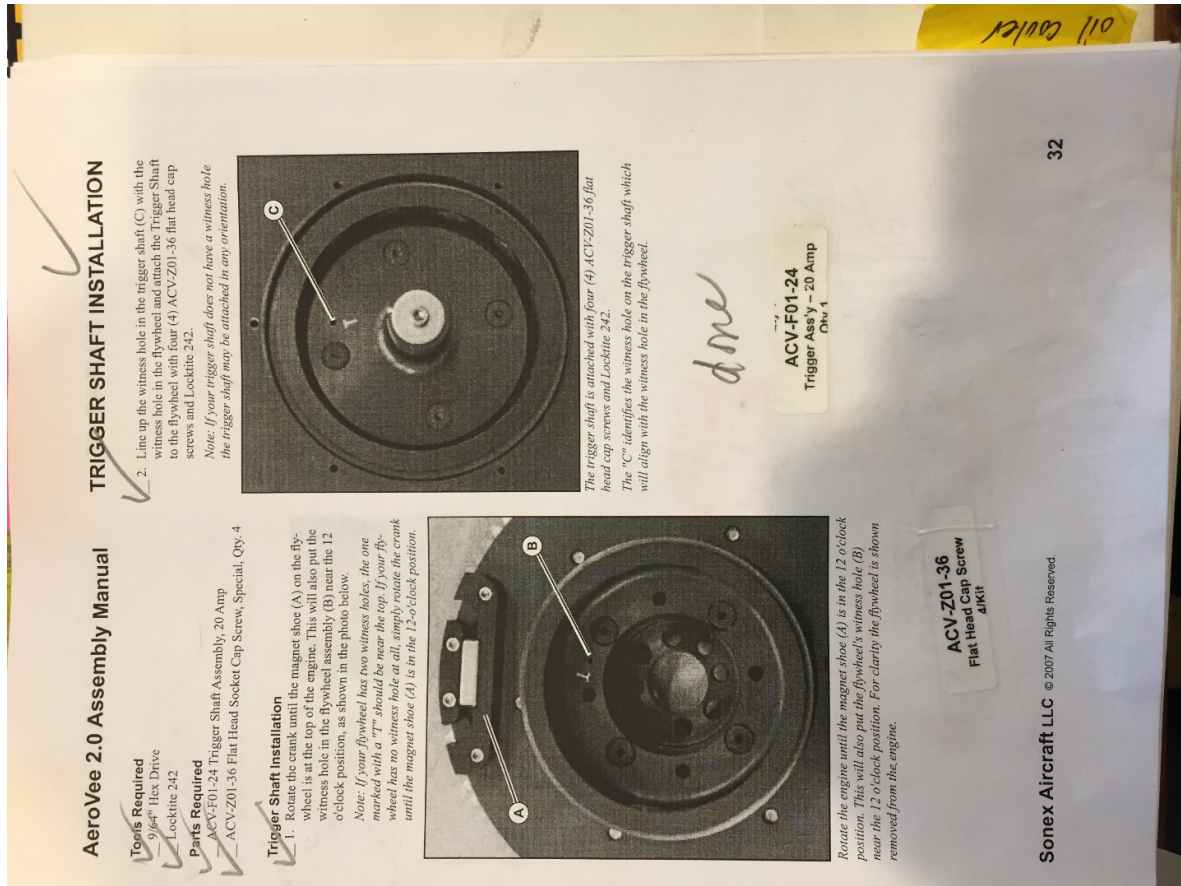
Figure 3

2. As the engine was purchased in 2007, a number of power plant changes were introduced and I made a very specific effort to ensure that they were all incorporated. However unless my notes clearly say that specific task was complete, I simply cannot recall what was completed. I think I incorporated all changes. (See figures 2 and 3. Power plants change and assembly instructions.)

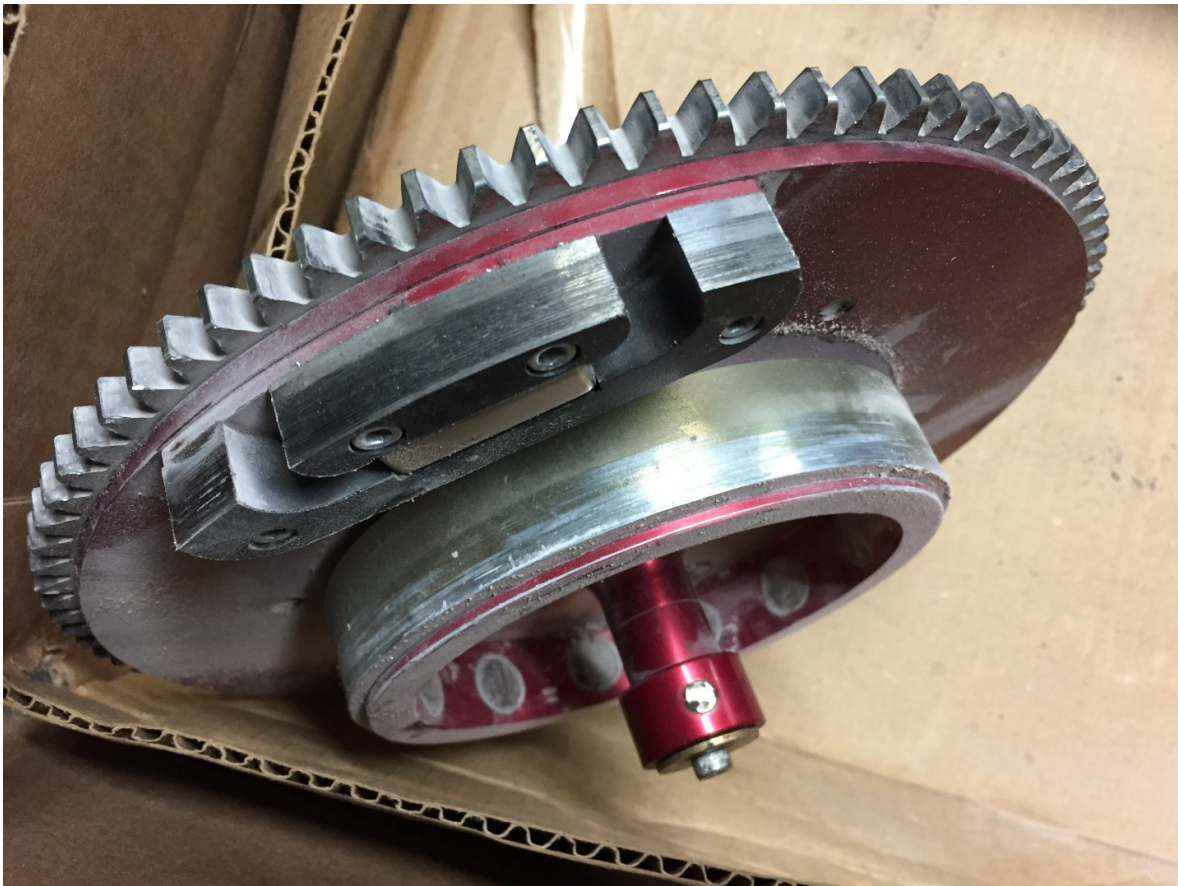
Figure 5

4. Your photography showed the distress on the flywheel end of the crank, with egged holes and evidence of working bolts. I have included photos of the flywheel end components, which show that the major parts appear to have moved, with contact and scrubbing between the stator and rotor on the alternator, and rubbing at the magneto magnets. Interestingly enough, at no time did the engine act unhappy, with good power, easy starts, and no indication that it was failing internally. (See figures 5, 6, and 7, showing scrubbing on the rotor, the magneto magnets, and indications of fastener loosening on the housing for the Hall Effect sensor.)

8. On reflection, it appears to me that the engine was going to fail on one end or the other, and the fact it failed when it did, and where it did was mostly good luck. If I were going to assemble and operate this engine again, I would ensure torque values on the alternator/magneto assembly end were known and used and that Loctite was present.

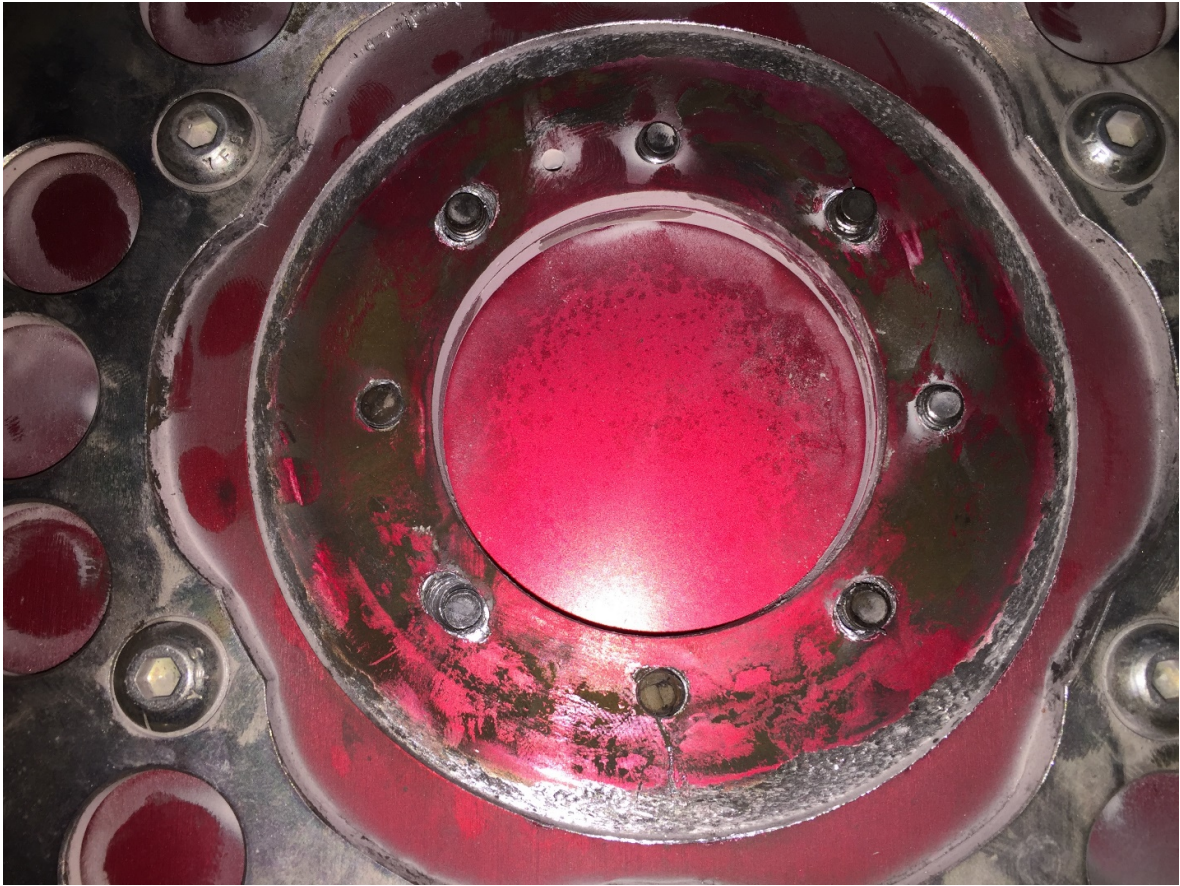
Figure 8

5. As I have mentioned to you before, the departure of the propeller occurred with a significant degree of violence, and the ELT activated from the motion. In fact my first action was to look and see if the motor and the tail were still attached. The airplane was flying fine, but I still had to look; it was a huge transient. How much of the wear on the flywheel end had occurred prior to the event, and what happened as the propeller departed is open to question. I think it is probable that the much of the damage occurred at the moment of the crank failure. (See figure 8.)

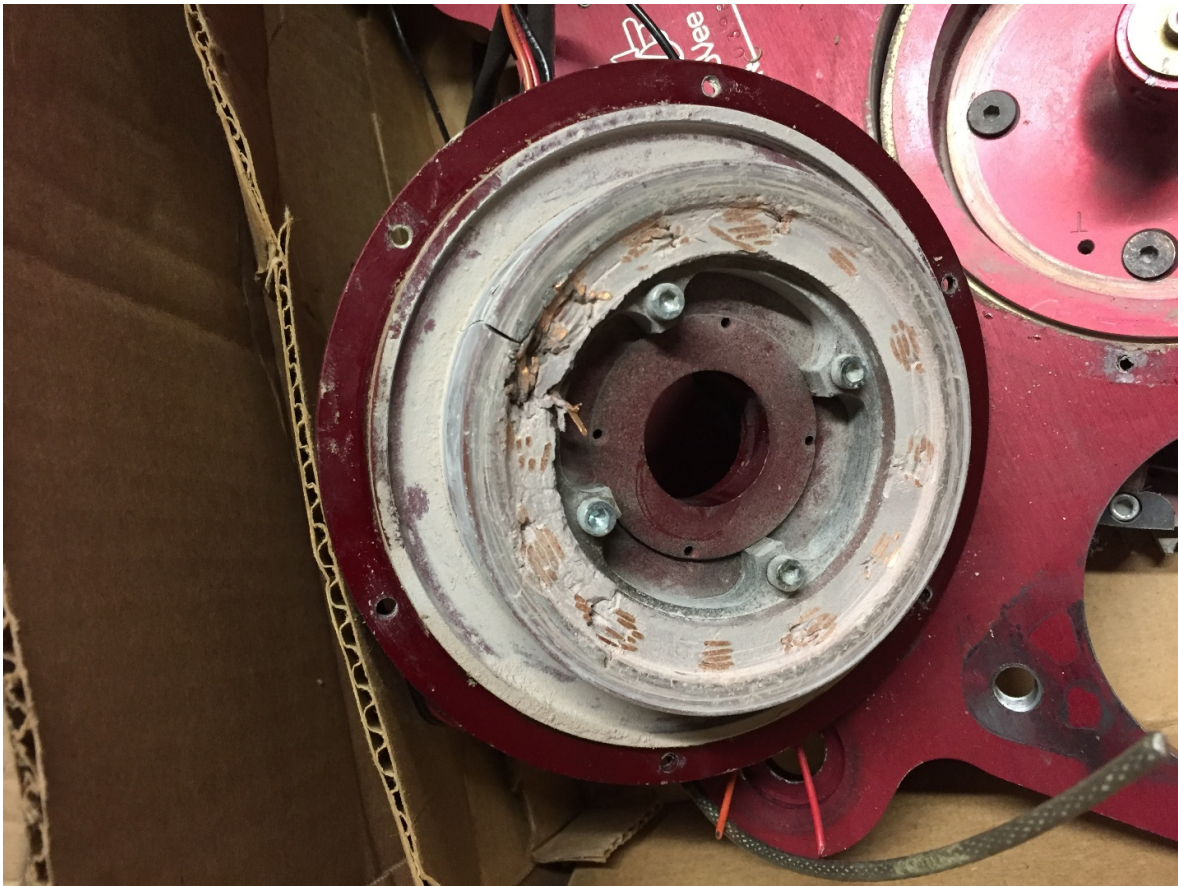
Figure 9

6. I did note that the maximum engine speed after the propeller departed was only 4940 rpm (engine log page 27), and when I shut the motor down, it was still running without any load. The propeller was a Prince propeller, 54-44 with p tips, and even with the solid spinner was part of a very light package. The amount of inertia in the assembly was low. I had pulled power at the onset of the major vibration, but at that point, the crank was in the process of disassembling

itself. (See figure 9 for evidence that the fasteners on the rotating end of the crank were loosening and abrading the windings on the alternator stator.)

12. The problem at the back of the crank came as an unpleasant surprise to me, and I would credit that issue as a result of improper assembly of the flywheel and alternator components.
