## **NATIONAL TRANSPORTATION SAFETY BOARD**

### **ENGINE EXAMINATION SUMMARY**

**WPR17LA119**

Location: Garfield, Washington  
Date: June 3, 2017  
Aircraft: N255BZ; Sonex  
NTSB Investigator-in-Charge: Andrew Swick

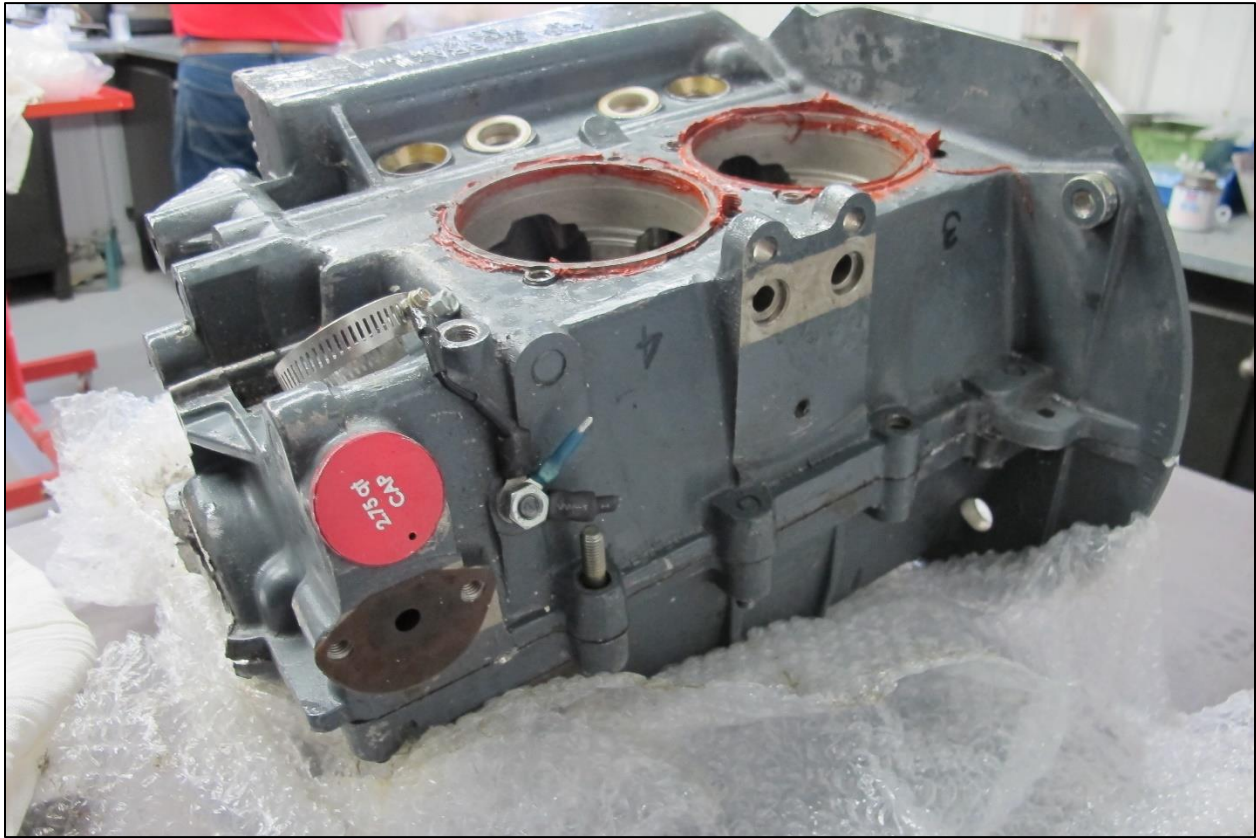
**Figure 1-Crankcase Halves**

The crankcase halves were removed from the shipping box and all four cylinder mounting surfaces were covered in an orange colored silicone sealant. The crankcase halves were separated, and the internal surfaces showed normal operating signatures. The forward cam bearing was not available during the examination.

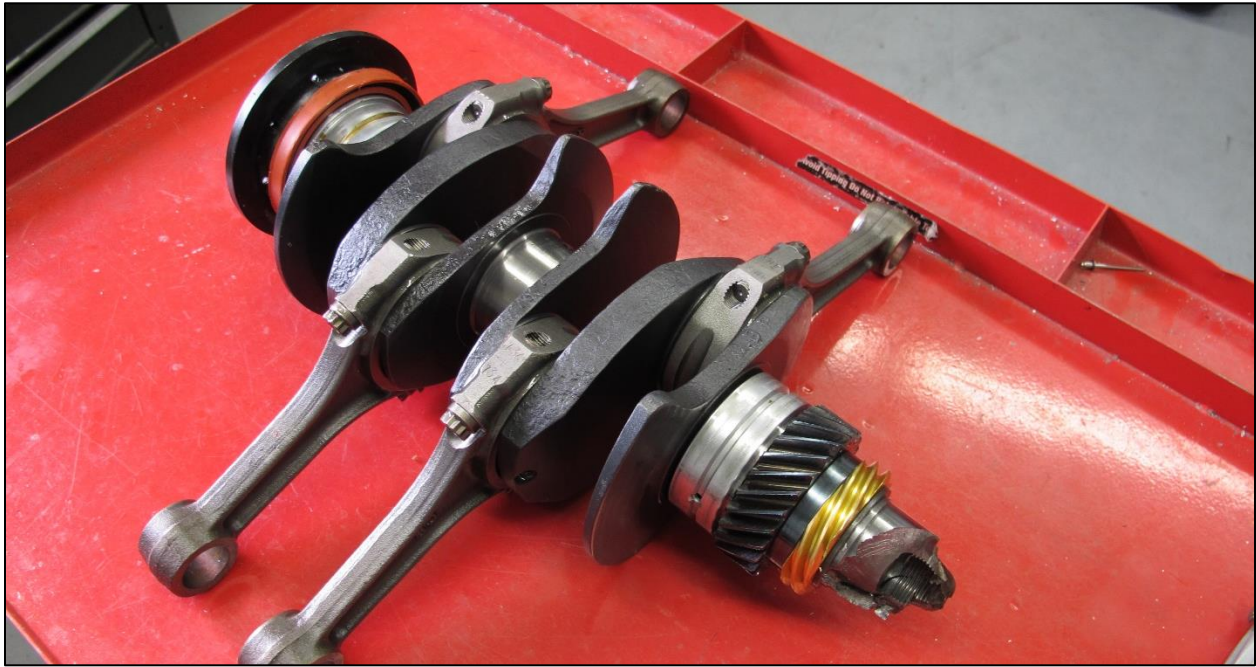
Figure 2-Crankshaft

The connecting rods remained attached to the crankshaft and were undamaged. (See figure 2.) The main bearing surface areas were undamaged and showed normal operating signatures. The separated surface at the forward main bearing journal area showed 'beach marks' covering most of the separated surface area, consistent with fatigue, propagating from the woodruff key slot area. (See figure 3.)

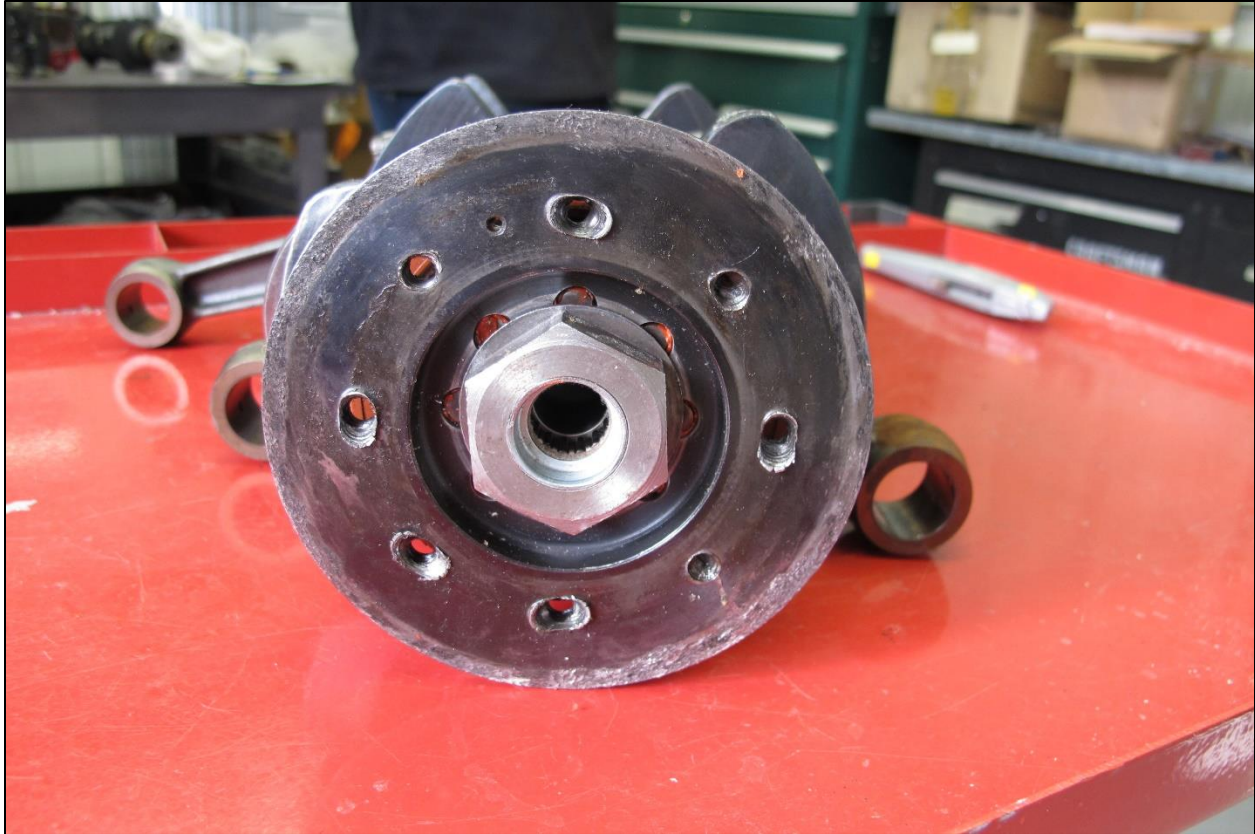
**Figure 4-Flywheel Mounting Flange**

The flywheel mounting flange remained attached to the crankshaft. The flywheel mounting flange had material deformation of several screw holes. In reference to the above photo, the screw holes in the 2 o'clock and 4 o'clock positions had threaded screw sections remaining in the holes. Fretting is noted around the outer circumference of the mounting flange and is about 1/4 of an inch wide.

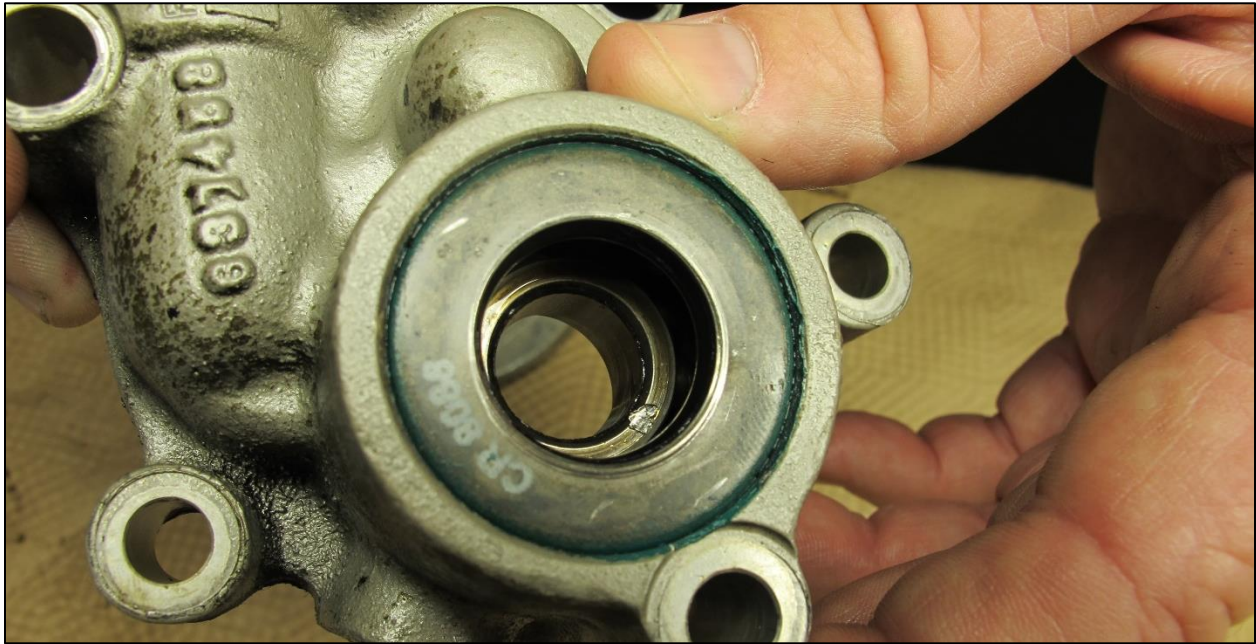
**Figure 5-Starter Adapter**

The starter adapter drive shaft was removed from the starter adapter and metal debris was found on the internal surfaces. The rubber seal driveshaft interface separated on one side.

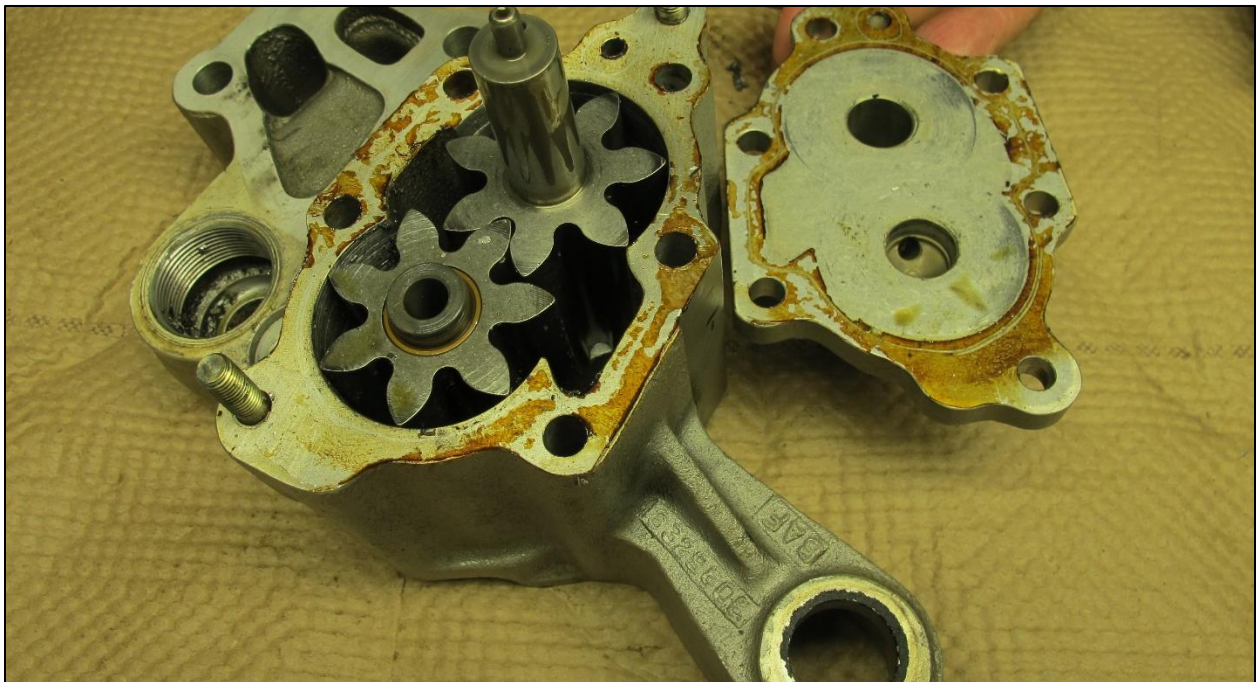
**Figure 6-Oil Pump**

The oil pump was removed and disassembled. Signatures of hard particle passage were found on the pump cavity walls. The drive and driven gears were removed from the pump. The drive gear separated near the splined end.

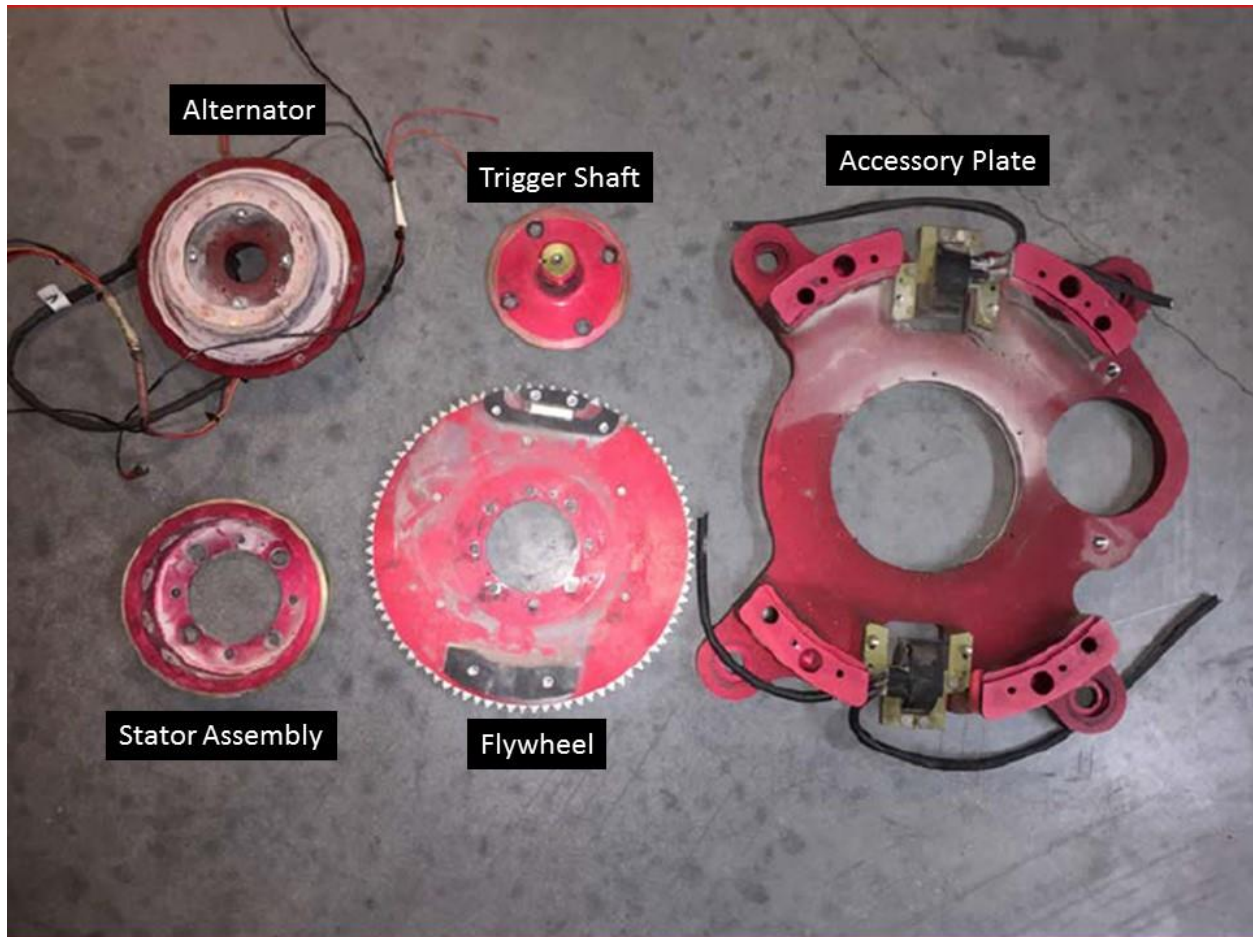
**Figure 7-Engine flywheel, alternator, and accessory plate components.**

Photos of the flywheel, ignition and accessory plate components were supplied by the owner. The flywheel and the upper half of the accessory plate shows a residue consistent with alternator potting compound. The alternator was damaged and showed signs of rubbing and material loss from the potting compound. The starter mounting bolt hole shows material deformation.

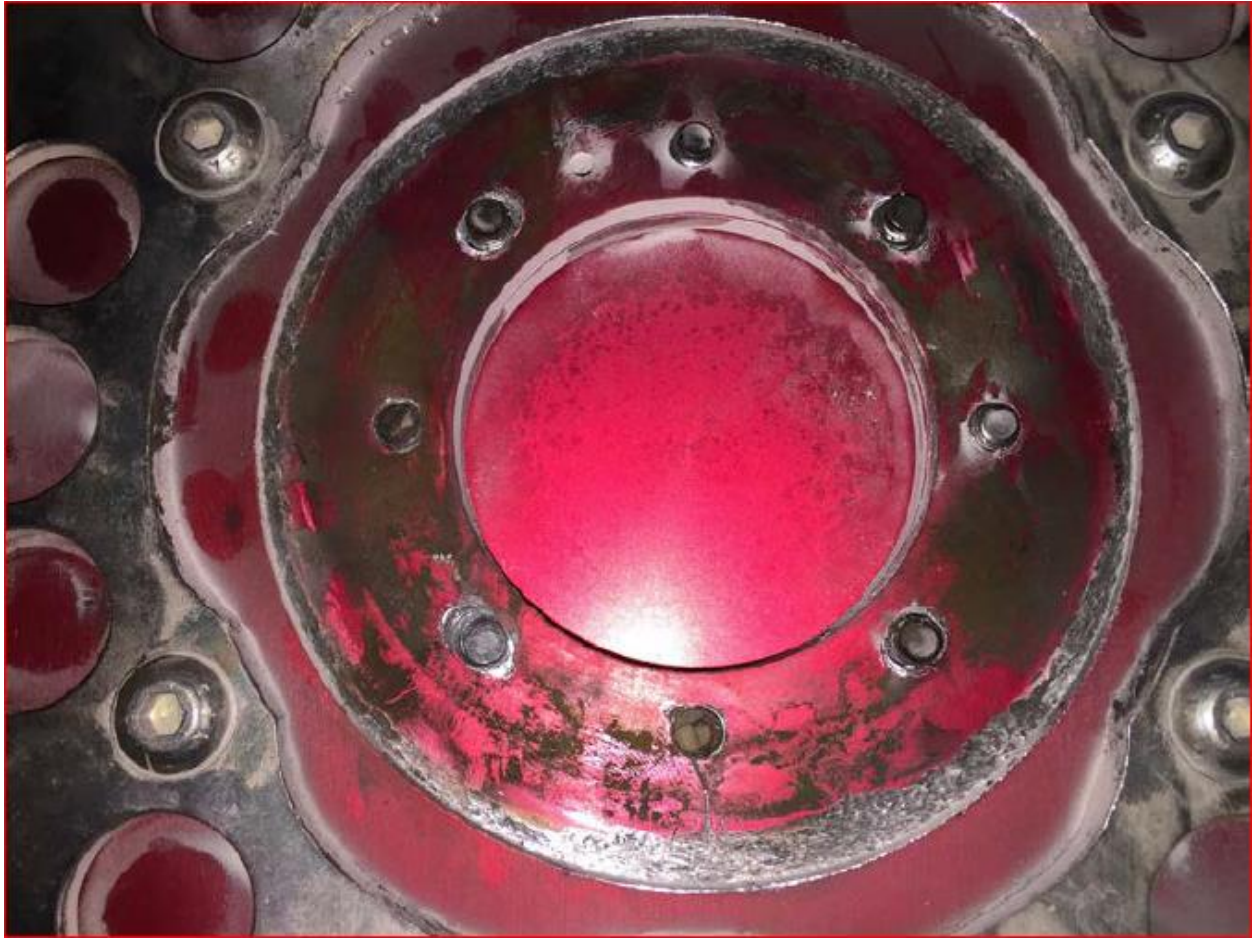
**Figure 8-Flywheel attachment area and trigger shaft (attached).**

The flywheel attachment area that mates with the flywheel crankshaft mounting flange shows fretting on the outer circumference and dark deposits. The screw holes show material deformation.

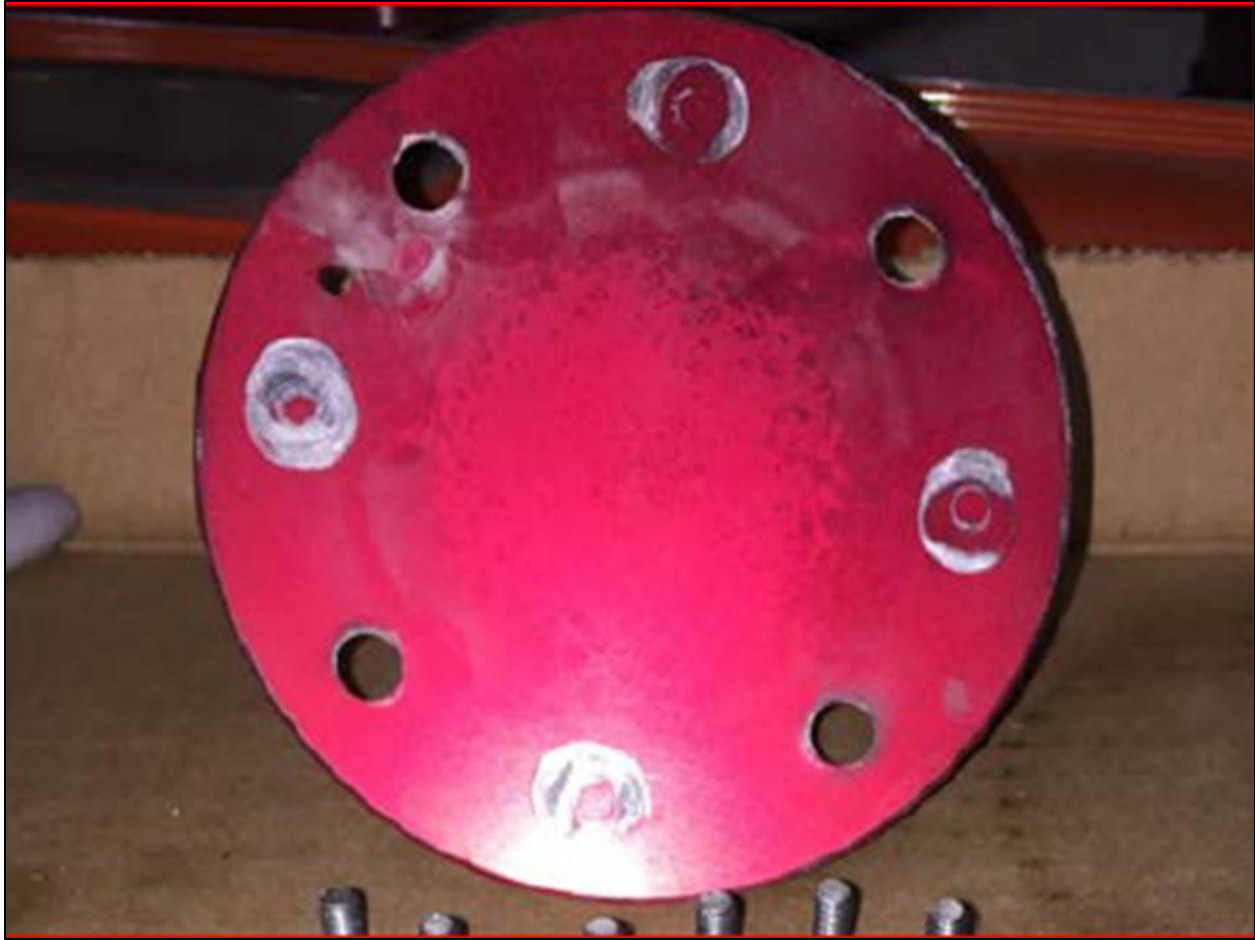
**Figure 9-Trigger shaft.**

The forward side of the trigger shaft had scuffing and material deformation at the locations of the flywheel mounting flange screw heads (4).
