## **NATIONAL TRANSPORTATION SAFETY BOARD**

# **RIGHT MAIN LANDING GEAR EXAMINATION SUMMARY**

**WPR17LA131**

Location: Carlsbad, California  
Date: June 22, 2017  
Aircraft: Cessna 421, N380AL  
NTSB Investigator-in-Charge: Joshua Cawthra

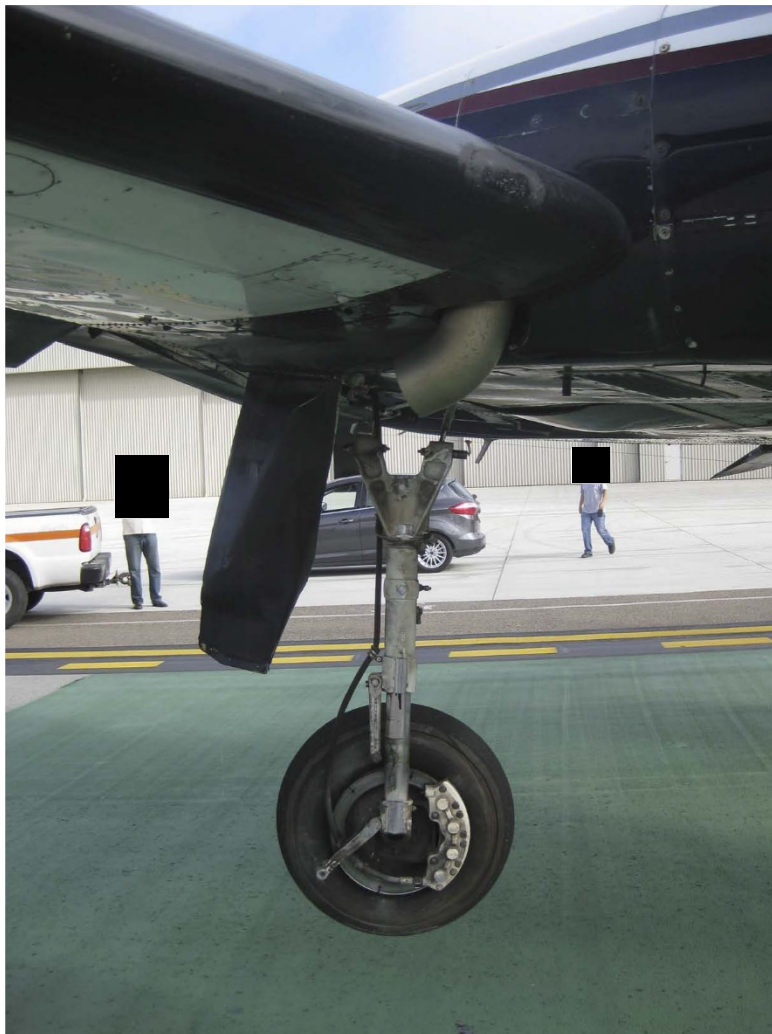
The FAA inspector assigned to the accident reported that their examination revealed the right main landing gear link rod pivot bolt assembly severed, with the nut and cotter key end, not located. Additionally, the landing gear trunnion was partially separated from the wing structure and the right main landing gear was separated, however, remained attached via hydraulic hoses.

Figure 1: View of the right main landing gear during recovery. (Courtesy of the FAA)

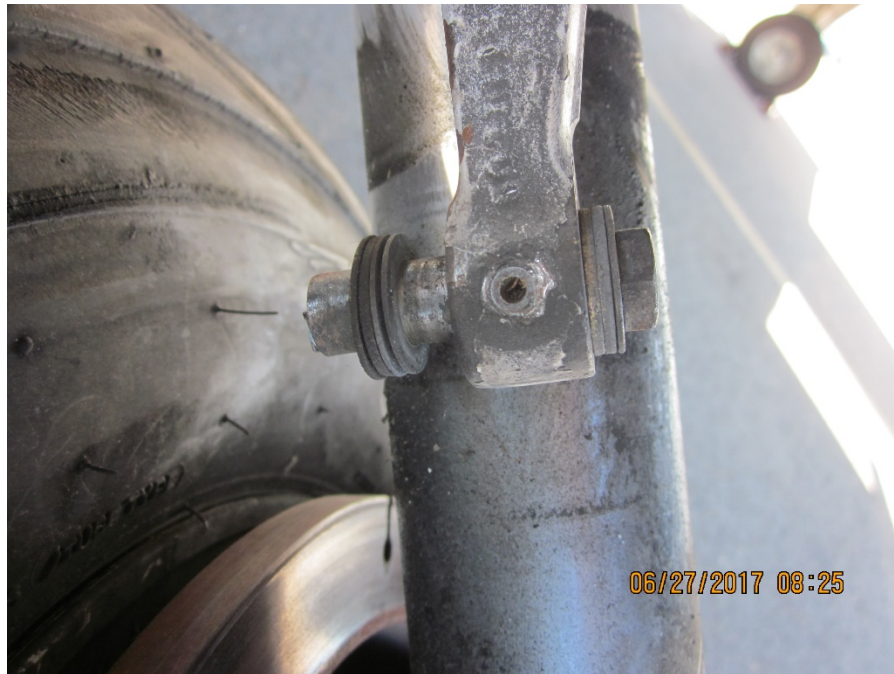
**Figure 2: Right main landing gear scissor link pivot bolt. Courtesy of the FAA.**

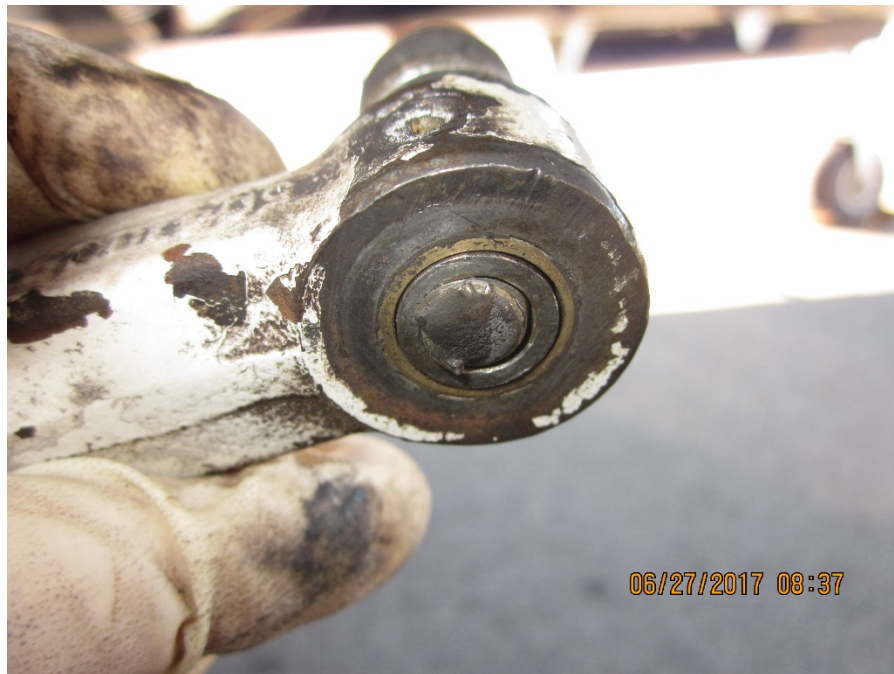
**Figure 3: Right main landing gear scissor link pivot bolt. Courtesy of the FAA.**

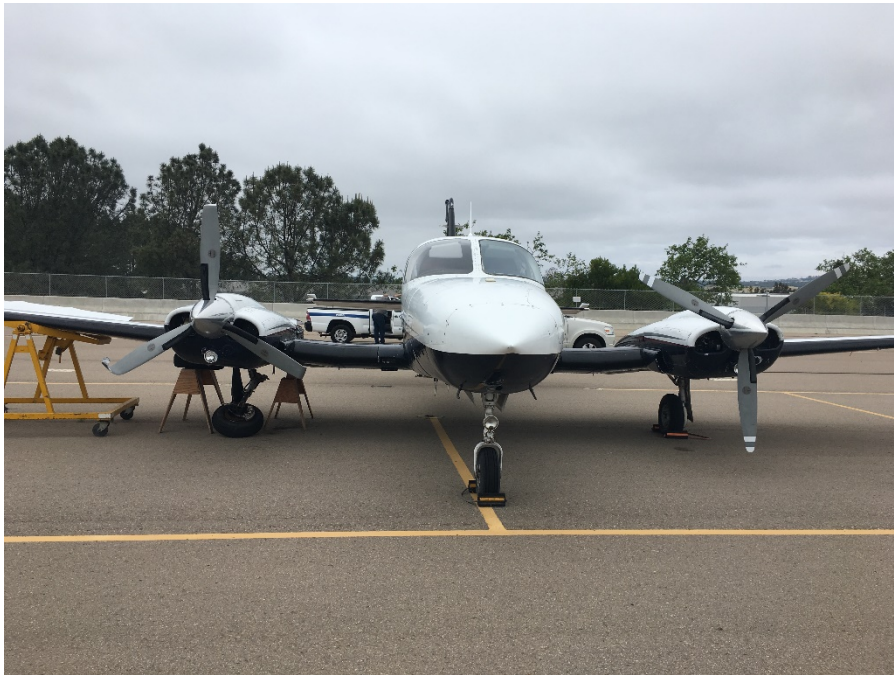
Examination of the airplane revealed that the forward right side landing gear trunnion was separated into two pieces. The lower portion was torn away from the upper portion. The landing gear assembly remained intact. Scraping was observed on the outboard side of the landing gear strut and brake caliper. The forward trunnion attach pin was undamaged. The aft trunnion attach

**Figure 4: View of the airplane as recovered.**

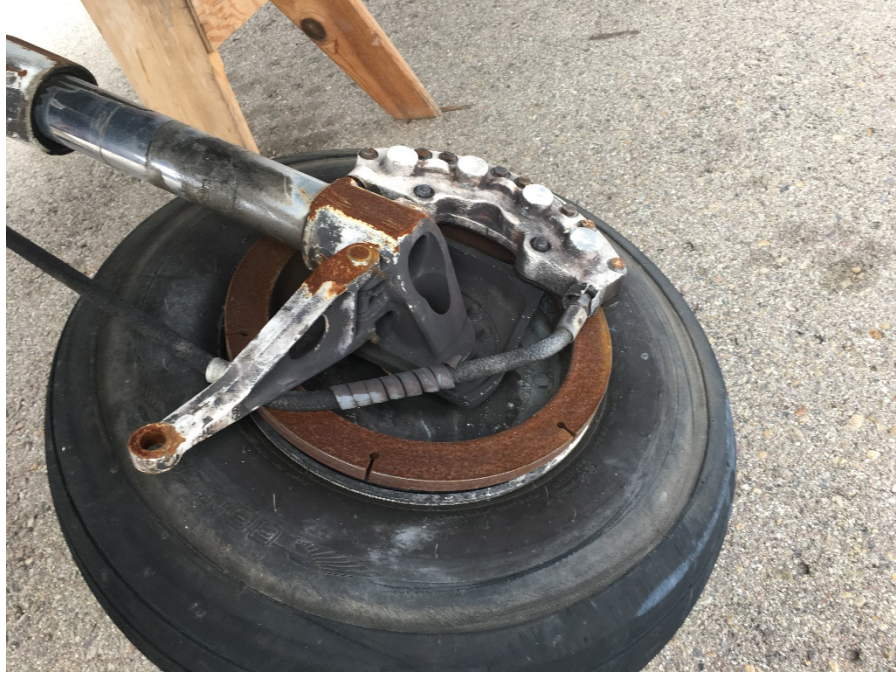
pin was bent downward. The right main landing gear tire exhibited vertical scuffing along the outboard crown of the tire. Additional multi directional striations were observed on the outboard portion of the lower scissor link assembly, brake caliper, and lower portion of the landing gear strut assembly.

**Figure 5: Right main landing gear wheel, brake, and lower link assembly.**
