## Service Kit

SK421-118  
Dated - 23 November 1983

TITLE: MAIN LANDING GEAR SCISSORS WASHER REPLACEMENT

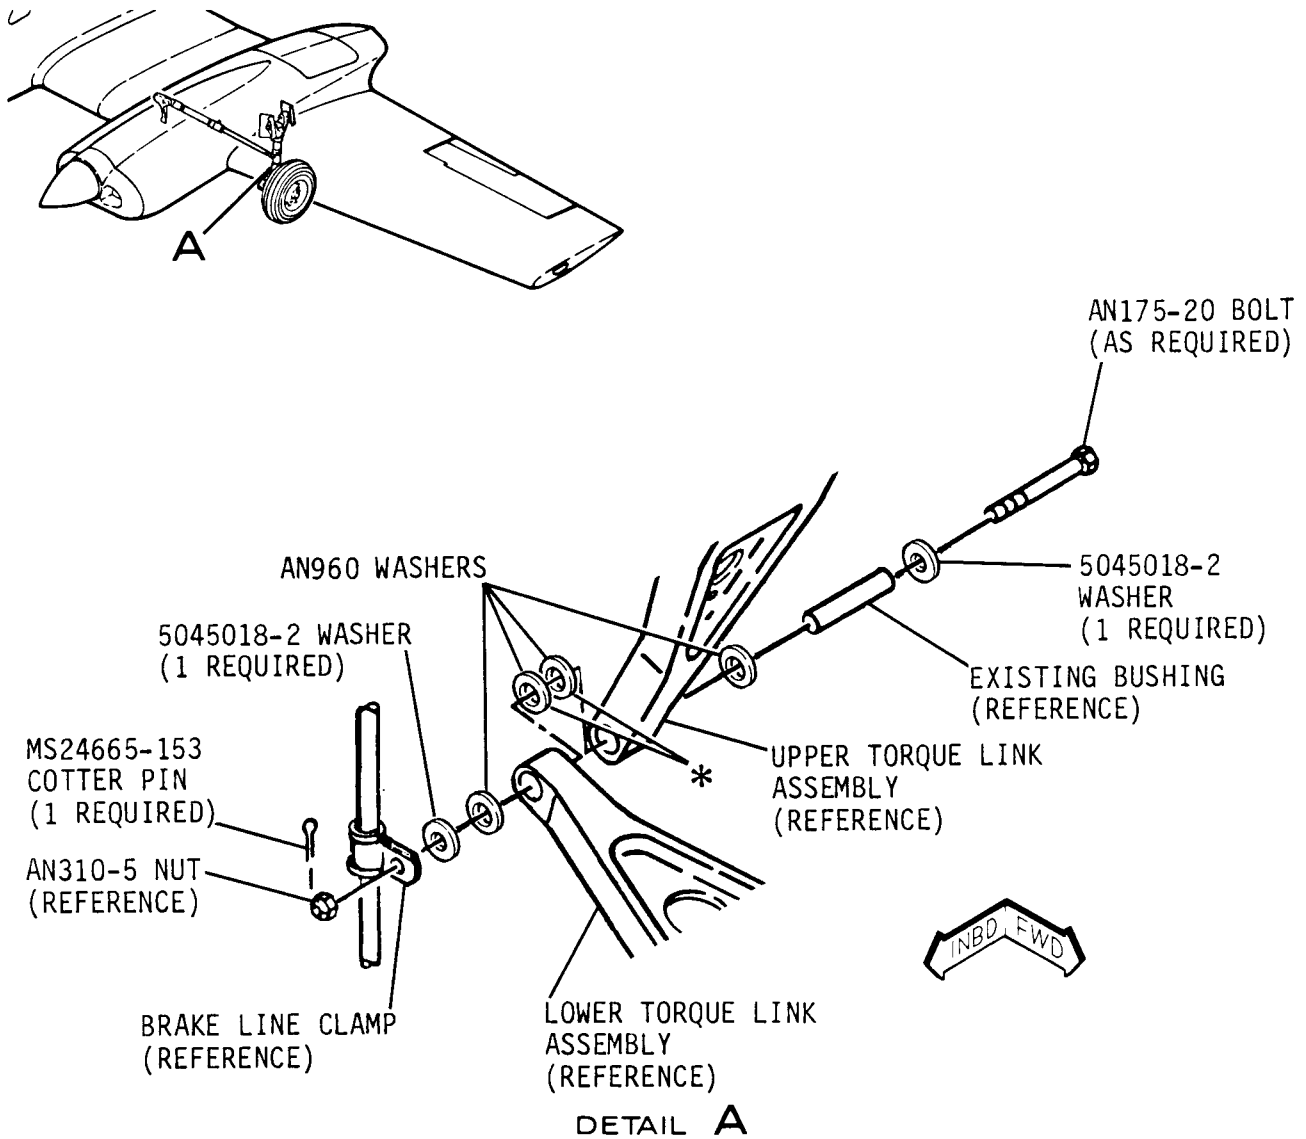
Figure 1. Main Landing Gear Scissors Washer Replacement

\*NOTE 1: RECORD NUMBER OF WASHERS AT EACH LOCATION BEFORE DISASSEMBLY AND REINSTALL SAME NUMBER OF WASHERS UPON REASSEMBLY.

1. Record number of washers installed between torque link assemblies (scissors) before disassembly.
2. Disassemble torque link assemblies as follows:
  - a. Remove cotter pin, nut, washers, bushing and bolt. Discard cotter pin and bolt.
  - b. Visually inspect the torque link assemblies in the area of washer contact. If any damage is evident, replace the torque link assemblies.
3. (Refer to Figure 1.) Reassemble torque link assemblies as follows:
  - a. Install same number of AN960 Washers, positioned on the existing bushing, as before disassembly.
  - b. Install new AN175-20 Bolt with a 5045018-2 Washer under the bolt head.

- c. Install the existing nut with a 5045018-2 Washer under the nut.
- d. Tighten the nut and check for proper cotter pin hole alignment and proper side play of the torque link assemblies. Maintain a 0.004 (minimum) to 0.020 (maximum) side play of the torque link assemblies. Be sure that the spacer washers are centered on the bushing before the nut is being torqued to 100 - 140 Inch-Pounds.
