## ENGINE EXAMINATION REPORT

| ENGINE MODEL | IO-520-M1B |
| AIRCRAFT MAKE & MODEL | Cessna 310R |
| FILE NUMBER | 16-697 |

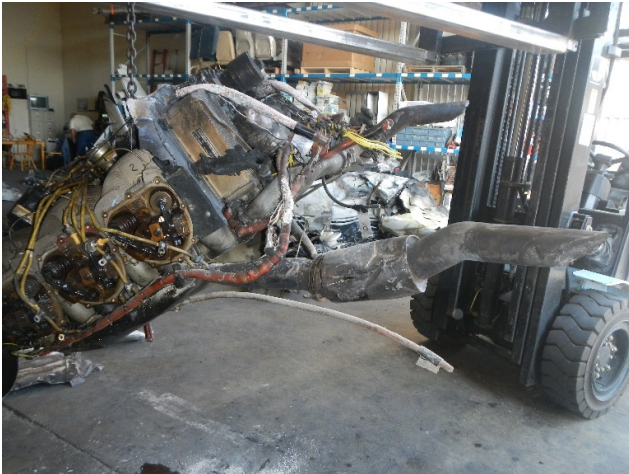
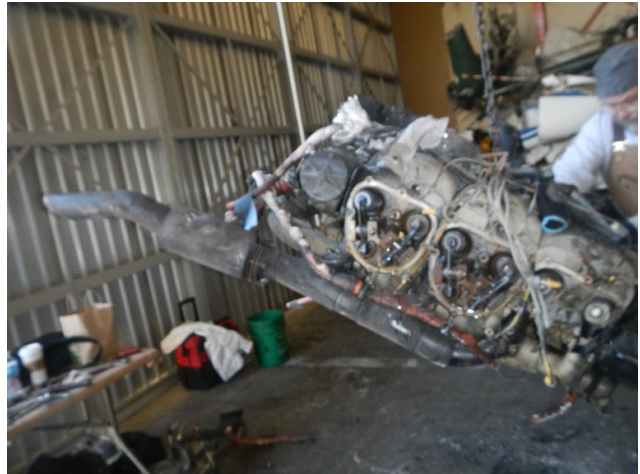
#### EXHAUST SYSTEM

The exhaust system remained intact with no pre-accident anomalies noted.

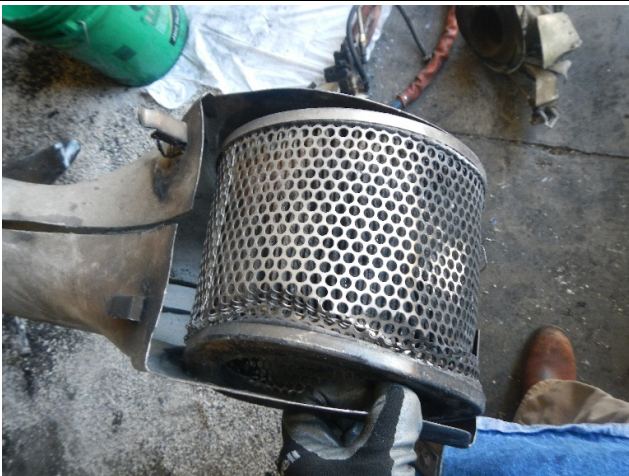
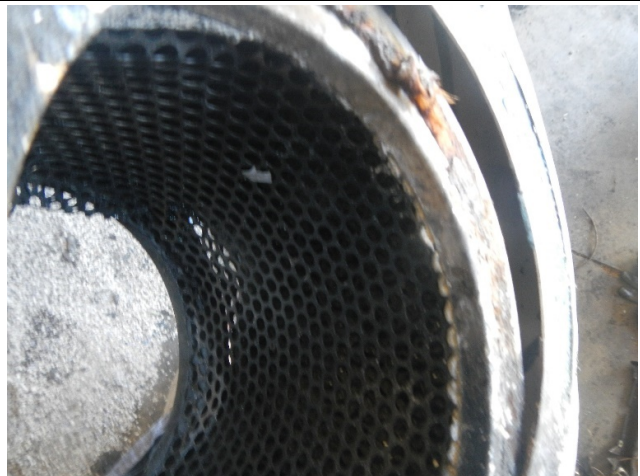
#### INDUCTION SYSTEM

The intake filter sustained impact and thermal damage, but no blockages were evident. The throttle body was separated from the intake wye plenum and remained attached to the engine nacelle. The left intake elbow was impact damaged and deformed. No pre-accident anomalies were noted with the induction system.

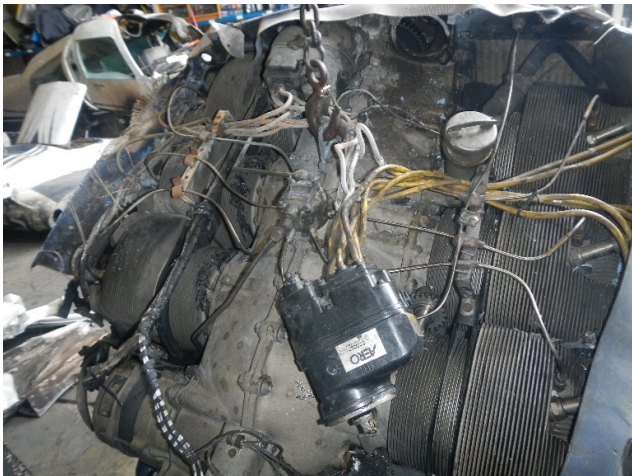
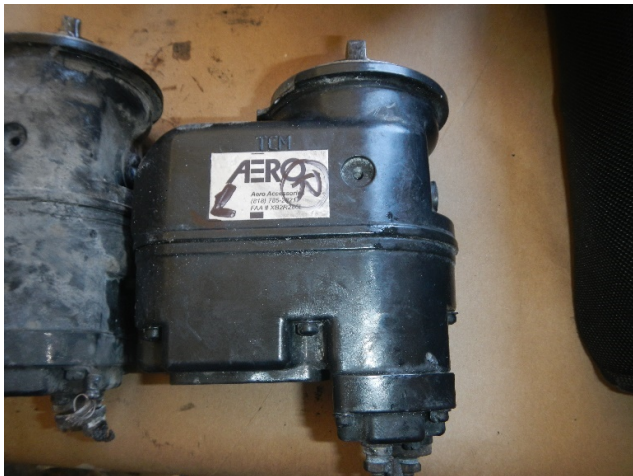
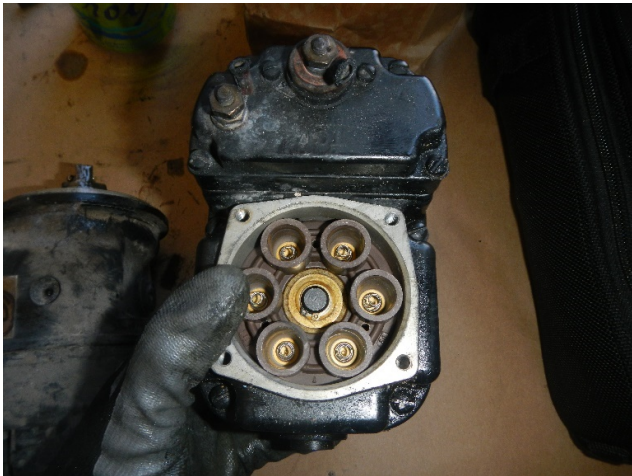
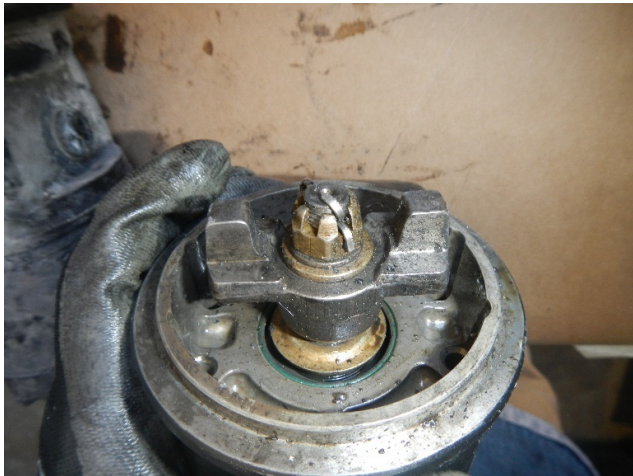
| Condition: | The left magneto was separated from its mounting pad and its mounting flange was fractured in the area of the attaching hardware. The magneto remained attached to the engine via the ignition harness. The vent cover was removed from the housing and the distributor gear was intact and rotated during drive shaft rotation. No pre-accident anomalies were noted and the magneto was retained for further testing (see Appendix A of this report for more details). | | |

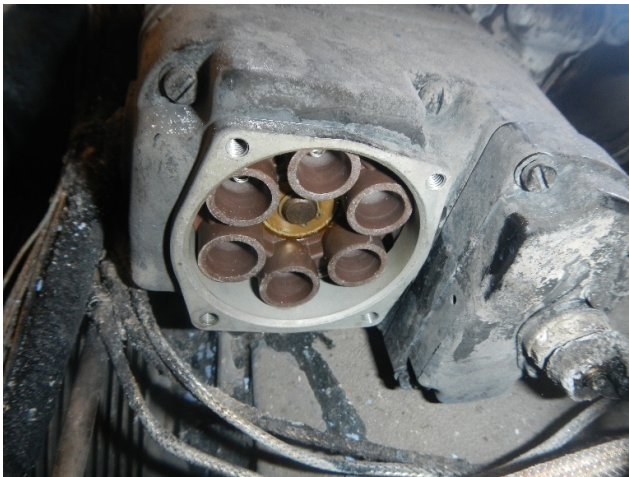
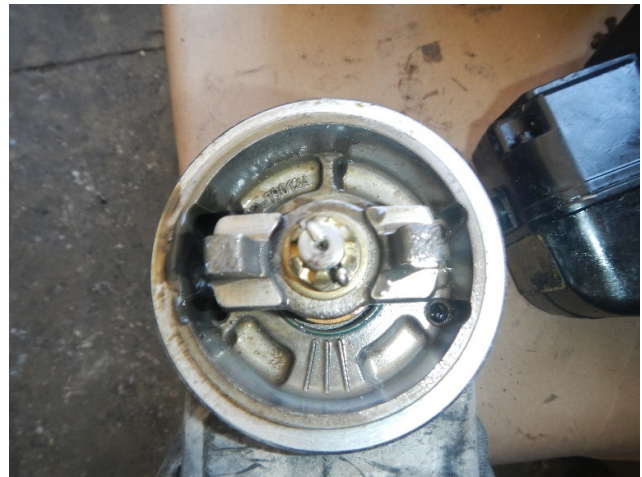
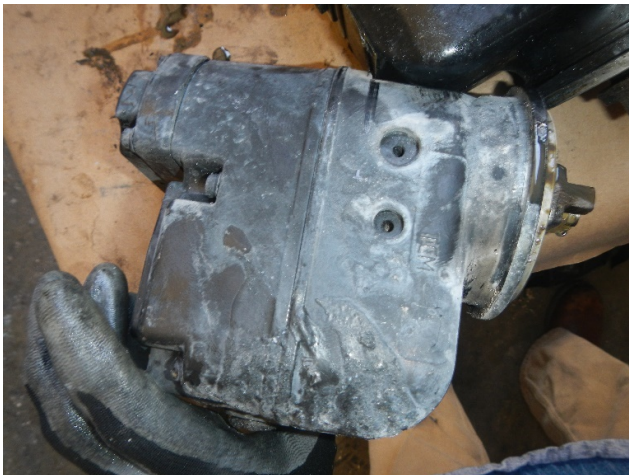
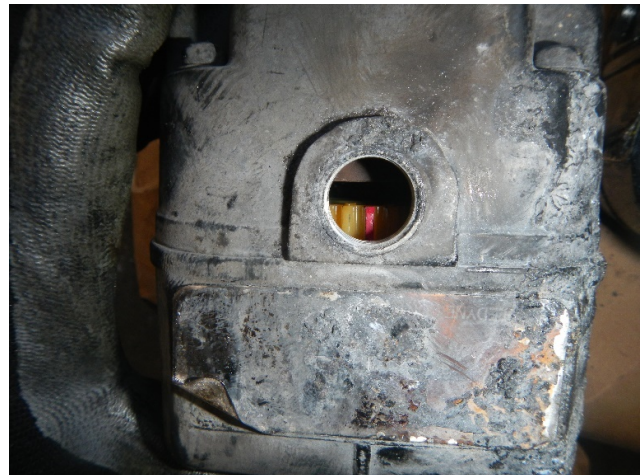
### RIGHT MAGNETO

Condition: The magneto remained secured to the topside of the engine and manual manipulation of the housing did not result in any slipping or rotation of the magneto on its mounting pad. It was soot covered and the vent plug was partially melted. The ignition harness remained in place on the magneto. The vent cover was removed from the housing and the distributor gear was intact and rotated during crankshaft rotation, with no pre-accident anomalies noted. The magneto was removed from the engine and its drive shaft was manually rotated with no binding noted. The magneto was retained for further testing (see Appendix A of this report for more details).

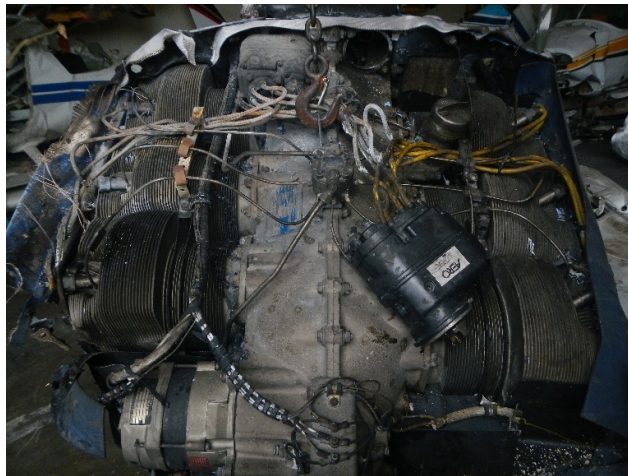
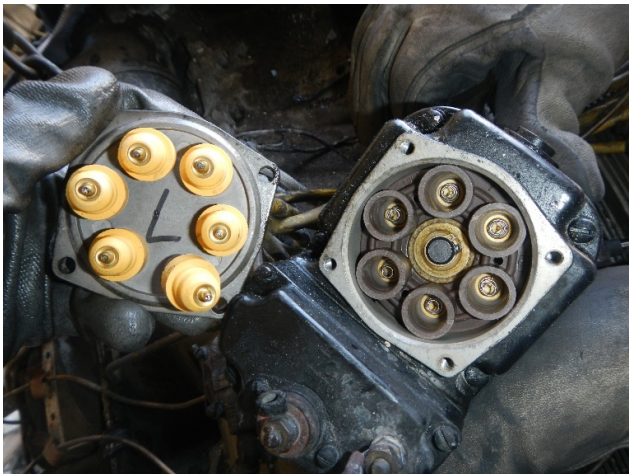
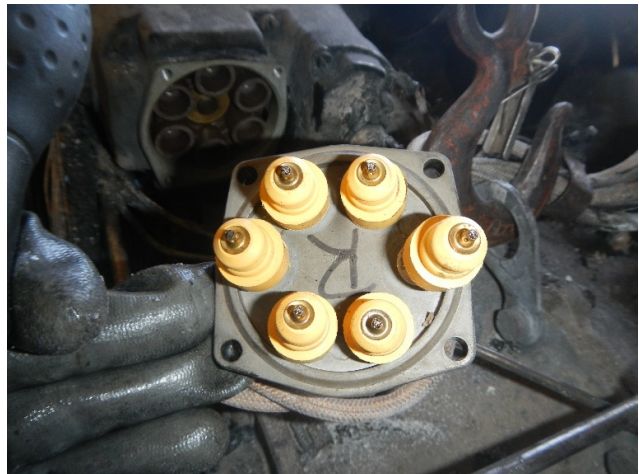
### IGNITION HARNESS

Condition: The ignition harness remained attached to both magnetos and each lead remained attached to their respective ignition harness. The right side leads were thermally damaged beyond functional testing. No pre-accident anomalies were noted with the ignition harness.

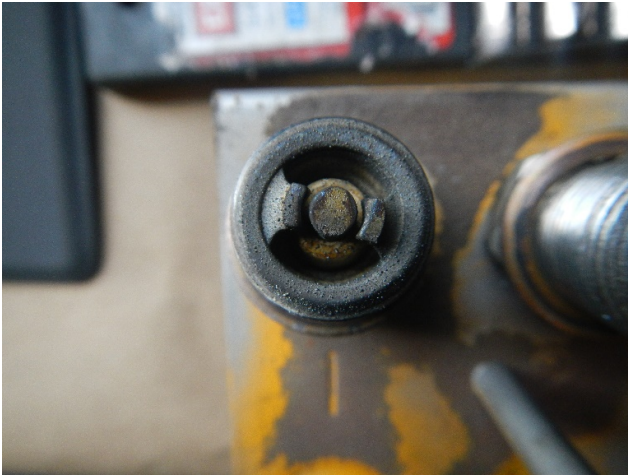
## SPARK PLUGS

Condition: The sparkplugs remained secured to their respective cylinders and each ignition terminal remained attached to its sparkplug. The top sparkplugs were removed from the cylinders and each displayed a normal worn condition with no evidence of carbon or lead fouling. The bottom sparkplugs were examined/photographed via lighted borescope.

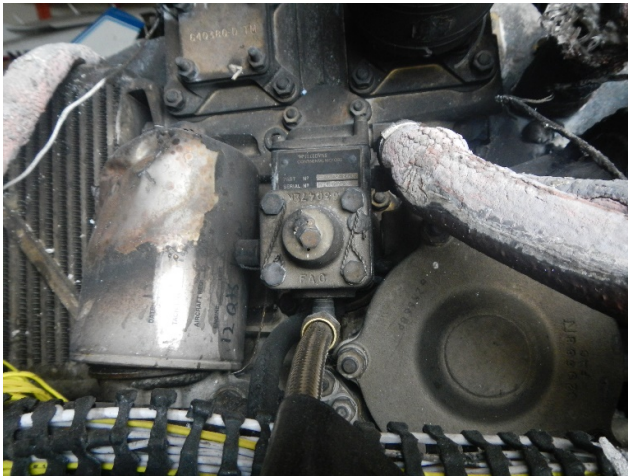
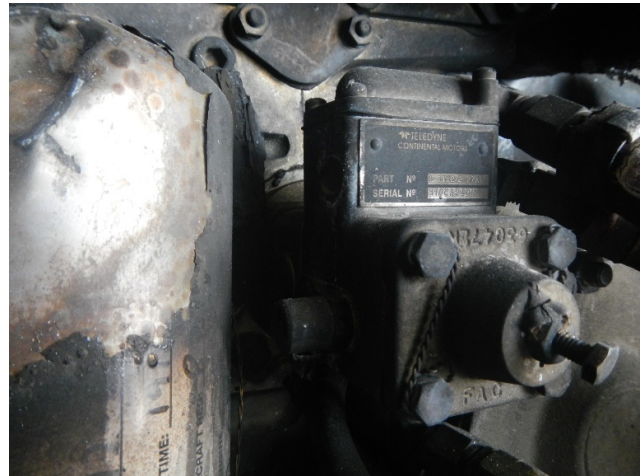
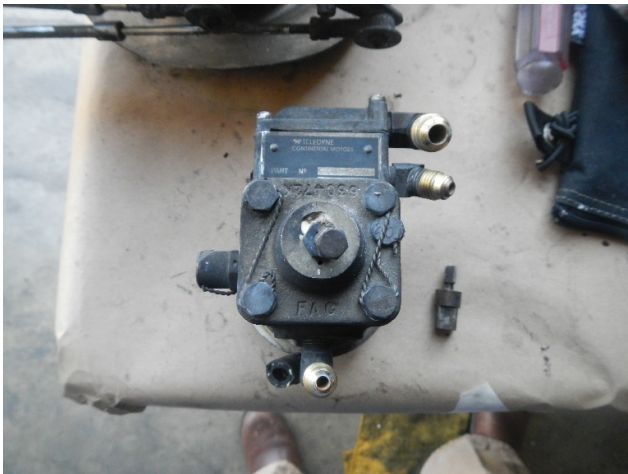
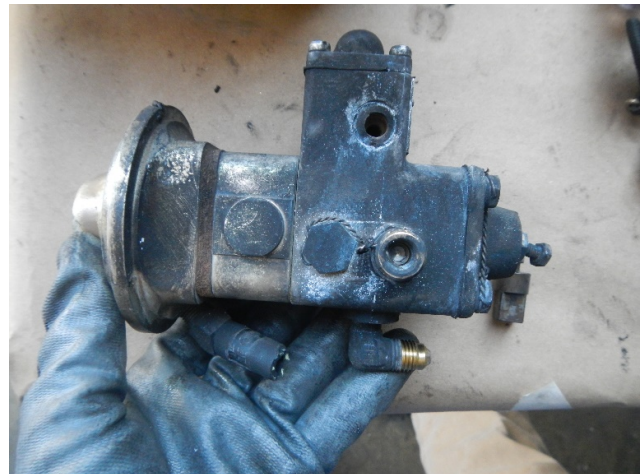
#### FUEL PUMP

**Condition:** The engine-driven fuel pump remained secured to the backside of the engine and all of the fuel lines remained secured to their respective fittings, though the fuel inlet fitting was fractured. The pump was removed and the drive coupling was intact. The pump could not be functionally tested due to the thermal damage, but disassembly revealed that the pump vanes were intact and no pre-accident anomalies were observed with the pump's internal components.

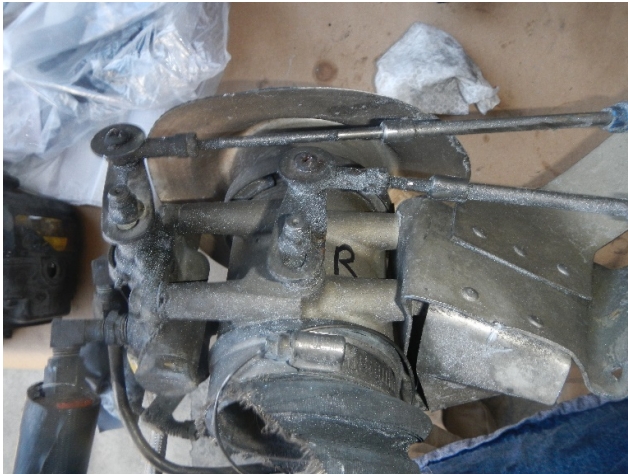
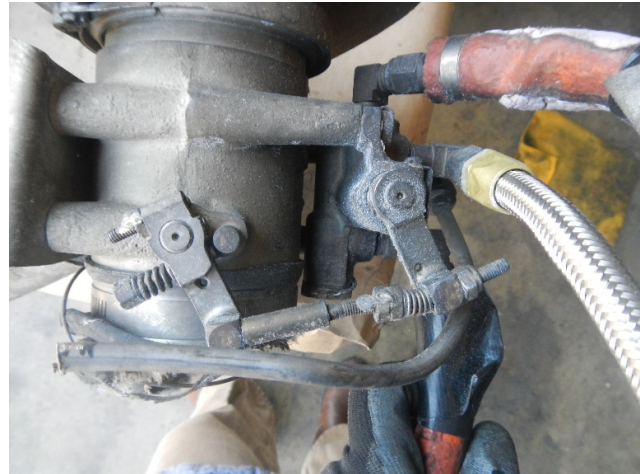
### THROTTLE BODY METERING UNIT

Condition: The throttle body/fuel metering unit was separated from the wye plenum and remained secured to the engine nacelle via the throttle and mixture control cables. The fuel lines leading to and from the fuel metering unit remained secured to their respective fittings, though the lines were cut by recovery personnel. Manual manipulation of the mixture and throttle control levers resulted in a coinciding movement in their control cams. The interconnect between the throttle valve shaft and the throttle metering cam was distorted. The fuel inlet screen was removed and no obstructions were observed; however, there was some debris noted on the edges of the screen.

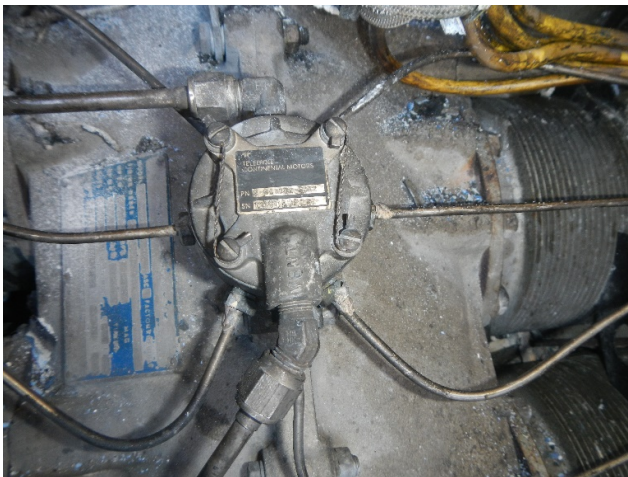
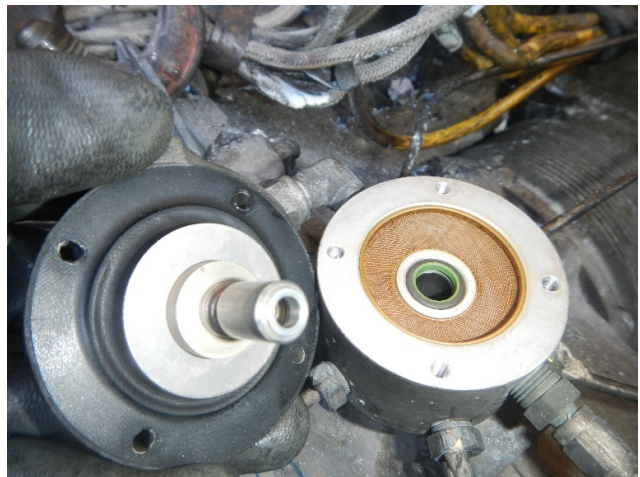
### FUEL MANIFOLD VALVE

Condition: The fuel manifold valve remained secured to the topside of the engine and all lines to and from the manifold valve remained secured in place. The cap was removed and the diaphragm was intact and the plunger was in place. The screen was clear.

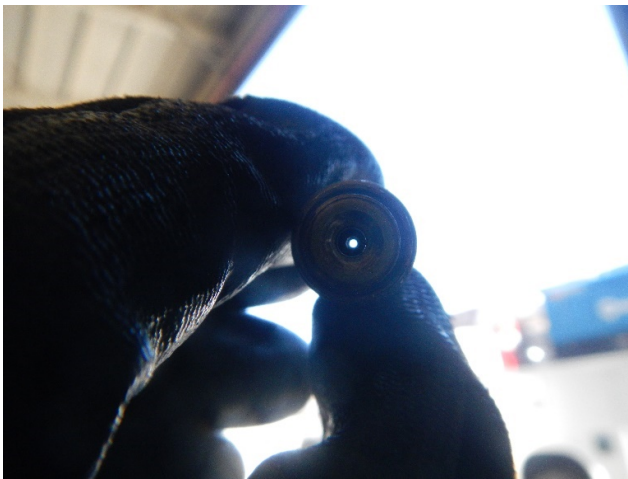
### FUEL NOZZLES AND LINES

Condition: The fuel injector nozzles remained secured to their respective cylinders and the fuel injection lines remained intact. The nozzles were removed and there were no obstructions or blockages noted in any of the nozzles.

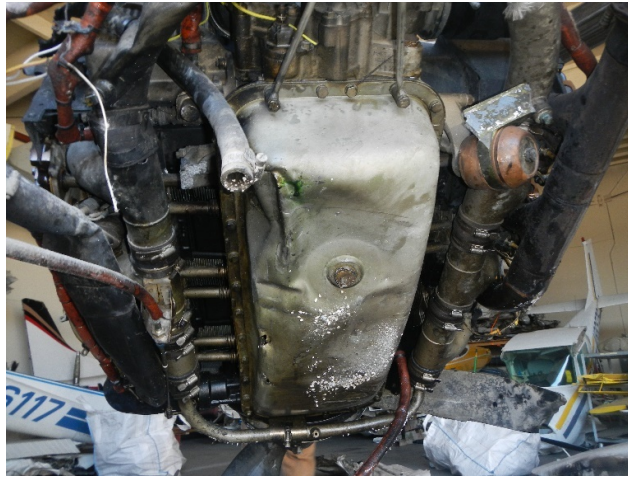
#### OIL SUMP

Condition: The oil sump remained secured to the bottom side of the engine and sustained deformation damage and punctures. The oil drain plug remained in place with no pre-accident anomalies noted.

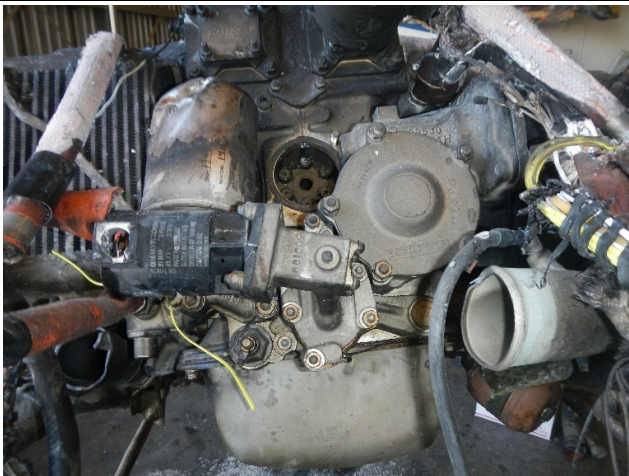
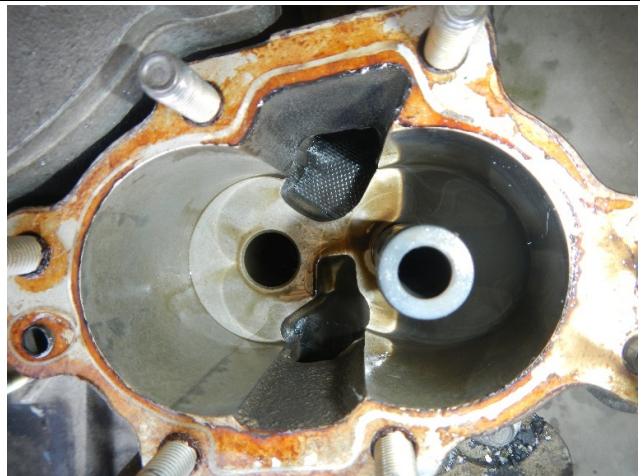
#### OIL PUMP

Condition: The oil pump remained attached to the backside of the engine with no evidence of oil leaks or pre-accident anomalies noted. Disassembly of the oil pump revealed residual oil in the housing. The gears were intact with light surface corrosion and wear noted in areas. The oil pressure relief valve and valve seat did not display and sign of abnormal seating.

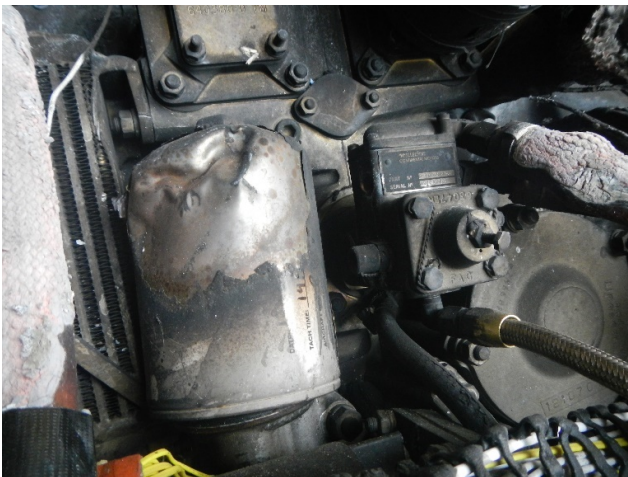
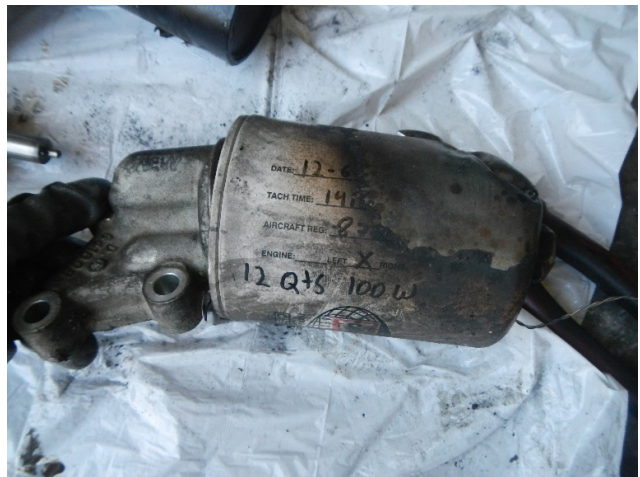
## OIL FILTER

The oil filter remained attached to the oil filter adapter, but it sustained deformation damage and was offset from the mount slightly. The safety-wire was intact. Hand-written information on the side of the filter was partially burned away. No pre-accident anomalies were noted with the filter.

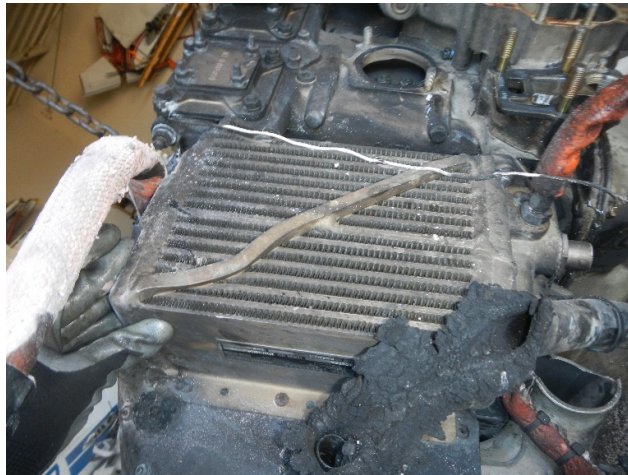
### OIL COOLER

**Condition:** The oil cooler remained attached to the back left side of the engine. It sustained slight deformation damage, but did not show any signs of leaking or pre-accident anomalies.

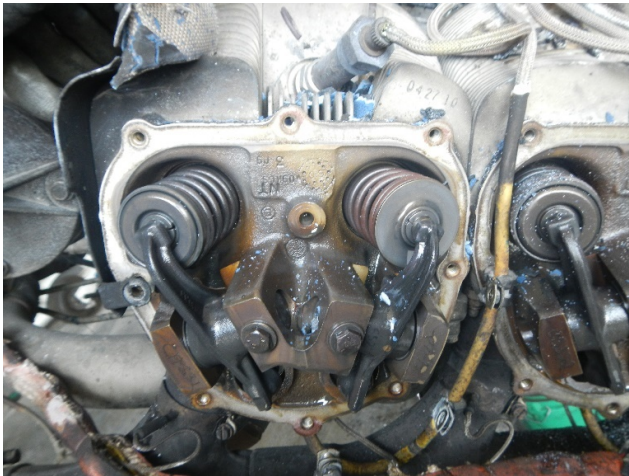
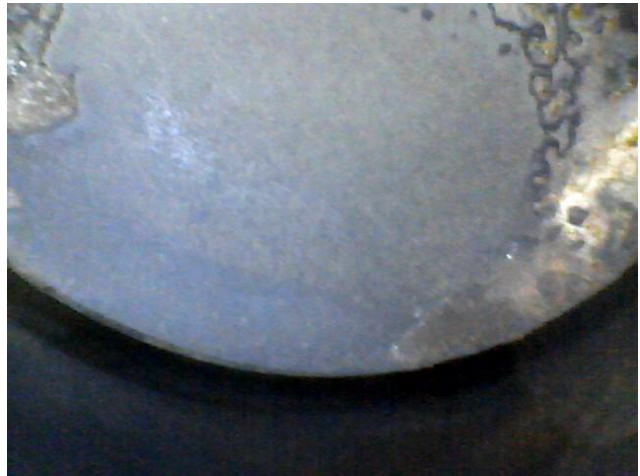
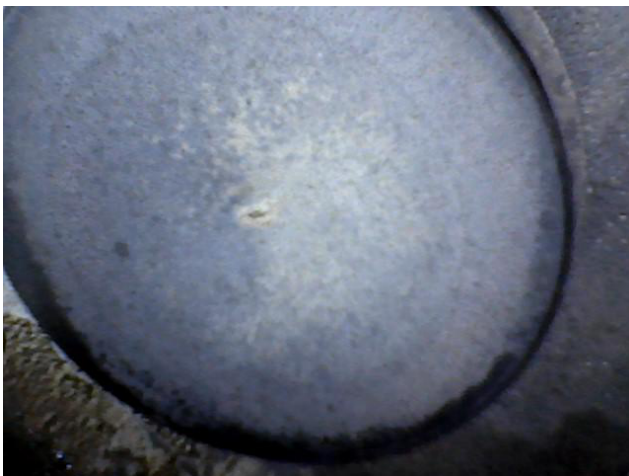
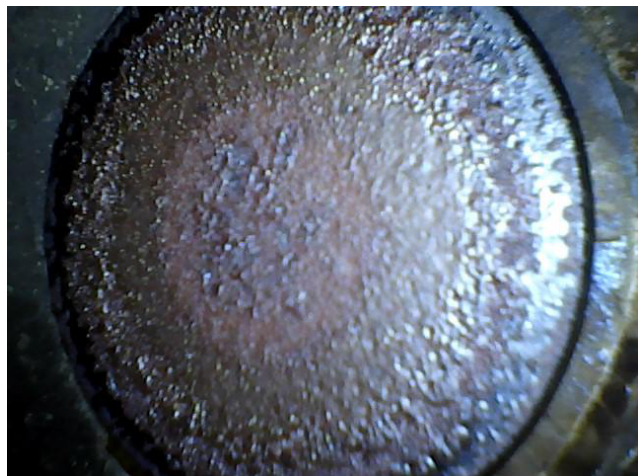
#### CYLINDER #1

**Condition:** The cylinder remained attached to the engine and the original torque putty appeared to be intact on the attaching hardware (the serial number matched that on the build record). The rocker cover was removed and no pre-accident anomalies were observed with the rockers or valve springs. A borescope inspection of the cylinder's internal components did not reveal any pre-accident anomalies with the barrel, piston, valves or valve seats. A thumb compression test resulted in compression and confirmed connecting rod, piston, and rocker arm movement.

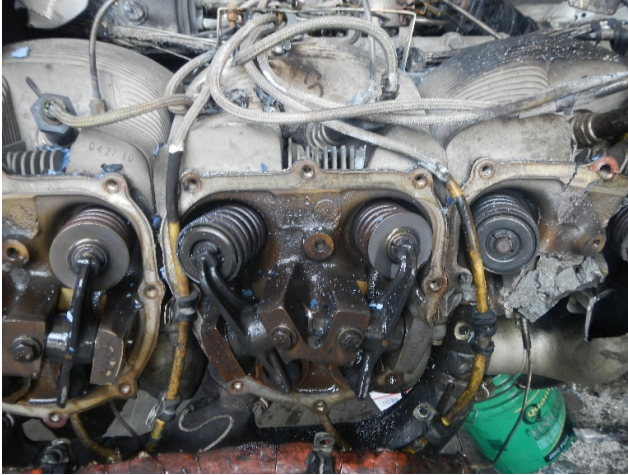
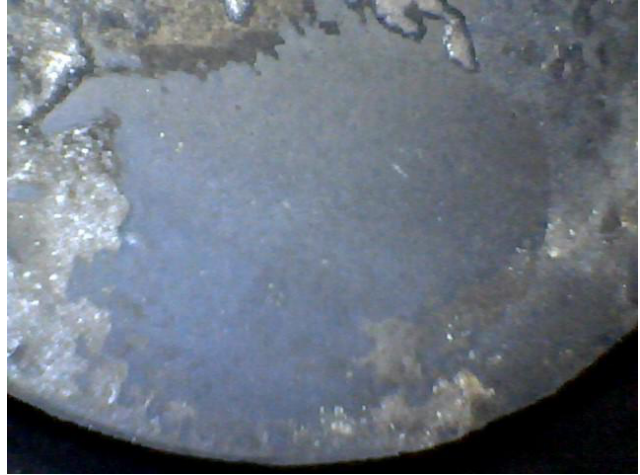
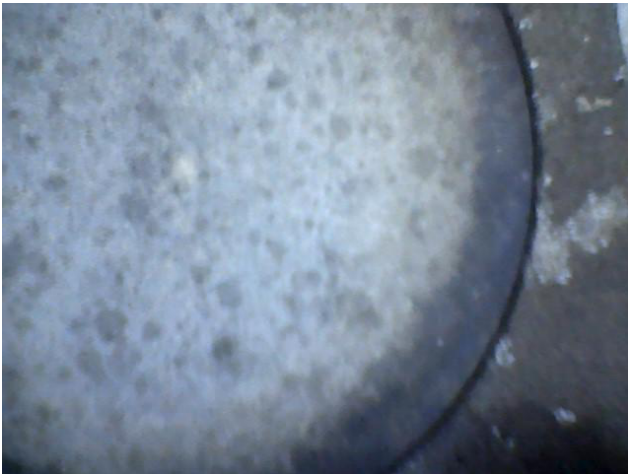
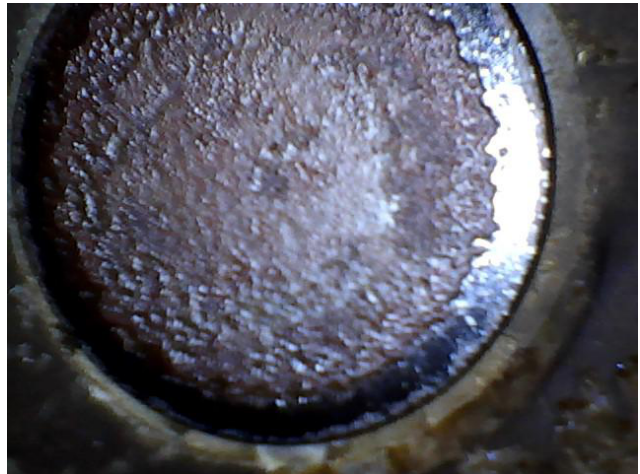
### CYLINDER #3

Condition: The cylinder remained attached to the engine and the original torque putty appeared to be intact on the attaching hardware (the serial number matched that on the build record). The rocker cover was removed and no pre-accident anomalies were observed with the rockers or valve springs. A borescope inspection of the cylinder's internal components did not reveal any pre-accident anomalies with the barrel, piston, valves or valve seats. A thumb compression test resulted in compression and confirmed connecting rod, piston, and rocker arm movement.

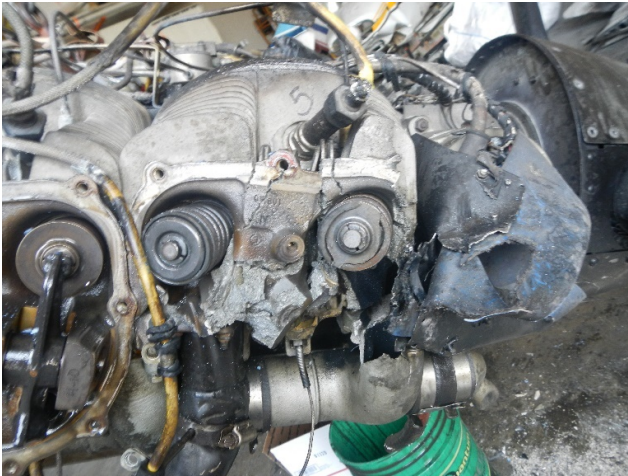
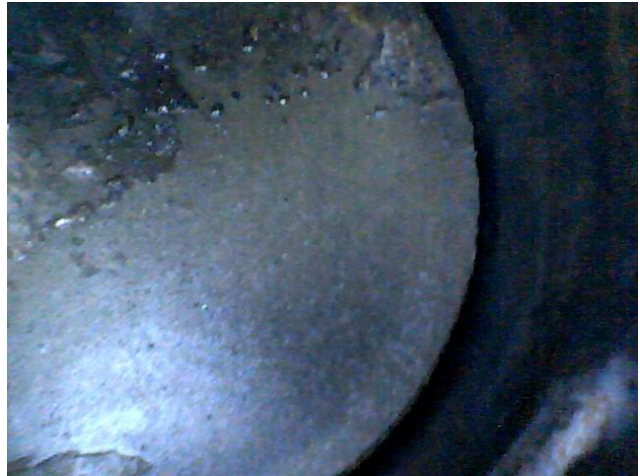
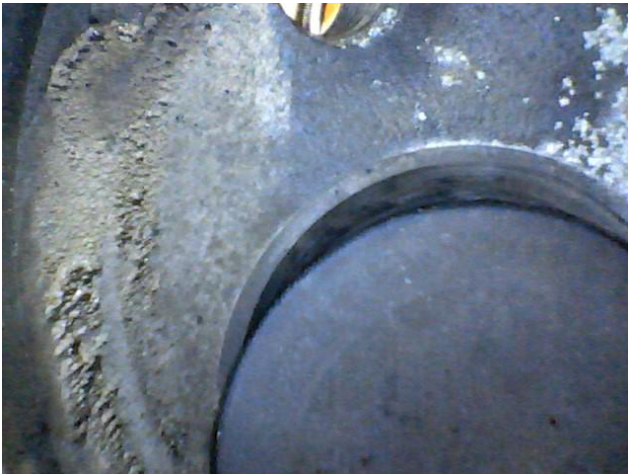
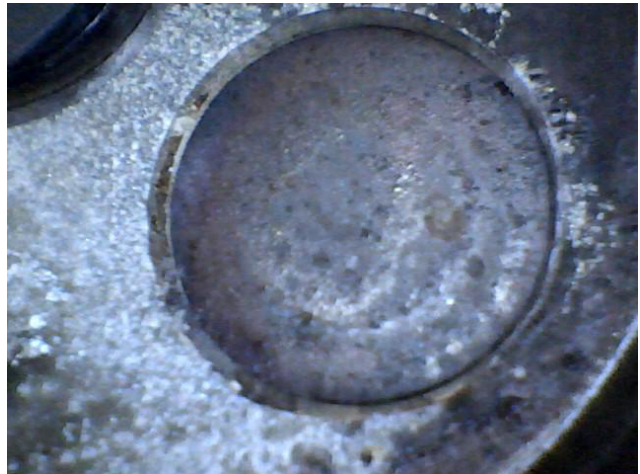
### CYLINDER #5

Condition: The cylinder sustained impact damage that fractured the cylinder head and separated the rocker cover, rockers, and rocker shafts along with the pushrods and pushrod housings. The cylinder was displaced aft toward the #3 cylinder and the intake valve and valve spring sustained deformation damage. A borescope inspection of the cylinder's internal components did not reveal any pre-accident anomalies with the barrel, piston, valves or valve seats. A thumb compression test did not result in compression, which was attributed to the offset intake valve; however, piston movement during crankshaft rotation was confirmed.

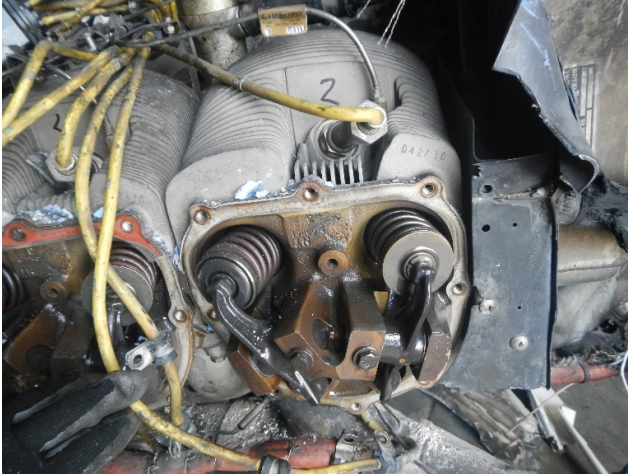
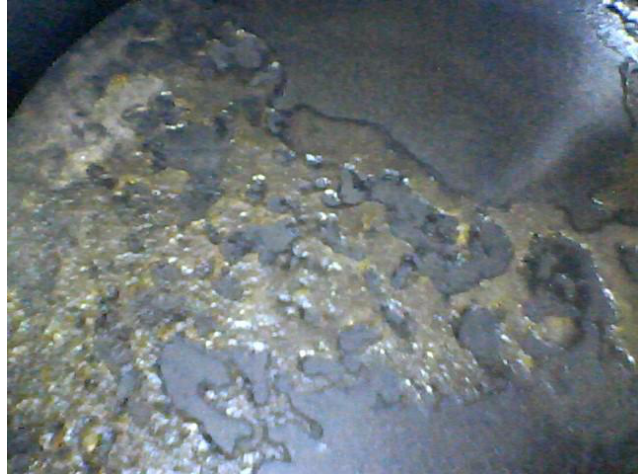
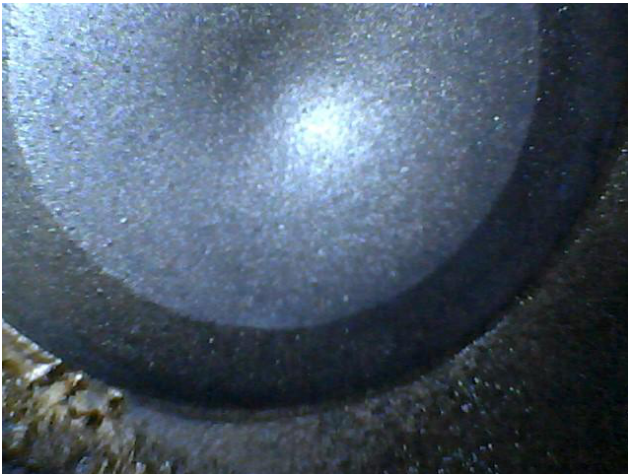
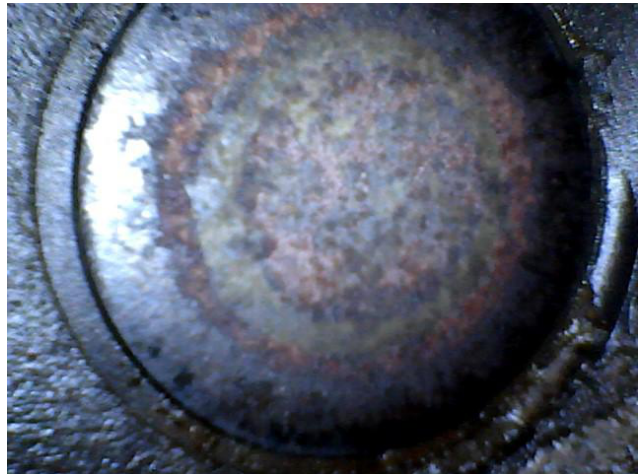
### CYLINDER #2

Condition: The cylinder remained attached to the engine and the original torque putty appeared to be intact on the attaching hardware (the serial number matched that on the build record). The rocker cover was removed and no pre-accident anomalies were observed with the rockers or valve springs. A borescope inspection of the cylinder's internal components did not reveal any pre-accident anomalies with the barrel, piston, valves or valve seats. A thumb compression test resulted in compression and confirmed connecting rod, piston, and rocker arm movement.

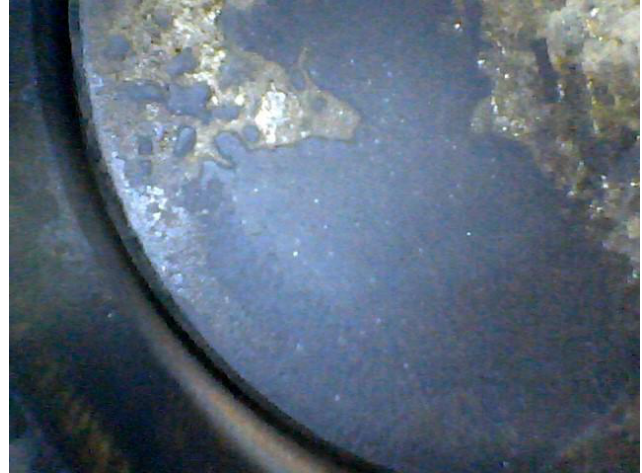
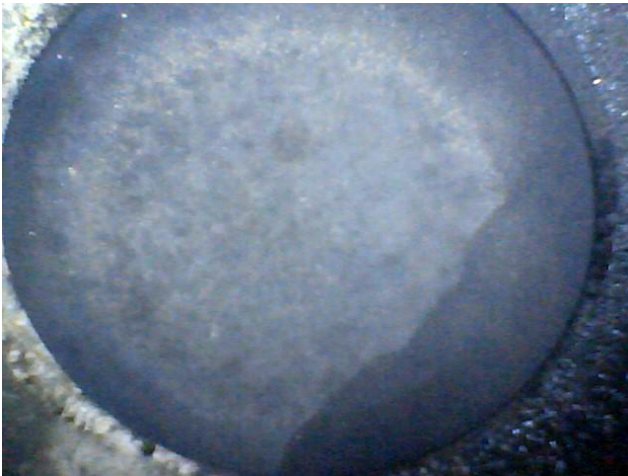
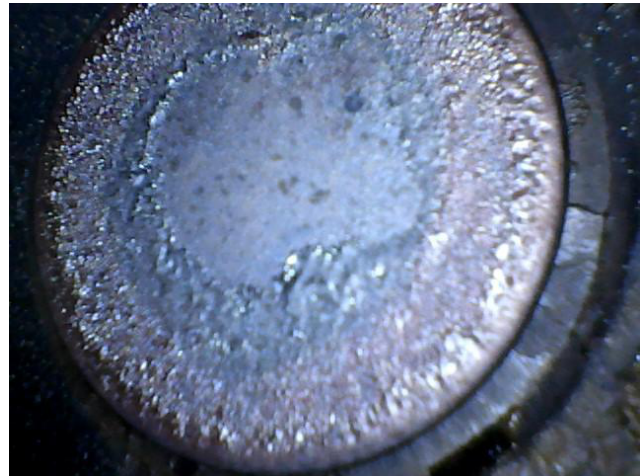
### CYLINDER #4

Condition: The cylinder remained attached to the engine and the original torque putty appeared to be intact on the attaching hardware (the serial number matched that on the build record). The rocker cover was removed and no pre-accident anomalies were observed with the rockers or valve springs. A borescope inspection of the cylinder's internal components did not reveal any pre-accident anomalies with the barrel, piston, valves or valve seats. A thumb compression test resulted in compression and confirmed connecting rod, piston, and rocker arm movement.

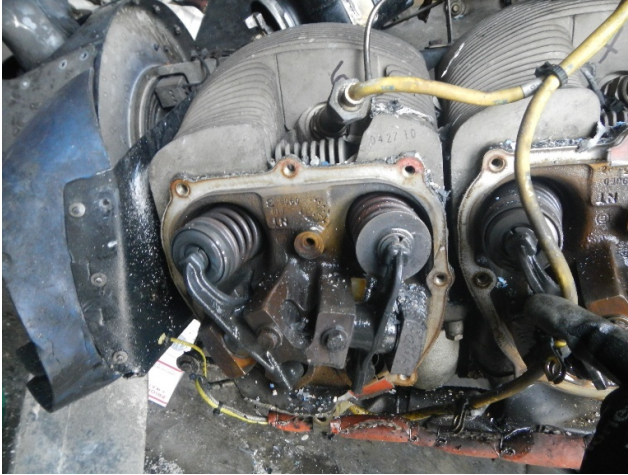
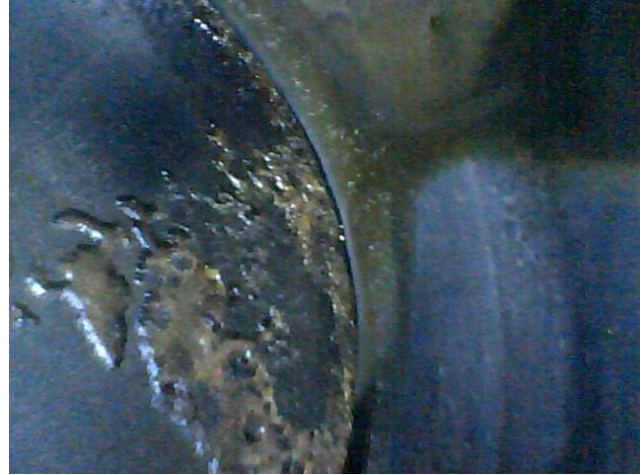
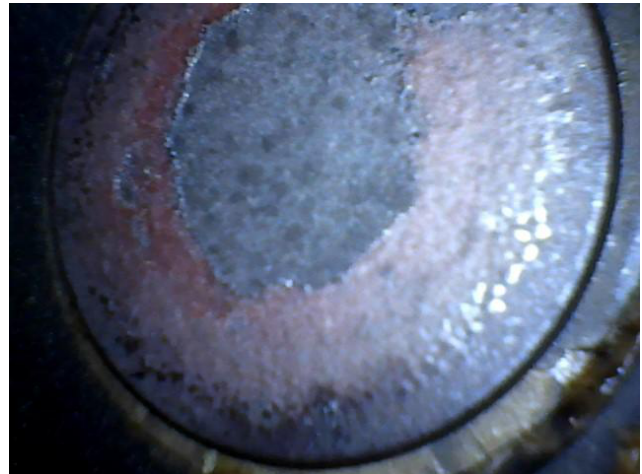
### CYLINDER #6

Condition: The cylinder remained attached to the engine and the original torque putty appeared to be intact on the attaching hardware (the serial number matched that on the build record). The rocker cover was removed and no pre-accident anomalies were observed with the rockers or valve springs. A borescope inspection of the cylinder's internal components did not reveal any pre-accident anomalies with the barrel, piston, valves or valve seats. A thumb compression test resulted in compression and confirmed connecting rod, piston, and rocker arm movement.

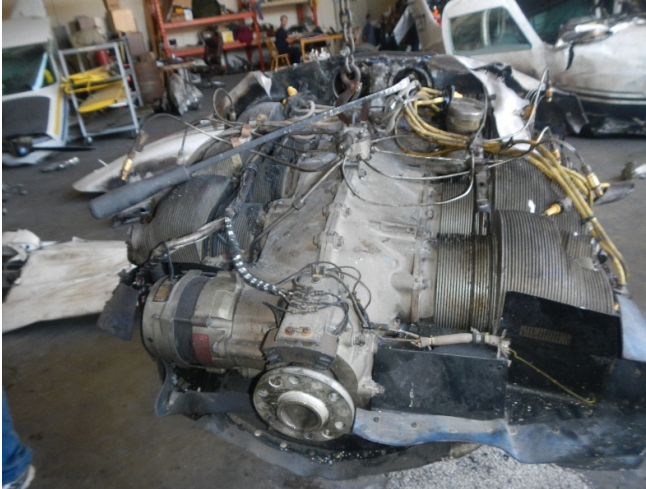
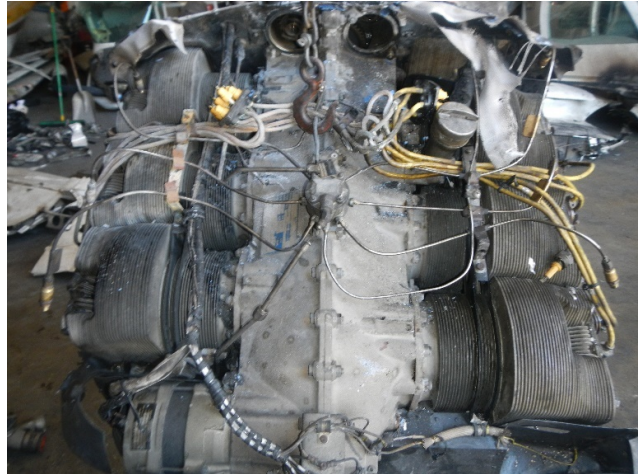
#### CRANKCASE

The crankcase remained intact with no pre-accident anomalies noted.

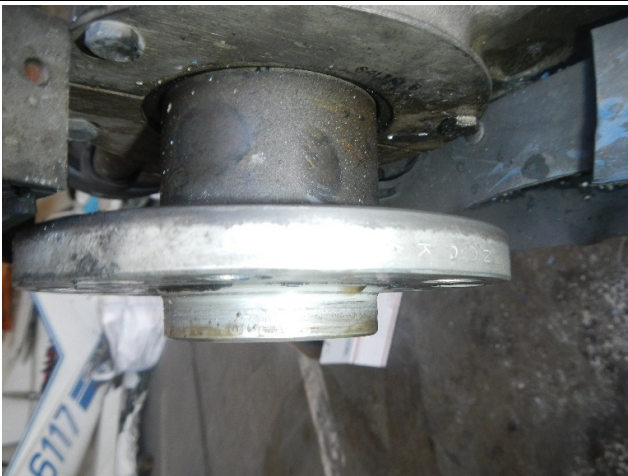
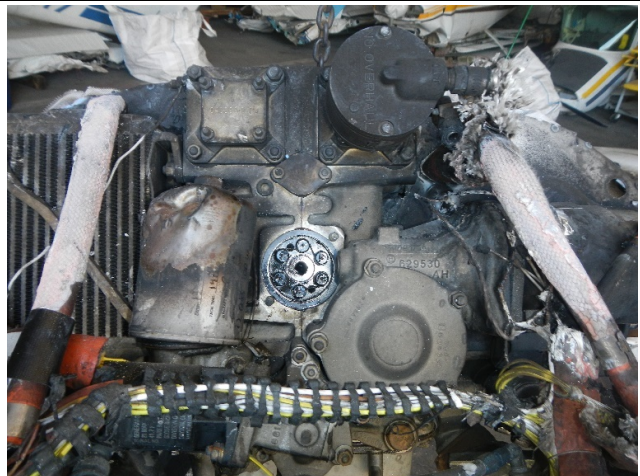
#### CRANKSHAFT

Though the crankshaft was not viewed in its entirety, crankshaft continuity was confirmed from the propeller flange aft to the crankshaft gear and out to each connecting rod/piston during a thumb compression test. The crankshaft gear bolts were safety-wired and in place. There was no binding noted during crankshaft rotation.

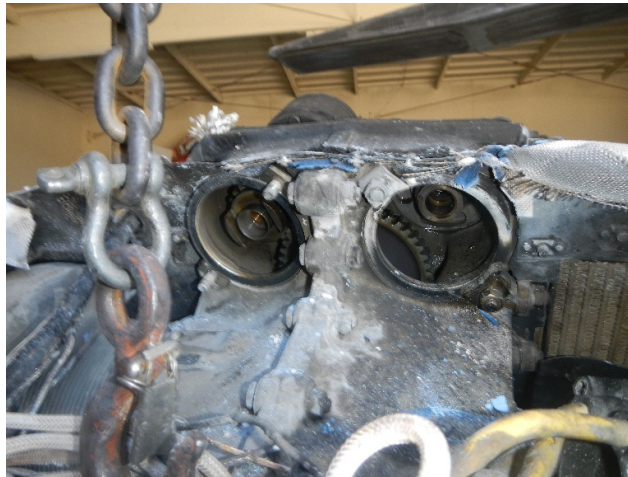
#### ACCESSORY GEARS

Condition: The accessory gears rotated during crankshaft rotation, with no pre-accident anomalies noted.

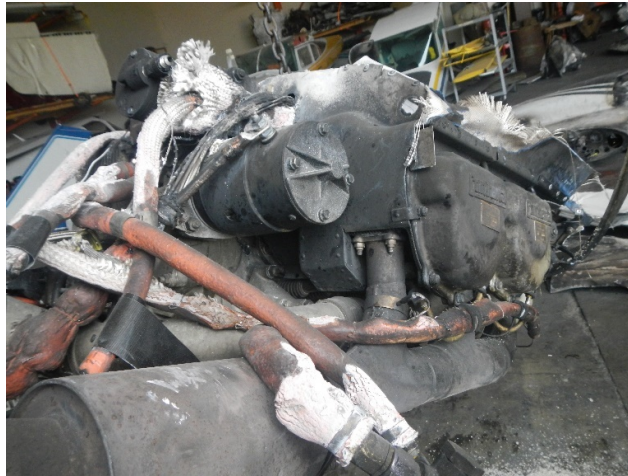
#### STARTER

The starter motor remained attached to the adapter with no pre-accident anomalies noted.

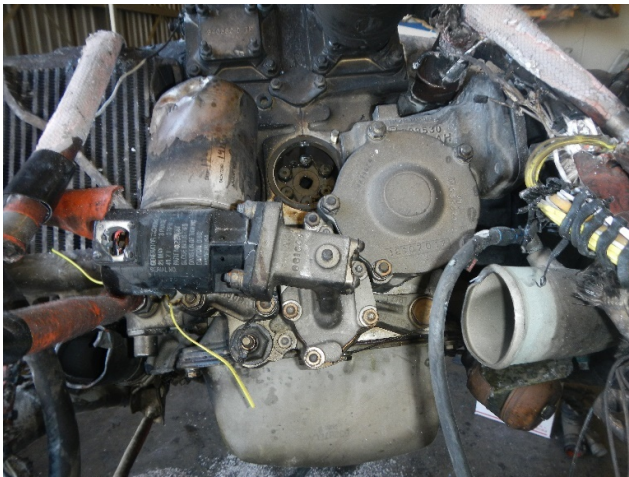
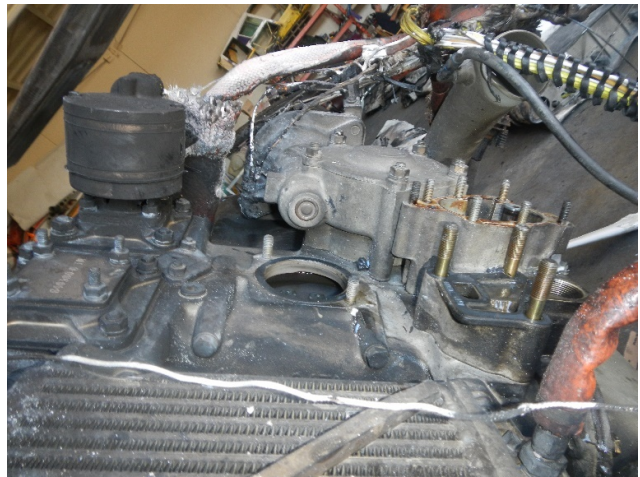
#### STARTER ADAPTER

The starter adapter remained intact and in place. No anomalies were noted during crankshaft rotation.

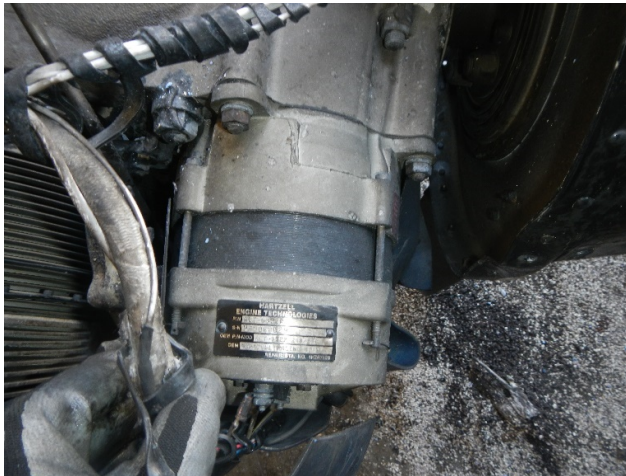
**ALT/GEN #1**

The engine-driven alternator remained attached to the front right side of the engine with no pre-accident anomalies noted with the unit.

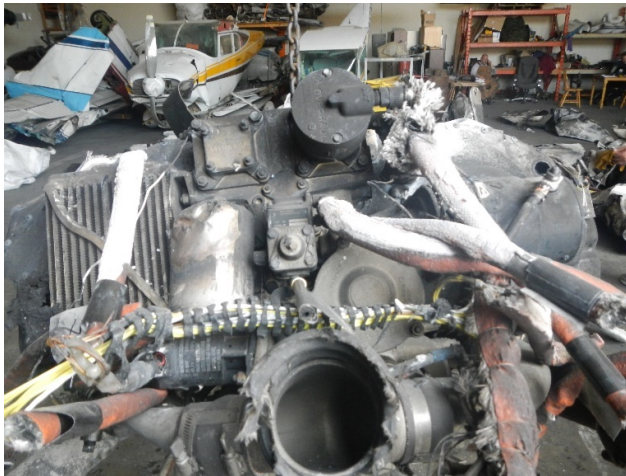
**VACUUM PUMP**

The vacuum pump remained attached to the accessory pad on the backside of the engine and was not examined as part of the investigation.

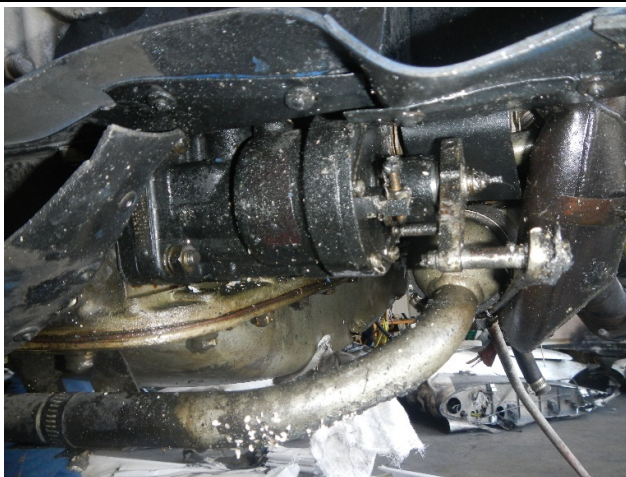
The propeller governor remained secured to the front left side of the engine and the control cable remained attached to the control lever.

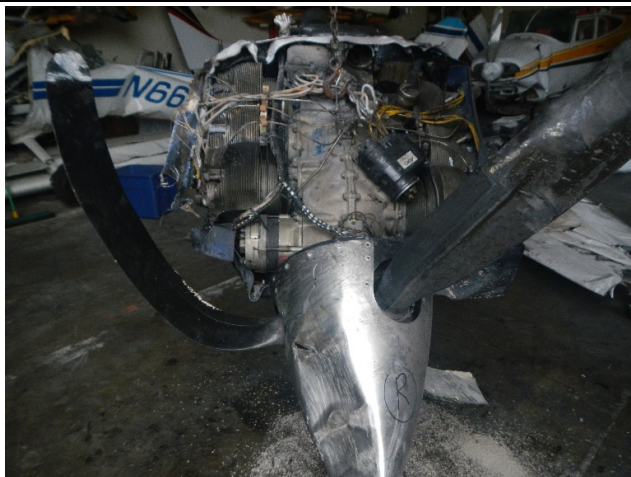
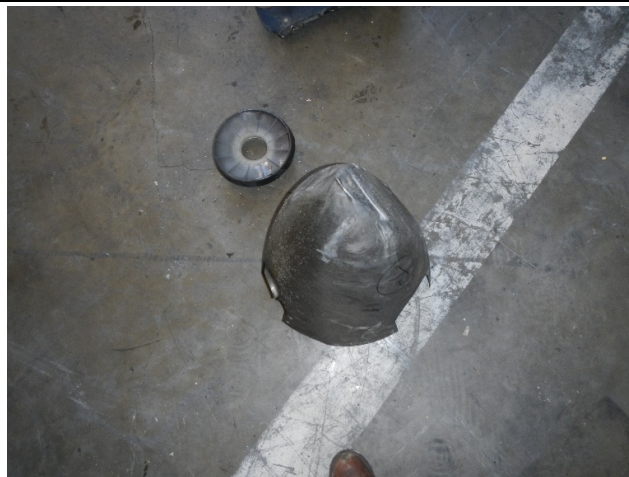
**PROPELLER**

The propeller remained attached to the engine crankshaft and all three propeller blades remained attached to the hub, though one was loose in the hub. The loose blade was bent aft and displayed chord-wise scrapes inboard of the tip that were overlaid by diagonal scrapes. Another blade tip was torn away from the blade about eight inches outboard of the deicing boot. That blade displayed gouges consistent in spacing as the grooves observed on the concrete road surface at the accident site. The separated blade tip displayed an s-bend and curled tip. The third blade displayed s-bending at the tip and as curled toward low pitch. The propeller will be sent to the manufacturer for a more detailed examination under NTSB or FAA supervision.
